To:	Amy Driessen Alberta Transportation	From:	Leslie Cho and Carrie Murray Stantec Consulting Ltd.
File:	123315222	Date:	June 12, 2022

Reference: North Central Region, Stony Plain, Site NC067 - Highway 216:06 Anthony Henday Bridge, Spring 2022 Instrumentation Monitoring Report

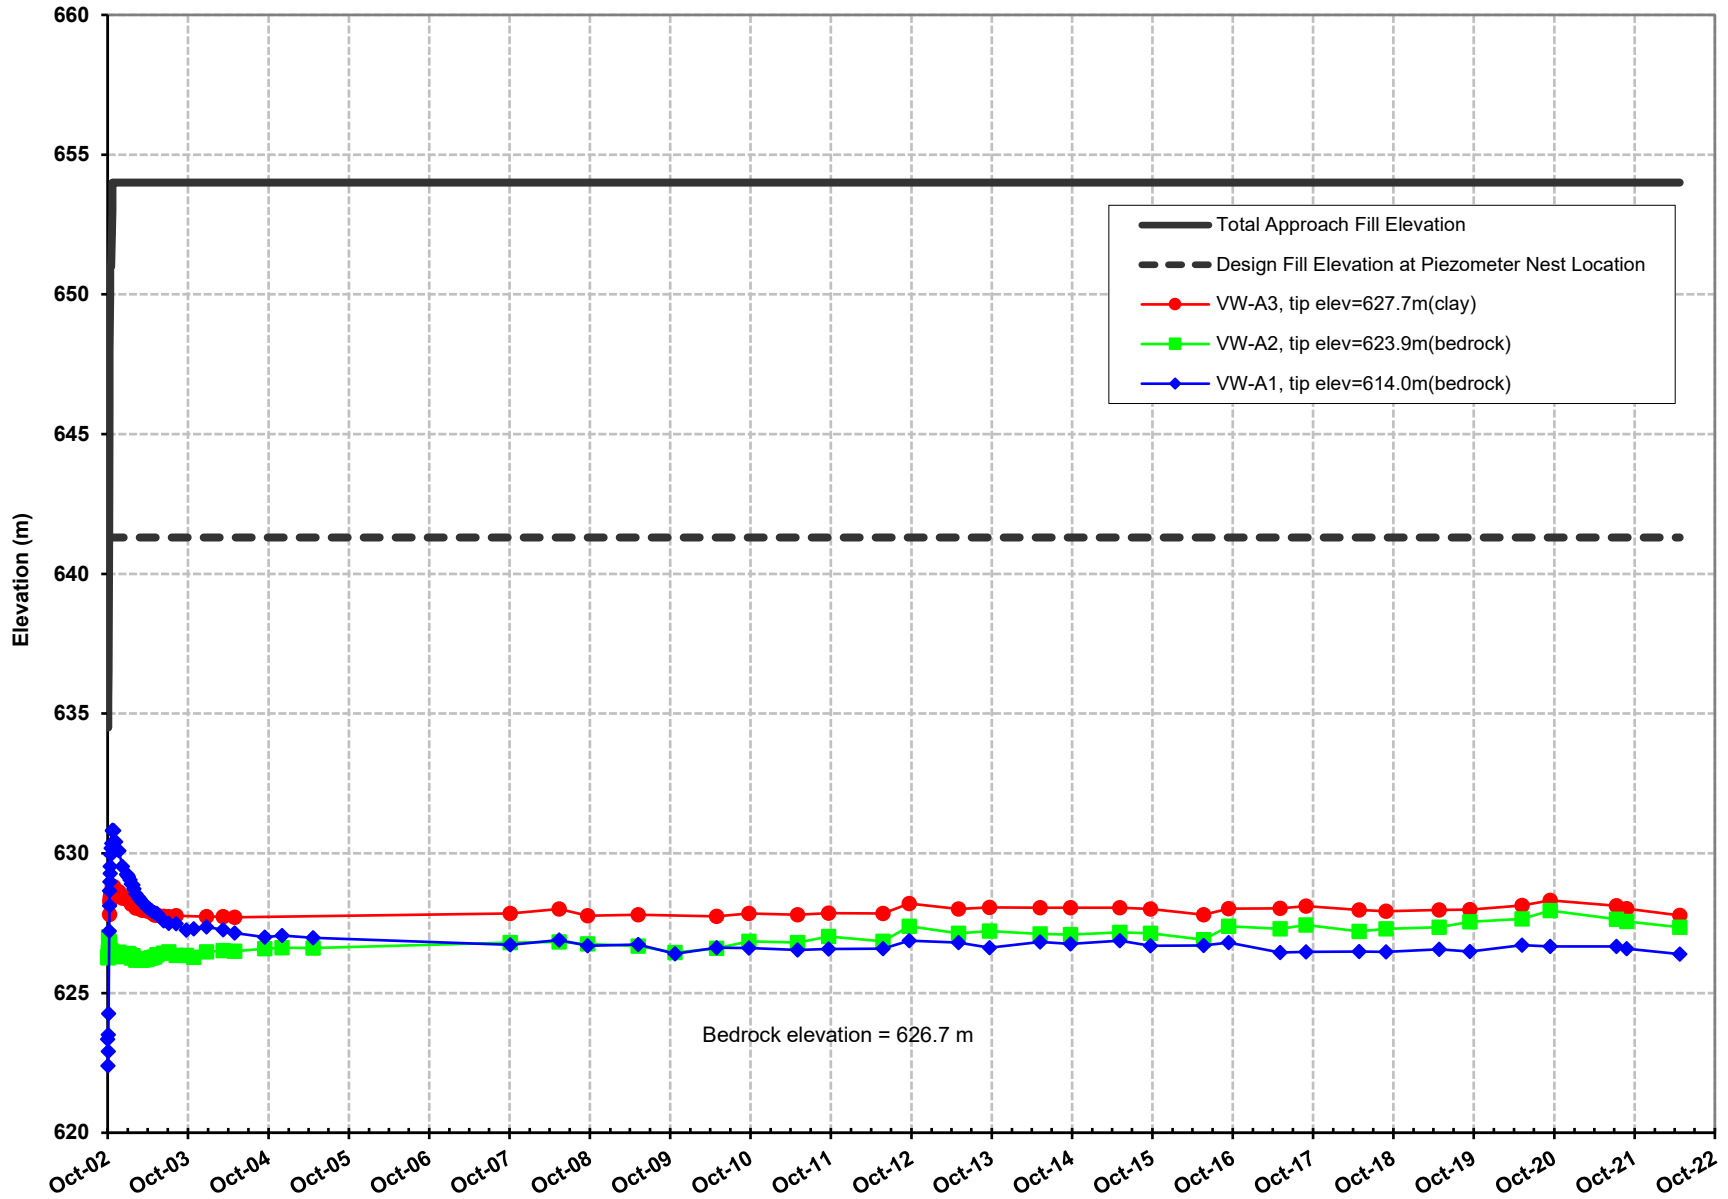
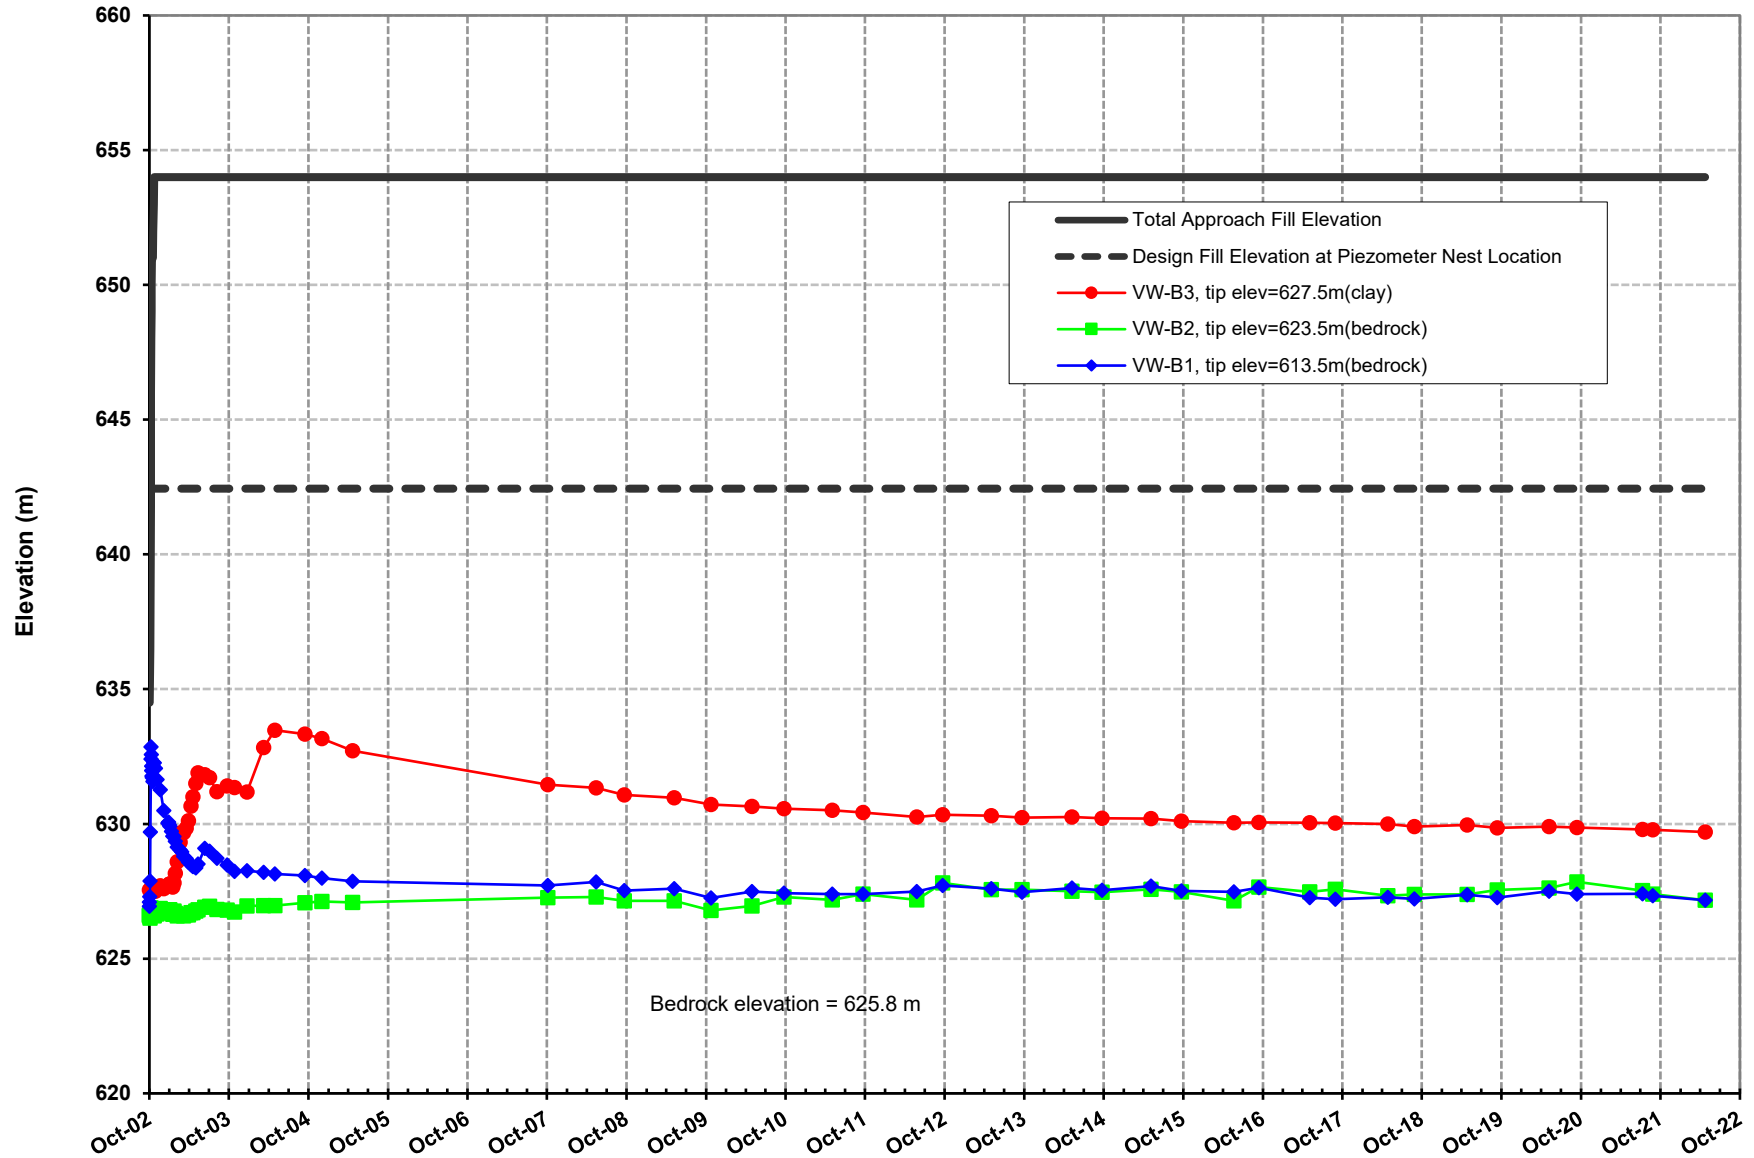
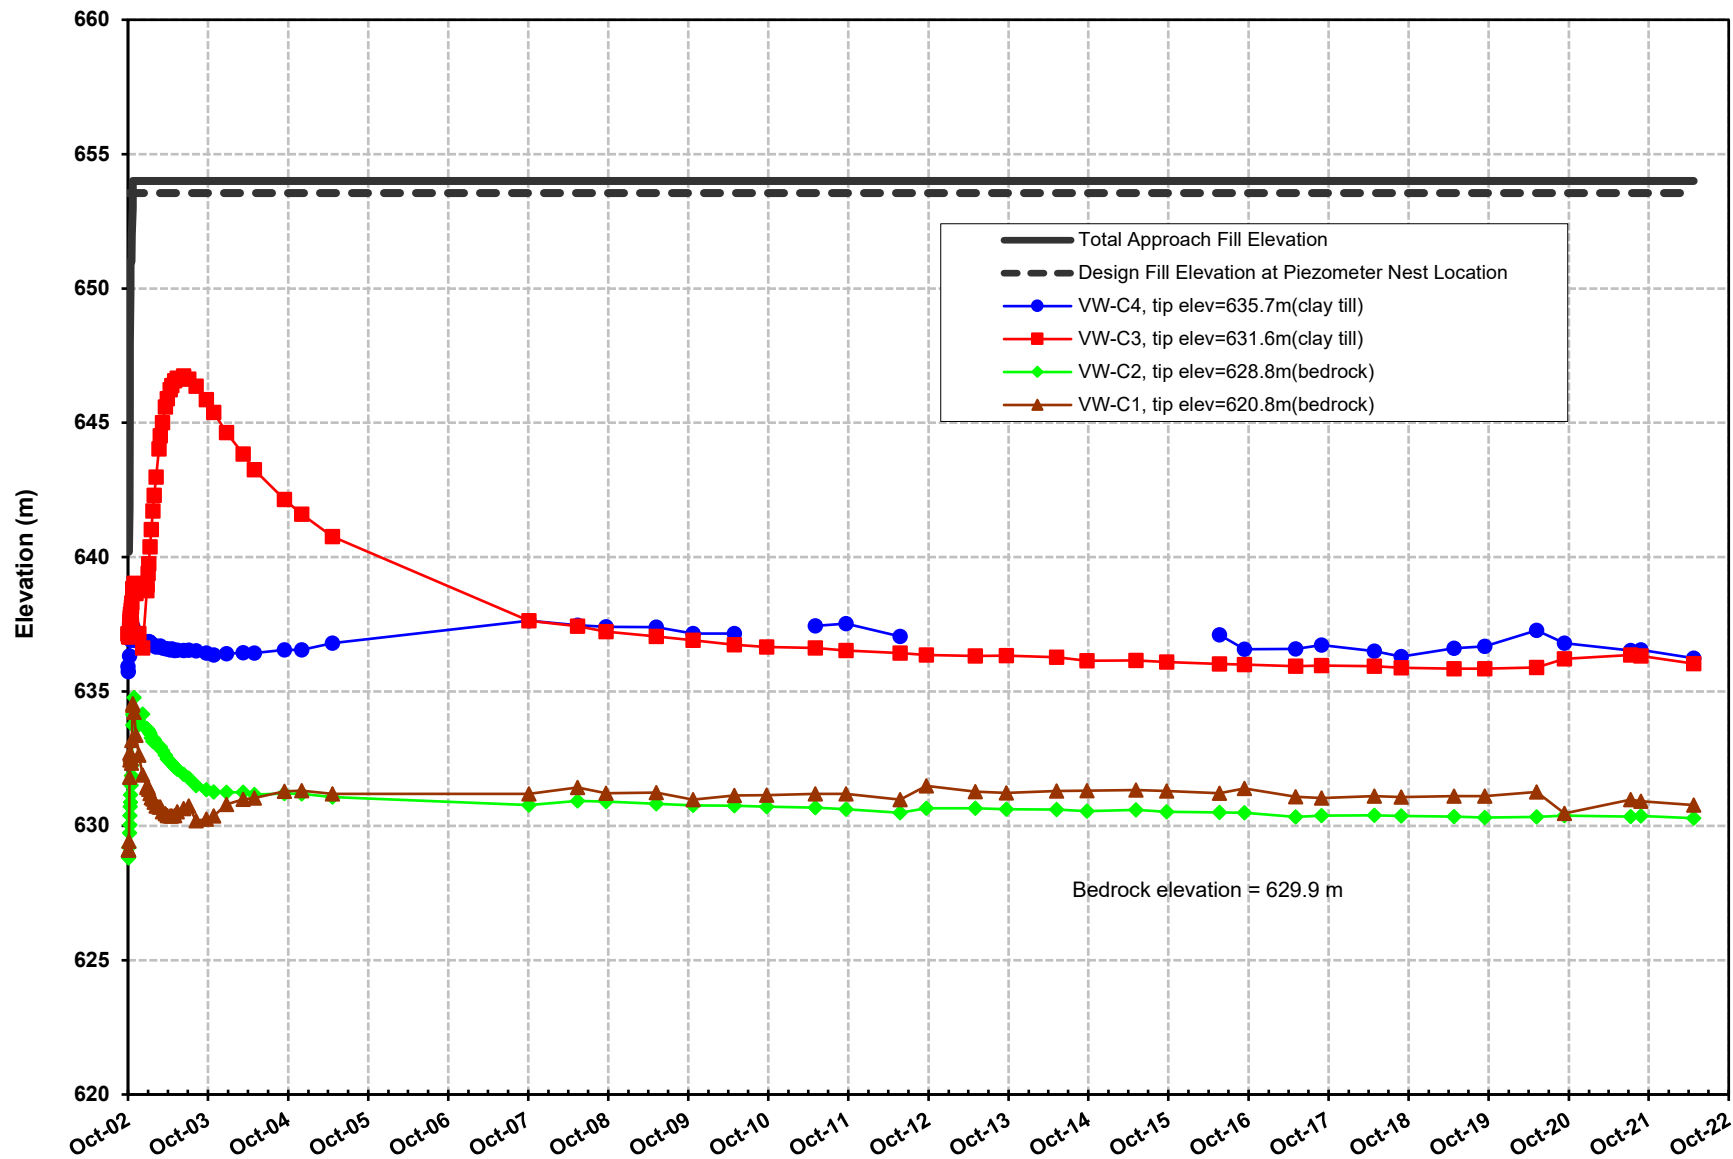
The VWs in the West abutment showed a decrease in the piezometric level up to 0.3 m.

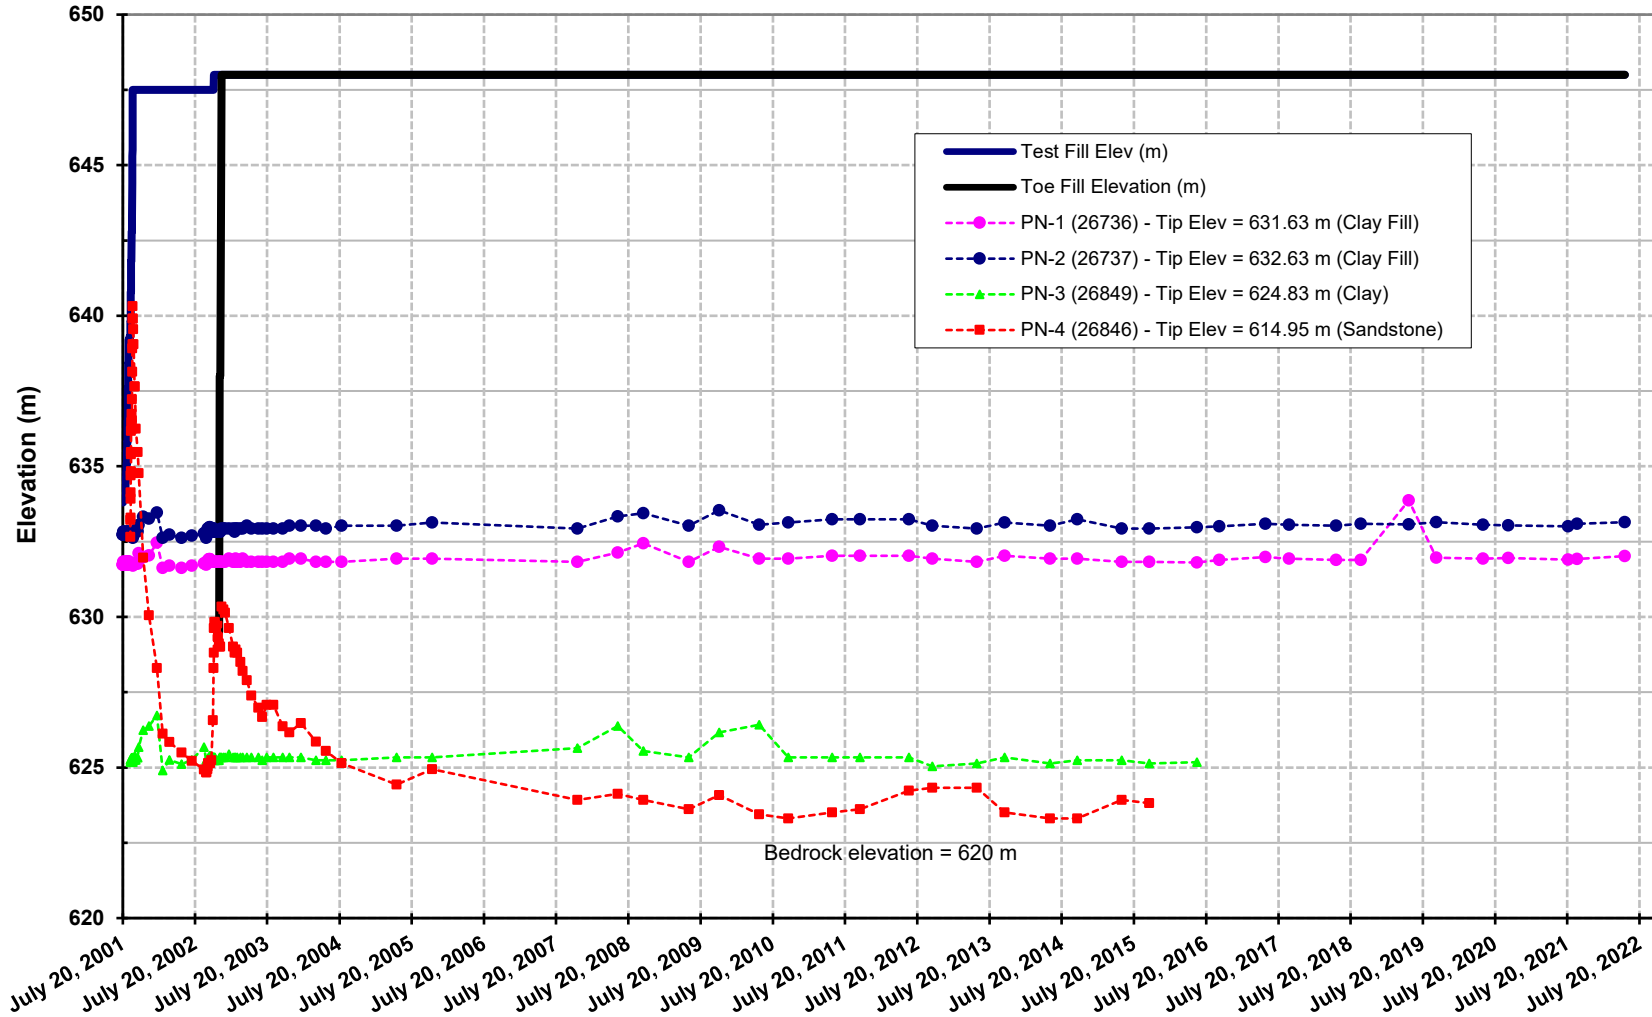
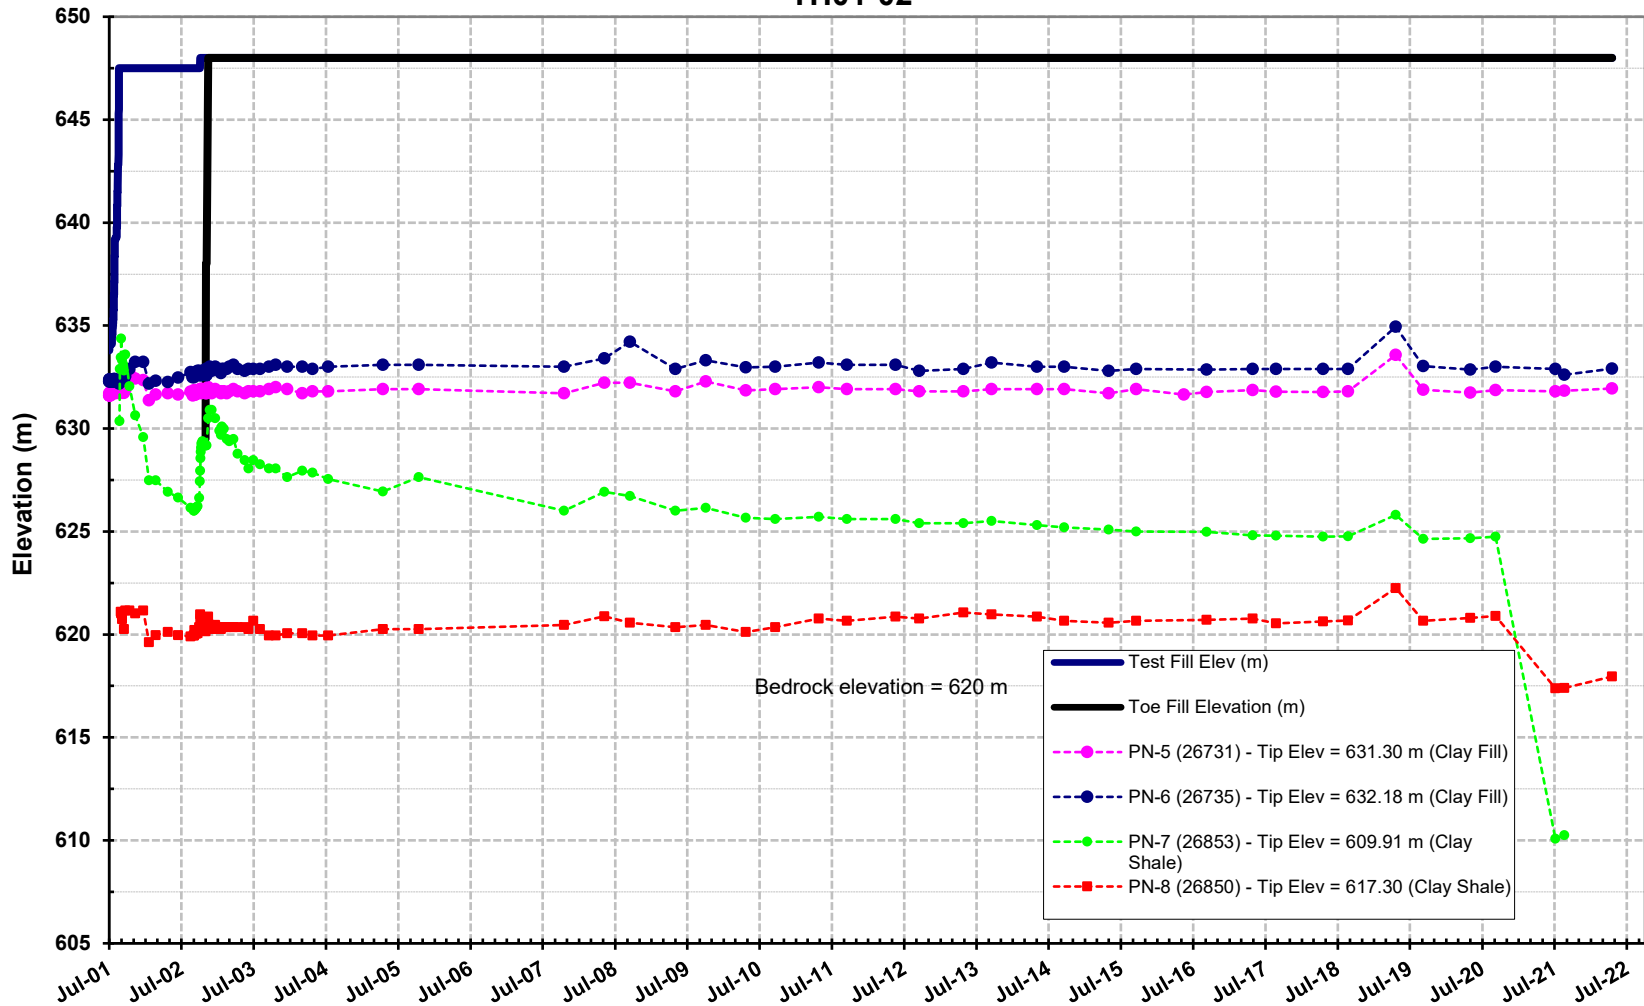
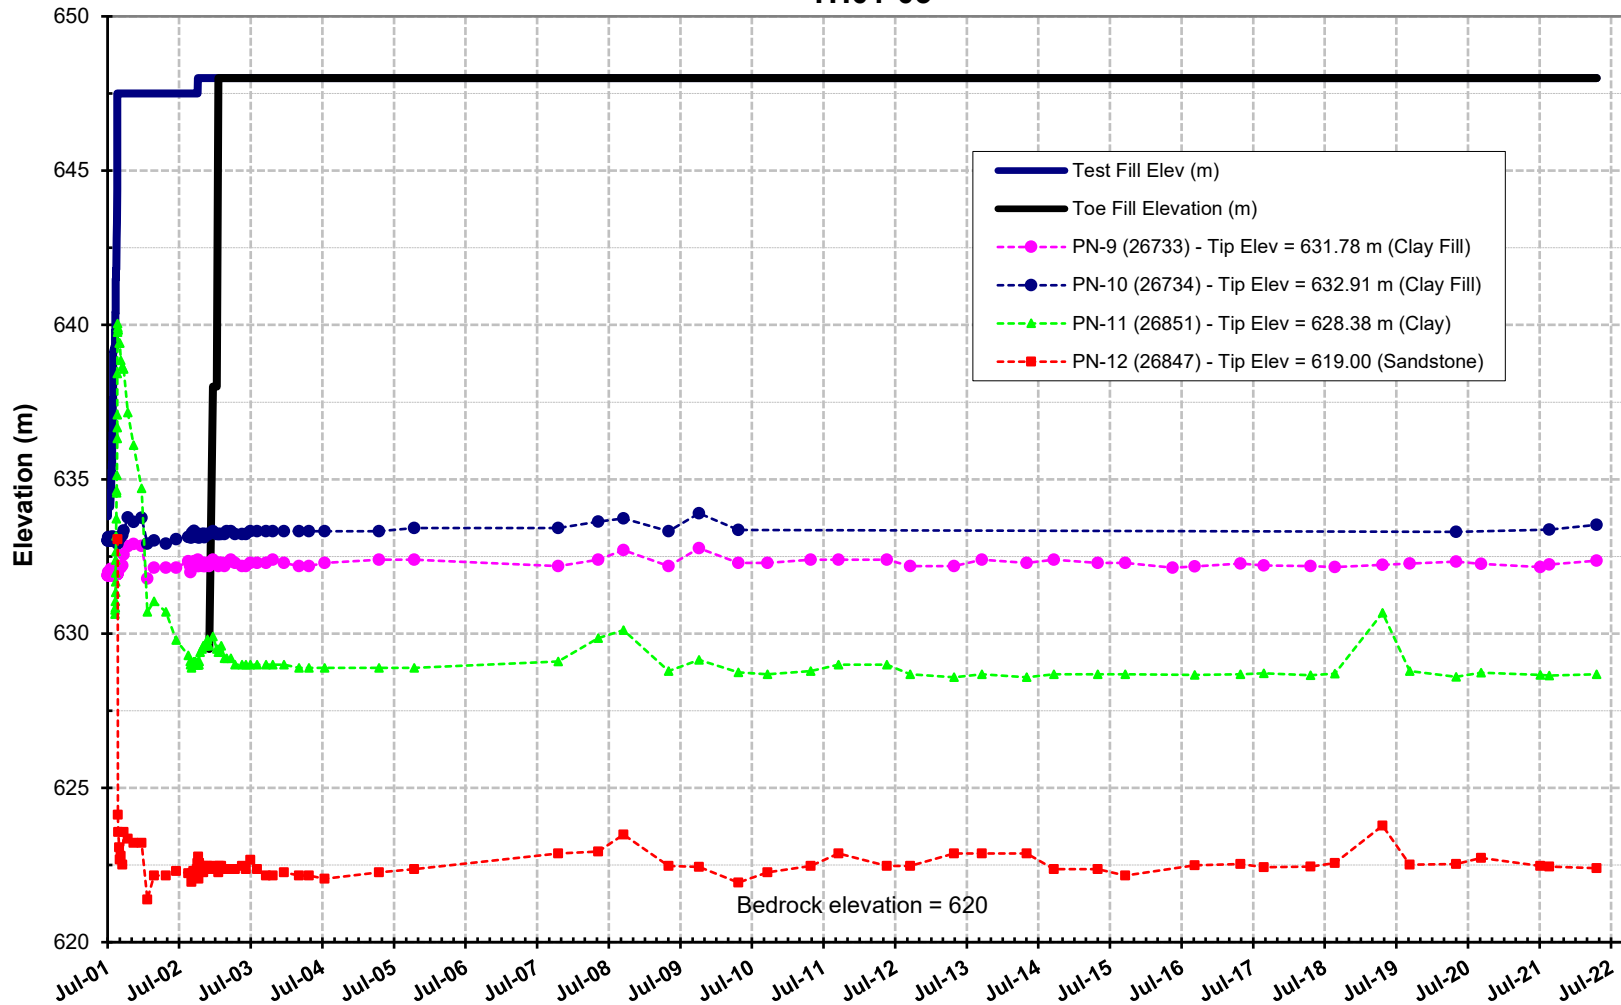
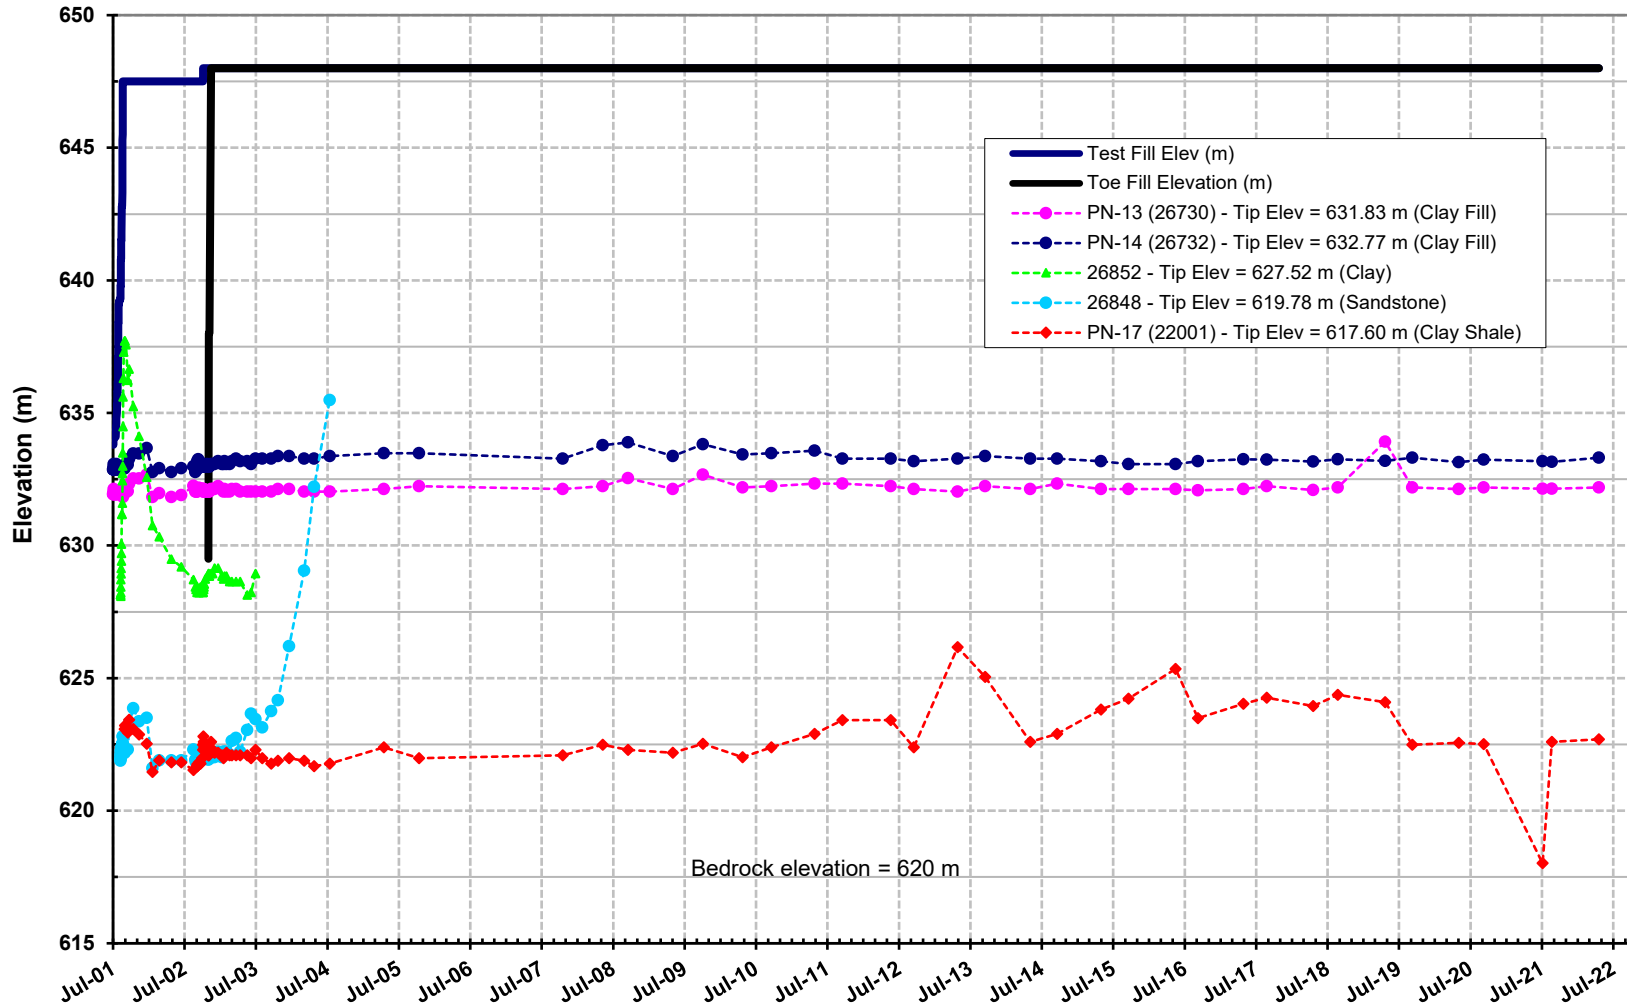
PN-7 could be potentially damaged during spring 2022 instrument readings since the readings were erratic.

In general, the PNs in the east abutment show a slight increase in the piezometric level up to 0.6 m since Fall 2021 readings.

PN-7 showed erratic readings which are an indicator of possible damage to the pneumatic tubing. However, it could also mean the tubes are dirty and need to be purged.

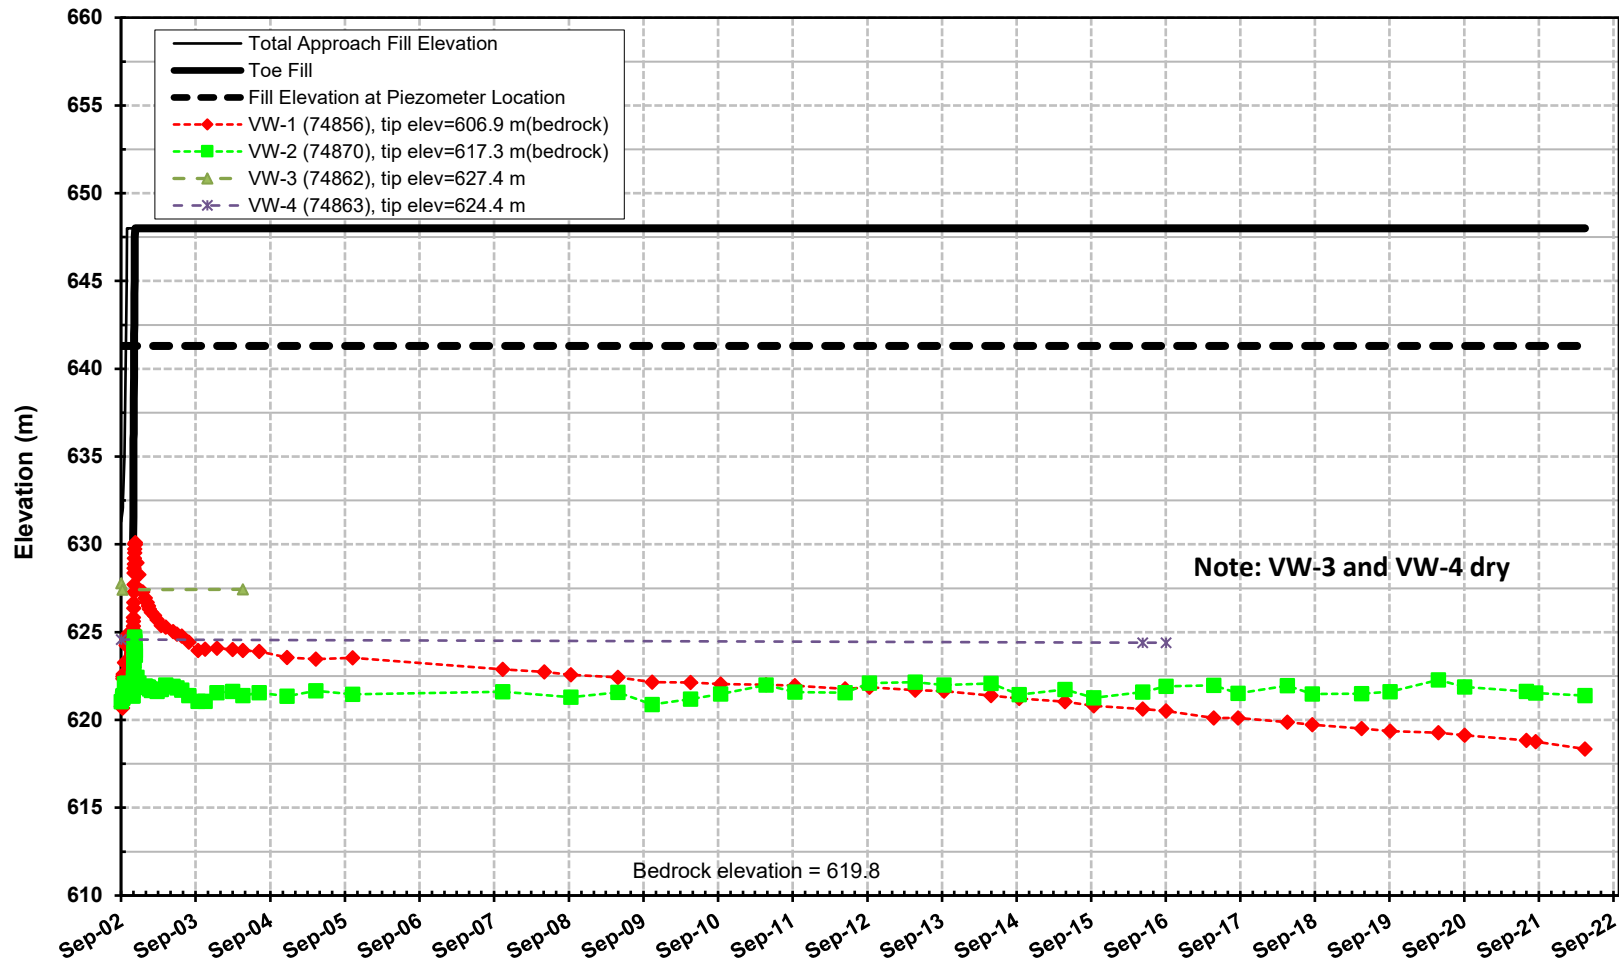
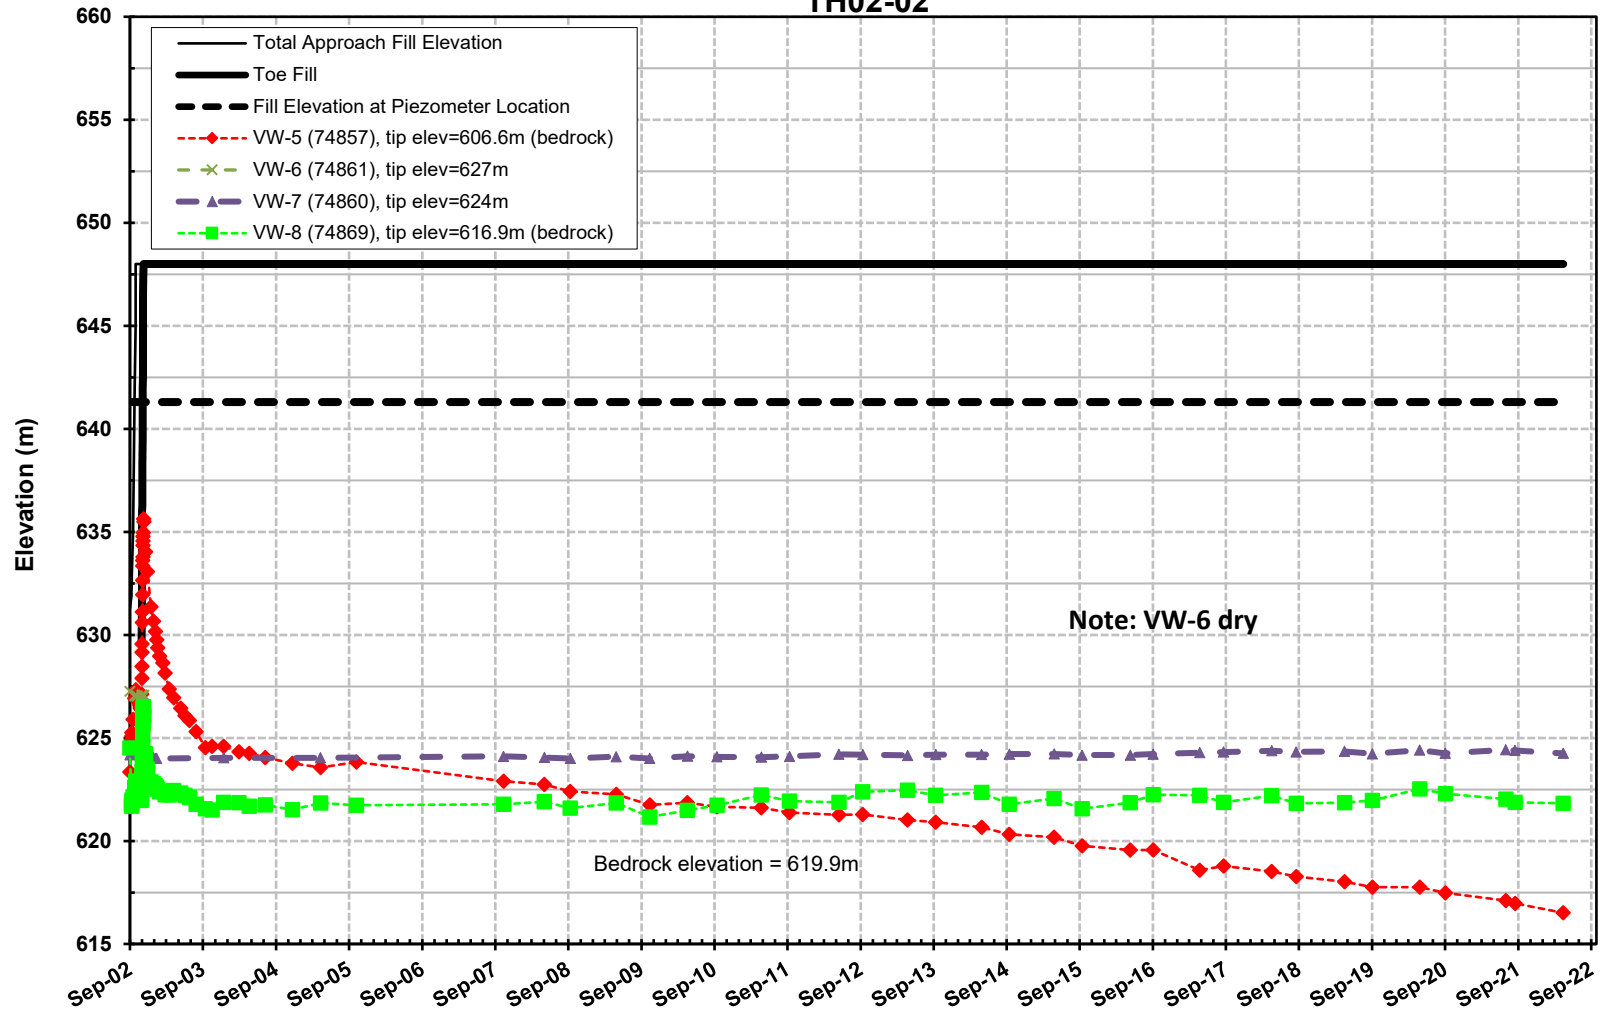
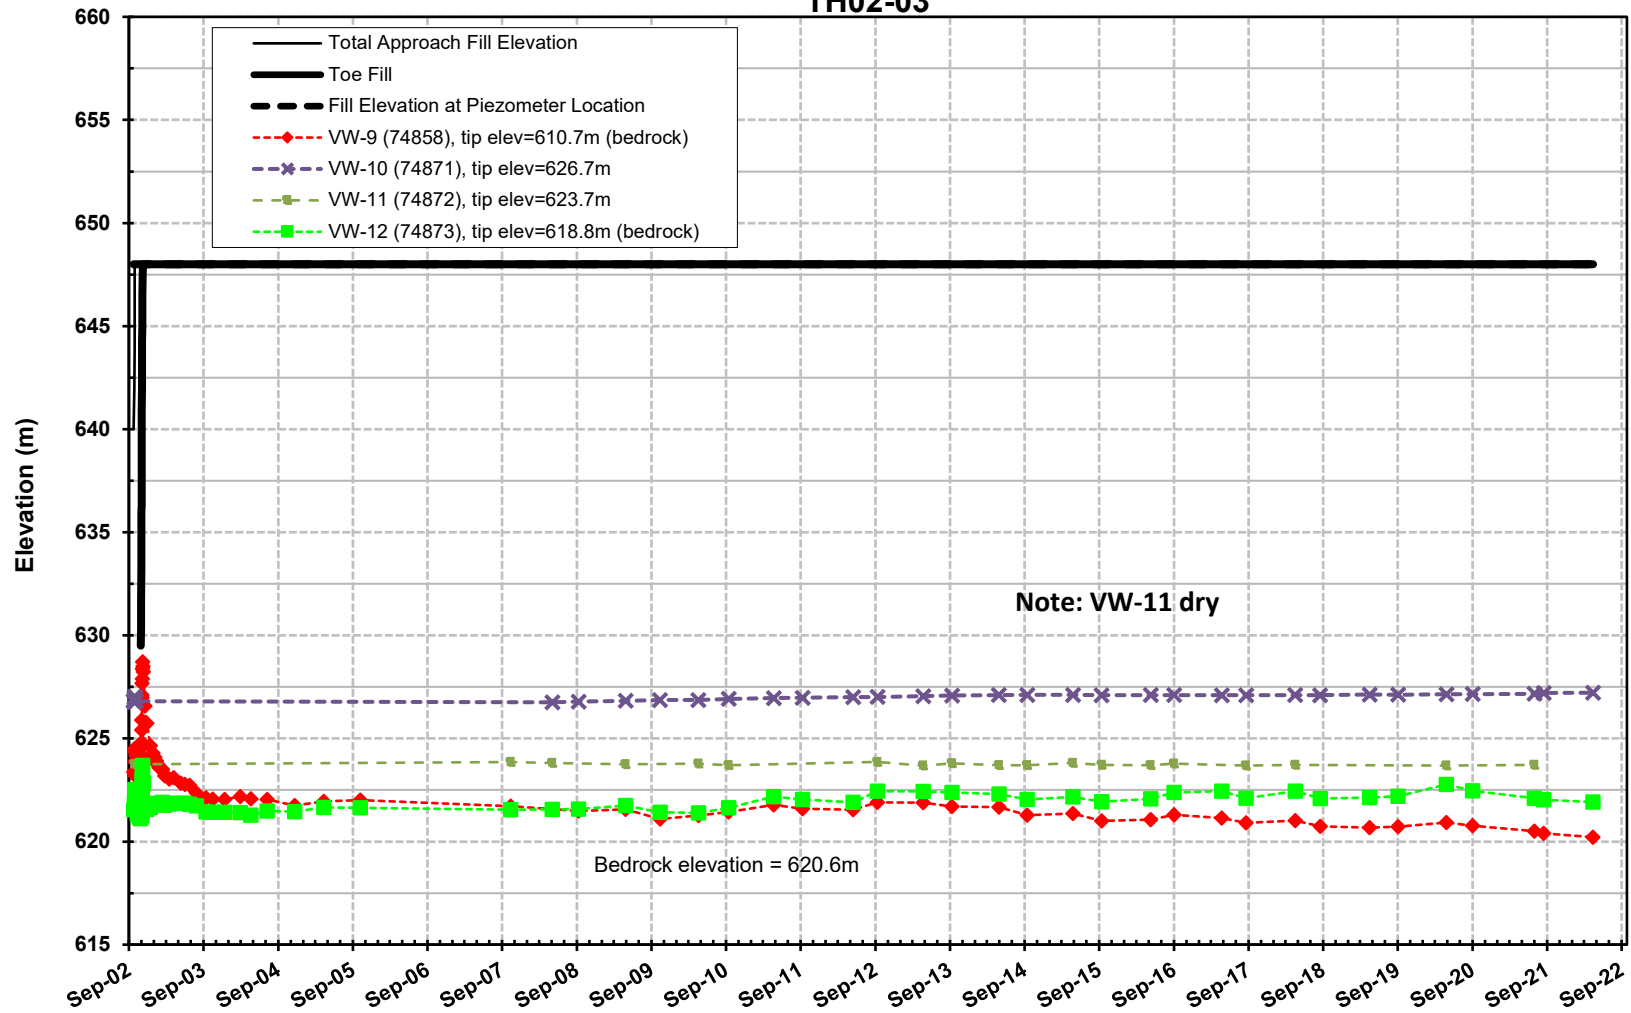
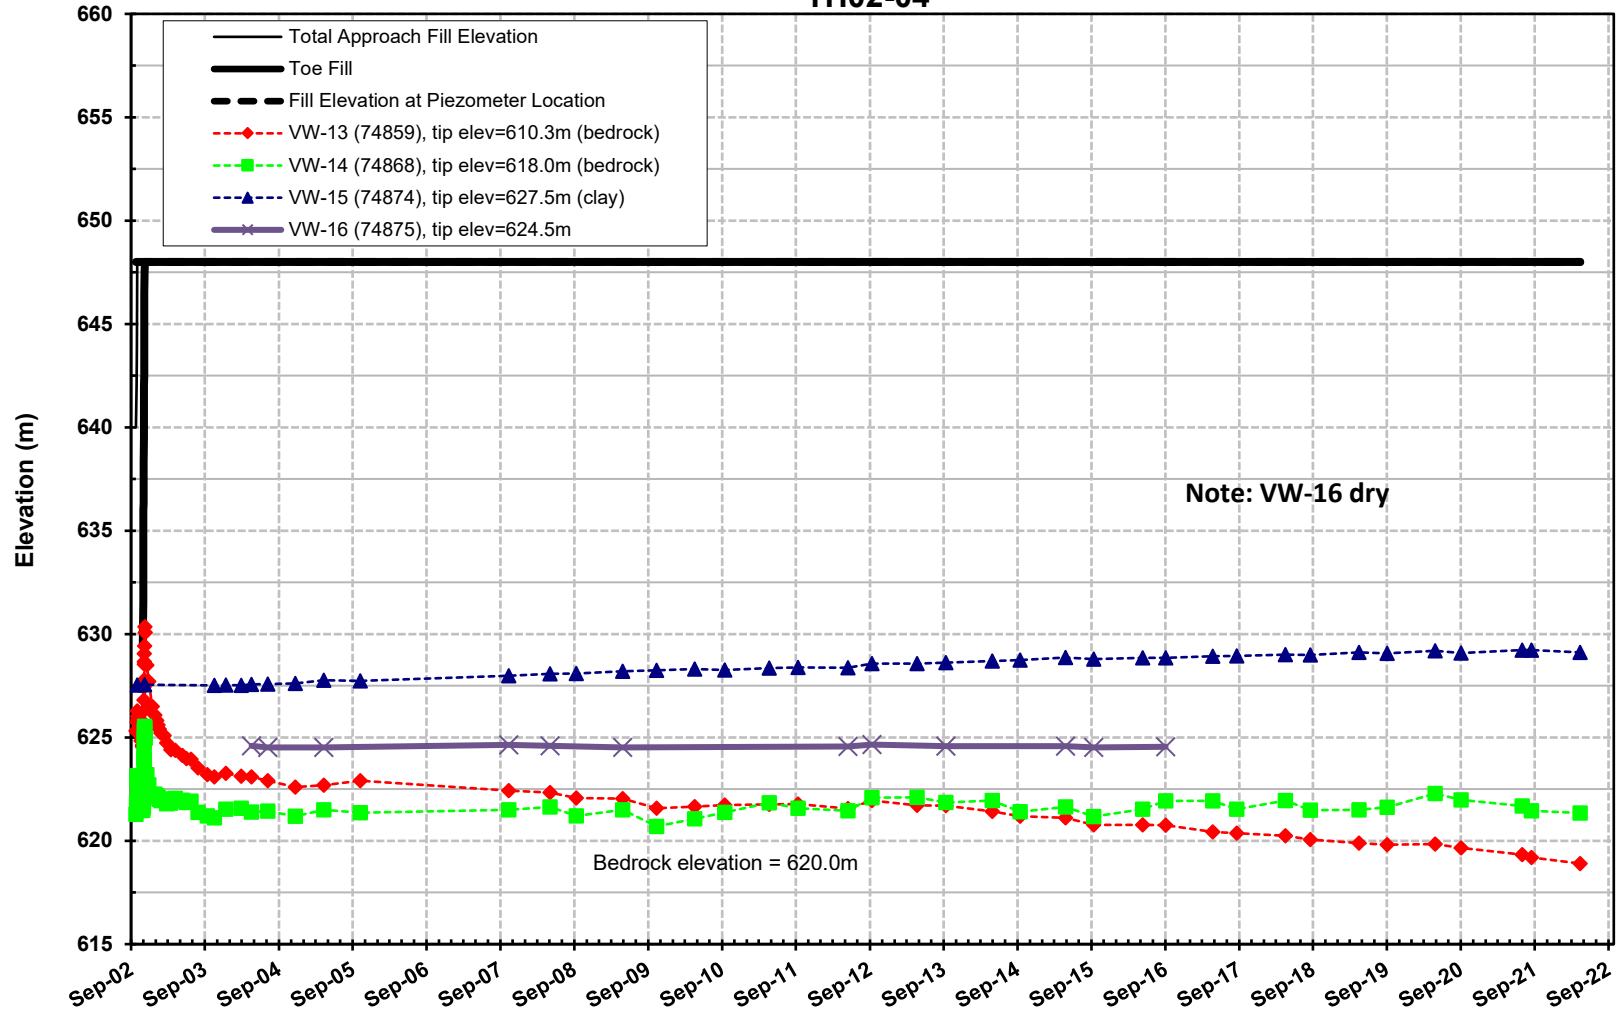
In general, the VW piezometers in the east abutment show a decrease in the piezometric level up to 0.5 m since Fall 2021 readings. Piezometers VW-3, VW-4, VW-6, VW-11 and VW-16 were inferred to be dry again this reading cycle. VW-10 continues to be at its highest recorded piezometric levels with no change observed since Spring 2021.
