**NORTH CENTRAL REGION GRMP  
EDSON / STONY PLAIN  
SITE INSPECTION FORM**

<b>SITE NUMBER AND NAME:</b> NC067 – Anthony Henday Bridge	<b>HIGHWAY AND KM:</b> 216:06, km 10.528	<b>PREVIOUS INSPECTION:</b> June 15, 2022	<b>CURRENT INSPECTION:</b> June 1, 2023
<b>LEGAL DESCRIPTION:</b> SE 4-52-25-W4	<b>NAD83 COORDINATES:</b> UTM12U 5926734N 326219E		<b>RISK ASSESSMENT:</b> PF: 5 CF: 10 Total: 50
<b>AVERAGE ANNUAL DAILY TRAFFIC (AADT):</b> 73,140 (2022)		<b>CONTRACTOR MAINTENANCE AREA (CMA):</b> AHD

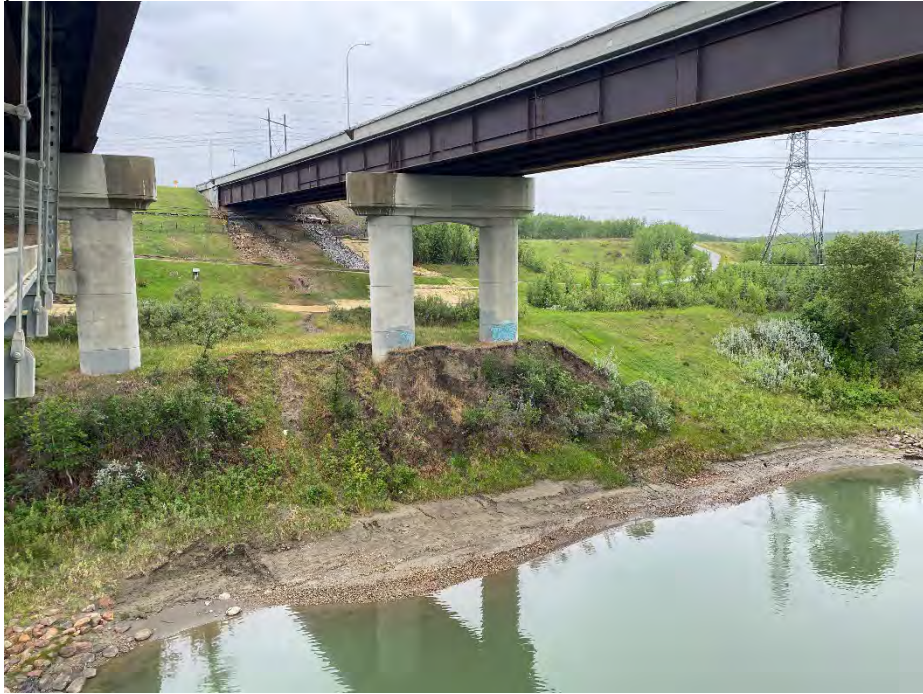
- Aside from ongoing erosion and slumping at the north abutment piers, the site appeared mostly unchanged.
- Significant erosion/slumping was observed at the land piers of the north bank (Photos 1 to 3). Ongoing erosion/slumping may be due to river scour and high intensity precipitation events. The extent of erosion appears to have increased resulting in additional loss of soil support around the piers. In discussion with AT, the bridge group was not concerned with loss of soil support at its current elevation since some loss of lateral soil support was assumed in the original design.

**Photo 1:** Erosion of land piers at the north bank. Looking north.

- North abutment slope: remediation includes flattening the slope to 2.5H:1V and armoring the slope with riprap. Additional surface drainage improvements will also be constructed. The estimated cost for construction is approximately \$1,575,000, excluding engineering costs. Construction was previously scheduled for 2024 and was rescheduled to 2026.

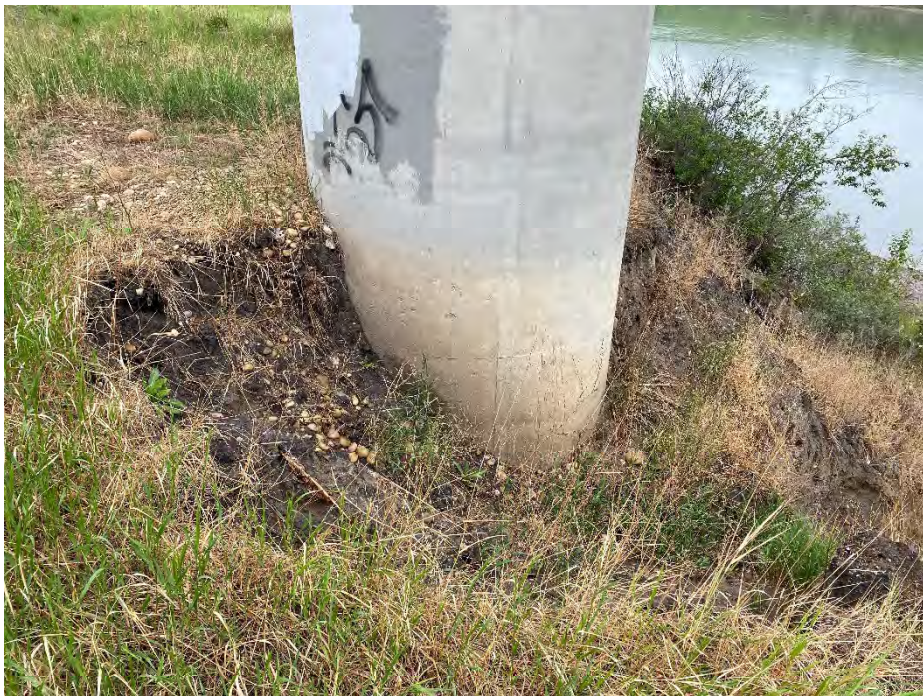
**Photo 2:** Loss of soil support at pier. Looking northeast.

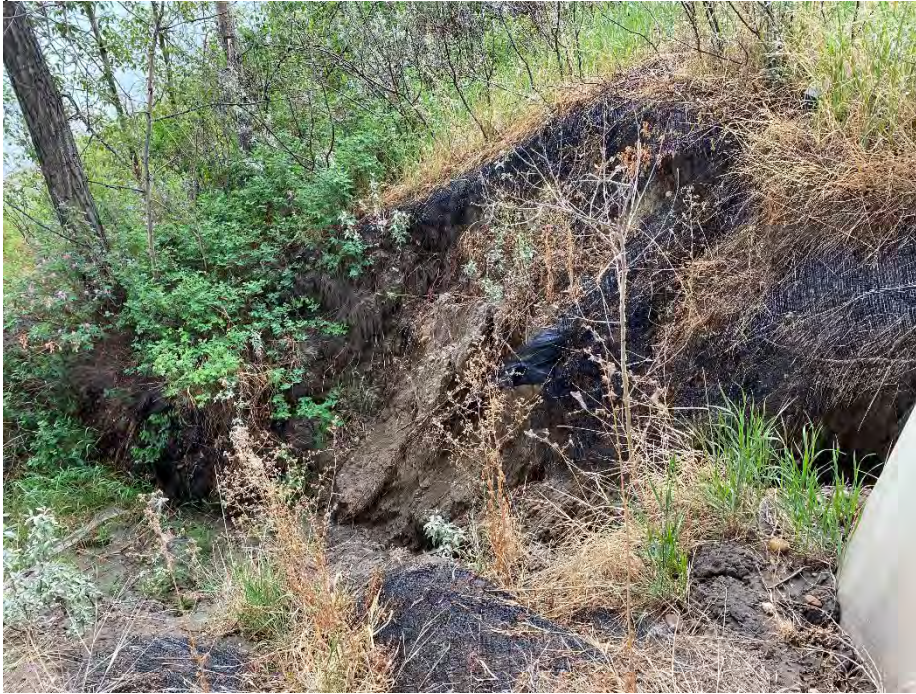
**Photo 3:** Erosion at outermost pier of southbound lane. Looking southwest.

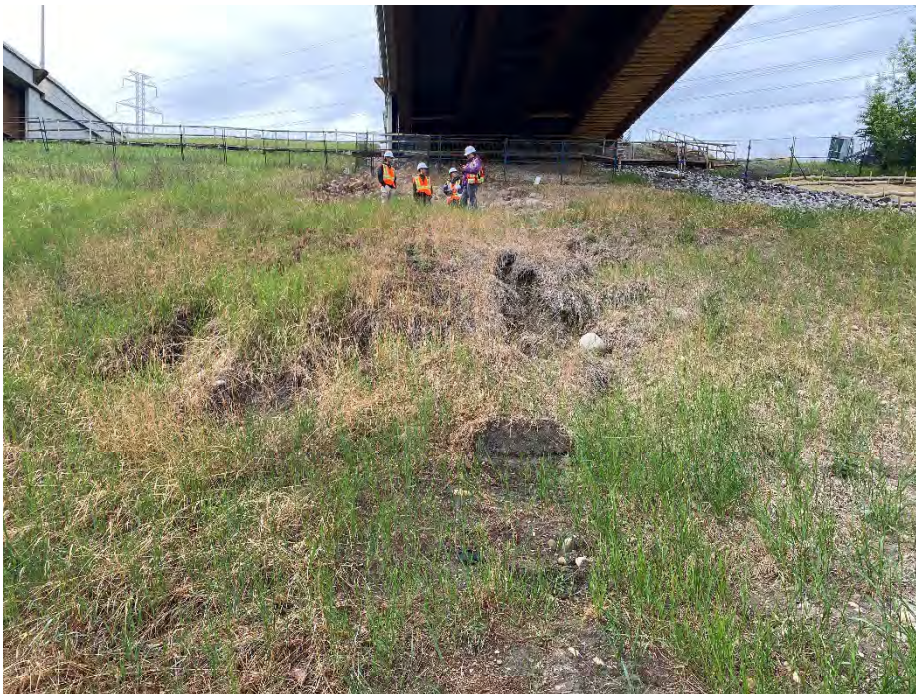
- Four large erosion gullies remain unchanged from the 2022 site inspection under the NBL downslope from the pedestrian trail at the north abutment. These gullies are up to 1 m deep and 0.9 m wide (Photo 4). The minor trail loss and pavement crack also appear unchanged since the 2022 site inspection (Photo 5).

**Photo 4:** Four scour holes downslope of pedestrian trail under NBL. Looking northwest.

- The erosion gullies should be regraded and reseeded to improve erosion protection and reduce the risk of additional loss of trail.
- Stantec submitted two tender packages for site remediation in 2019:

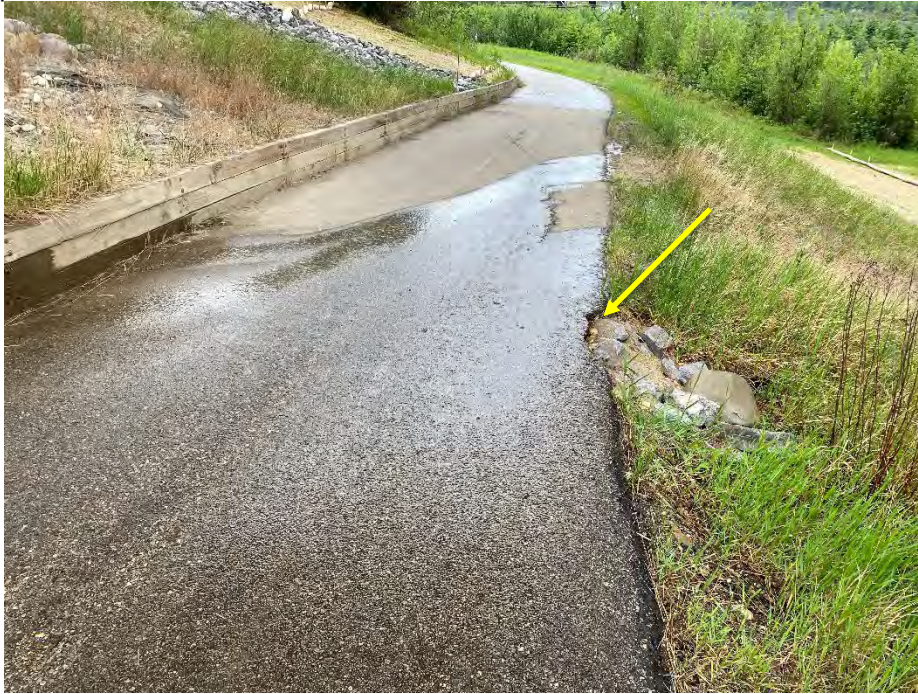
**Photo 5:** No change to trail crack pattern. Minor loss of trail. Looking northeast.

- Pavement cracks along the pedestrian trail should be sealed to reduce surface water infiltration into the slope.
- The waterproofing membrane behind the abutment walls on the NBL should be repaired to direct water into the drainage trough on both sides of the river. Any associated catch basins/ drainage chutes should be checked for blockage and cleaned as necessary.

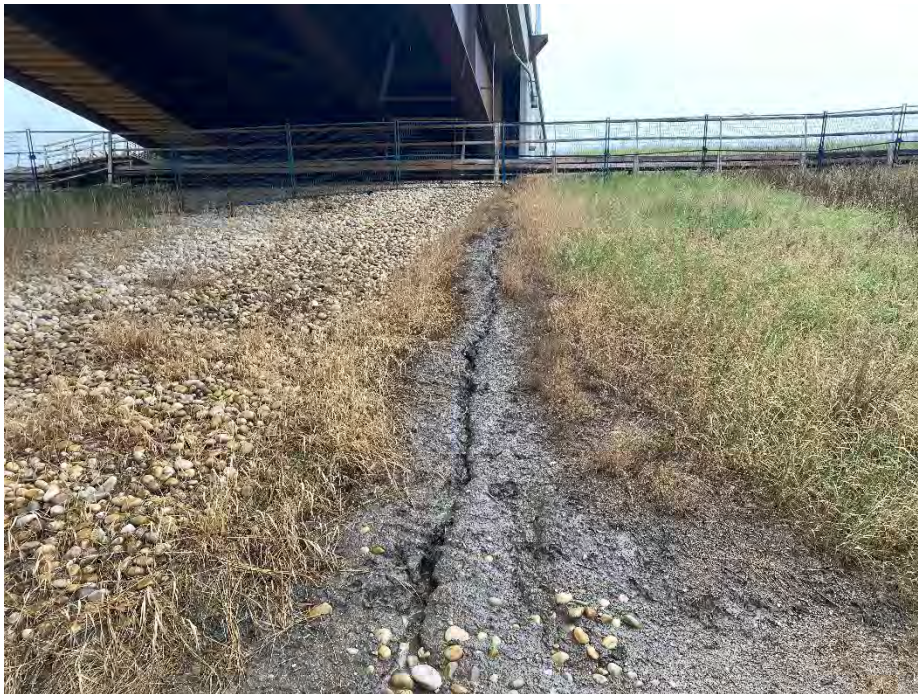
- Erosion is ongoing down the informal biking/ walking trail on the south slope near the bend in the unpaved access road.
- Ongoing erosion was observed on the south slope below the abutment of the NBL. Water is flowing off a waterproofing membrane behind the abutment wall, missing the trough that would direct water to a catch basin, and flowing downslope resulting in erosion of the head slope (Photo 6).

**Photo 6:** Erosion below the NB abutment on the south slope due to damaged waterproof membrane on abutment. Looking southeast.

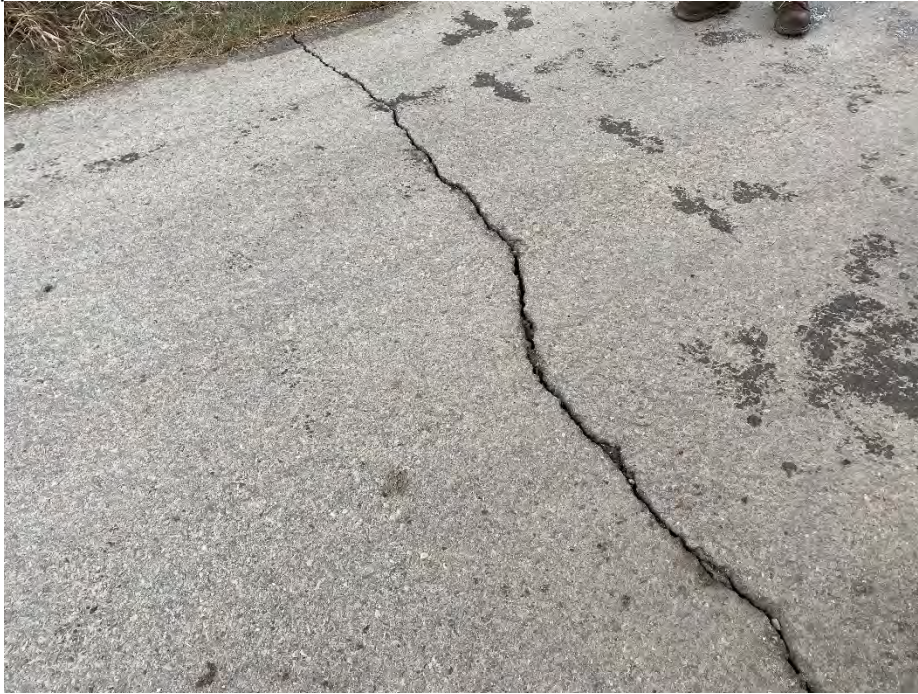
- A crack across the paved trail was observed on the south slope below the NBL (Photo 7).
- The erosion/slumping adjacent to the outfall at the south abutment appeared to have progressed since the 2022 site inspection. The scarp is still 6 m wide but has retrogressed 1 m southeast and is currently 5 m from the catch basin (Photo 8).

**Photo 7:** Crack in the paved trail below the NB lane of south abutment. Looking northeast.

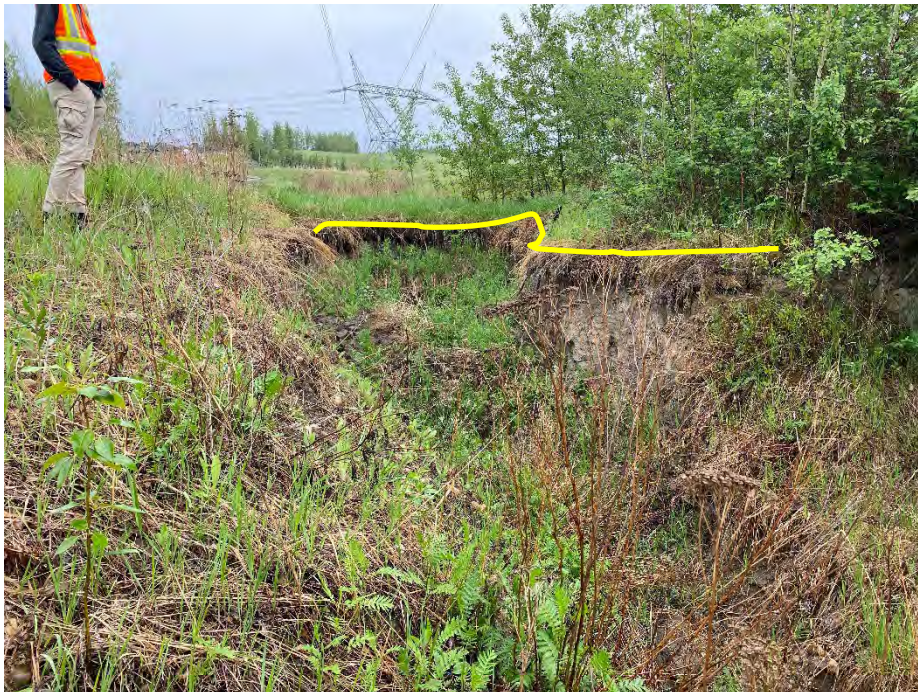
**Photo 8:** Two slumps adjacent and behind the outfall on the south bank of the river. Looking southeast.

- Outfall remediation as part of NC79 work: Replace separated sections of pipe with 750 mm reinforced concrete pipe. Reline storm sewer with cured-in-place pipe installed at 5% slope. The estimated cost for

construction is approximately \$950,000, excluding engineering costs. Construction has been rescheduled for 2025.

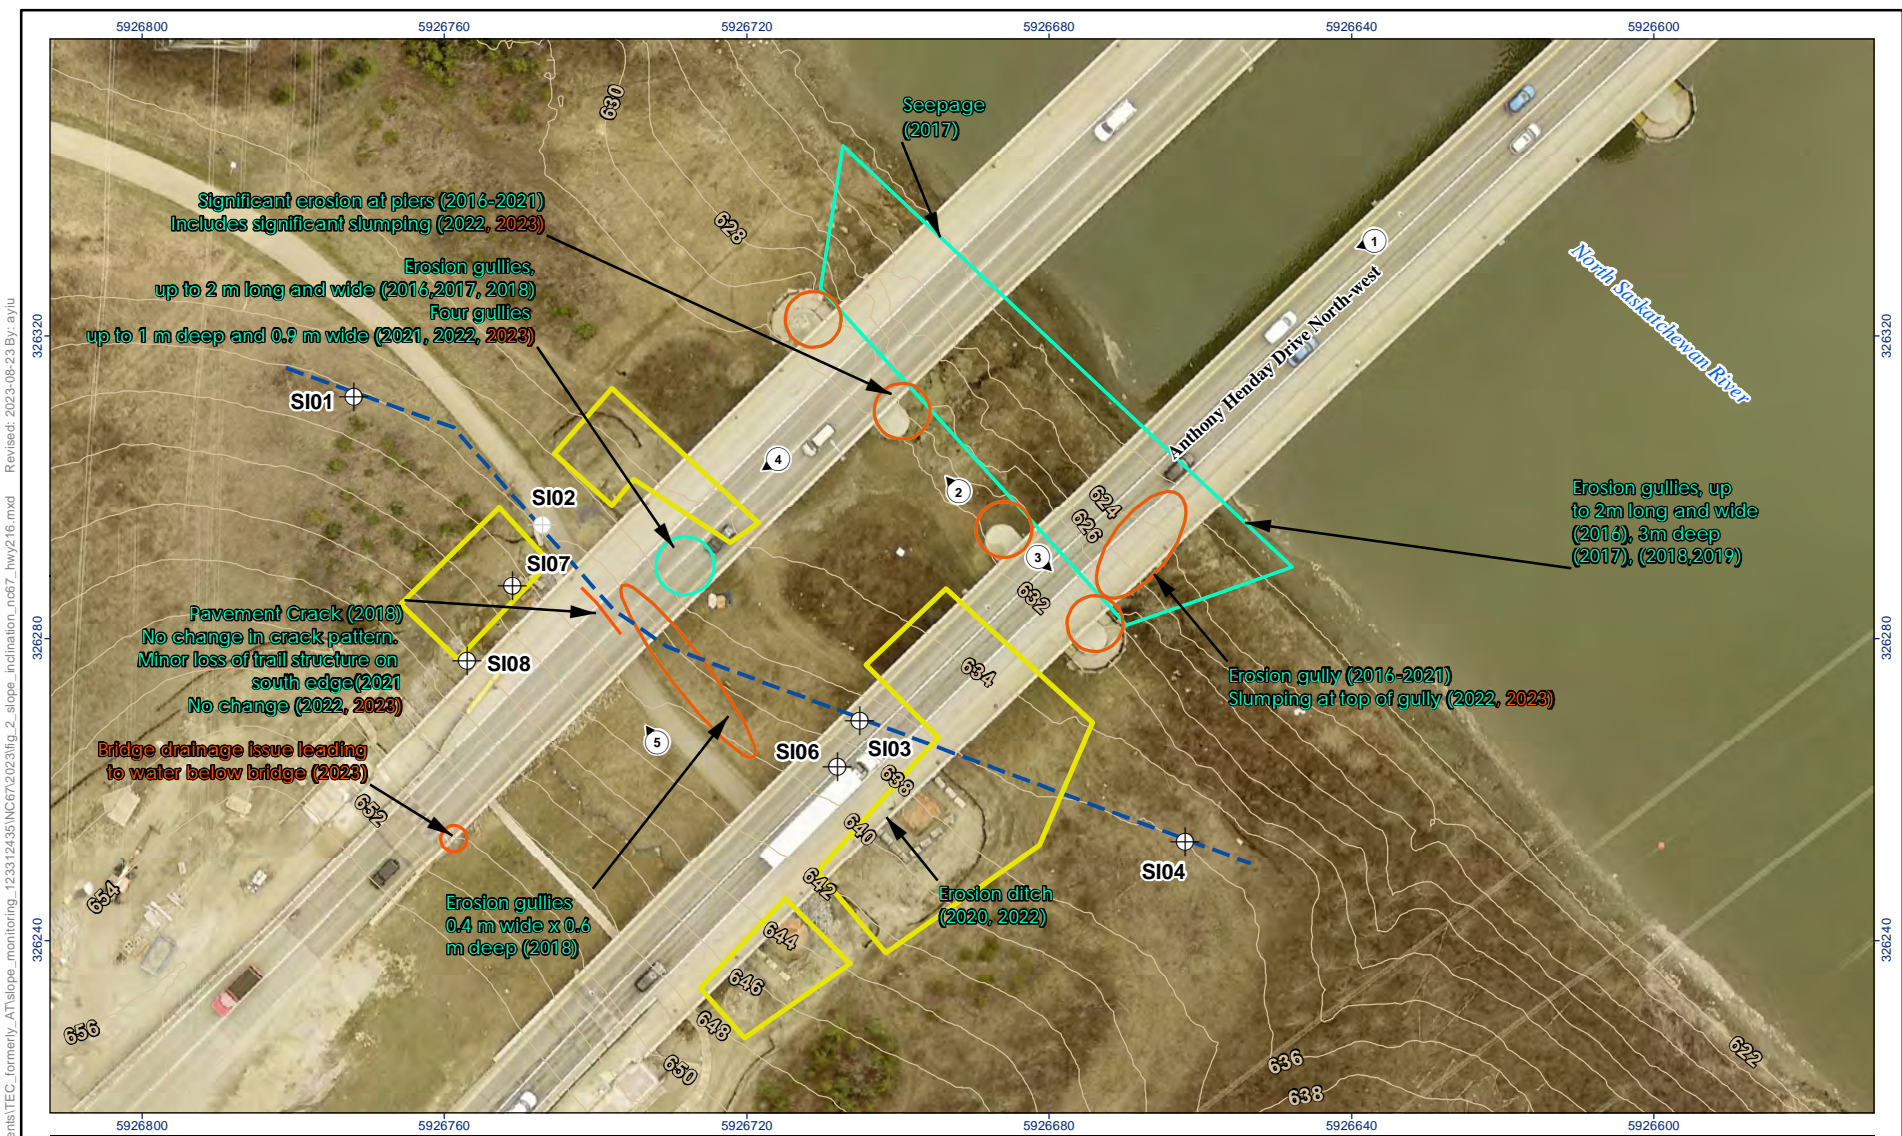
**Figure No.**  
**2**  
**Title**  
**Slope Inclinometer Locations**

- SI2 and SI7 previously showed movement in the fill. SI2 was installed in the pile wall and showed an average rate of movement of about 3 mm/yr in the upper zone (~3 m depth) since 2014. The instrument was destroyed in 2022 during construction activities. SI7 showed a similar rate of movement as SI2 for the middle movement zone (~7 m depth) since 2009 and a slightly higher rate of movement than SI2 for the upper zone (4 mm/yr at about 3 m depth). An increase in movement rate to 32 mm/year was observed in the upper zone of SI7 during the 2022 instrument reading cycle which was likely due to excavations and spoil pile placed around the SI. SI7 was sheared at approximately 6 m below the top of the pipe during the 2023 spring reading cycle. SI1 and SI3, installed in the pile wall, have shown no discernable movement in the pile wall aside from pile wall deformation, but do show movement in the fill (~2.5 m depth) with current rates of movement of 5 and 6 mm/yr, respectively. Approximate SI locations are shown on Figure 2.
