To:	Amy Driessen	From:	Leslie Cho and Xiteng Liu
	Transportation and Economic Corridors		Stantec Consulting Ltd.
File:	123315222	Date:	October 18, 2024

Reference: North Central Region, Stony Plain, Site NC067 - Highway 216:06 Anthony Henday Bridge, Fall 2024 Instrumentation Monitoring Report

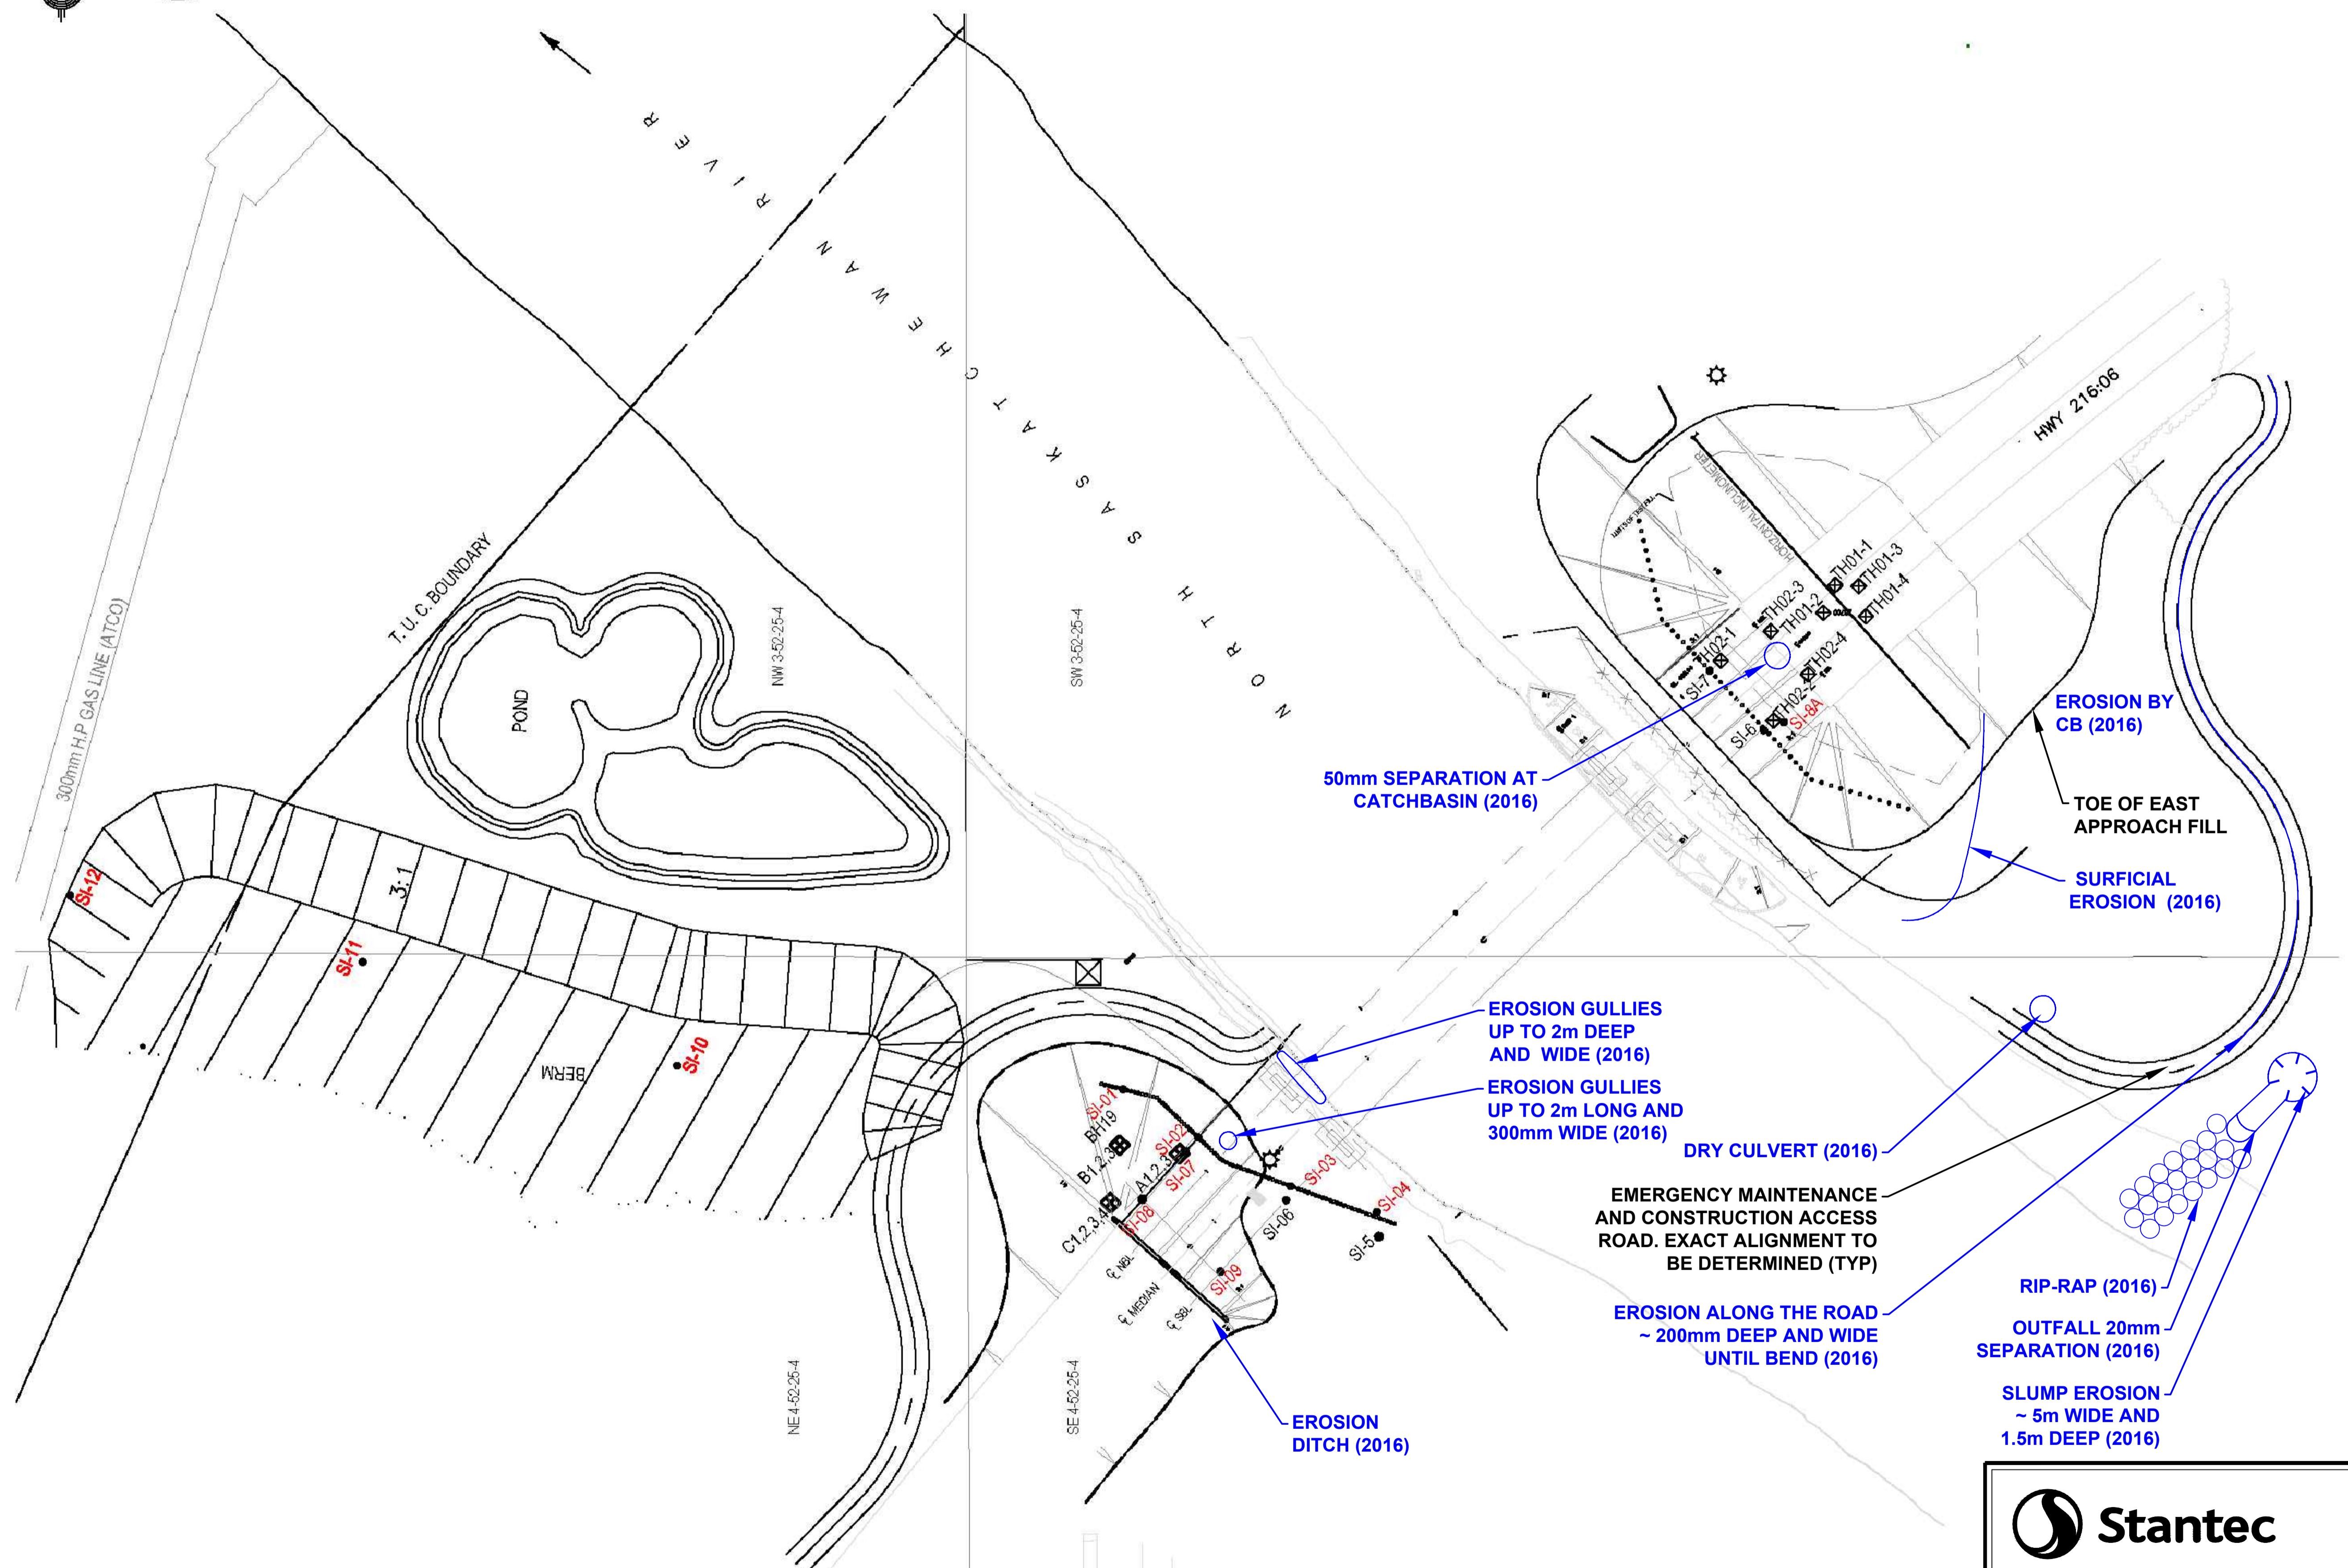
STANTEC CONSULTING 10160-112 STREET EDMONTON ALBERTA CANADA	
ALBERTA TRANSPORTATION GEOHAZARD MONITORING PROGRAM NC67 HWY 216-06 SITE PLAN			
DRAWN	WW	CHECK	CDM
DATE	22 JULY, 2016	SCALE	AS SHOWN
APPROVE	ID	PROJECT #	123315222
FIGURE - 1			-

50mm SEPARATION AT CATCHBASIN (2016)

EROSION BY CB (2016)

SURFICIAL EROSION (2016)

EROSION GULLIES UP TO 2m DEEP AND WIDE (2016)

EROSION GULLIES UP TO 2m LONG AND 300mm WIDE (2016)

EROSION ALONG THE ROAD ~ 200mm DEEP AND WIDE UNTIL BEND (2016)

RIP-RAP (2016)
OUTFALL 20mm SEPARATION (2016)

SLUMP EROSION ~ 5m WIDE AND 1.5m DEEP (2016)

EROSION ON WEST DITCH OF SOUTH LANE ~ 600m AWAY FROM BRIDGE (2016)

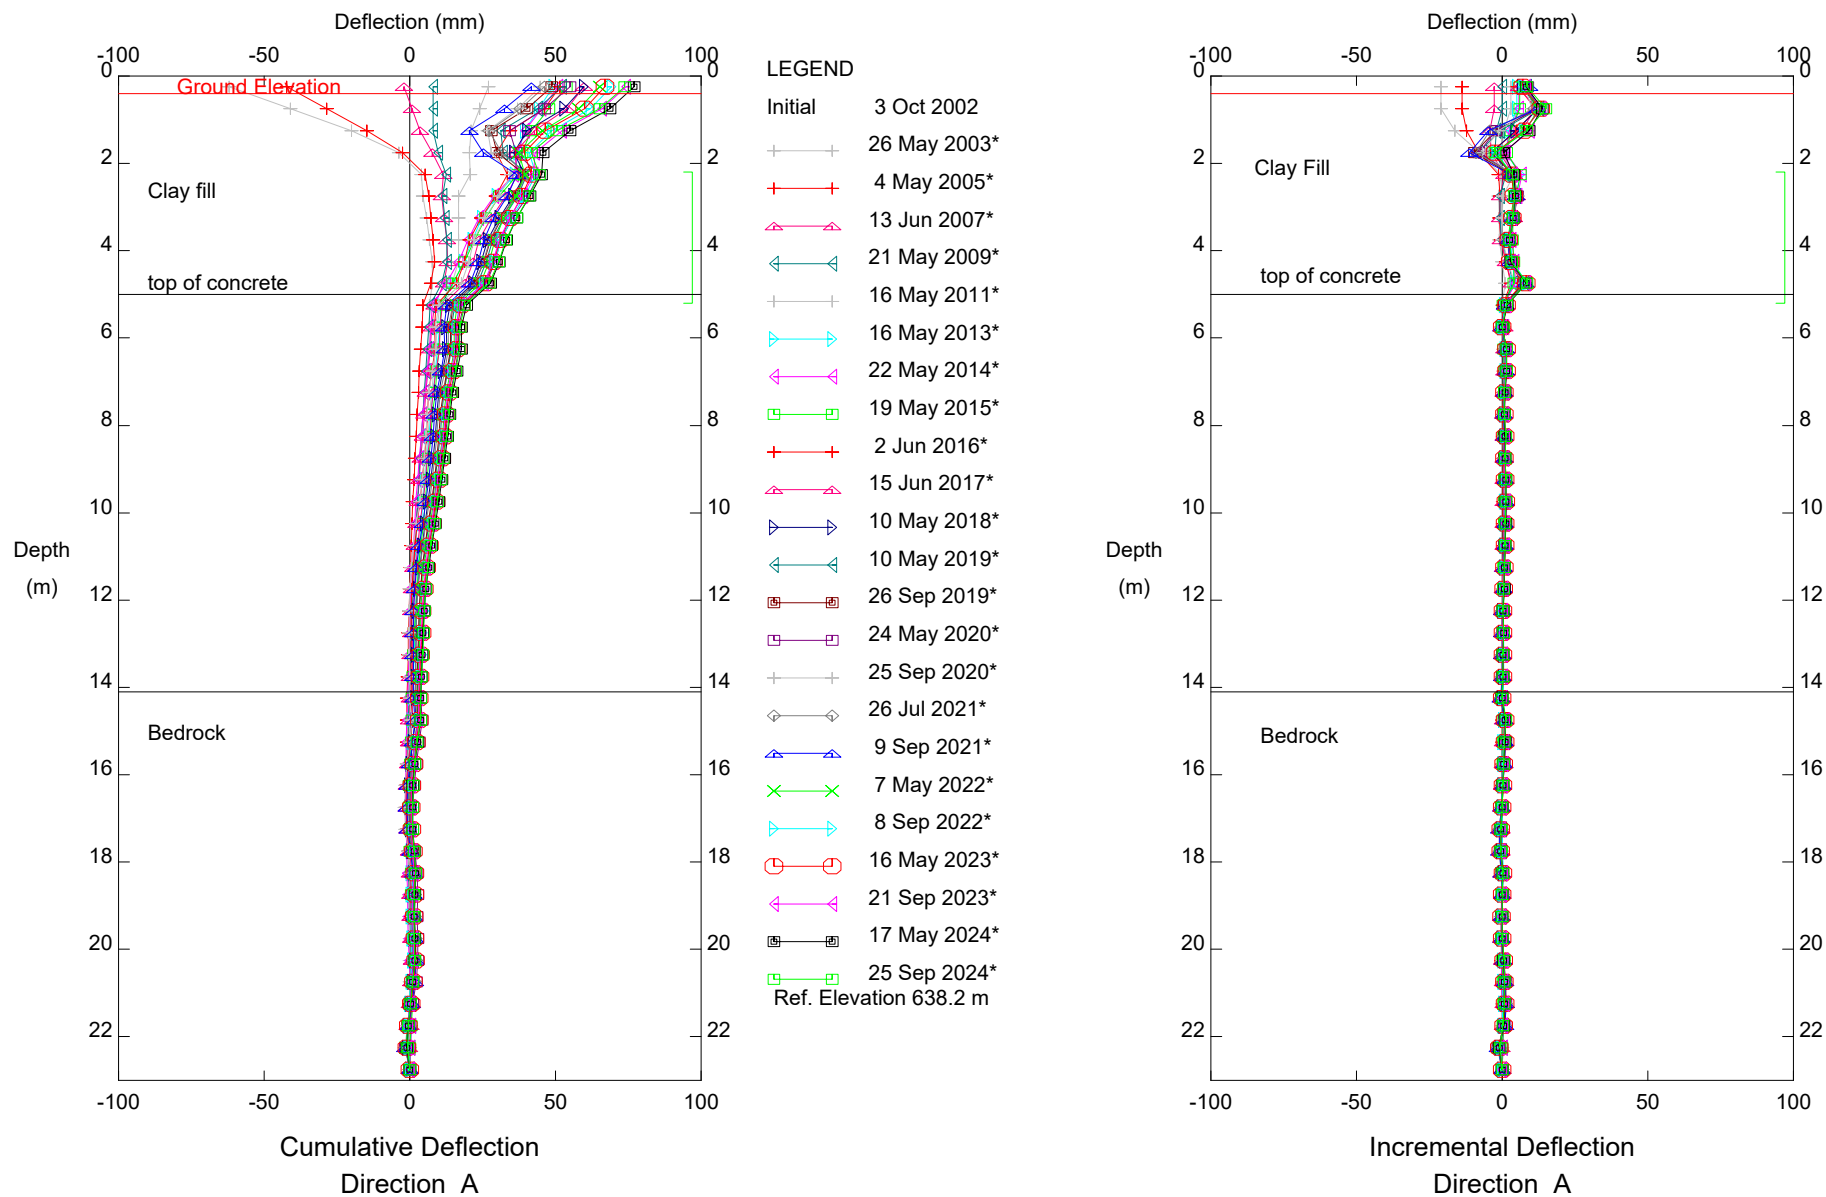
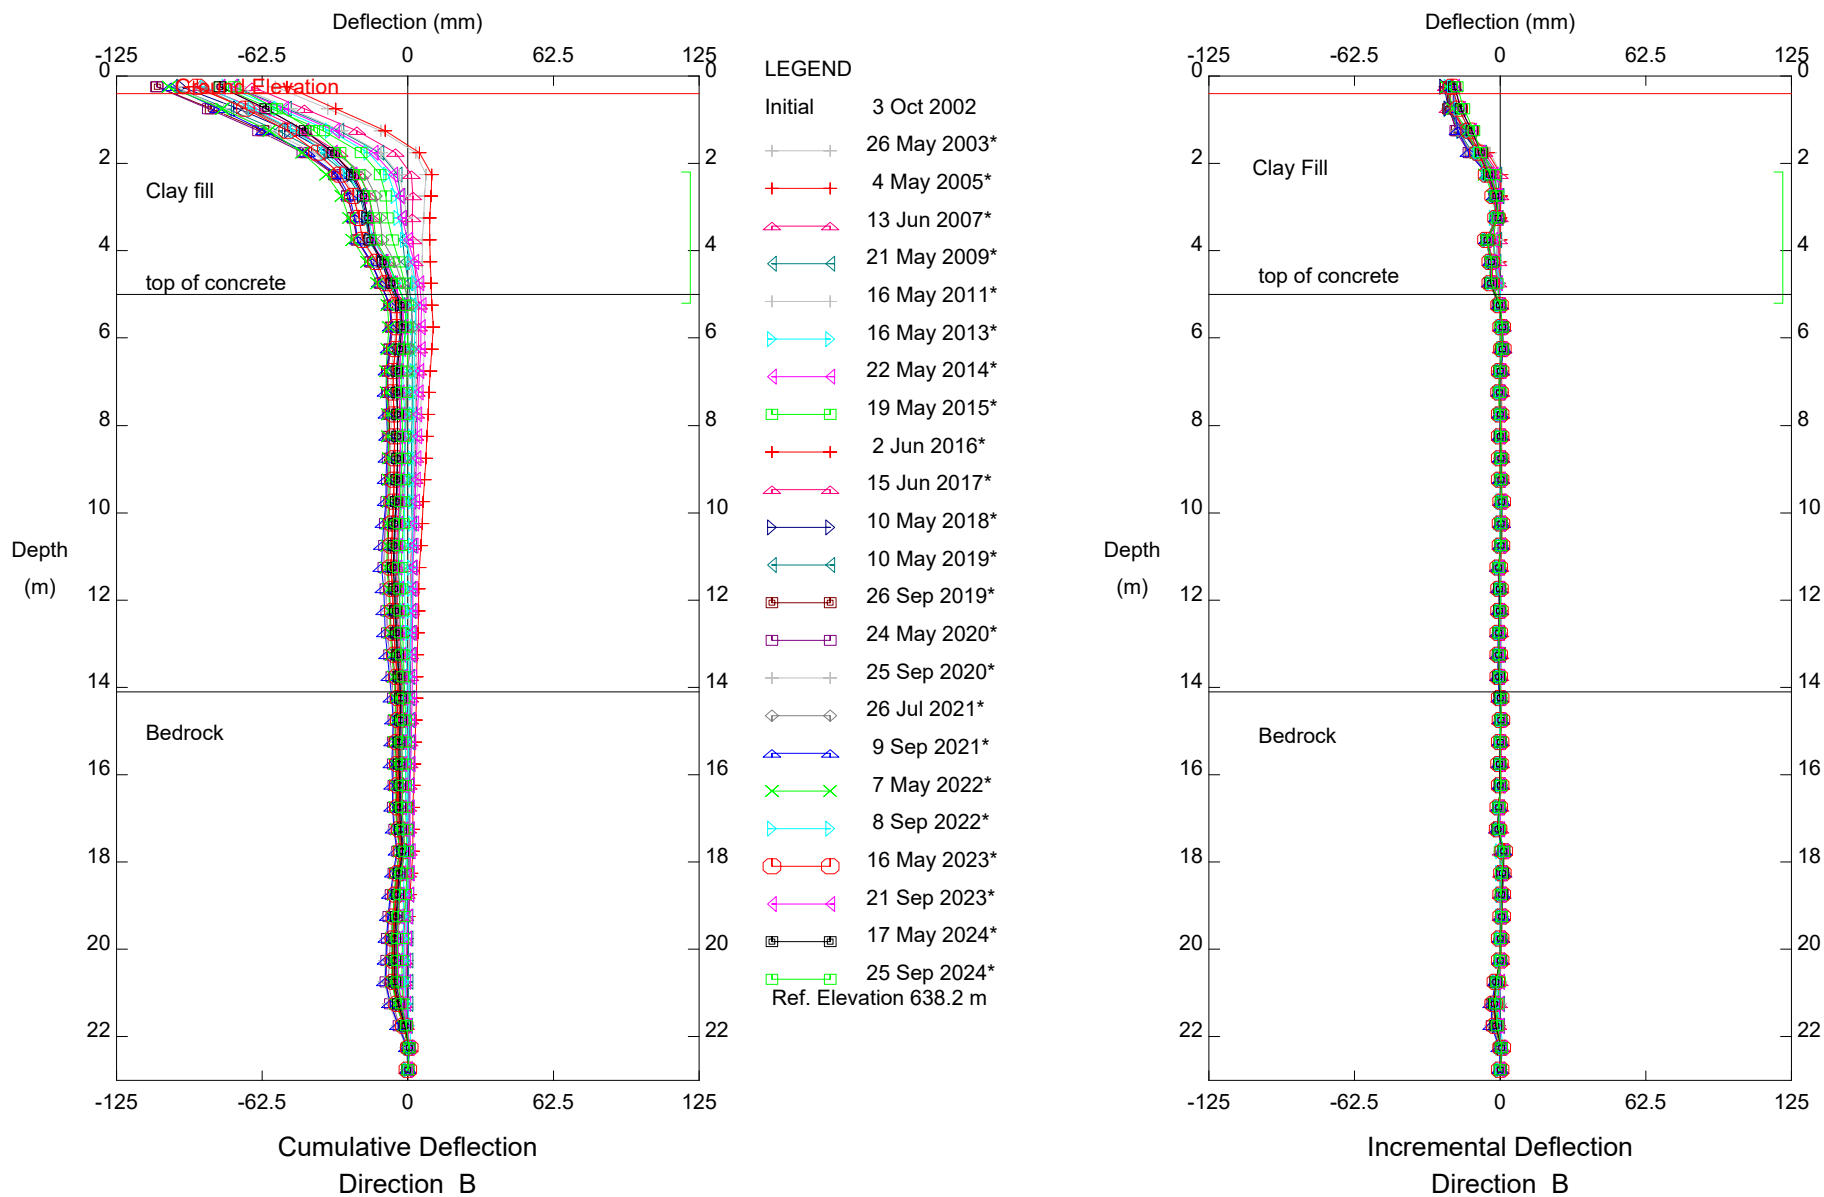
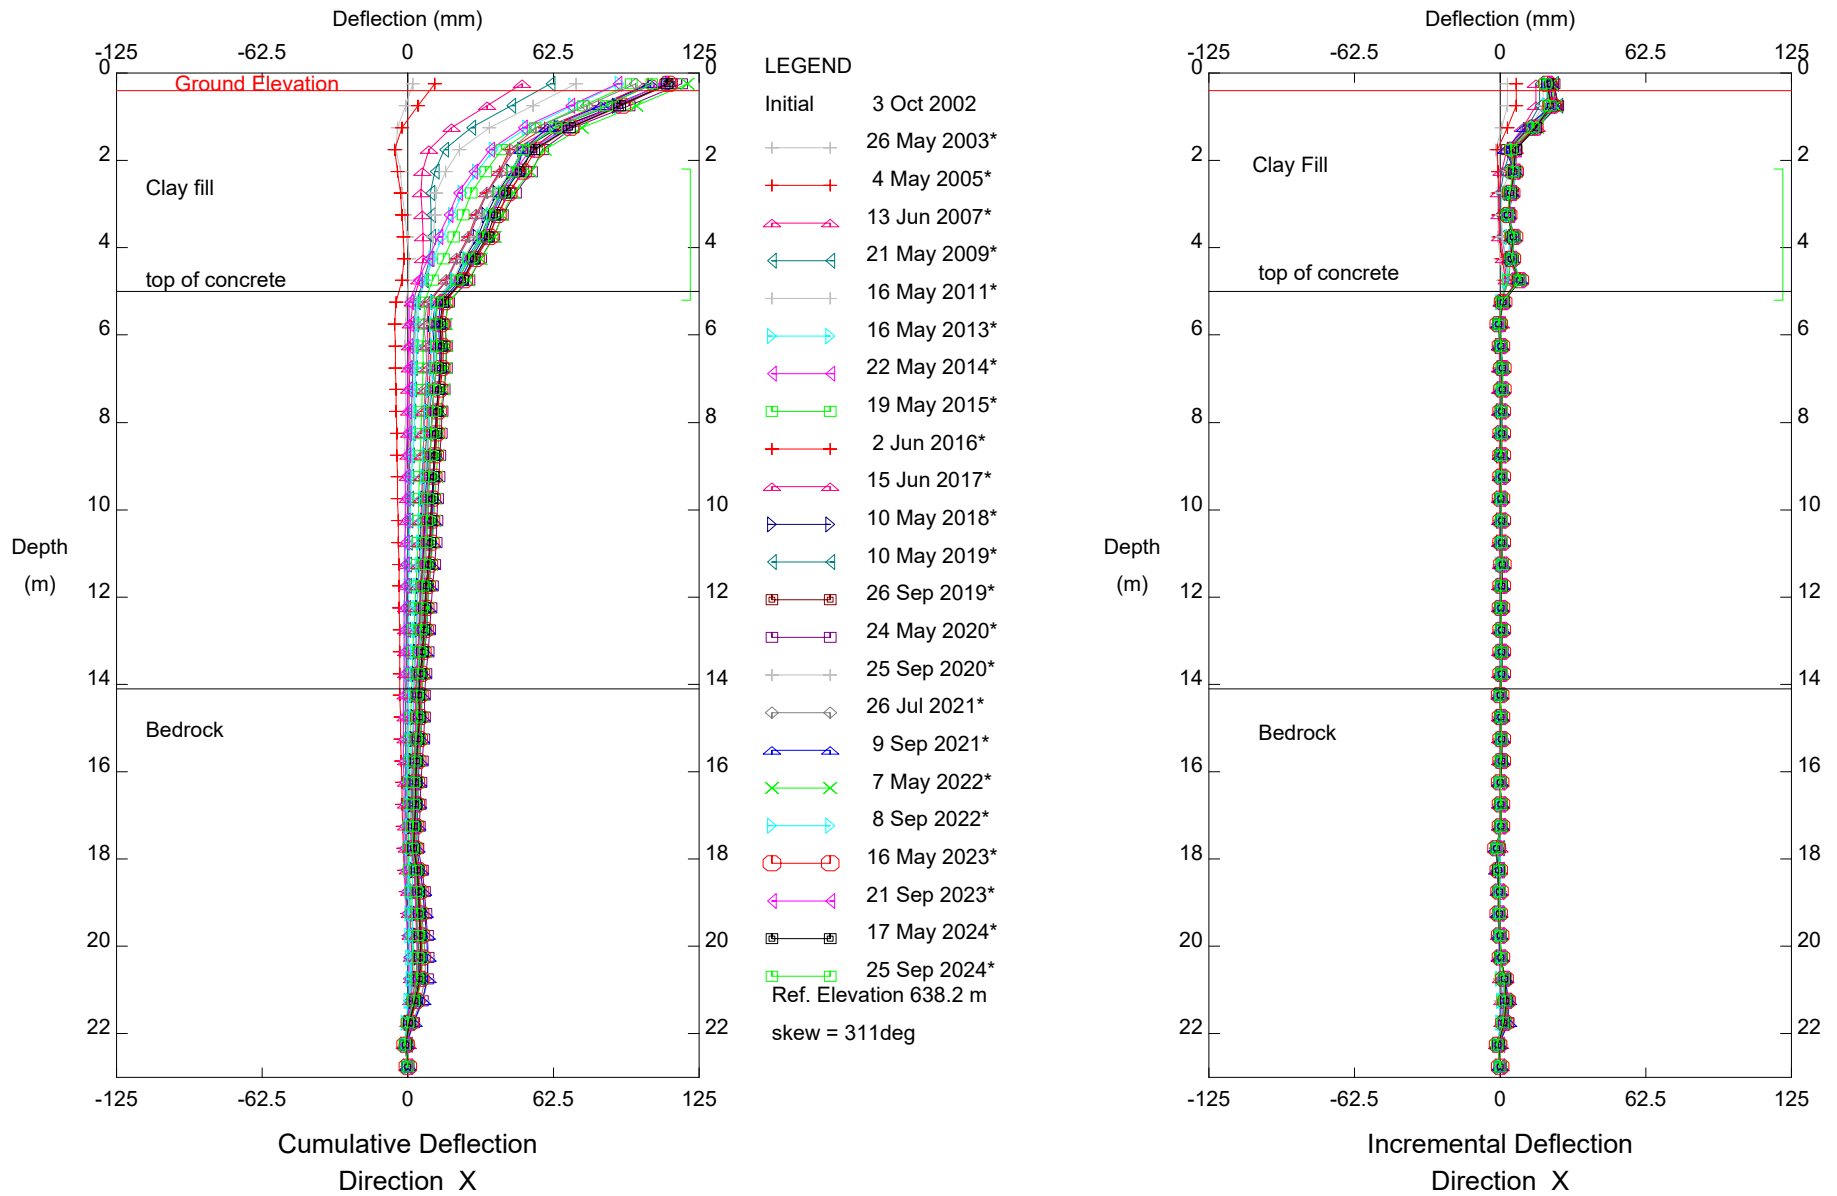
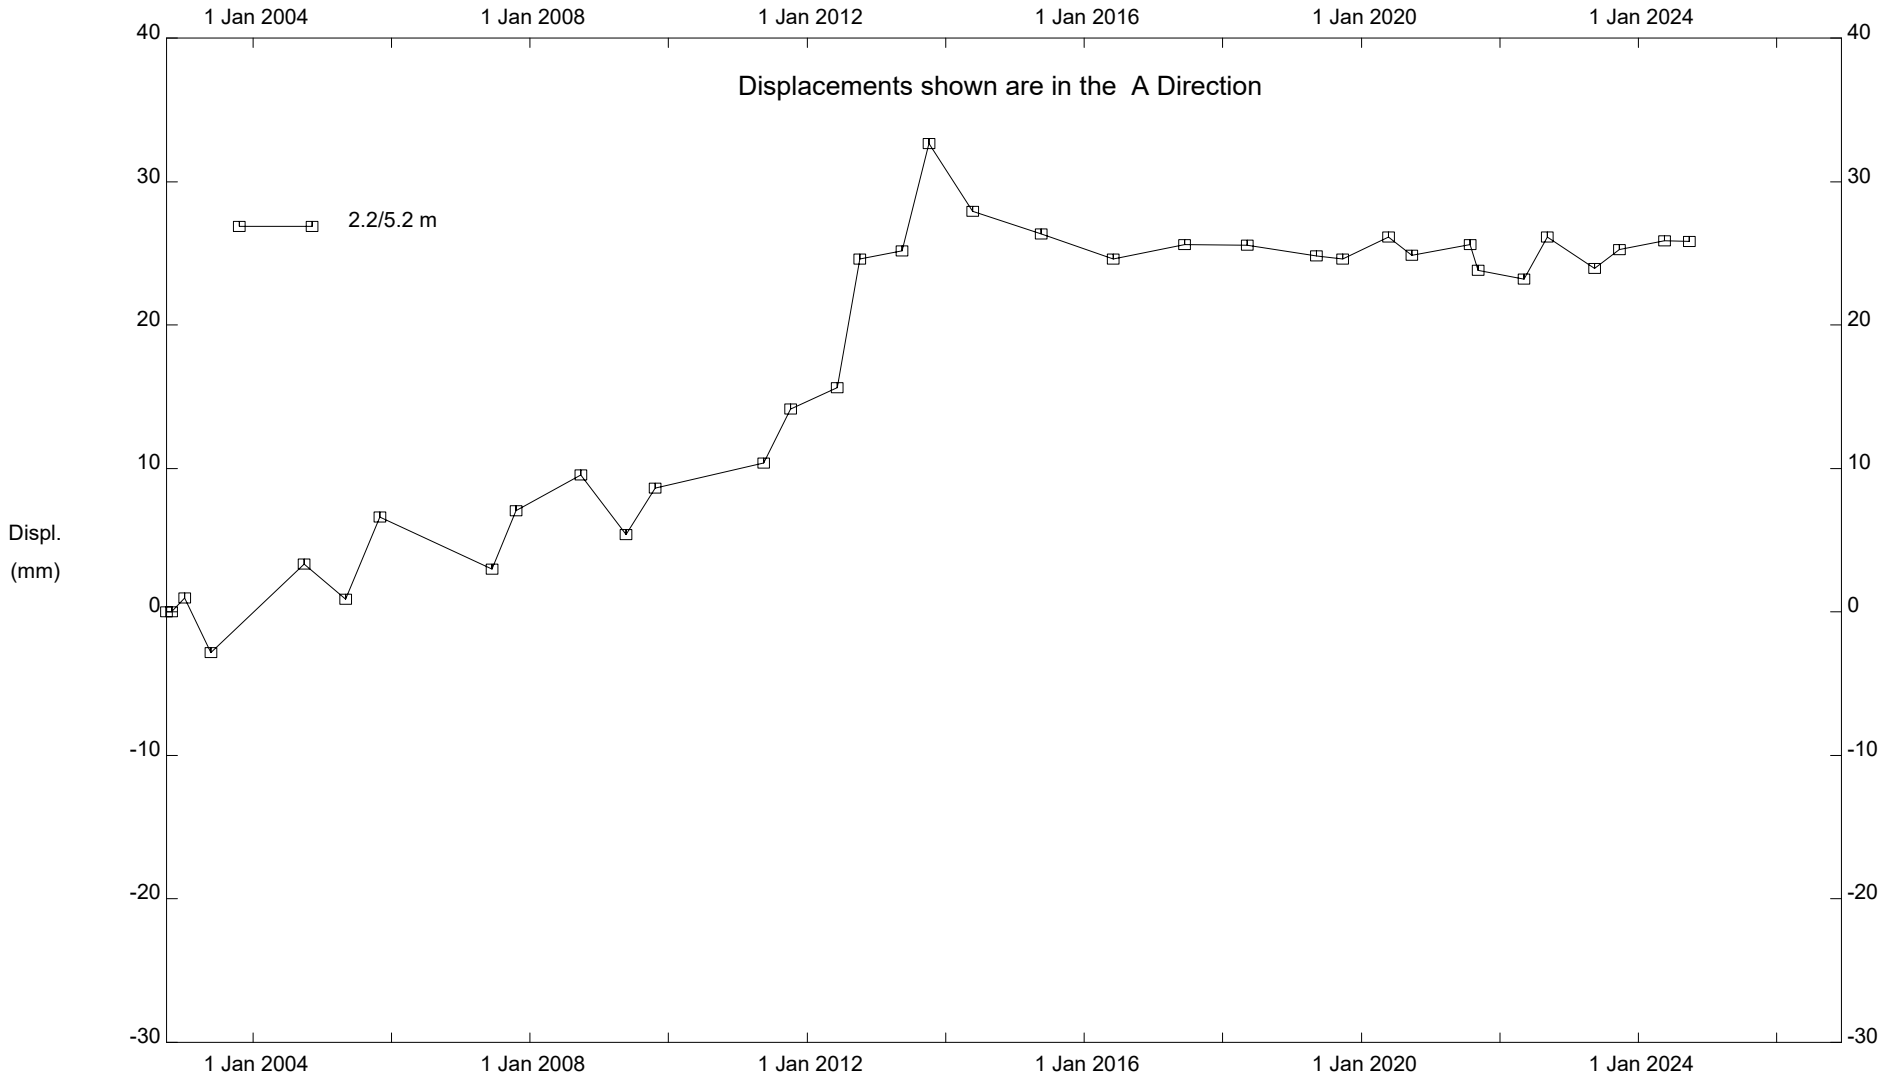
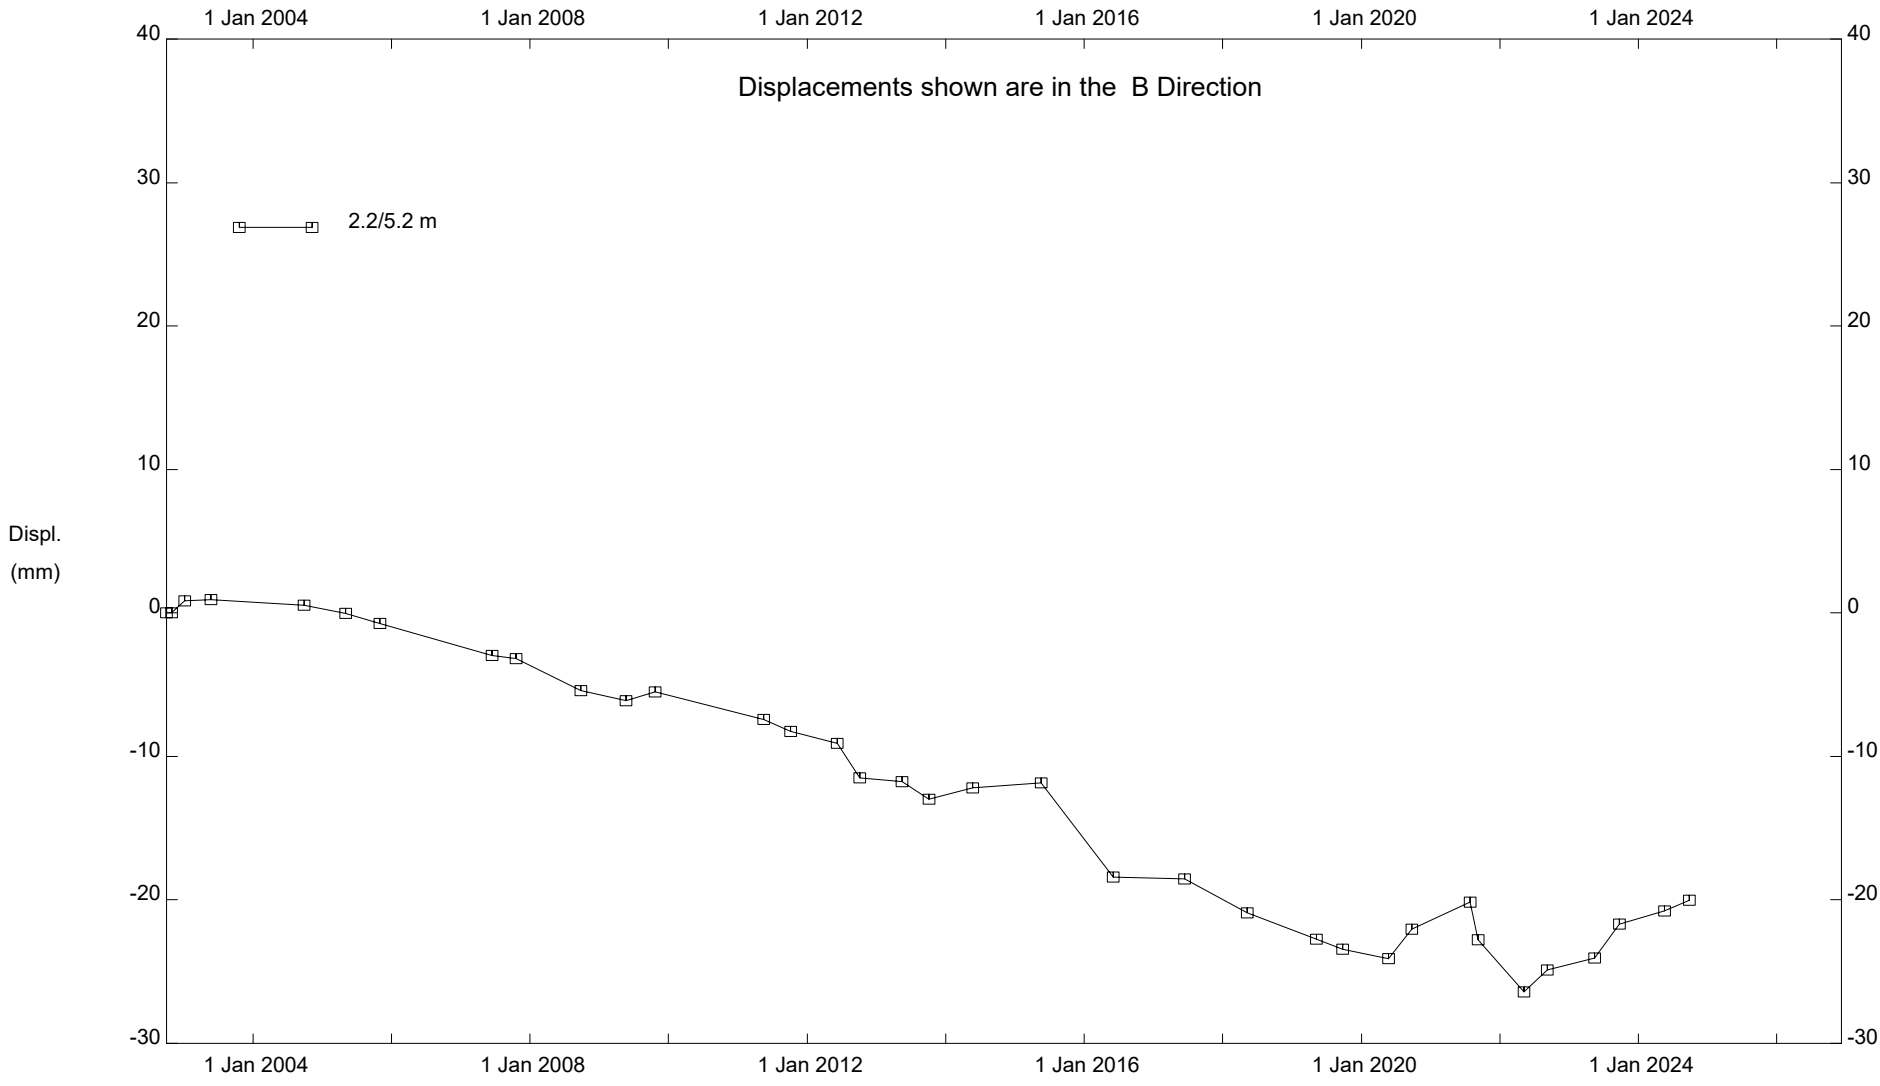
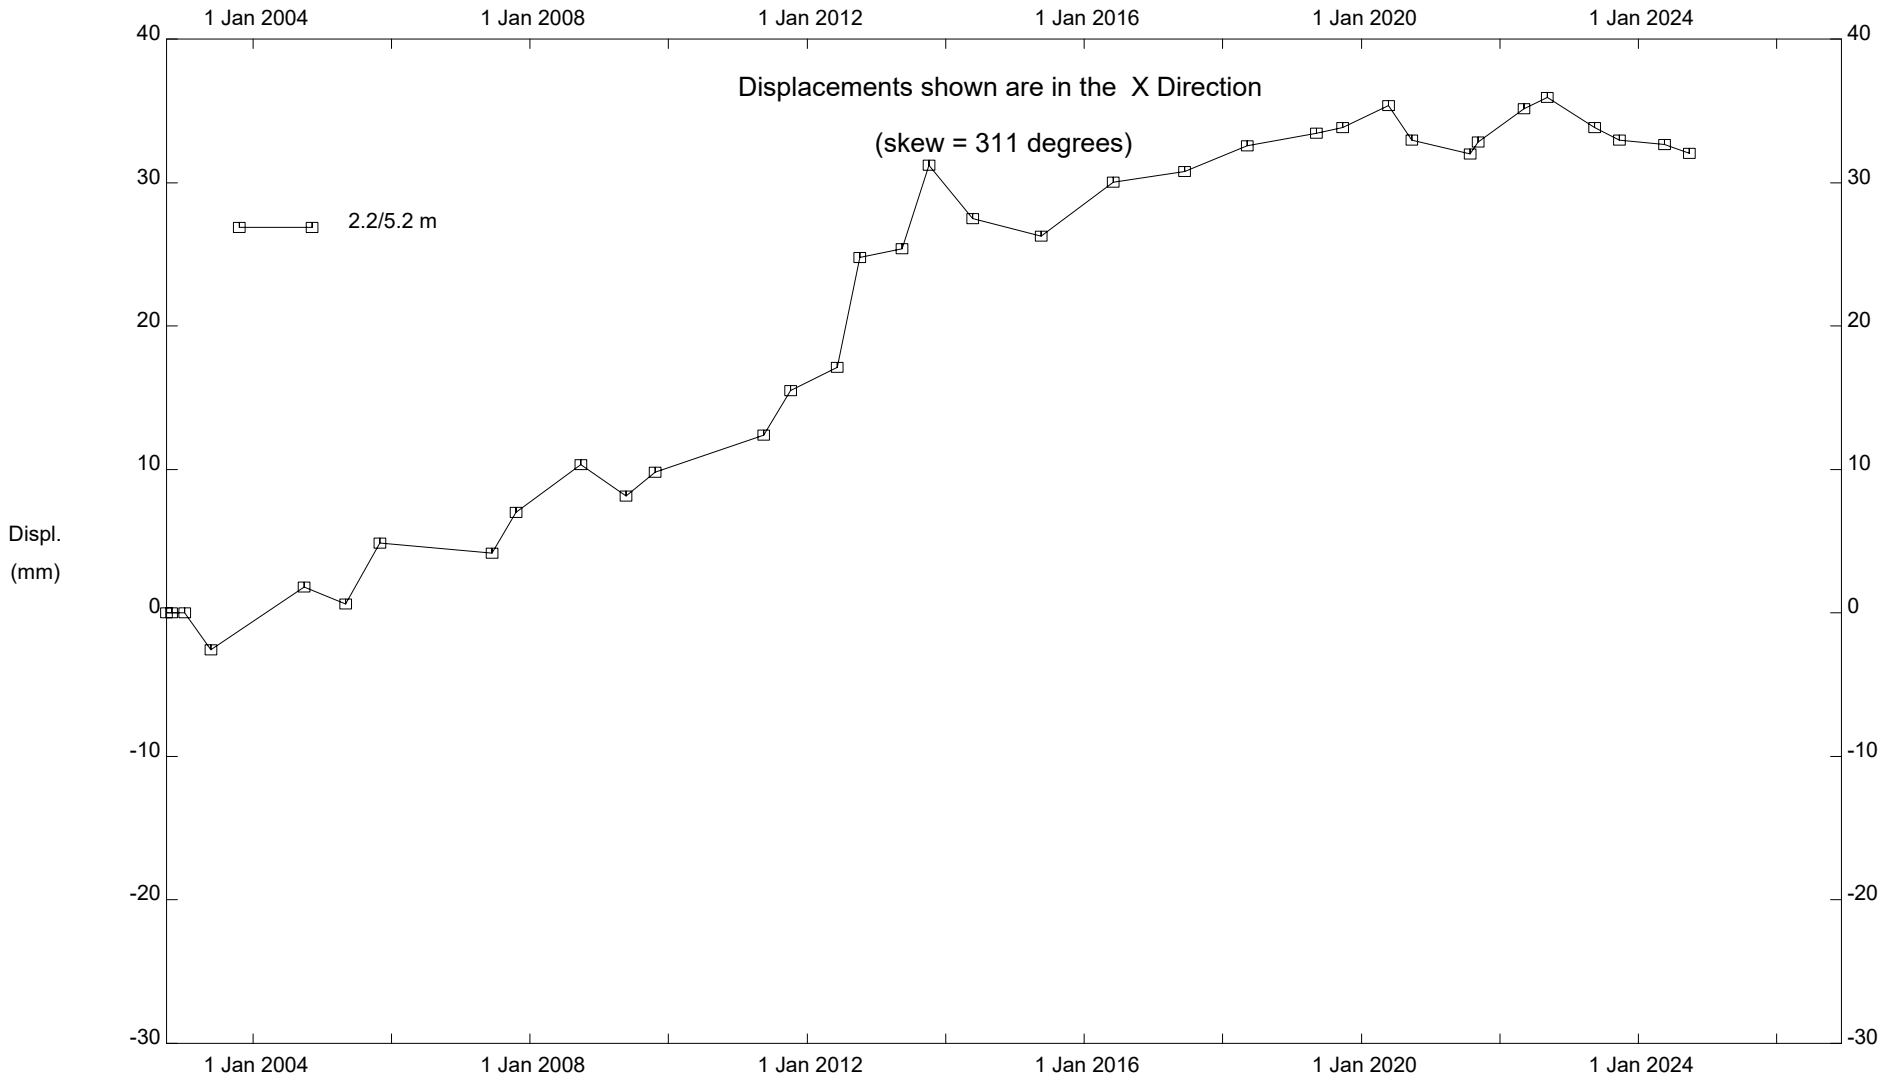
NC67, Inclinometer SI-01

- SI-01 showed little change since the Spring 2024 reading cycle. The current movement rate is about 2 mm/yr.
- SI-03 showed decreasing cumulative movement between 2018 and 2021 before returning to 2018 values. The cumulative movement decreased by 1 mm to 105 mm during the Fall 2024 readings with a rate of movement of 3 mm/yr.
