To:	Amy Driessen	From:	Leslie Cho and Xiteng Liu
	Transportation and Economic Corridors		Stantec Consulting Ltd.
File:	123315222	Date:	October 18, 2024

Reference: North Central Region, Stony Plain, Site NC067 - Highway 216:06 Anthony Henday Bridge, Fall 2024 Instrumentation Monitoring Report

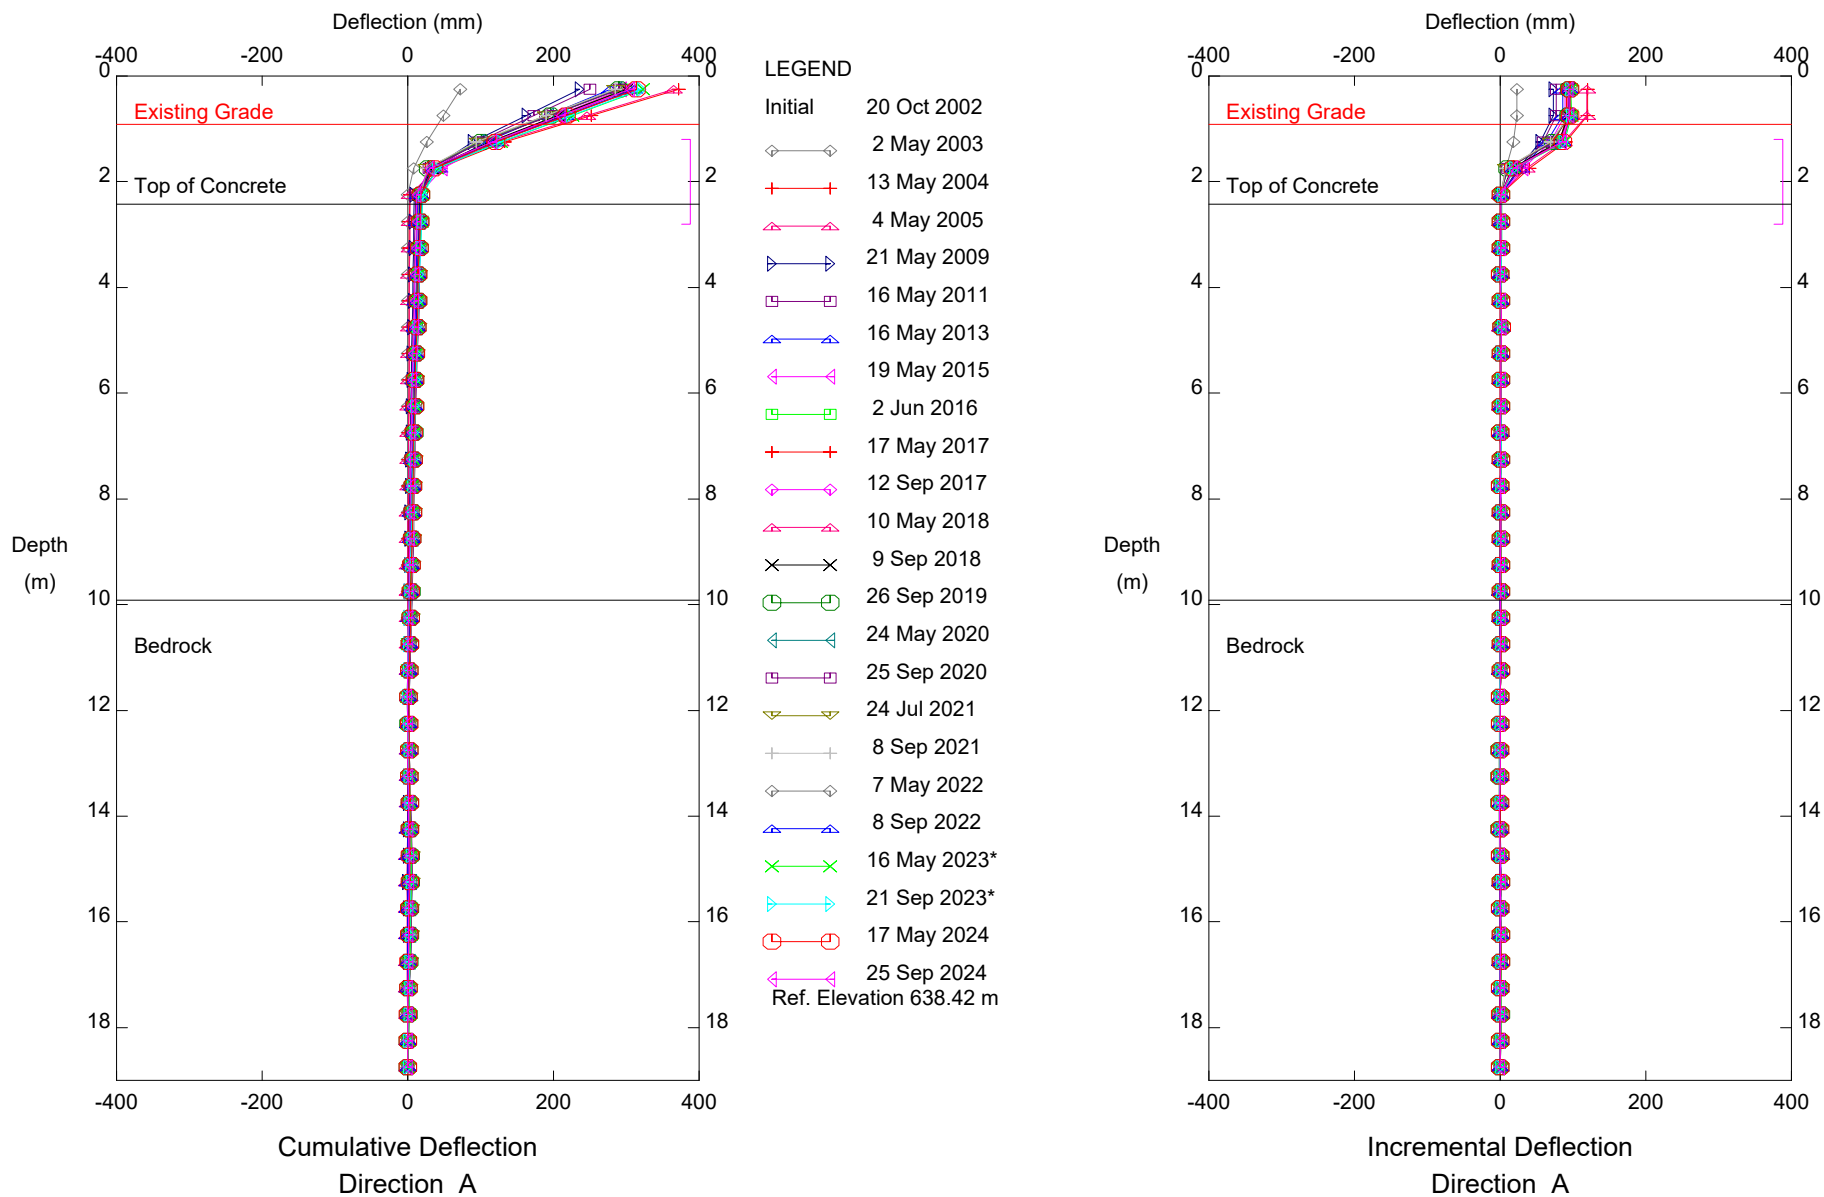
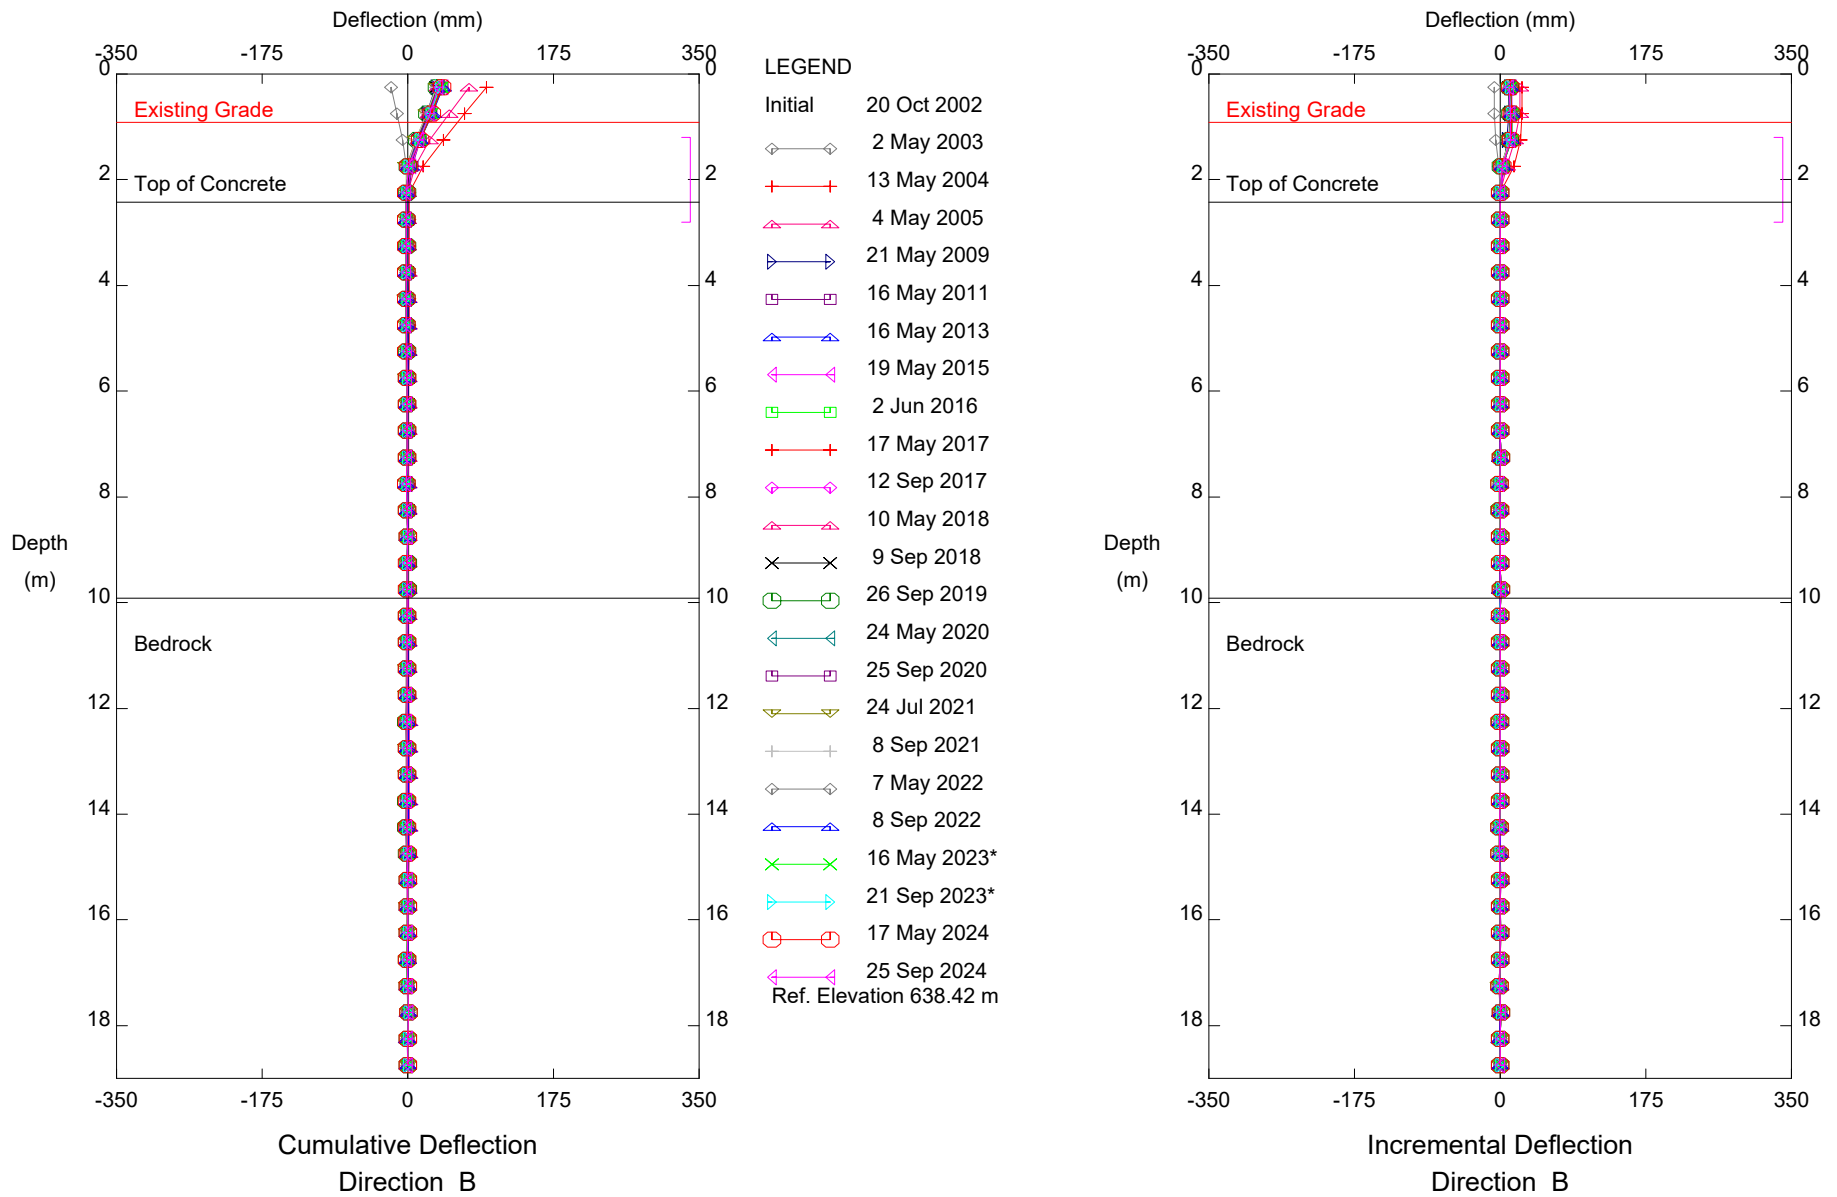
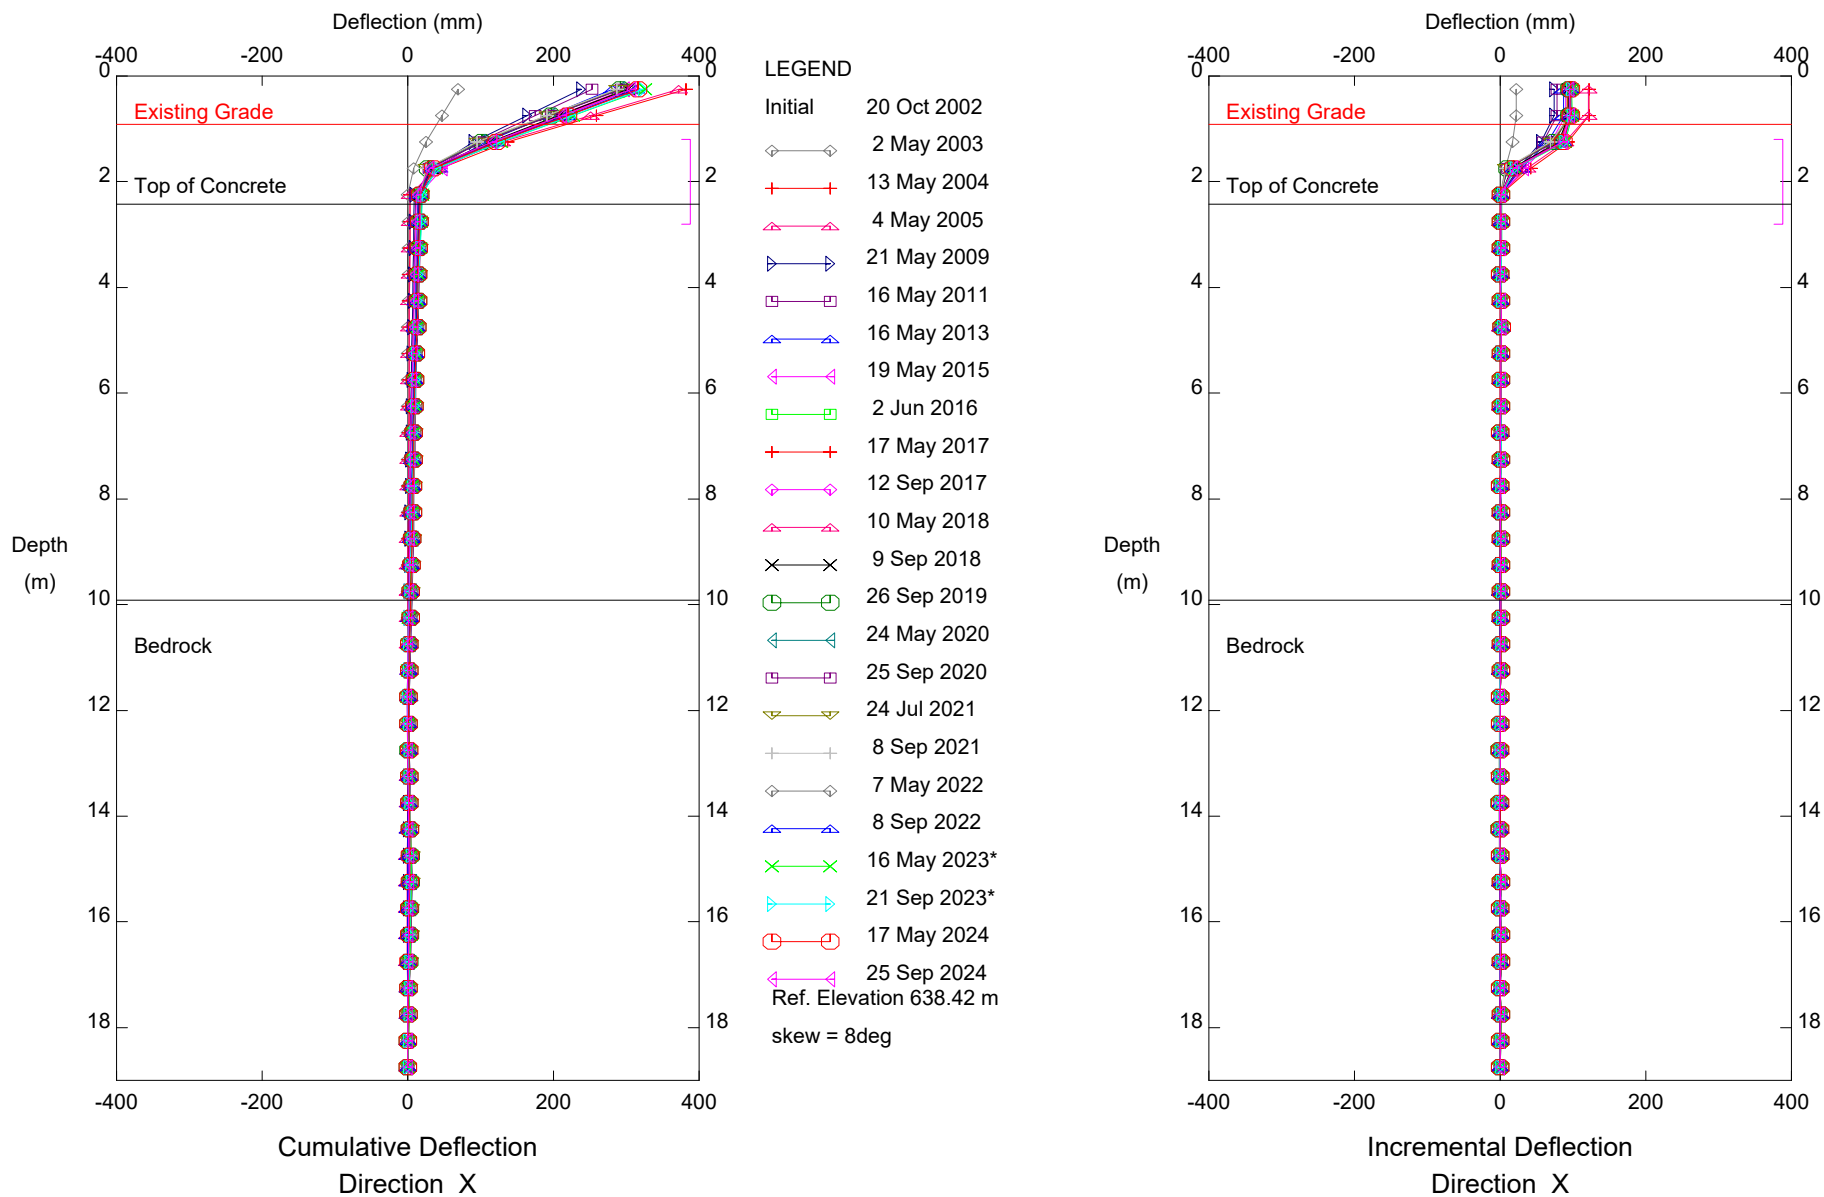
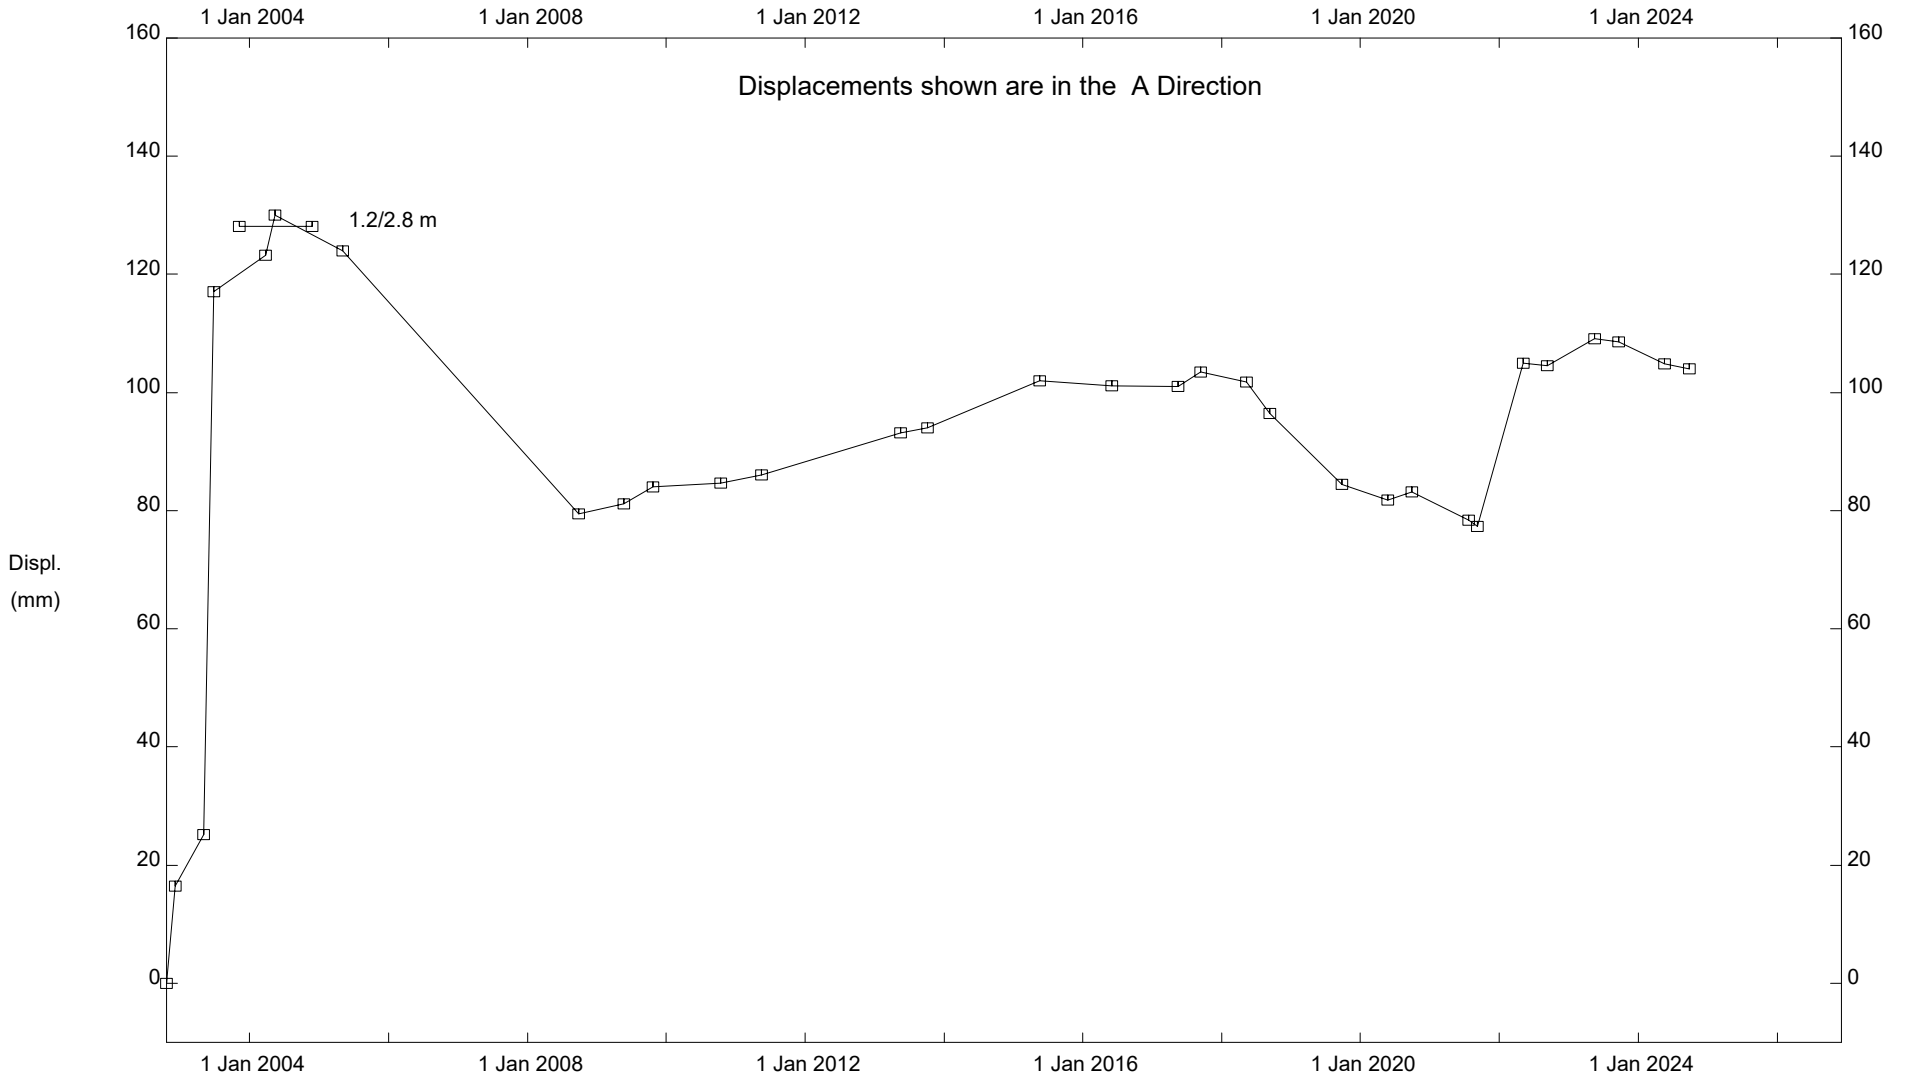
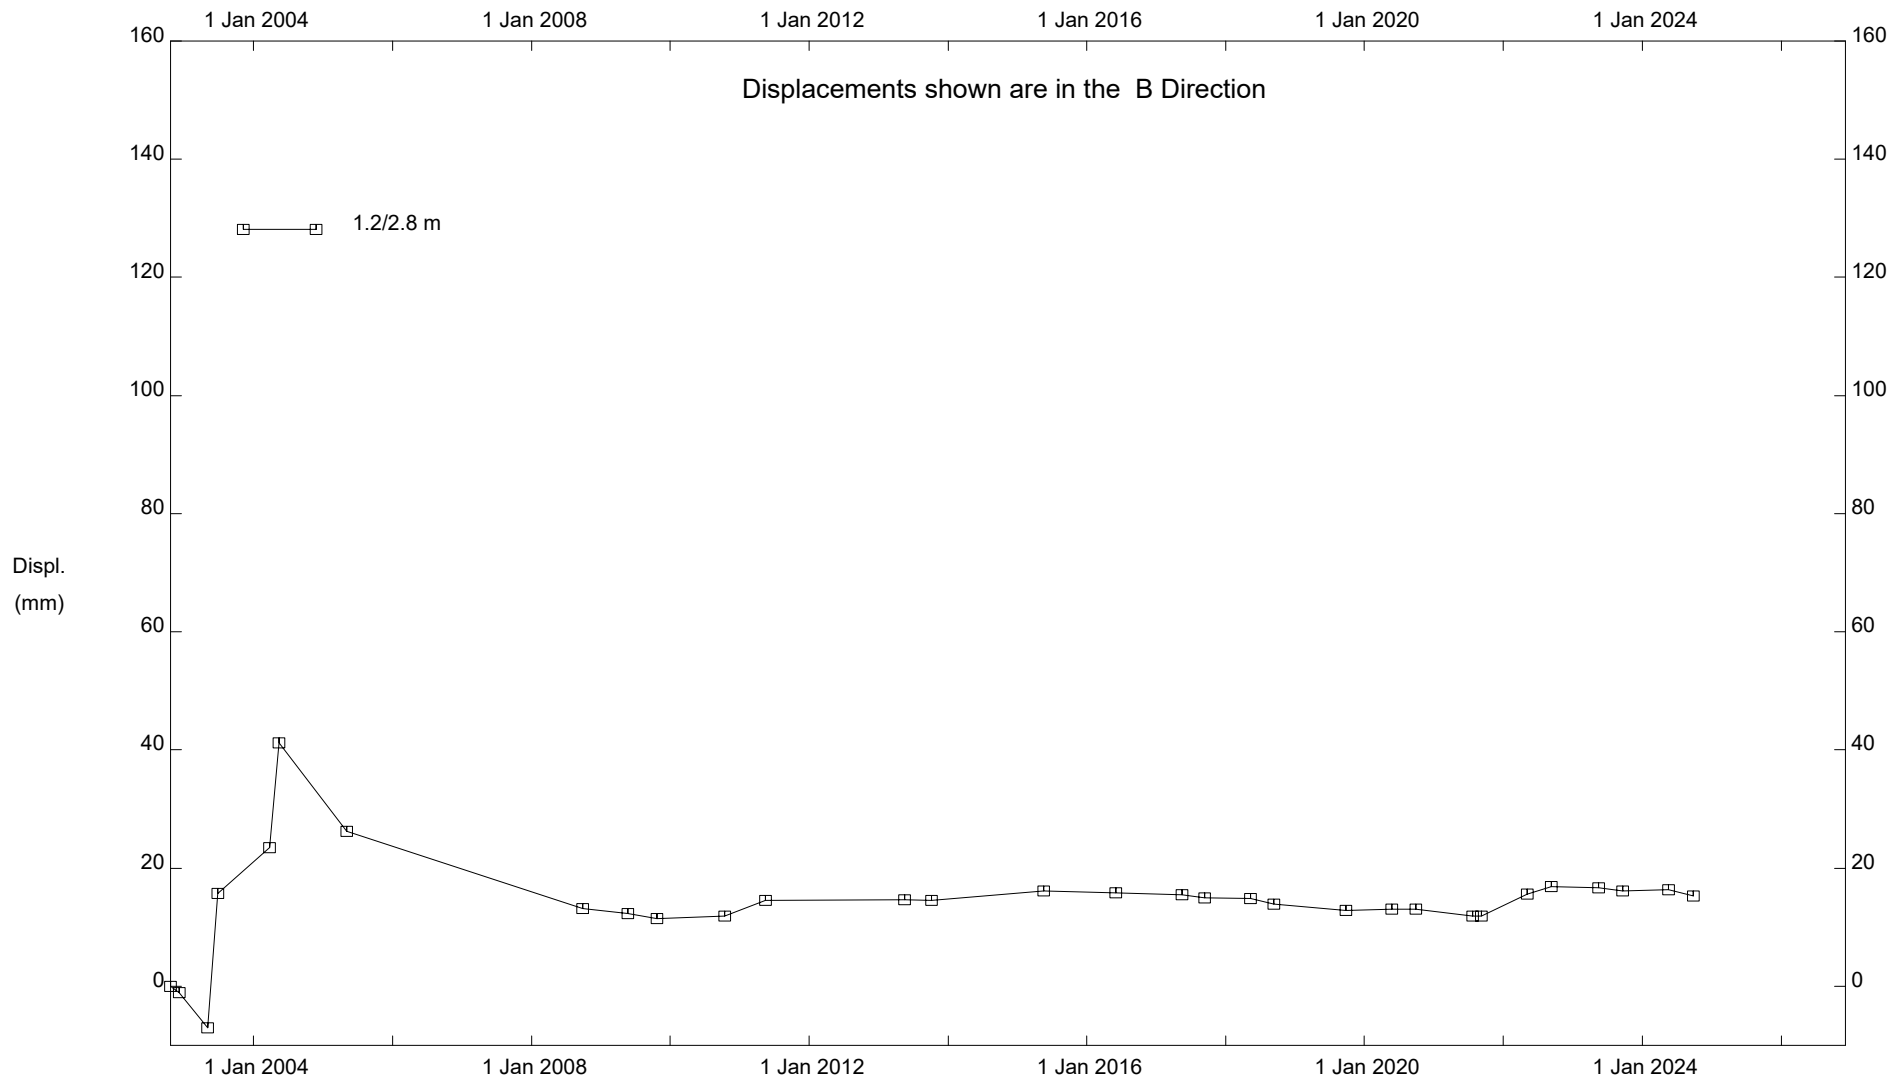
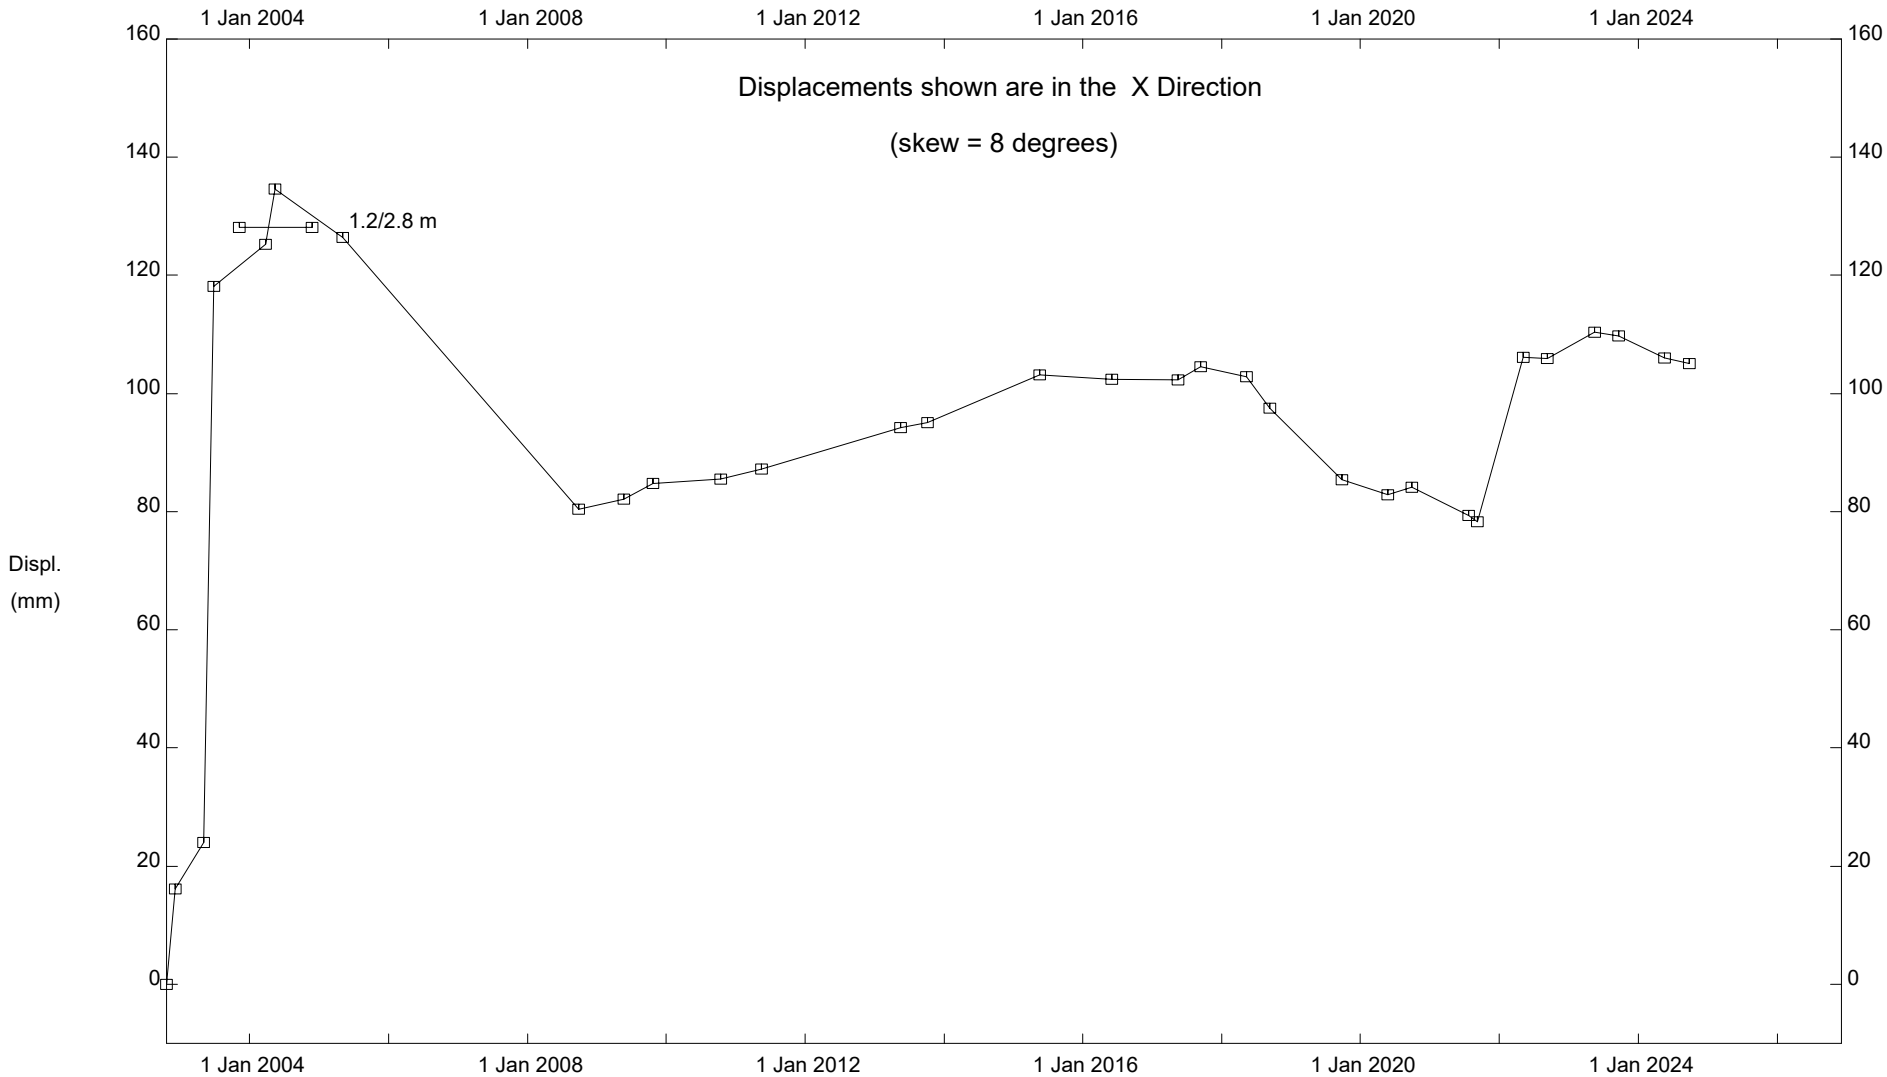
NC67, Inclinometer SI-03

- SI-01 showed little change since the Spring 2024 reading cycle. The current movement rate is about 2 mm/yr.
- SI-03 showed decreasing cumulative movement between 2018 and 2021 before returning to 2018 values. The cumulative movement decreased by 1 mm to 105 mm during the Fall 2024 readings with a rate of movement of 3 mm/yr.
