To:	Amy Driessen	From:	Leslie Cho and Xiteng Liu
	Transportation and Economic Corridors		Stantec Consulting Ltd.
File:	123315222	Date:	October 18, 2024

Reference: North Central Region, Stony Plain, Site NC067 - Highway 216:06 Anthony Henday Bridge, Fall 2024 Instrumentation Monitoring Report

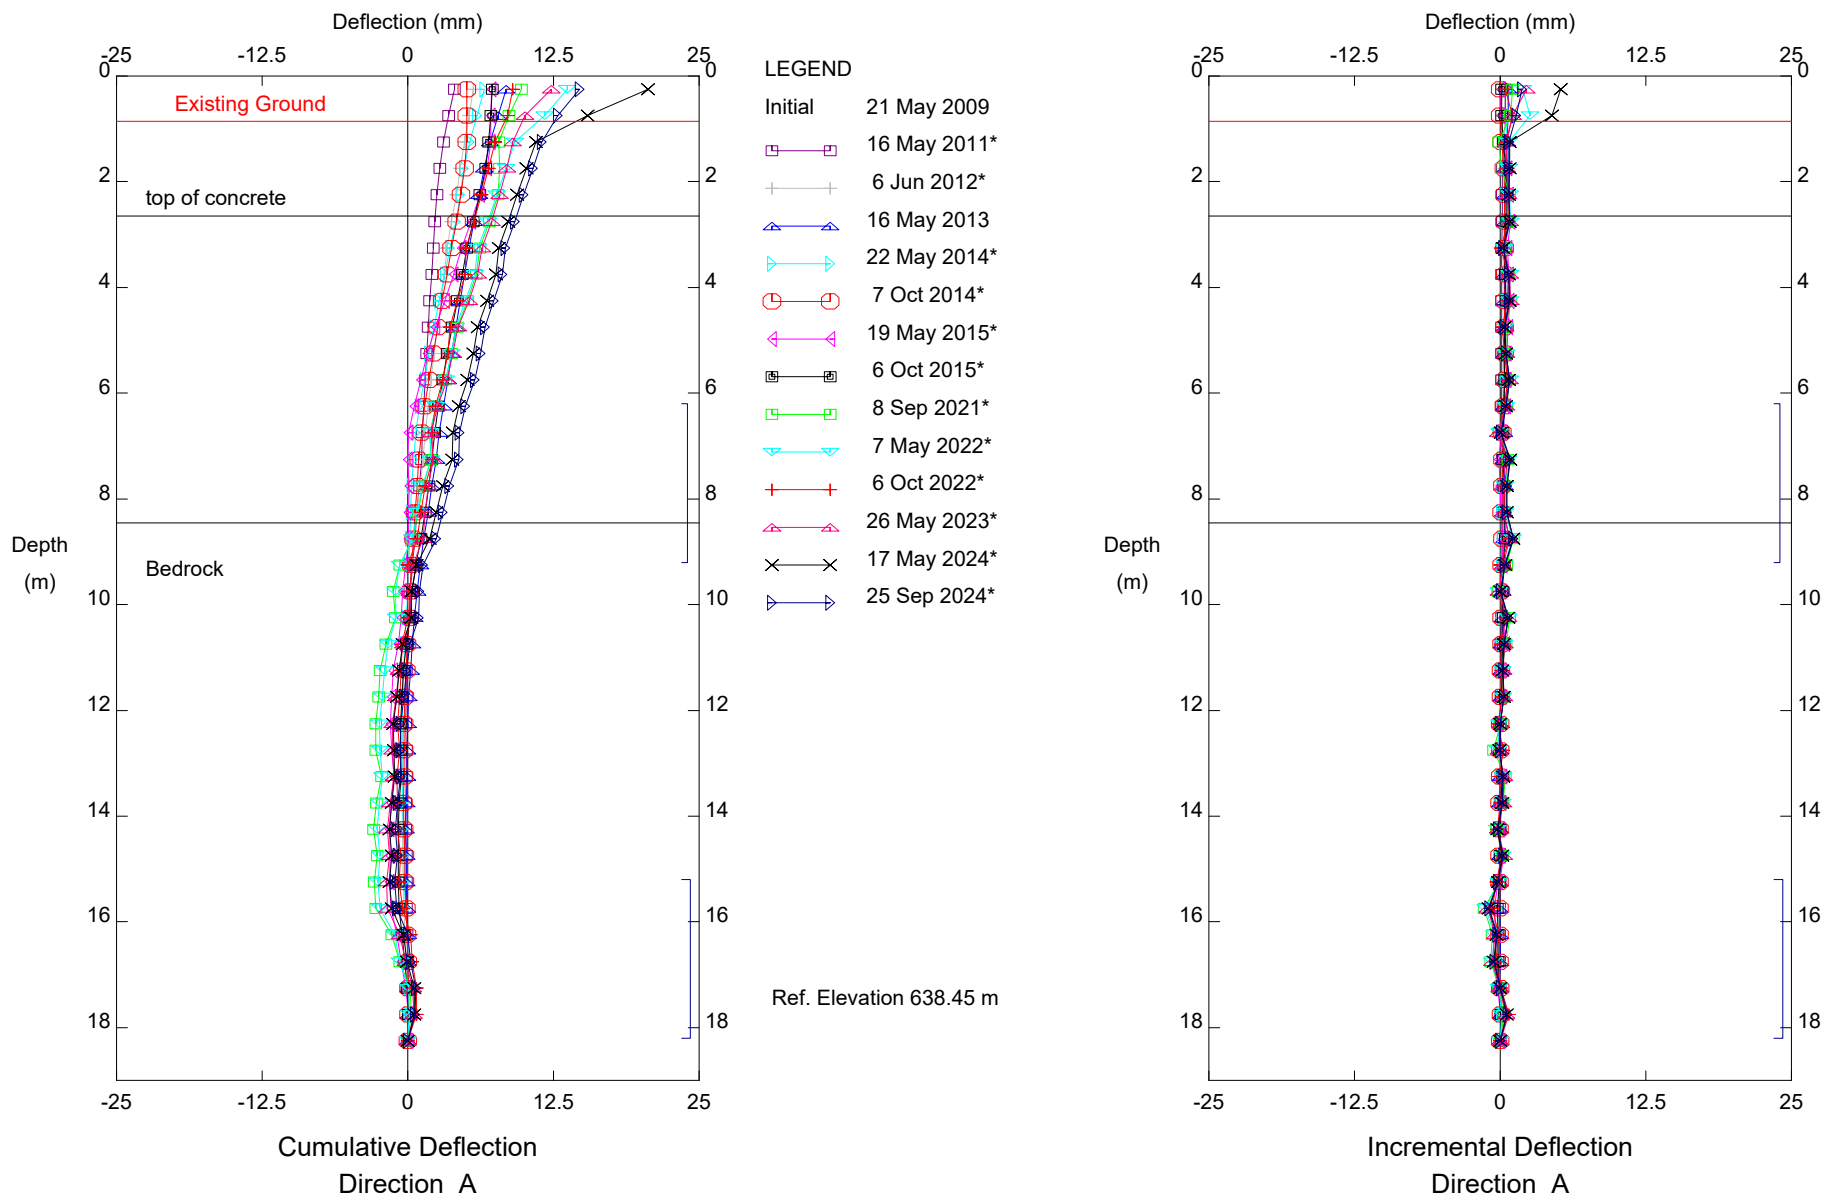
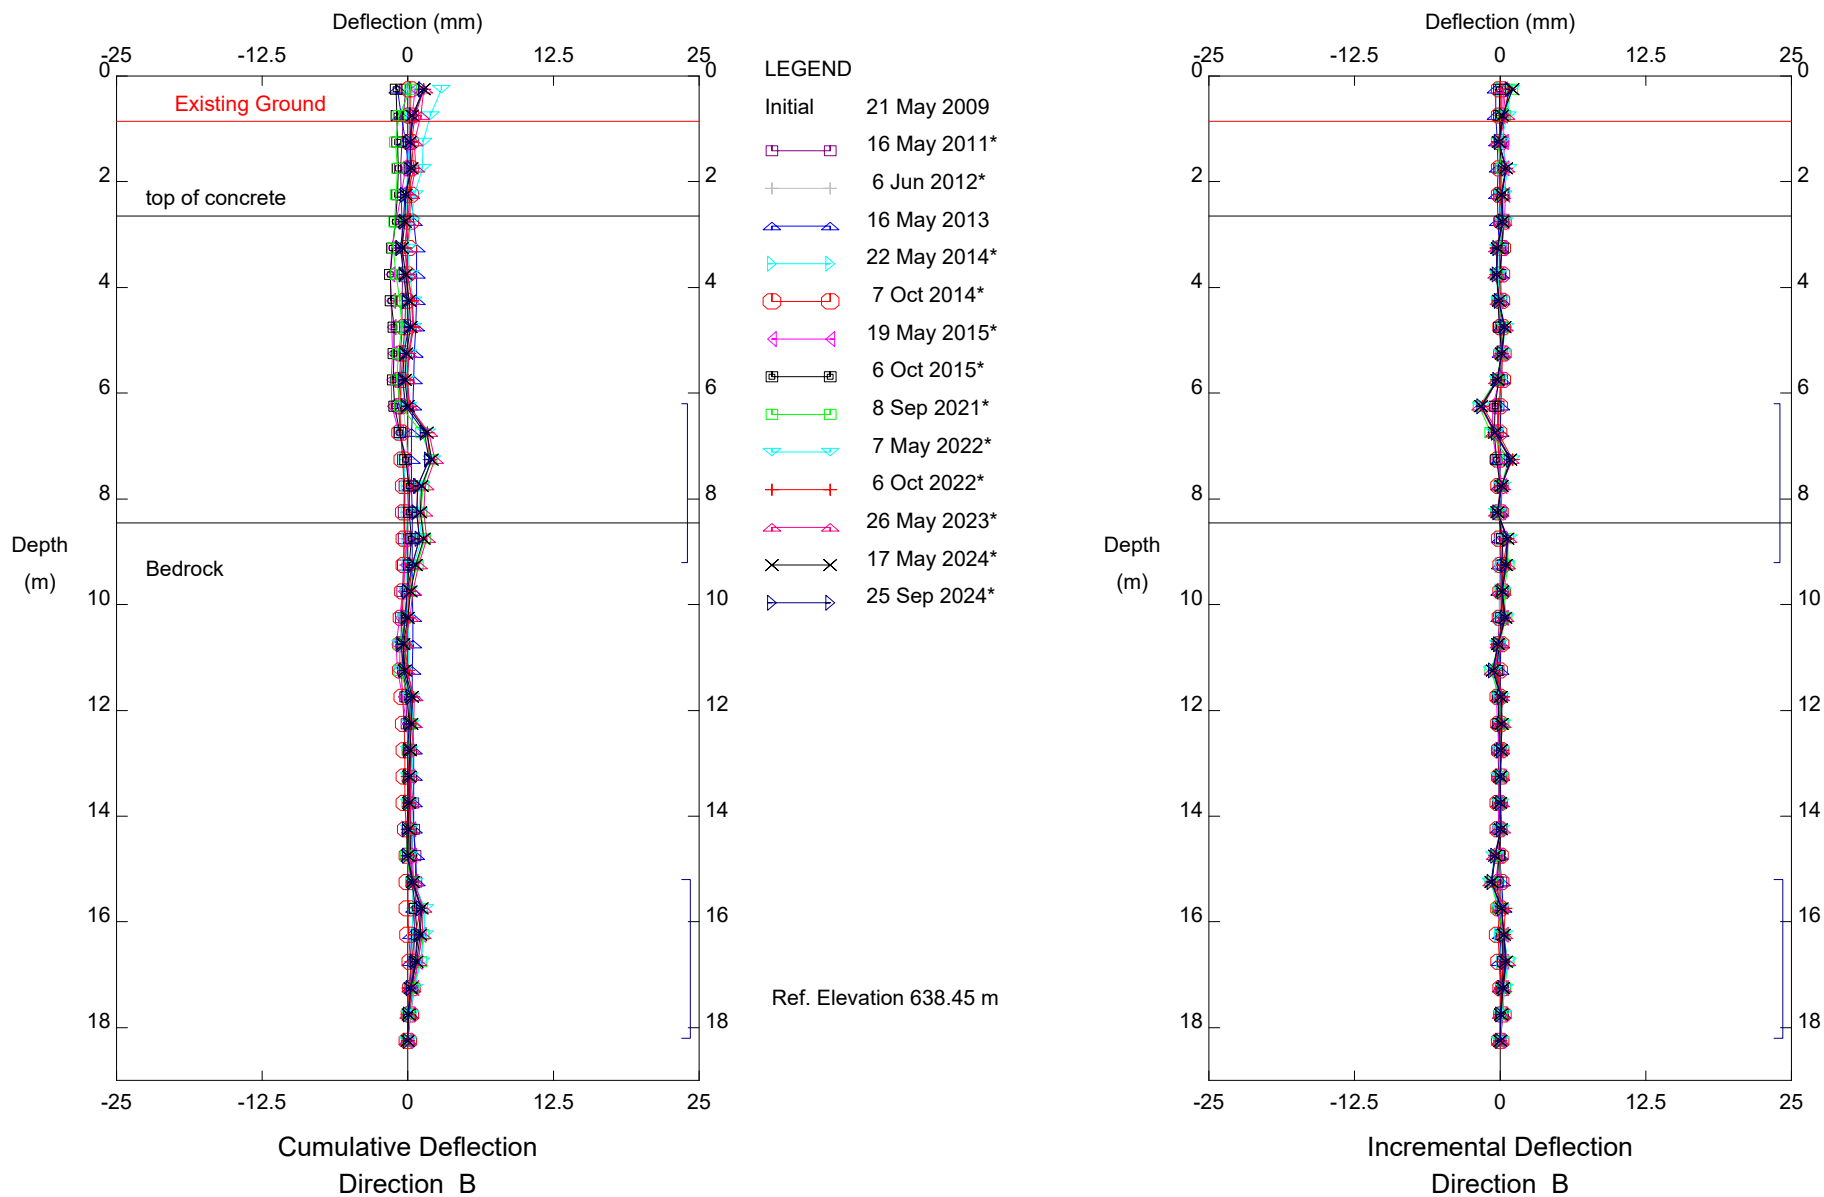
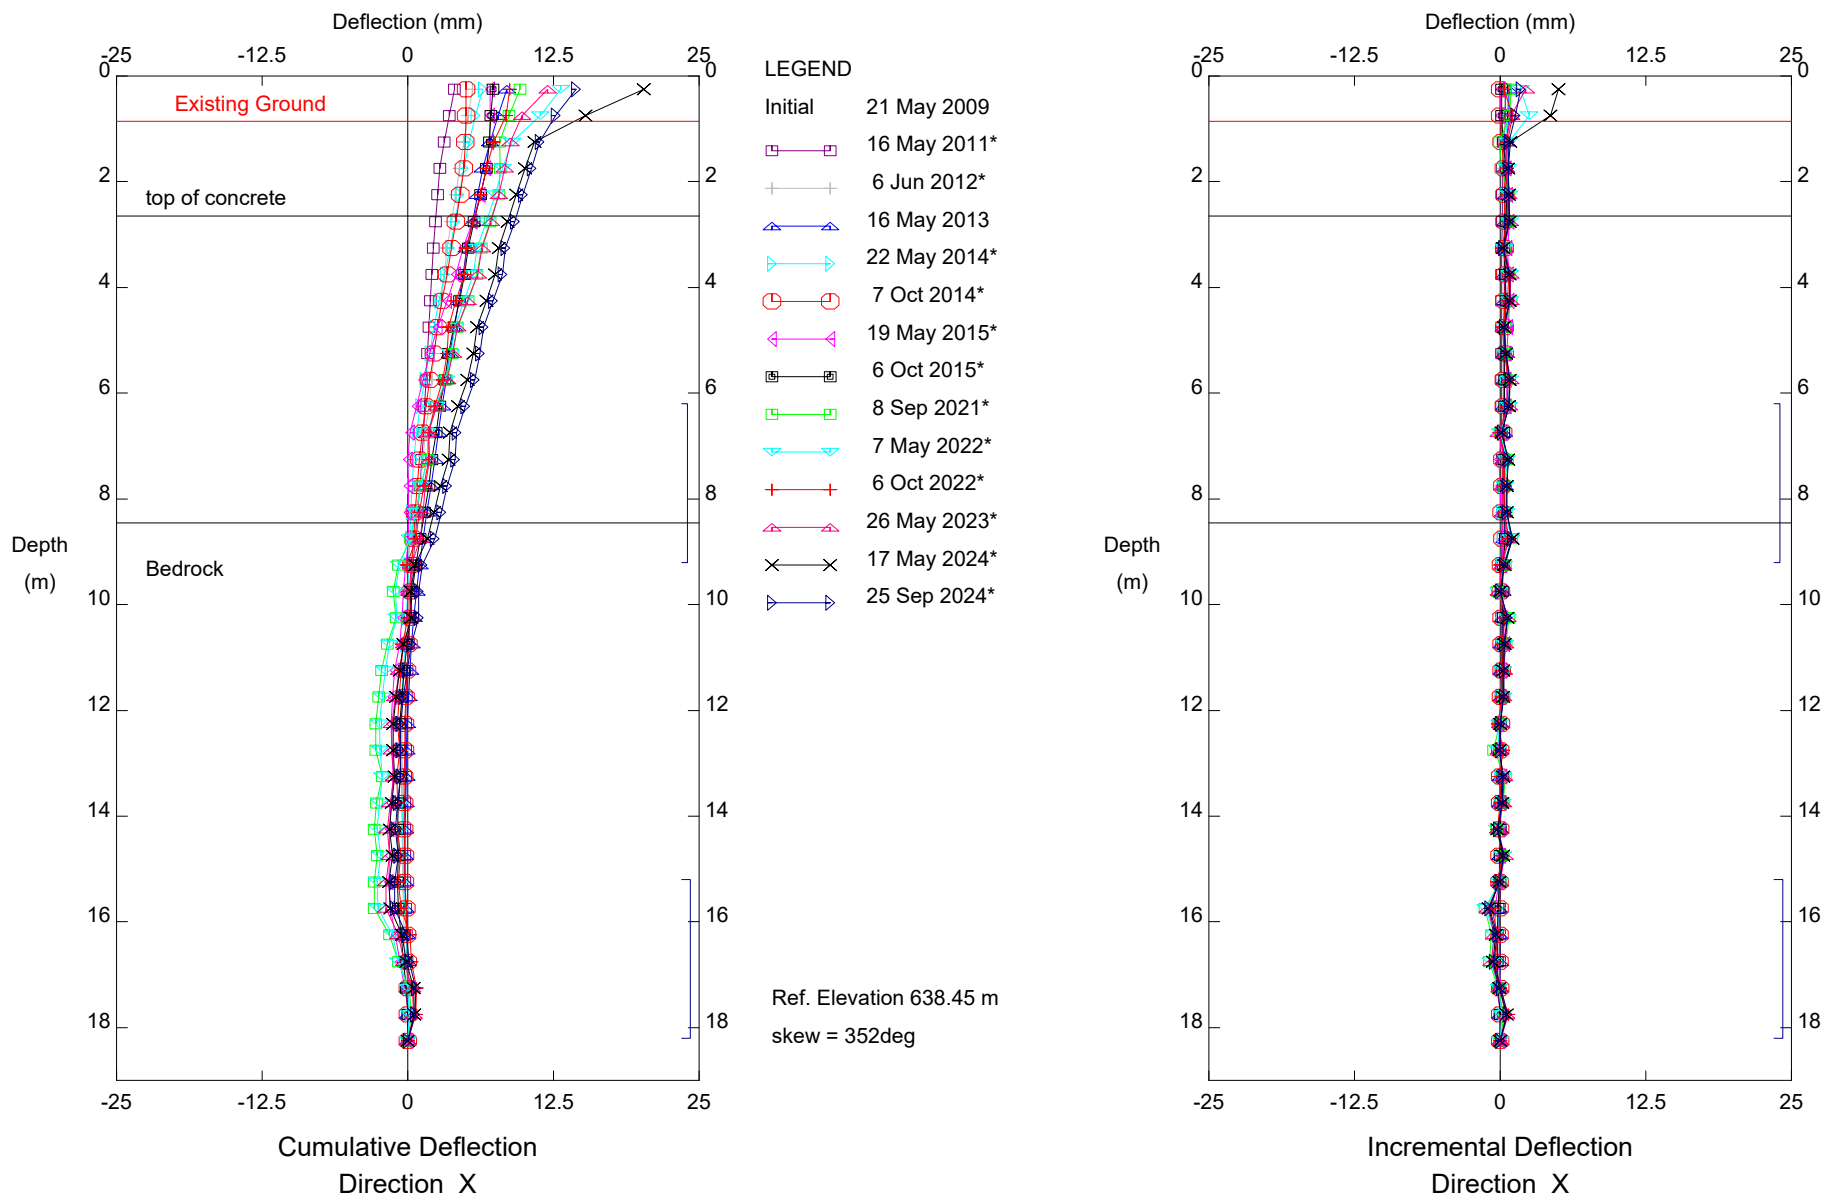
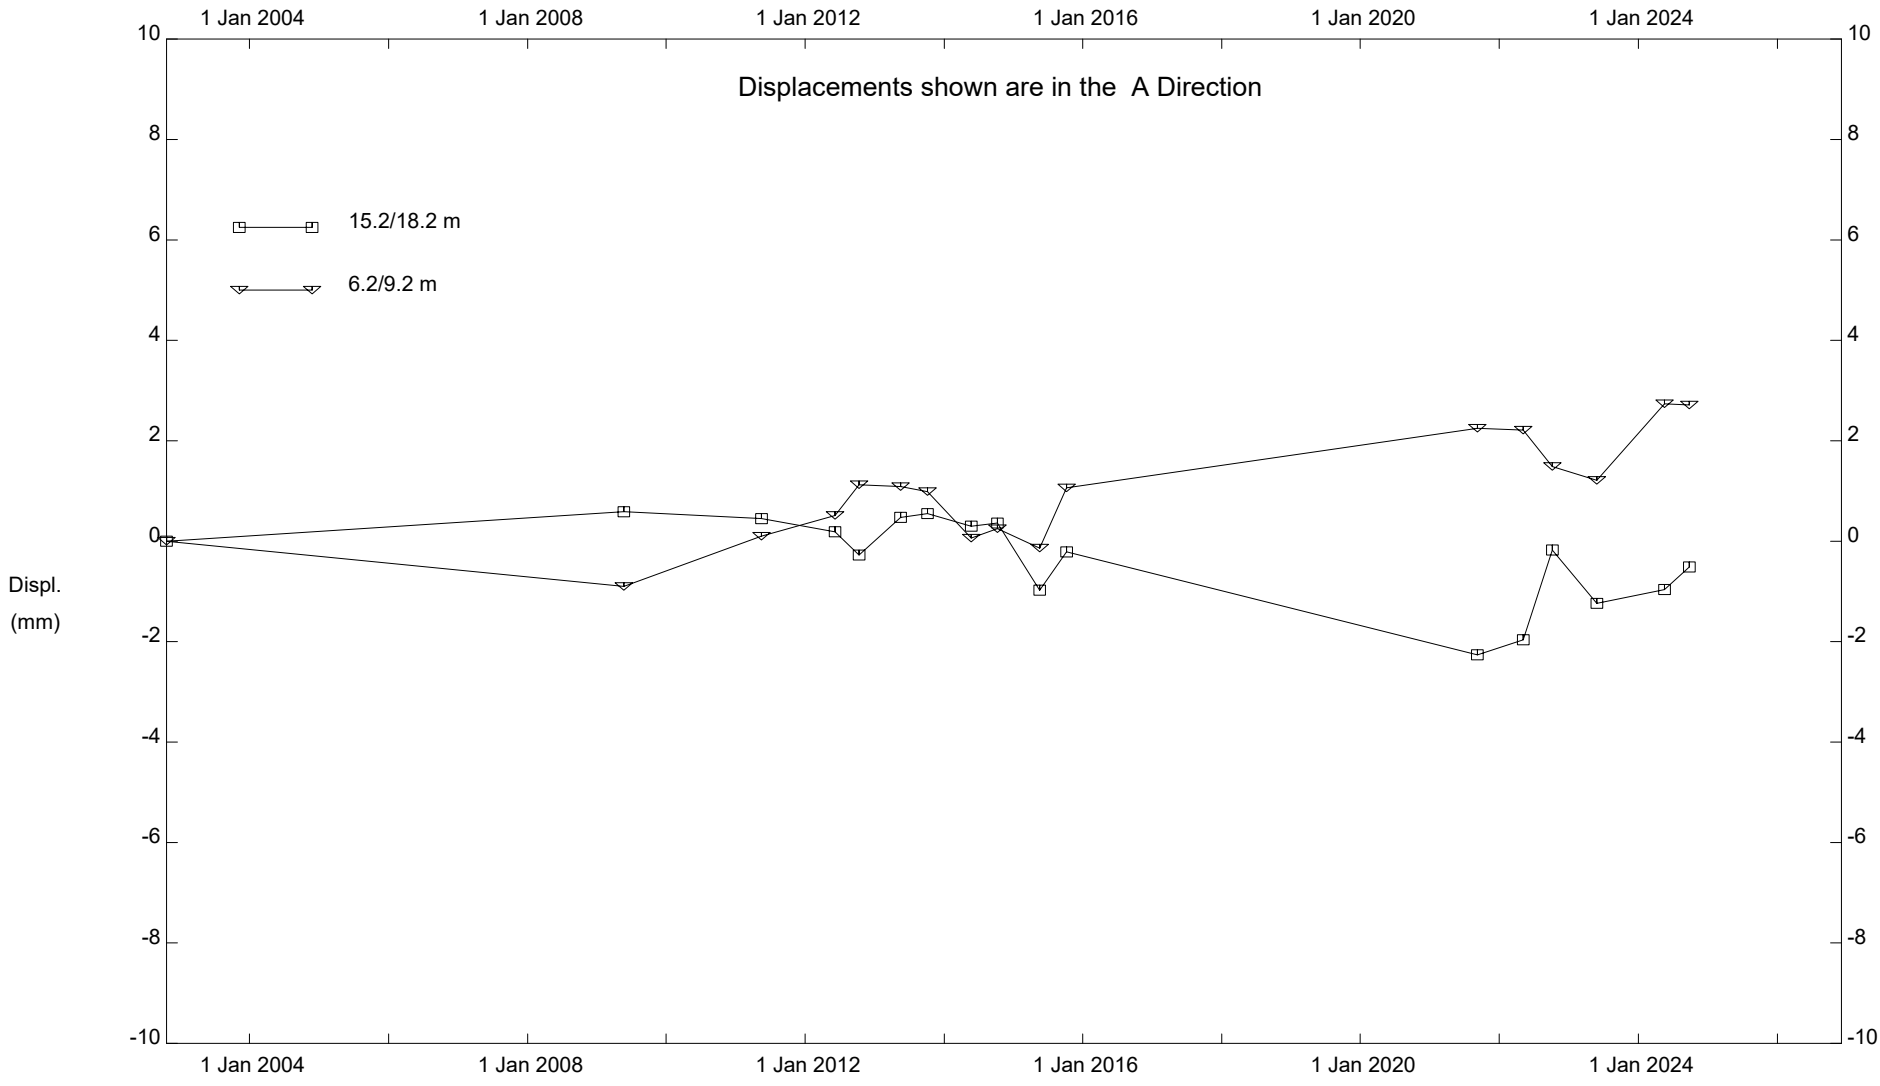
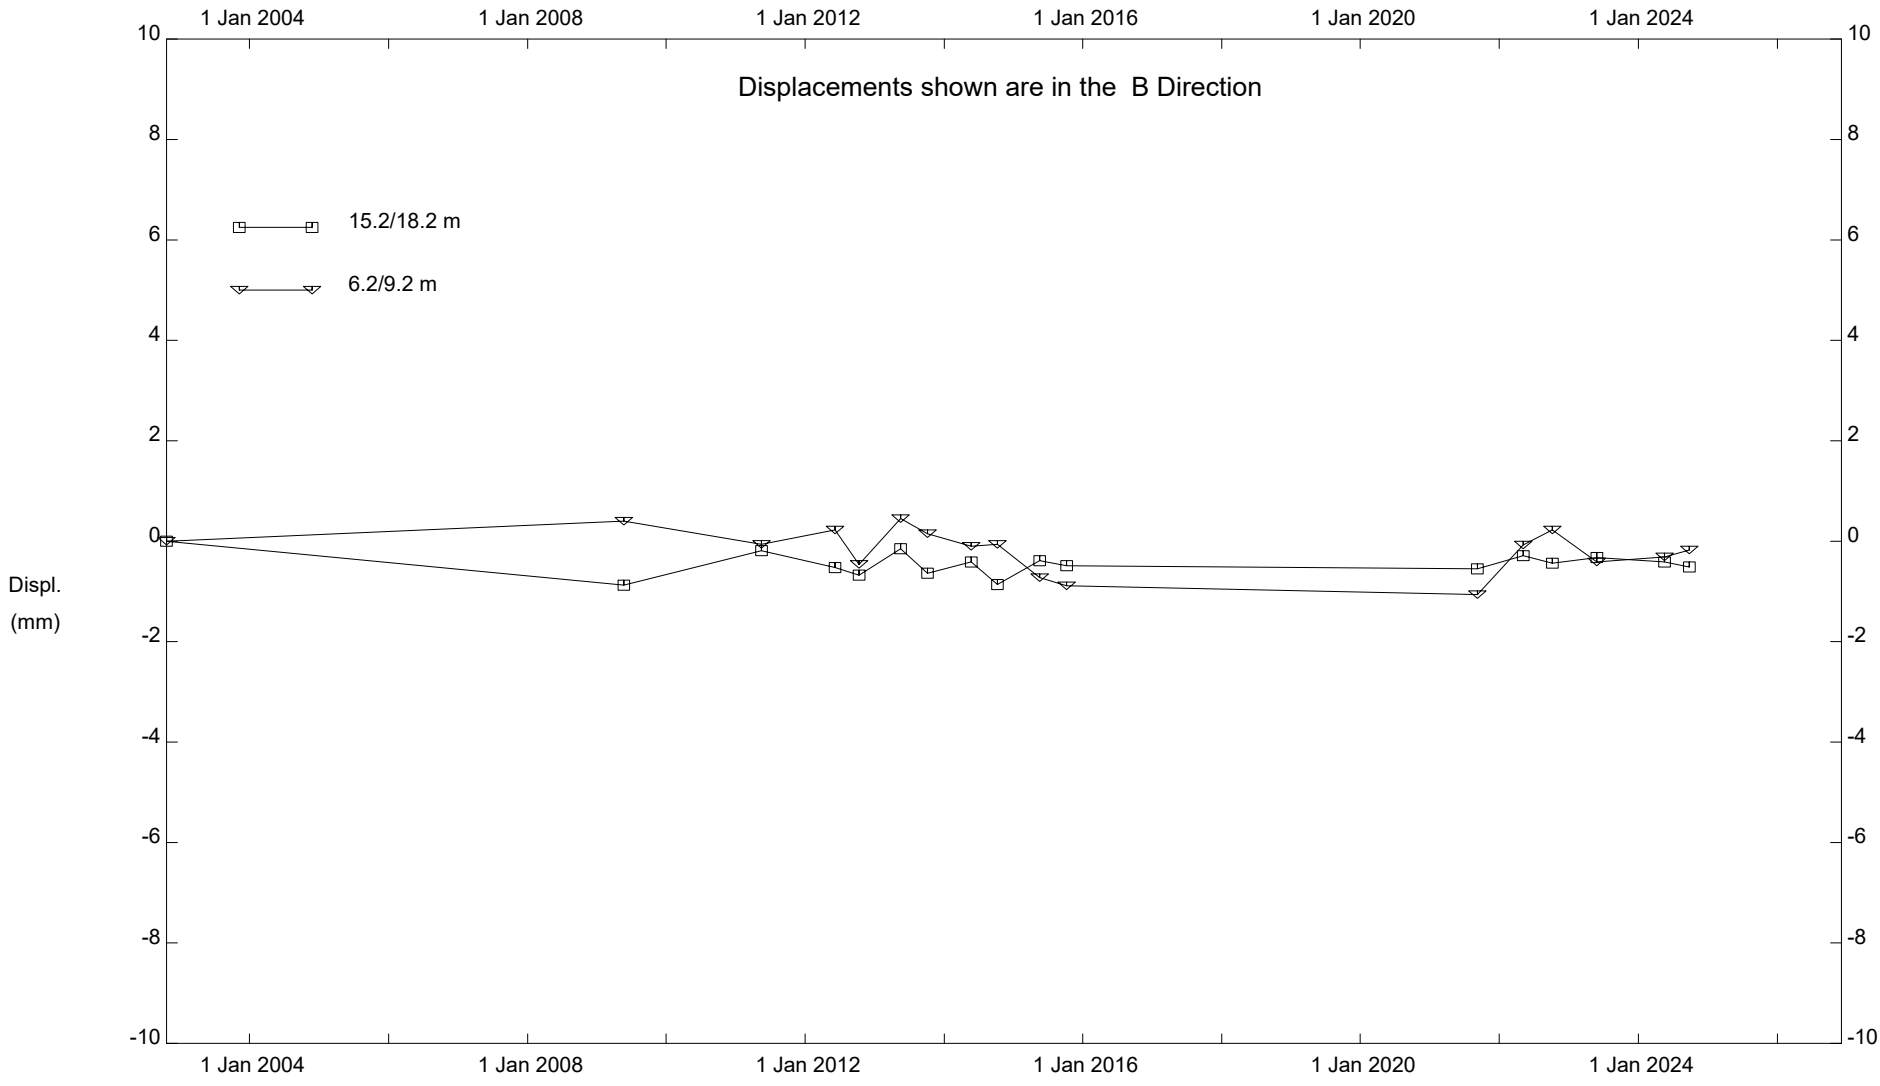
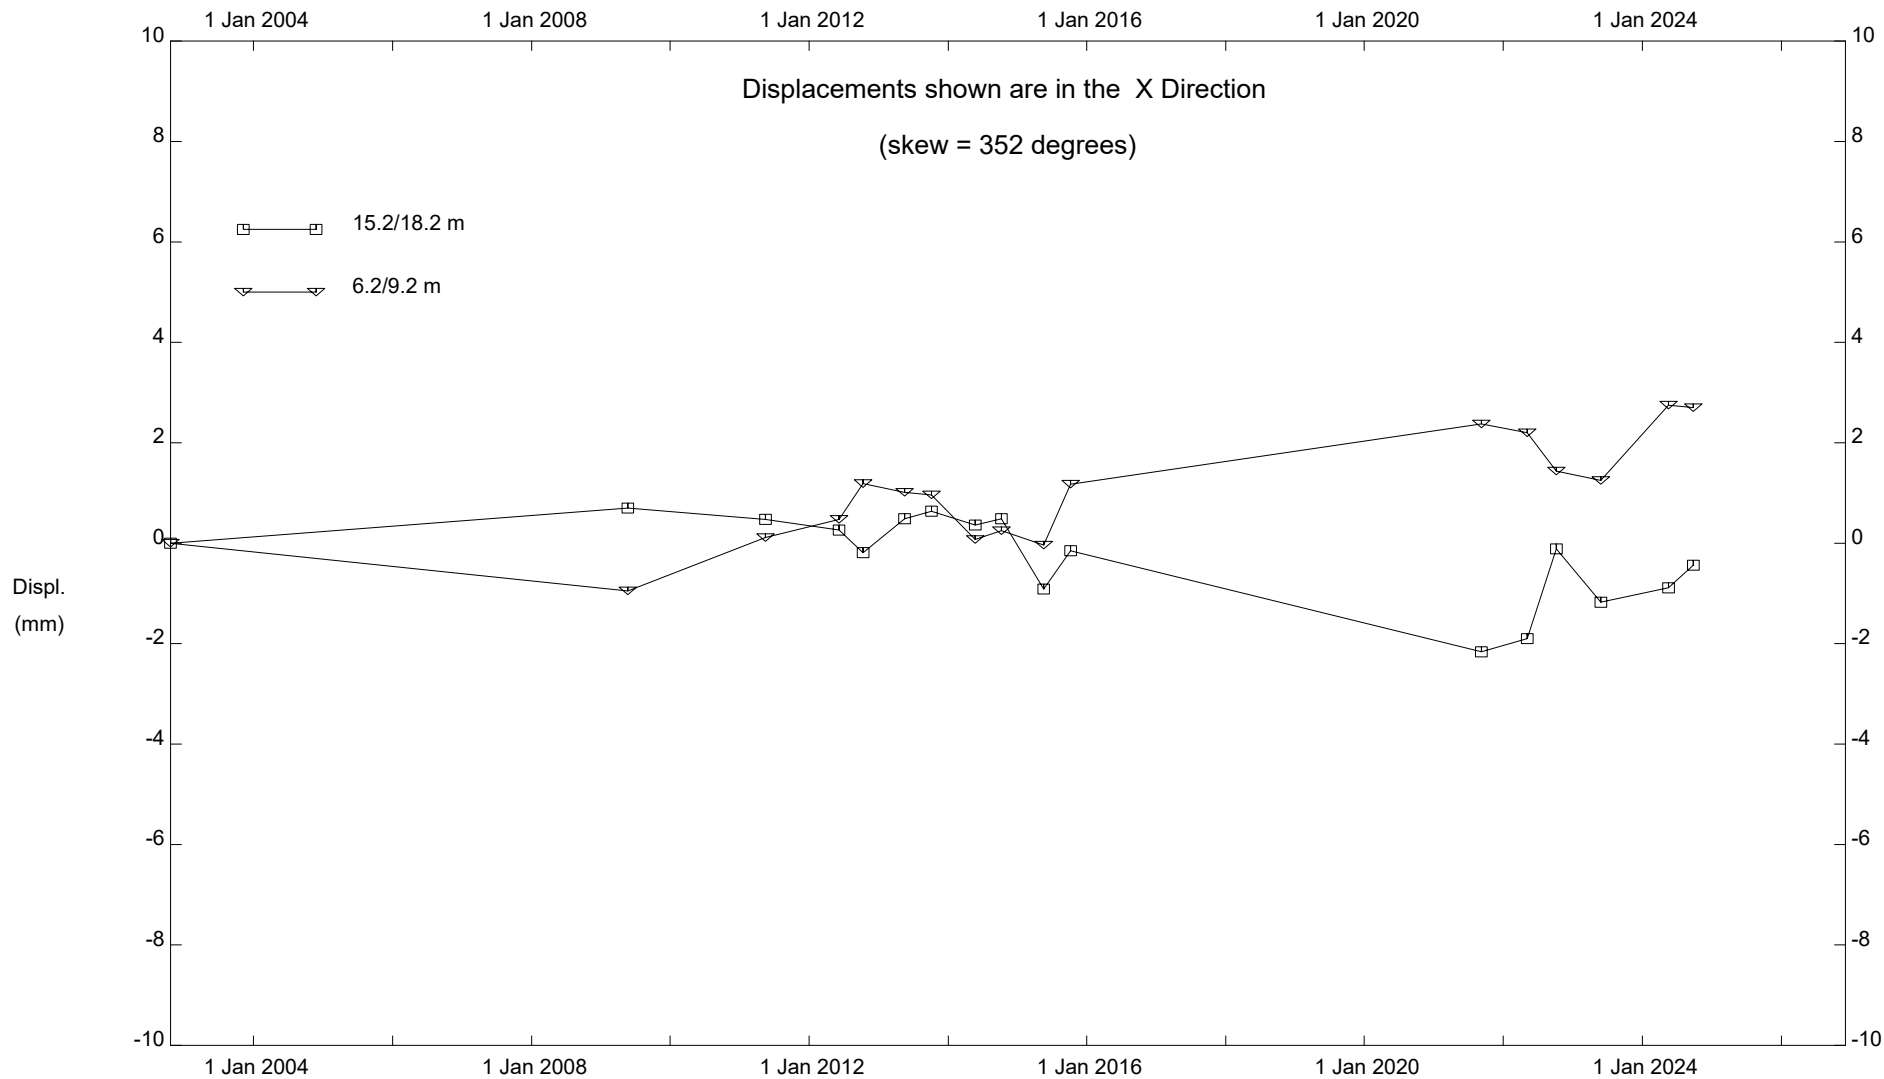
NC67, Inclinometer SI-04

SI-04 has two potential zones of movement. The one between 6.2 m and 9.2 m has a movement rate of less than 1 mm/yr and a total cumulative movement of 3 mm. The movement zone between 15.2 m and 18.2 m has a movement rate less than 1 mm/yr and a total cumulative movement of less than 1 mm.
