To:	Amy Driessen	From:	Leslie Cho and Xiteng Liu
	Transportation and Economic Corridors		Stantec Consulting Ltd.
File:	123315222	Date:	October 18, 2024

Reference: North Central Region, Stony Plain, Site NC067 - Highway 216:06 Anthony Henday Bridge, Fall 2024 Instrumentation Monitoring Report

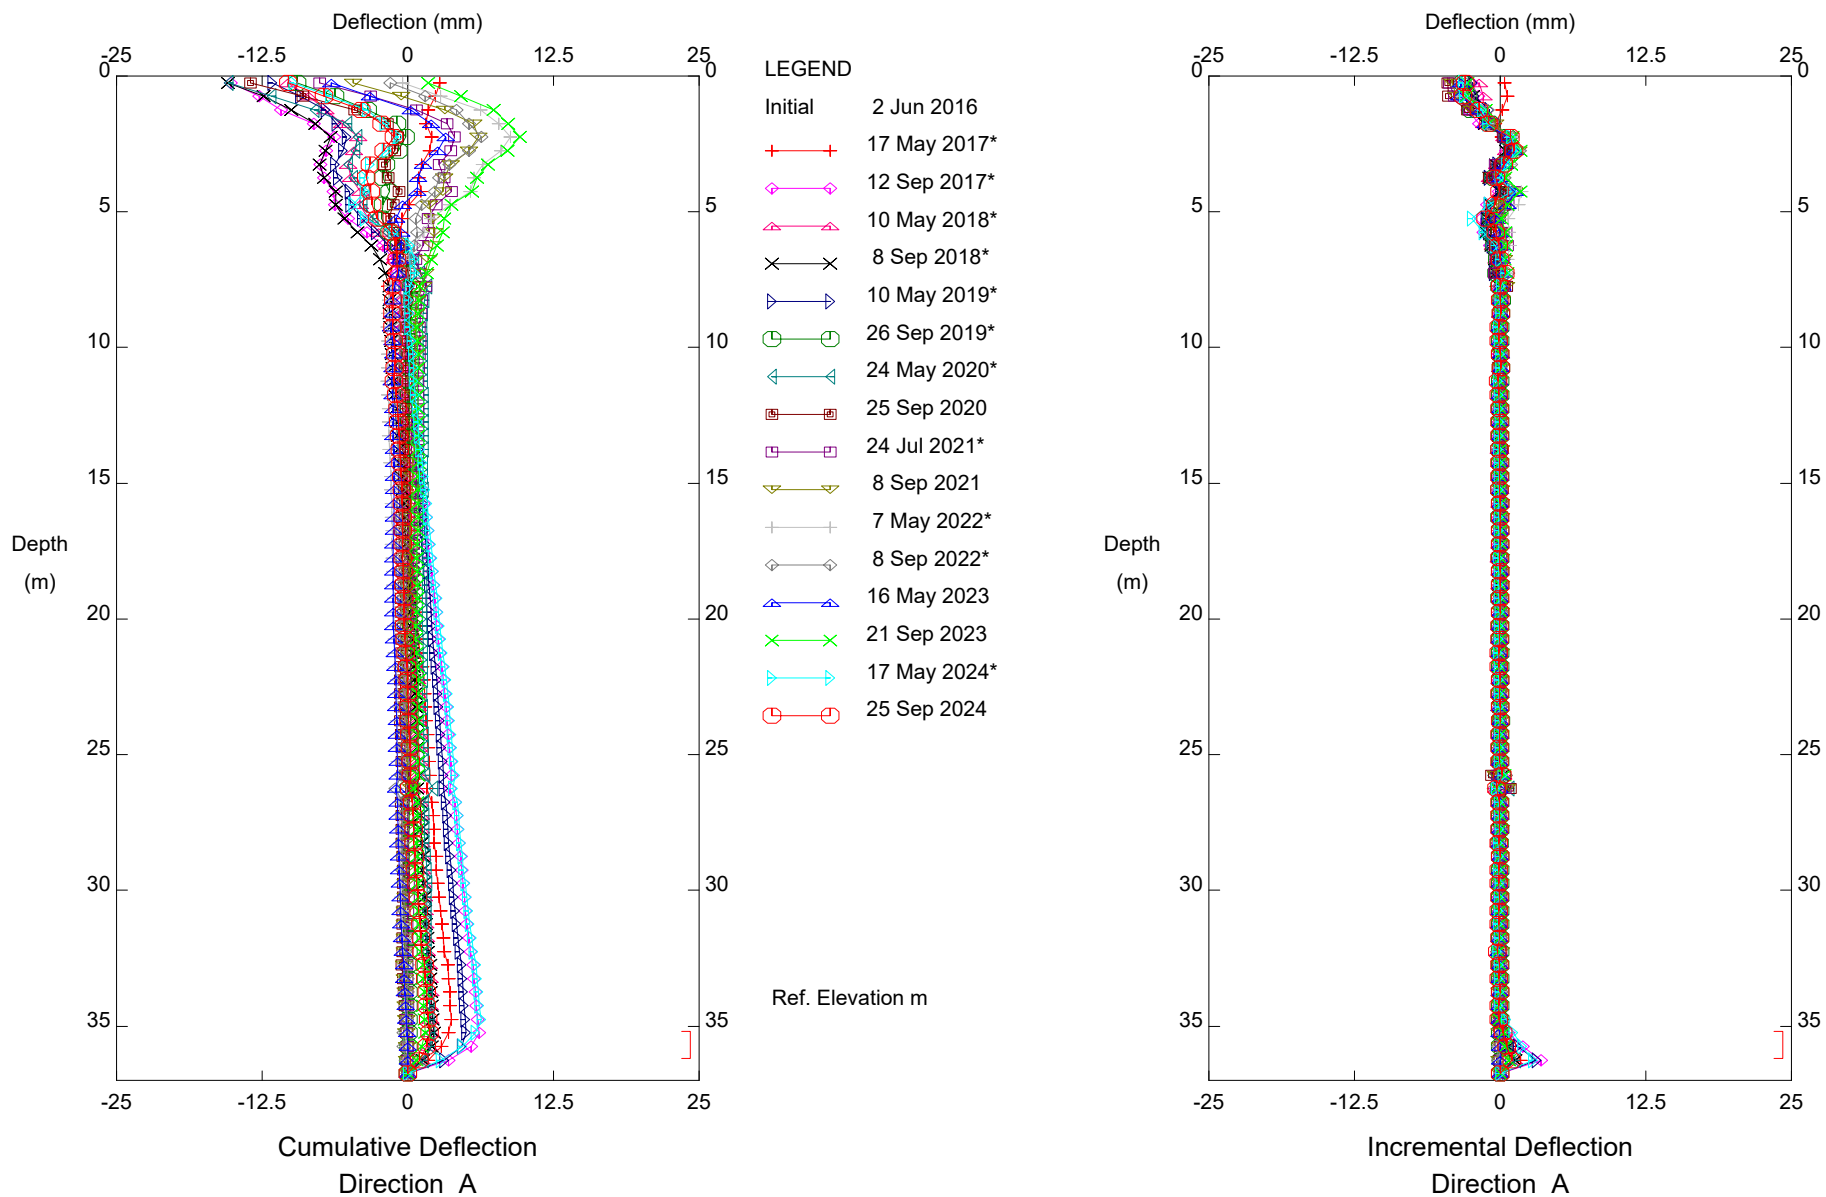
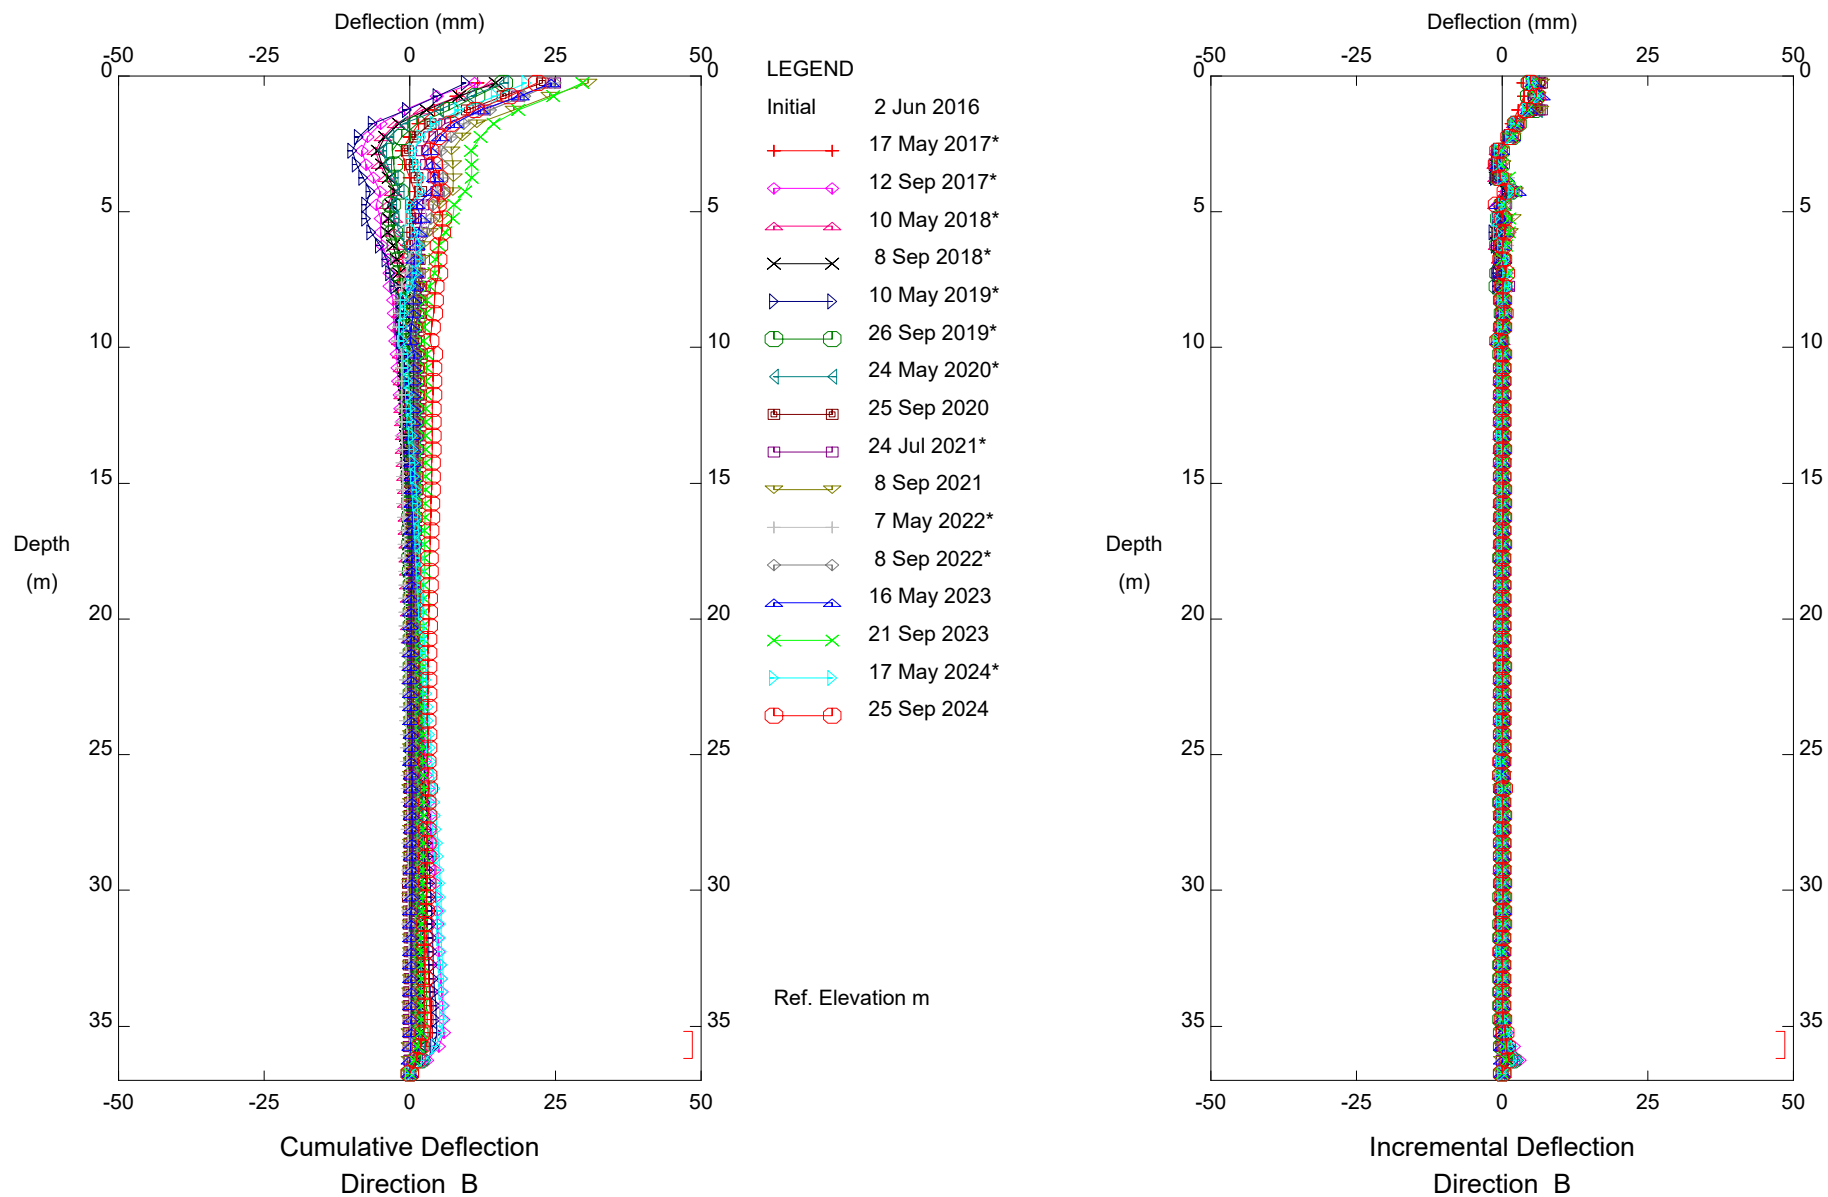
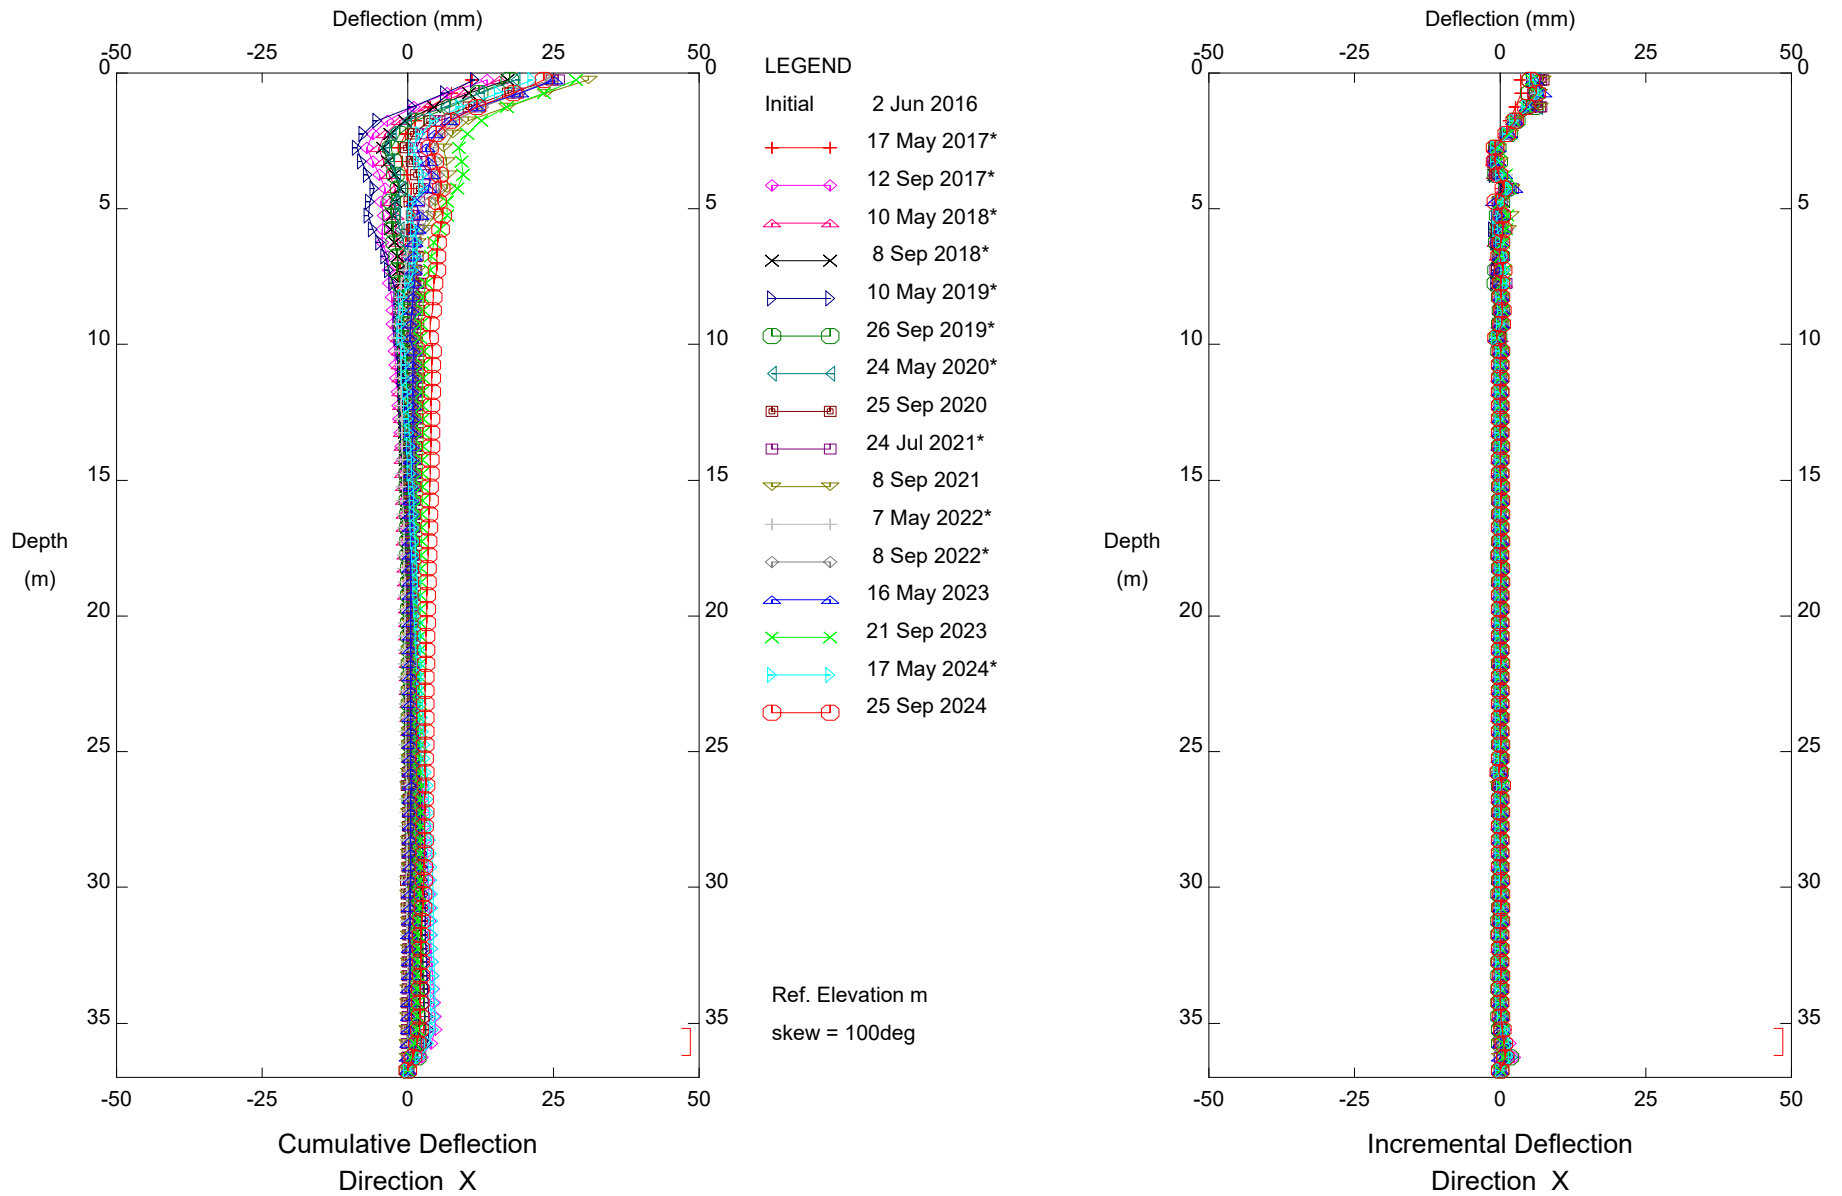
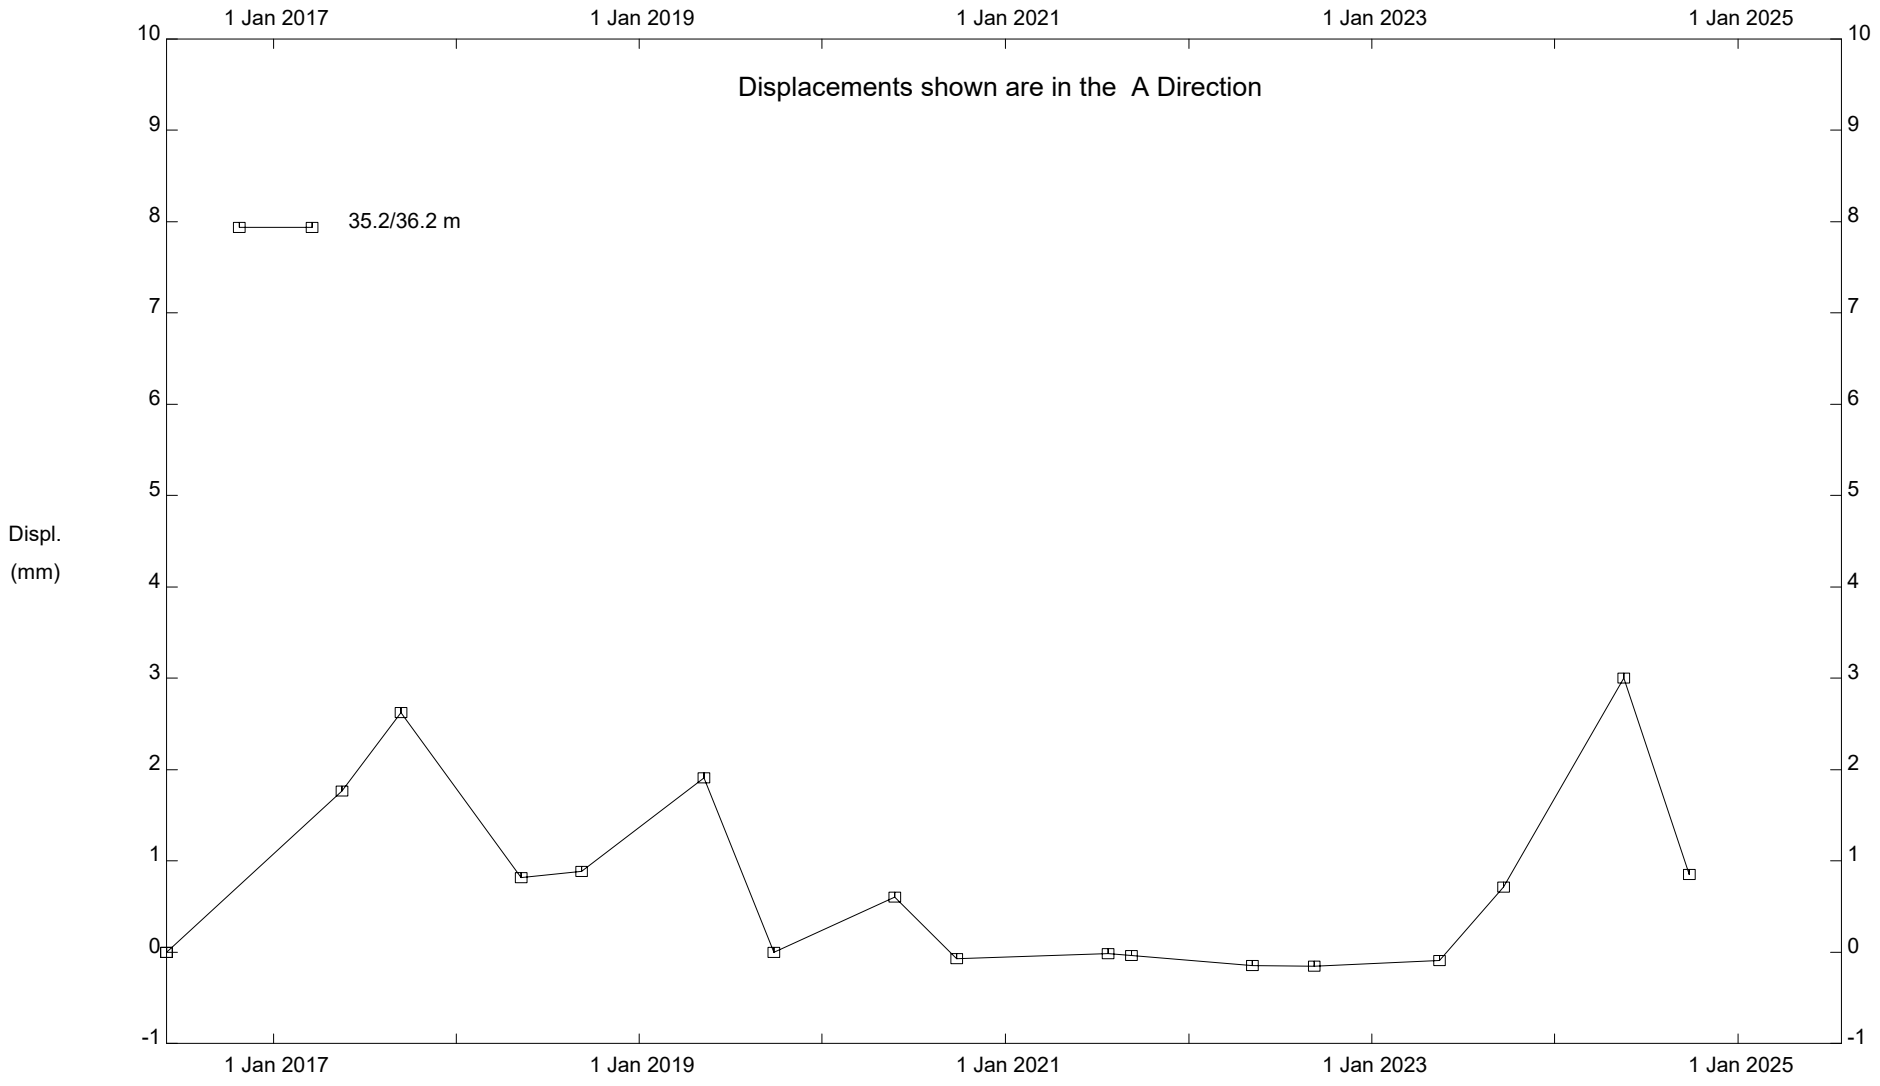
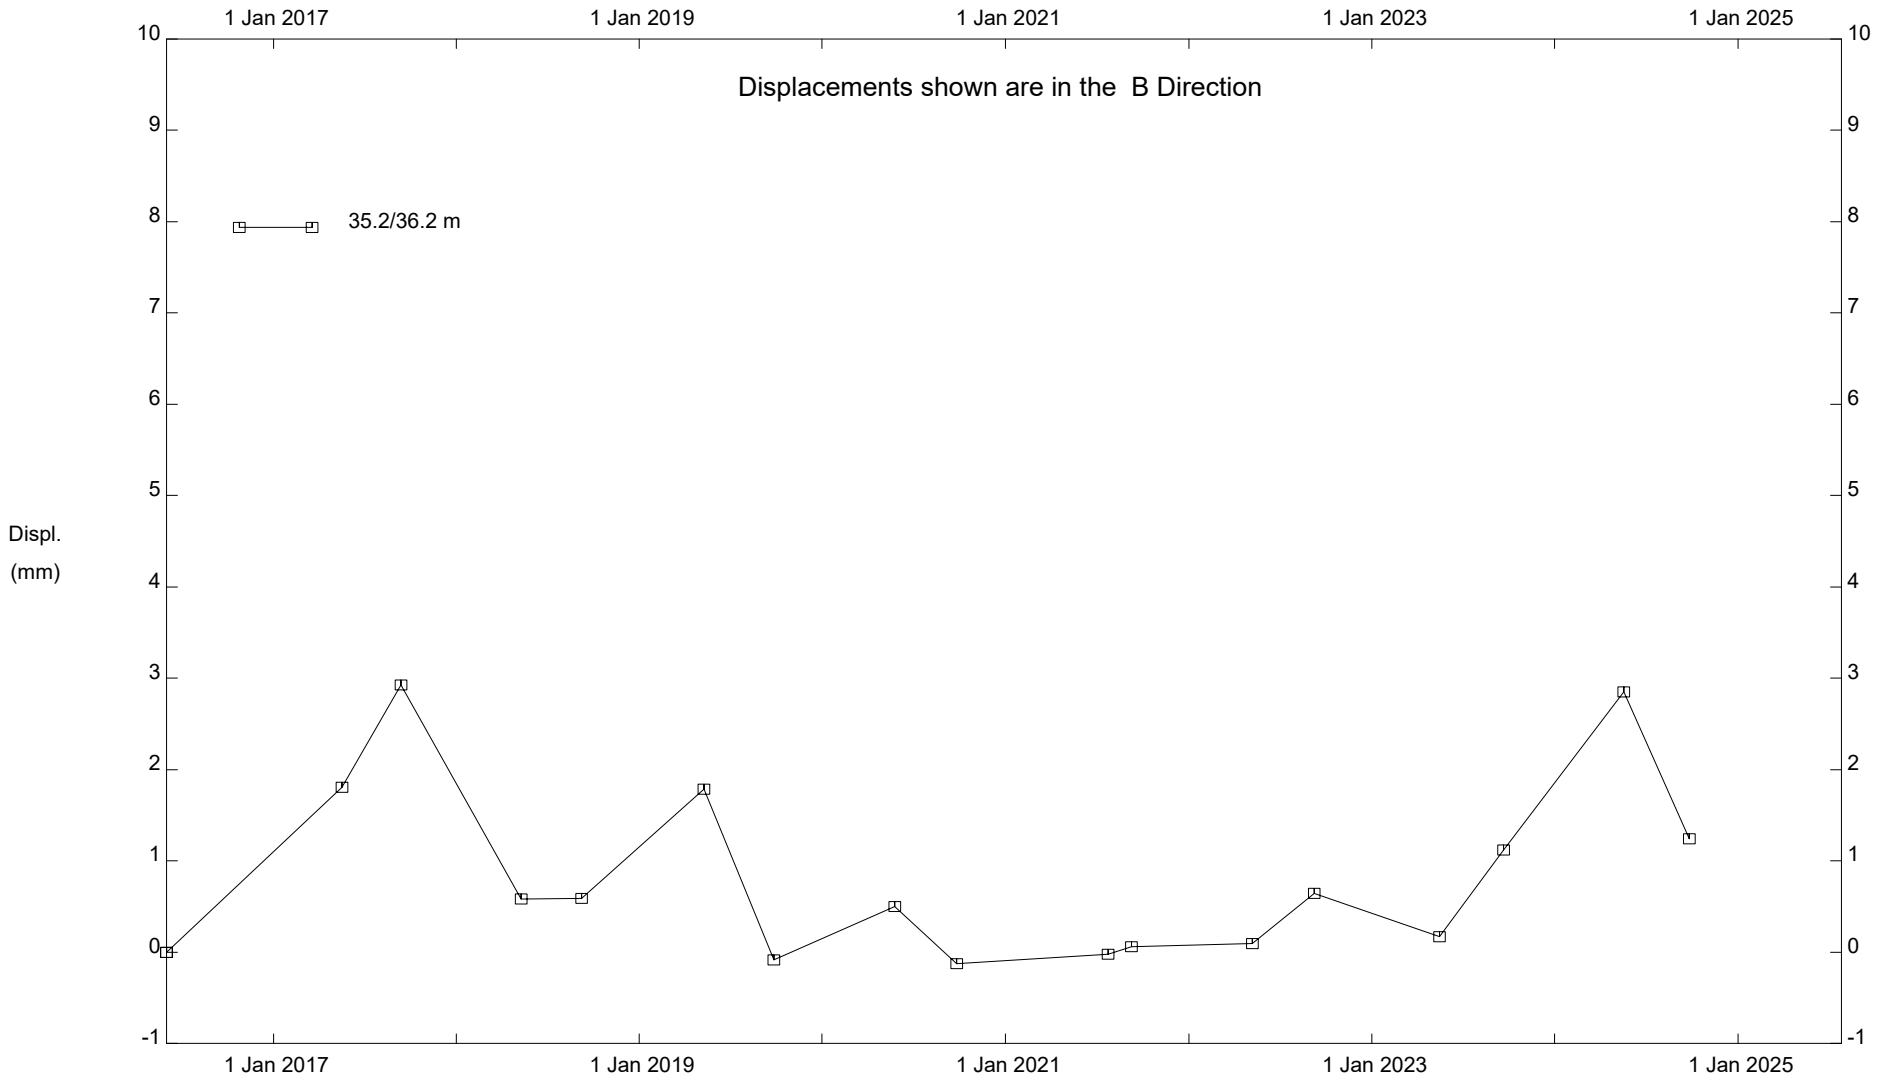
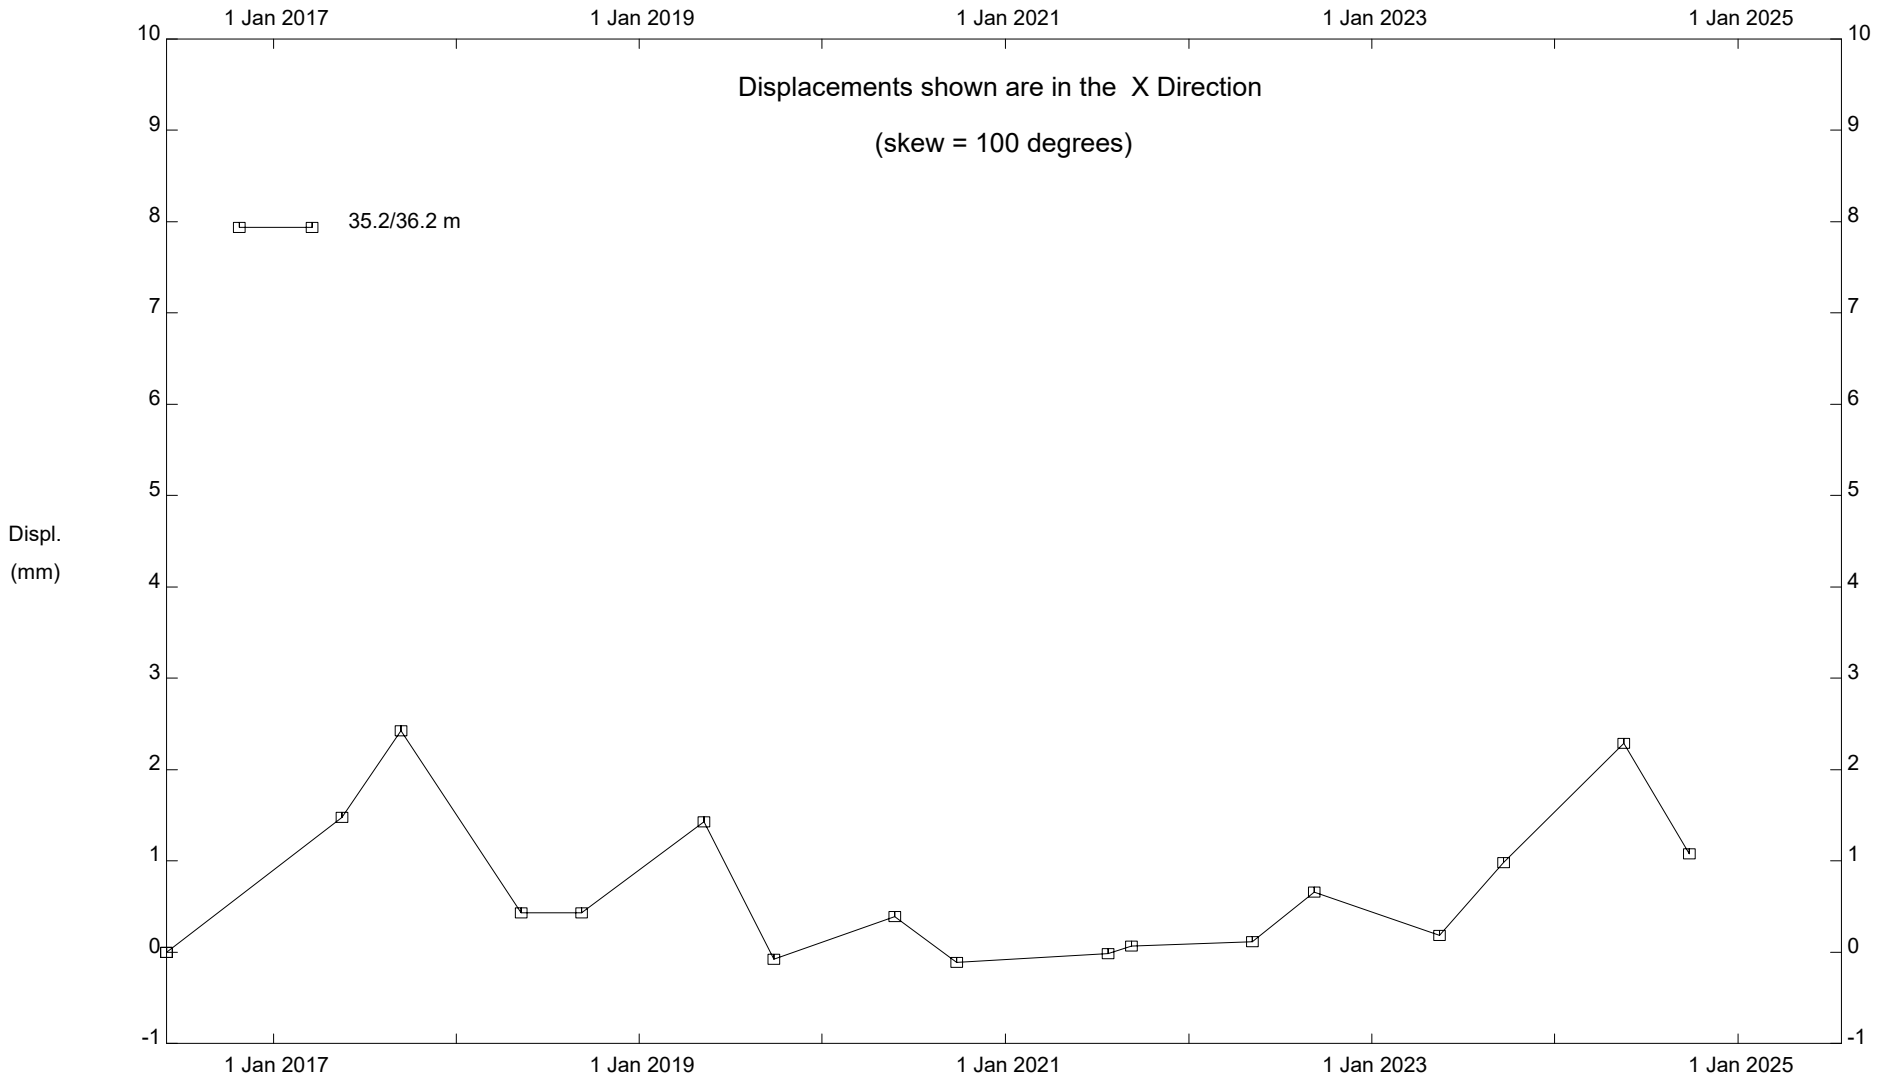
NC67, Inclinometer SI-06

SI-06 has historically shown some erratic movement near the base of the casing. Currently, SI-06 shows a movement rate of about 1 mm/yr with a cumulative movement of 1 mm. Additional readings will be required to confirm slope movement.
