To:	Amy Driessen	From:	Leslie Cho and Xiteng Liu
	Transportation and Economic Corridors		Stantec Consulting Ltd.
File:	123315222	Date:	October 18, 2024

Reference: North Central Region, Stony Plain, Site NC067 - Highway 216:06 Anthony Henday Bridge, Fall 2024 Instrumentation Monitoring Report

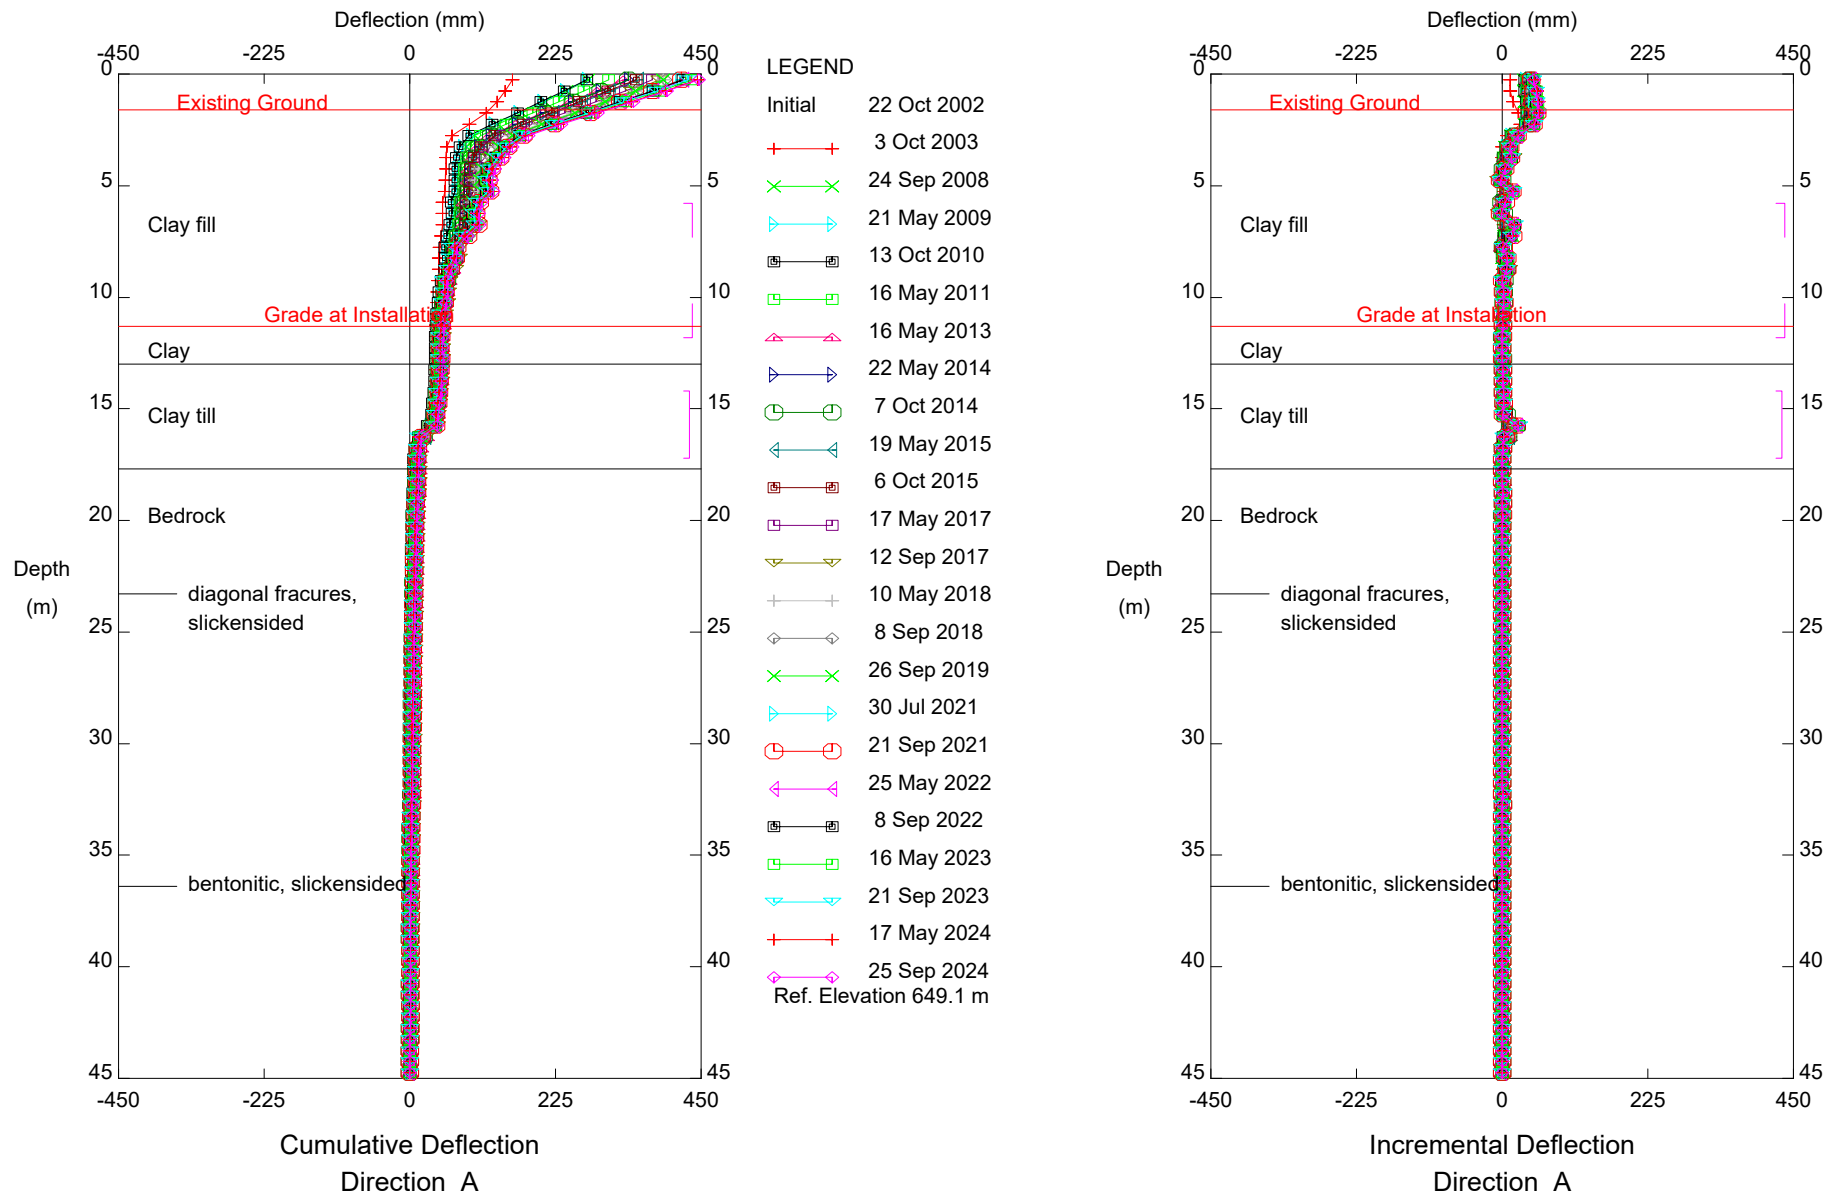
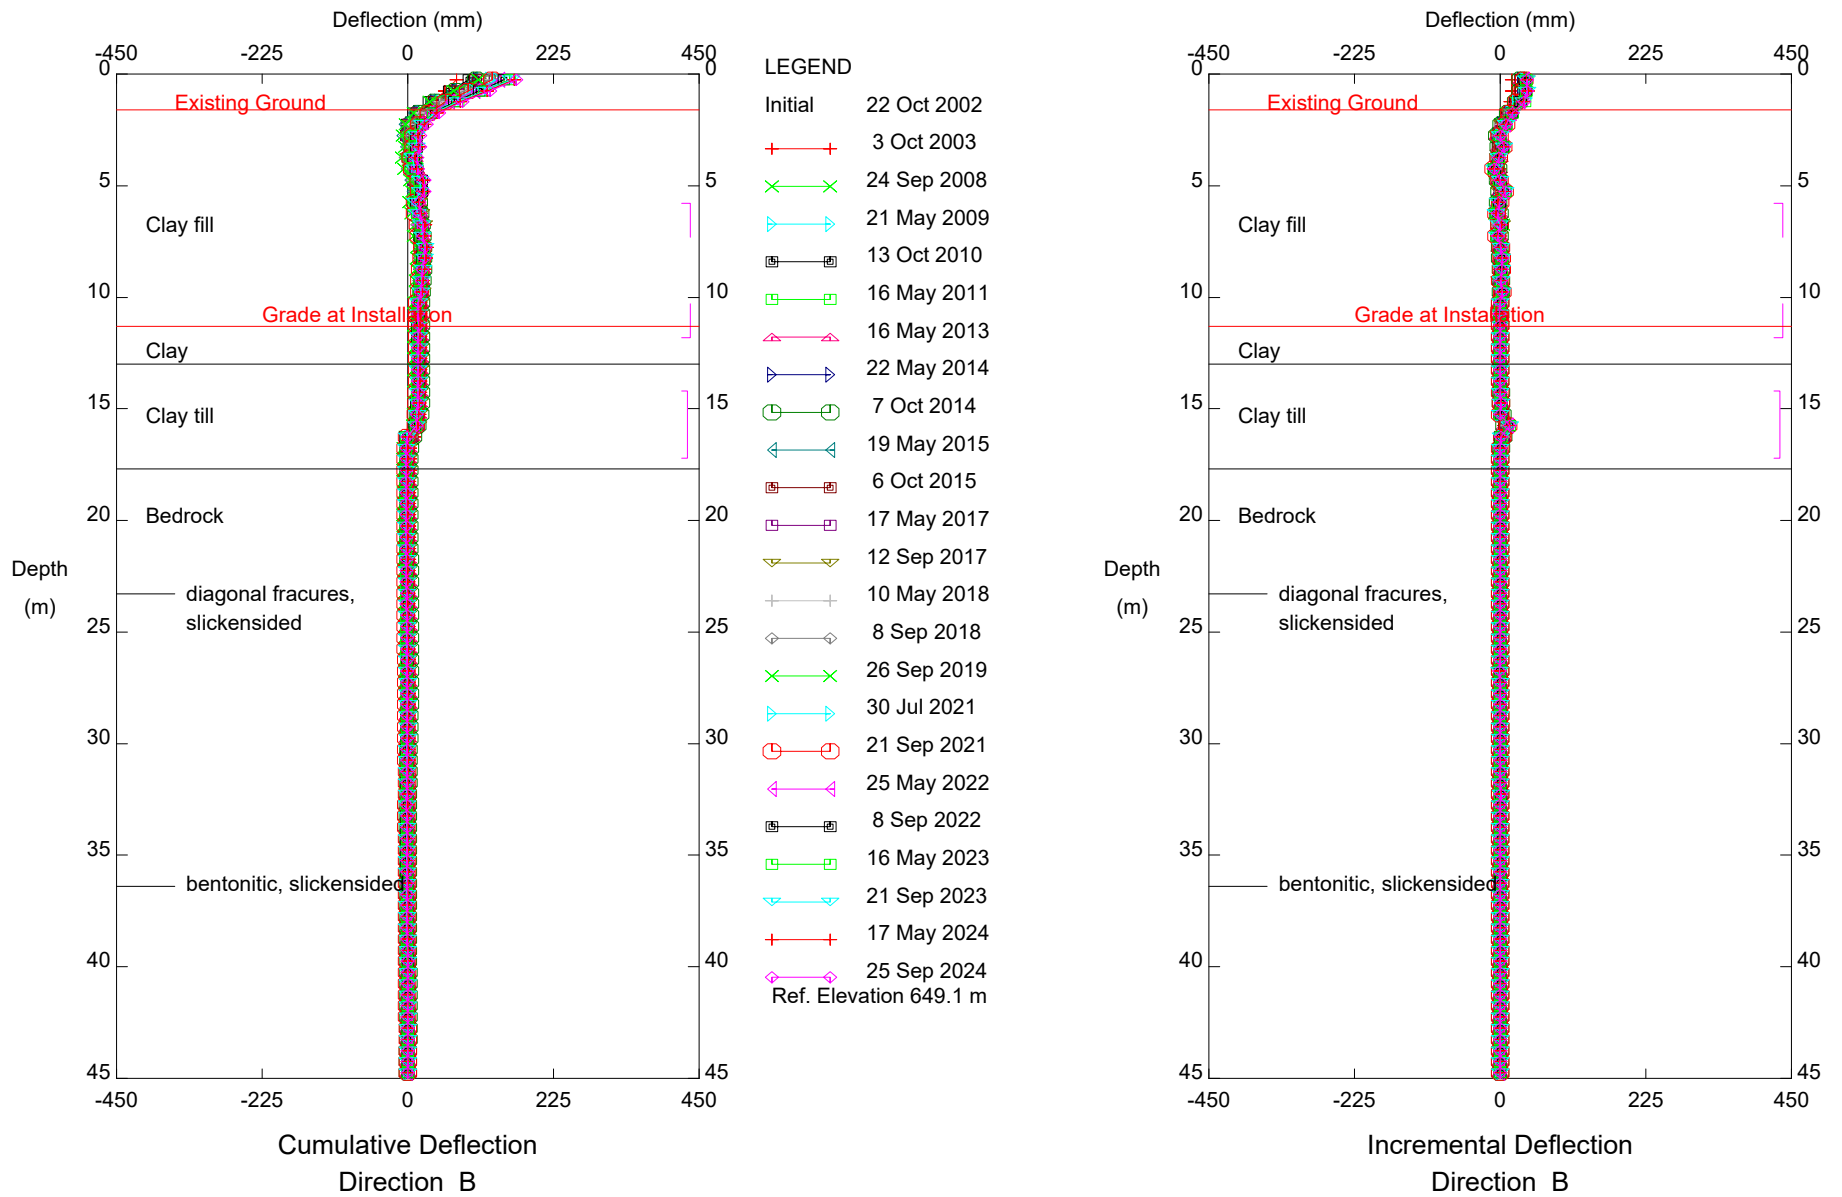
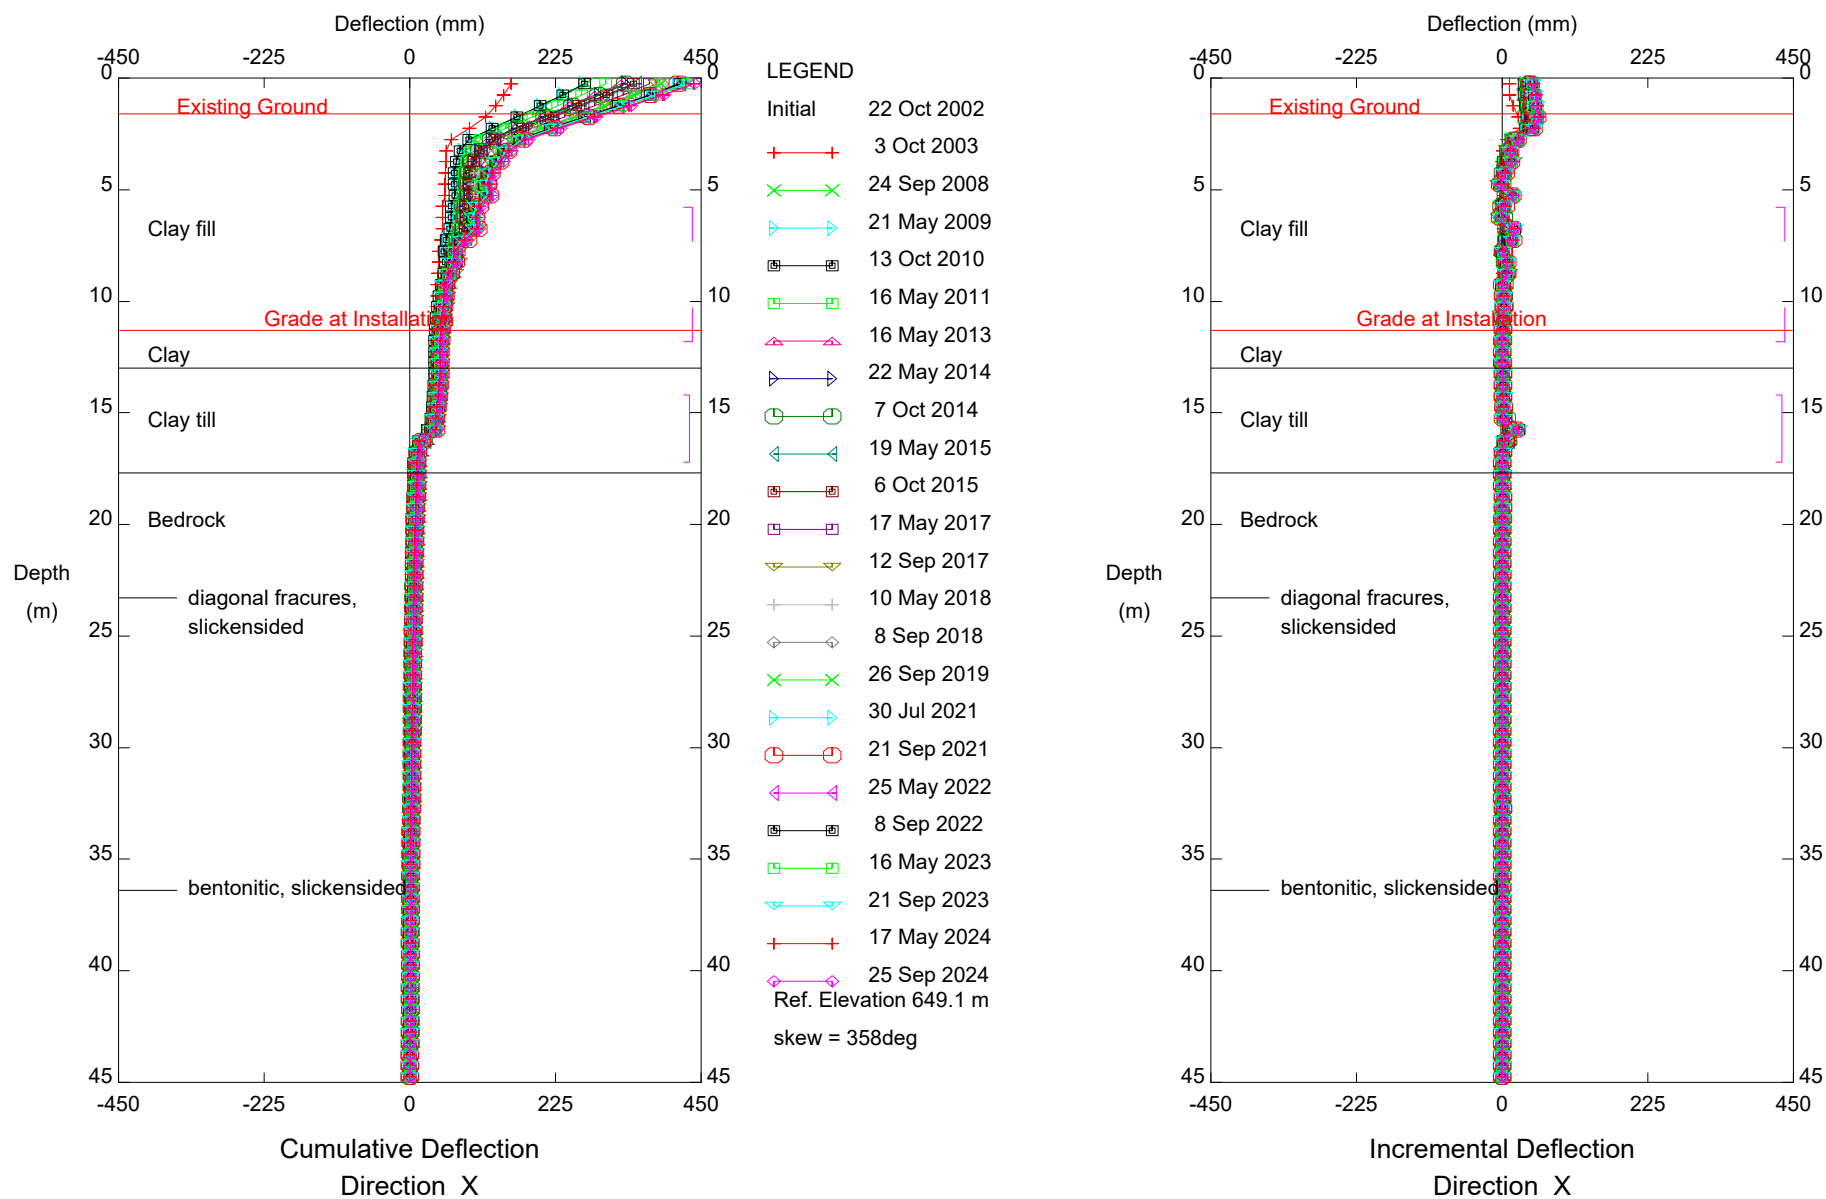
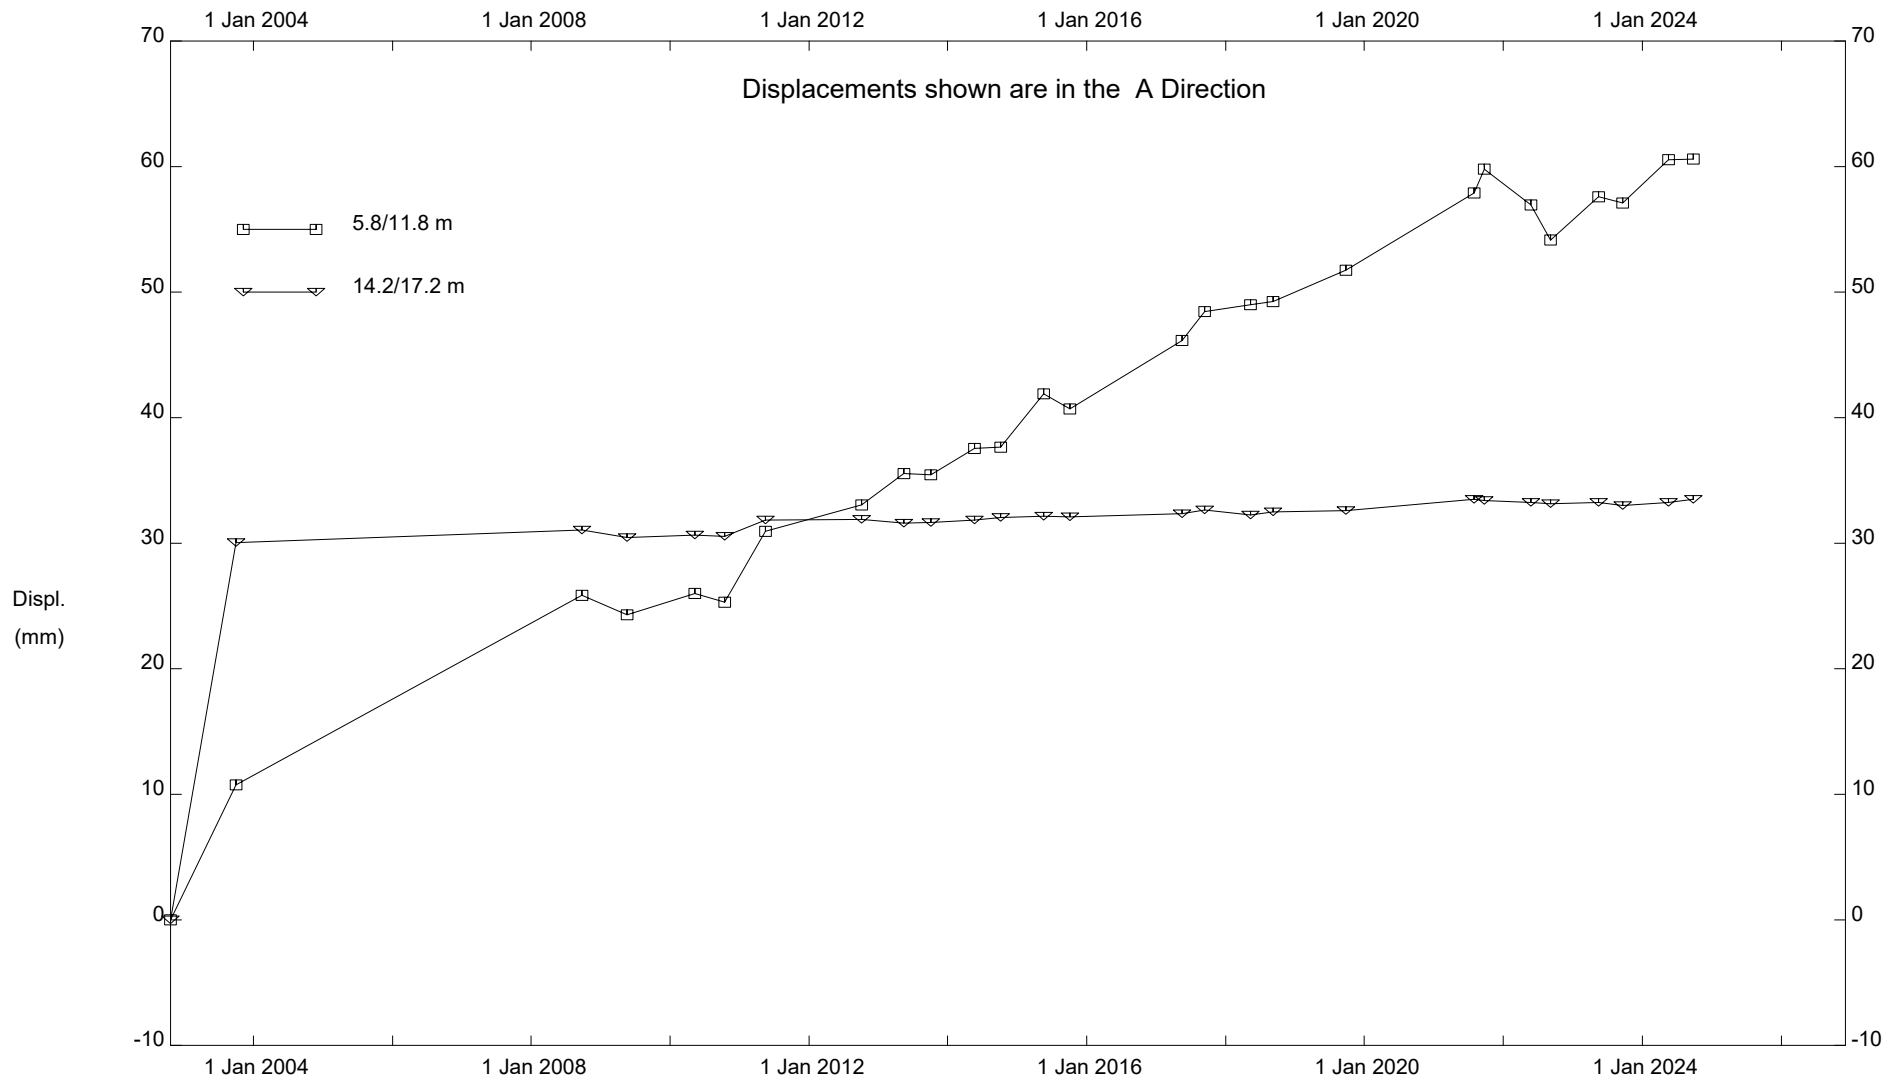
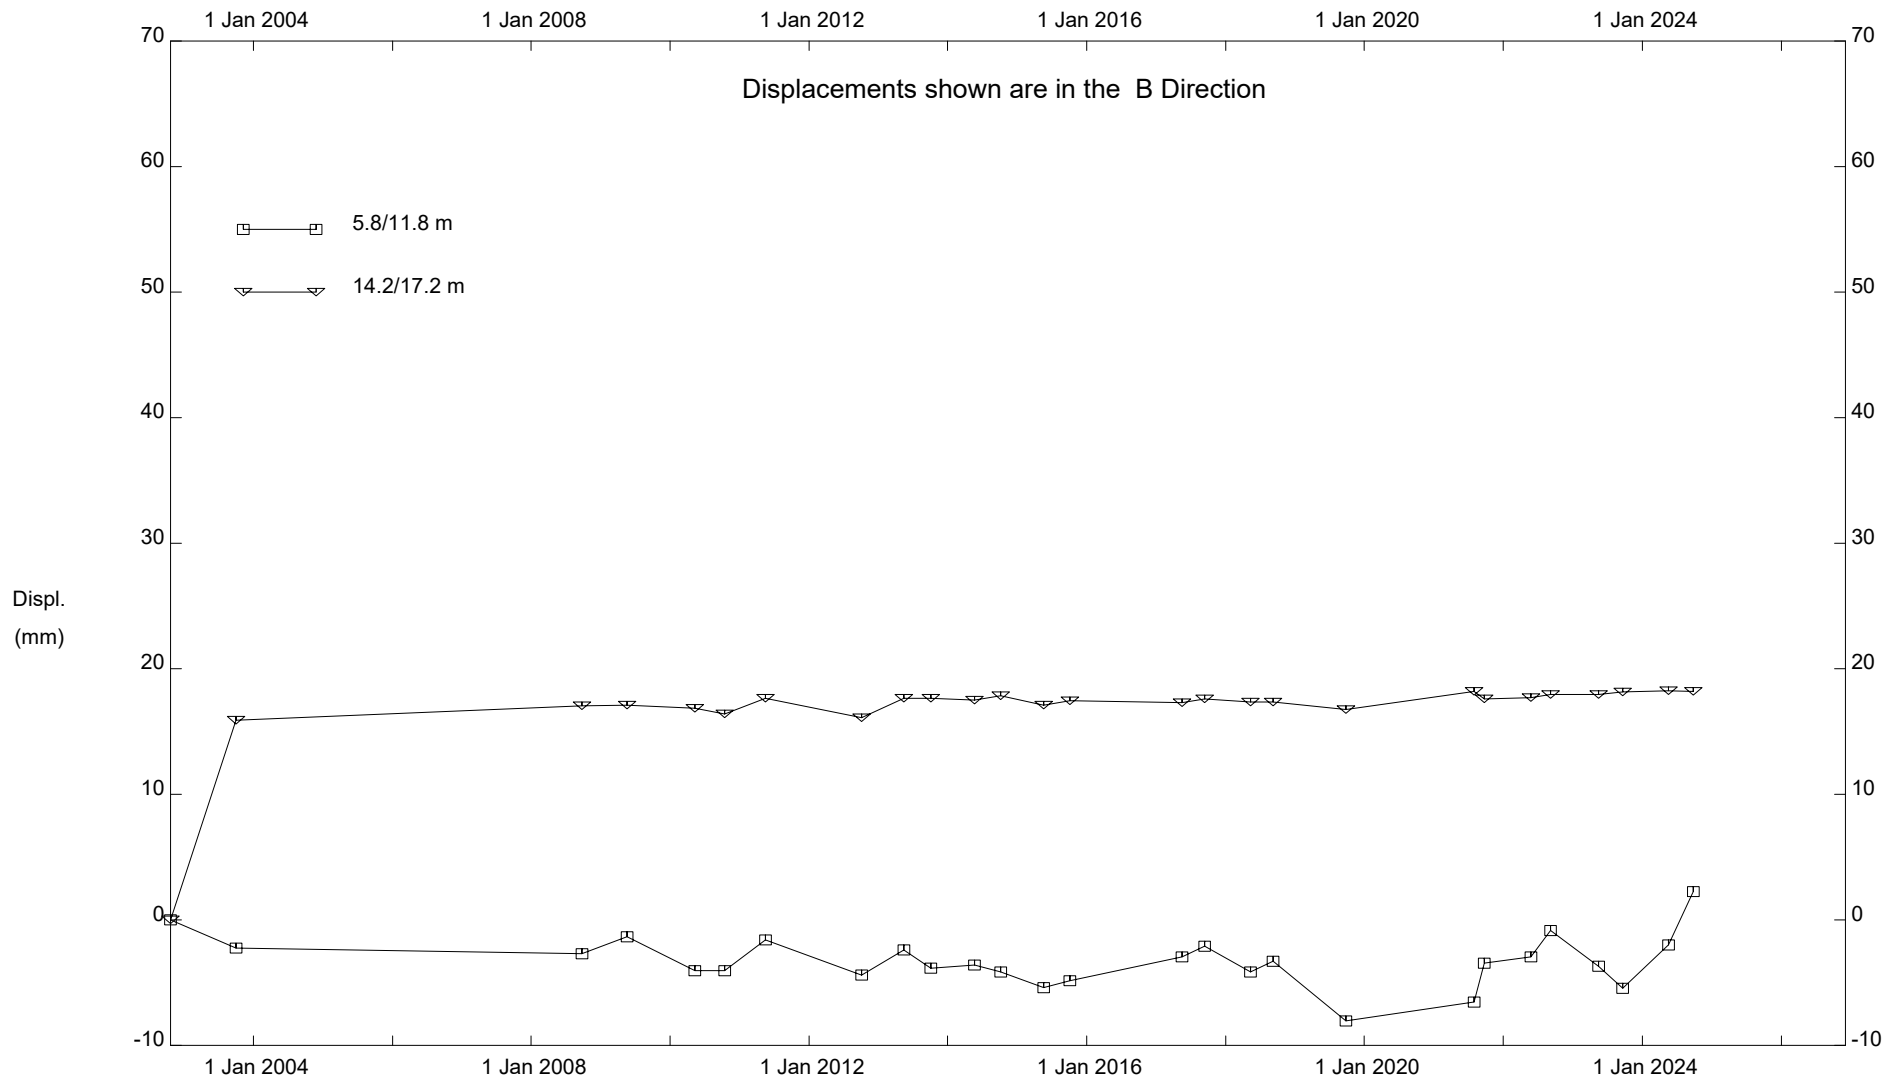
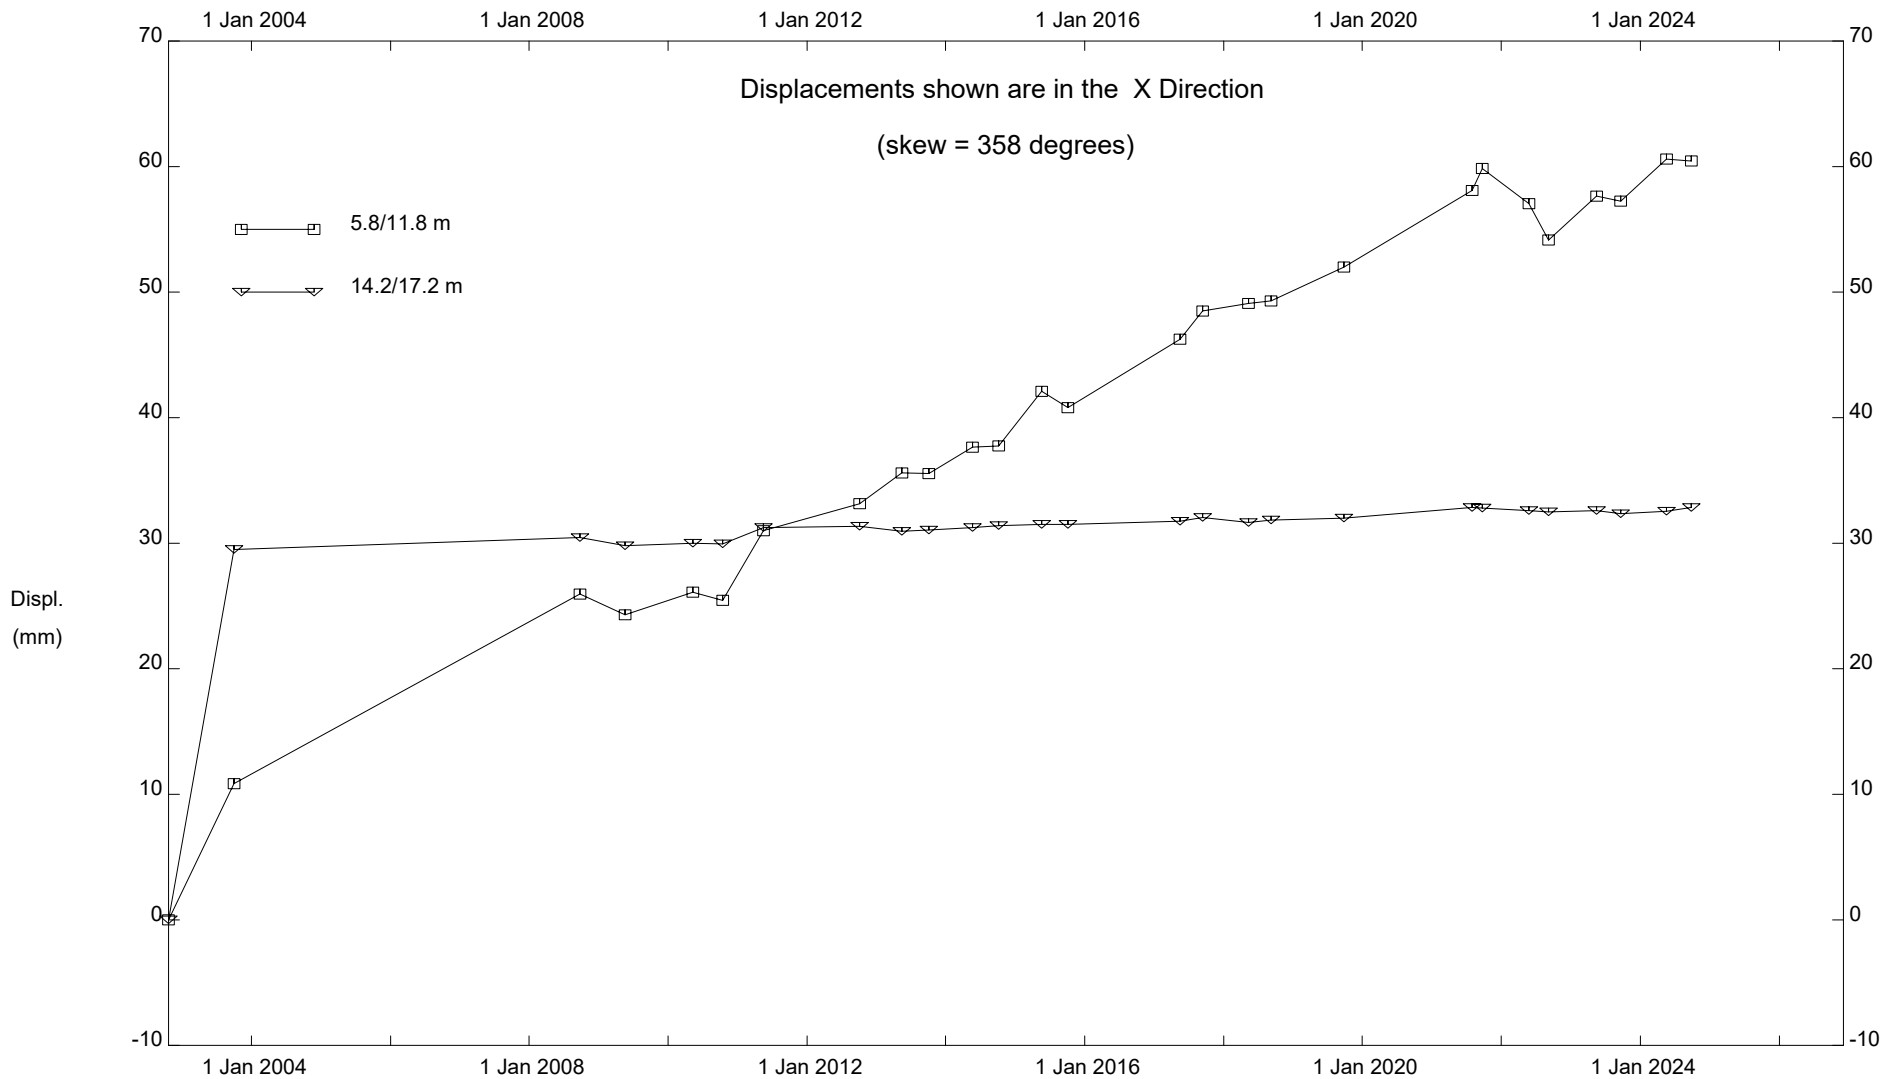
NC67, Inclinometer SI-08
Transportation & Economic Corridors

SI-08 has two zones of movement observed at around 8 m and 16 m depth. The average rate of movement in the upper zone was about 3 mm/yr since 2003. Total cumulative movement appears to be erratically moving around 58 mm since Spring 2021 with its current total cumulative movement at about 61 mm. The lower movement zone appears to be creeping at a rate of less than 1 mm/yr since 2003.
