To:	Amy Driessen	From:	Leslie Cho and Xiteng Liu
	Transportation and Economic Corridors		Stantec Consulting Ltd.
File:	123315222	Date:	October 18, 2024

Reference: North Central Region, Stony Plain, Site NC067 - Highway 216:06 Anthony Henday Bridge, Fall 2024 Instrumentation Monitoring Report

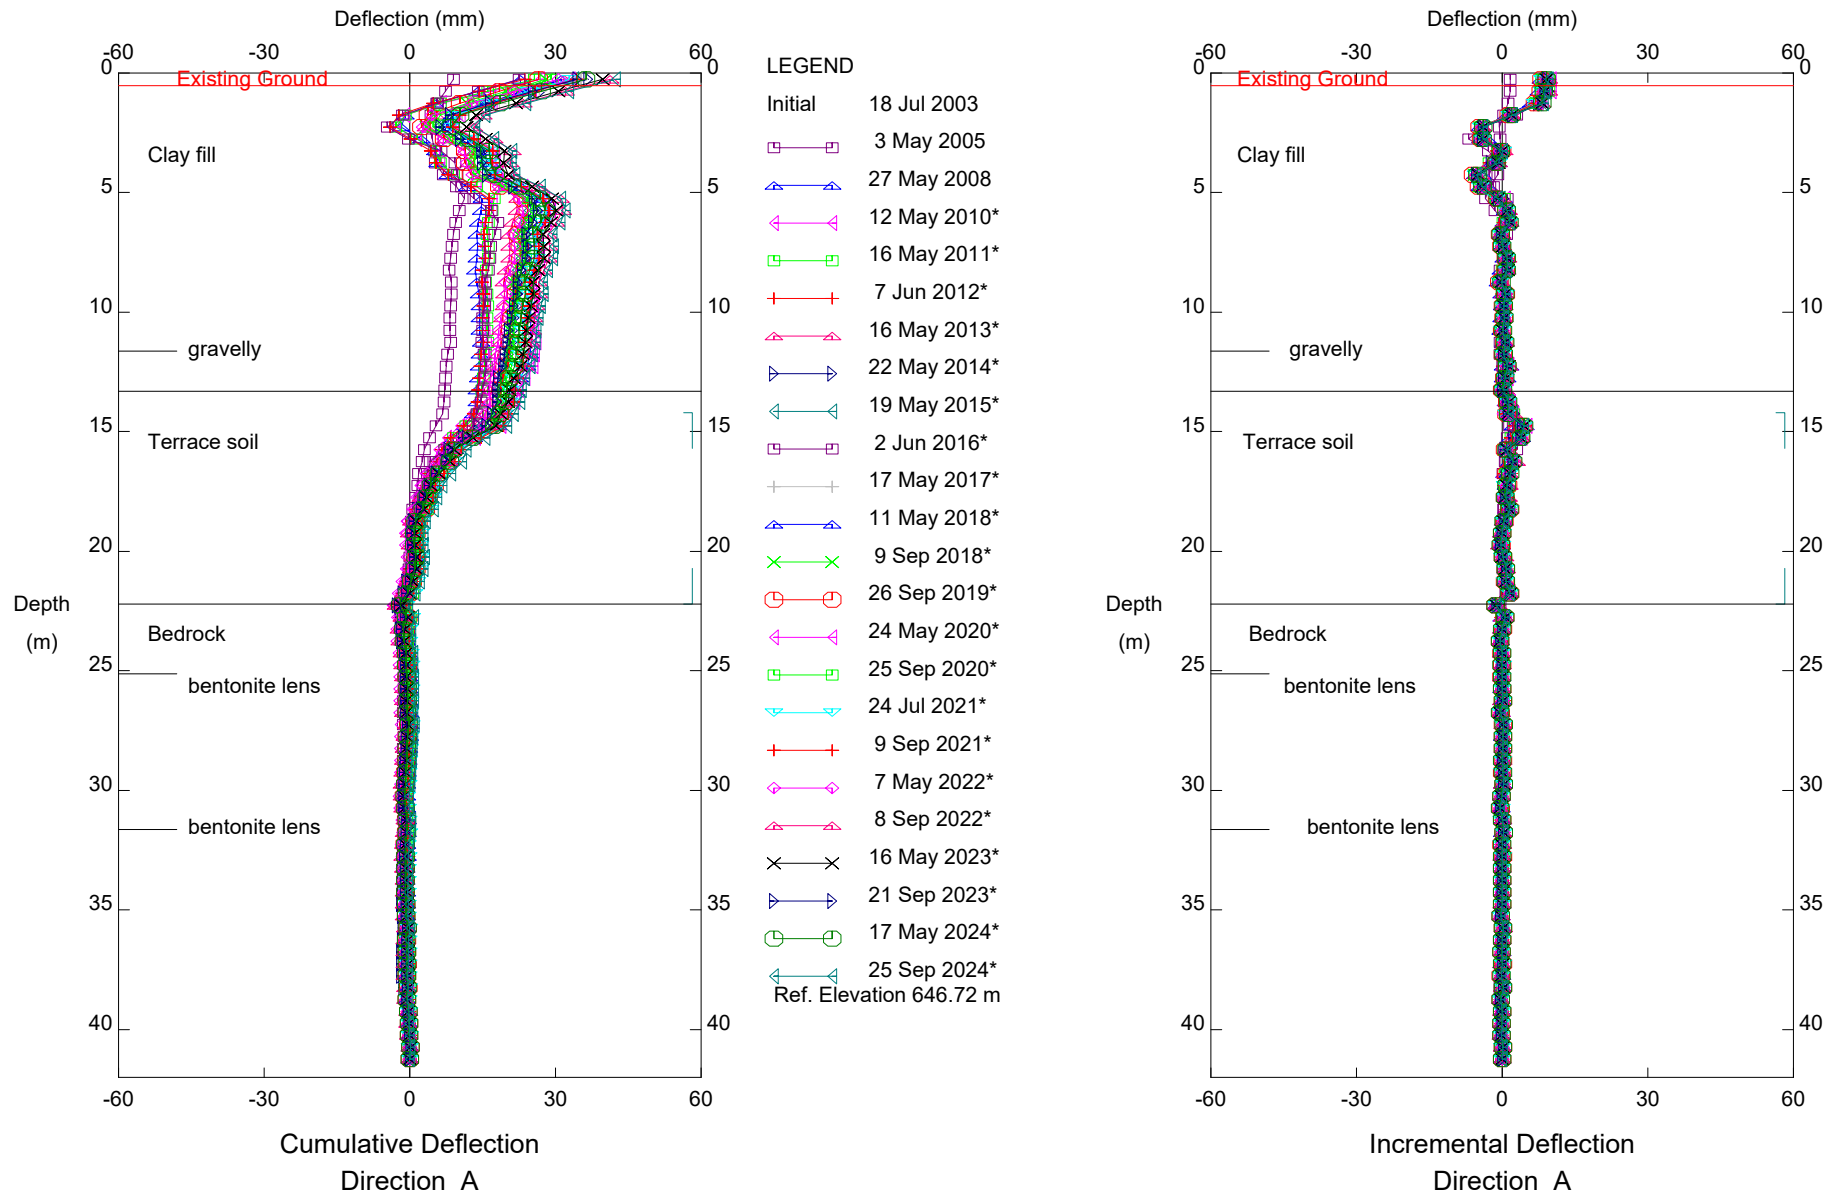
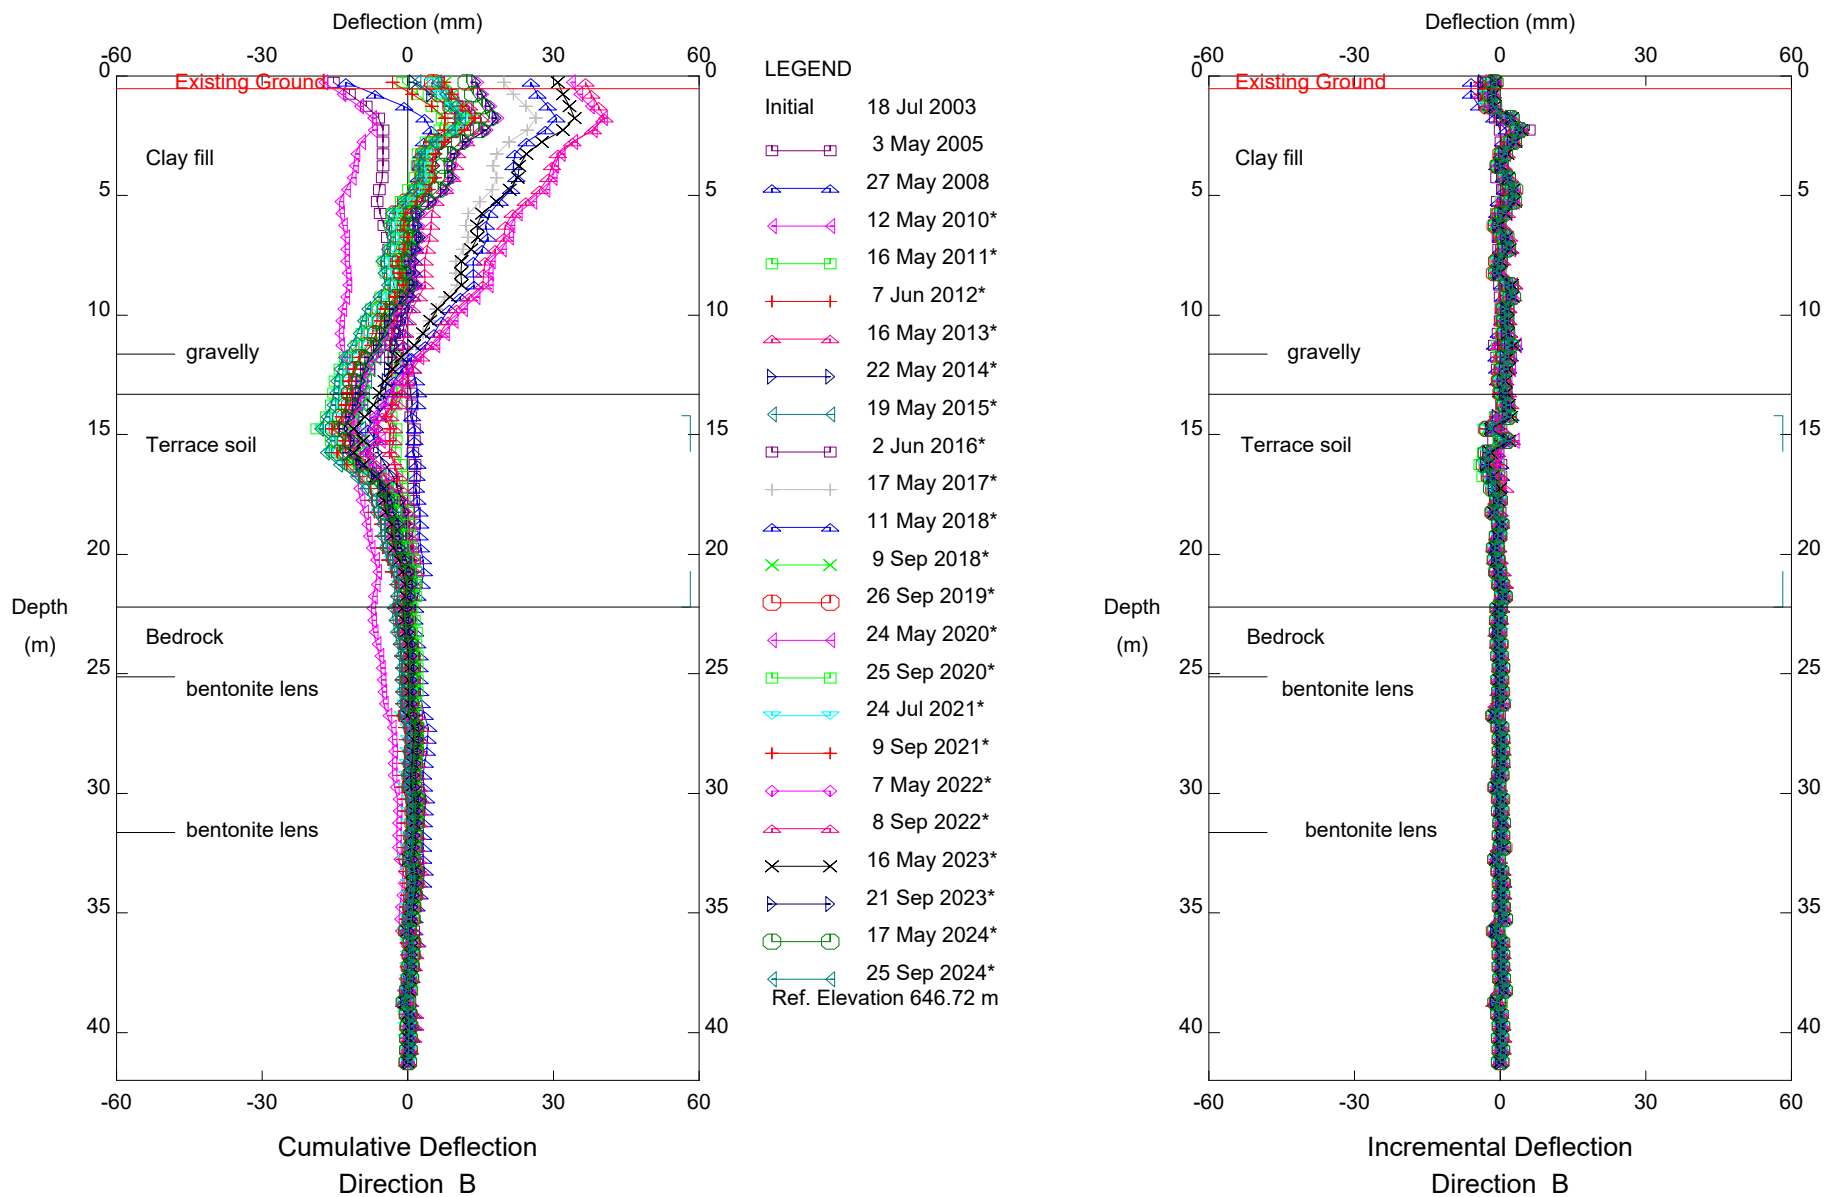
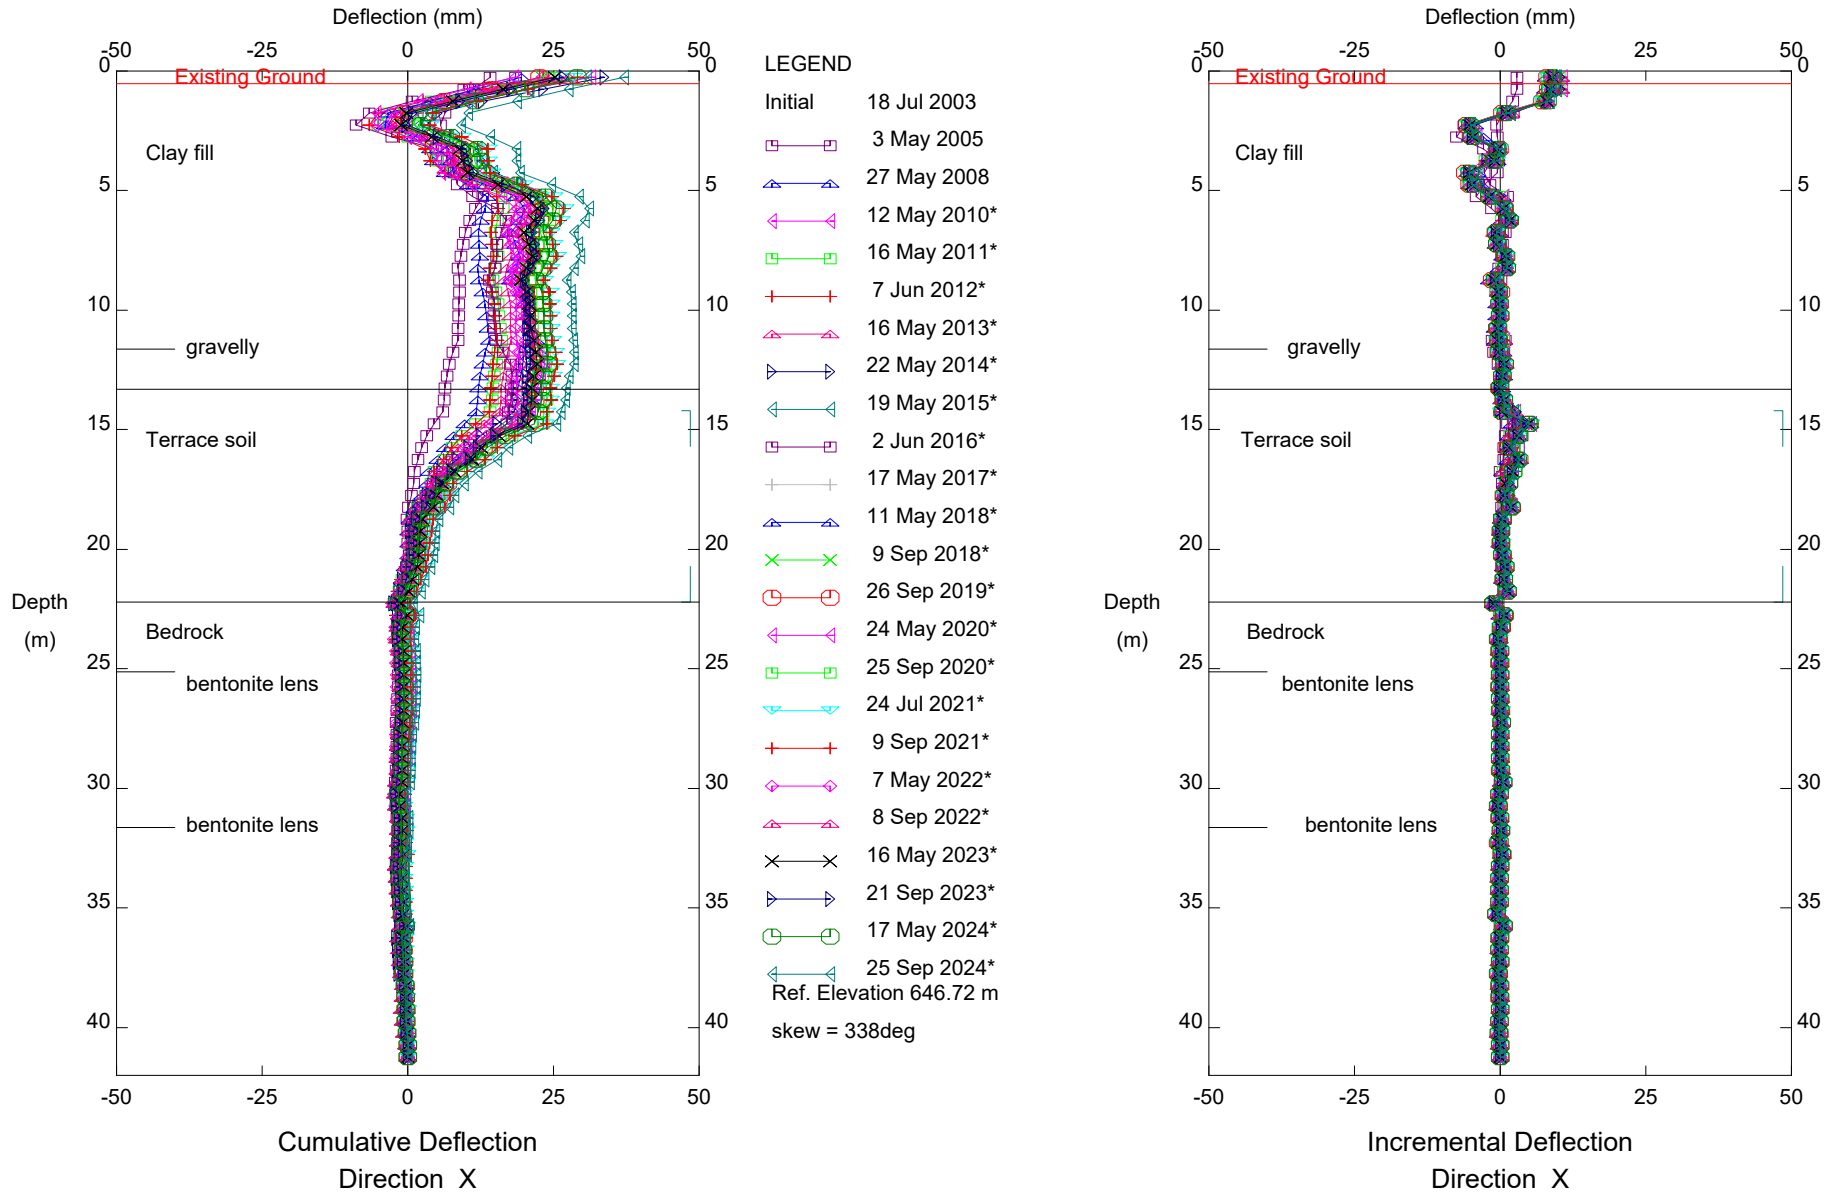
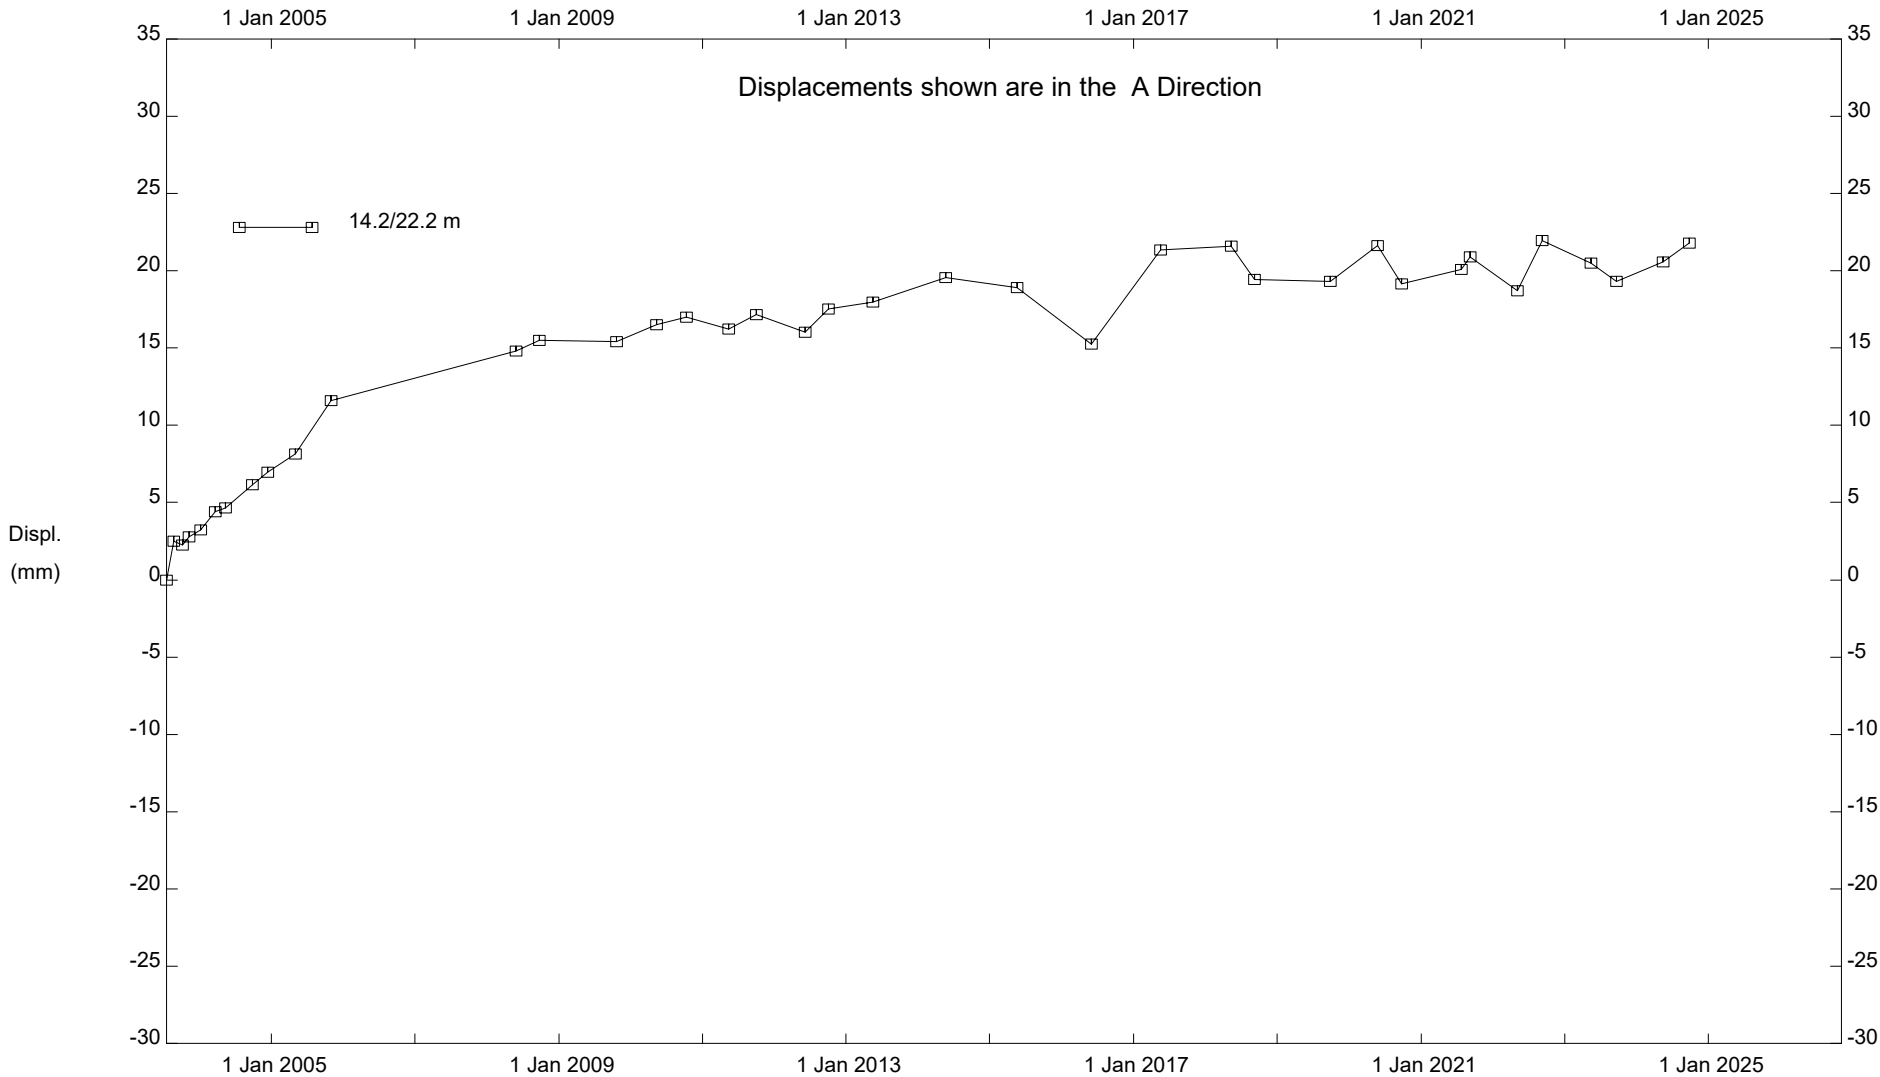
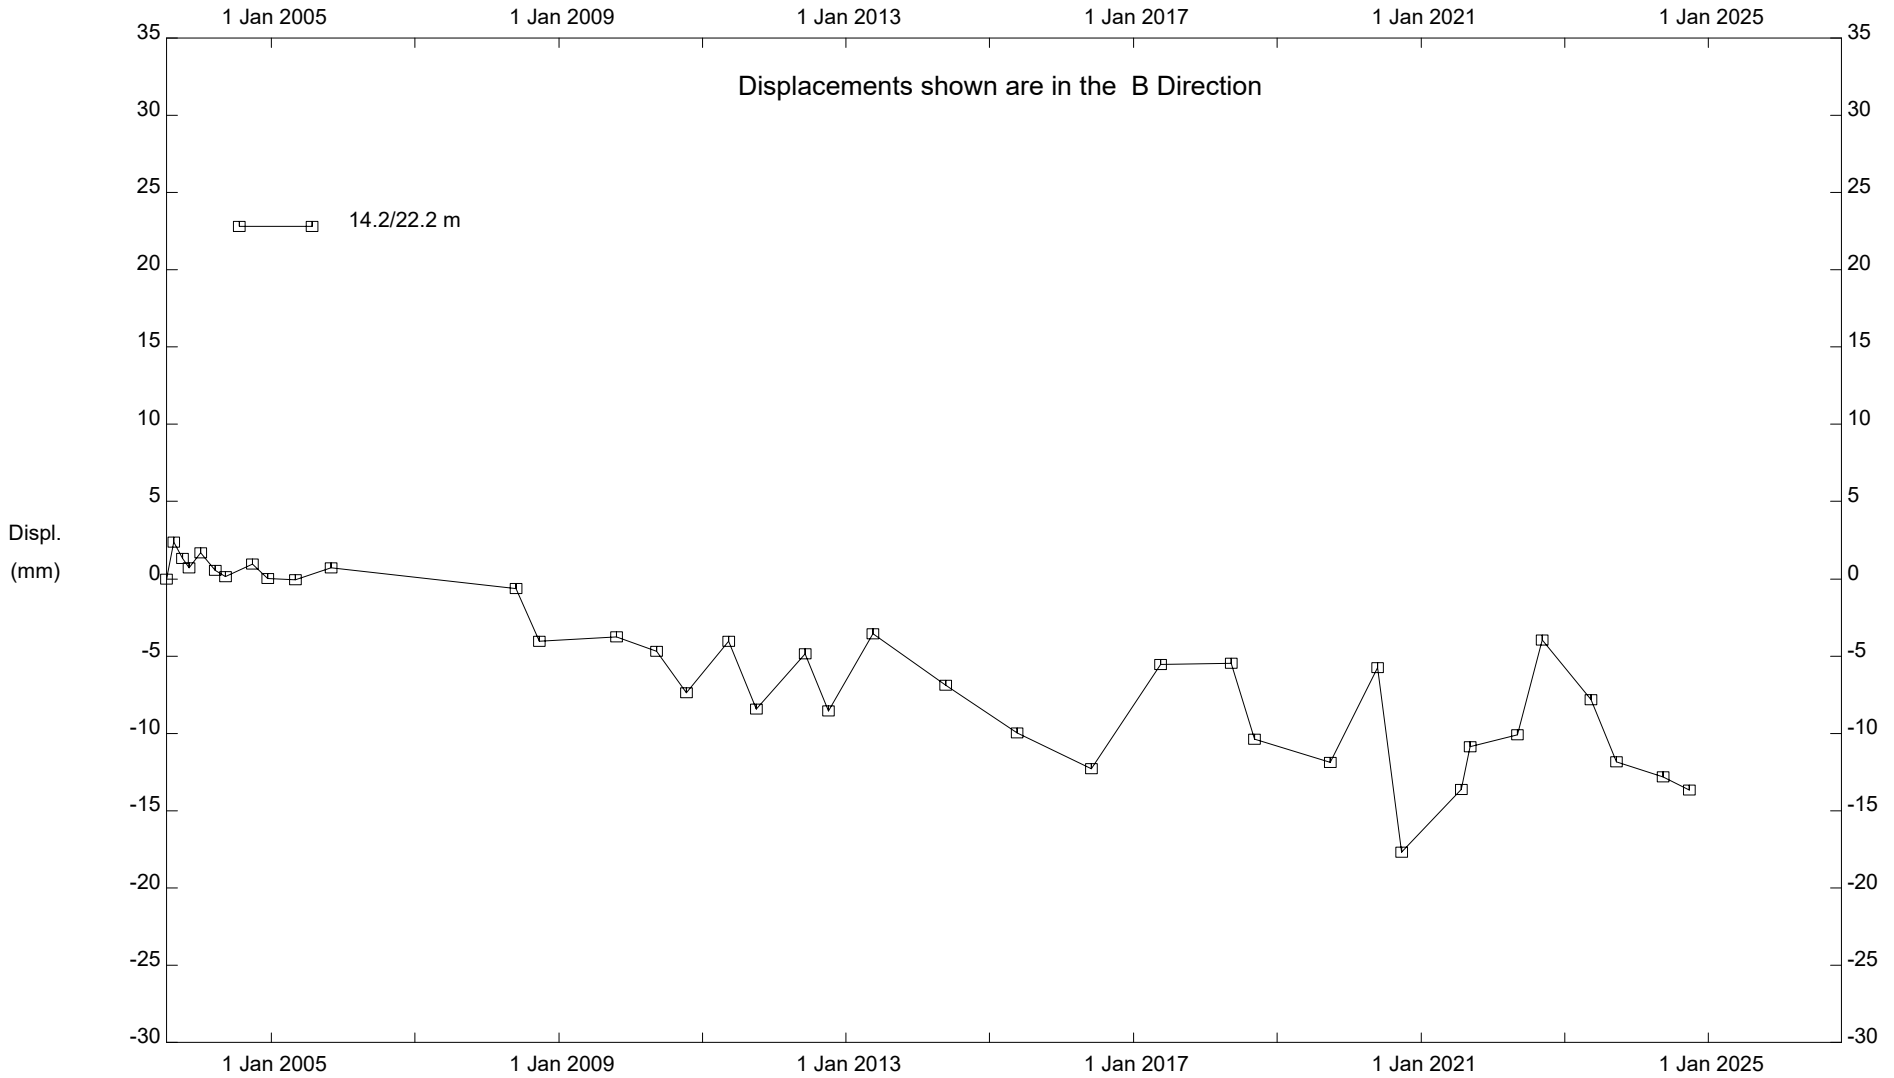
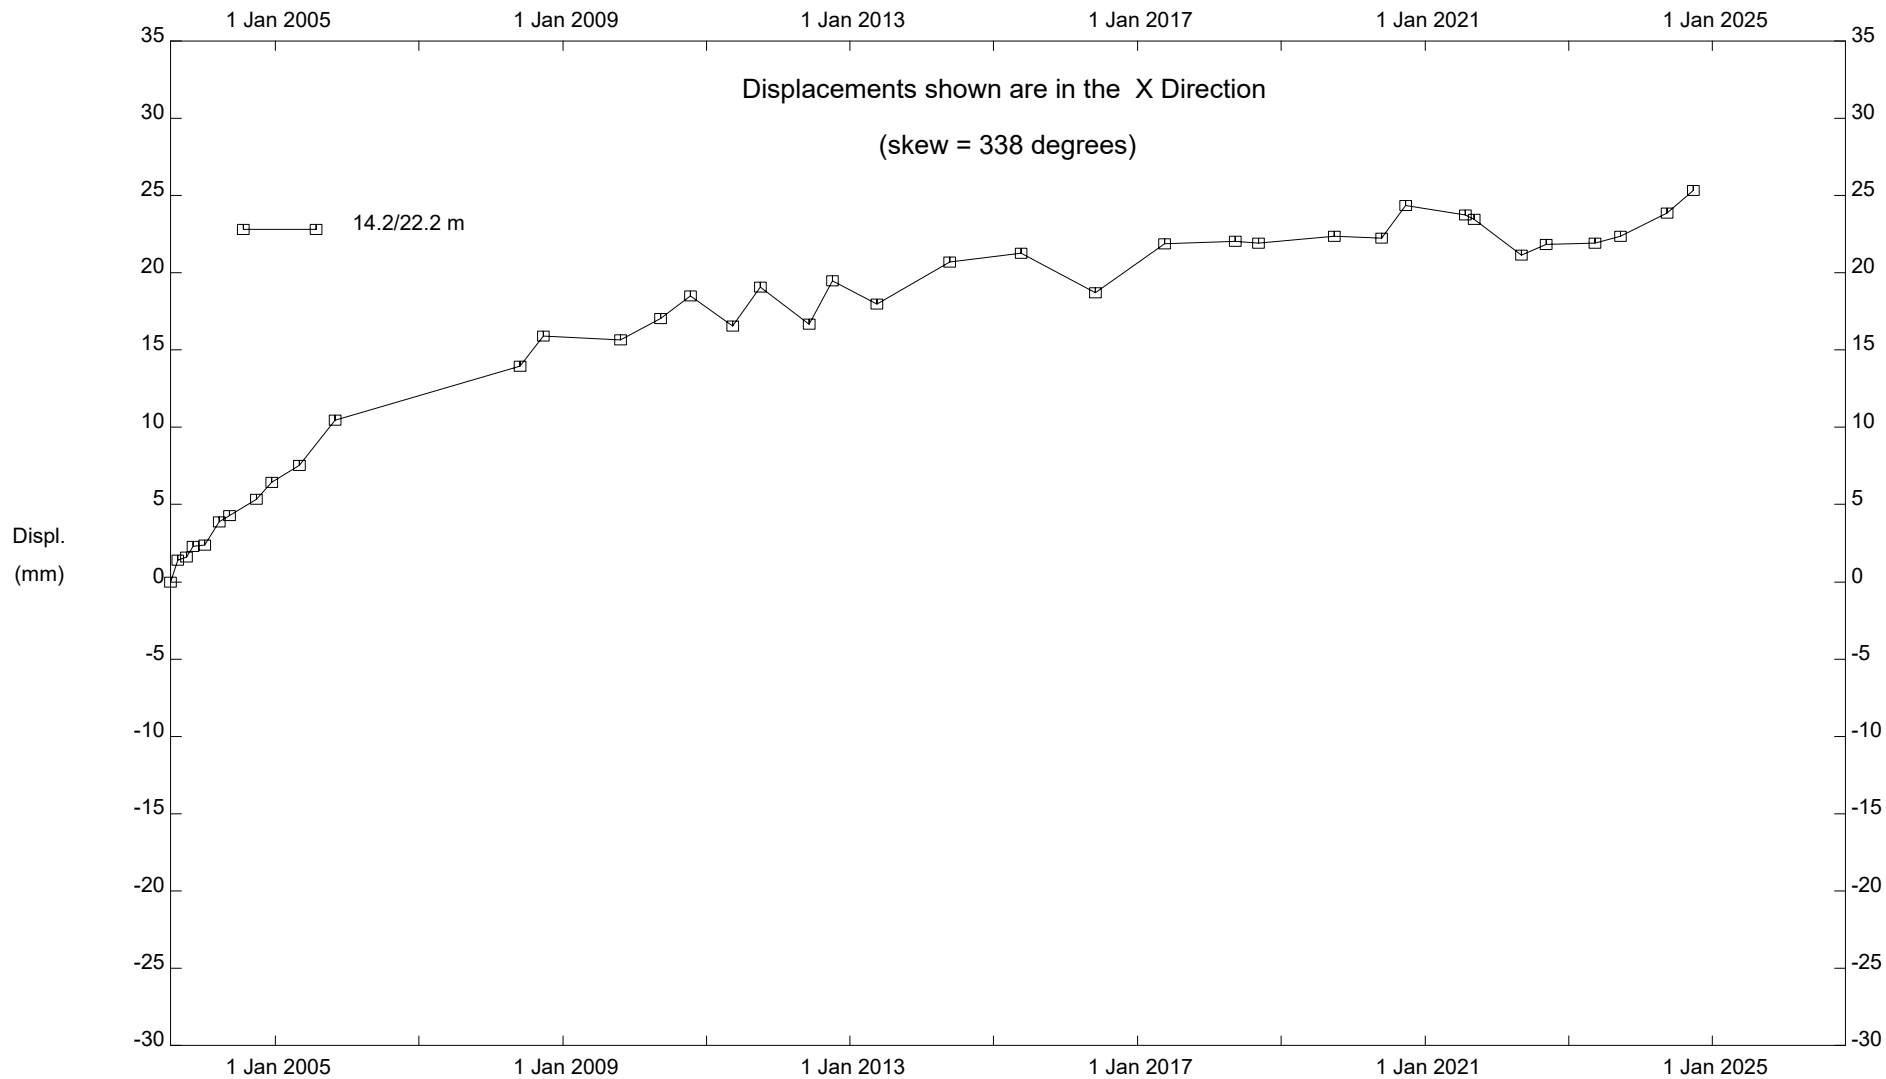
NC67, Inclinometer SI-10

SI-10 shows a current rate of movement of about 4 mm/yr. The average rate of movement since 2006 is about 1 mm/yr. The total cumulative movement is approximately 25 mm.
