To:	Amy Driessen	From:	Leslie Cho and Xiteng Liu
	Transportation and Economic Corridors		Stantec Consulting Ltd.
File:	123315222	Date:	October 18, 2024

Reference: North Central Region, Stony Plain, Site NC067 - Highway 216:06 Anthony Henday Bridge, Fall 2024 Instrumentation Monitoring Report

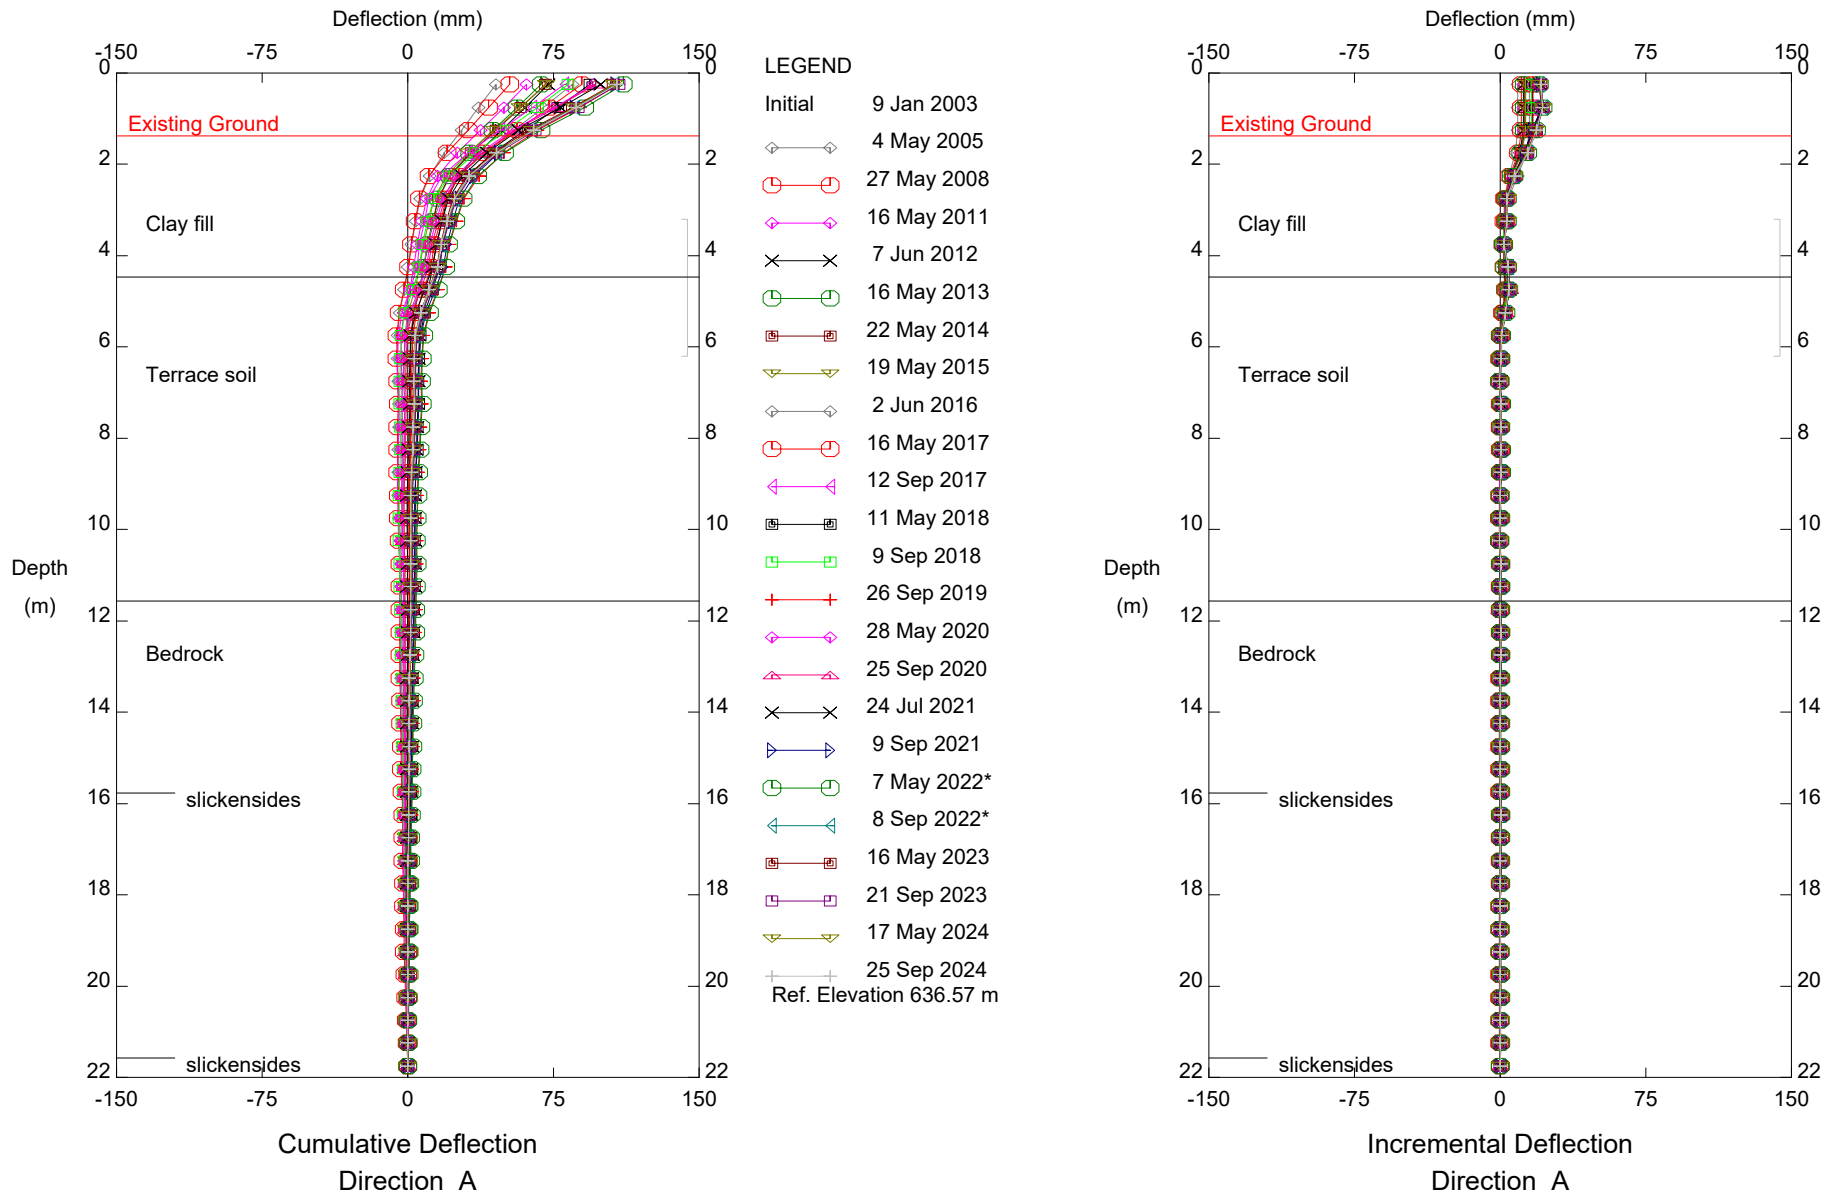
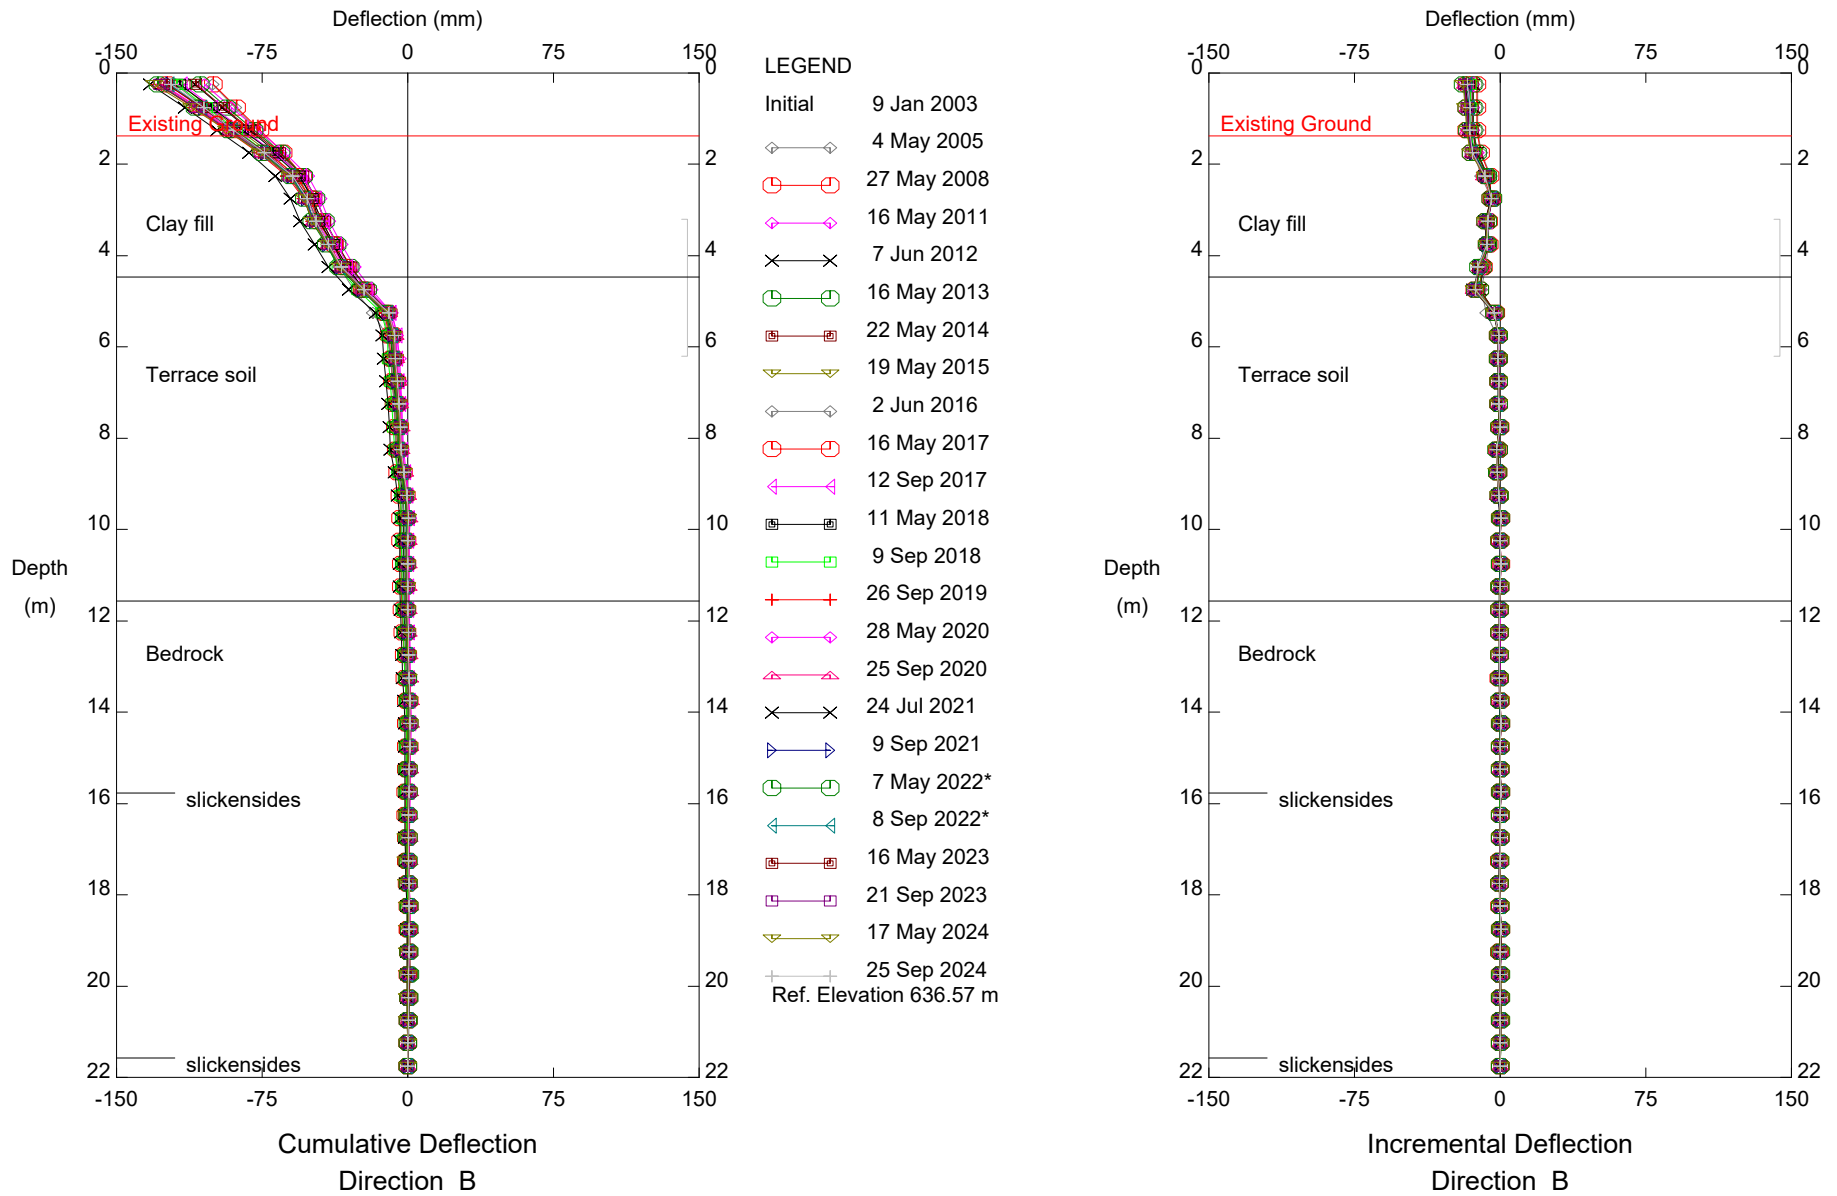
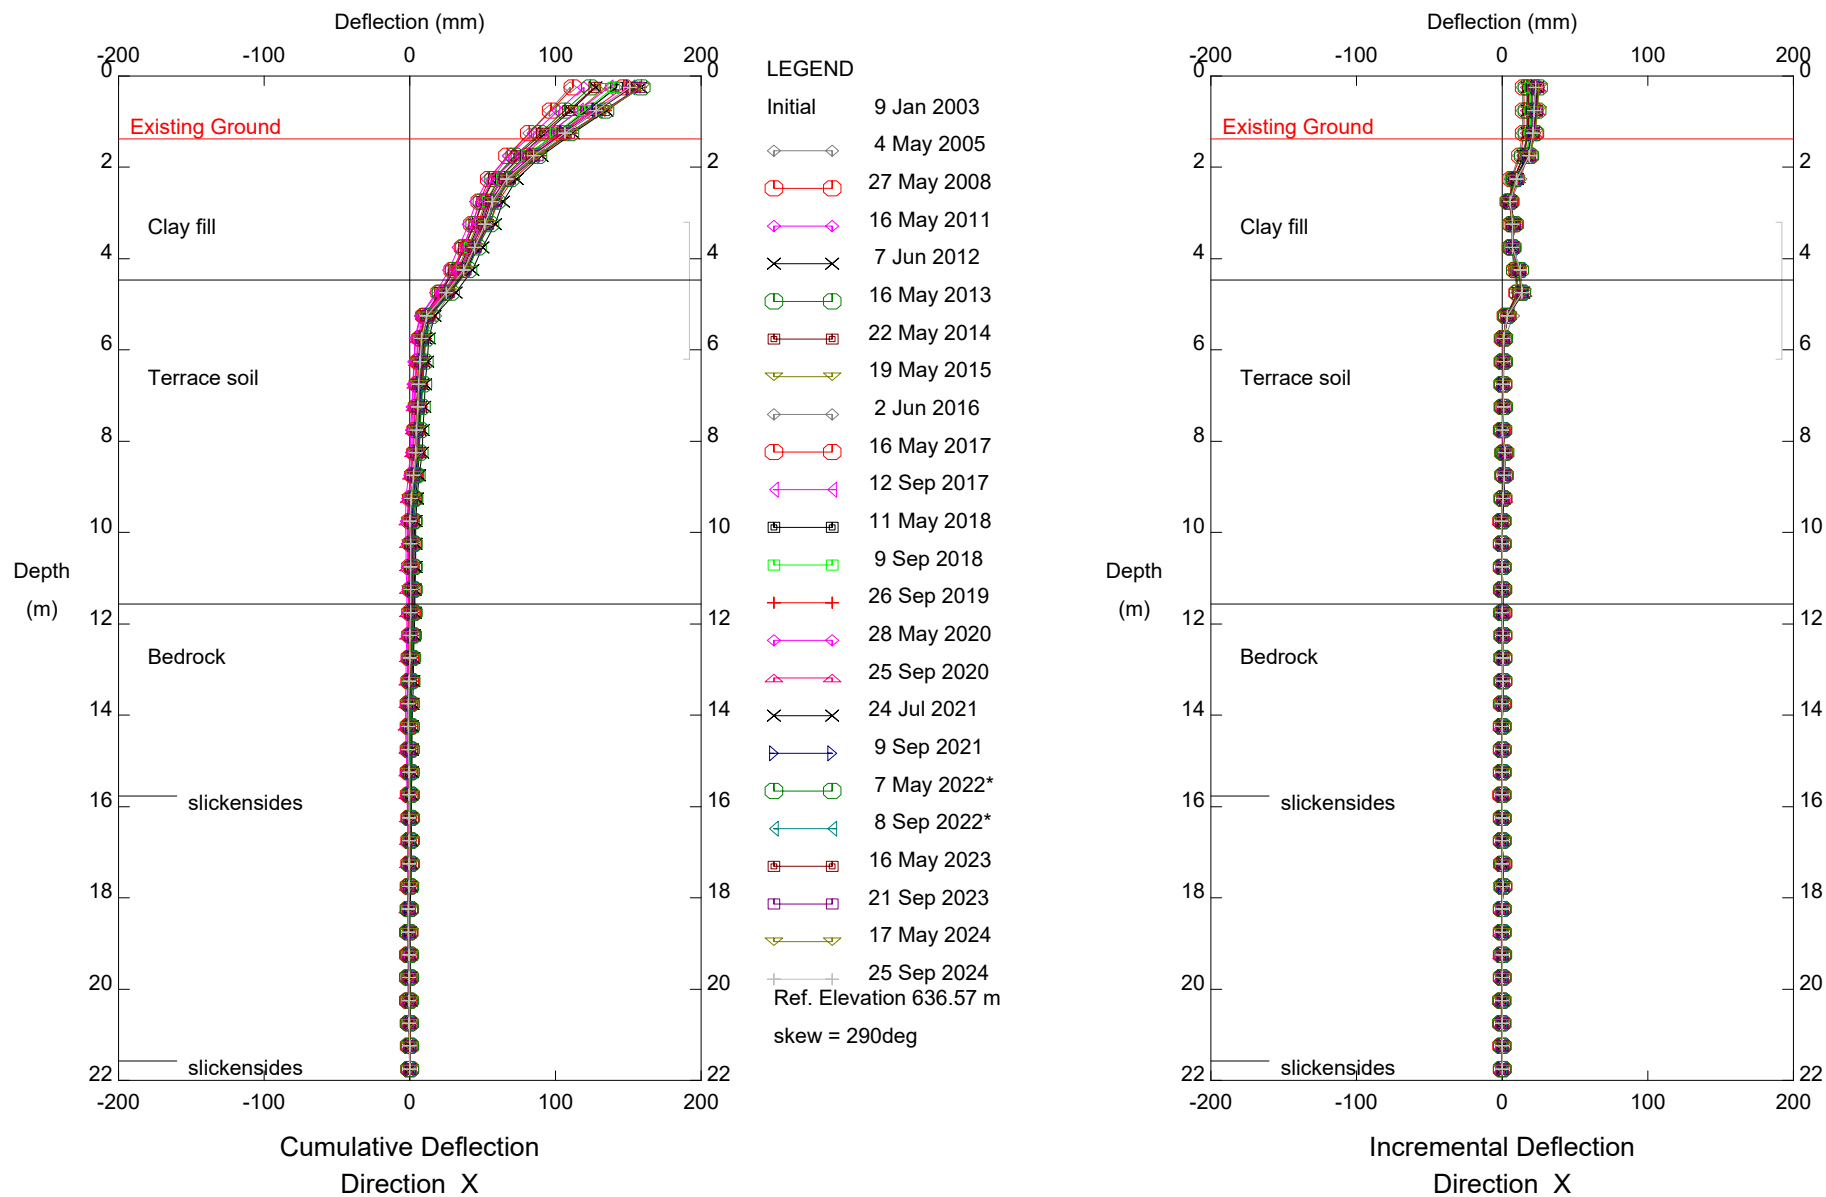
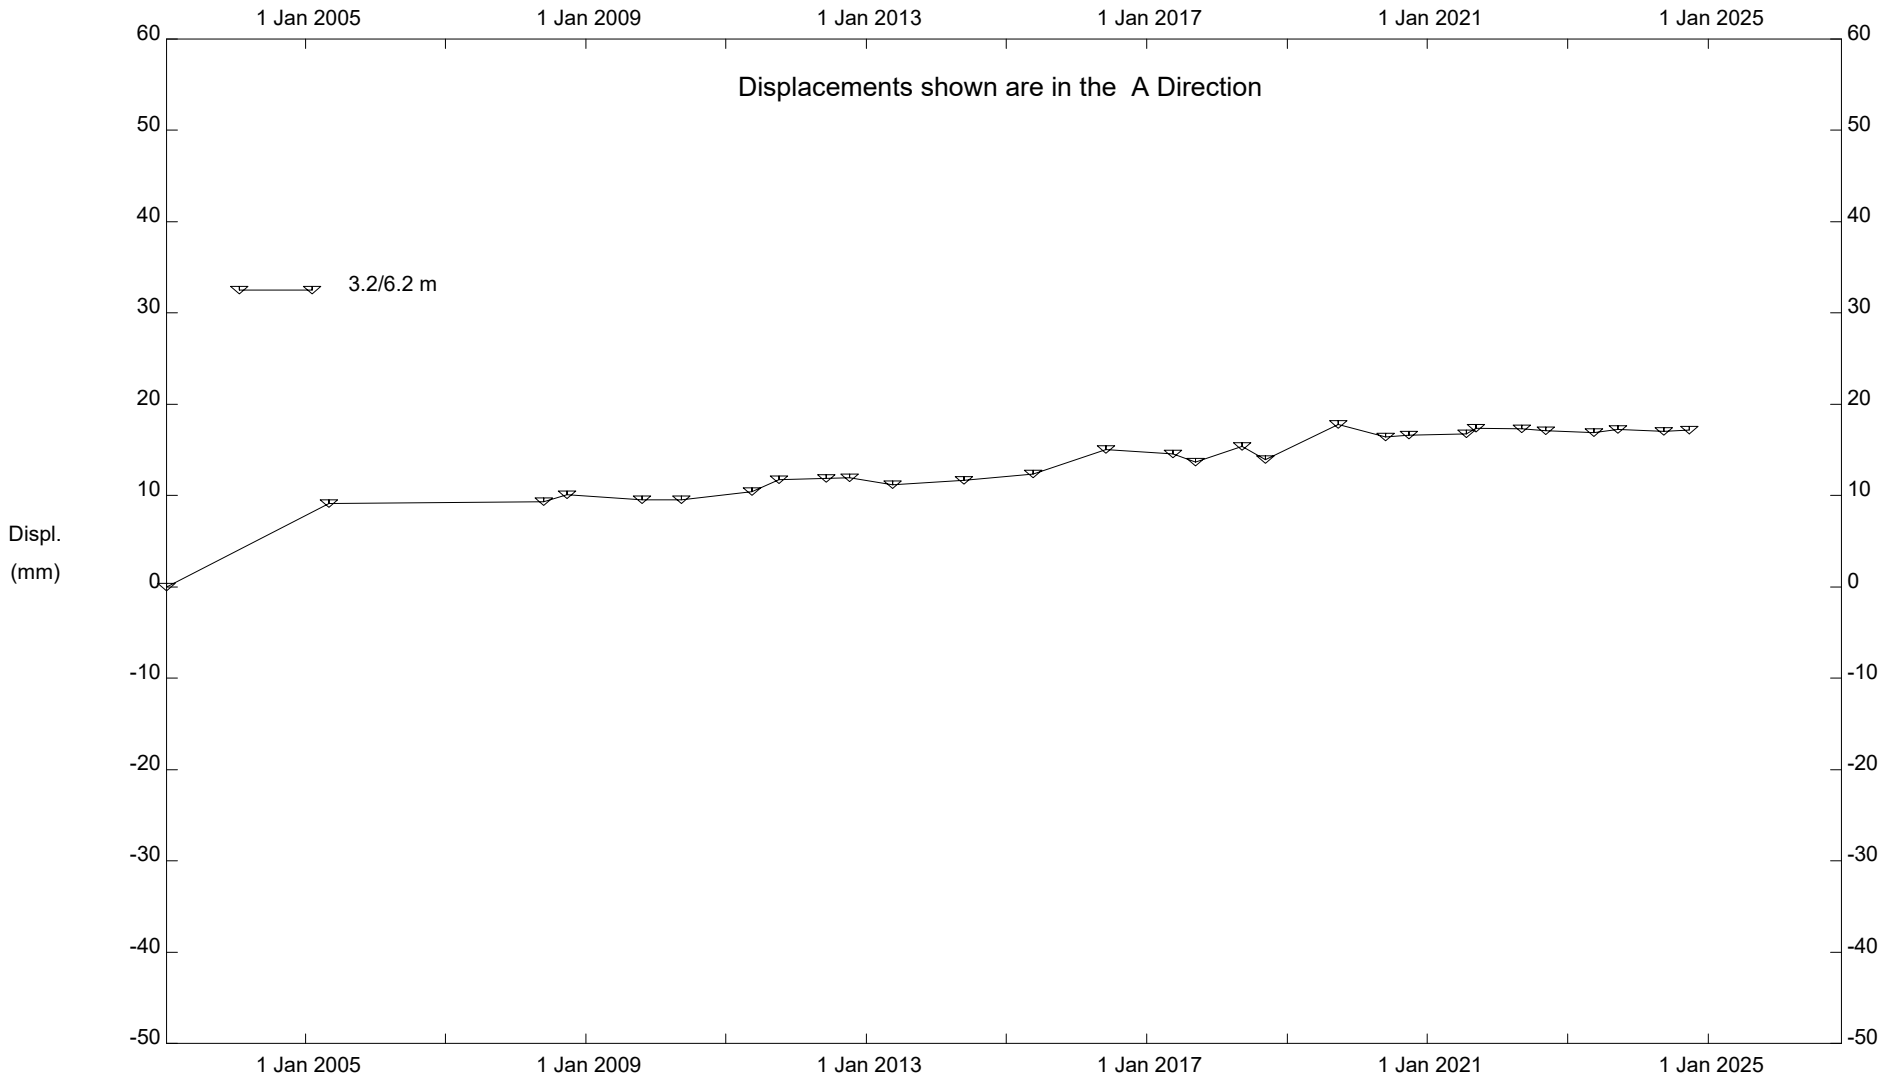
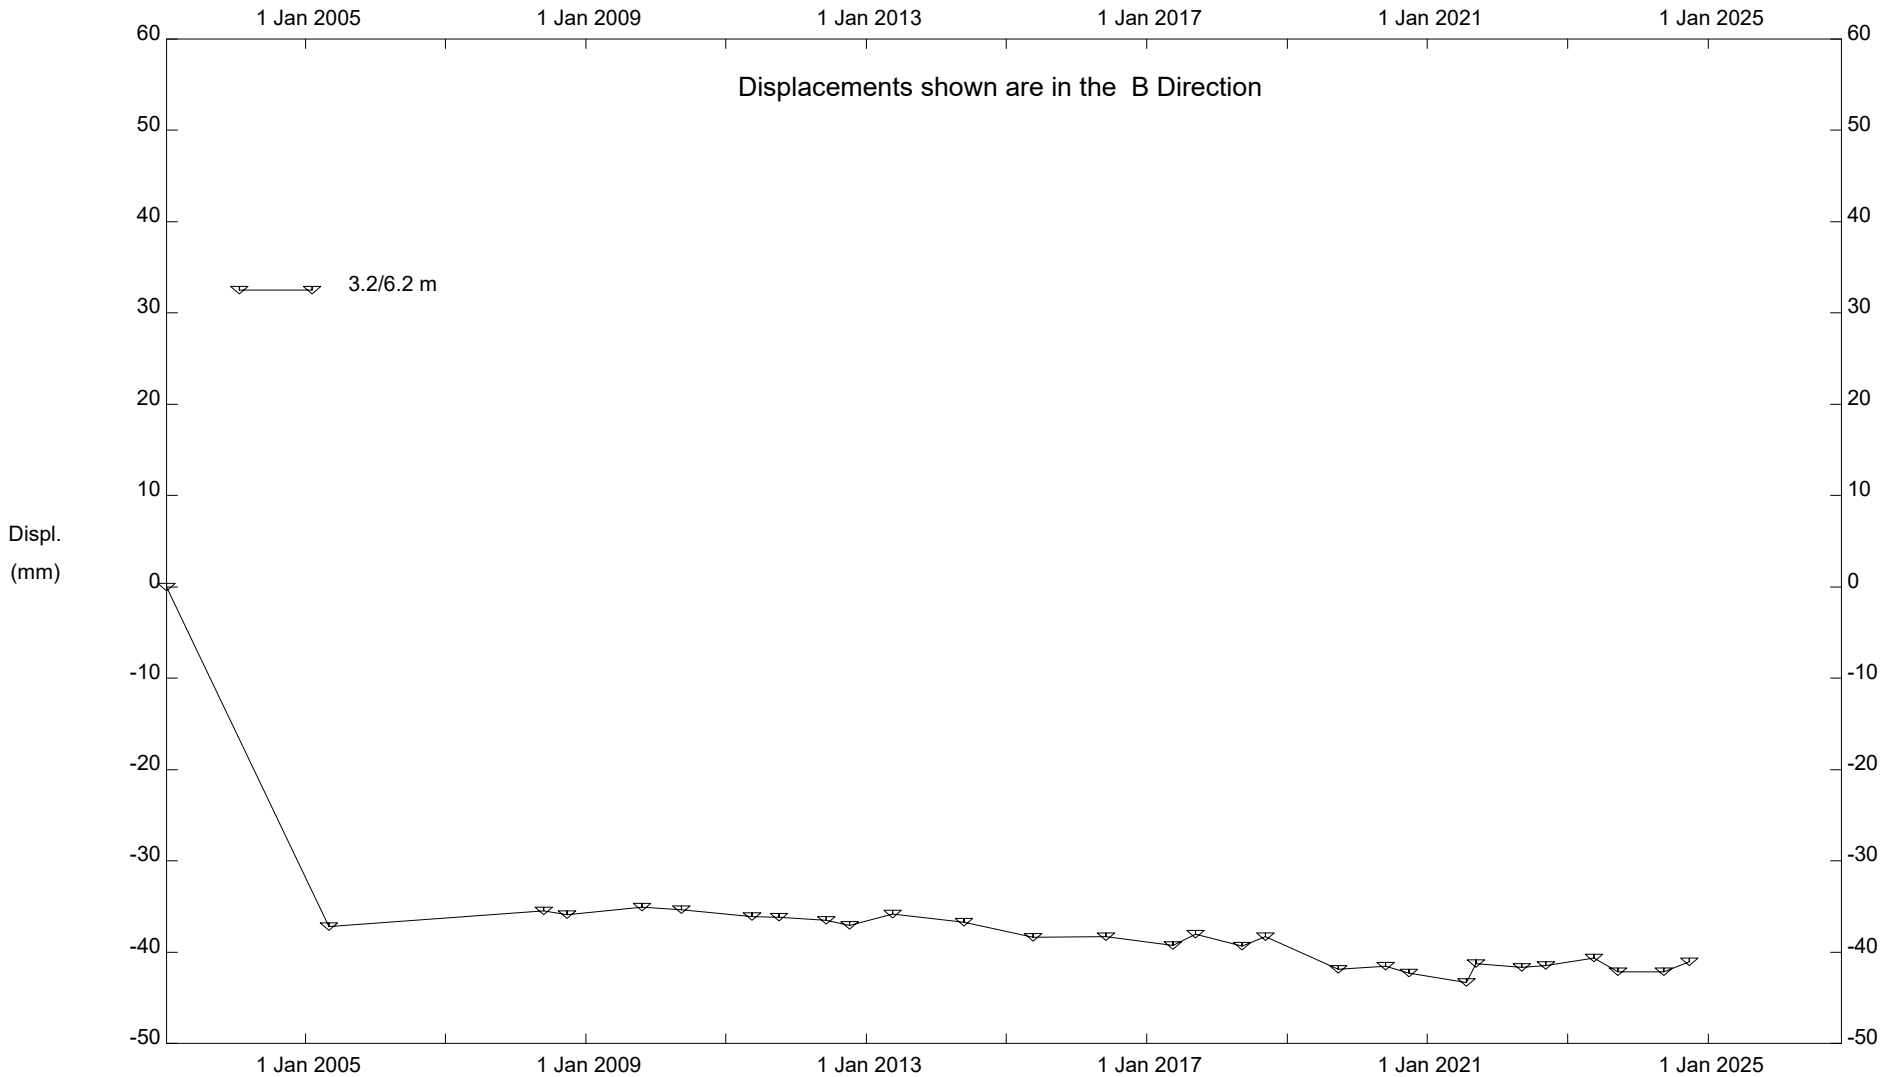
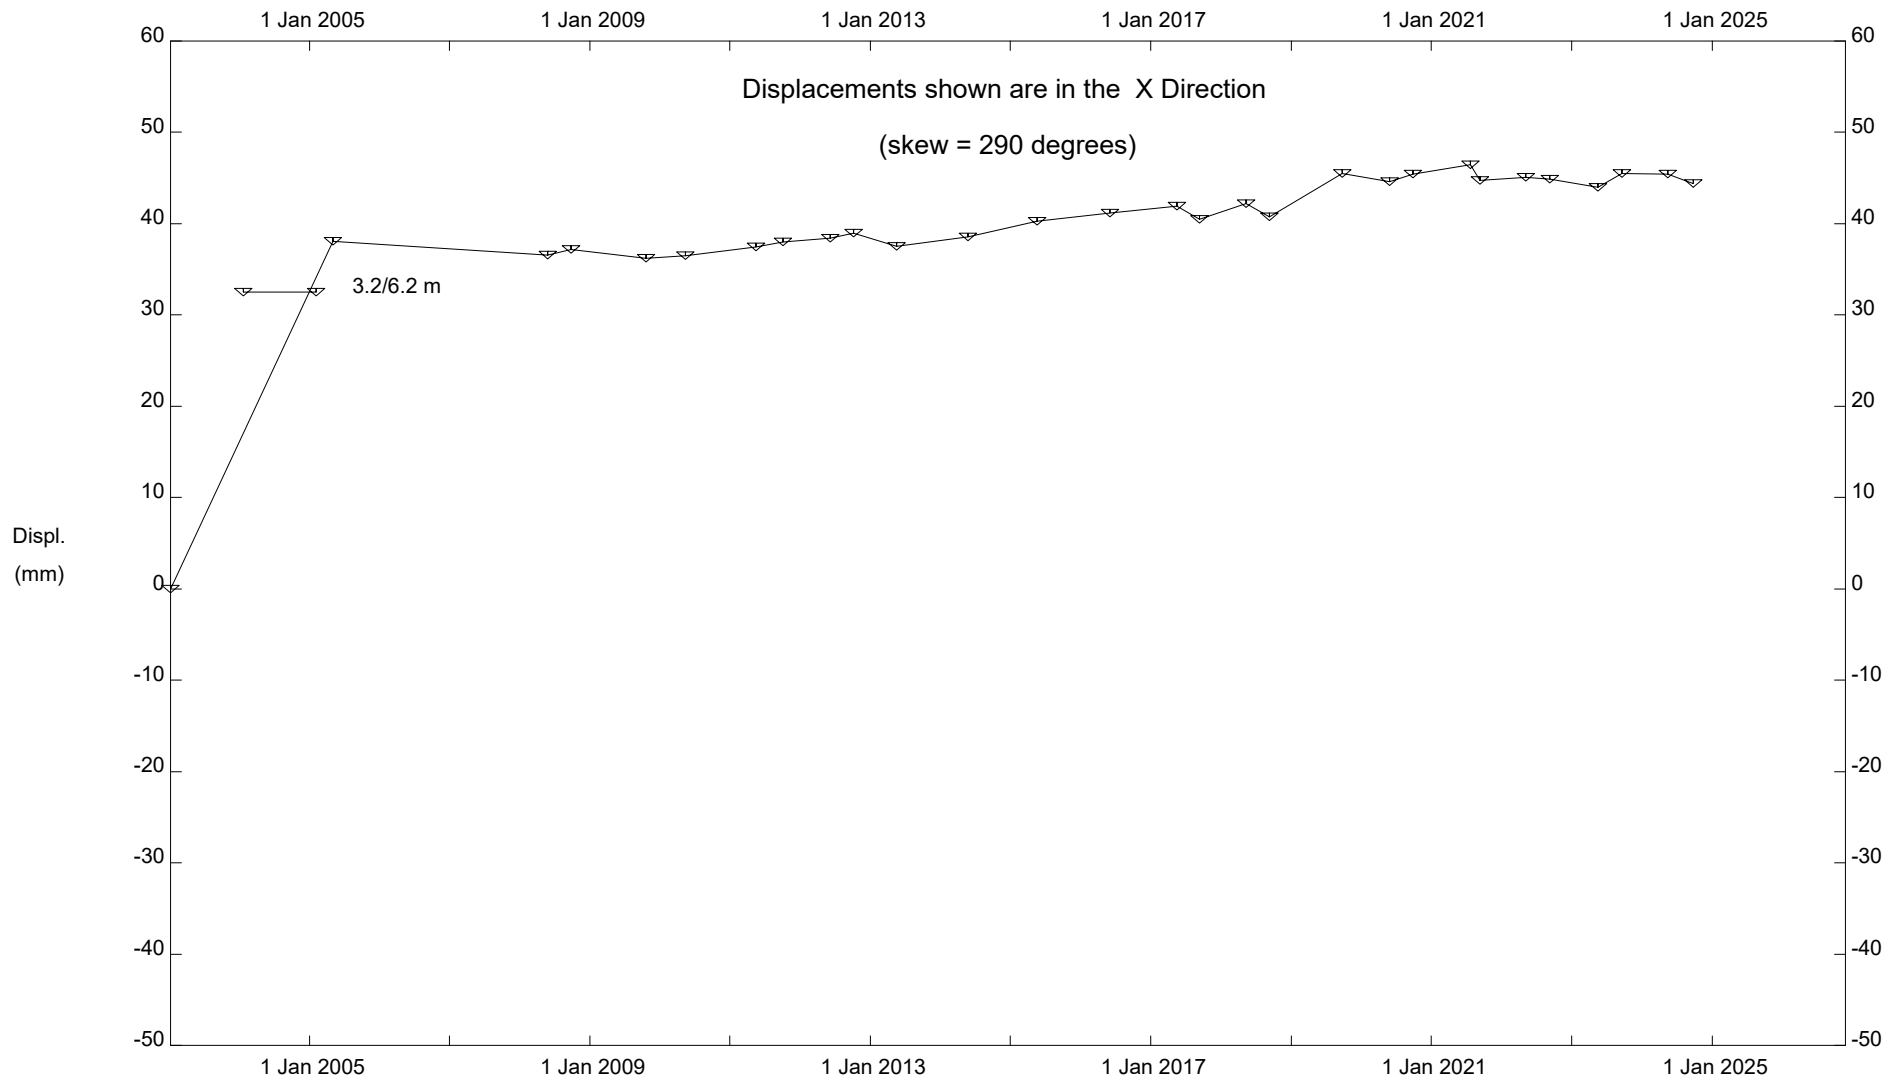
NC67, Inclinometer SI-12

SI-12 has a zone of movement between 3.2 m and 6.2 m and shows creep at a rate of about 1 mm/yr since 2008 with a total cumulative movement of 45 mm.
