Seepage	X		Seepage within the slumping at the north abutment piers and in erosion gullies on north bank below NBL.		X

Bridge/Culvert Distress	X		Outfall pipe separated behind outlet. Ponding under separated pipe. Beveled end separated with about 50 mm gap.		X
----------------------------	---	--	---	--	---

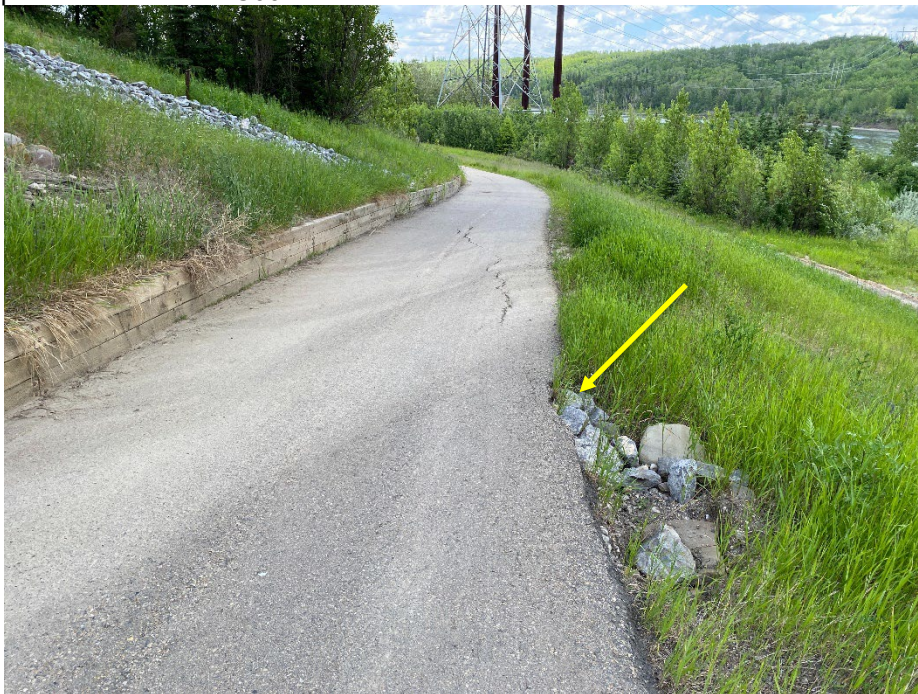
Photo 7: No change to trail crack pattern. Minor loss of trail. Looking northeast.

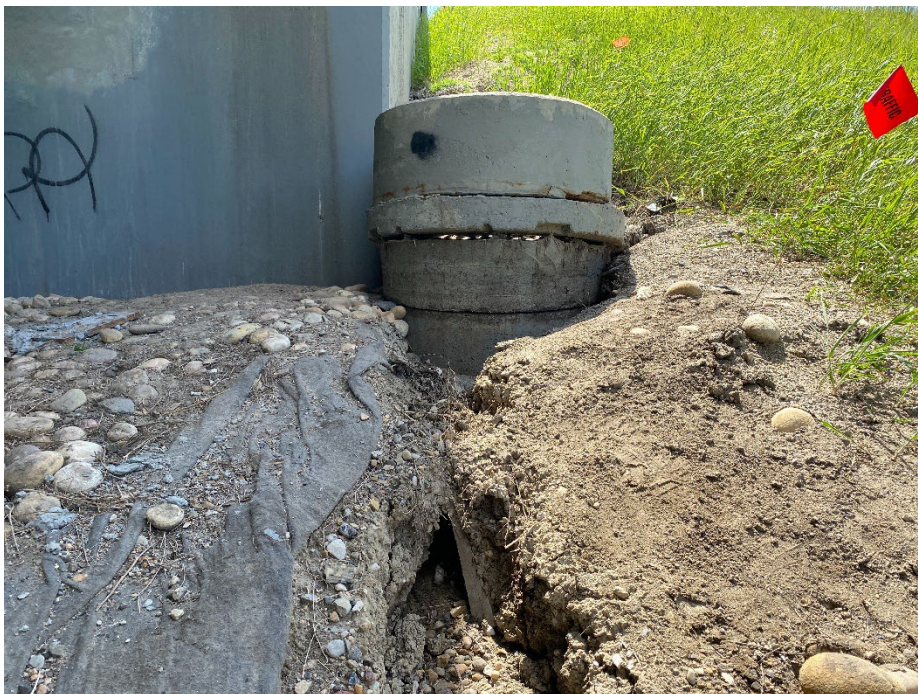
Photo 8: Catch basin on west side of NBL south abutment, not connected to an underground drainage system. Looking southeast.

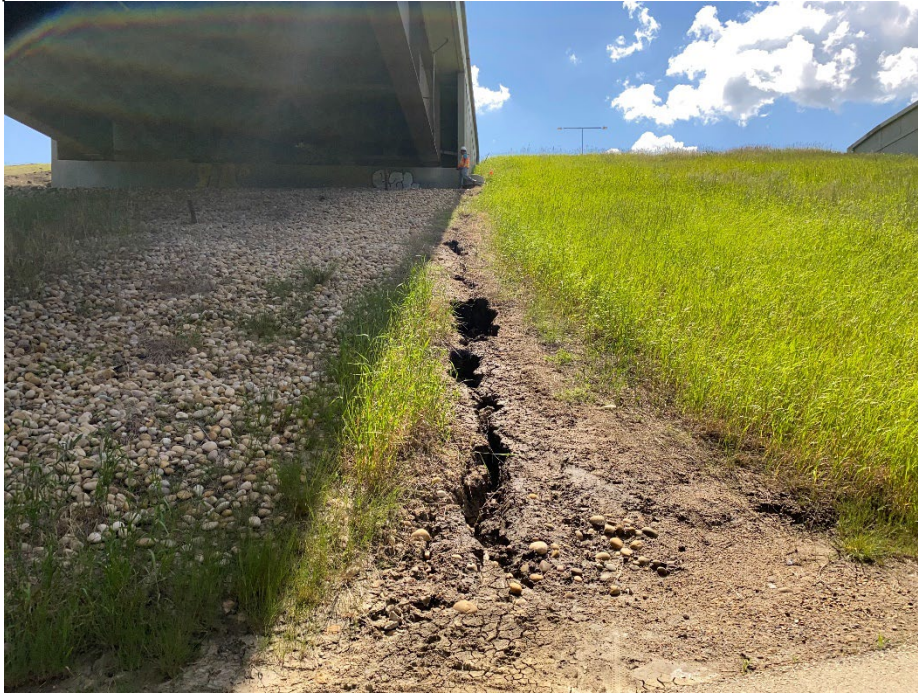
Photo 9: Erosion below the NB abutment on the south slope due to damaged waterproof membrane on abutment. Looking southeast.

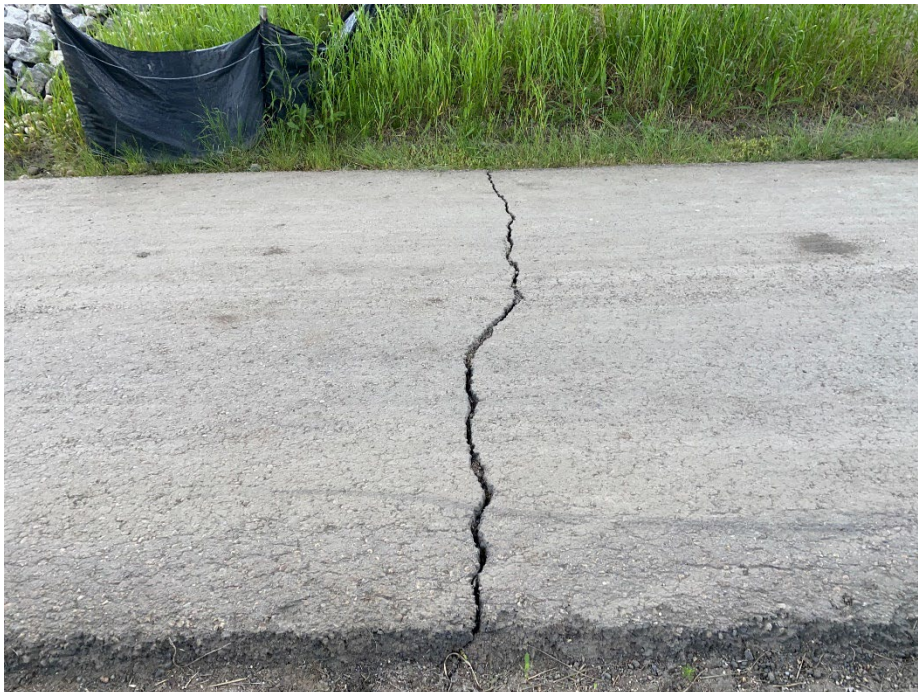
Photo 10: Crack in the paved trail below the NB lane of south abutment. Looking southeast.

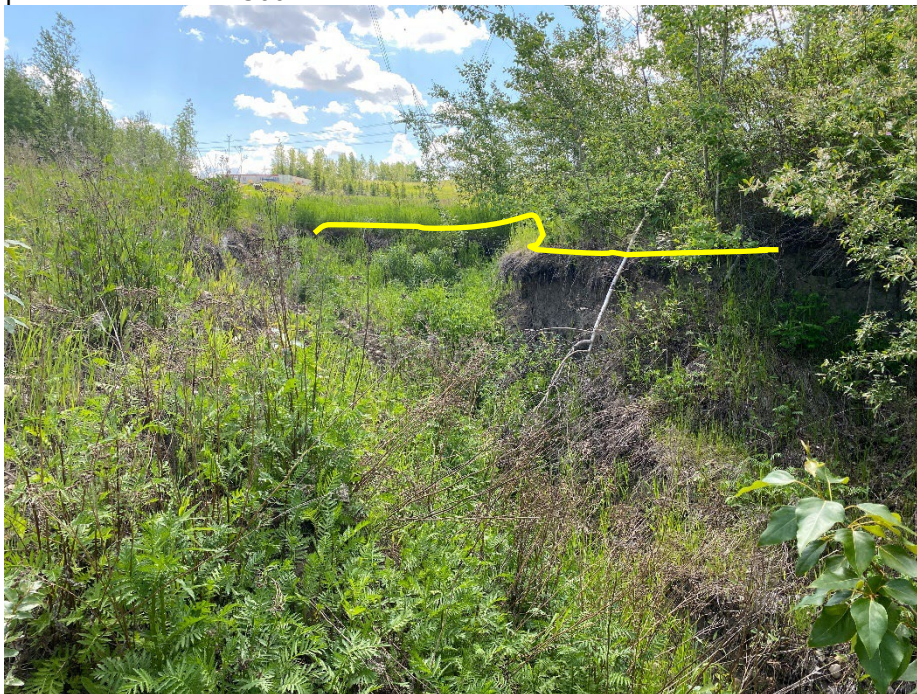
Photo 11: Two slumps adjacent and behind the outfall on the south bank of the river. Looking southeast.
