To: Amy Driessen
Transportation and Economic Corridors
From: Leslie Cho and Xiteng Liu
Stantec Consulting Ltd.
File: 123315222 Date: June 18, 2024

Reference: North Central Region, Stony Plain, Site NC067 - Highway 216:06 Anthony Henday Bridge, Spring 2024 Instrumentation Monitoring Report

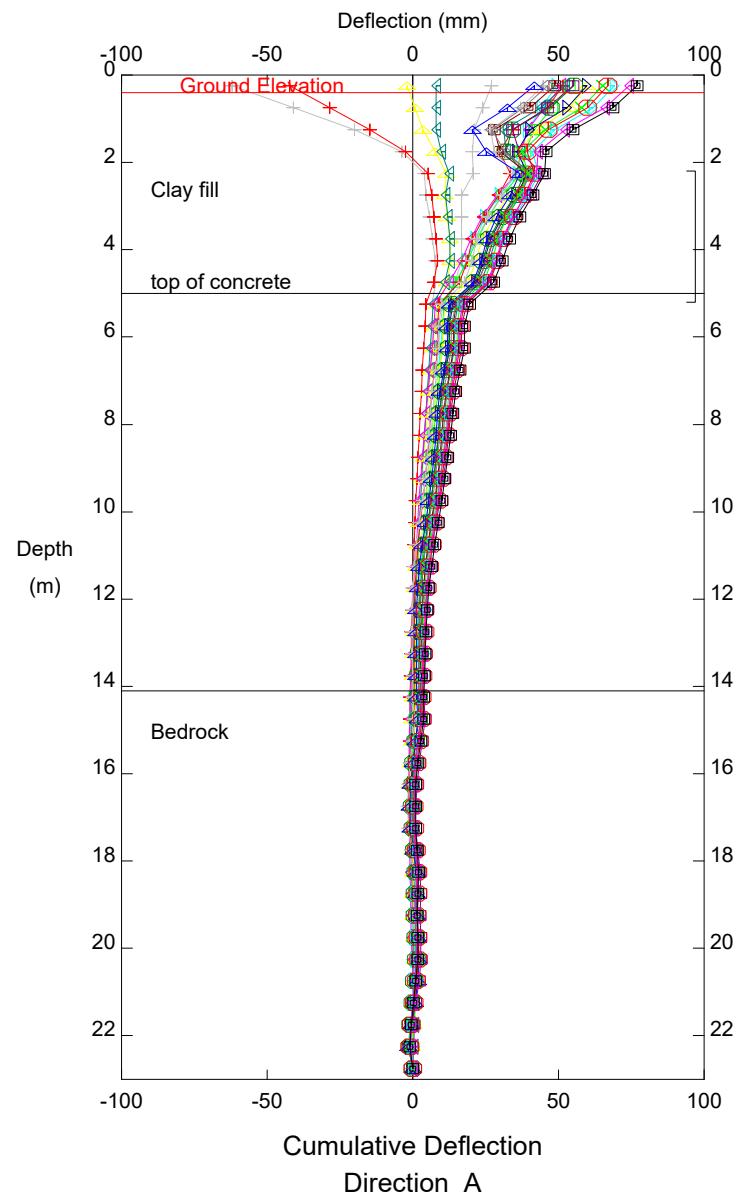
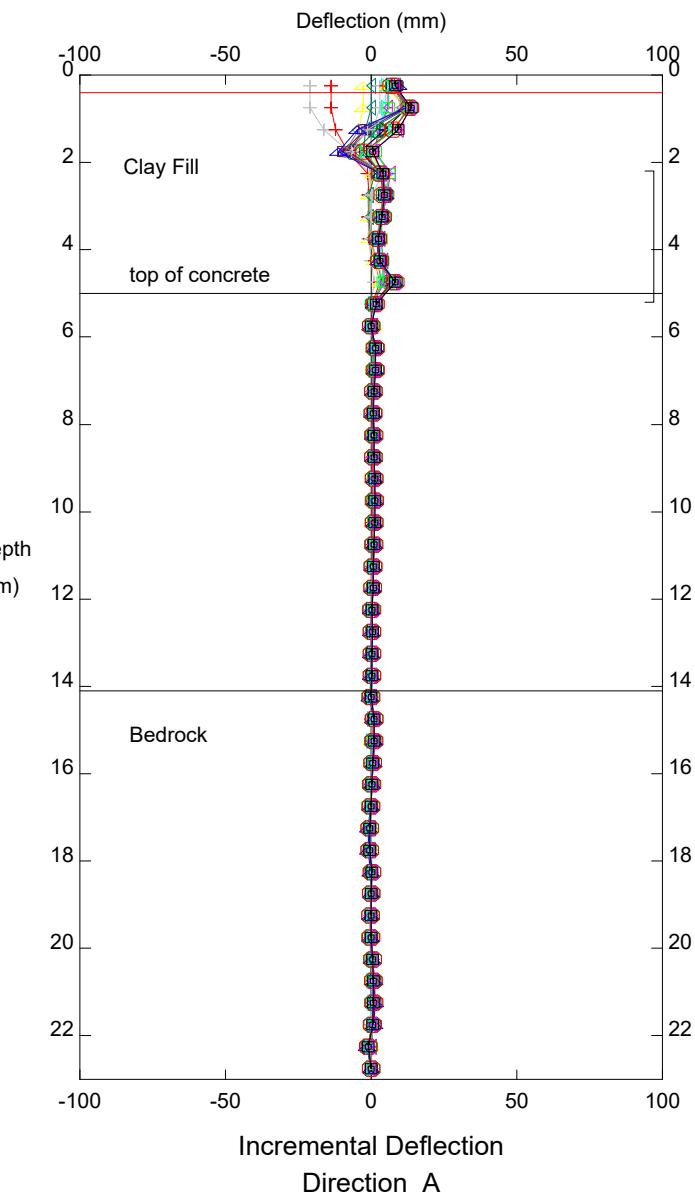
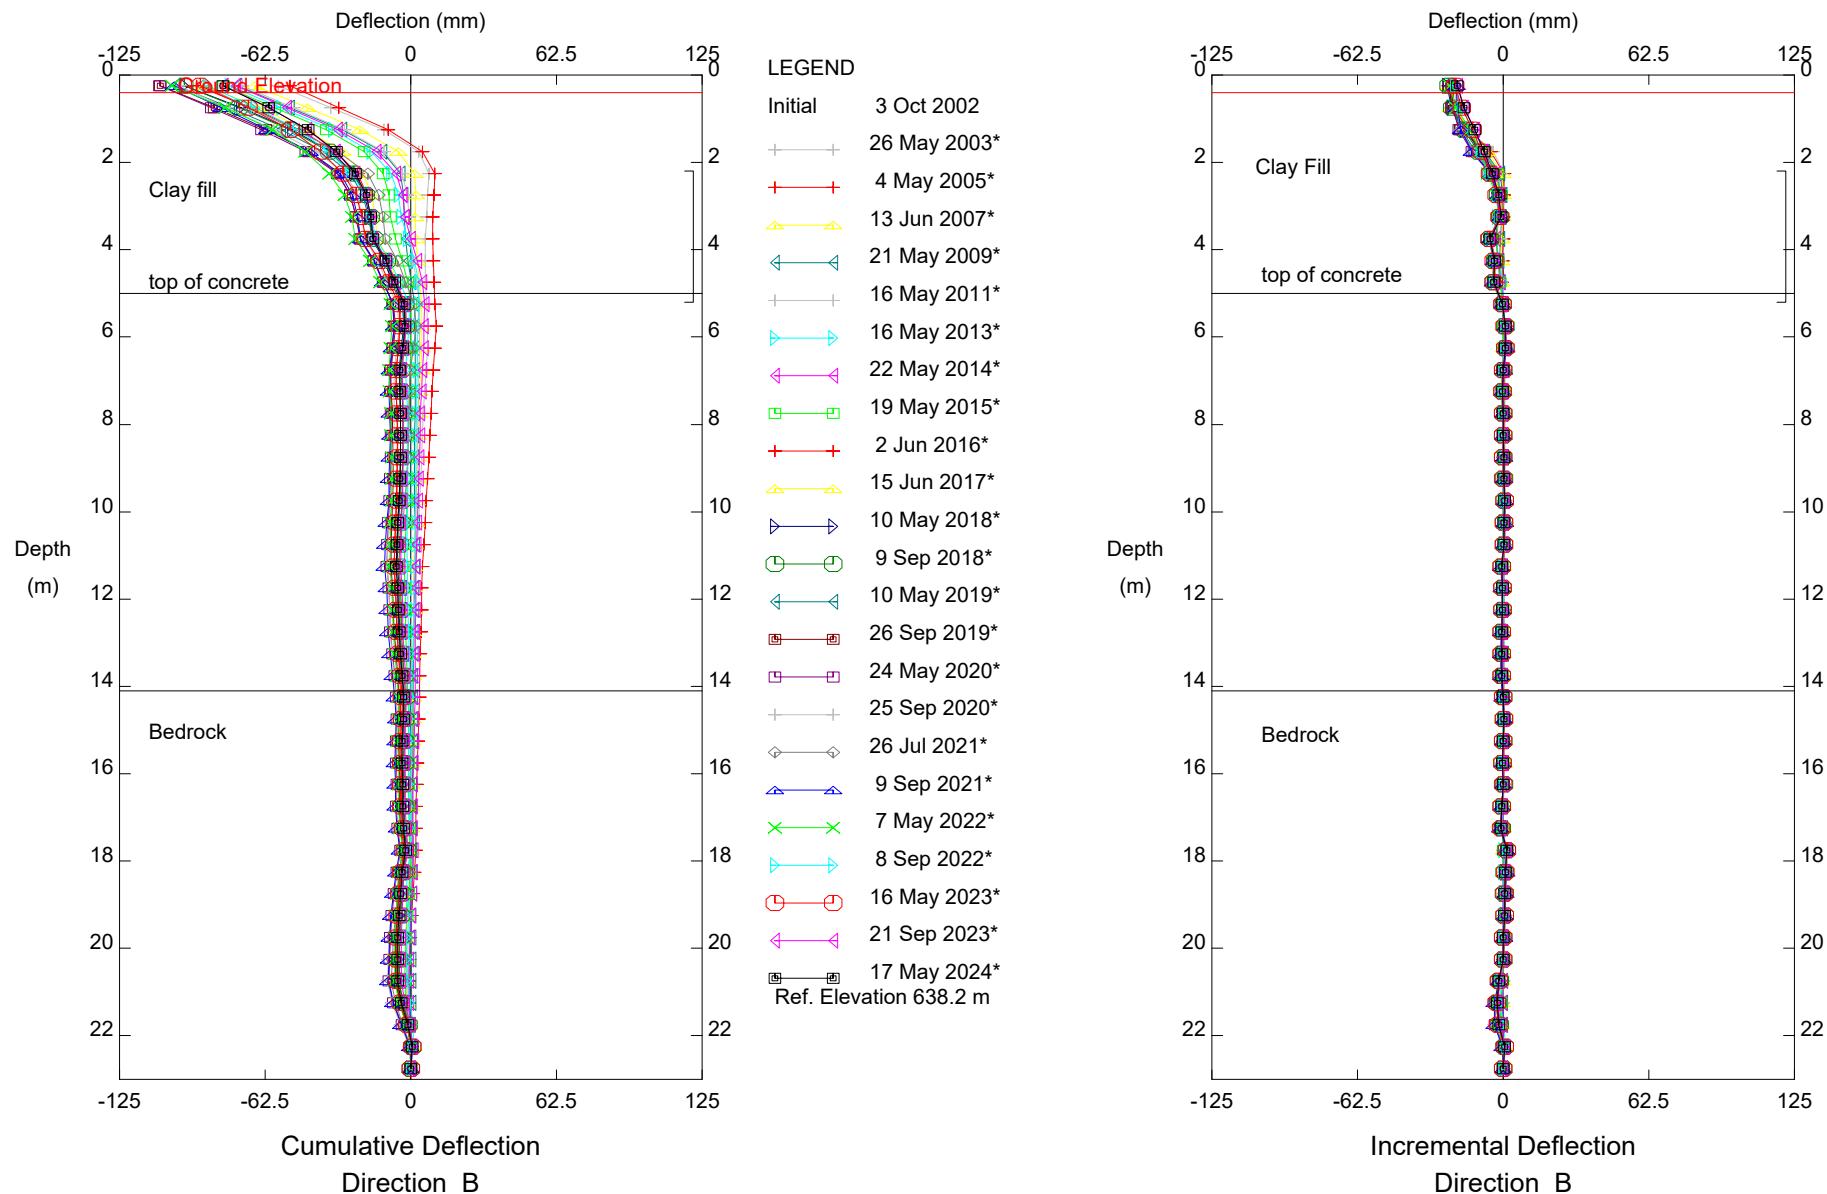
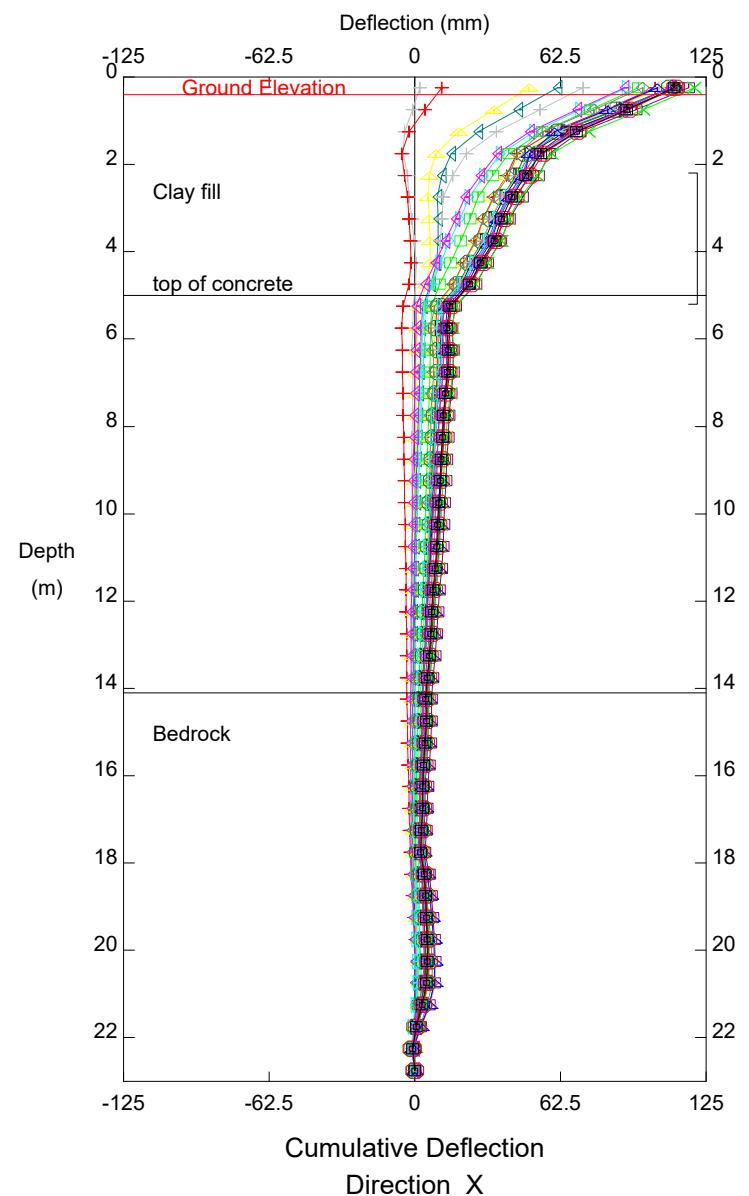
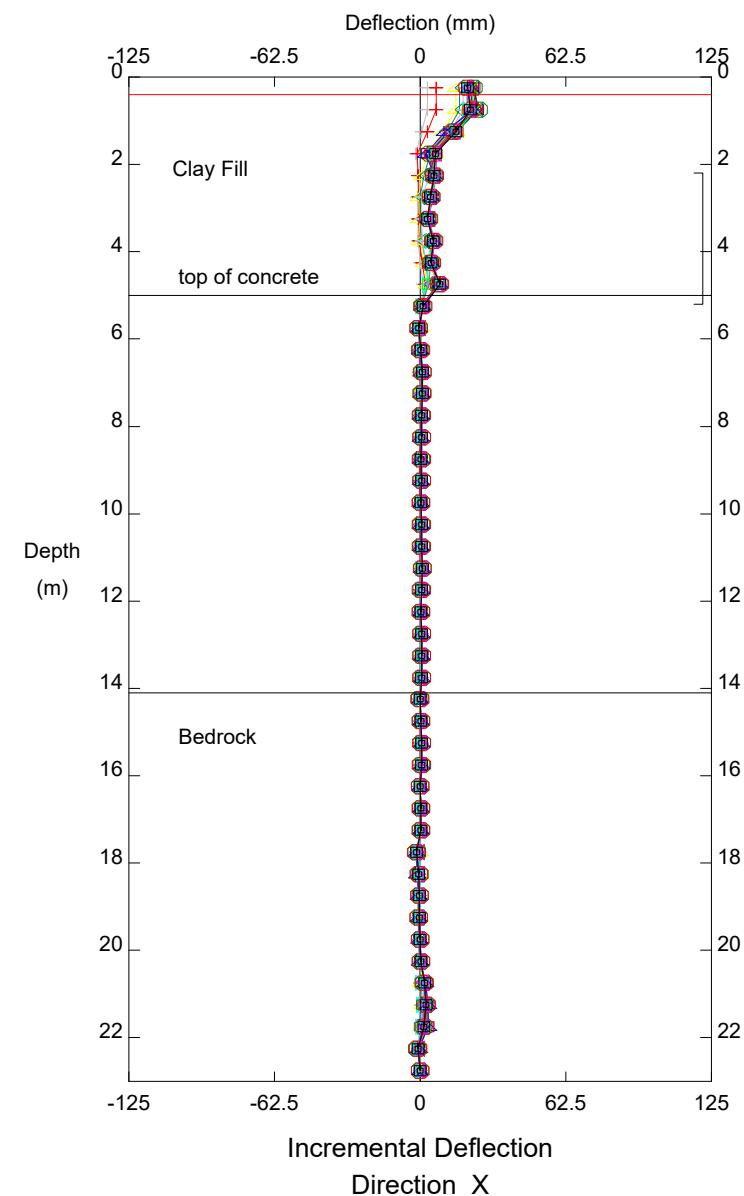
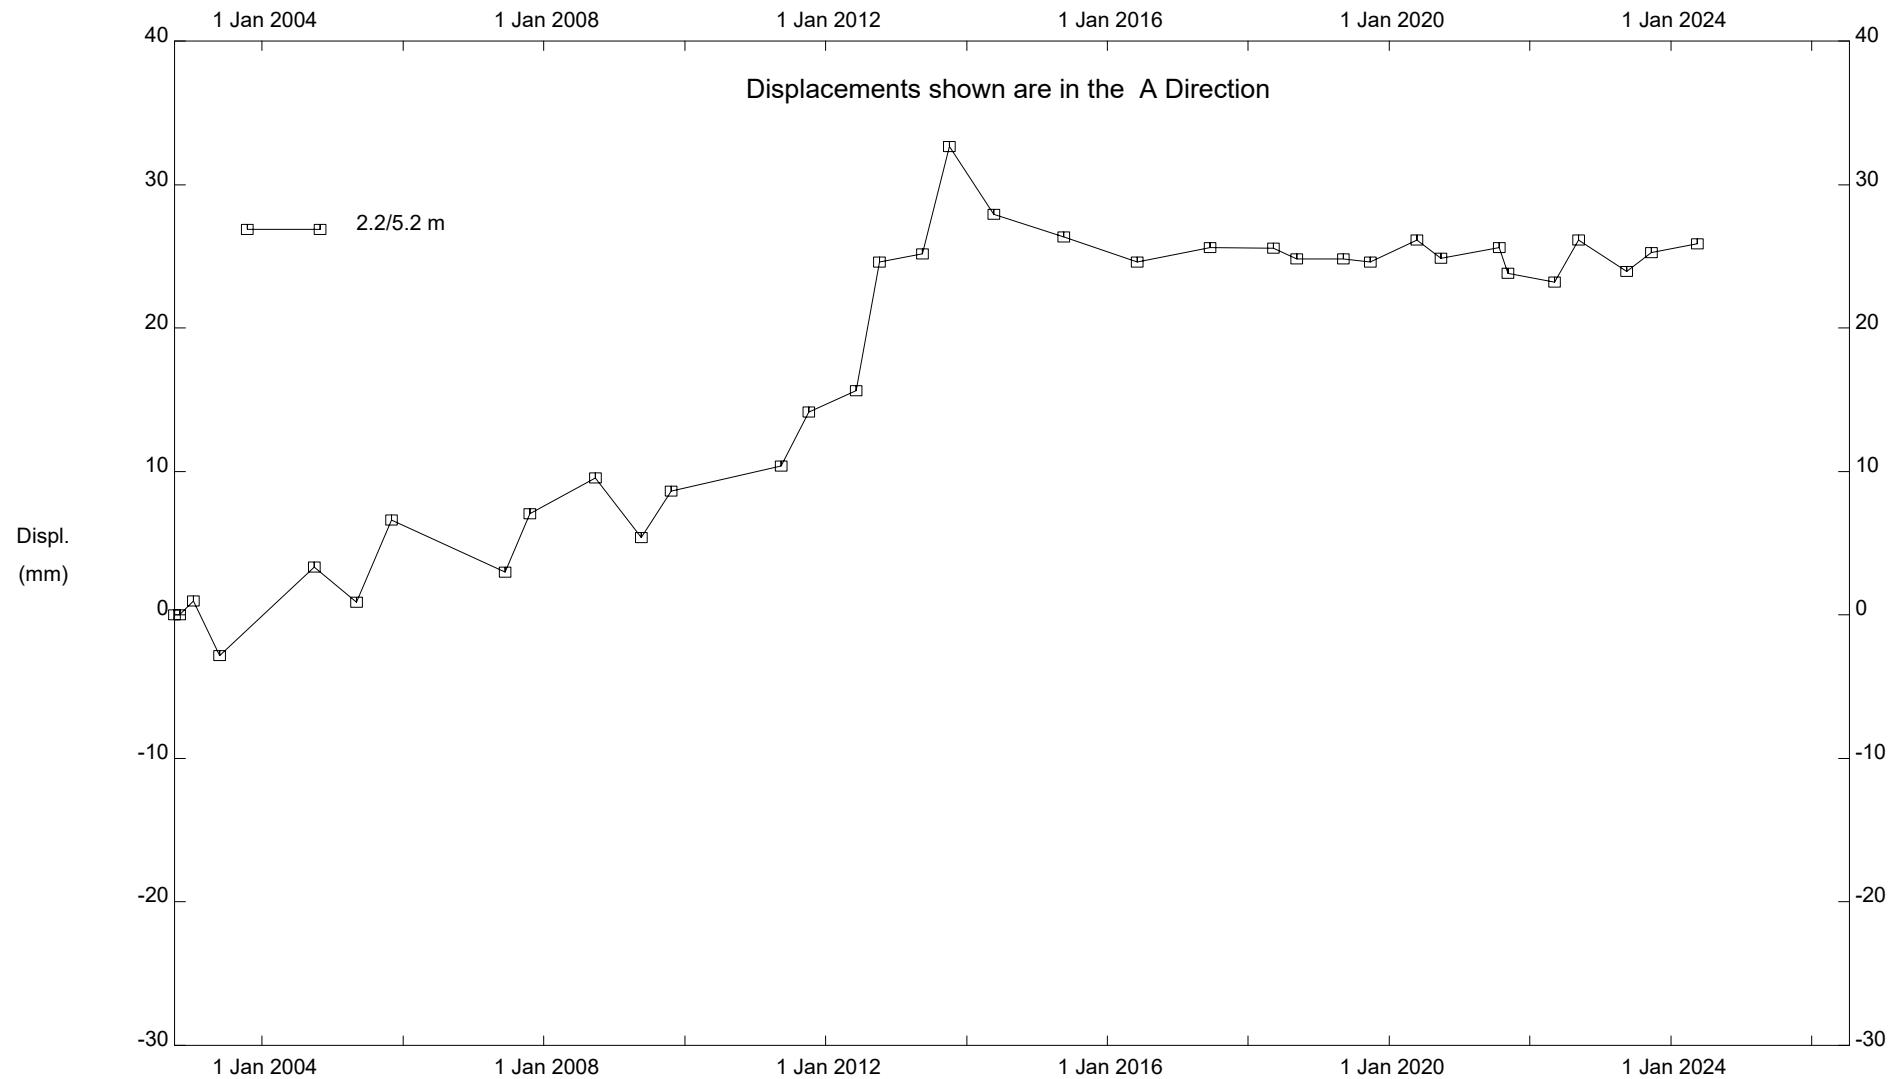
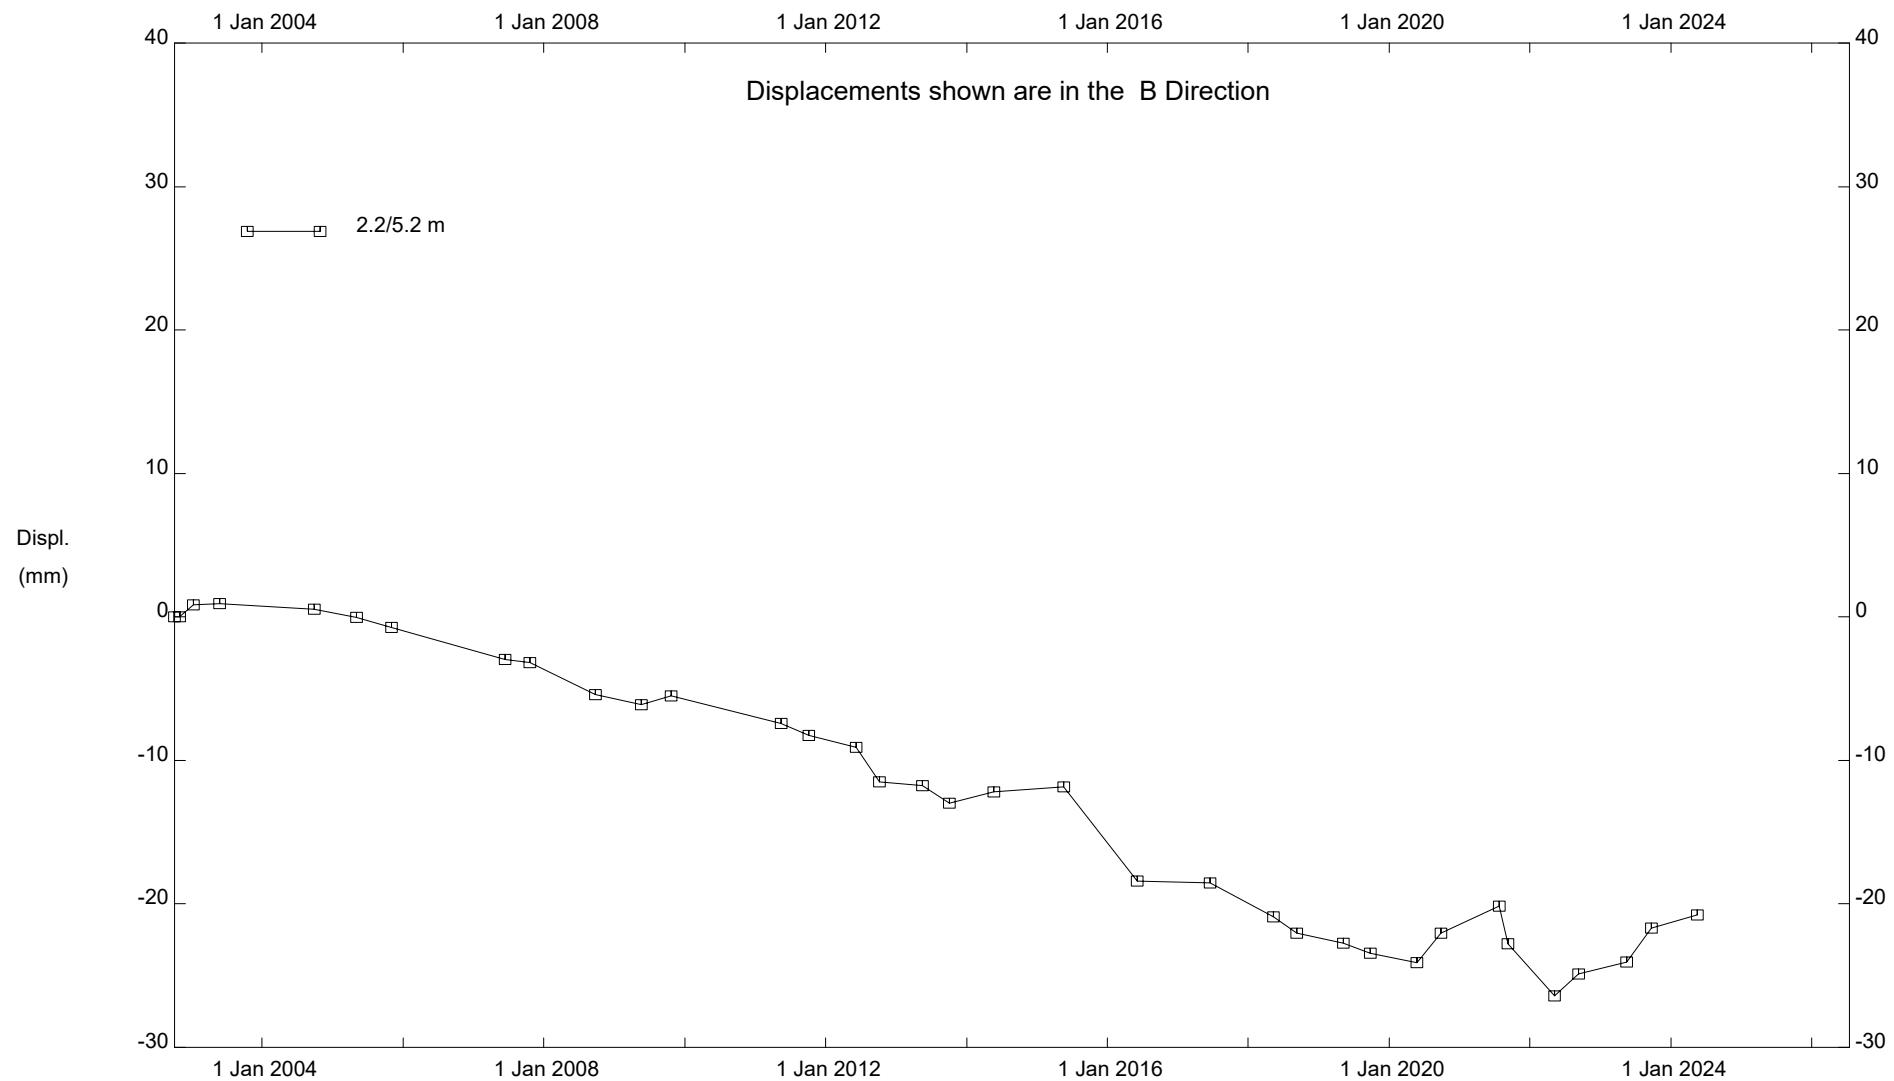
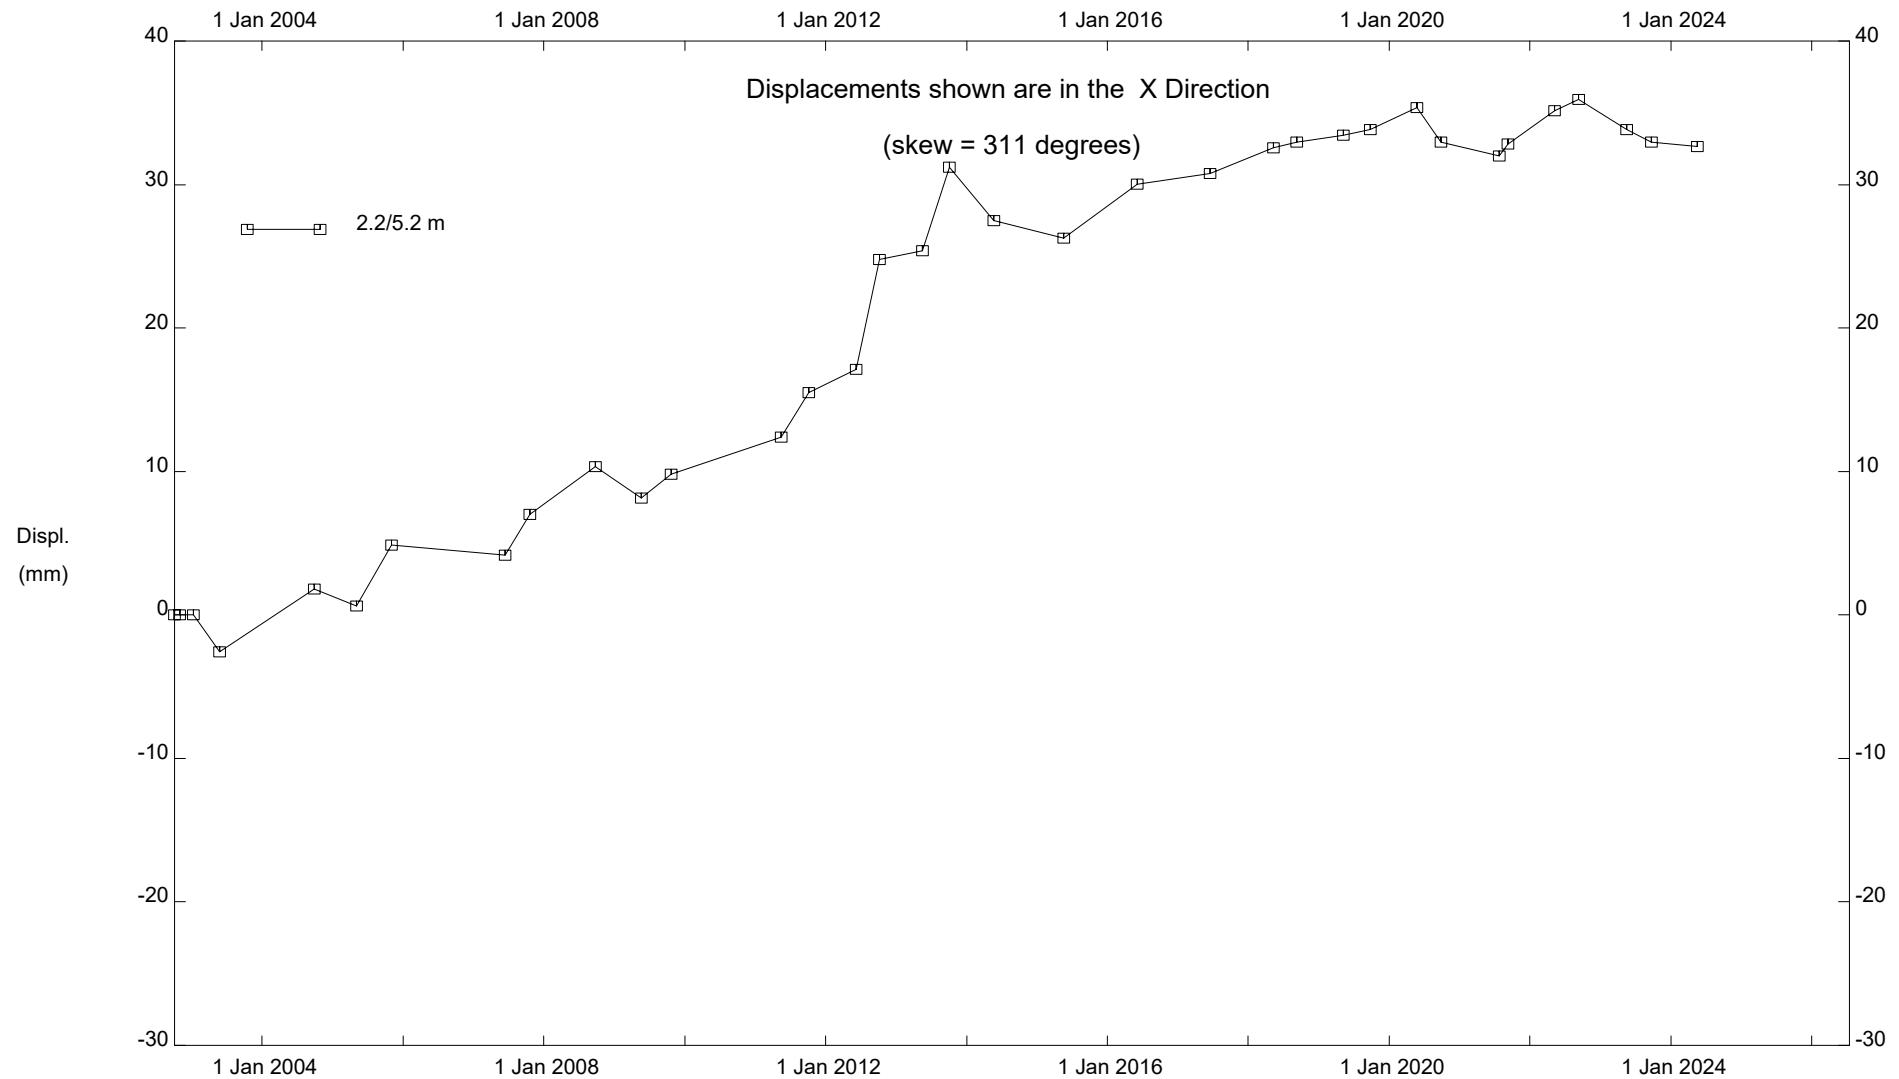
NC67, Inclinometer SI-01
Transportation & Economic Corridors

- SI-01 showed almost no change since the Fall 2023 reading cycle. The current movement rate is less than 1 mm/yr.
- SI-03 showed decreasing cumulative movement between 2018 and 2021. The cumulative movement decreased by 4 mm to 106 mm during the Spring 2024 readings with a rate of movement of 6 mm/yr.
