To: Amy Driessen
Transportation and Economic Corridors
From: Leslie Cho and Xiteng Liu
Stantec Consulting Ltd.
File: 123315222 Date: June 18, 2024

Reference: North Central Region, Stony Plain, Site NC067 - Highway 216:06 Anthony Henday Bridge, Spring 2024 Instrumentation Monitoring Report

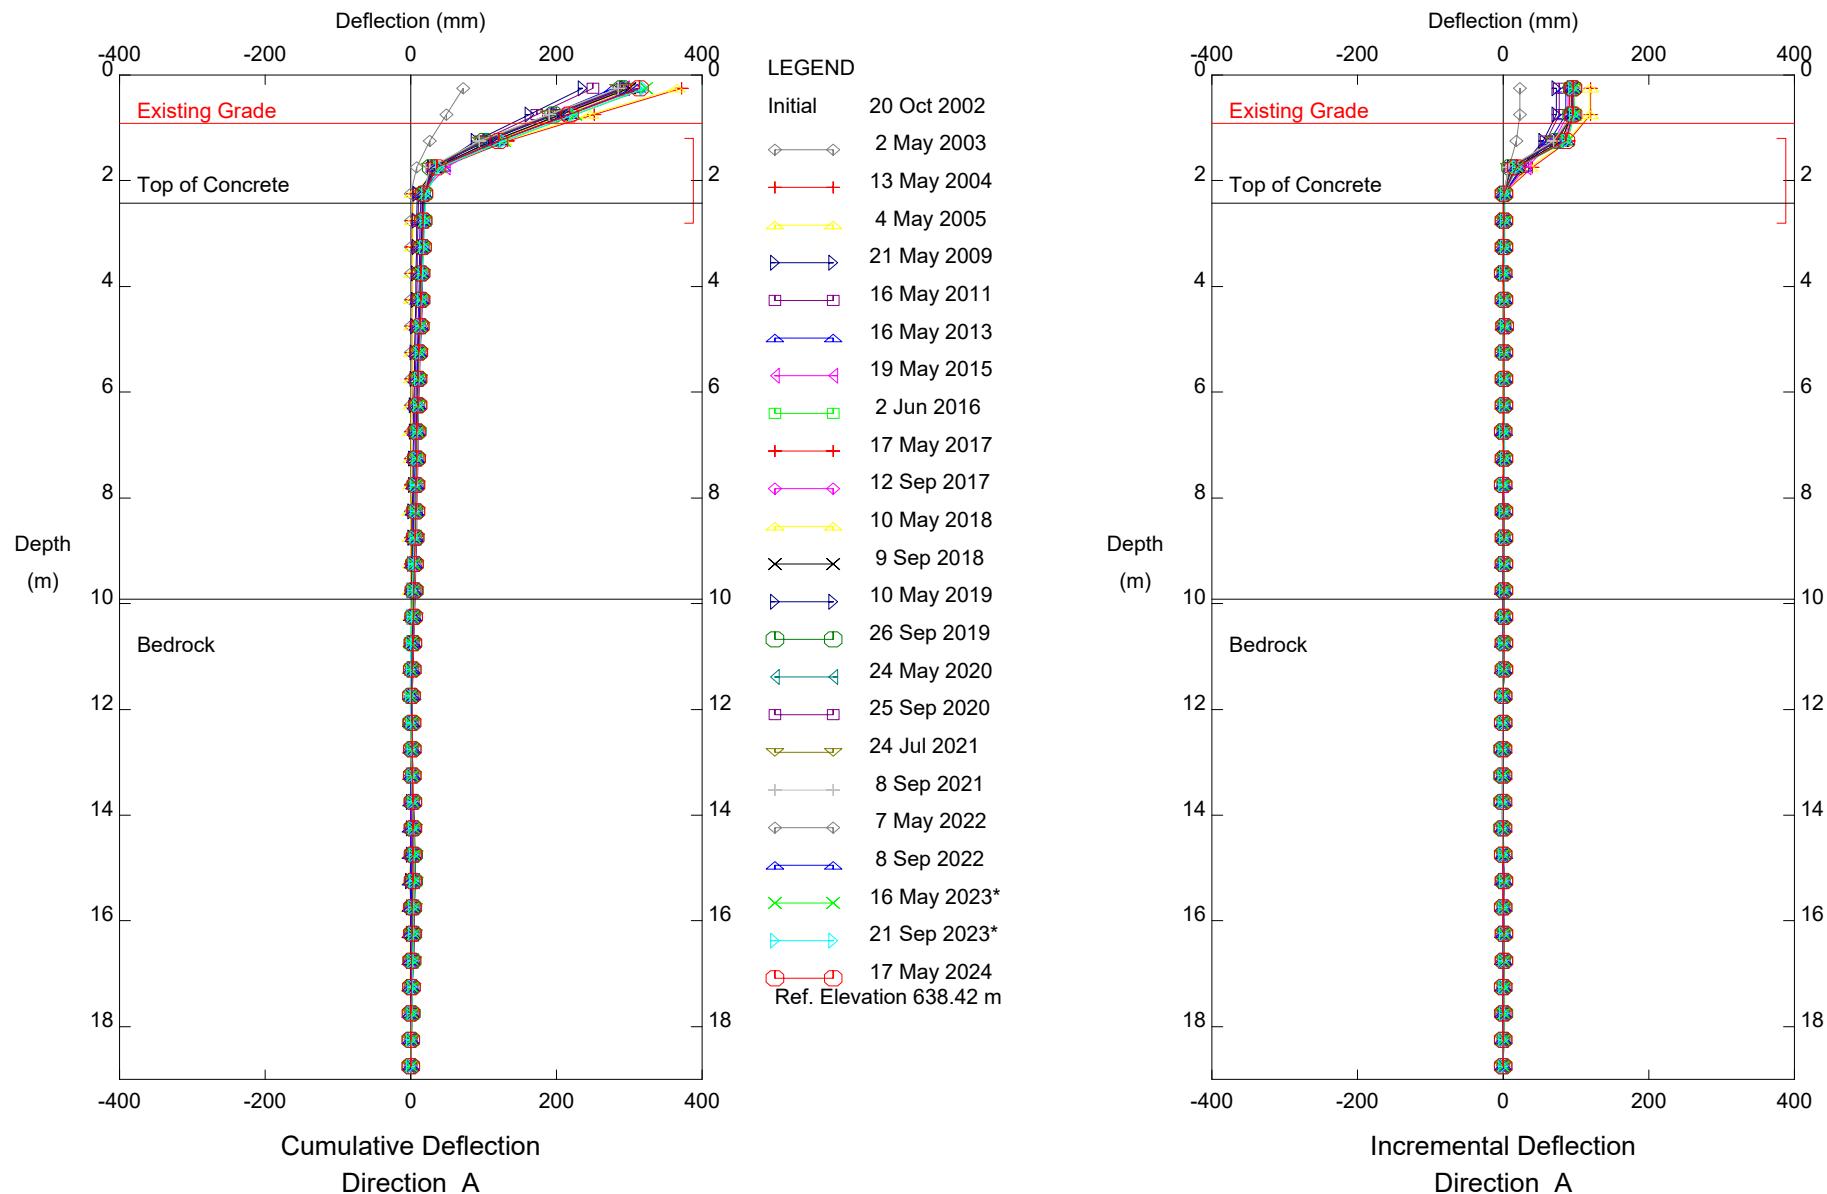
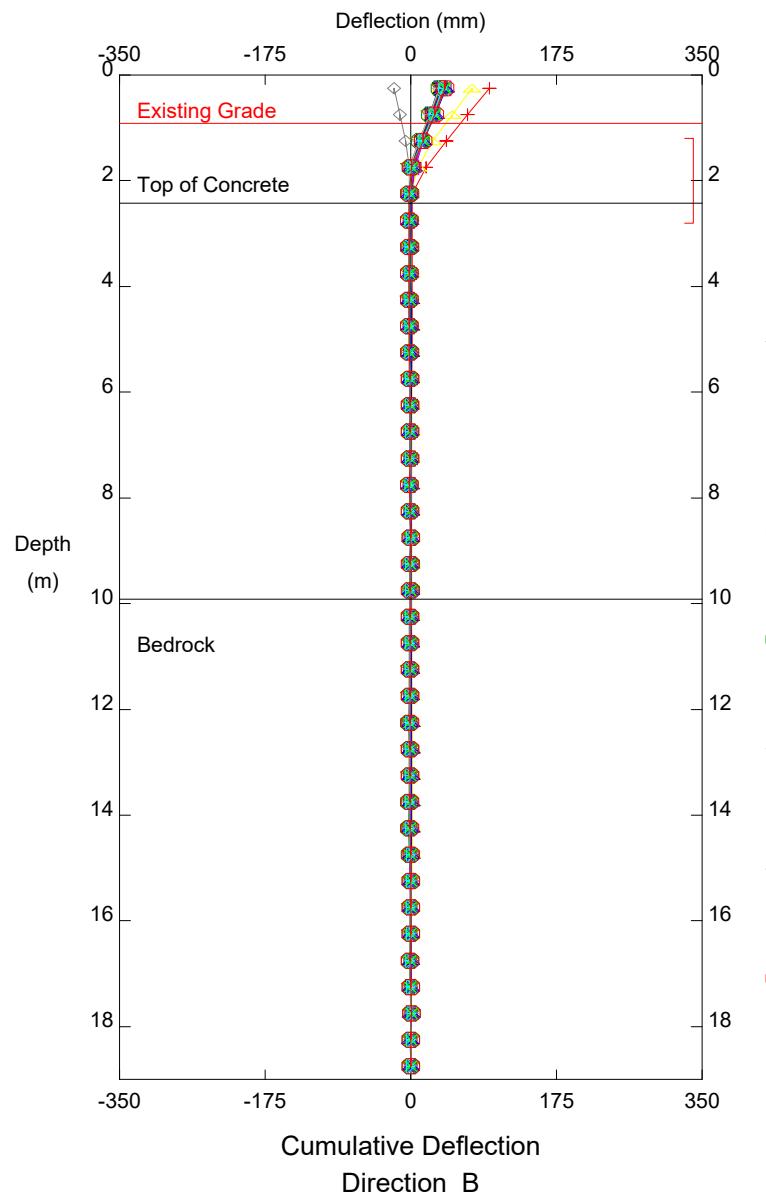
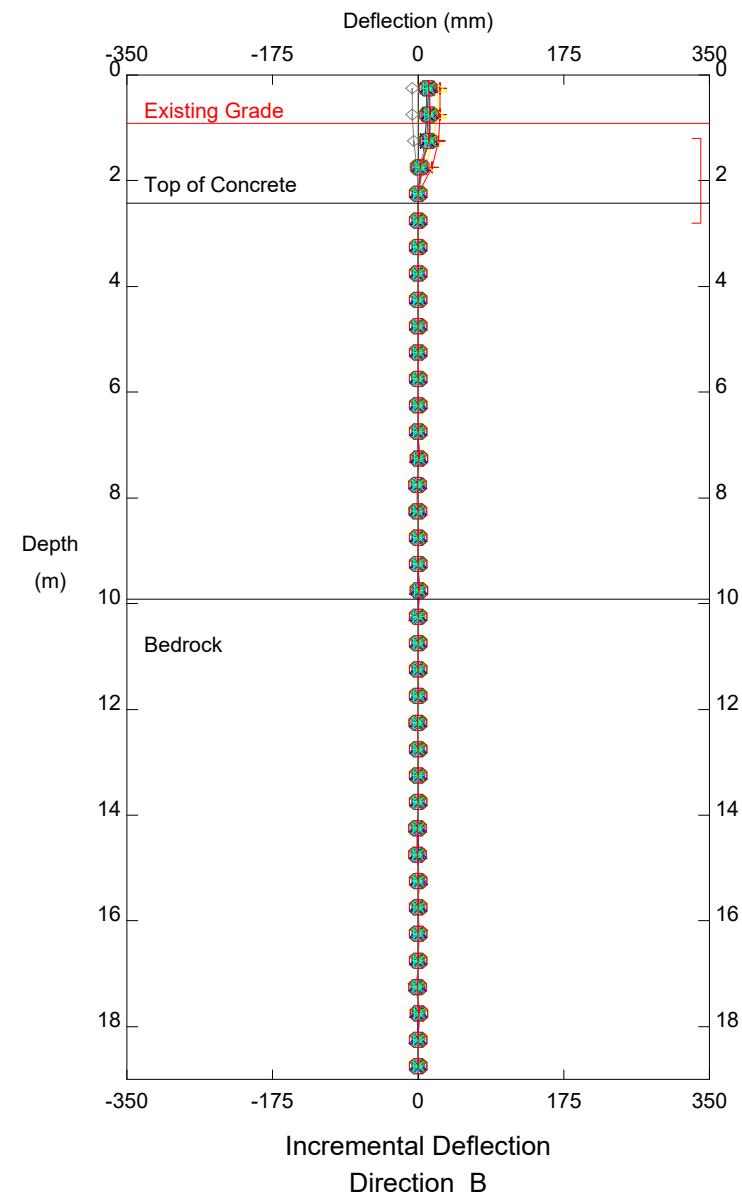
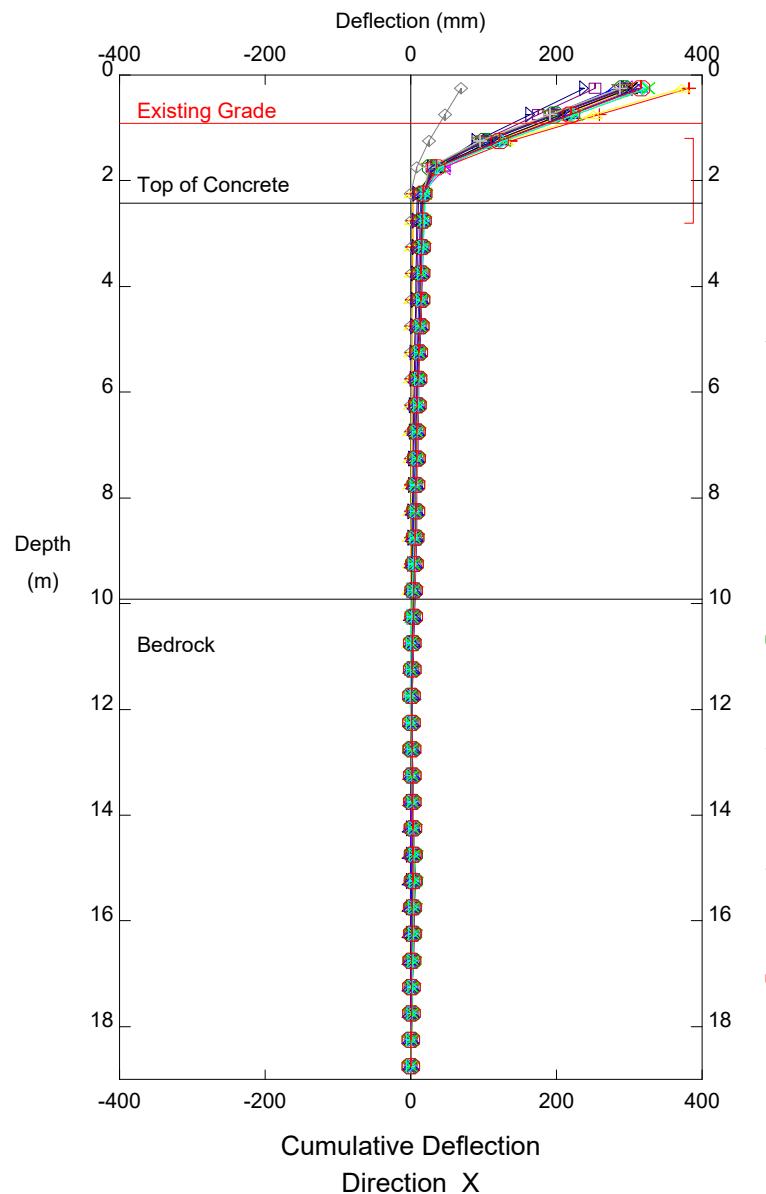
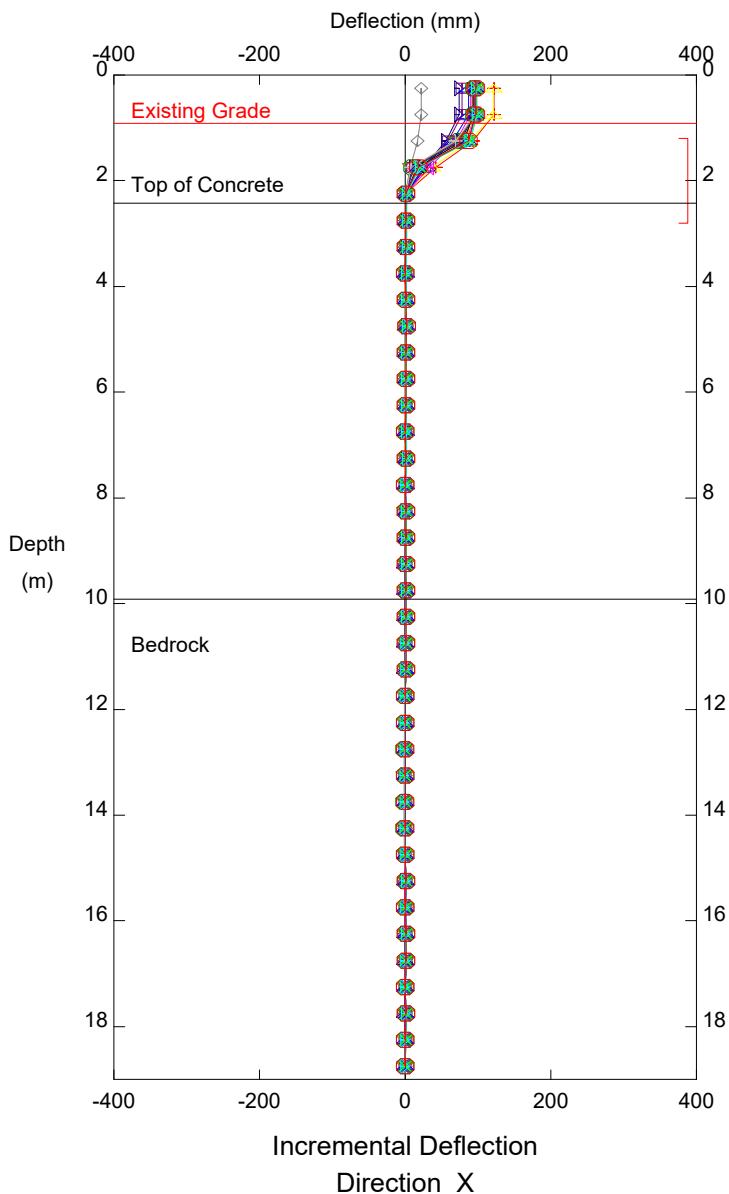
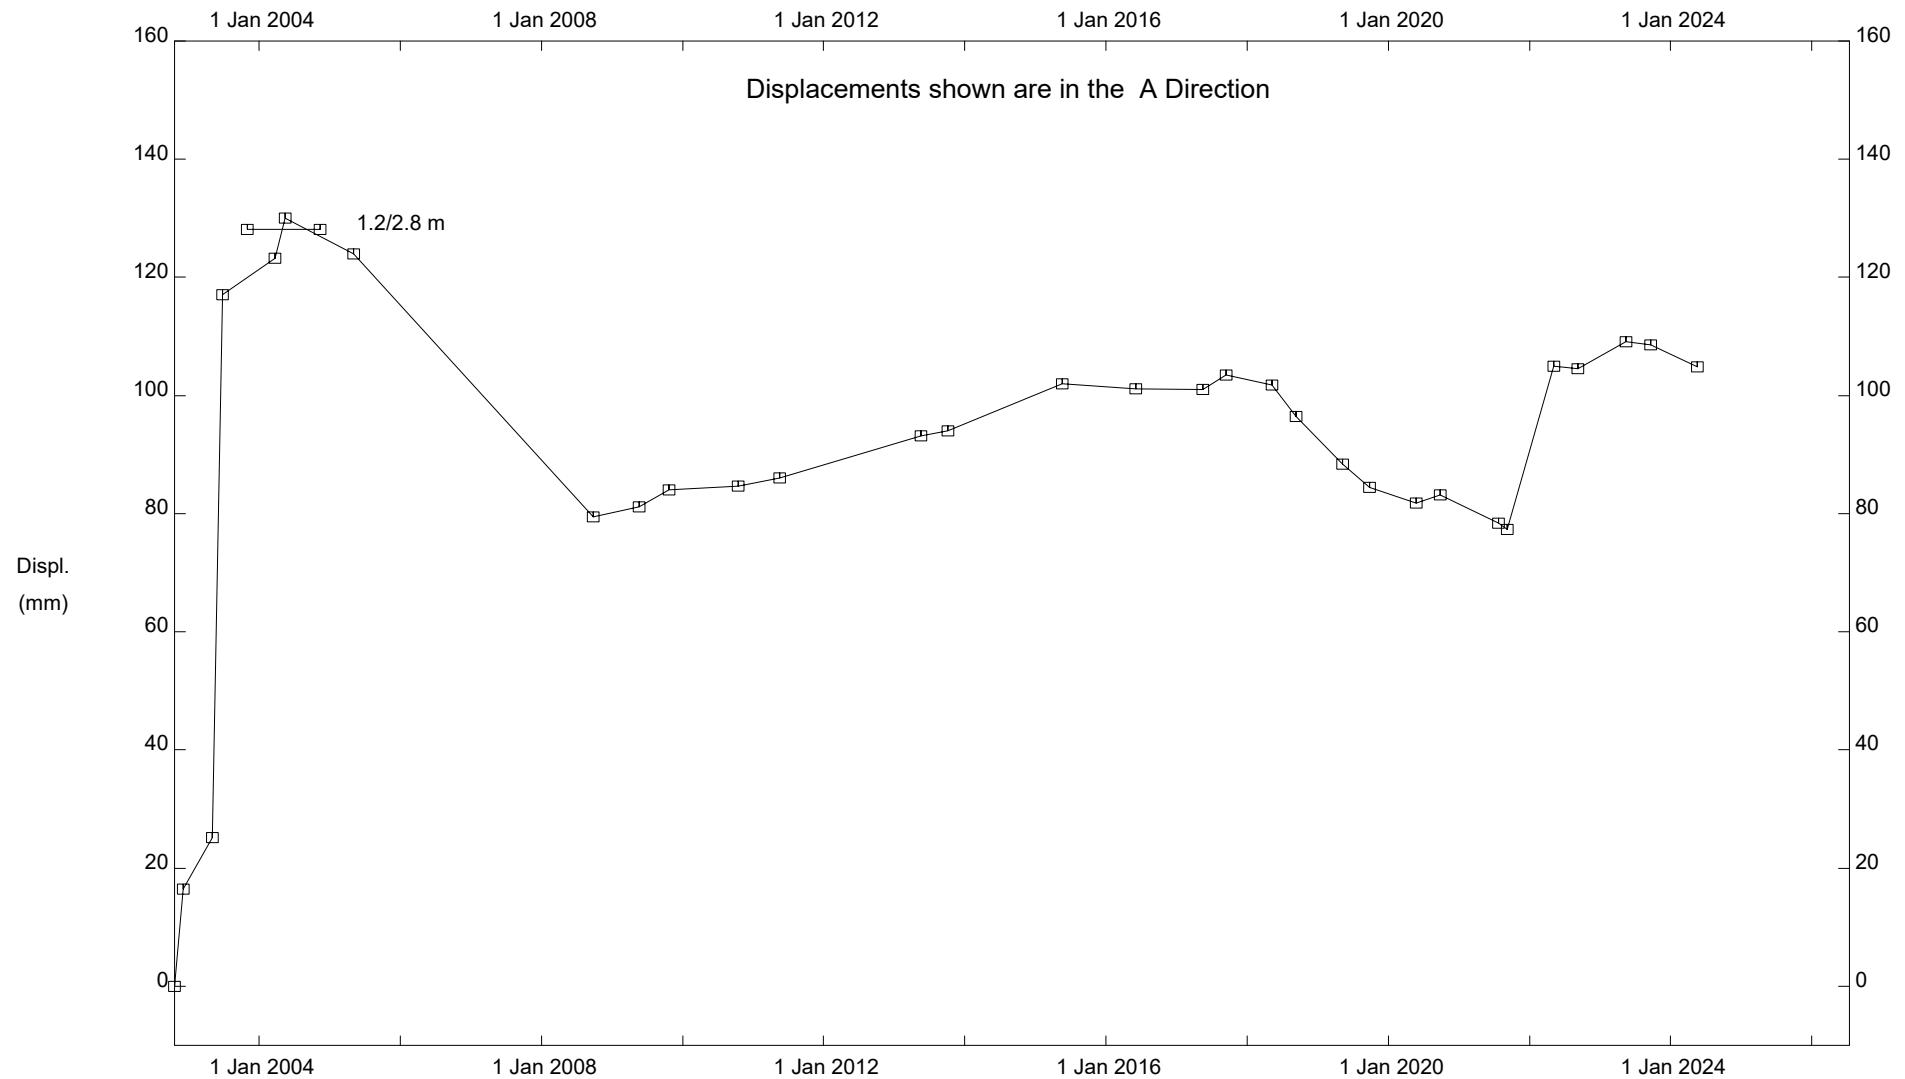
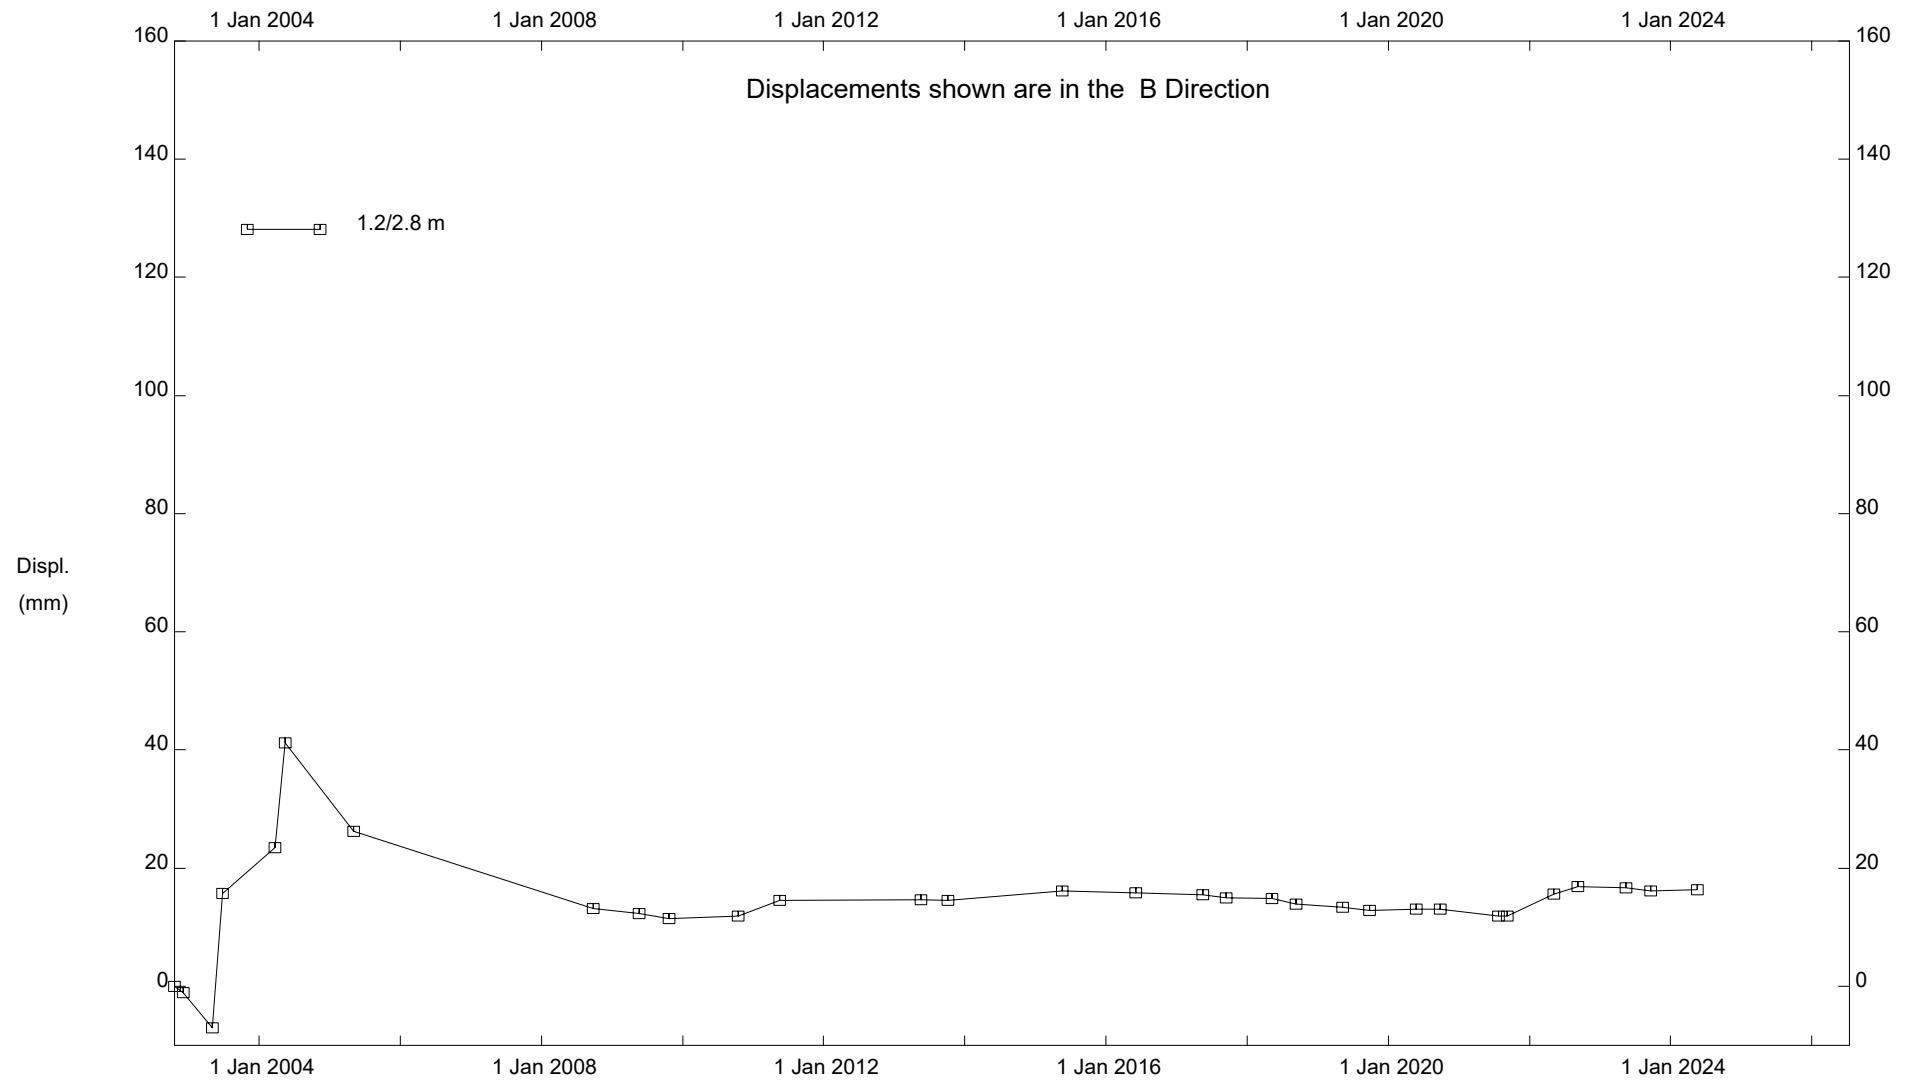
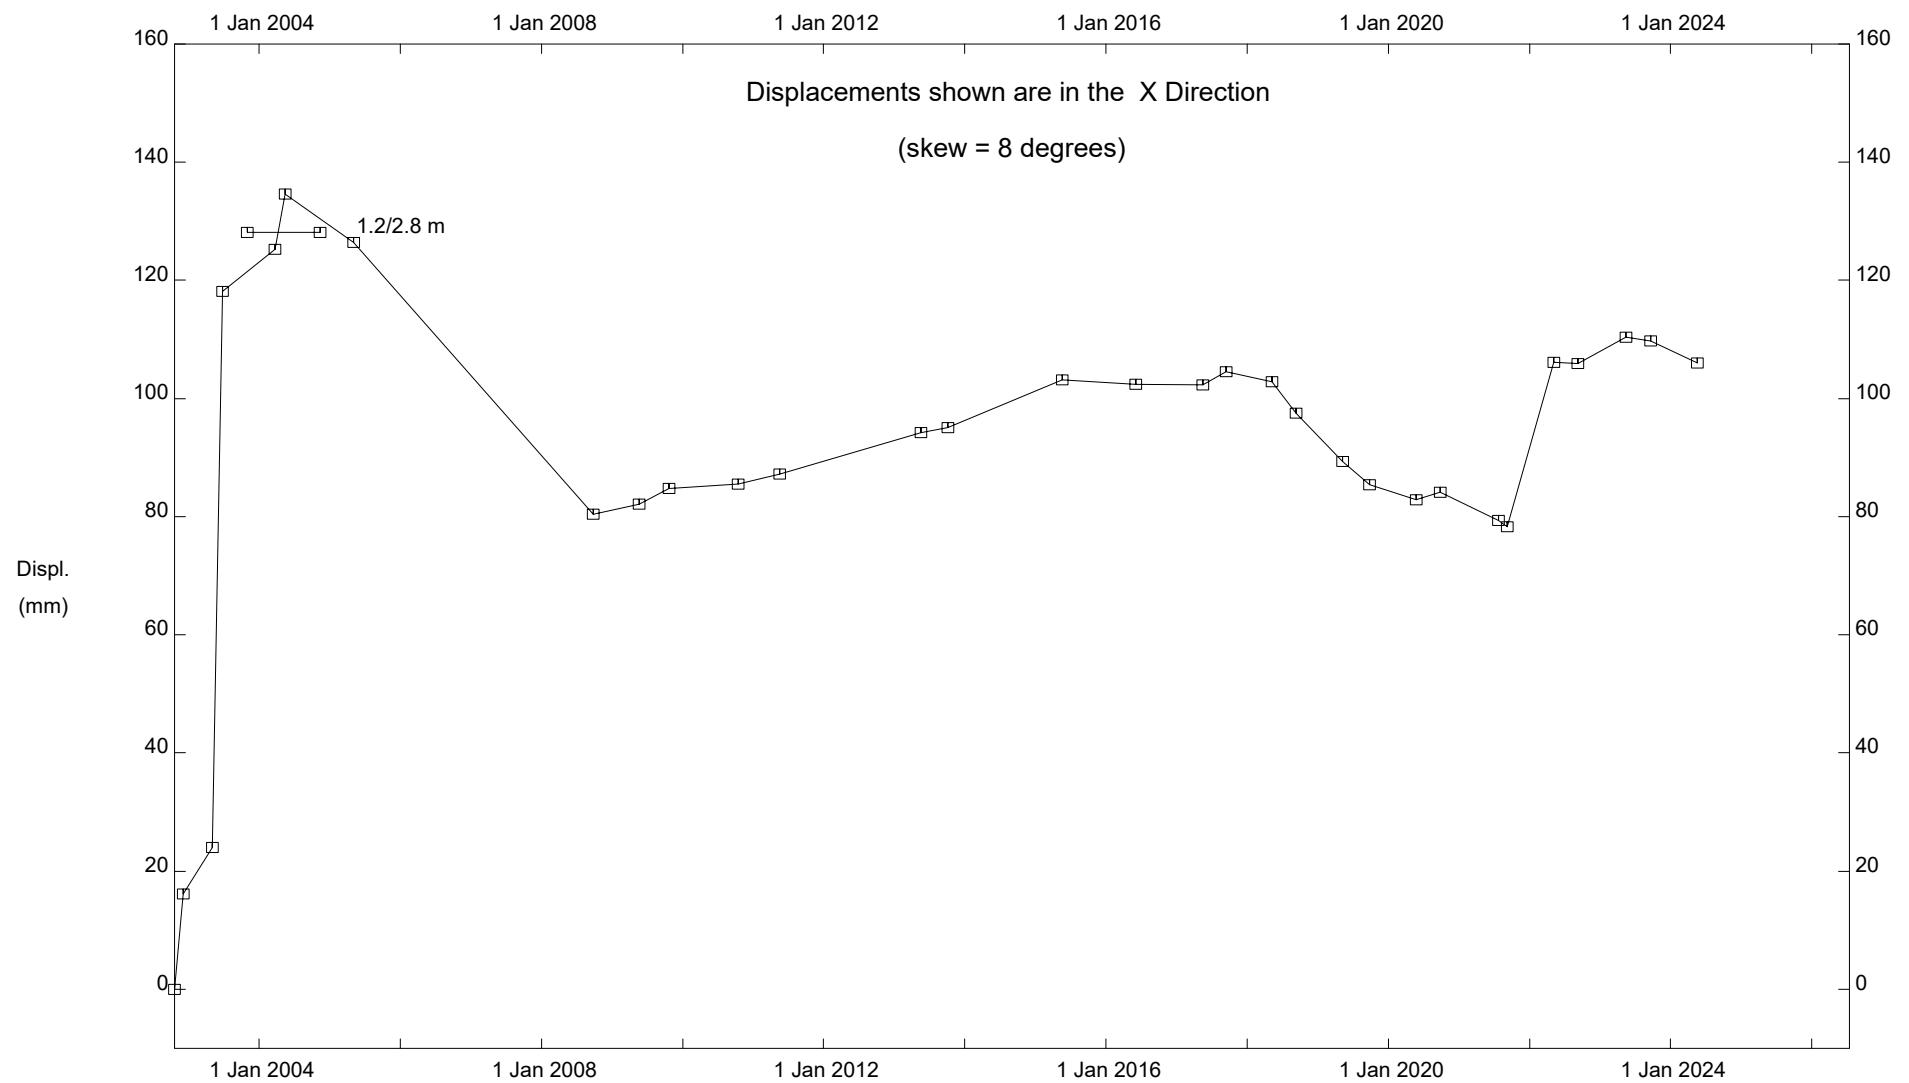
NC67, Inclinometer SI-03

- SI-01 showed almost no change since the Fall 2023 reading cycle. The current movement rate is less than 1 mm/yr.
- SI-03 showed decreasing cumulative movement between 2018 and 2021. The cumulative movement decreased by 4 mm to 106 mm during the Spring 2024 readings with a rate of movement of 6 mm/yr.
