To: Amy Driessen
Transportation and Economic Corridors
From: Leslie Cho and Xiteng Liu
Stantec Consulting Ltd.
File: 123315222 Date: June 18, 2024

Reference: North Central Region, Stony Plain, Site NC067 - Highway 216:06 Anthony Henday Bridge, Spring 2024 Instrumentation Monitoring Report

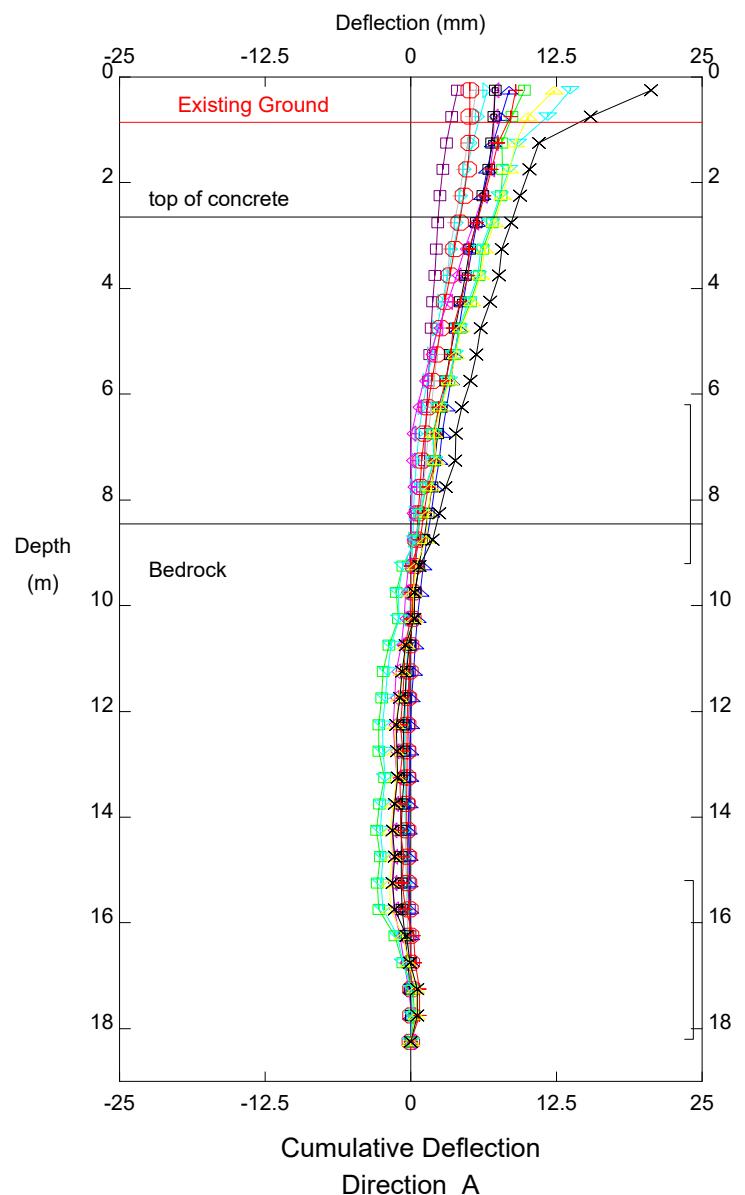
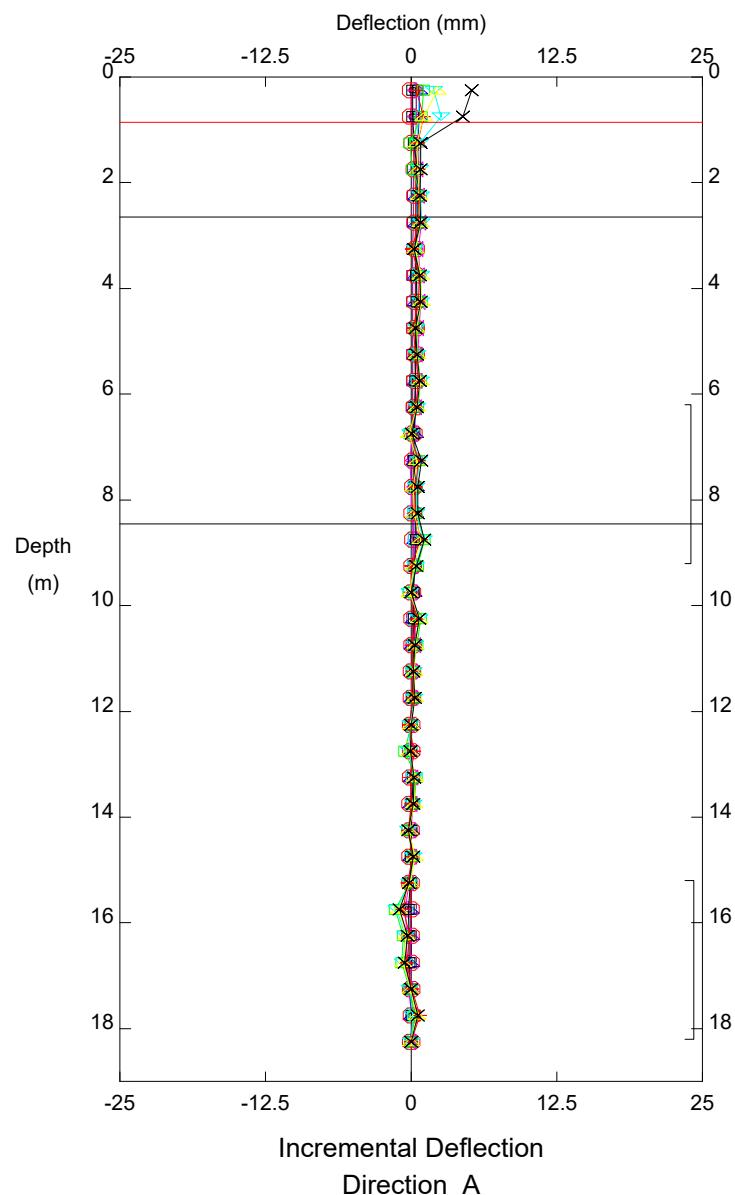
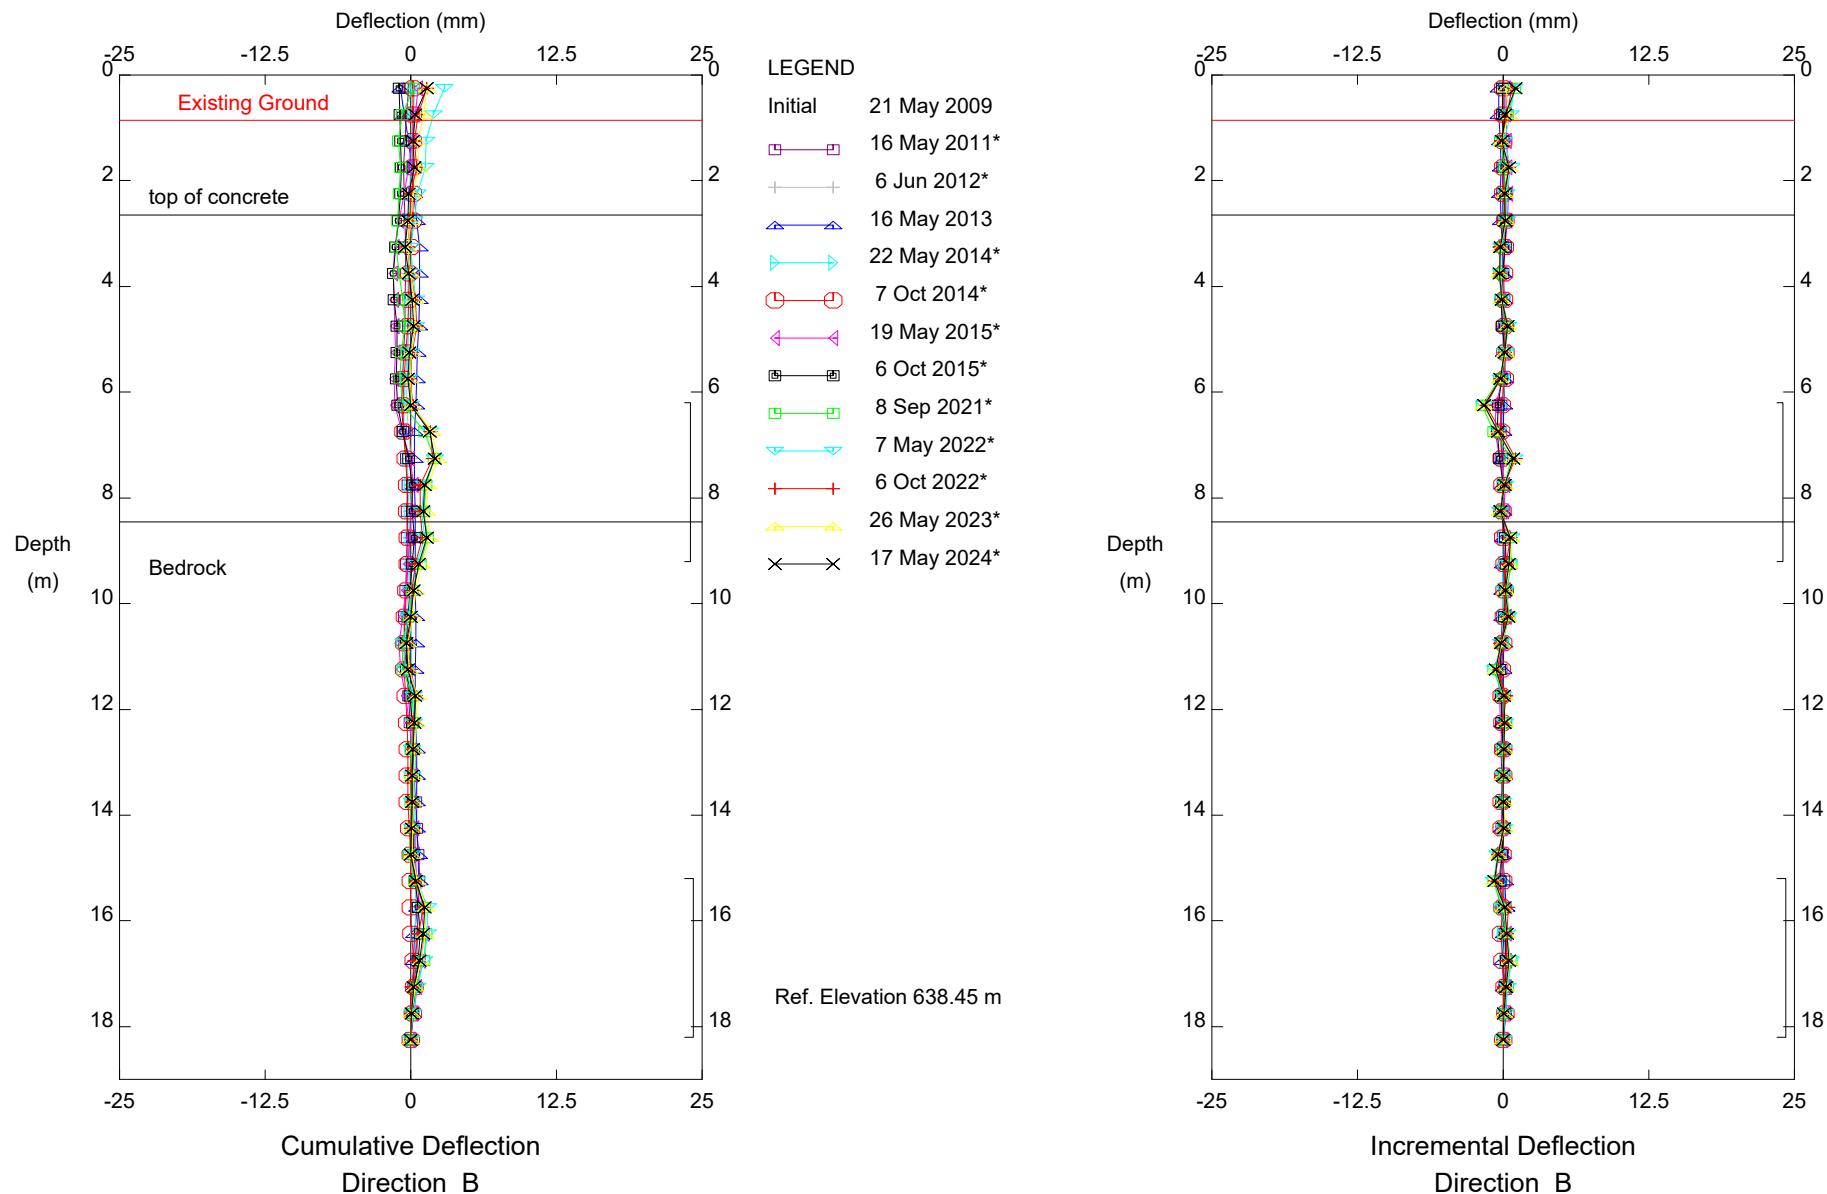
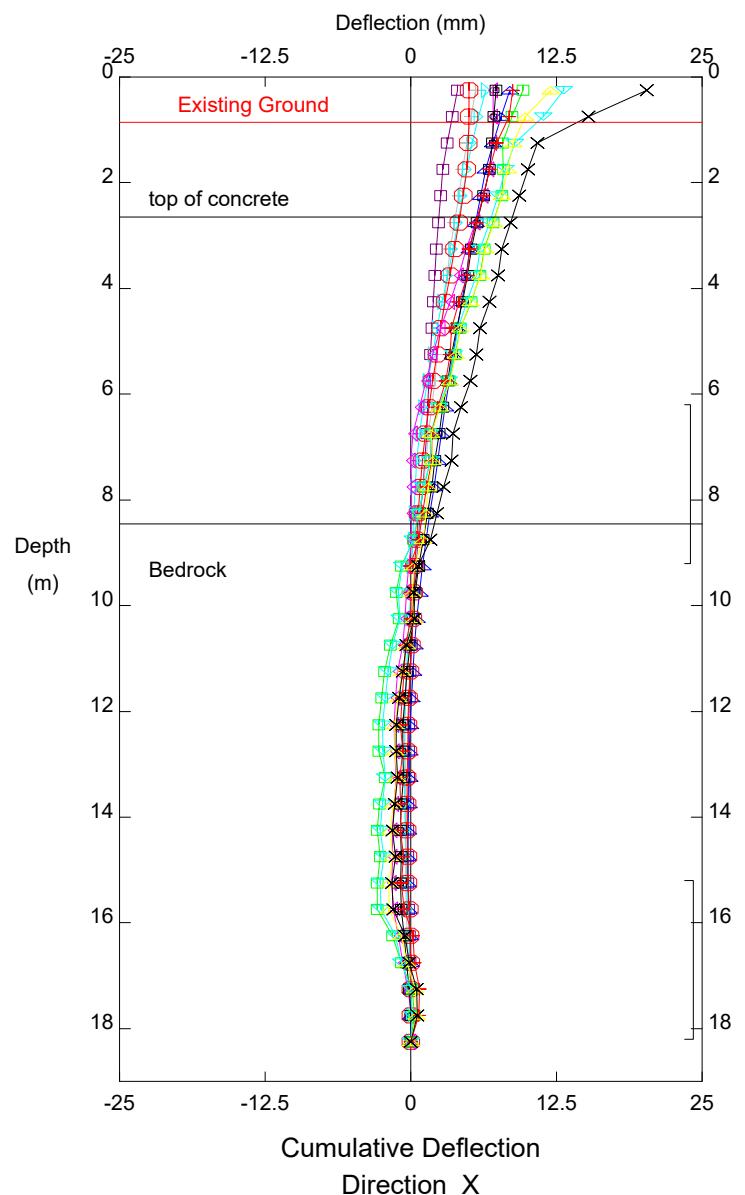
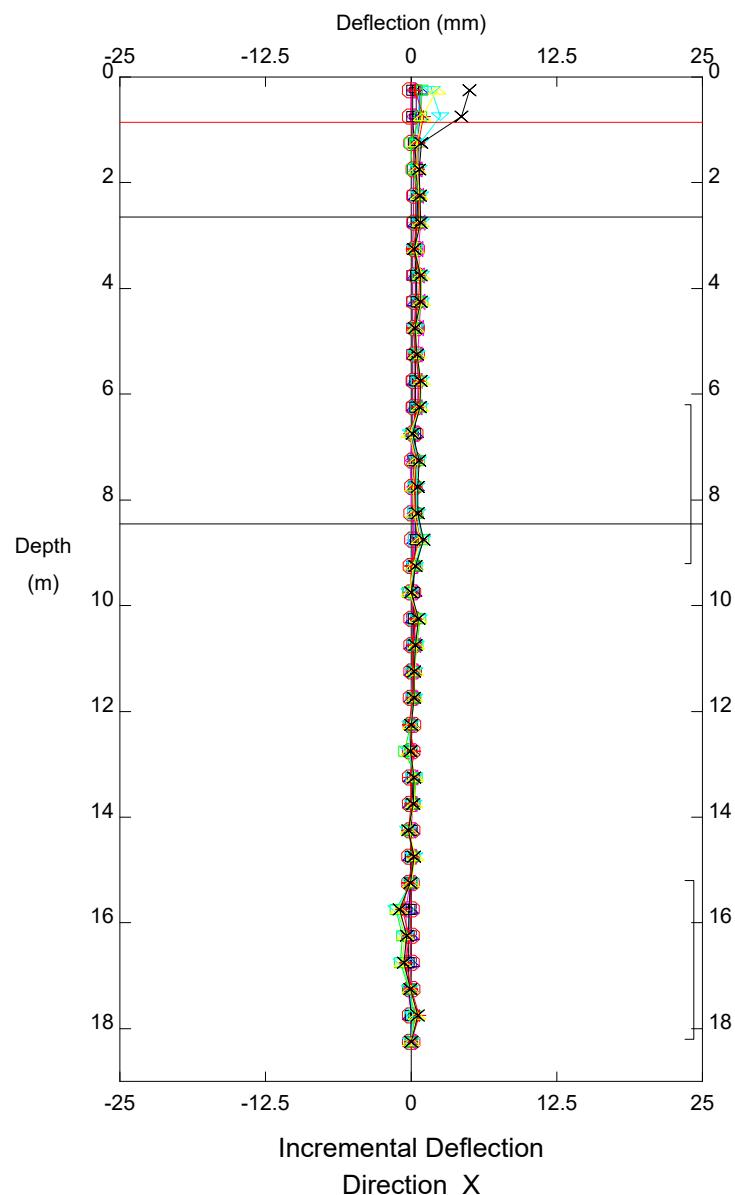
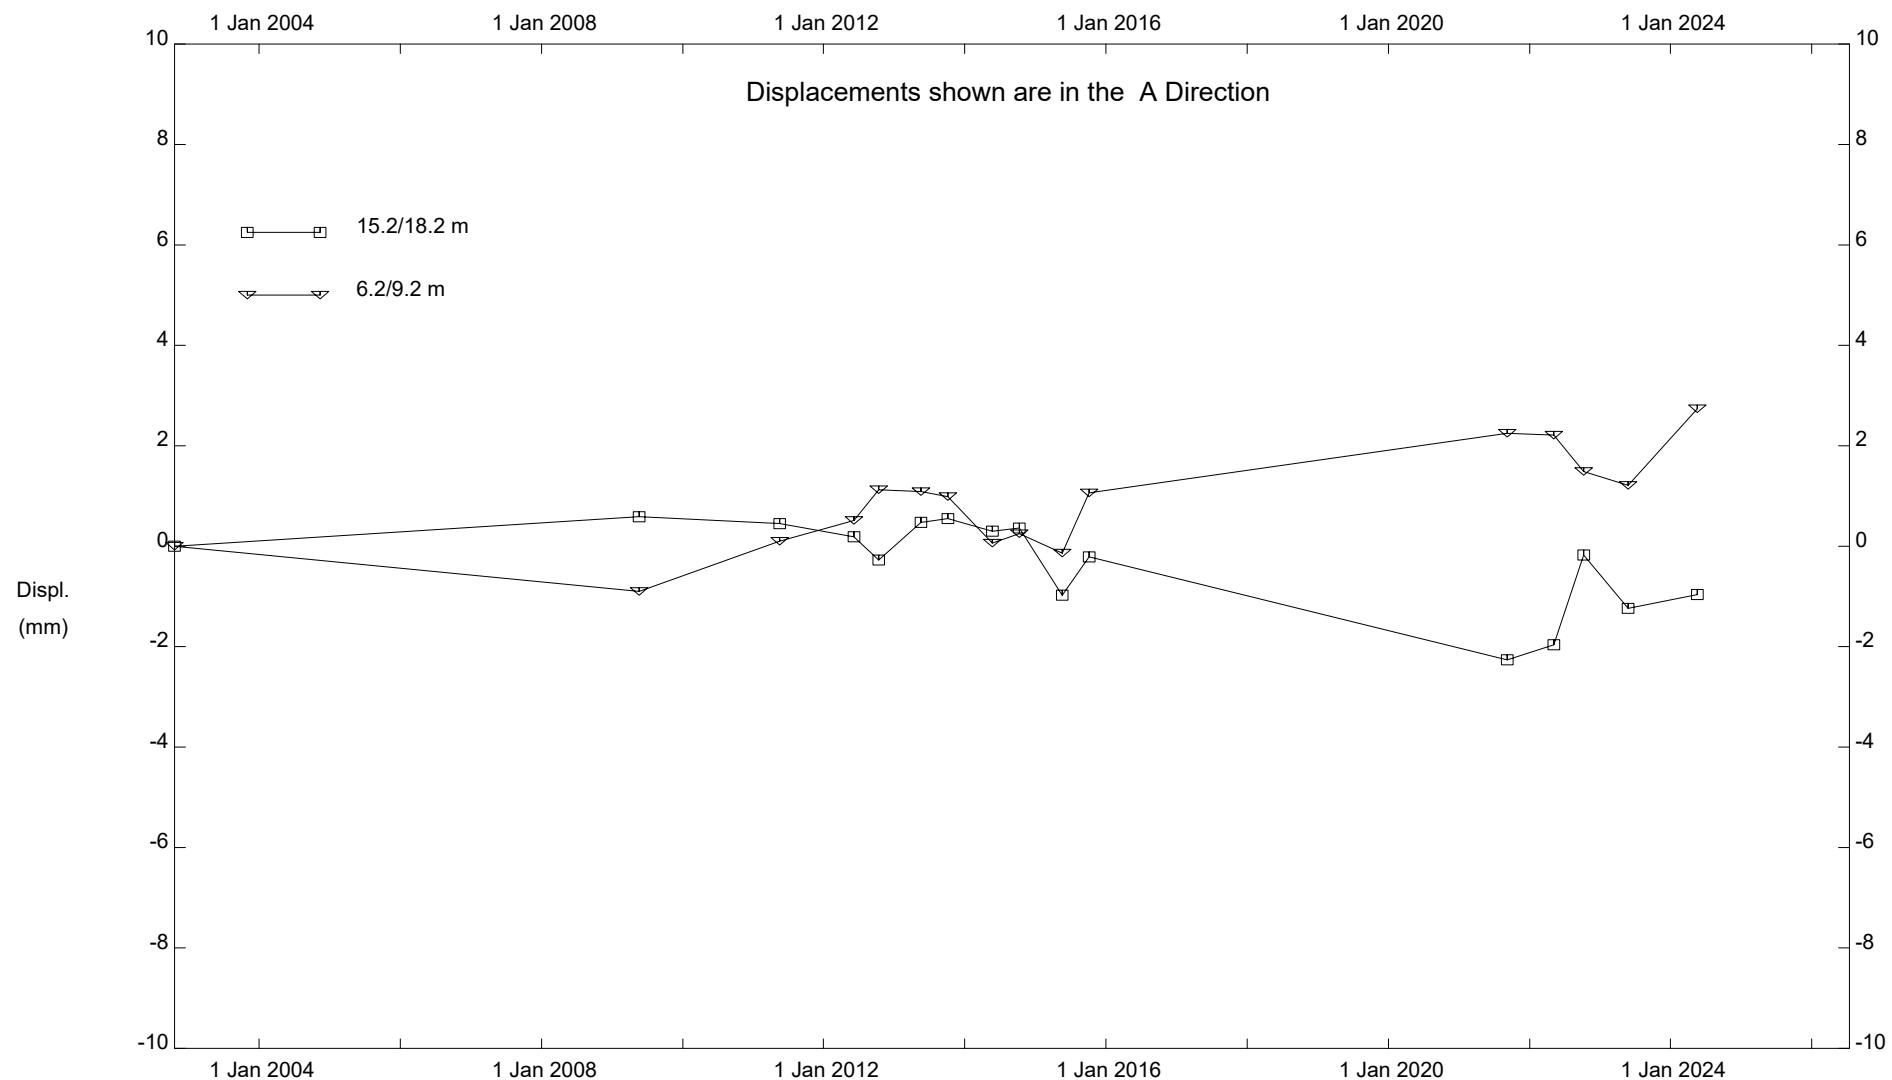
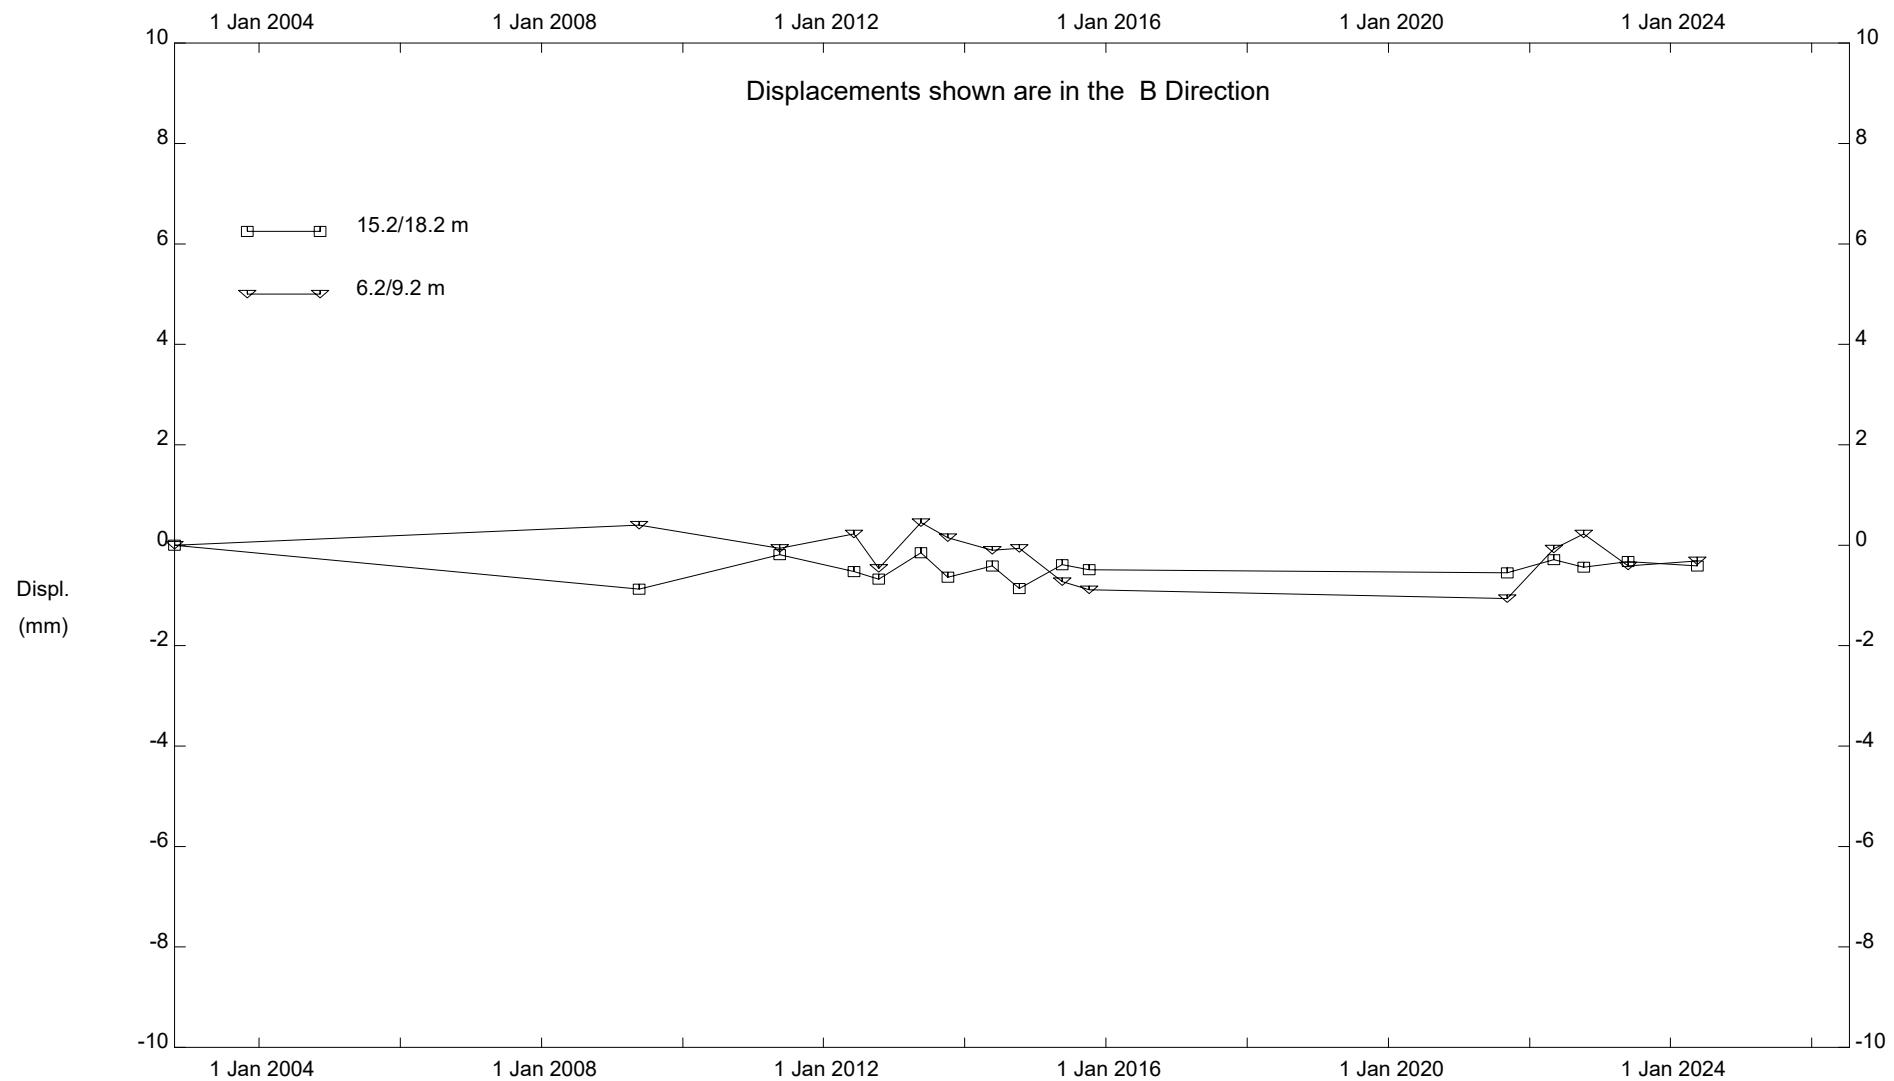
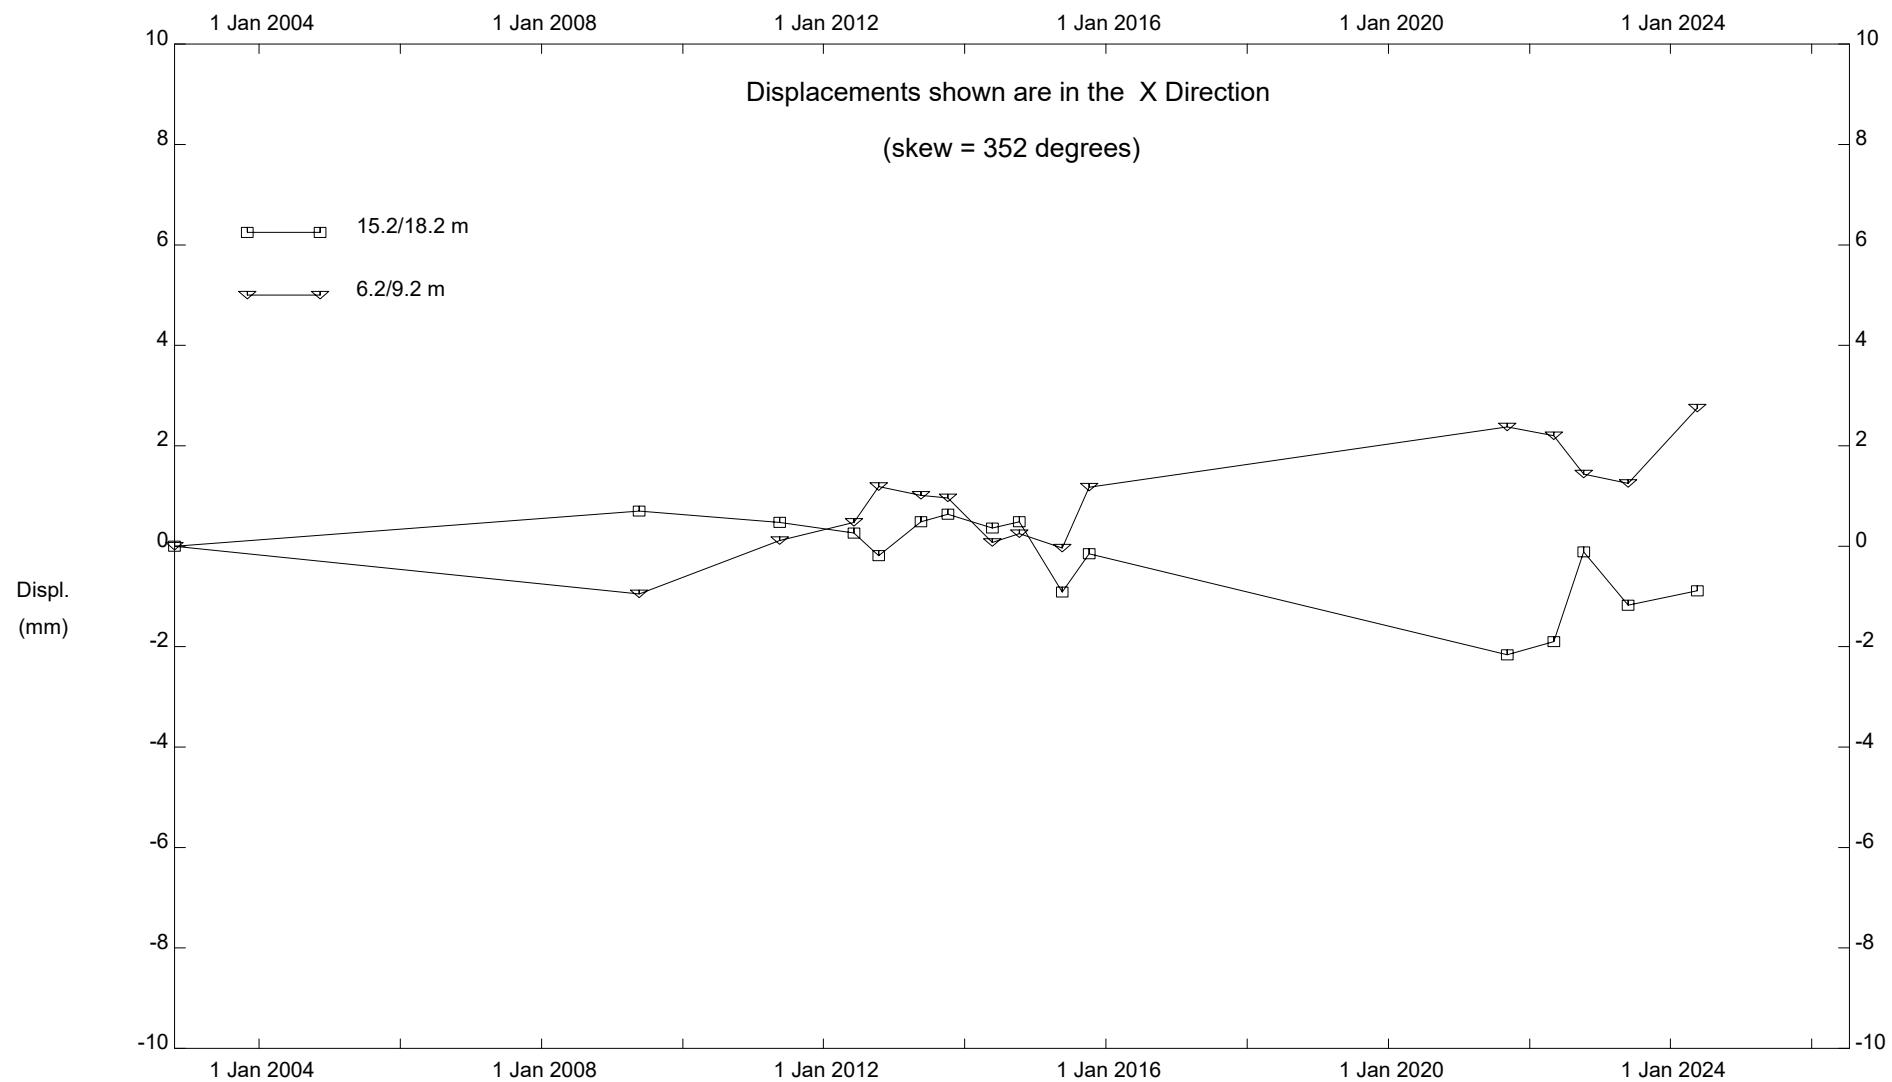
NC67, Inclinometer SI-04

SI-04 has two potential zones of movement. The one between 6.2 and 9.2 m has a movement rate of about 2 mm/yr and a cumulative movement of 3 mm. The one between 15.2 and 18.2 m has a movement rate less than 1 mm/yr and a cumulative movement of less than 1 mm.
