To: Amy Driessen
Transportation and Economic Corridors
From: Leslie Cho and Xiteng Liu
Stantec Consulting Ltd.
File: 123315222 Date: June 18, 2024

Reference: North Central Region, Stony Plain, Site NC067 - Highway 216:06 Anthony Henday Bridge, Spring 2024 Instrumentation Monitoring Report

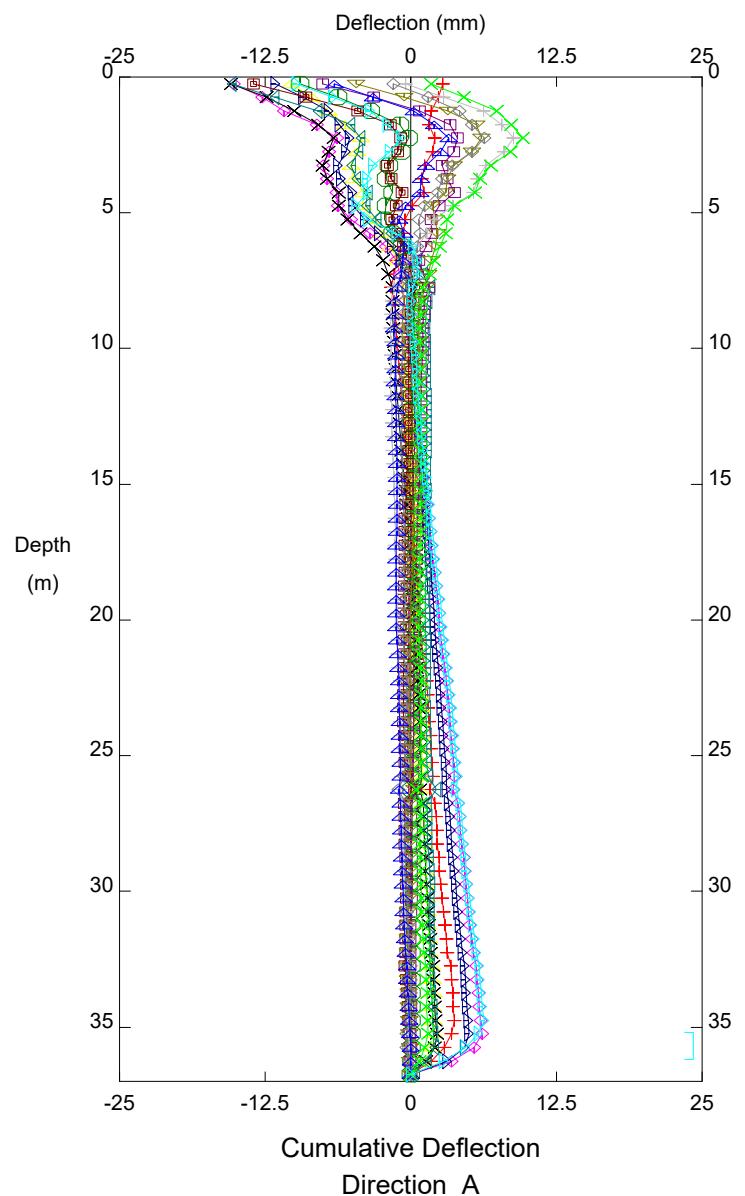
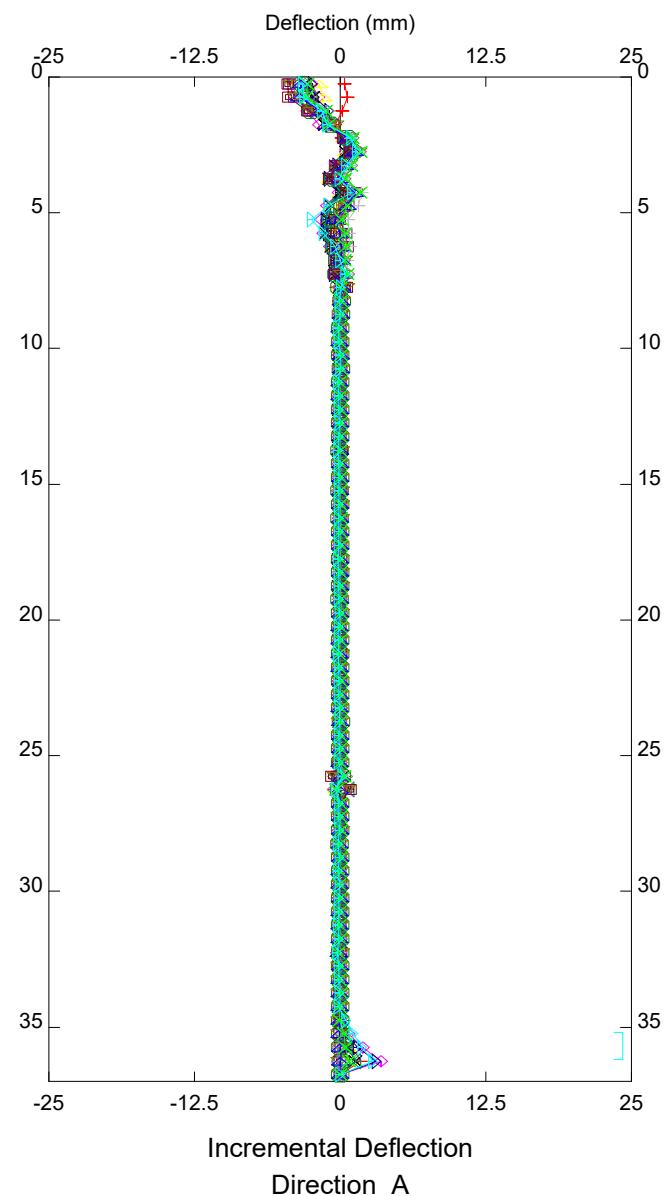
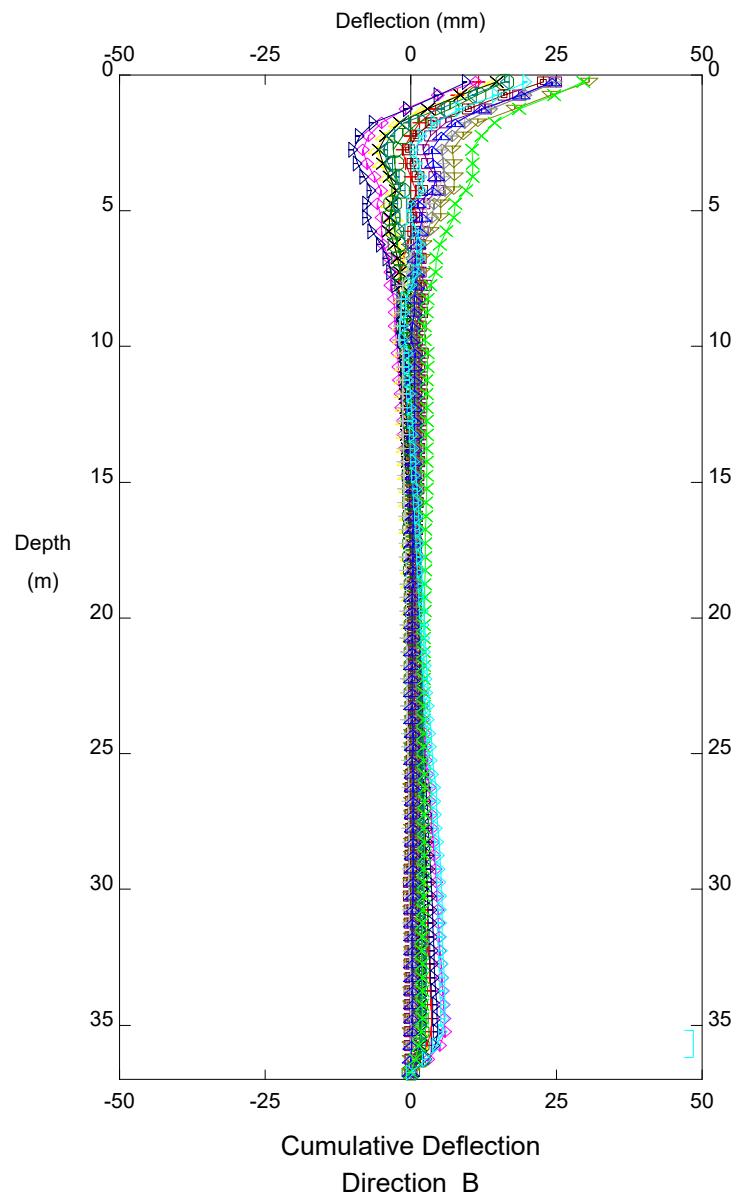
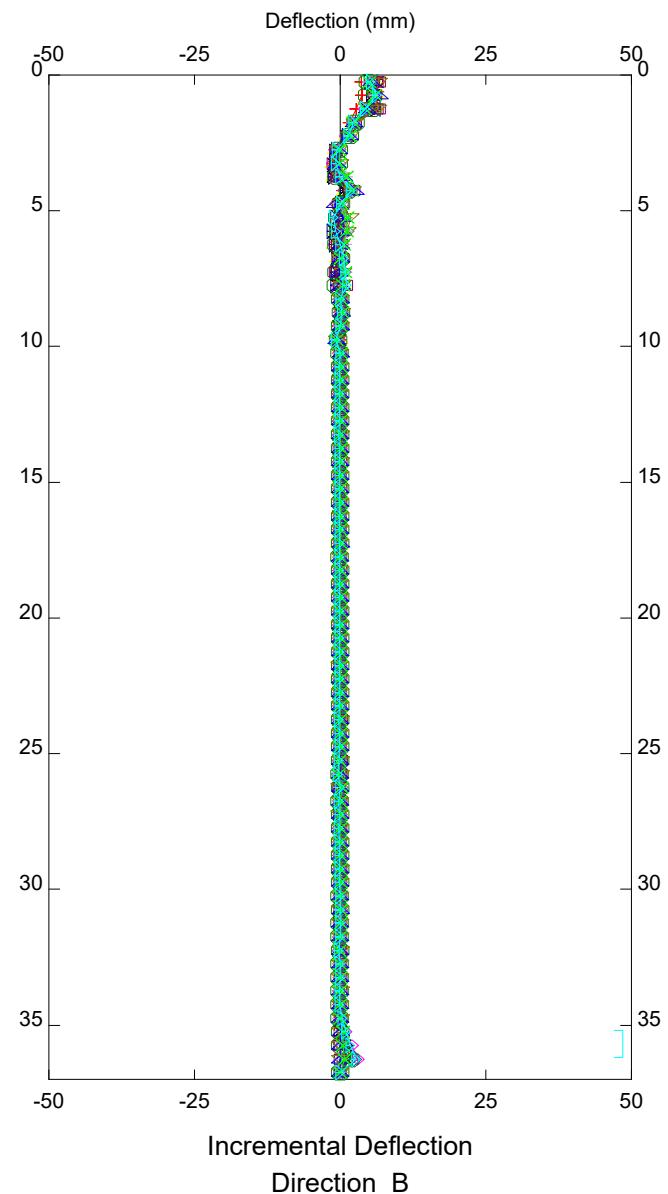
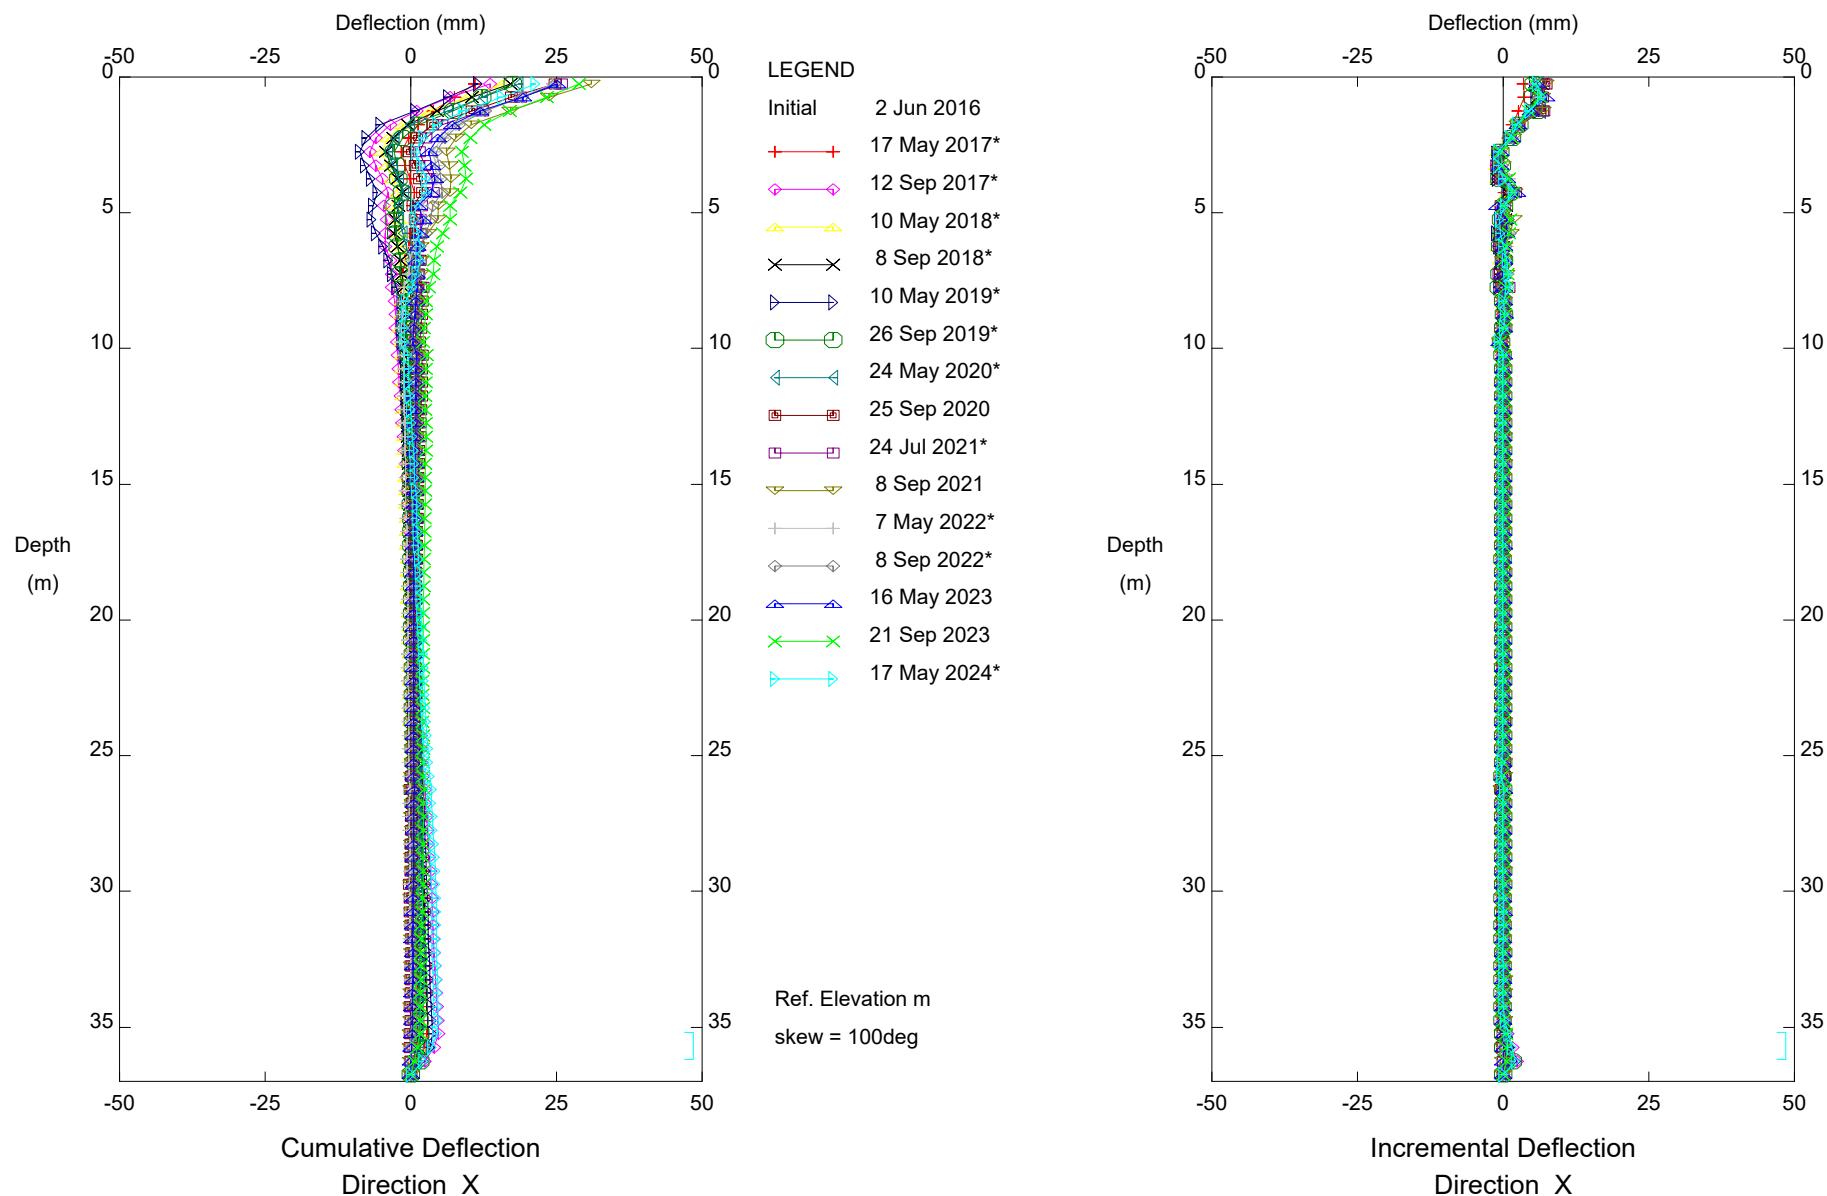
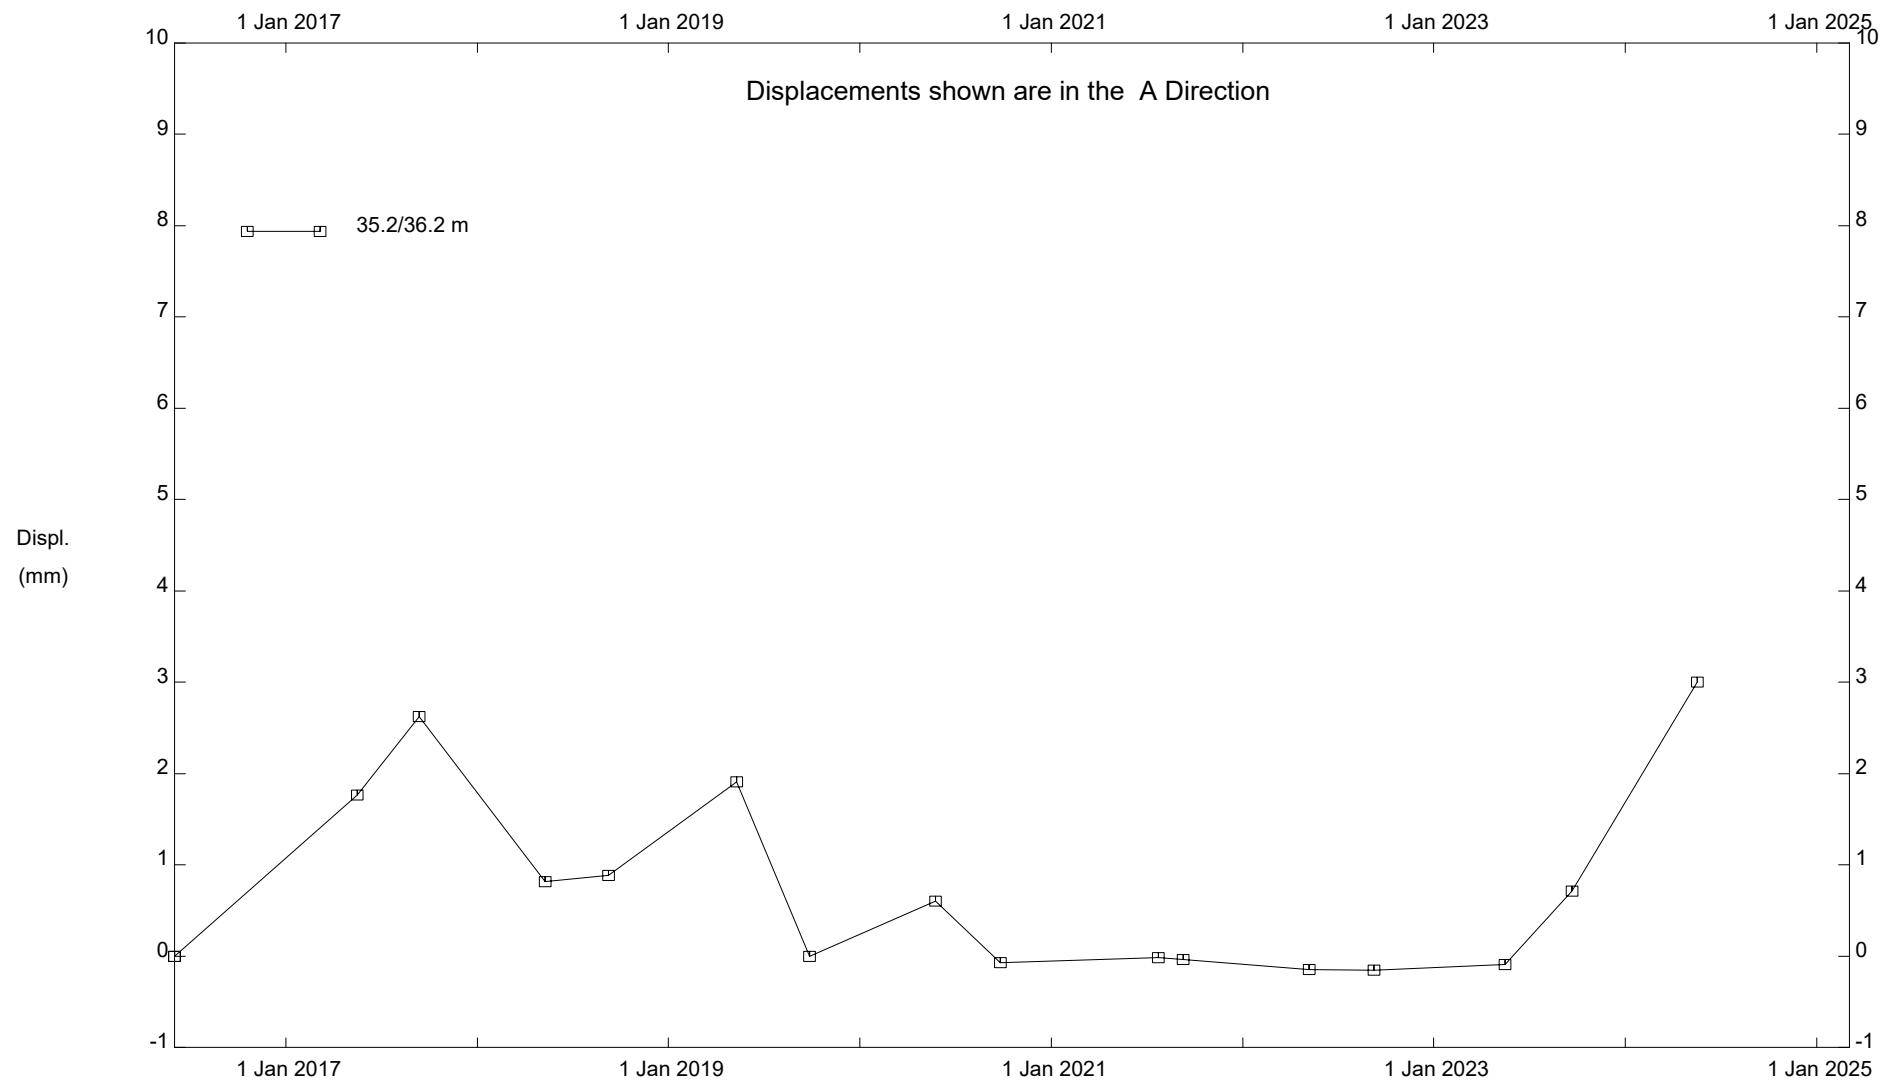
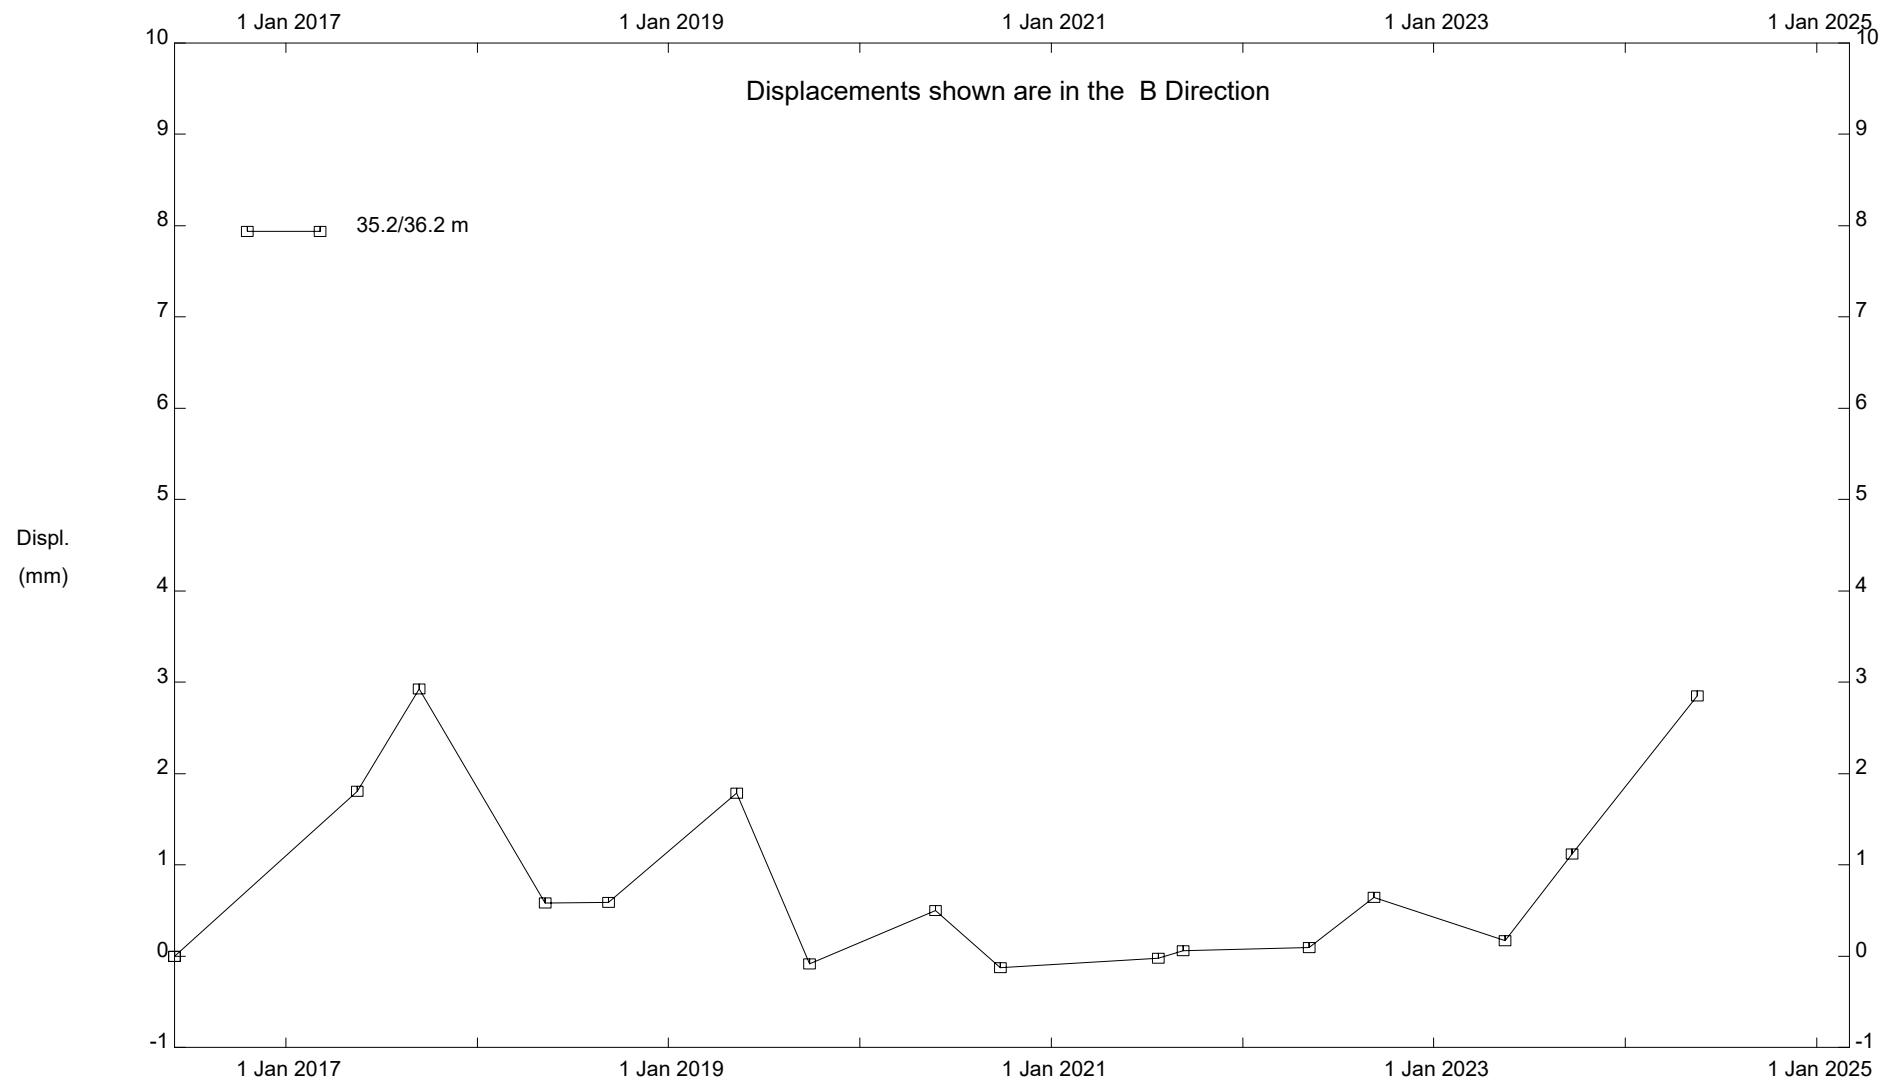
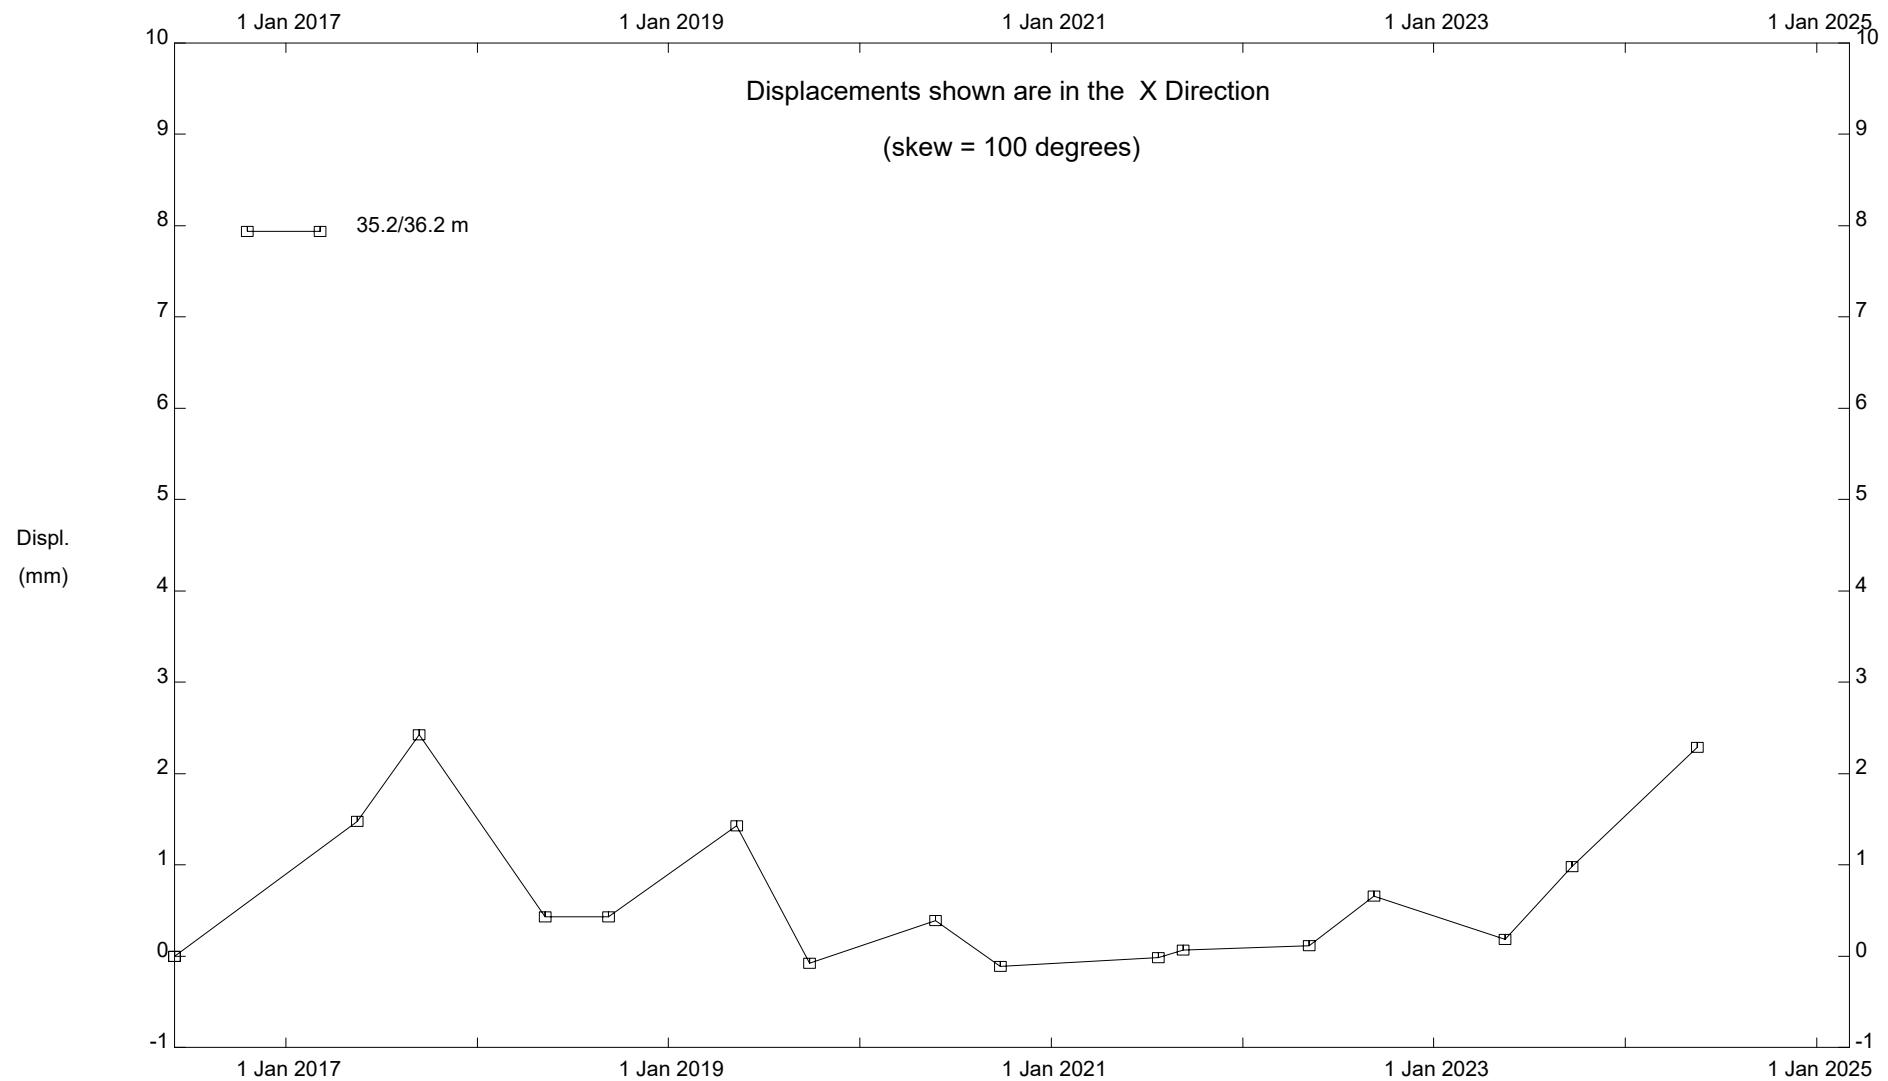
NC67, Inclinometer SI-06
Transportation & Economic Corridors

SI-06 has historically shown some erratic movement near the base of the casing. Currently, SI-06 shows a movement rate of about 1 mm/yr with a cumulative movement of 2 mm. Additional readings will be required to confirm slope movement.

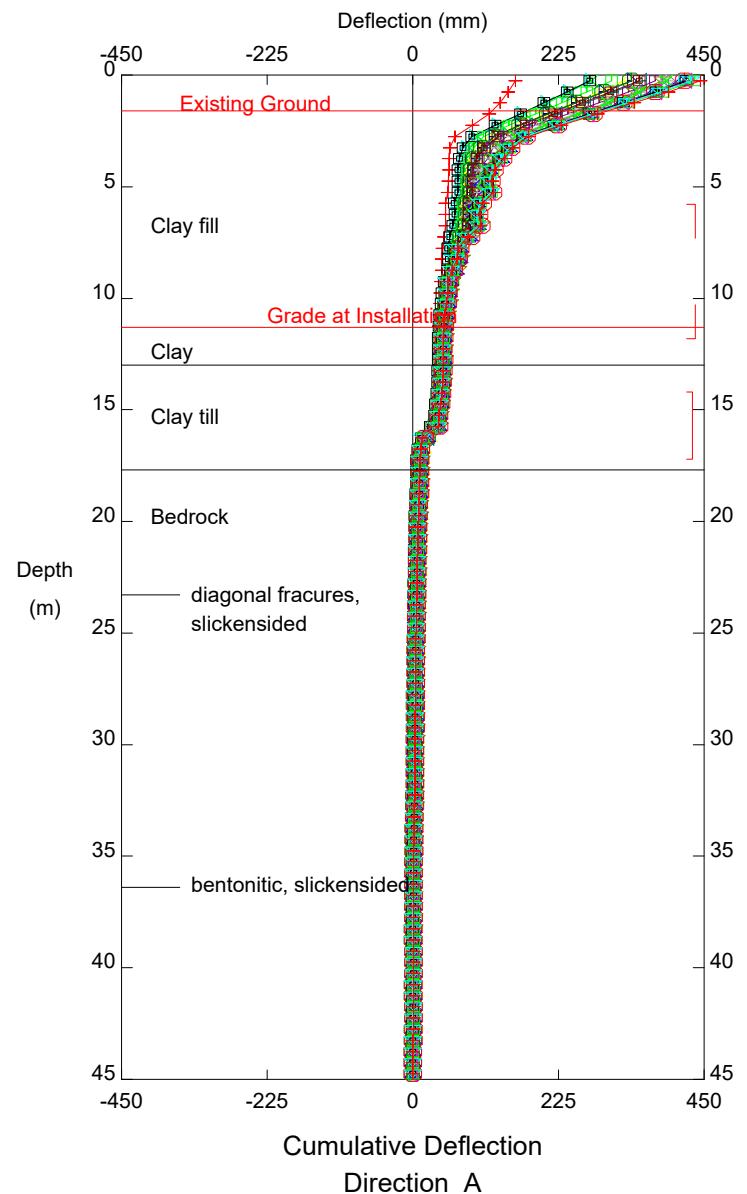
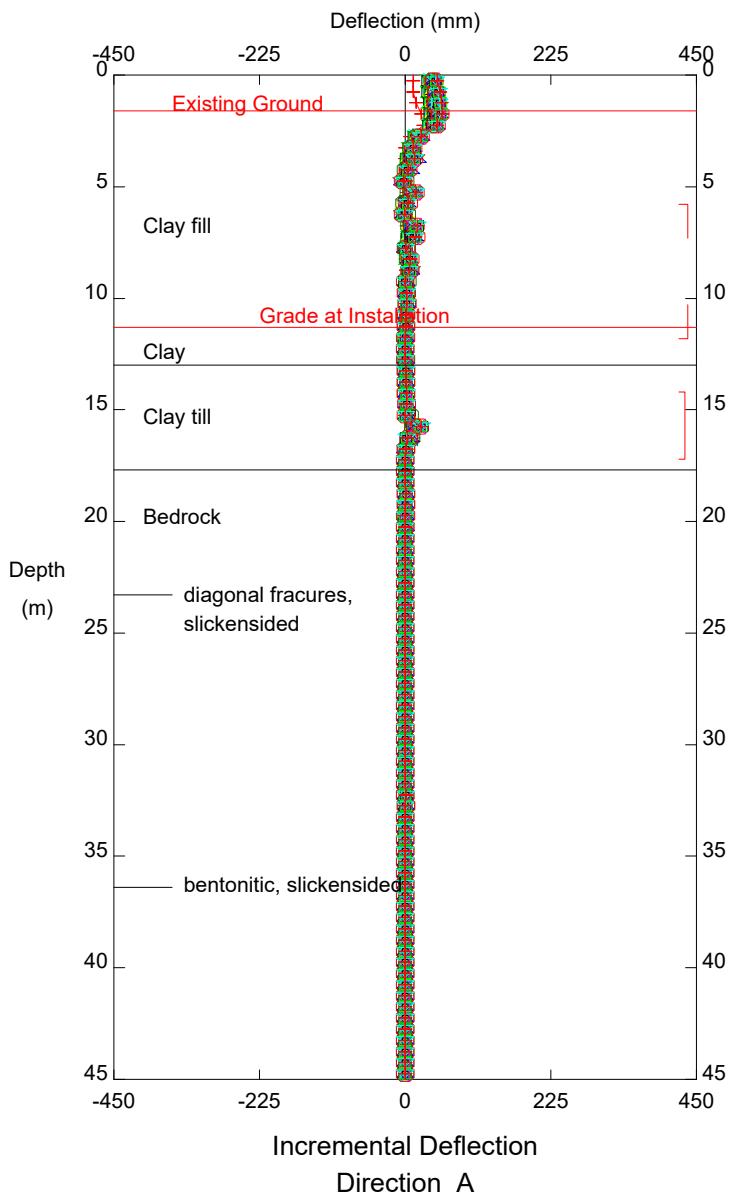
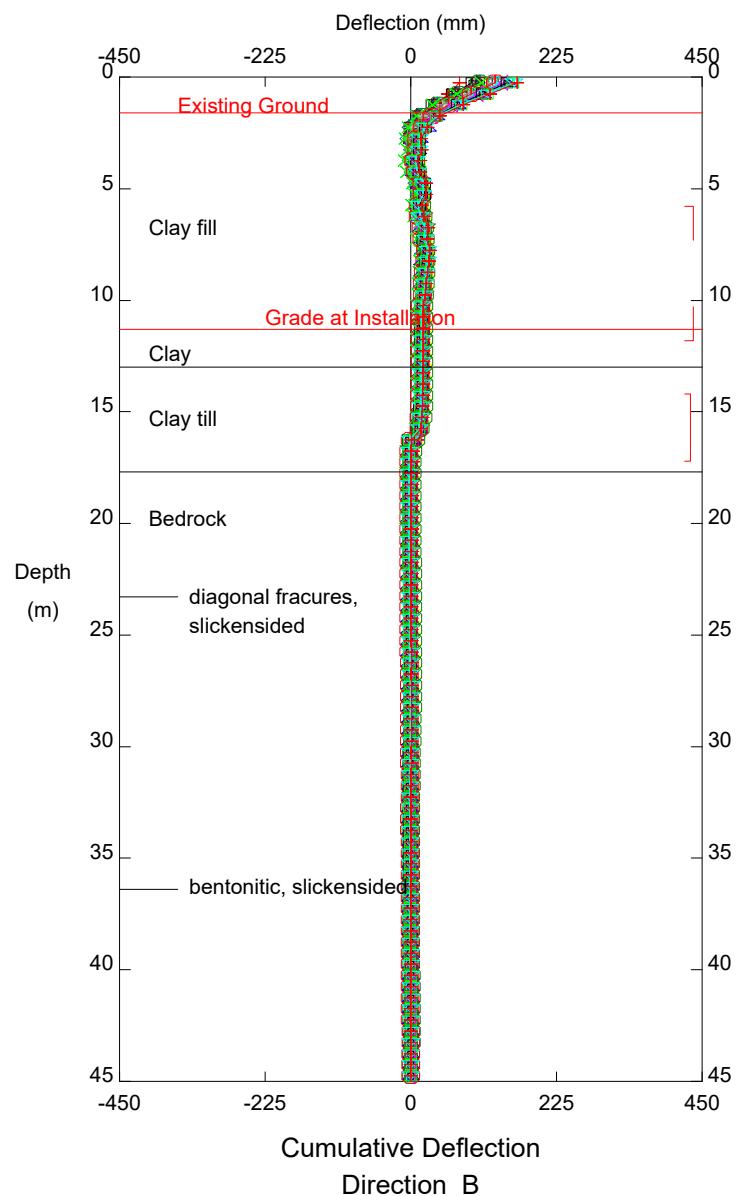
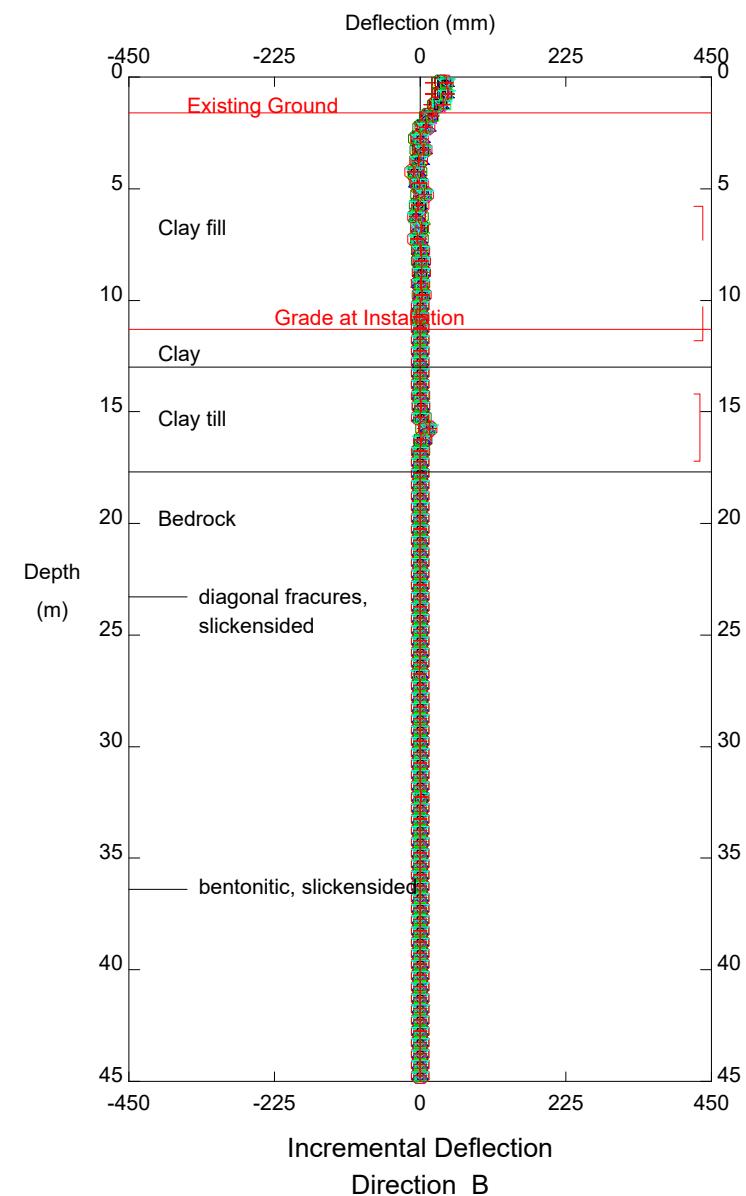
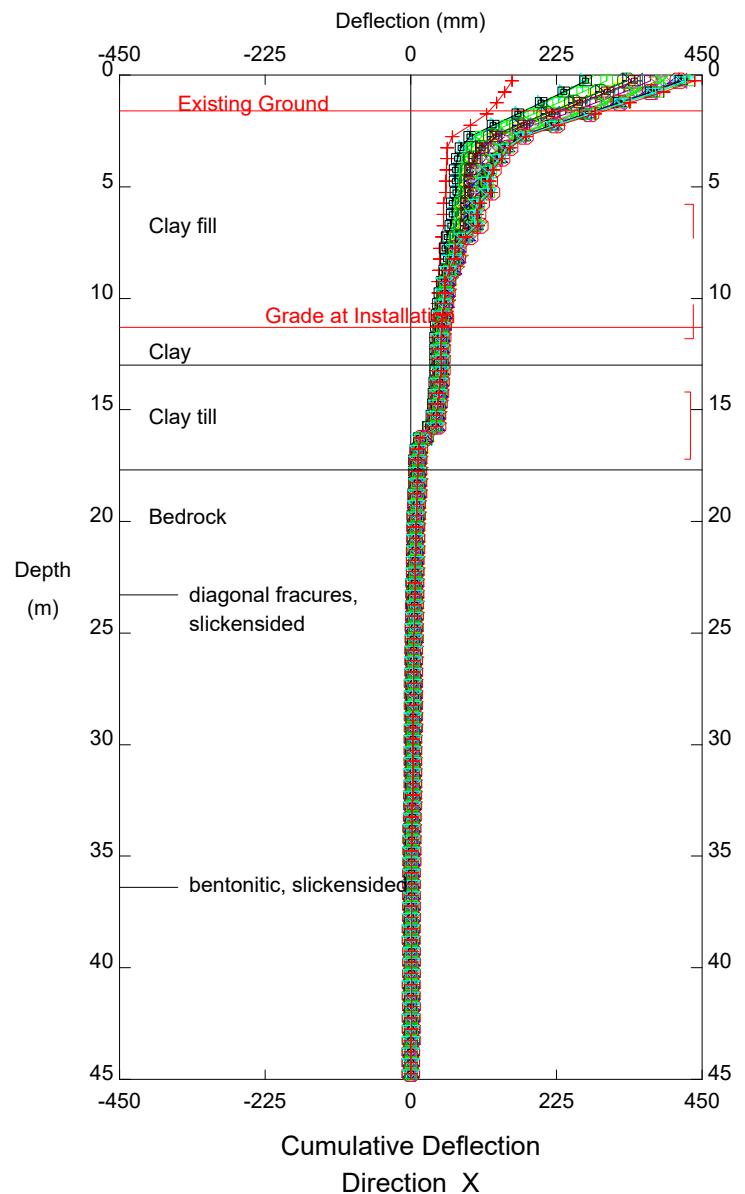
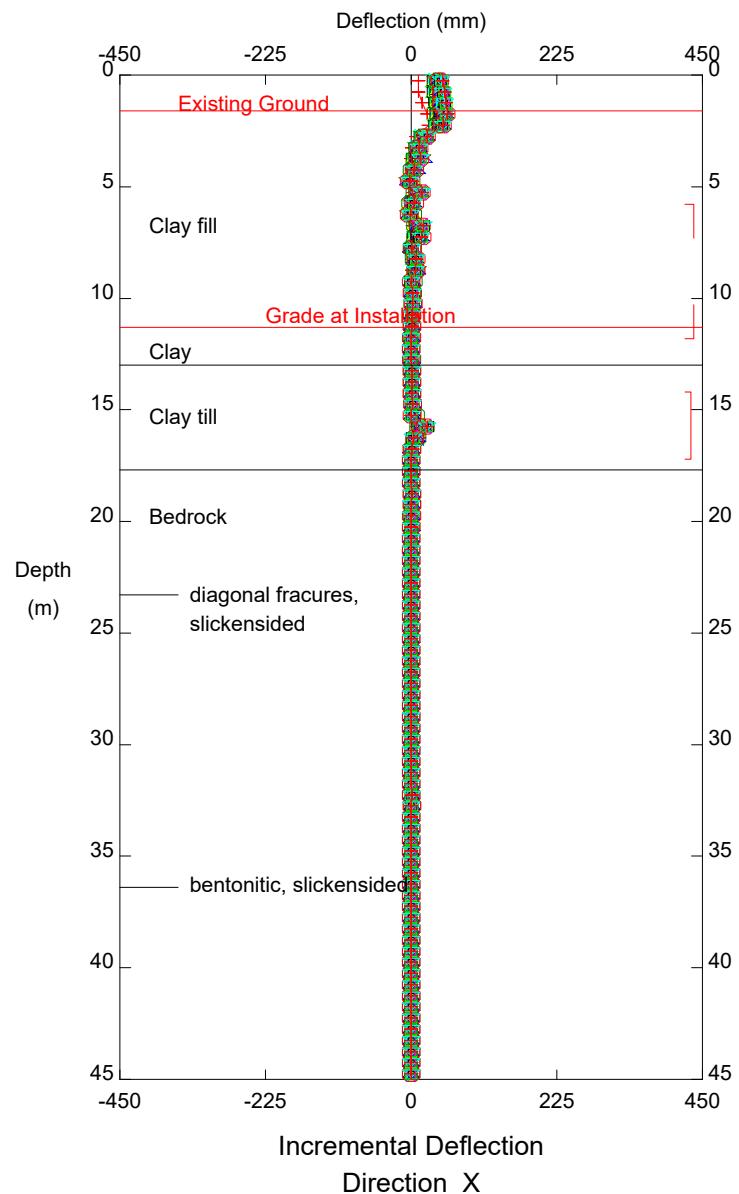
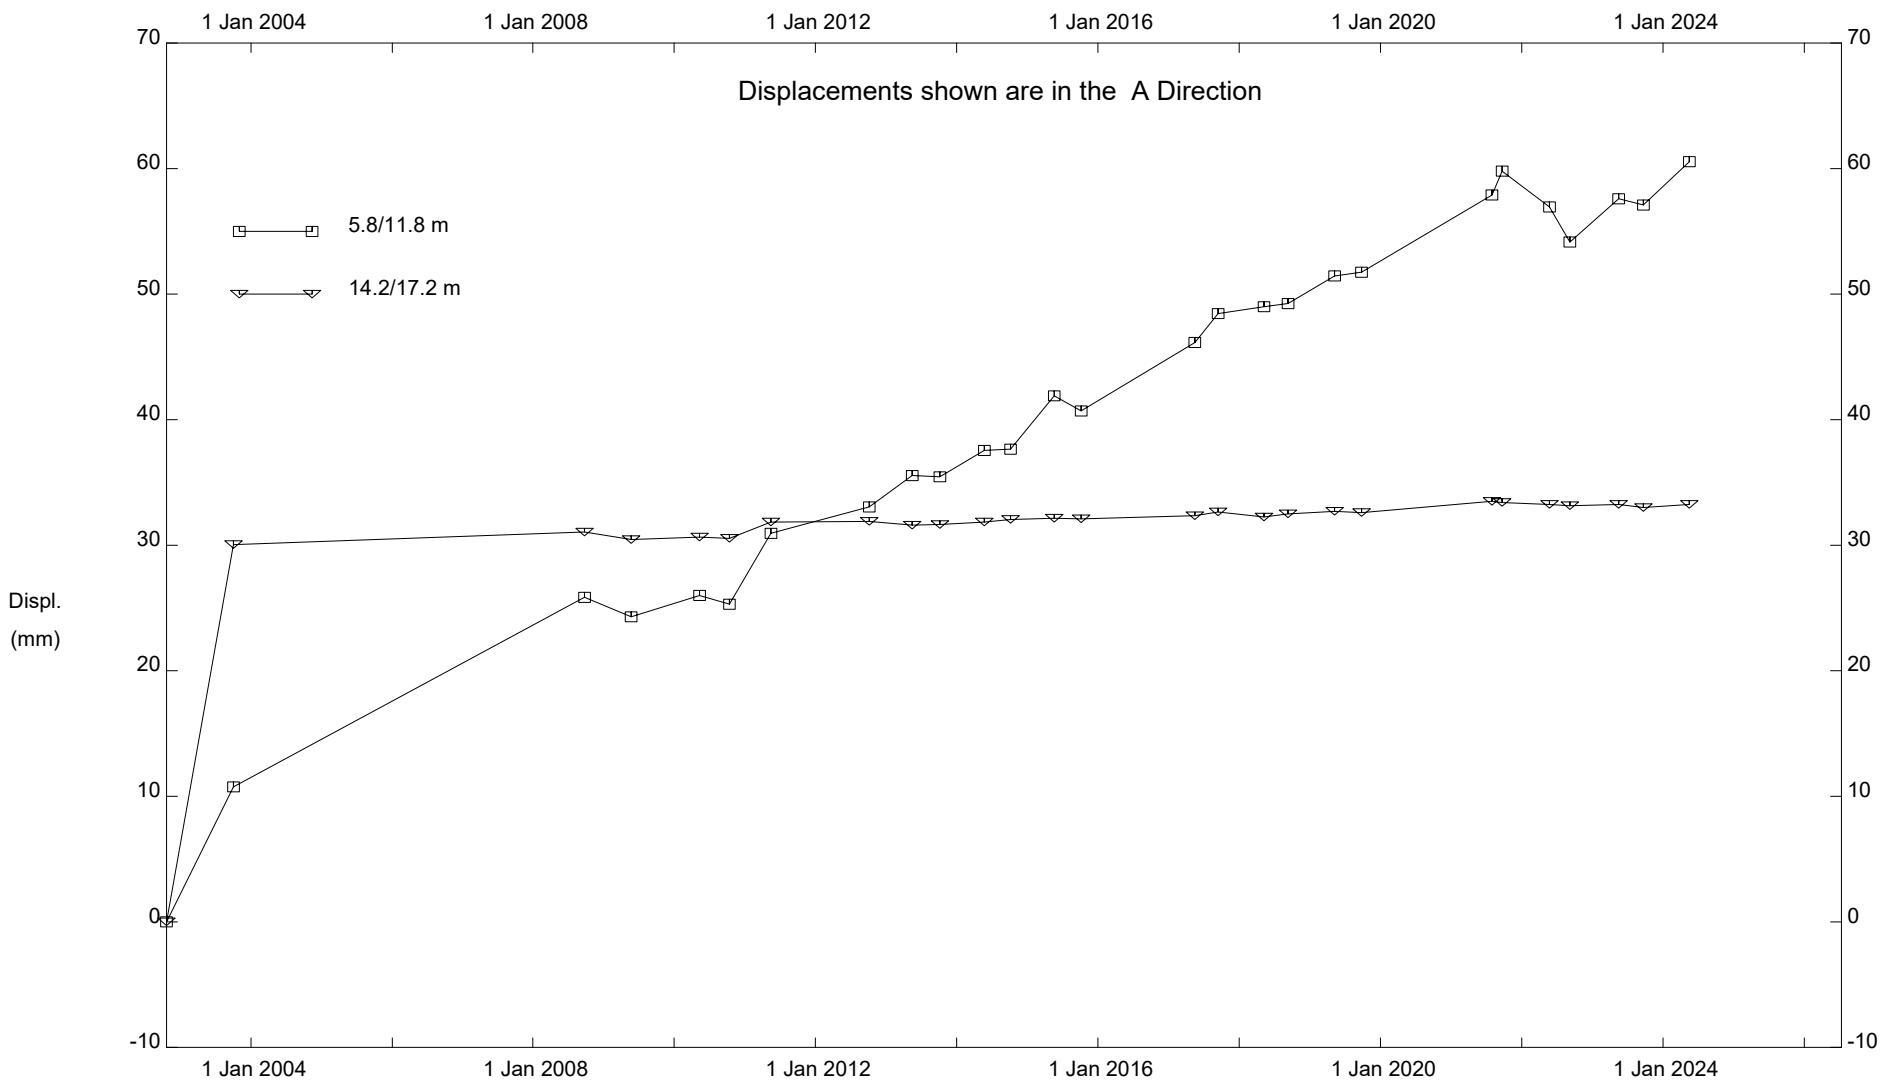
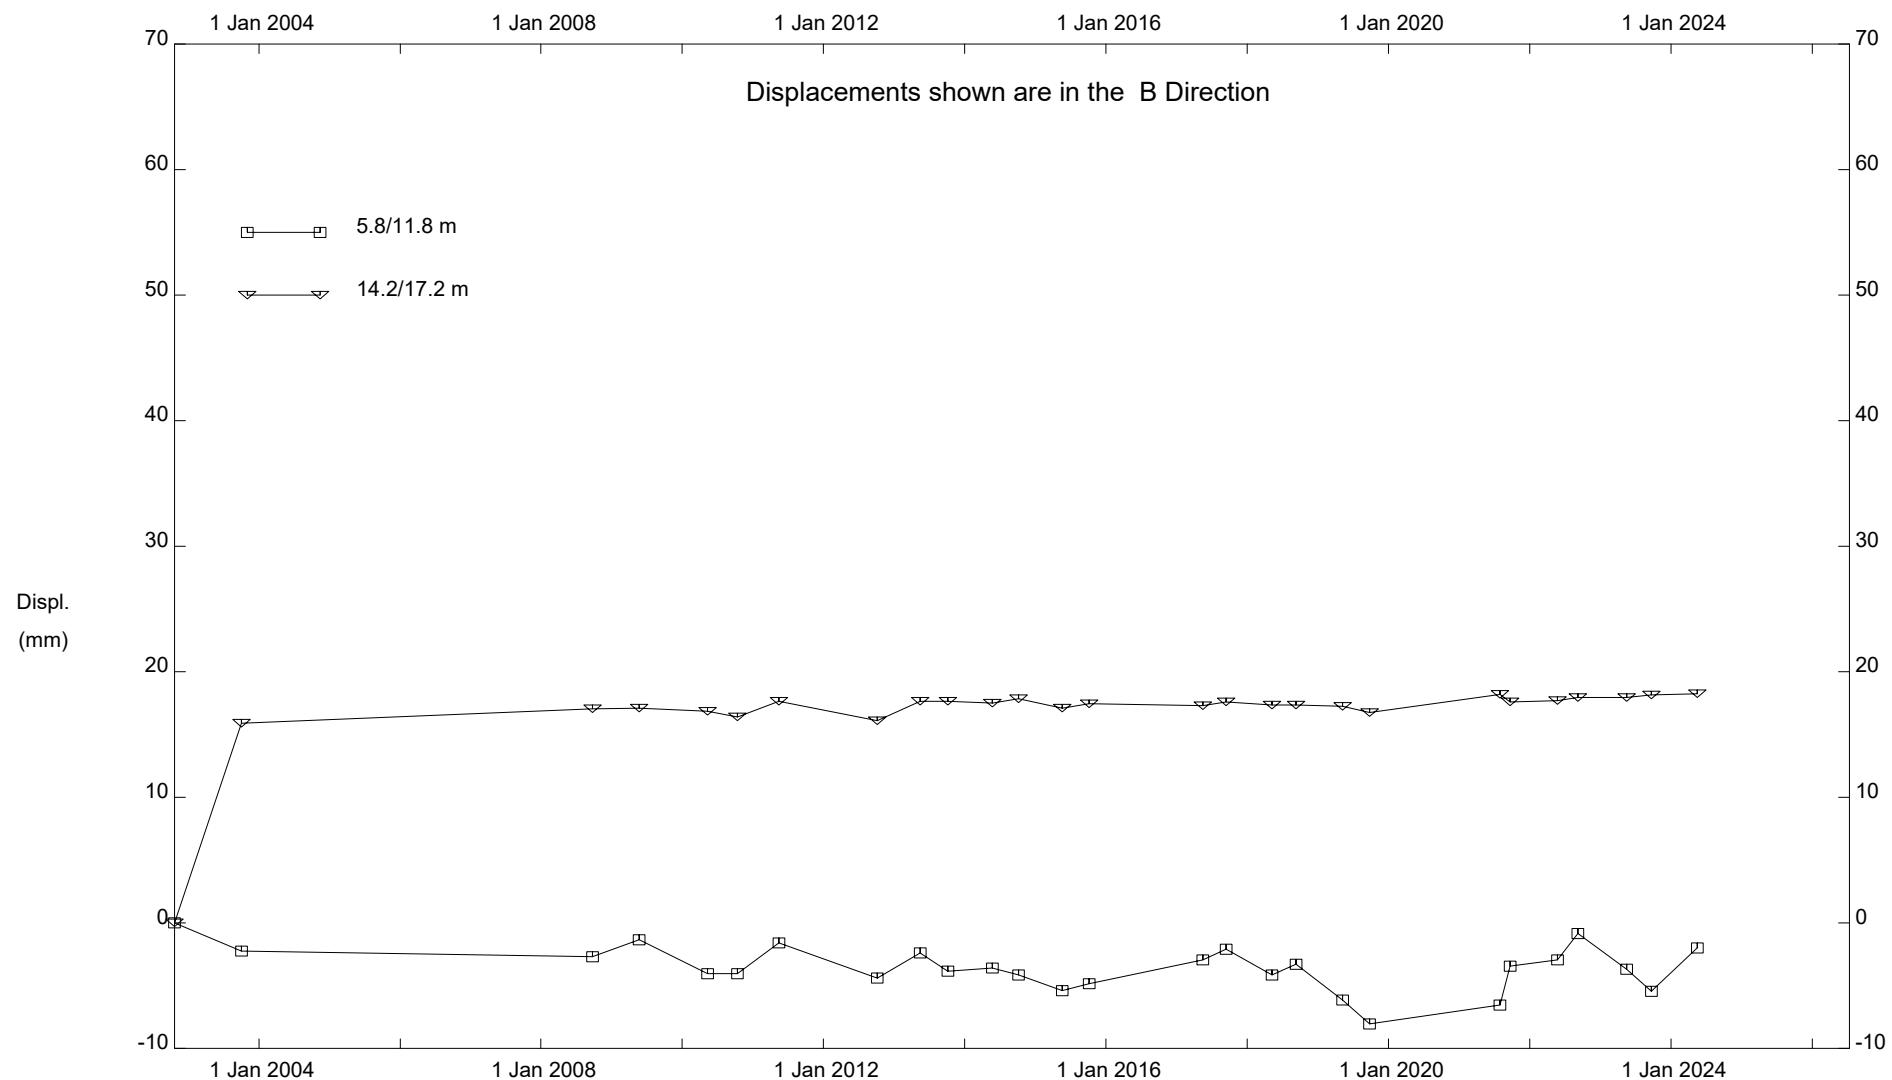
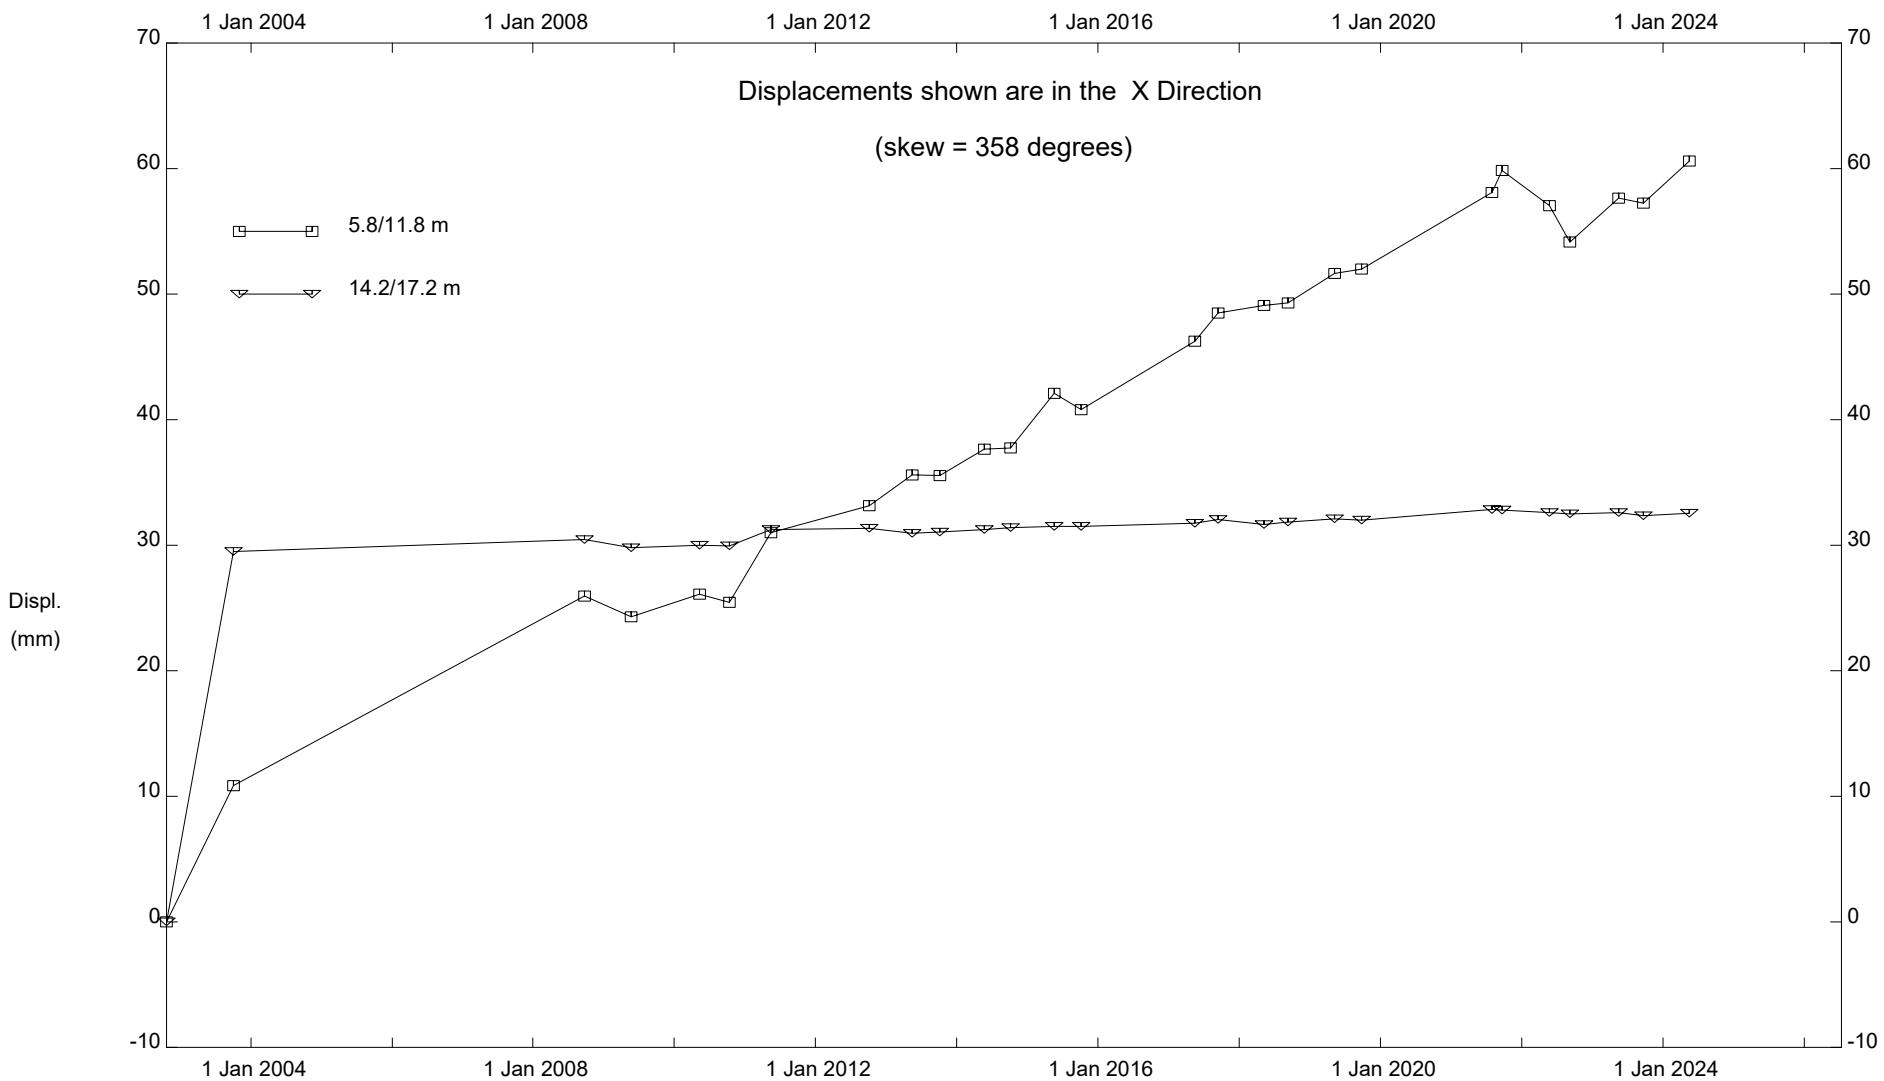
NC67, Inclinometer SI-08
Transportation & Economic Corridors

SI-08 has two zones of movement observed at around 8 m and 16 m depth. The average rate of movement in the upper zone was about 3 mm/yr since 2003. Total cumulative movement appears to be erratically moving around 58 mm since Spring 2021. The lower movement zone appears to be creeping at a rate of less than 1 mm/yr since 2003.
