To: Amy Driessen
Transportation and Economic Corridors
From: Leslie Cho and Xiteng Liu
Stantec Consulting Ltd.
File: 123315222 Date: June 18, 2024

Reference: North Central Region, Stony Plain, Site NC067 - Highway 216:06 Anthony Henday Bridge, Spring 2024 Instrumentation Monitoring Report

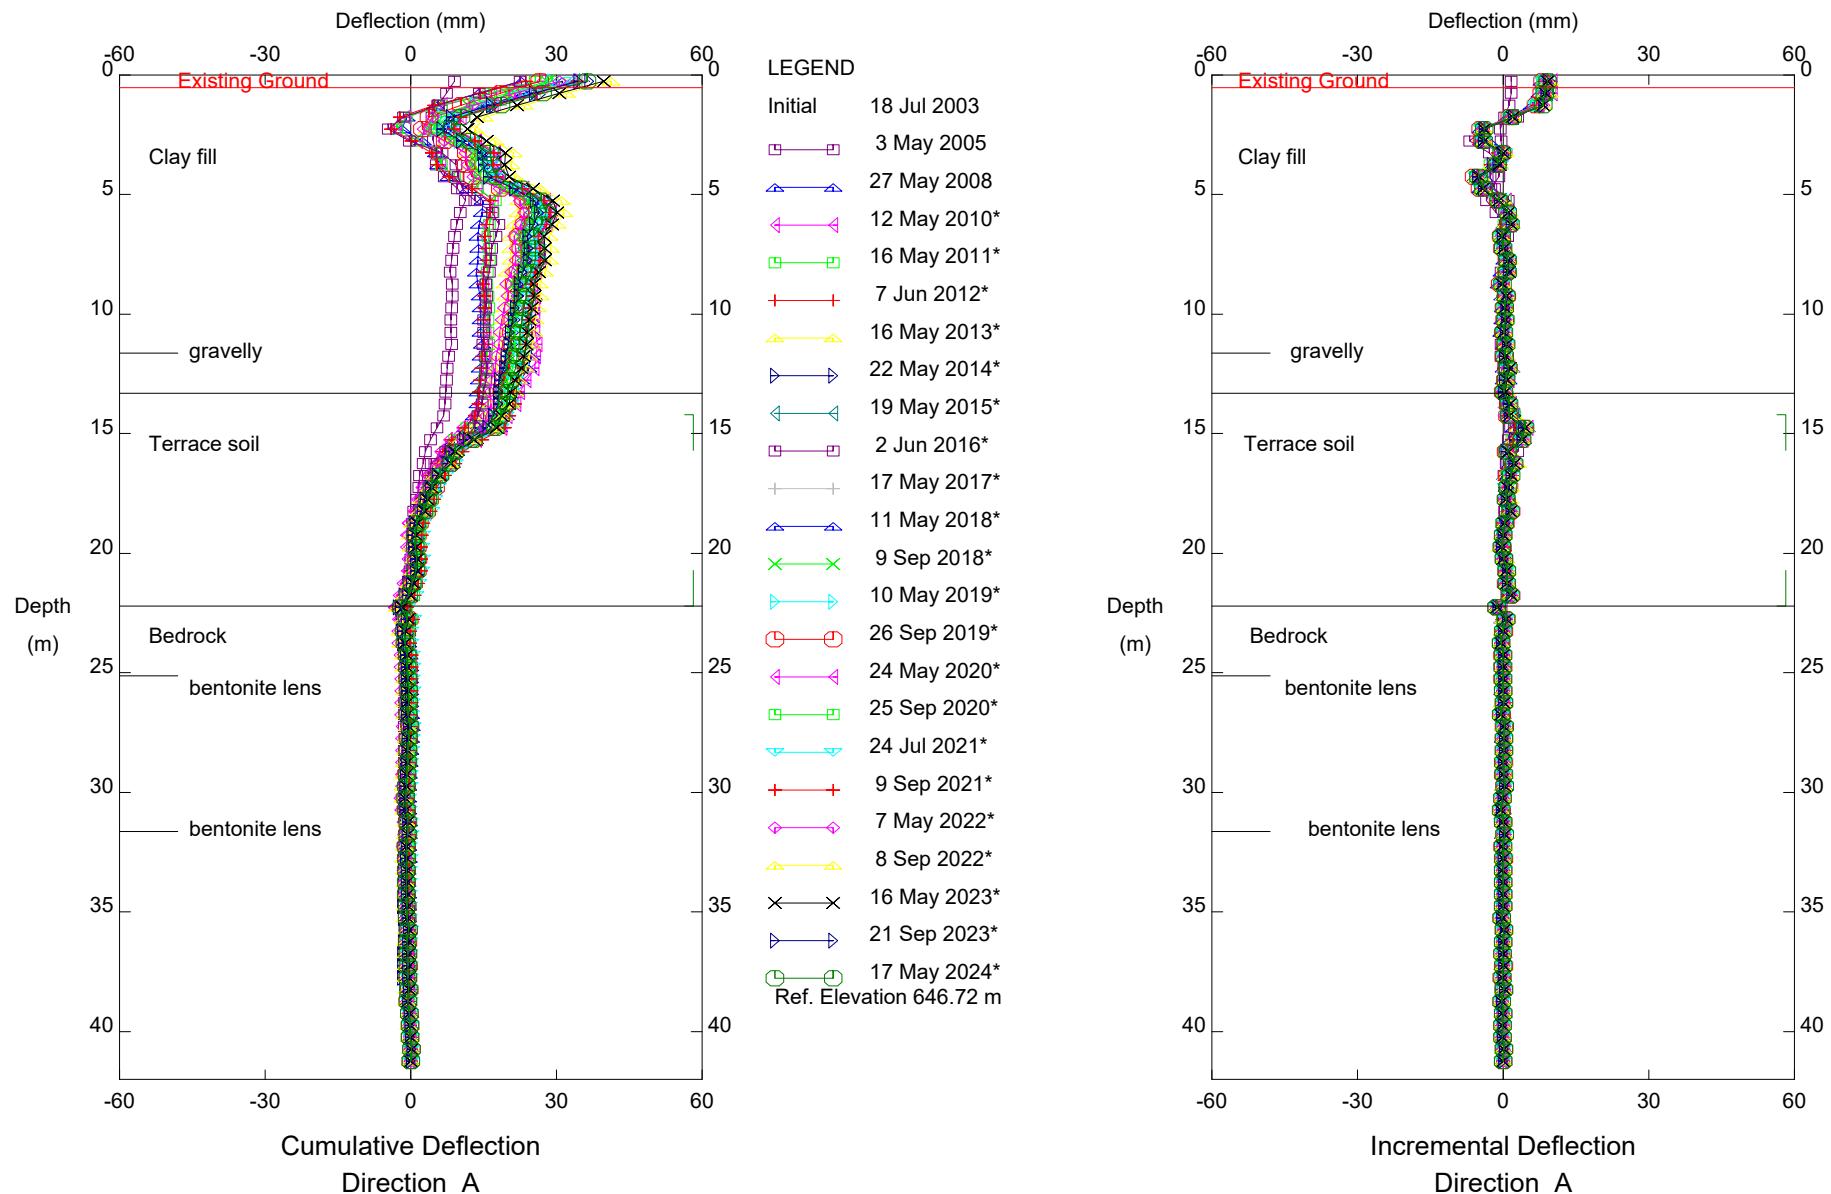
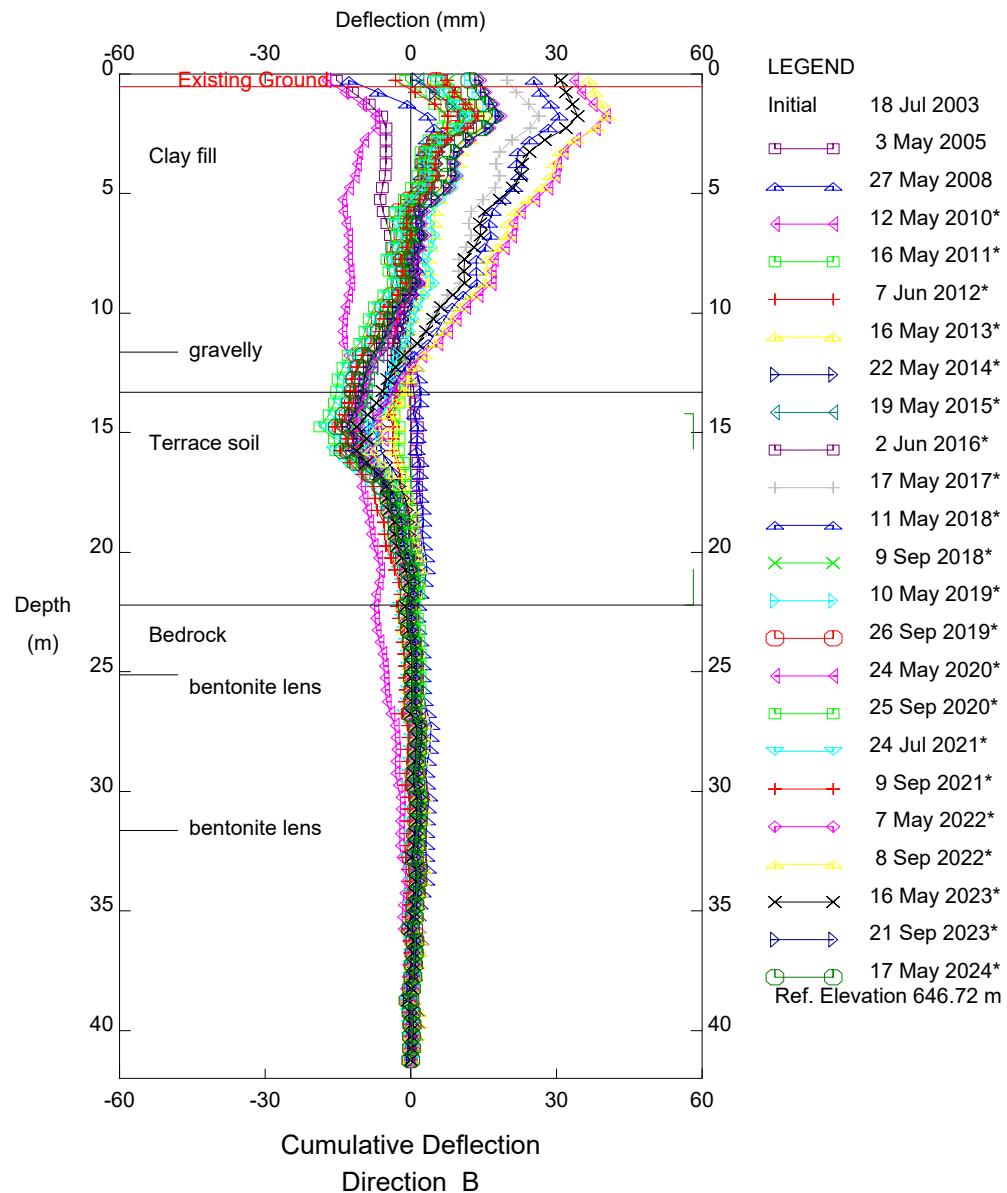
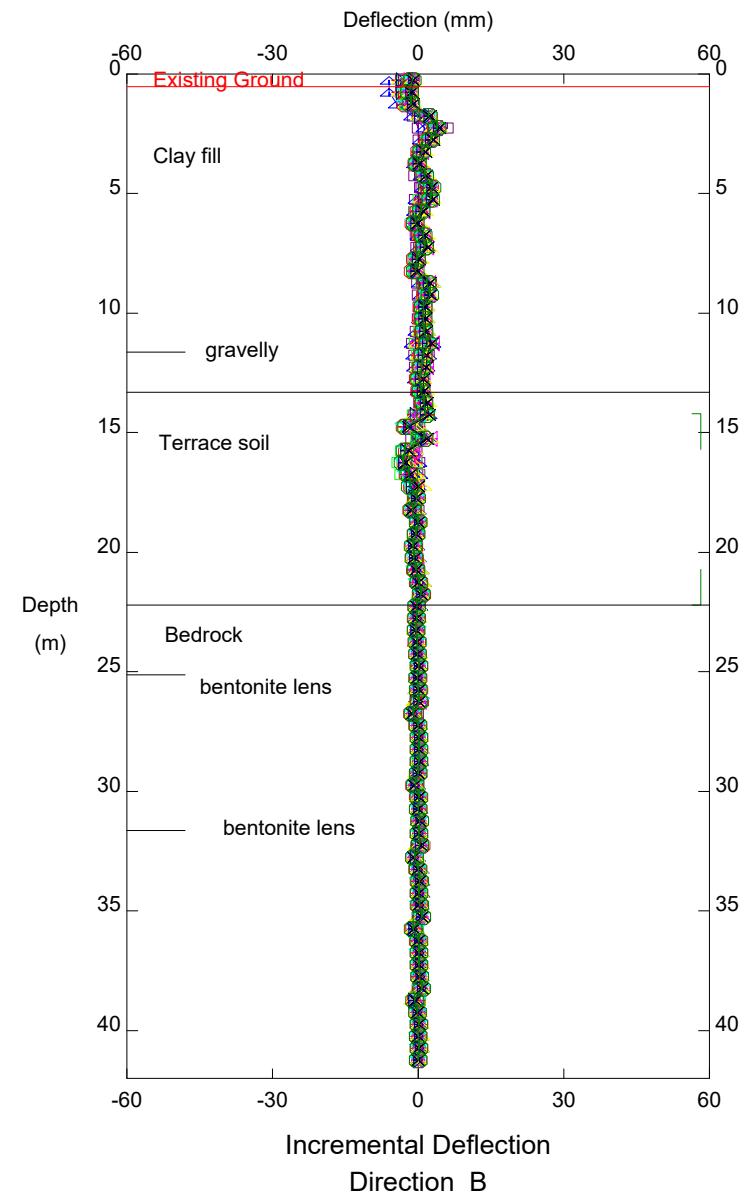
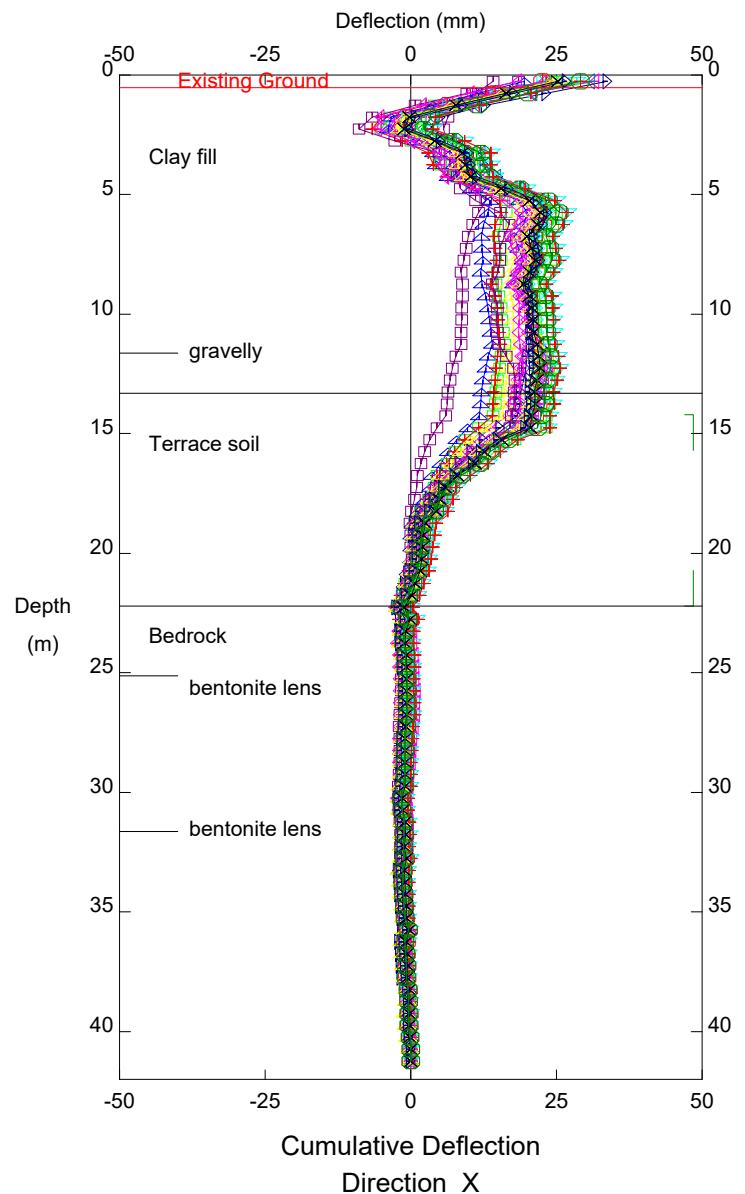
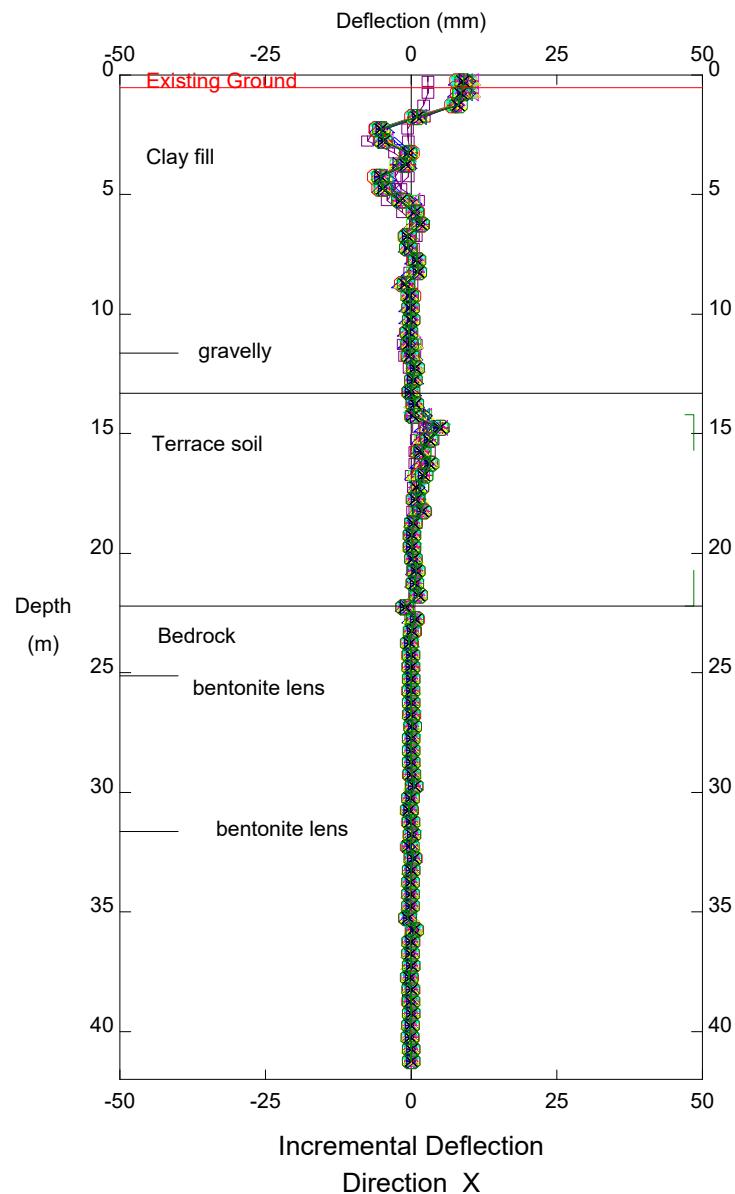
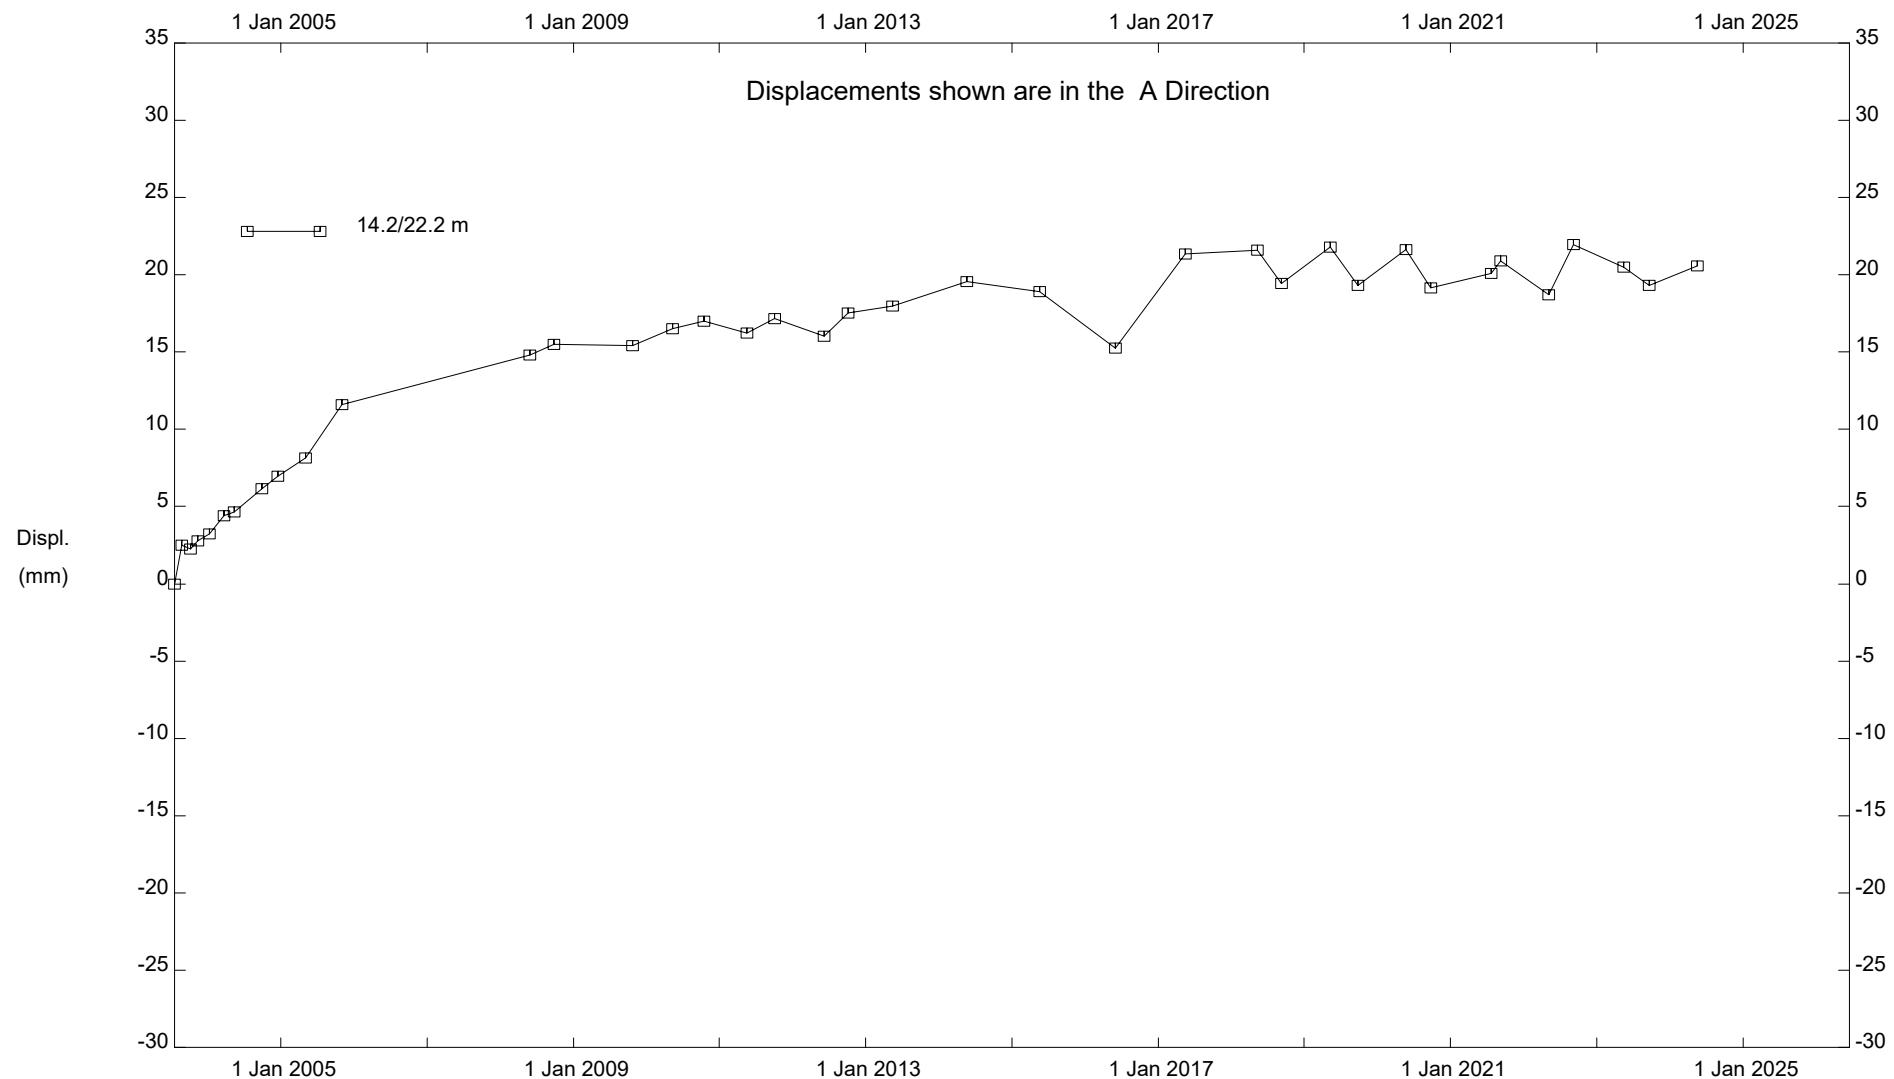
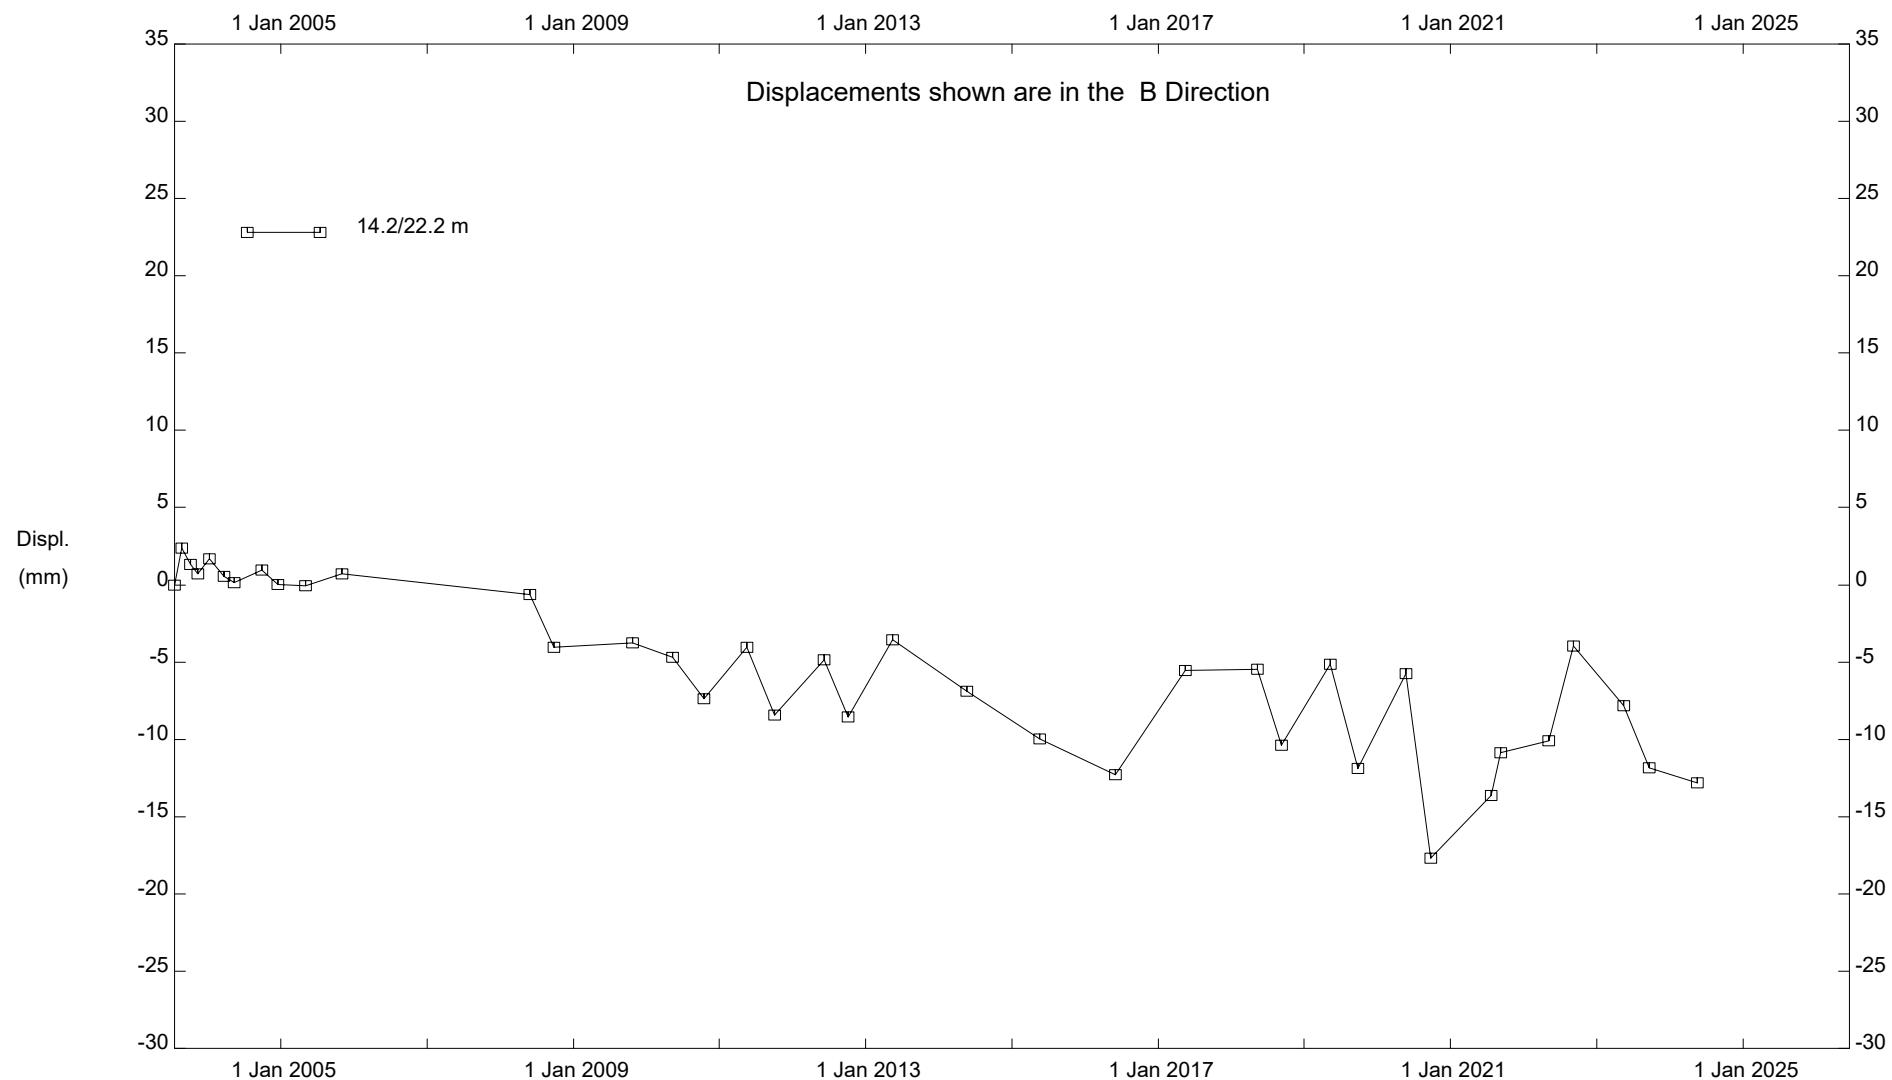
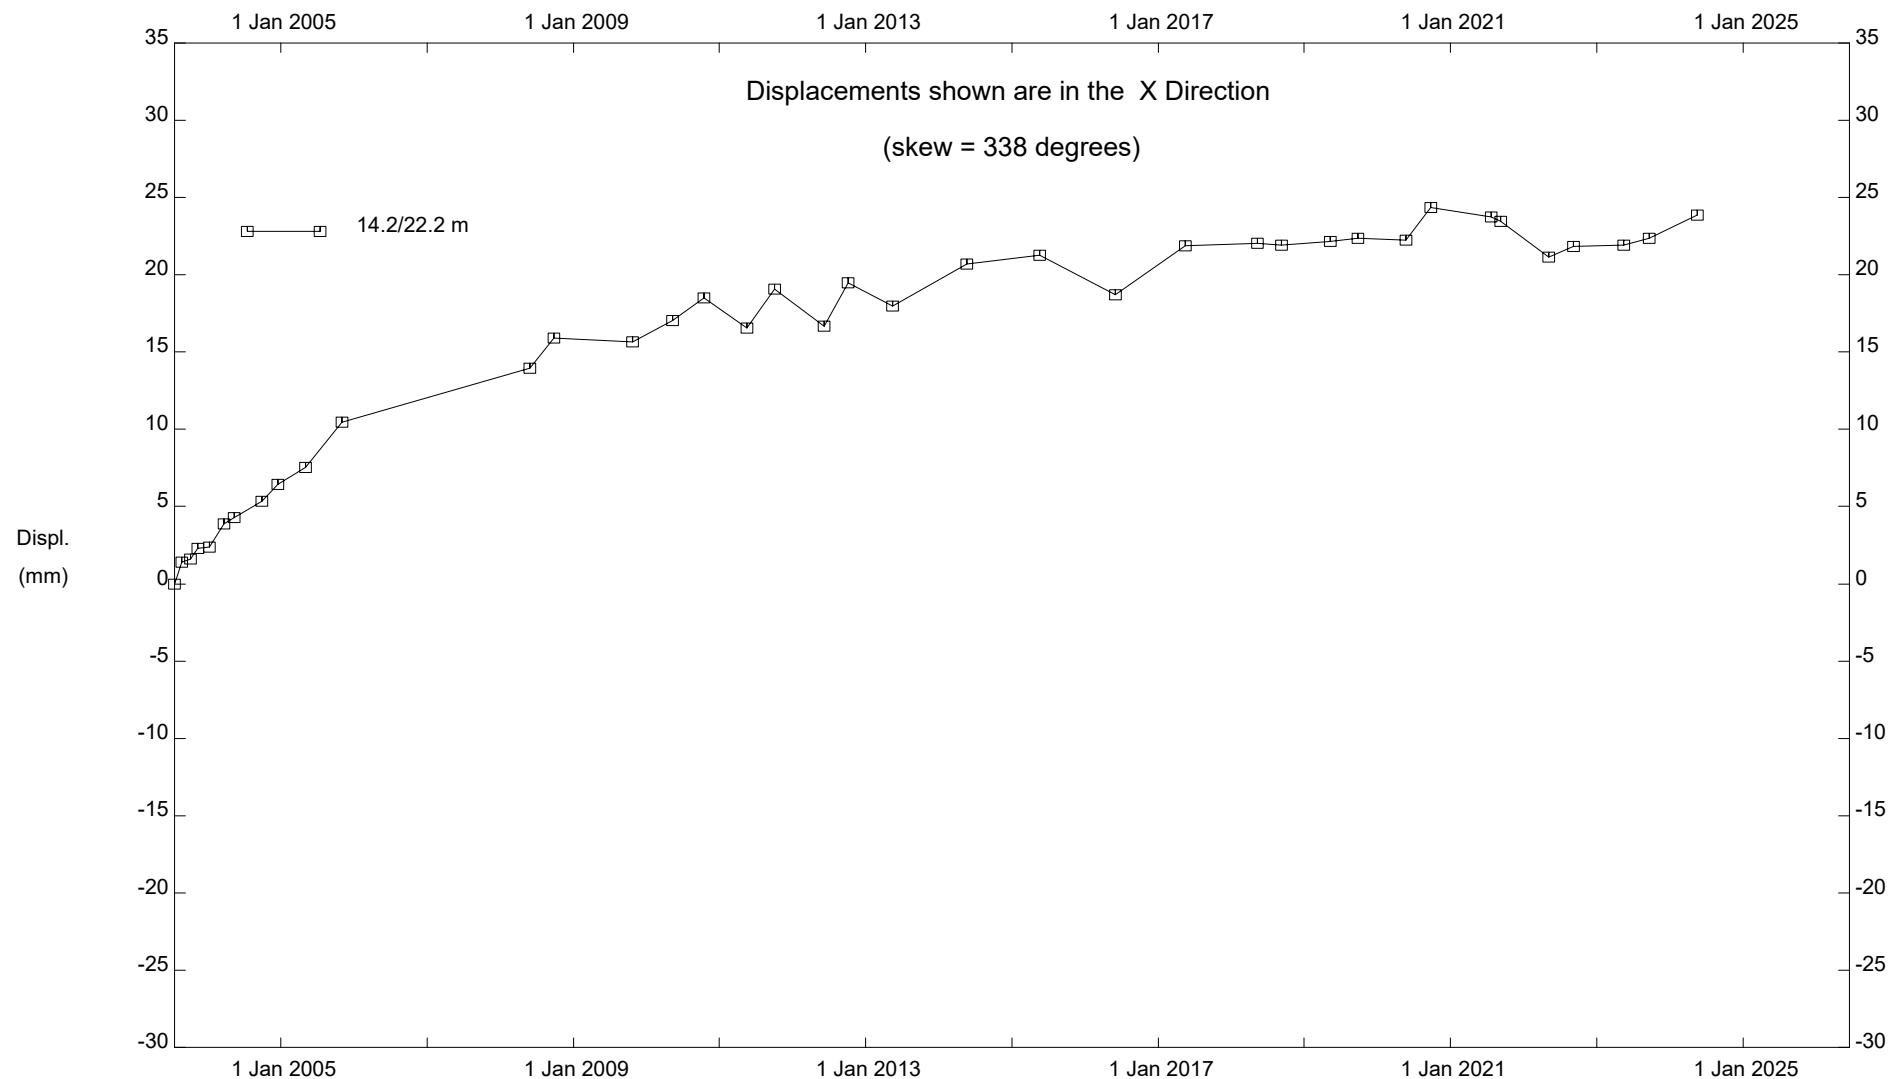
NC67, Inclinometer SI-10

SI-10 shows a current rate of movement of about 2 mm/yr. The average rate of movement since 2006 is also 2 mm/yr. The total cumulative movement is 24 mm.
