To: Amy Driessen
Transportation and Economic Corridors
From: Leslie Cho and Xiteng Liu
Stantec Consulting Ltd.
File: 123315222 Date: June 18, 2024

Reference: North Central Region, Stony Plain, Site NC067 - Highway 216:06 Anthony Henday Bridge, Spring 2024 Instrumentation Monitoring Report

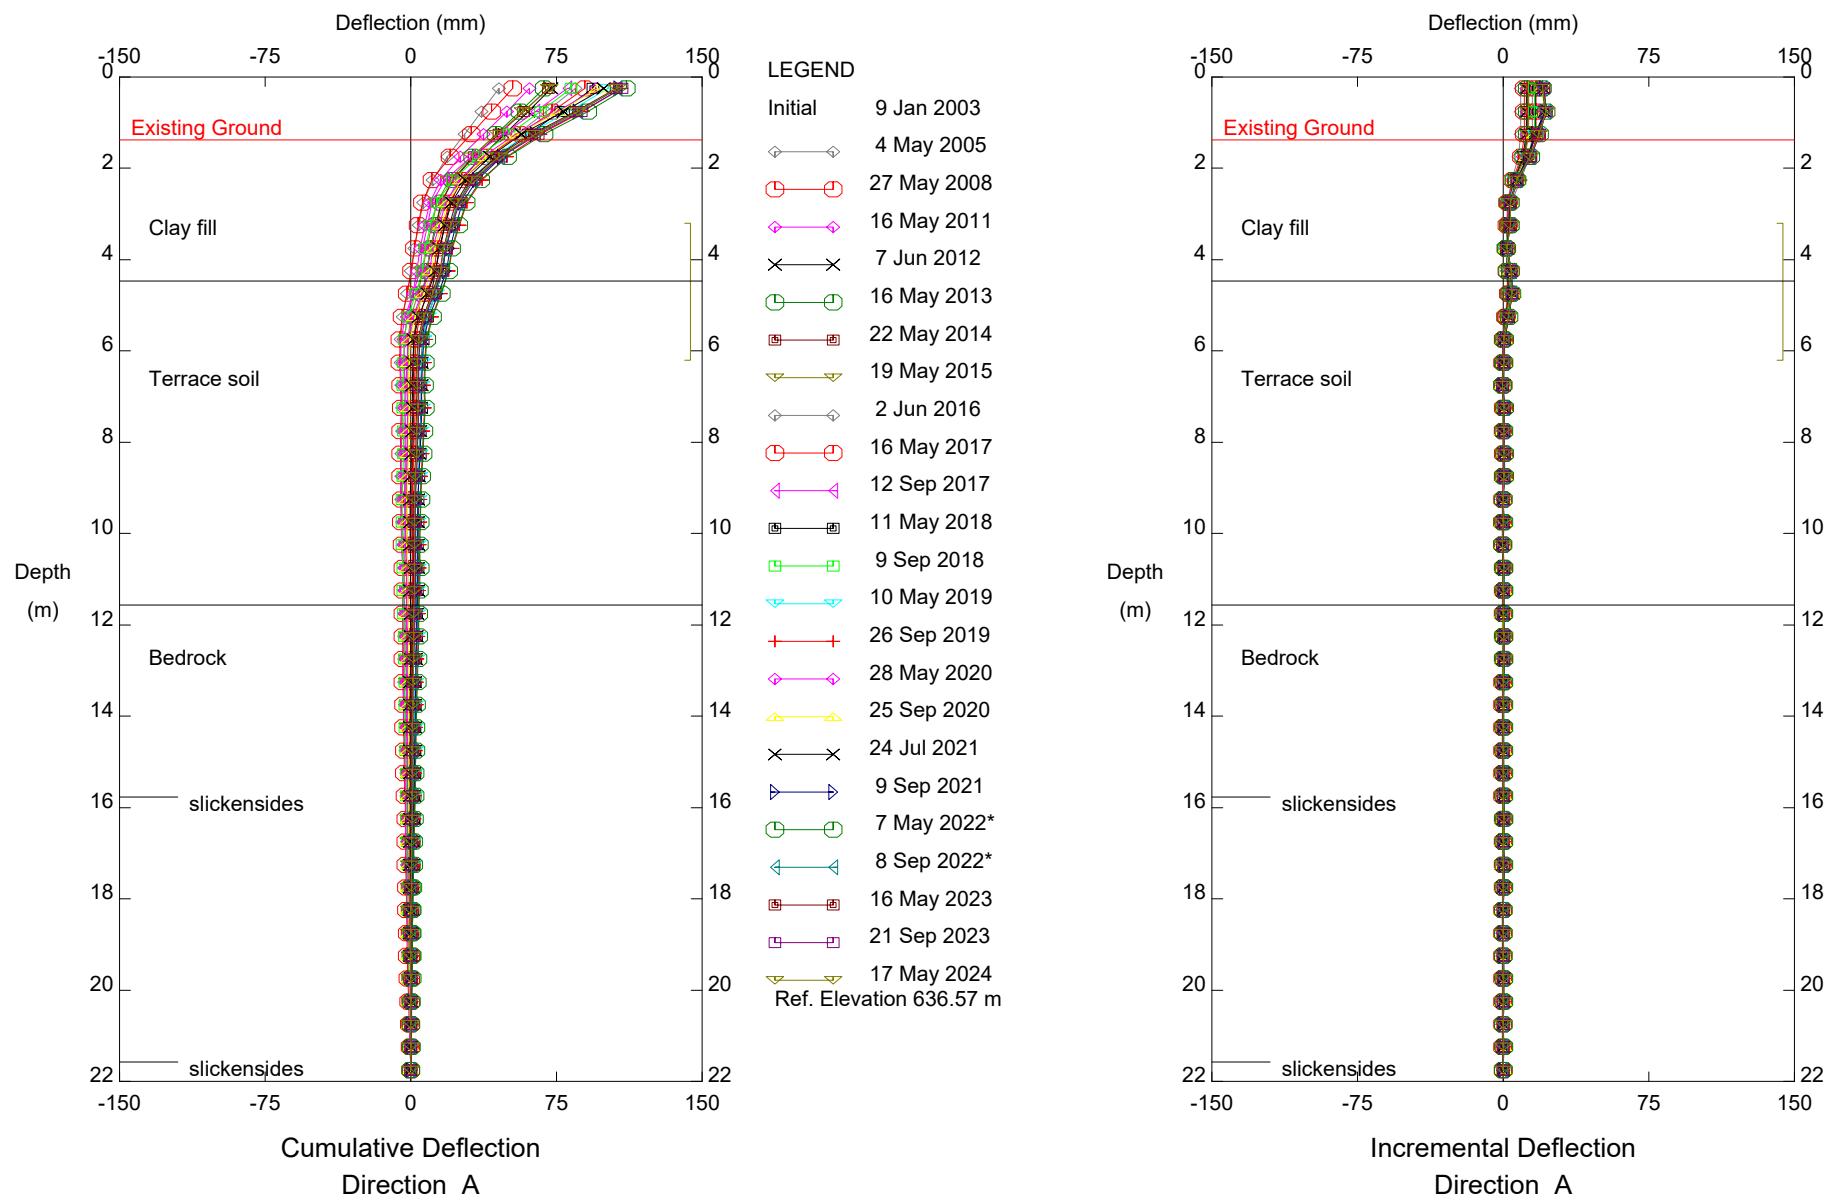
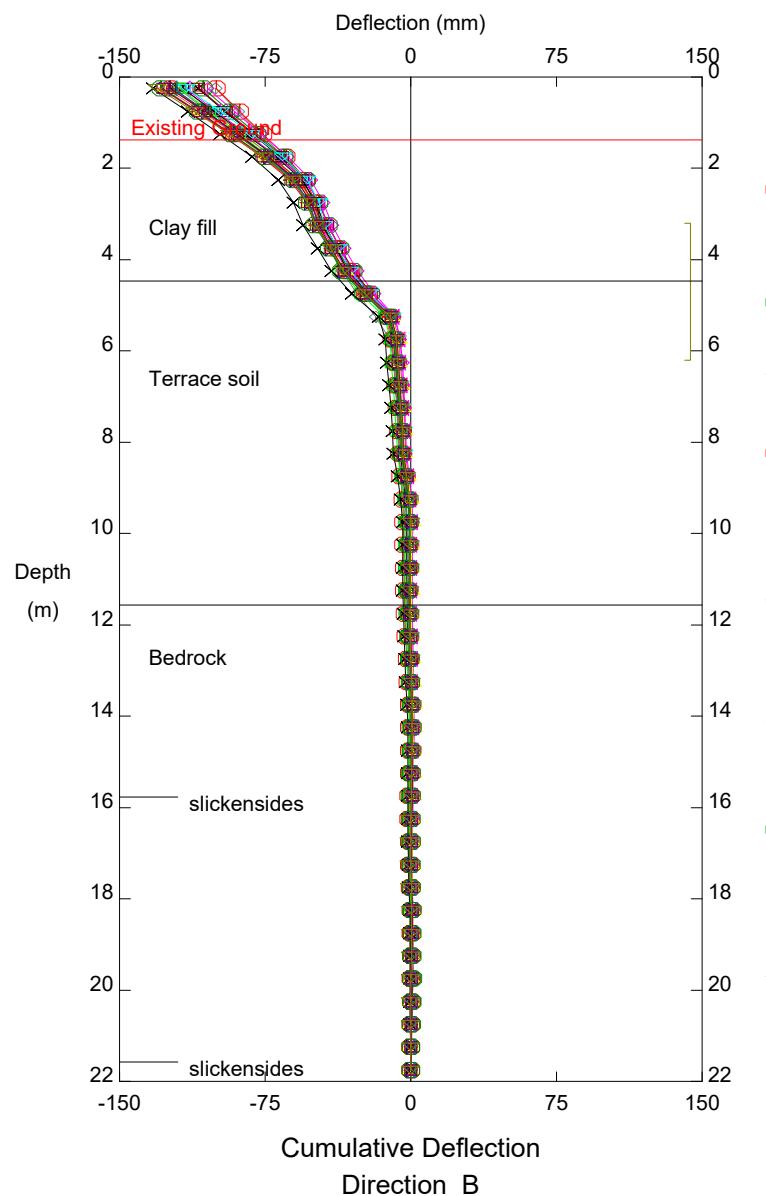
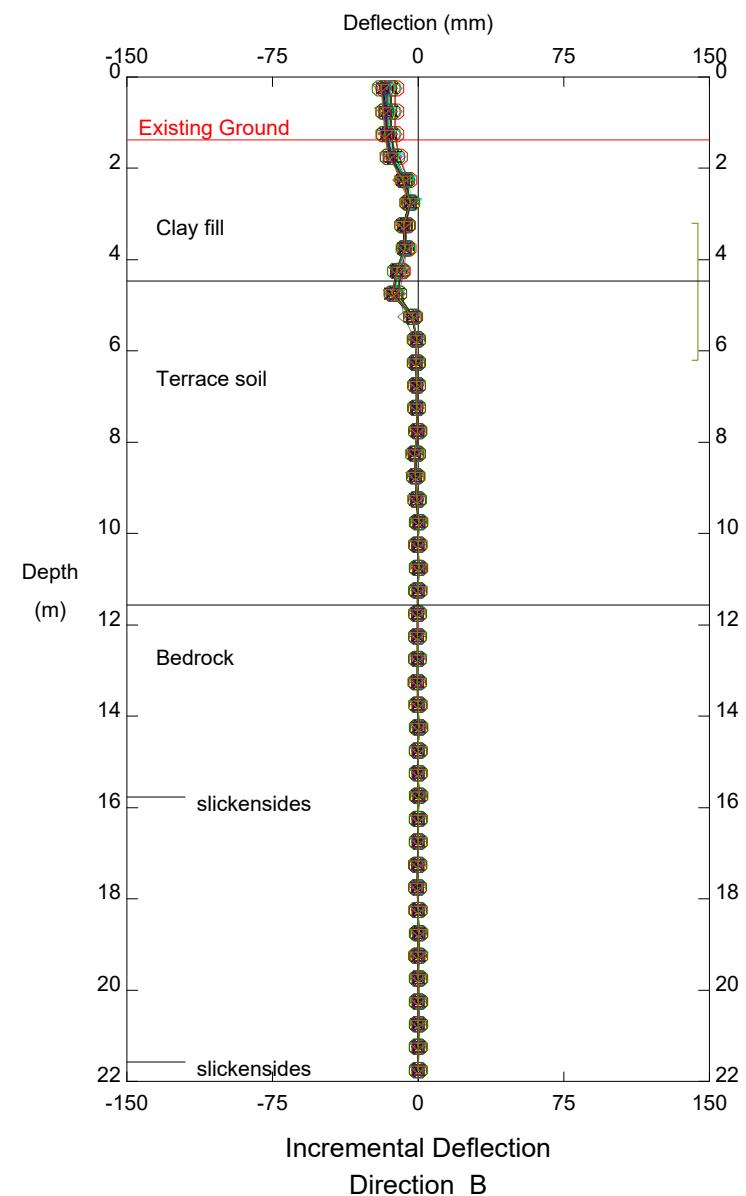
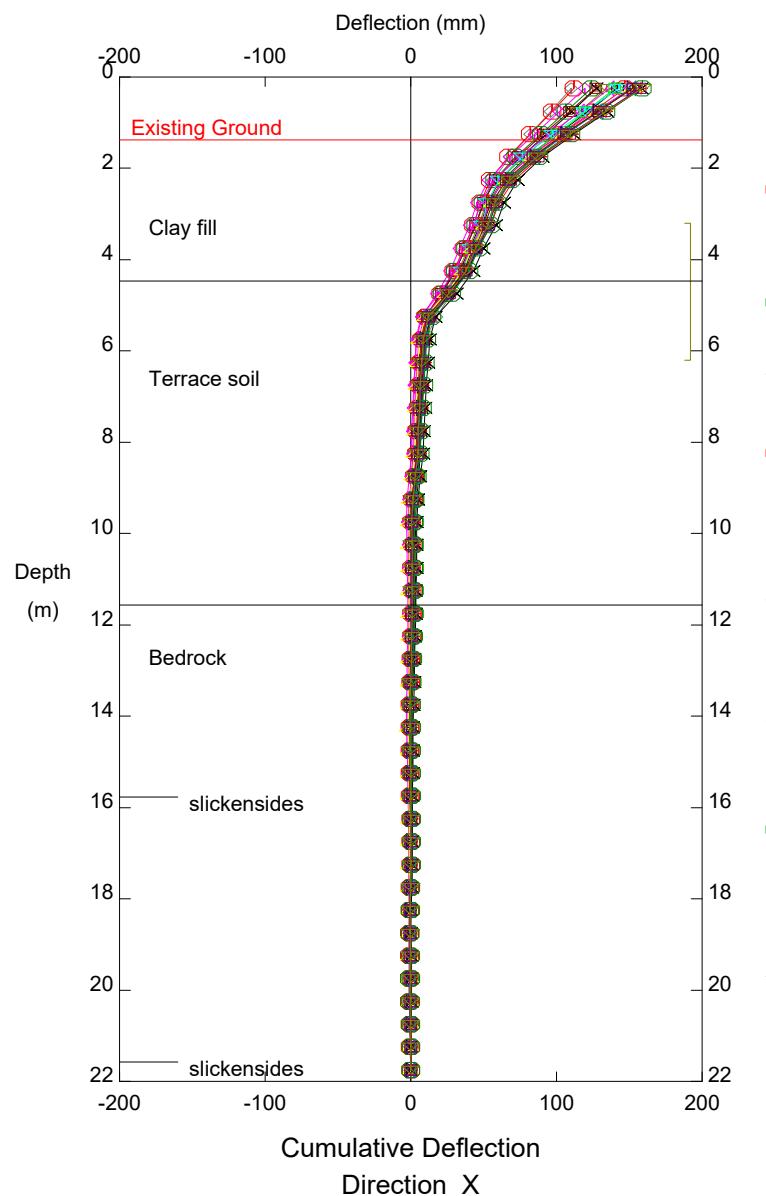
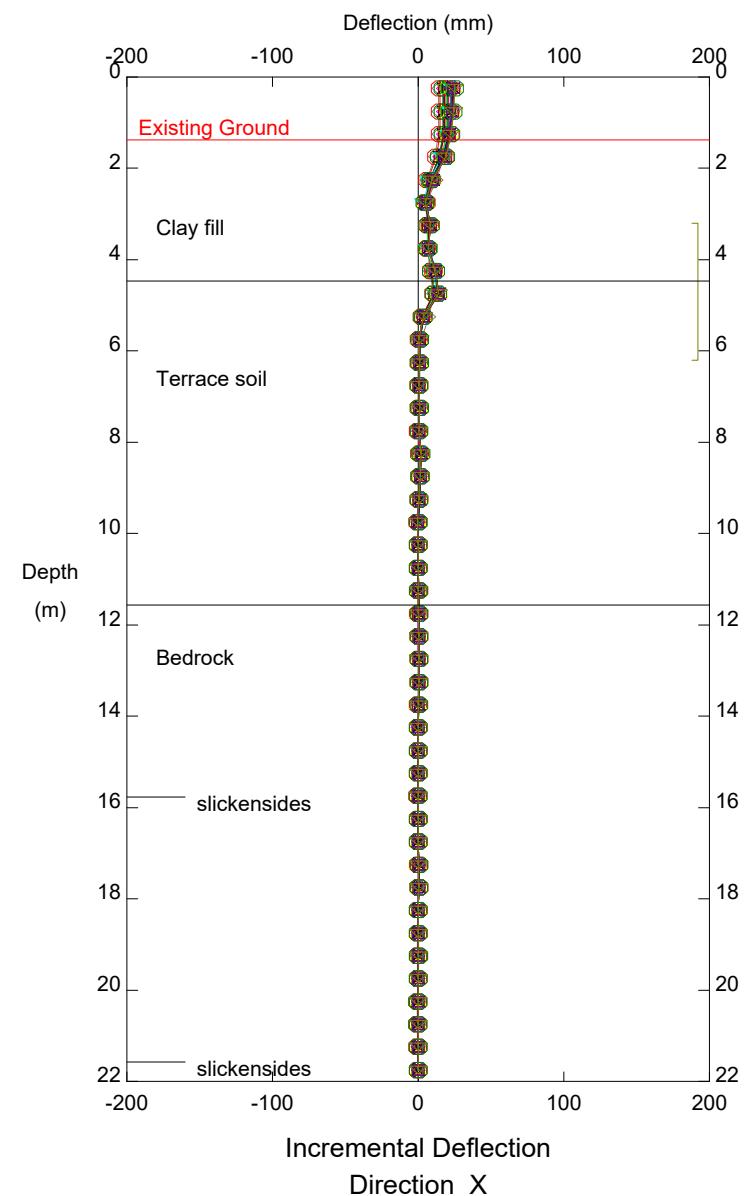
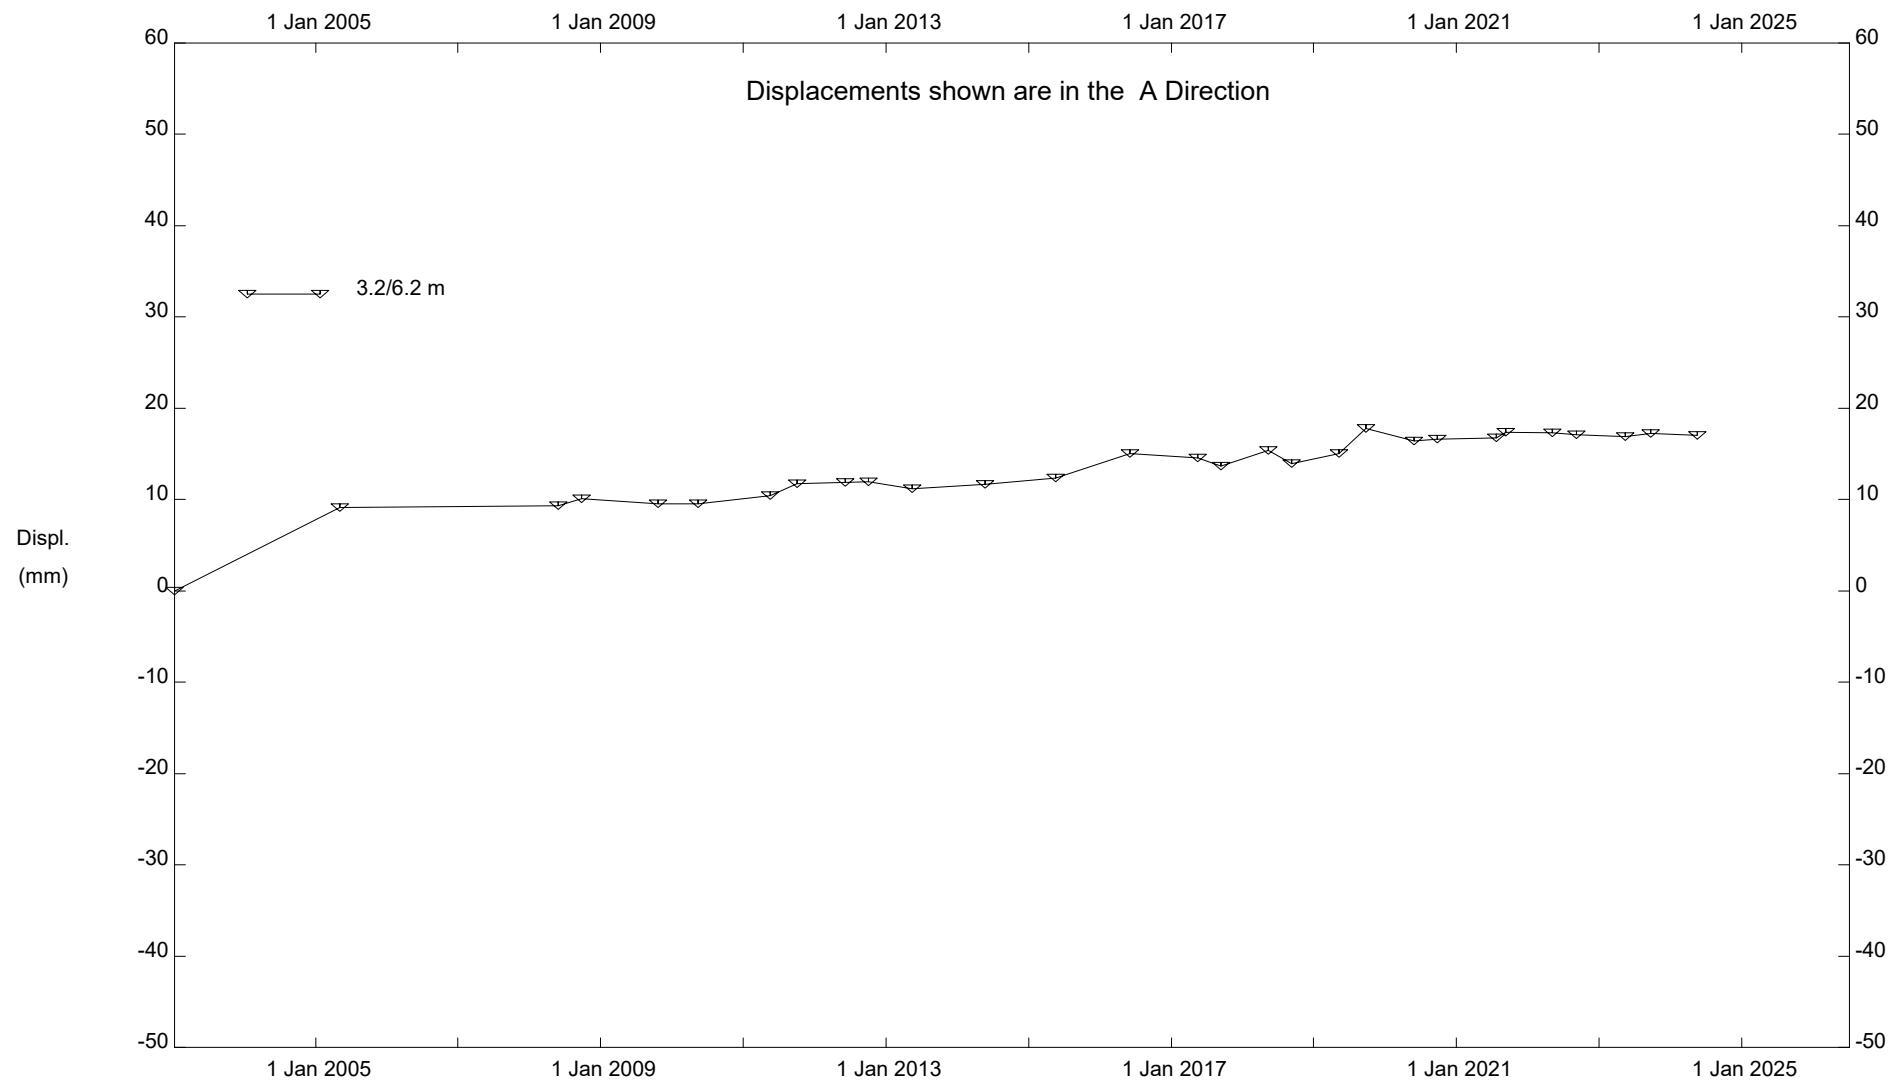
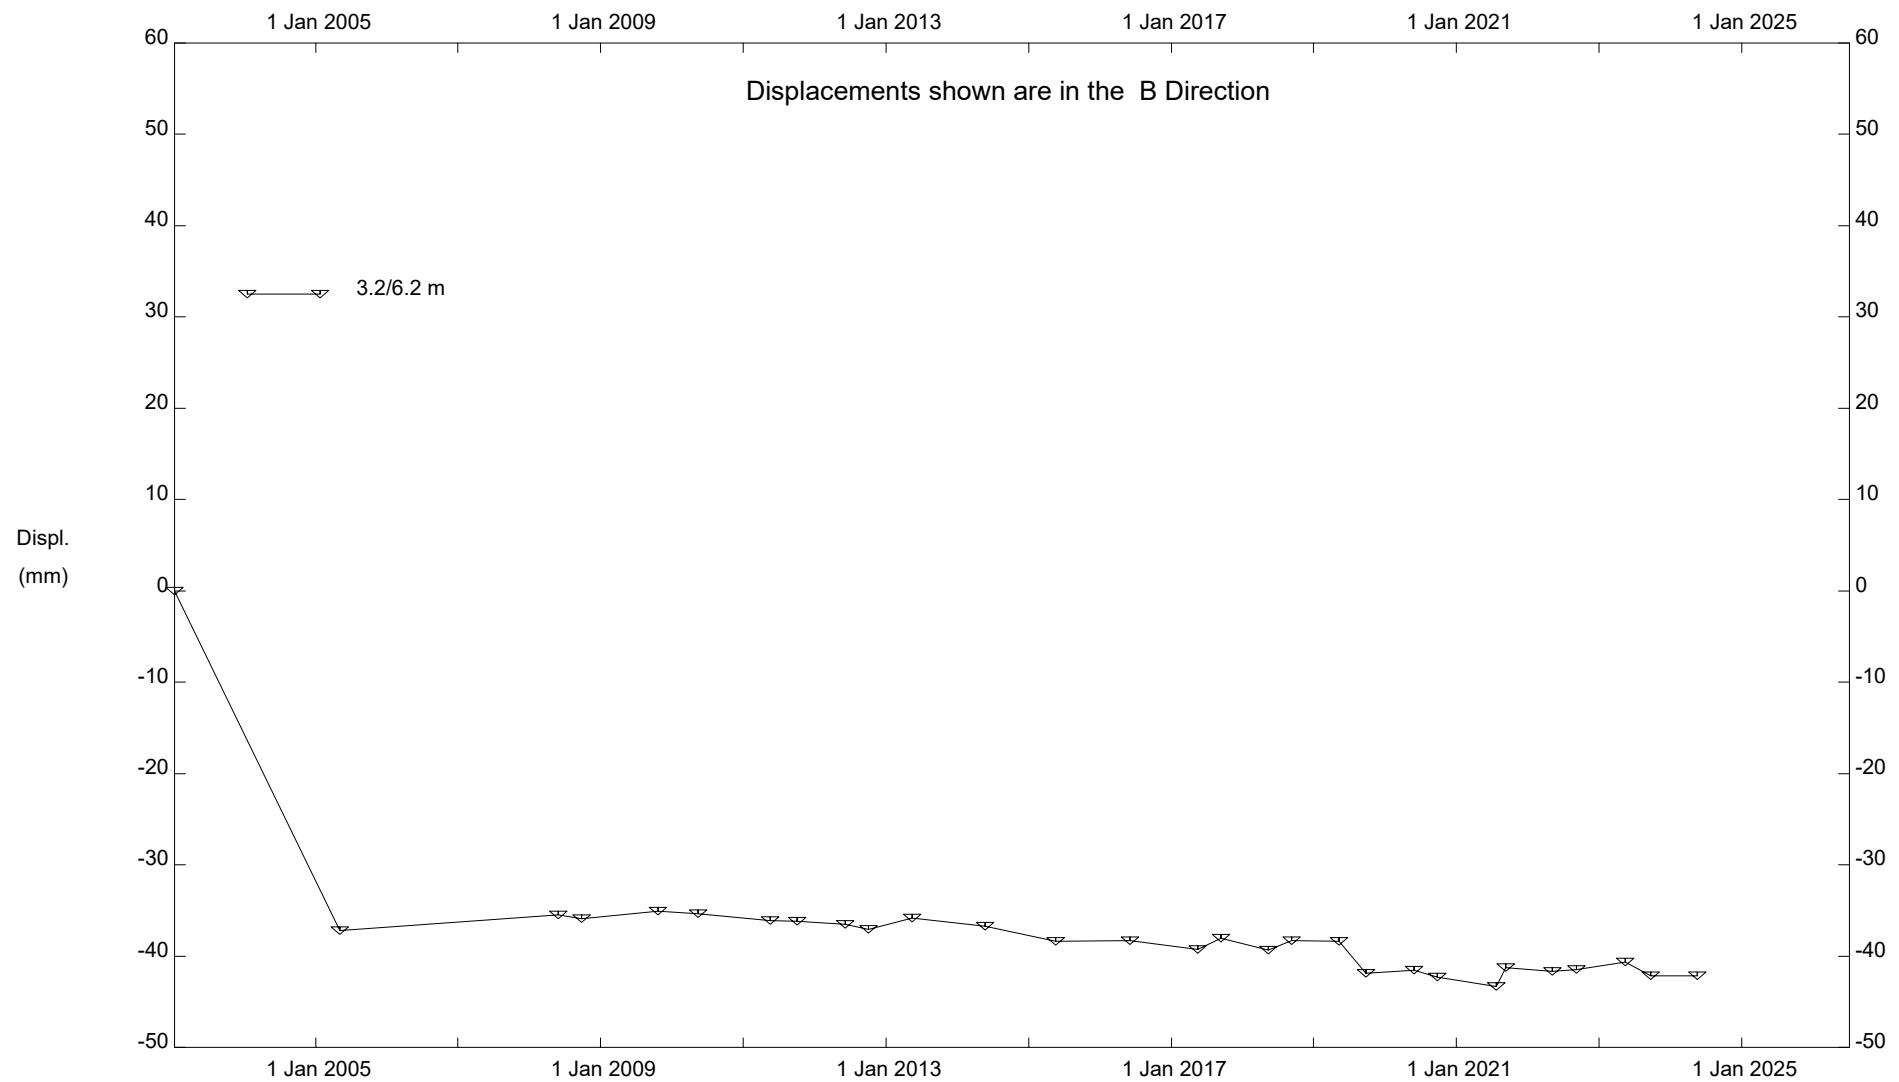
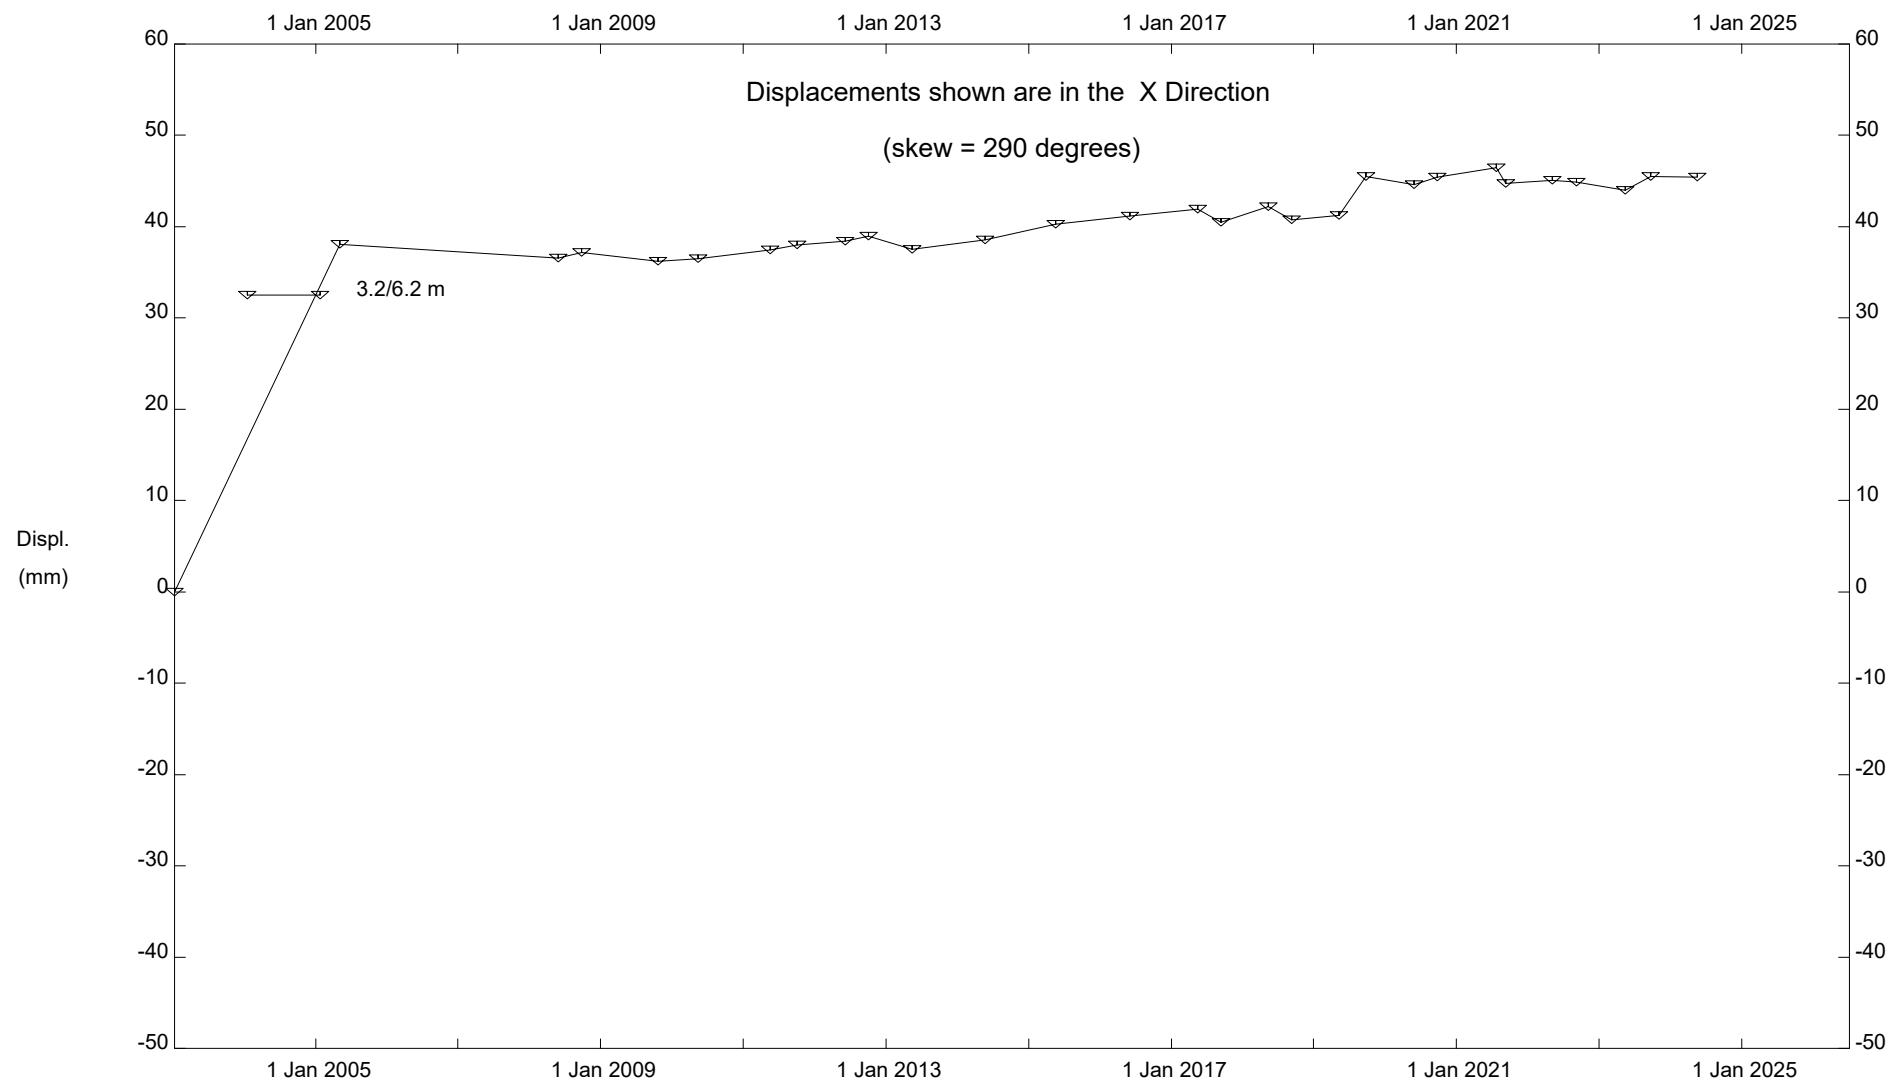
NC67, Inclinometer SI-12

SI-12 has a zone of movement between 3.2 m and 6.2 m and shows creep at a rate of about 1 mm/yr since 2008 with a total cumulative movement of 45 mm.
