ALBERTA TRANSPORTATION LANDSLIDE RISK ASSESSMENT

SECTION A: GEOTECHNICAL FILE REVIEW

SITE NC79: WEDGEWOOD SLIDE

LEGAL LOCATION:	SE 8-52-25-W4
NEAREST LANDMARK:	1 km SOUTH OF LESSARD ROAD EXIT 14 ON ANTHONY HENDAY ROAD
Highway Control Section:	HWY 216:06, km 13.1
Date of Initial Observation:	2013
Date of Last Inspection:	2017
Last Inspected By:	Stantec Consulting Inc.
Instruments Installed:	None
Instruments Operational:	N/A
Risk Assessment:	Slide – $PF(9) \cdot CF(3) = RL (27)$ Erosion – $PF(8) \cdot CF(3) = RL (24)$
Last Updated:	September 2017 – Stantec Consulting Ltd.

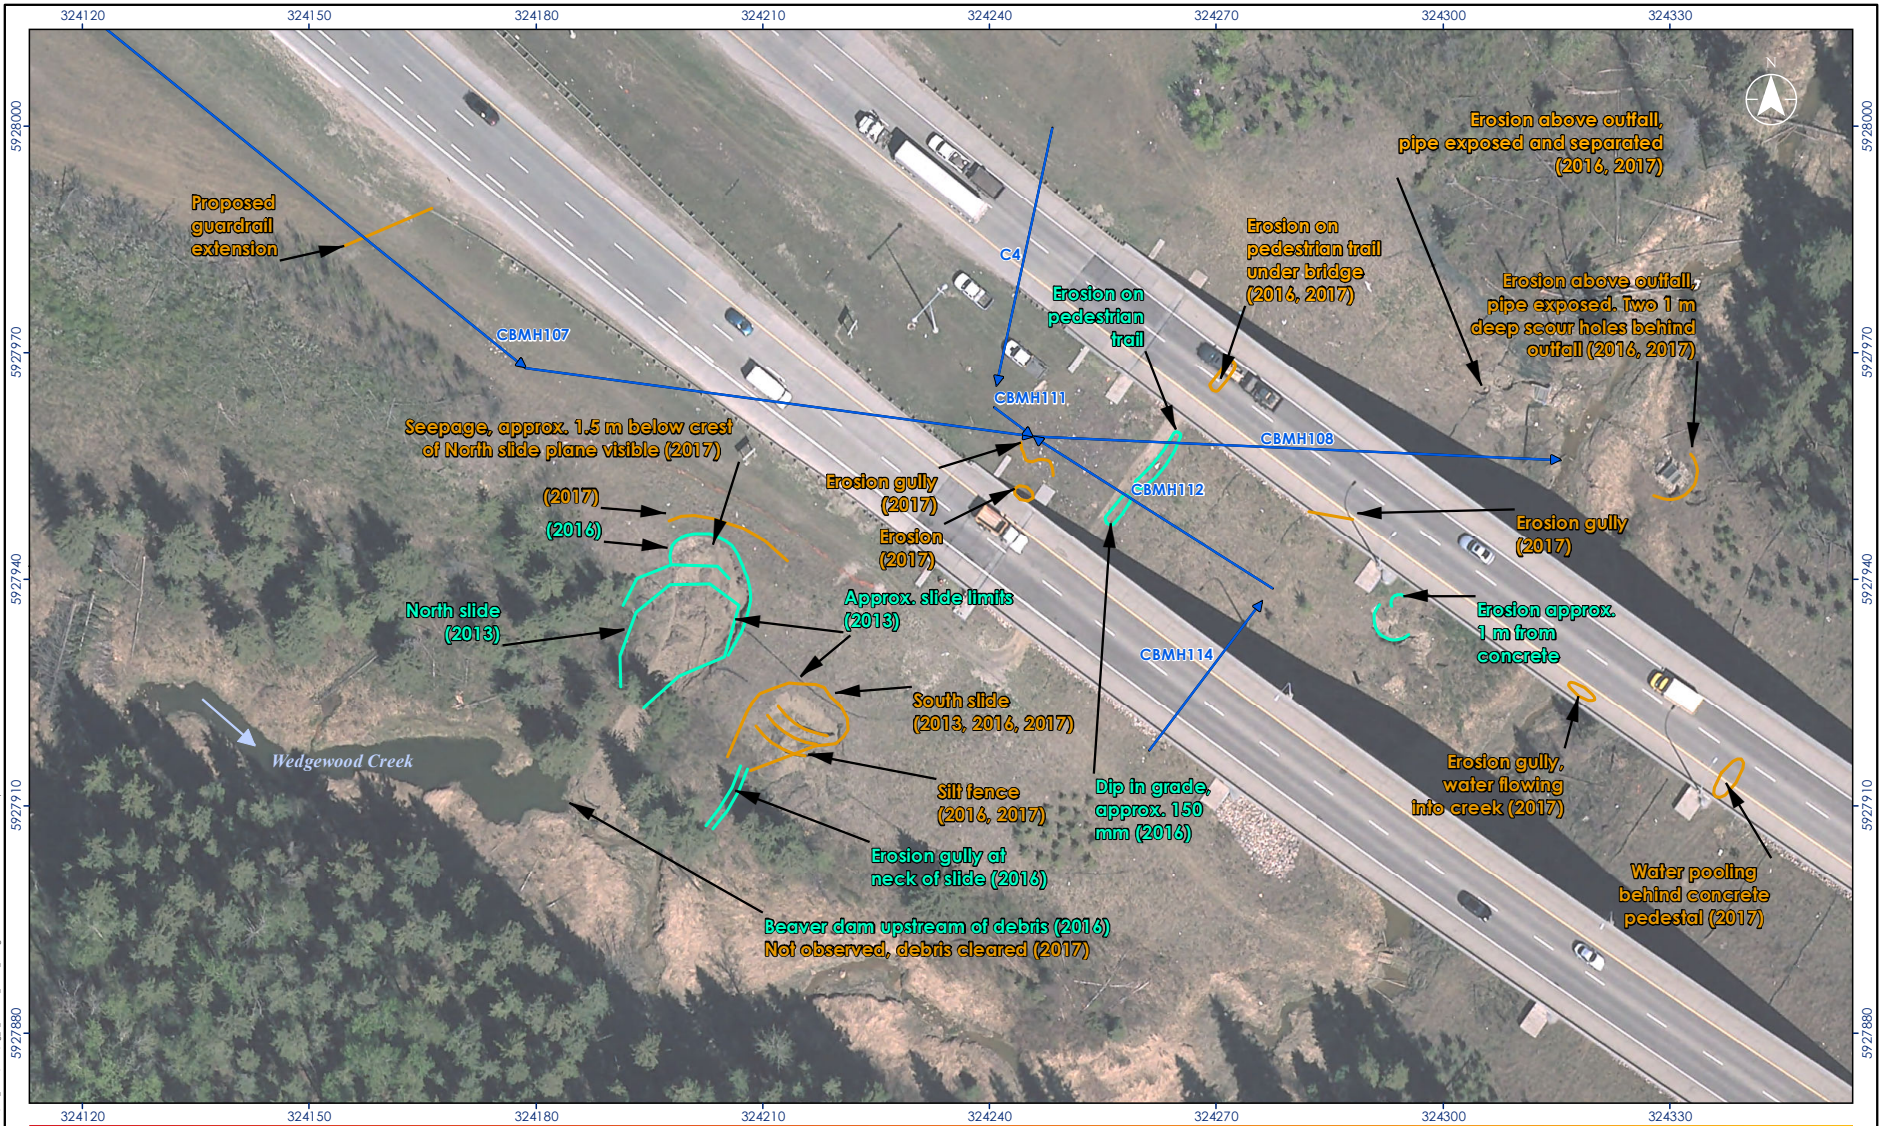
Figure No.
 1

Title
Site Plan
