<b>SITE NUMBER AND NAME:</b> NC079 – Wedgewood Ravine Slides	<b>HIGHWAY AND KM:</b> 216:06, km 12.849	<b>PREVIOUS INSPECTION:</b> May 21, 2020	<b>CURRENT INSPECTION:</b> June 28, 2021
<b>LEGAL DESCRIPTION:</b> SE 28-52-25-W4	<b>NAD83 COORDINATES:</b> UTM12U 5927932N, 324250E		<b>RISK ASSESSMENT:</b> PF: 11 CF: 8 Total: 88
<b>AVERAGE ANNUAL DAILY TRAFFIC (AADT):</b> 66,510 (2020)		<b>CONTRACTOR MAINTENANCE AREA (CMA):</b> Anthony Henday Drive (AHD)

<b>SUMMARY OF INSTRUMENTATION:</b> No instrumentation installed at this site. <b>LAST READING DATE:</b> N/A	<b>INSPECTED BY:</b> Stantec: Leslie Cho and Owen Zhang AT: Bernard Ching and Rishi Adhikari
<b>PRIMARY SITE ISSUE:</b> Two slope failures south of the northwest approach of Anthony Henday Drive (AHD). Erosion above both outfalls north of AHD crossing over Wedgewood Creek	
<b>APPROXIMATE DIMENSIONS:</b> North slide: Approximately 12 m wide by 6 m high South Slide: Approximately 9.5 m wide by 4 m high with several successive scarps up to 3 m high.	
<b>DATE OF ANY REMEDIAL ACTION:</b> Riprap extended south under southbound lane (SBL) in Fall 2020 / Spring 2021.

2021 Site Inspection Photos at NC079

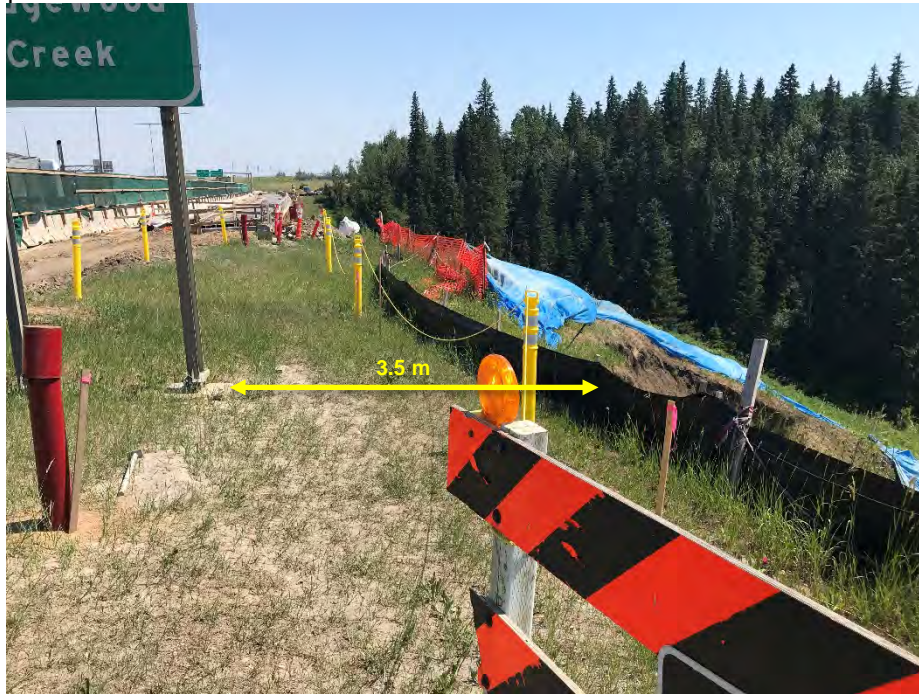
**Photo 1:** Edge of scarp approximately 3.5 m away from sign pedestal. Looking southeast.

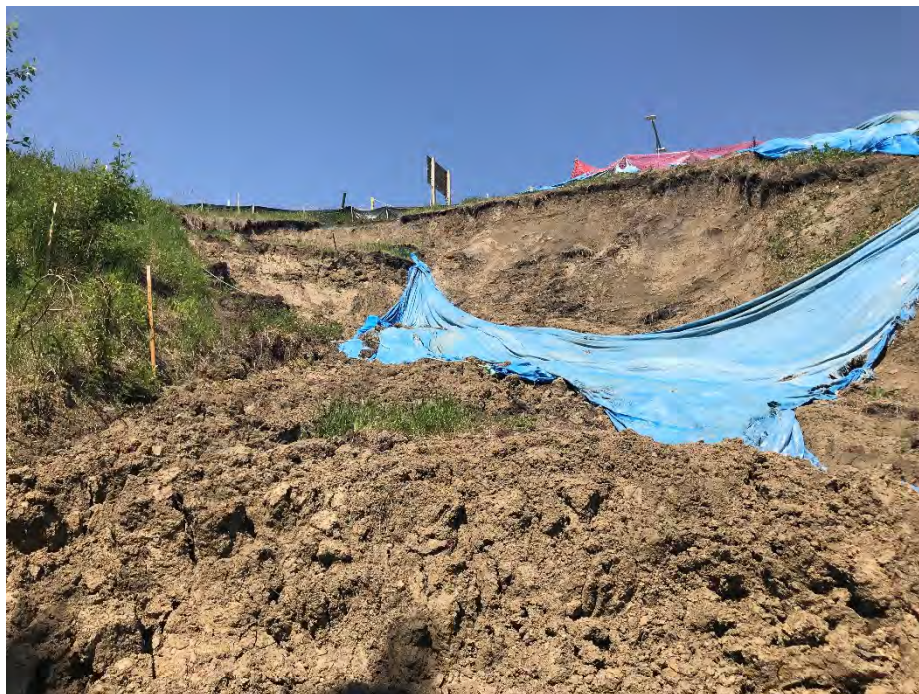
**Photo 2:** Scarp at north slide. Looking north.

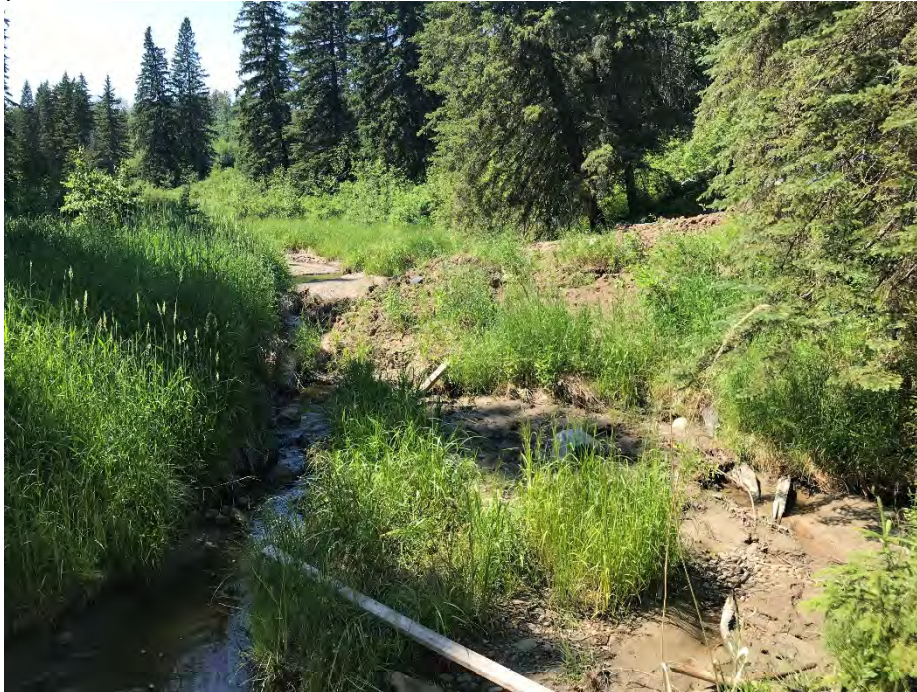
**Photo 3:** Run-out at north slide encroaching into Wedgewood Creek. Looking west.

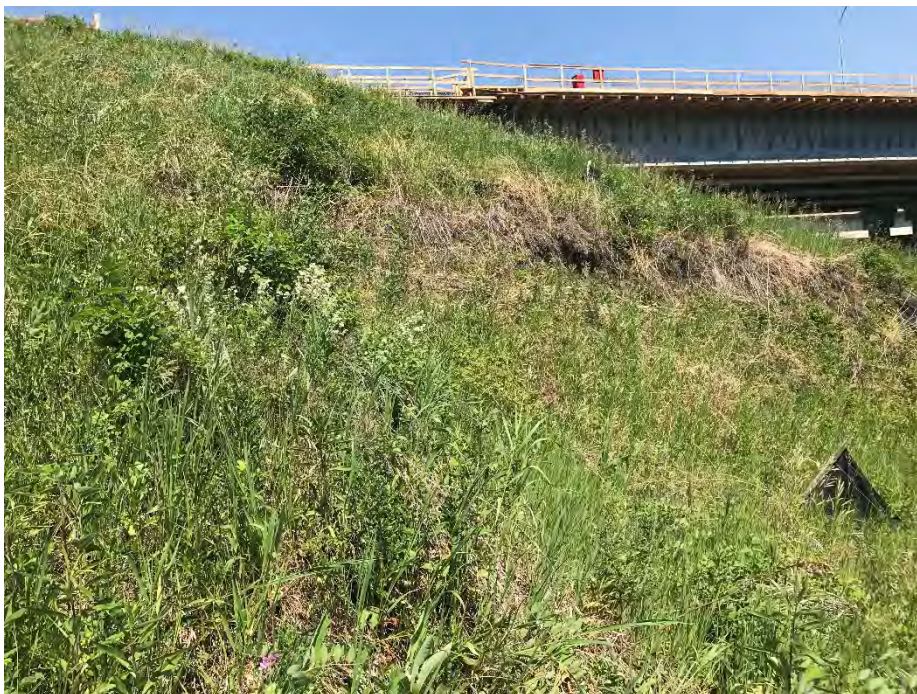
**Photo 4:** Scarp at south slide. Looking northeast.

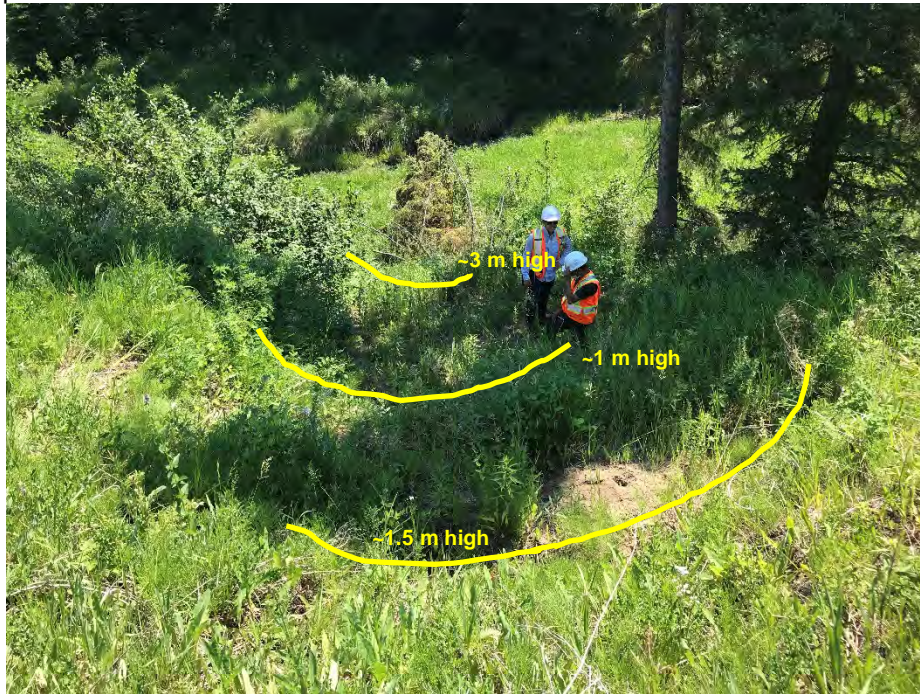
**Photo 5:** Successive scarps below Photo 4. Looking south.

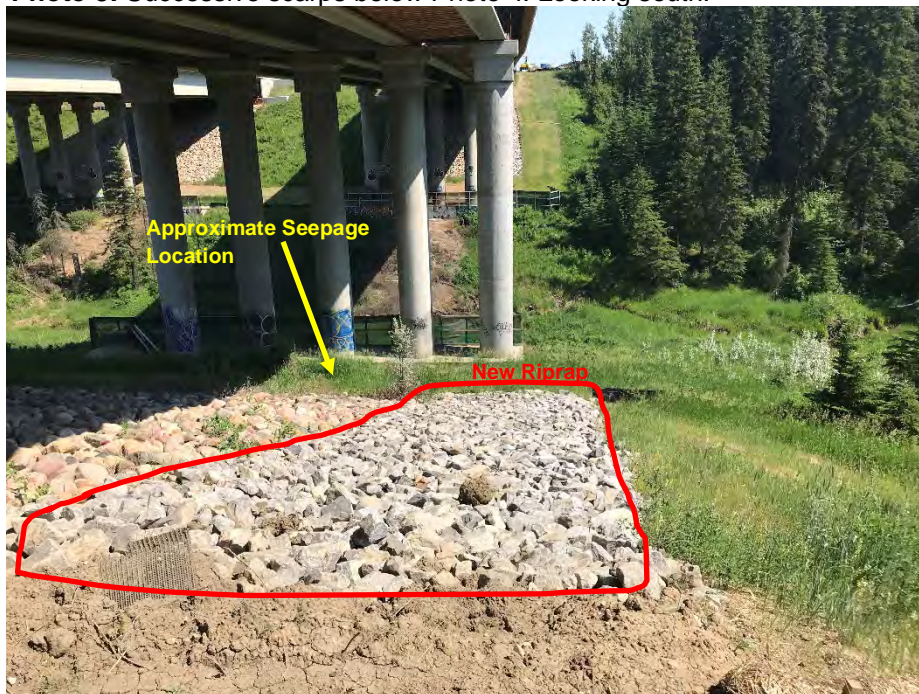
<b>COMMENTS</b>
<ul style="list-style-type: none"> <li>Both the north and south slides appear related to surface water infiltration and erosion. The north slide is actively retrogressing towards the highway whereas the south slide is developing successive scarps downslope.</li> <li>The north slide has retrogressed about 1.2 m further towards the highway since the July 2020 call-out. The run-out is encroaching into the creek and reduced it to less than 0.5 m width. (Photos 1 to 3)</li> <li>The upper scarp of the south slide looks relatively unchanged (Photo 4). Additional slumping observed further downslope consisting of three smaller scarps up to about 3 m high (Photo 5).</li> <li>Riprap between the eastbound east abutment and piers extended south since the previous site visit.</li> <li>Seepage observed on the west slope between the riprap and piers (Photo 6).</li> <li>Wedgewood Creek level relatively low at time of inspection.</li> </ul>

**Photo 6:** Riprap extended under southbound lane. Looking southeast.

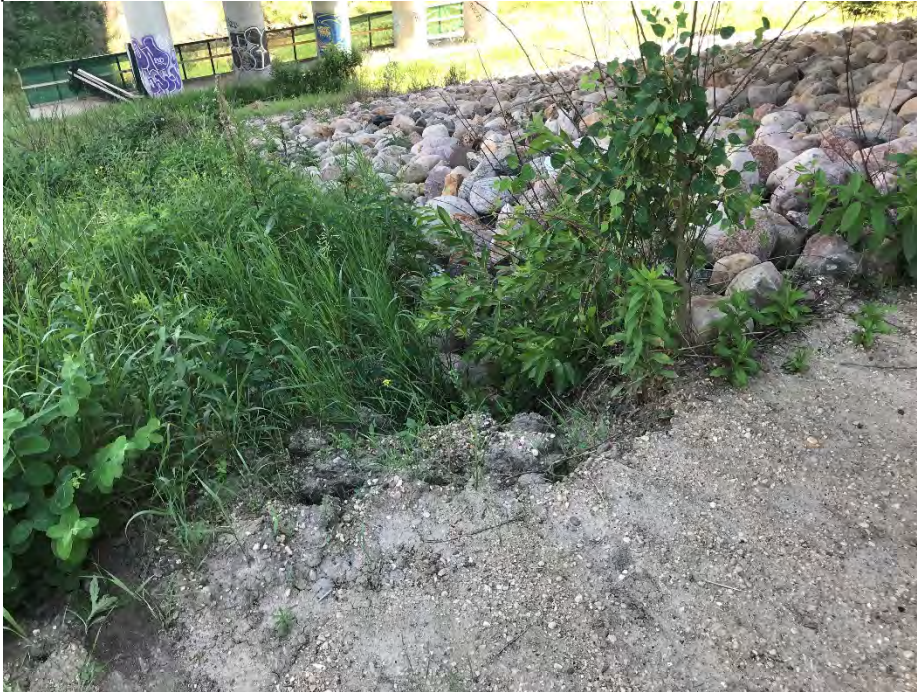
- Erosion/slumping of the footpath at the north corner of the riprap below the SBL developing a scarp (Photo 7). Scarp is about 900 mm high and is starting to retrogress into footpath. Surface water appears to be flowing between the highway towards this slump.
- Erosion observed behind both outfalls located on the west and east sides of Wedgewood Creek north of AHD (Photo 8). Erosion above west outfall appears to be retrogressing further upslope with a new scarp developed (Photo 9). East outfall condition looked similar to the previous inspection (Photos 10 and 11).
- The gap (fill settlement) at the northeast corner of the northernmost pedestal increased by 30 mm to 200 mm.
- The two slumps on the west slope between the concrete piers appear unchanged (Photo 12).

**Photo 7:** Erosion/slump retrogressing to footpath. Looking southeast.

- A concrete trough may be considered upslope of the footpath to direct surface water towards the riprap instead of into existing erosion channels.
- Stantec submitted a tender package for outfall remediation consisting of replacing the disjointed and broken pipe segments with new pipe and regrading the surrounding slopes. The existing outfalls will be removed and replaced with an energy dissipater consisting of Class 2 riprap. Construction is currently scheduled for 2024. The estimated cost for construction is approximately \$800,000 adjusting for the removal of the Tecco mesh and excluding engineering costs. This cost also includes outfall repair for the nearby NC67.

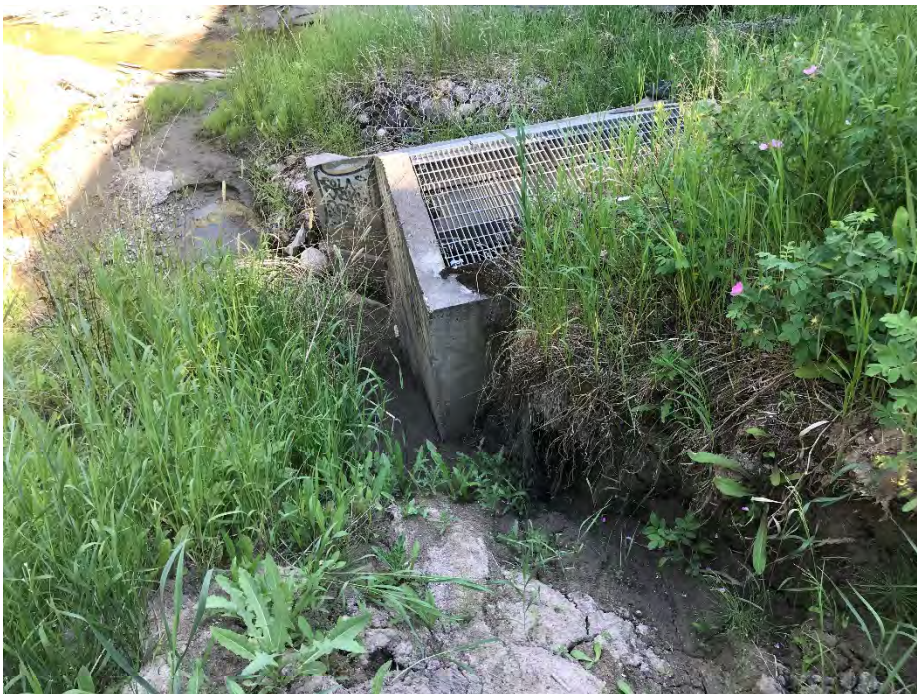
**Photo 8:** Erosion and wet soil behind west outfall. Looking east

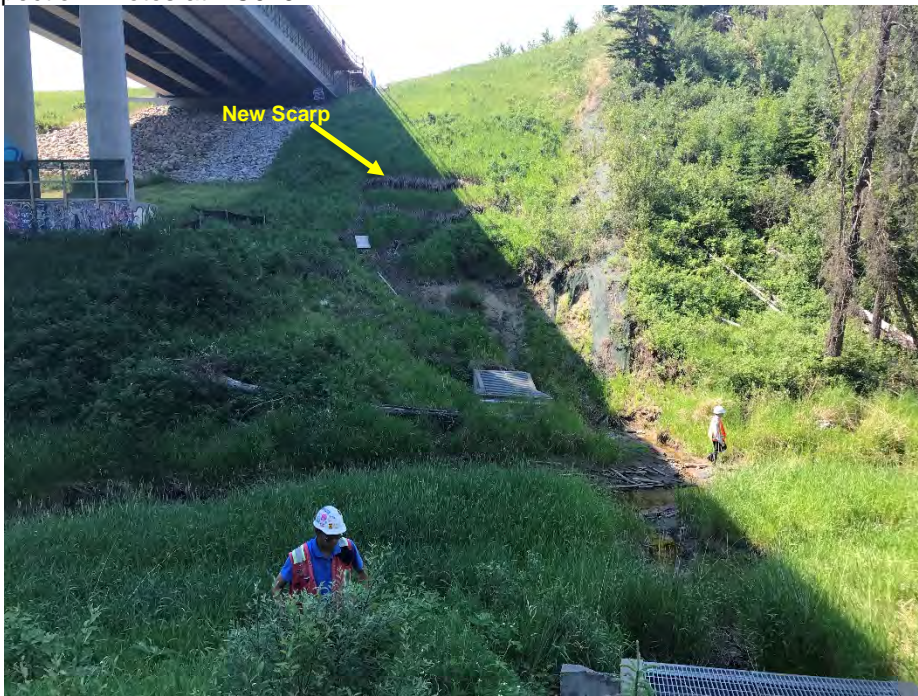
**Photo 9:** Erosion above west outfall. Looking west.

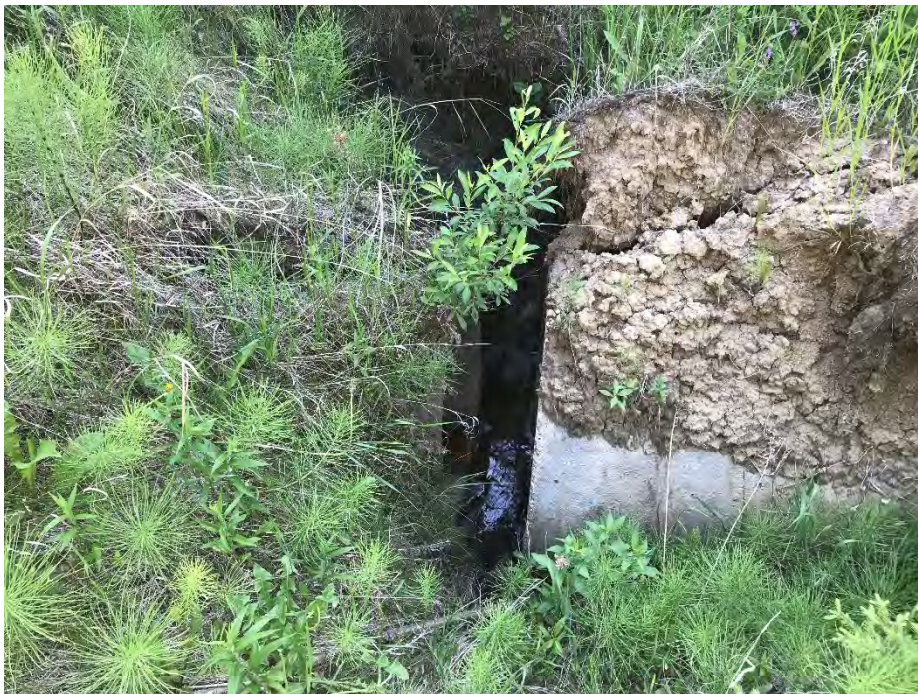
**Photo 10:** Separation behind east outfall. Looking south.

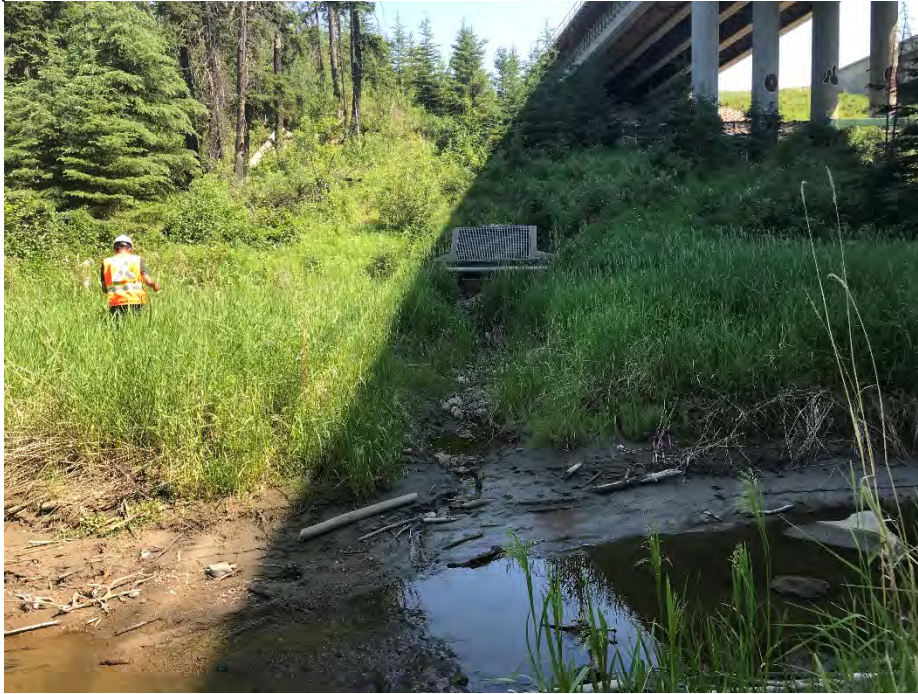
**Photo 11:** East outfall. Looking southeast.

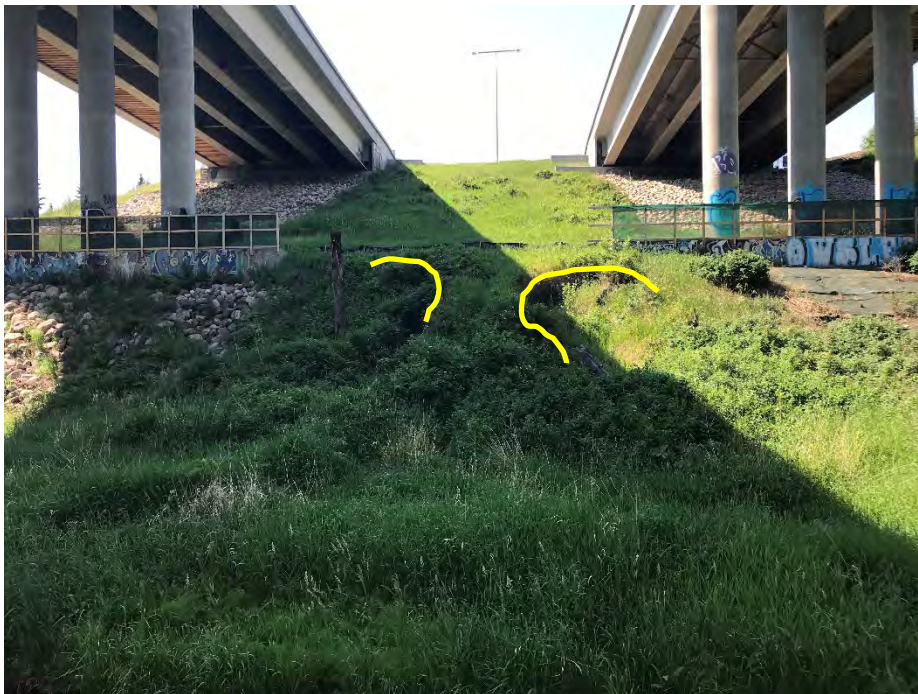
**Photo 12:** Two slumps between the two concrete pedestals for bridge piers. Looking northwest.
