SITE NUMBER AND NAME: NC079 – Wedgewood Ravine Slides	HIGHWAY AND KM: 216:06, km 12.849	PREVIOUS INSPECTION: June 28, 2021	CURRENT INSPECTION: June 15, 2022
LEGAL DESCRIPTION: SE 28-52-25-W4	NAD83 COORDINATES: UTM12U 5927932N, 324250E		RISK ASSESSMENT: PF: 11 CF: 8 Total: 88
AVERAGE ANNUAL DAILY TRAFFIC (AADT): 64,930 (2021)		CONTRACTOR MAINTENANCE AREA (CMA): Anthony Henday Drive (AHD)

2022 Site Inspection Photos at NC079

Alberta Transportation
 Geotechnical Monitoring Program
 NC79 Wedgewood Ravine Slides

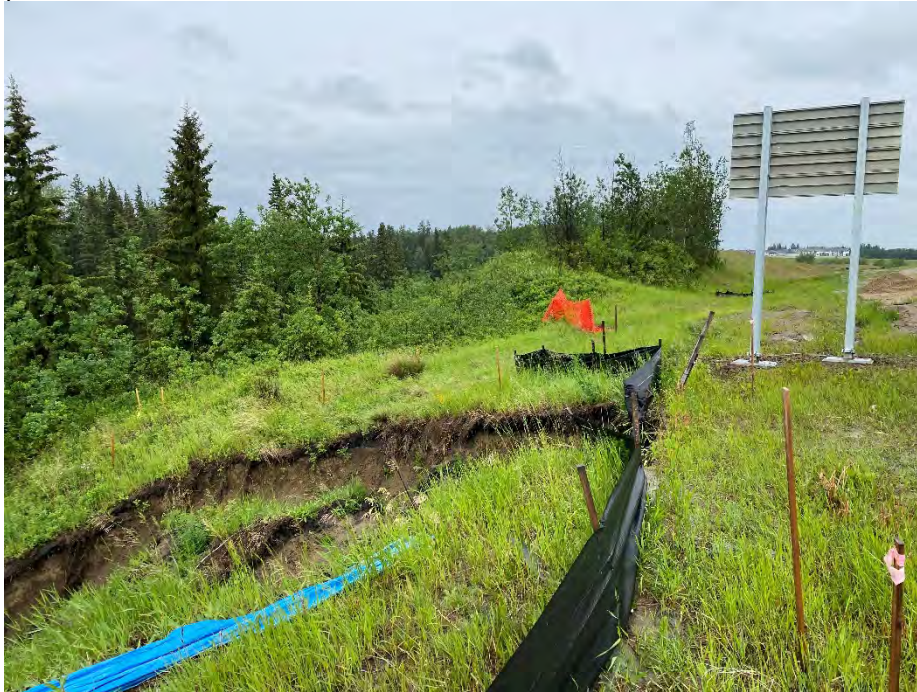
Photo 1: Distance from edge of scarp to sign pedestal is 2.6 m. Looking northwest.

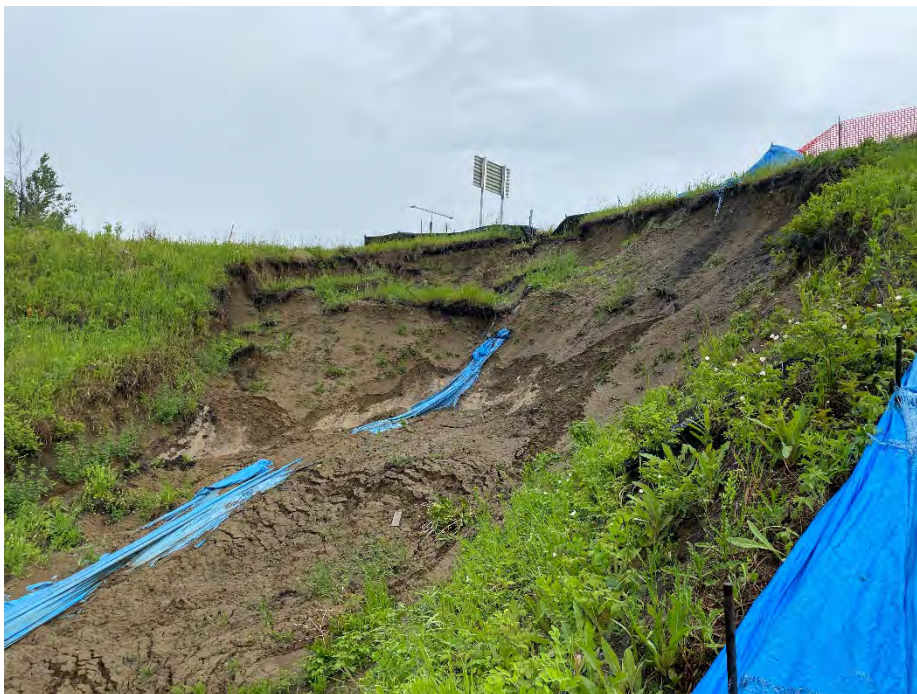
Photo 2: North slide. Looking north from midslope.

- From discussions during the July 2020 Call-Out Inspection, remediation of the north and south slides will be undertaken by the SWAHD geotechnical consultant. It is understood that the site will be remediated using soil nails.

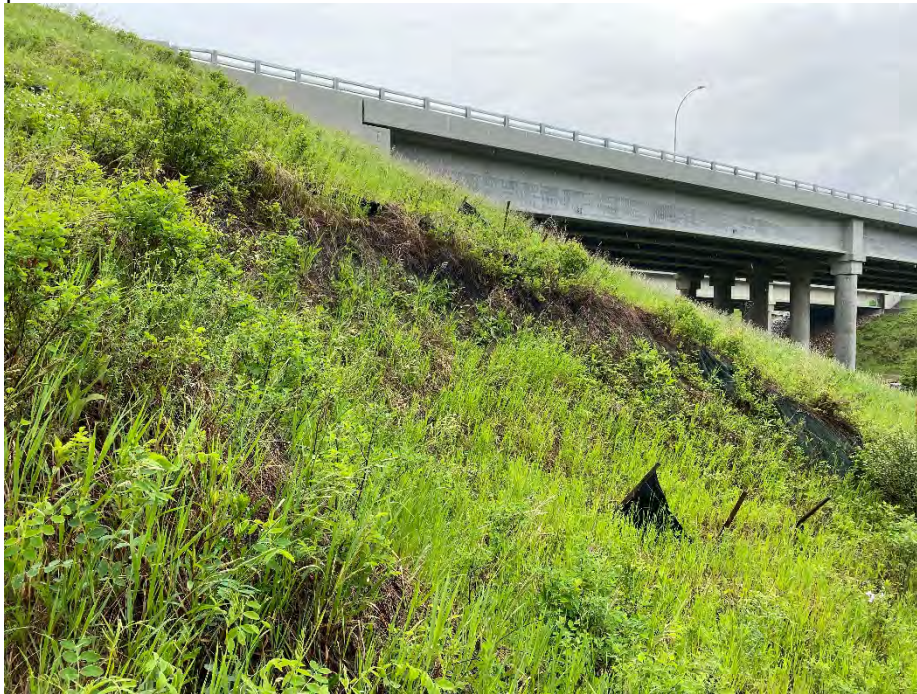
Photo 3: Scarp at south slide. Looking northeast.

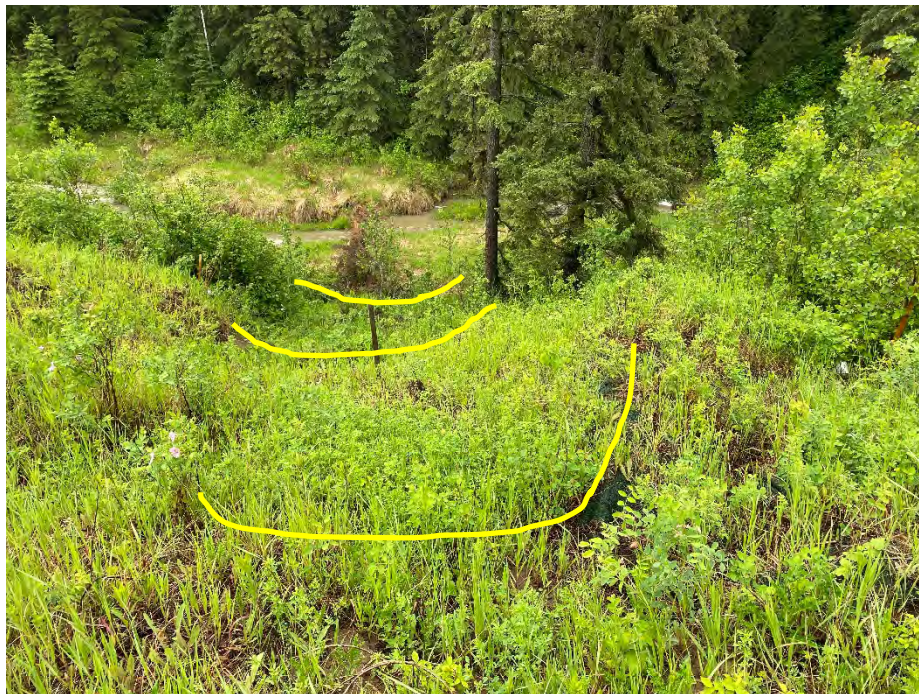
COMMENTS
<ul style="list-style-type: none"> Both the north and south slides appear related to surface water infiltration and erosion. The north slide is actively retrogressing towards the highway whereas the south slide is developing successive scarps downslope. The north slide has retrogressed about 0.9 m further towards the highway since the June 2021 inspection (Photos 1 and 2). The upper scarp of the south slide looks relatively unchanged (Photo 3). The slumping observed further downslope consisting of three smaller scarps up to about 3 m high also appears relatively unchanged (Photo 4).

Photo 4: Successive scarps below Photo 3. Looking south.

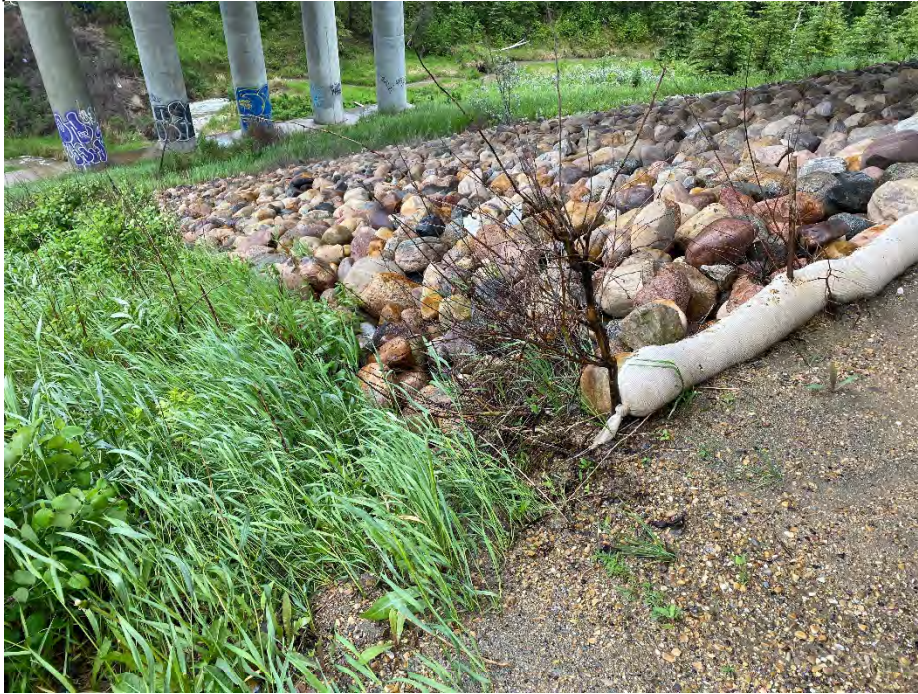
- Erosion/slumping of the footpath at the north corner of the riprap below the SBL appears relatively unchanged (Photo 5). Minor works may have been completed around the erosion gully as evidenced by new straw wattle with live staking at the top of riprap.

Photo 5: Erosion/slump retrogressed to footpath, increasing vegetation from 2021. Looking southeast.

- Slope inclinometer data should be requested from the SWAHD geotechnical consultant for review and inclusion in the GRMP monitoring cycle.
- A concrete trough may be considered upslope of the footpath to direct surface water towards the riprap instead of into existing erosion channels.

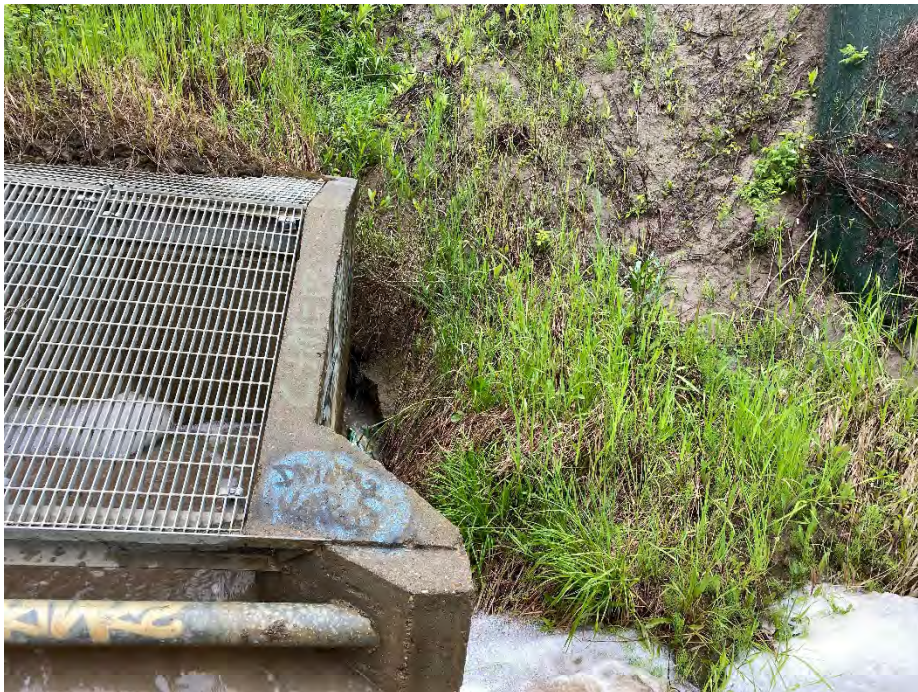
- Erosion observed behind both outfalls located on the west and east sides of Wedgewood Creek north of AHD (Photo 6 and 7). Erosion above west outfall appears to be slightly worse with more tilting of the outfall. East outfall condition looked similar to the previous inspection (Photo 8).

Photo 6: Erosion and wet soil behind west outfall. Looking northwest

- Stantec submitted a tender package for outfall remediation consisting of replacing the disjointed and broken pipe segments with new pipe and regrading the surrounding slopes. The existing outfalls will be removed and replaced with an energy dissipater consisting of Class 2 riprap. Construction is currently scheduled for 2024. The estimated cost for construction is approximately \$900,000 adjusting for the removal of the Tecco mesh and excluding engineering costs.

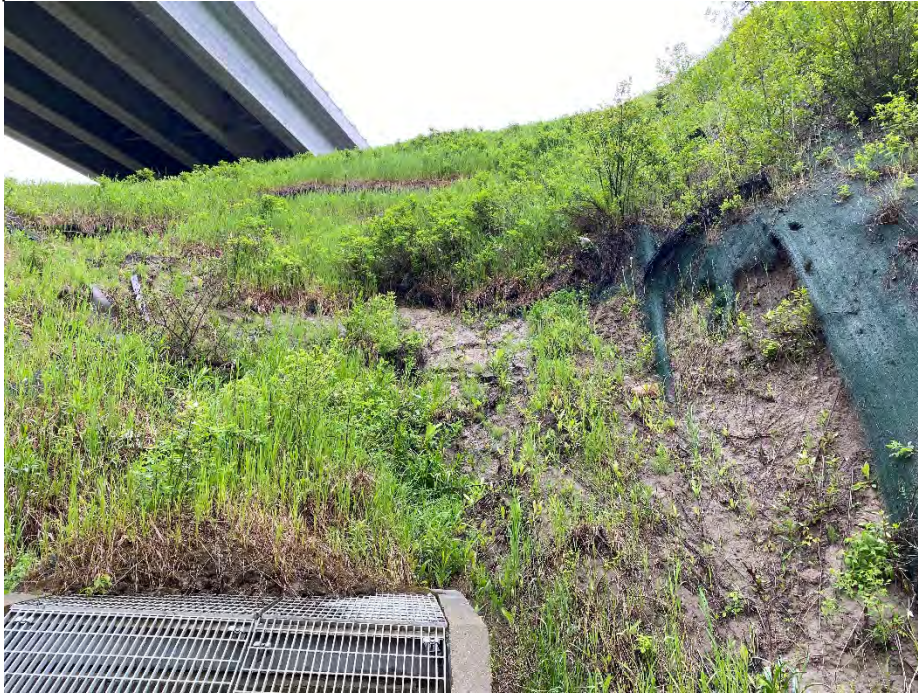
Photo 7: Erosion above west outfall. Looking west.

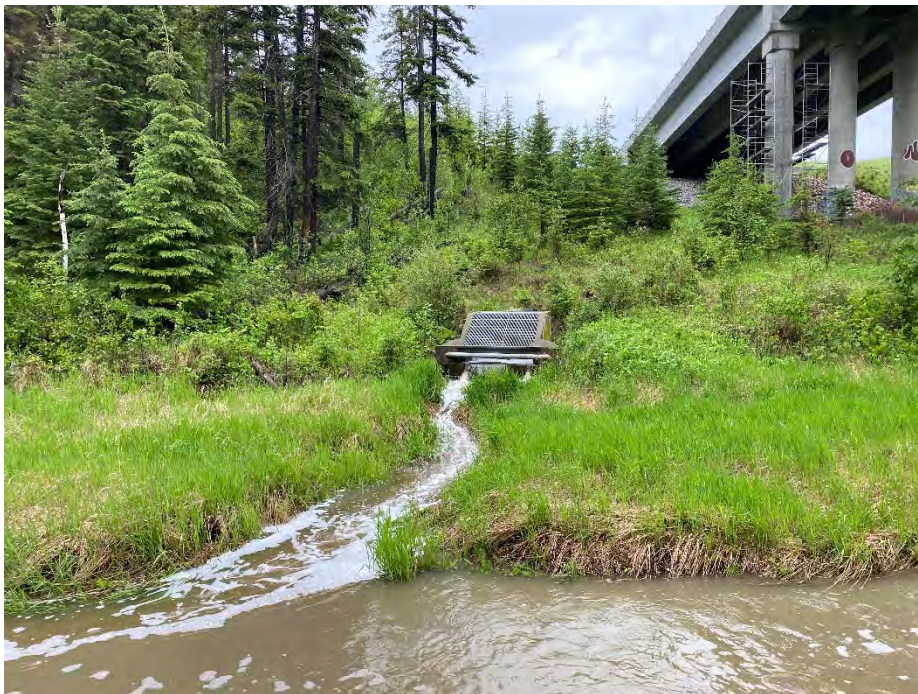
Photo 8: East outfall. Looking southeast.

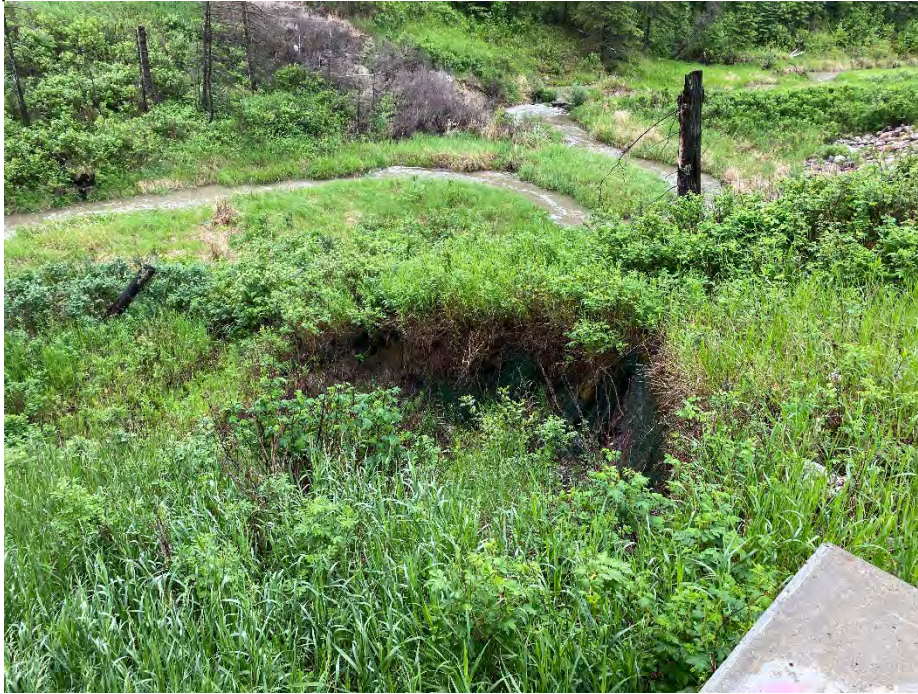
- The gap (fill settlement) at the northeast corner of the northernmost pedestal increased 40 mm to a total settlement of 200 mm.
- The south slump on the west slope between the concrete piers appears unchanged, while the north slump appears to have retrogressed approximately 1.0 m further up the slope (Photo 9).

Photo 9: Progressing slump southeast from NW pedestal. Looking southeast.

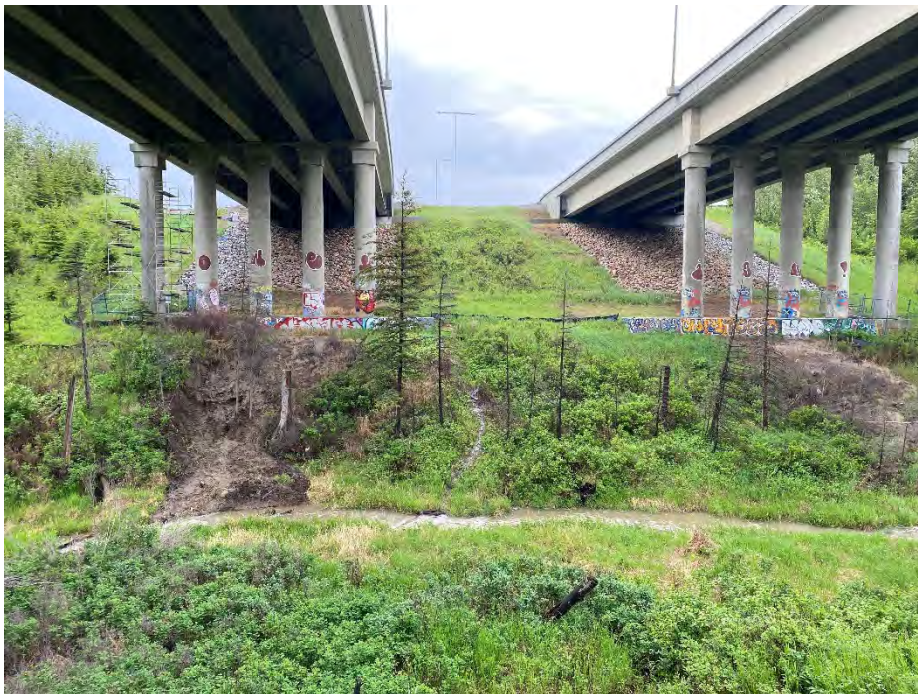
- The slope below the northernmost pedestal on the east bank has failed, with debris piled at the edge of the creek (Photo 10). The slope below the southernmost pedestal on the east bank appears to be experiencing erosion and most of the vegetation appears dead.

Photo 10: Slope failure on east bank below AHD NB pedestal, erosion below AHD SB pedestal. Looking southeast.

- Stantec submitted a proposal for remediation of the new slump on the east bank. Remediation of the slump is expected to consist of removal and replace. The estimated cost of construction for removal and replace is in the order of \$500,000 to \$650,000 including engineering.
