SITE NUMBER AND NAME: NC079 – Wedgewood Ravine Slides	HIGHWAY AND KM: 216:06, km 12.849	PREVIOUS INSPECTION: June 15, 2022	CURRENT INSPECTION: June 1, 2023
LEGAL DESCRIPTION: SE 28-52-25-W4	NAD83 COORDINATES: UTM12U 5927932N, 324250E		RISK ASSESSMENT: PF: 9 CF: 10 Total: 90
AVERAGE ANNUAL DAILY TRAFFIC (AADT): 67,340 (2022)		CONTRACTOR MAINTENANCE AREA (CMA): Anthony Henday Drive (AHD)

NORTH CENTRAL REGION GRMP
EDSON / STONY PLAIN
SITE INSPECTION FORM

2023 Site Inspection Photos at NC079

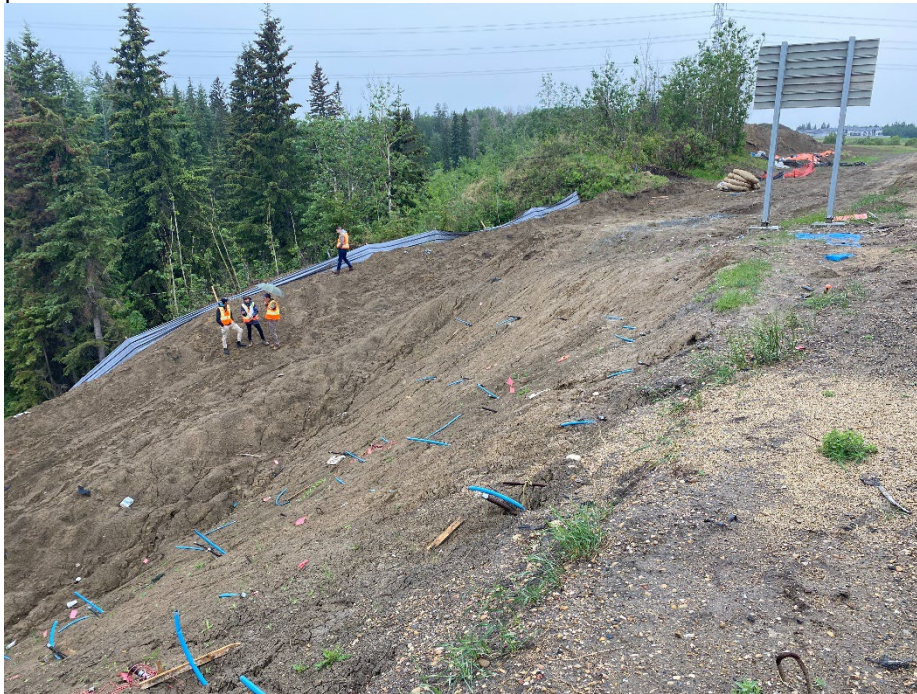
COMMENTS
<ul style="list-style-type: none"> Both the north and south slides near the northwest approach of AHD are undergoing repair using soil nails. (Photos 1 and 2). The crest of the regraded slope is approximately 2.8 m south from SI20-01 and 3.3 m south from SI20-02 (Figure 1). No vegetation or erosion control was present on the soil nailed slope at the time of the site visit. It is assumed that vegetation and erosion control will be placed as part of the remediation design by others. Multiple erosion rills were present across the slope and one erosion gully approximately 0.1 m wide and 50 mm deep was observed near the west side of the regraded slope.

Photo 1: Soil nailed slope at north and south slides. Looking northwest.

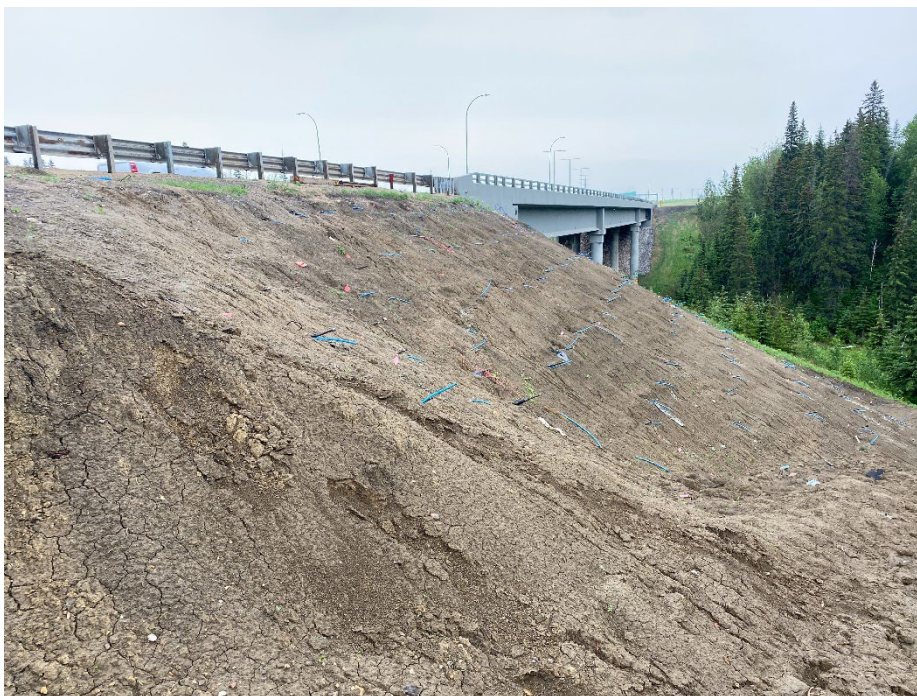
Photo 2: Soil nailed slope at north and south slide area. Looking southeast.

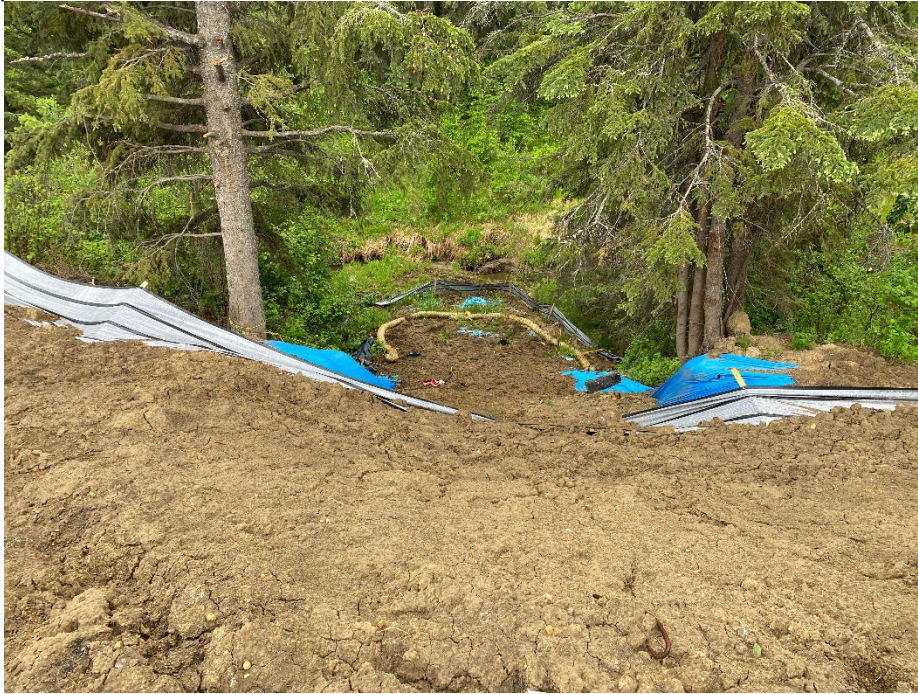
Photo 3: Debris chute below soil nailed area north slide area, repairs ongoing. Looking southwest.

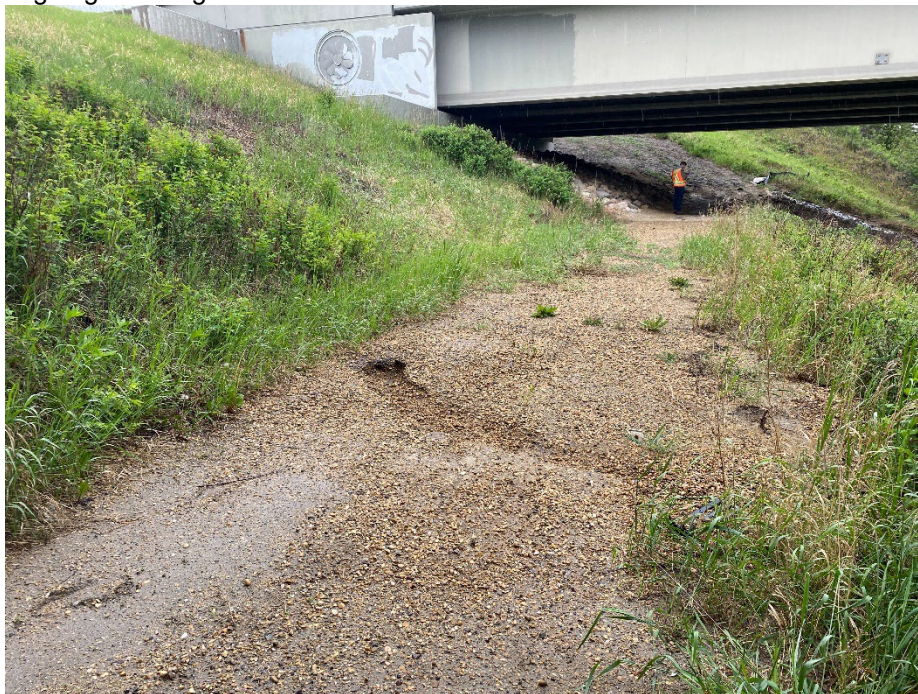
- A new erosion gully was observed across the trail, northwest of the previous erosion/slumping at the north corner of the riprap below the SBL. The gully is approximately 0.15 m wide, 1.2 m long and up to 50 mm deep (Photo 4).

Photo 4: Erosion on footpath near NW abutment for SBL. Looking northeast.

- A concrete trough may be considered upslope of the footpath to direct surface water towards the riprap instead of into existing erosion channels.
- Stantec submitted a tender package for outfall remediation consisting of replacing the disjointed and broken pipe segments with new pipe and regrading the surrounding slopes. The existing outfalls will be removed and replaced with an energy dissipater consisting of Class 2 riprap. Construction was previously scheduled for 2024 but has been moved to 2025. The estimated cost for construction is approximately \$950,000 excluding engineering costs.

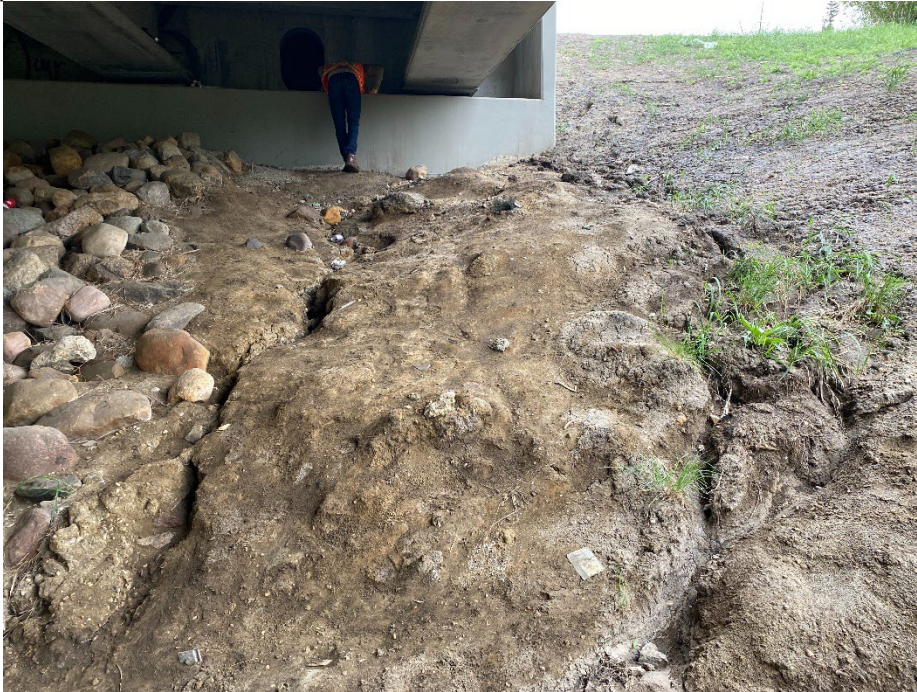
- New erosion gullies were observed at the north corner of the northwest abutment down to the trail. The gullies were up to 0.1 m deep and 0.1 m wide. The slope near these gullies is poorly vegetated (Photo 5).

Photo 5: Erosion gullies at the north corner of NW abutment. Looking northwest.

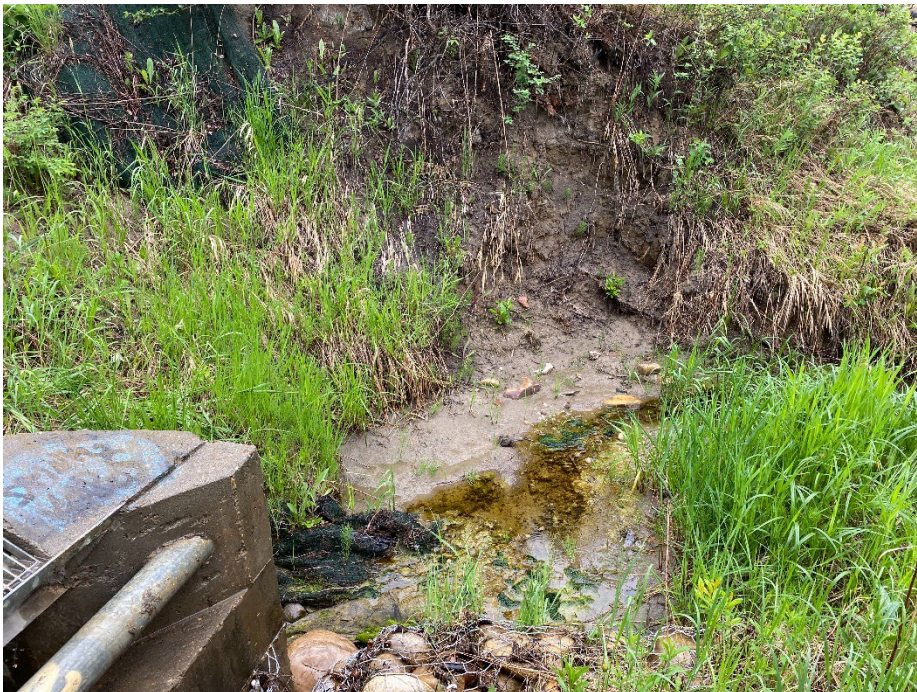
- Erosion was observed behind both outfalls located on the west and east sides of Wedgewood Creek north of AHD (Photo 6 and 7). Erosion above west outfall appears to be slightly worse with more tilting of the outfall.

- It is surmised that water is flowing out of the separated pipe upslope from the west outfall and eroding the west creekbank (Photo 6). A small channel appears to have developed leading from the outfall to Wedgewood Creek due to erosion.

Photo 6: Water from separated pipe eroding the creekbank north of the west outfall. Looking northeast.

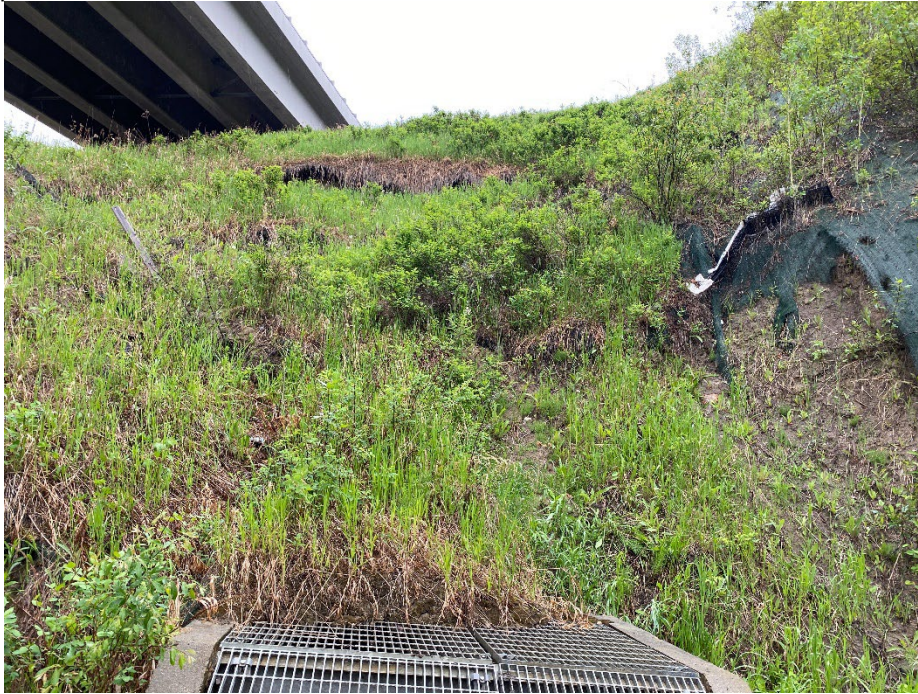
Photo 7: Erosion above west outfall. Looking west.

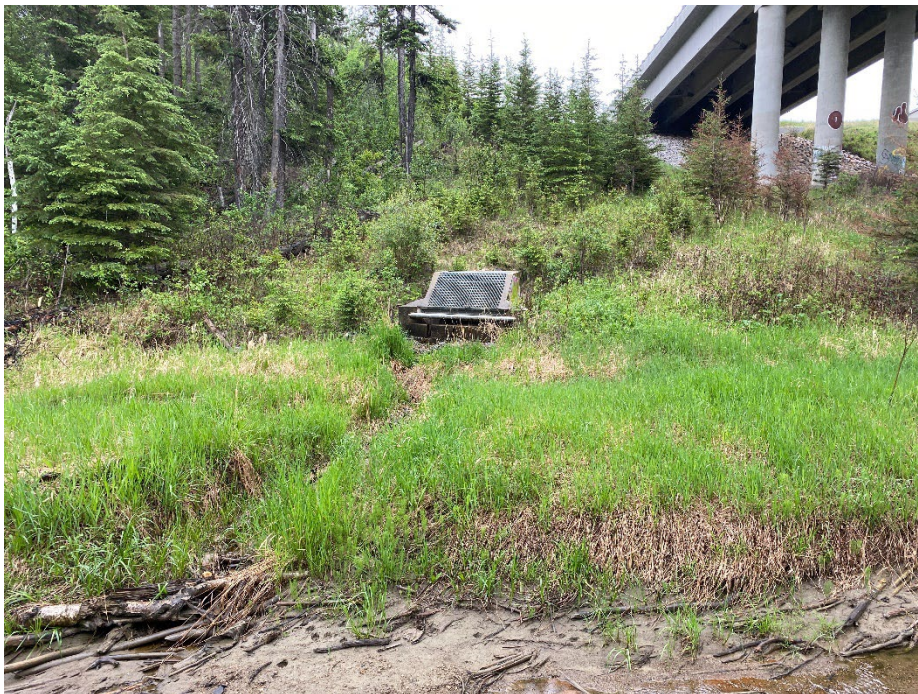
- East outfall condition looked similar to the previous inspection (Photo 8).
- The gap (fill settlement) at the northeast corner of the northernmost pedestal remained the same with a total settlement of 240 mm.

Photo 8: East outfall. Looking southeast.

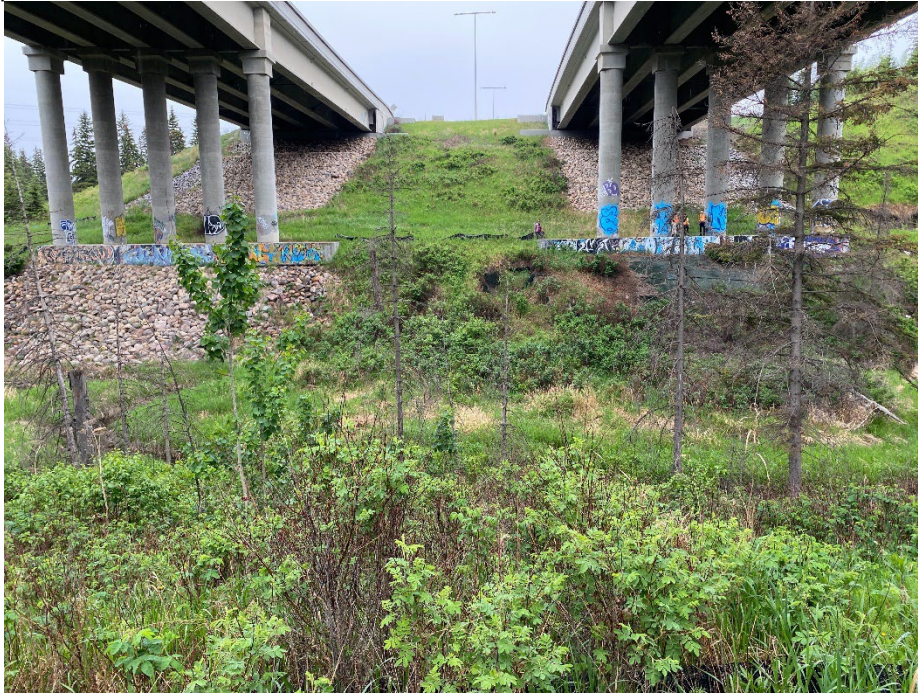
- The south slump on the west slope between the concrete piers appears to have retrogressed approximately 1 m upslope, and the north slump appears to have also retrogressed slightly upslope (Photo 9). The scarp of the north slump was measured to be 0.7 m away from the concrete pedestal.

Photo 9: West slope with two slumps between pedestals and erosion mat exposed below northernmost pedestal. Looking northwest.

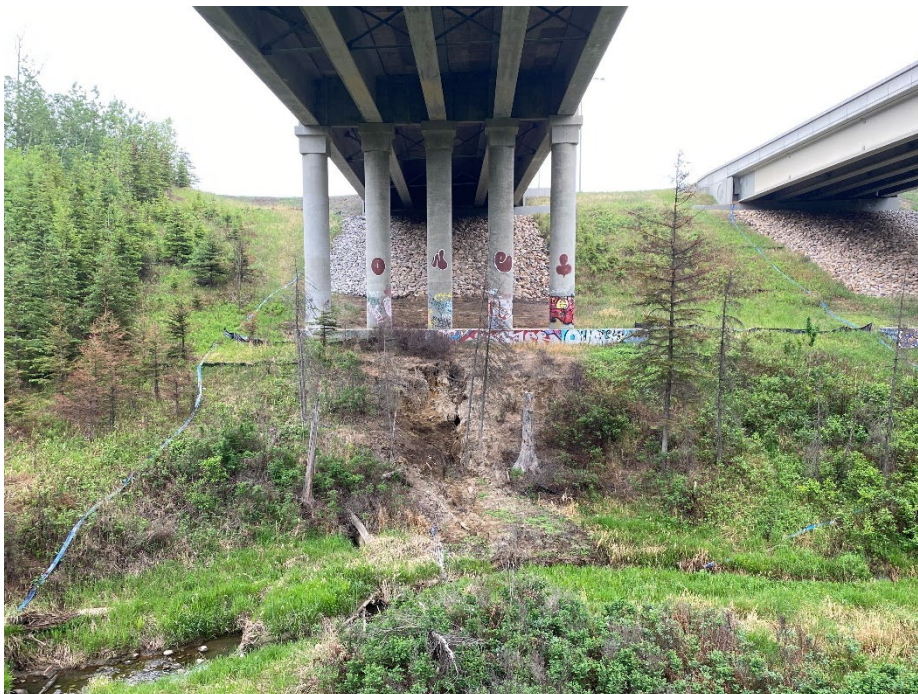
- The erosion mat below the north pedestal on the west bank has been further exposed.
- The slope below the northernmost pedestal on the east bank has failed, with debris piled at the edge of the creek (Photo 10). The erosion gully downslope from the south corner of the northernmost pedestal was observed to be well-vegetated. The slope below the southernmost pedestal on the east bank appears to be experiencing erosion and most of the vegetation appears dead.

Photo 10: Slope failure on east bank below AHD NB pedestal. Looking southeast.

- Stantec completed remediation design of the new slump on the east bank. Remediation of the slump is expected to consist of removal and replace. The estimated cost of construction for removal and replace is in the order of \$80,000.
