SITE NUMBER AND NAME: NC079 – Wedgewood Ravine Slides	HIGHWAY AND KM: 216:06, km 12.849	PREVIOUS INSPECTION: June 1, 2023	CURRENT INSPECTION: June 20, 2024
LEGAL DESCRIPTION: SE 28-52-25-W4	NAD83 COORDINATES: UTM12U 5927932N, 324250E		RISK ASSESSMENT: PF: 7 CF: 10 Total: 70
AVERAGE ANNUAL DAILY TRAFFIC (AADT): 73,970 (2023)		CONTRACTOR MAINTENANCE AREA (CMA): Anthony Henday Drive (AHD)

SUMMARY OF INSTRUMENTATION: Two slope inclinometers installed during AHD Widening works and being monitored by others. LAST READING DATE: N/A	INSPECTED BY: Stantec: Leslie Cho, Sonja Pharand TEC: Kristen Tappenden, Ryan Luider
PRIMARY SITE ISSUE: Two slope failures south of the northwest approach of Anthony Henday Drive (AHD). Erosion above both outfalls north of AHD crossing over Wedgewood Creek. Slope failure below concrete pedestal for AHD north bound on east slope of Wedgewood Creek.	
APPROXIMATE DIMENSIONS: North slide: Approximately 12 m wide by 6 m high South Slide: Approximately 9.5 m wide by 4 m high with several successive scarps up to 3 m high.	
DATE OF ANY REMEDIAL ACTION: Riprap extended south under southbound lane (SBL) in Fall 2020 / Spring 2021. Summer/Fall 2022: two slope failures s

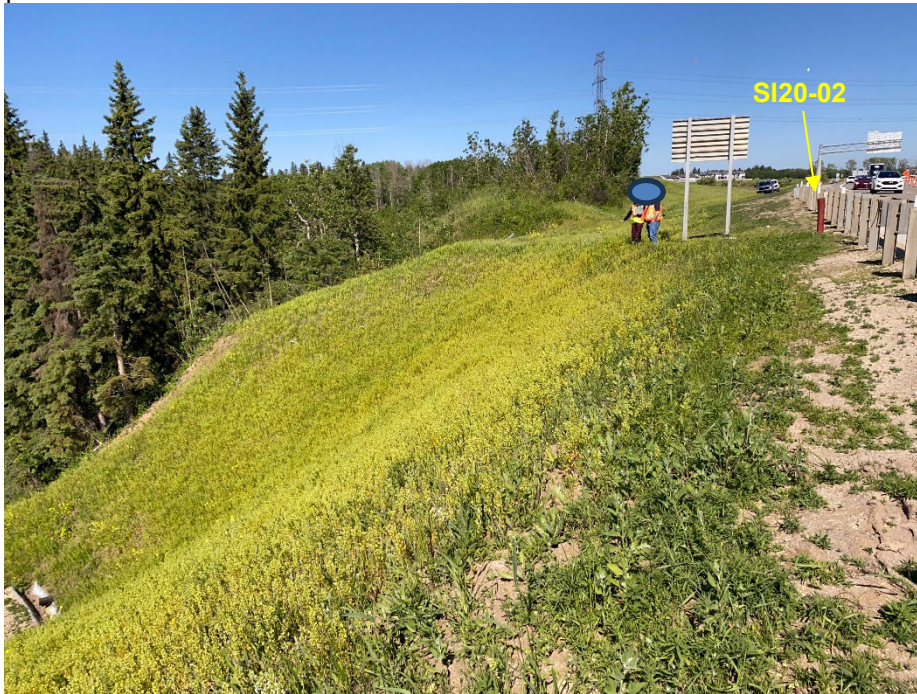
COMMENTS
<ul style="list-style-type: none"> Repair of both the north and south slides near the northwest approach of AHD has been completed using soil nails. The repaired slopes were well vegetated, and no significant erosion was observed. A steel half-culvert collector drain has also been installed at the toe of the slope repair since the 2023 inspection. (Photos 1 to 3). The crest of the regraded slope is approximately 2.8 m south from SI20-01 and 3.3 m south from SI20-02 (Figure 1). Garbage and sediment was observed to have collected within the new collector drain below the slope repair (Photo 4).

Photo 1: Soil nailed slope at north and south slides. Looking northwest.

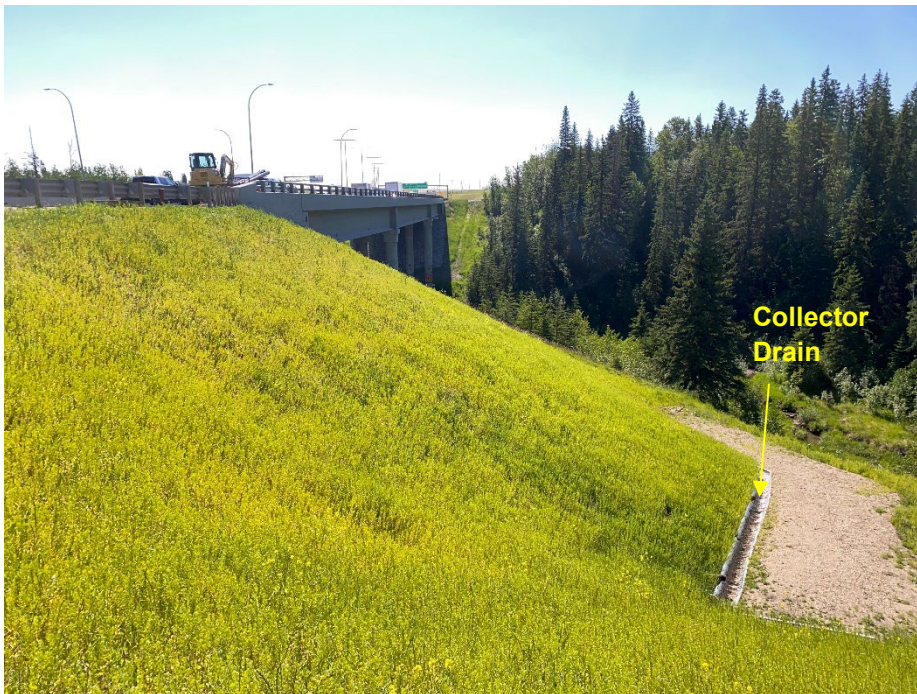
Photo 2: Soil nailed slope at north and south slide area, collector drain installed at toe of repaired slope. Looking southeast.

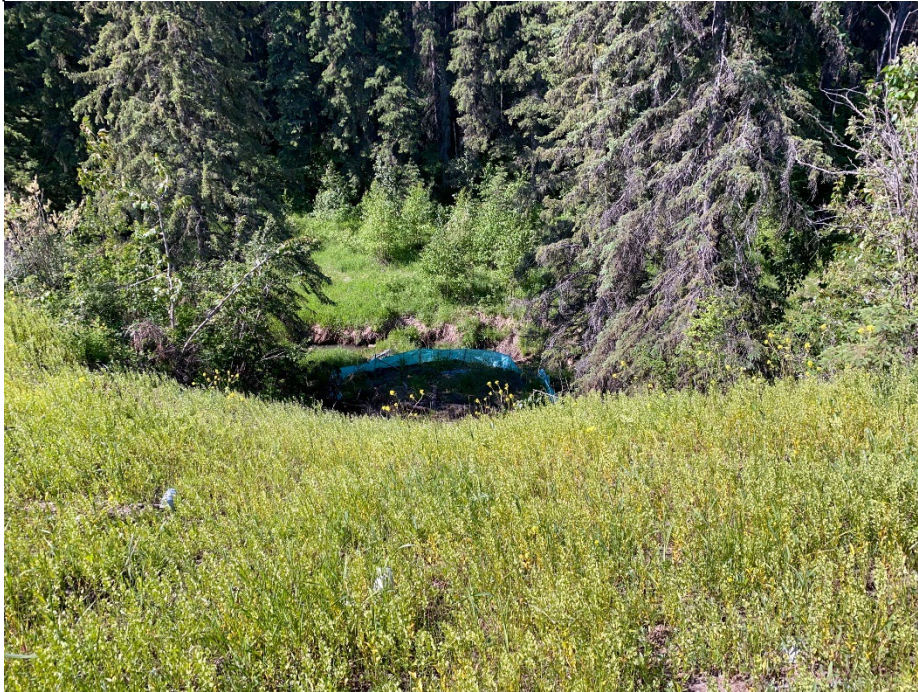
Photo 3: Repaired debris chute below soil nailed area north slide area. Looking southwest.

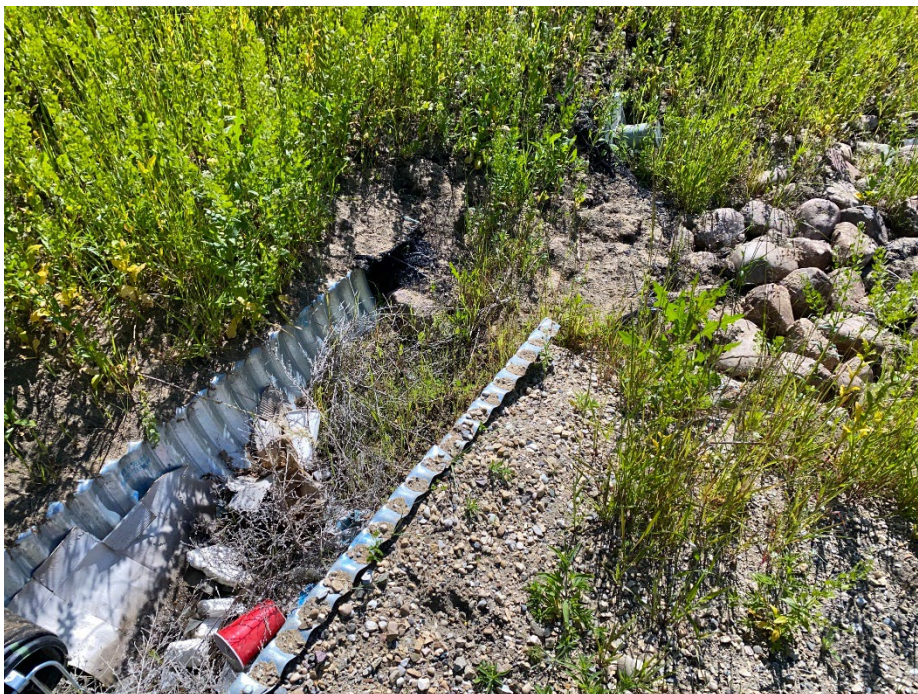
Photo 4: Garbage and sediment collecting in collector drain, sedimentation at outlet of channel. Looking east.

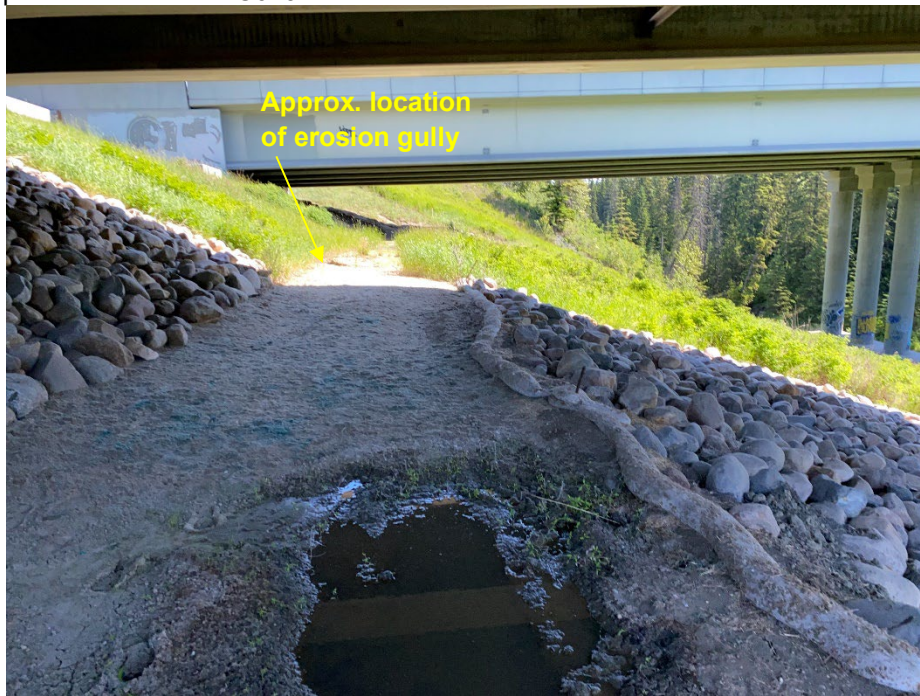
- Wedgewood Creek's water level was relatively low at time of inspection likely due to the relatively dry spring this year.
- Erosion rills were observed on the slope near the southwest end of the footpath near the northwest abutment for the SBL. Ponded water was observed on the footpath (Photo 5).

Photo 5: Erosion and ponded water on footpath near NW abutment for SBL. Looking northeast.

- A concrete trough may be considered upslope of the footpath to direct surface water towards the riprap instead of into existing erosion channels.
- Stantec submitted a tender package for outfall remediation consisting of replacing the disjointed and broken pipe segments with new pipe and regrading the surrounding slopes. The existing outfalls will be removed and replaced with an energy dissipater consisting of Class 2 riprap. Construction is understood to be scheduled for 2026. Given the time between design and construction, the design and tender package should be reviewed for feasibility and applicability against newer TEC specifications. The estimated cost for construction is approximately \$950,000 excluding engineering costs.

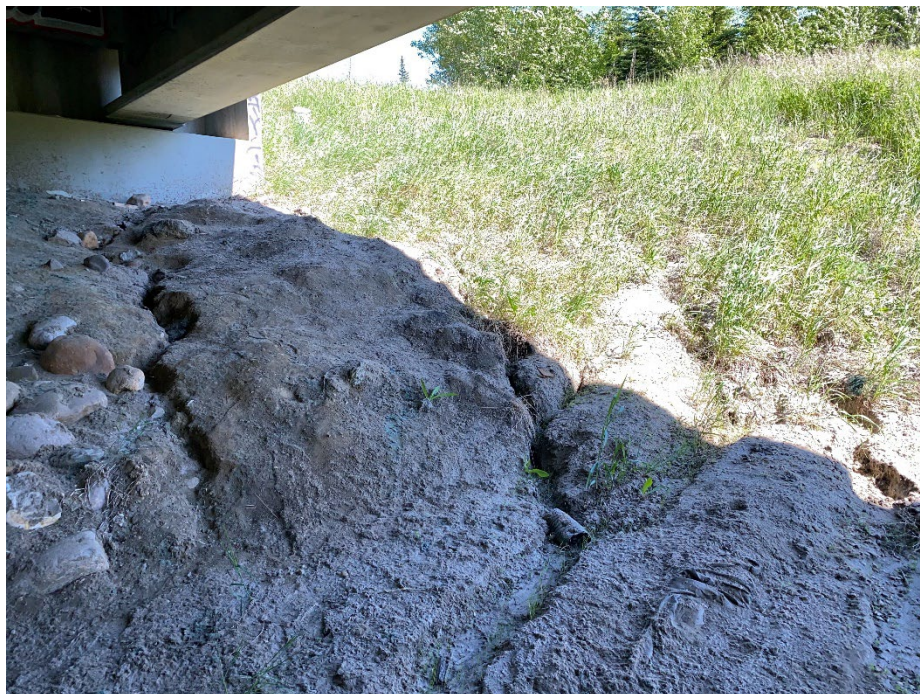
- Erosion gullies were observed at the north corner of the northbound lane abutment down to the trail. The gullies appeared relatively unchanged from 2023 and were up to 0.1 m deep and 0.1 m wide. The slope near the gullies is more vegetated than previously observed (Photo 6).

Photo 6: Erosion gullies at the north corner of NW abutment. Looking northwest.

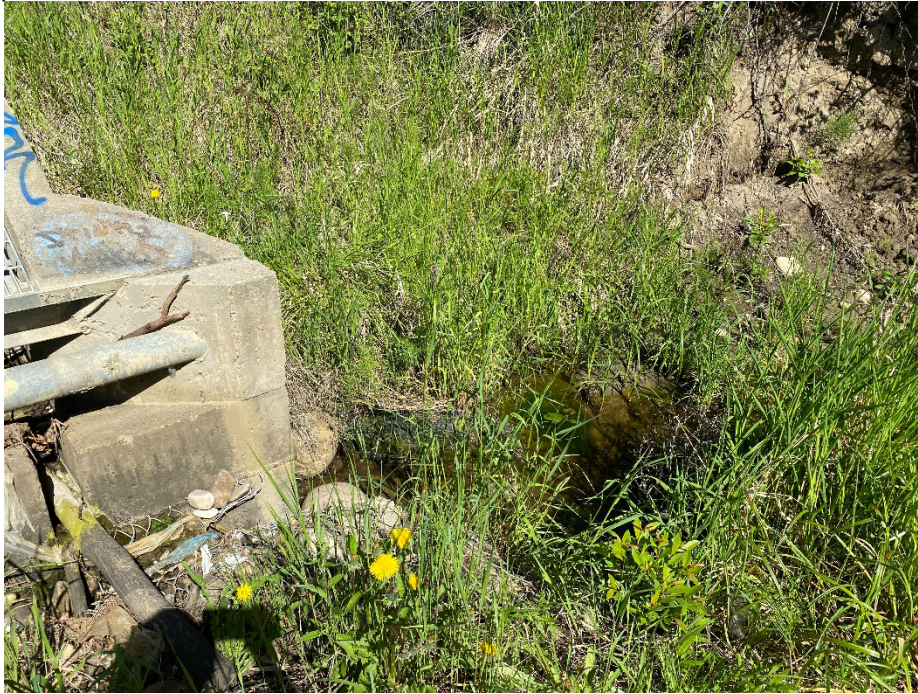
- Erosion was observed behind both outfalls located on the west and east sides of Wedgewood Creek north of AHD (Photos 7 & 8). Erosion above west outfall appears to be similar to 2023, with more tilting of the outfall.

- It is surmised that water is flowing out of the separated pipe upslope from the west outfall and eroding the west creekbank (Photo 7). A small channel has developed from the outfall to the creek due to erosion.

Photo 7: Water from separated pipe eroding the creekbank north of the west outfall. Looking north.

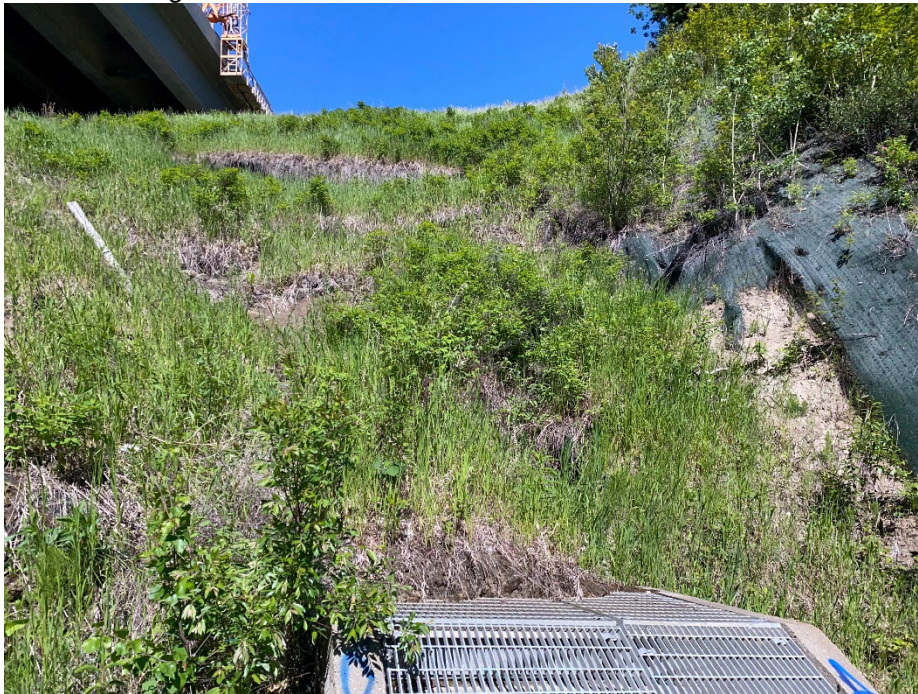
Photo 8: Erosion above west outfall. Looking west.

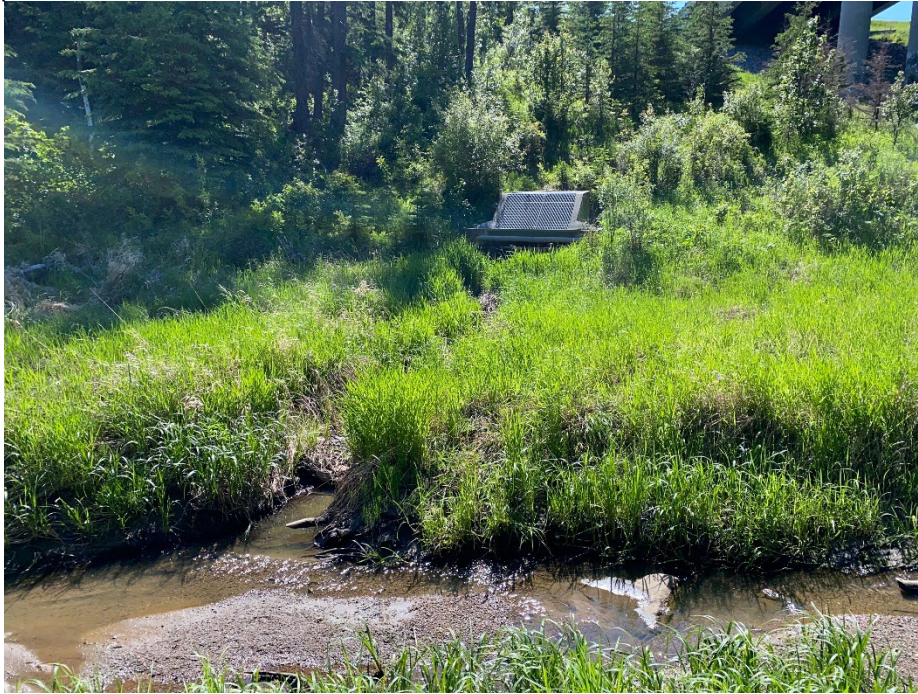
- East outfall condition looked similar to the previous inspection (Photo 9). The separation in the pipe behind the outfall has increased to 270 mm.
- The gap (fill settlement) at the northeast corner of the northernmost pedestal remained the same with a total settlement of 240 mm.

Photo 9: East outfall. Looking southeast.

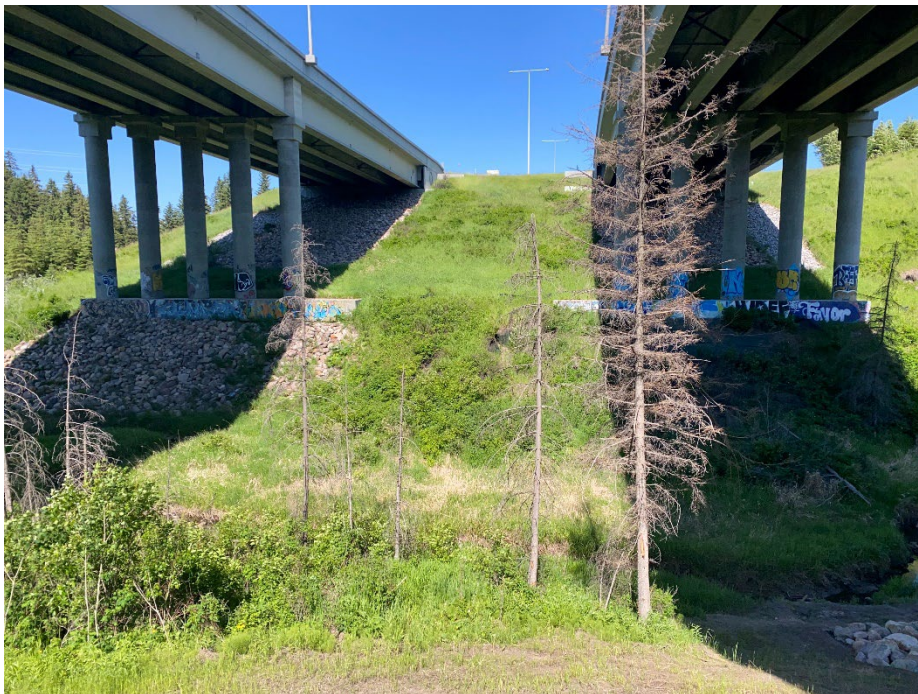
- The two slumps on the west slope between the concrete piers appear relatively unchanged from 2023 (Photo 10). The scarp of the north slump was measured to be 0.7 m away from the concrete pedestal.

- The erosion mat below the north pedestal on the west bank is exposed, but appears similar to 2023.
- The slope failure below the northernmost pedestal on the east bank has been repaired via removal and replacement with Class 1 angular riprap (Photo 11).

Photo 10: West slope with two slumps between pedestals and erosion mat exposed below northernmost pedestal. Looking northwest.

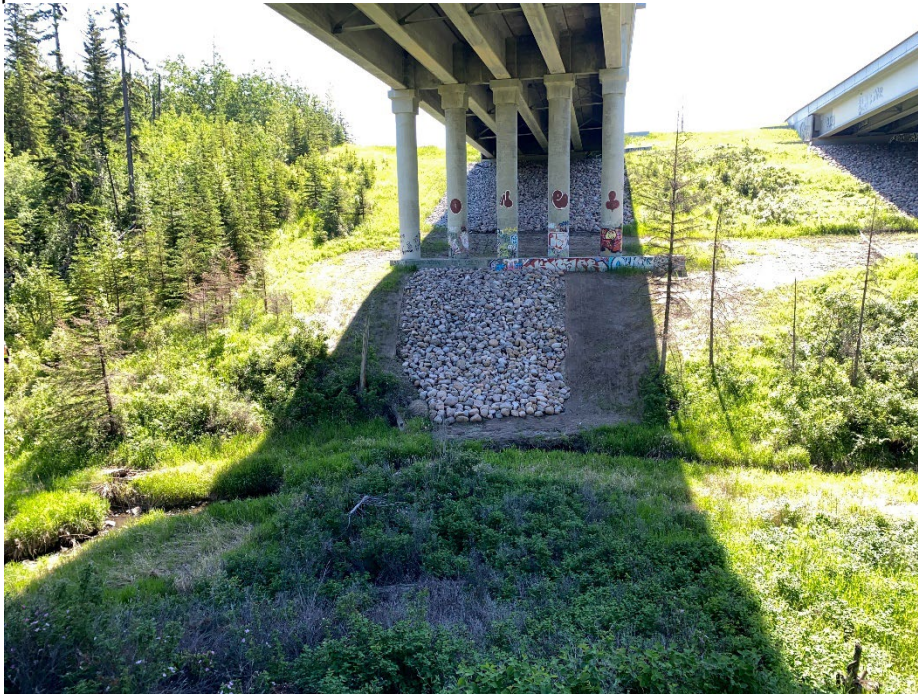
Photo 11: Repaired slope failure on east bank below AHD northbound pedestal. Looking southeast.

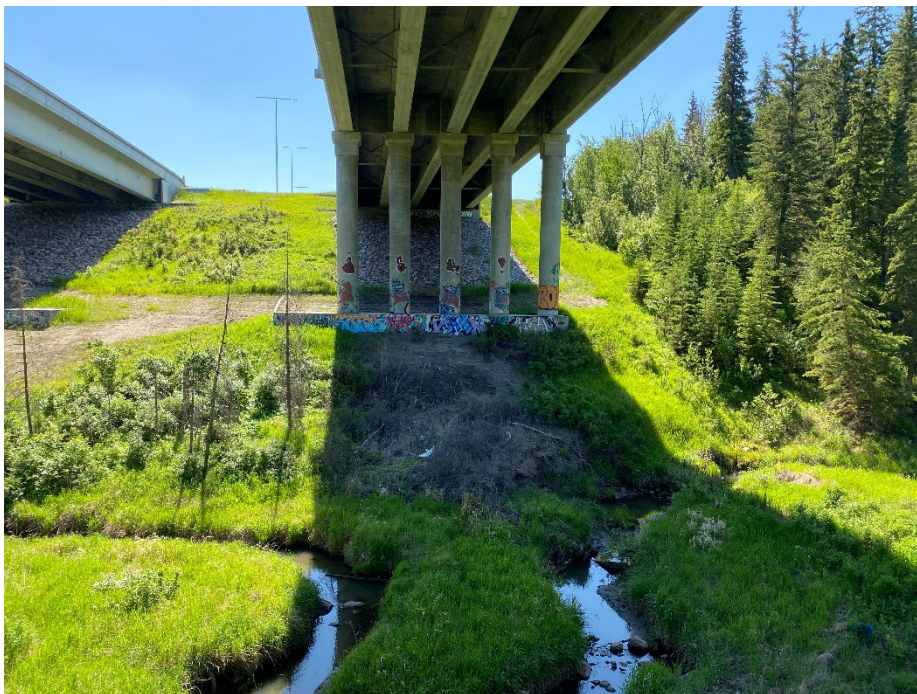
- The vegetation on the east bank below the AHD southbound pedestal appears to be dead, similar state to 2023 (Photo 12).
- The Probability Factor for the site has been decreased to 7 as a number of the slope failures have been repaired while others appear relatively inactive at this time or active with a perceptible movement rates. The primary concern at this site is now the erosion around the outfalls and distress to the outfall structure.

Photo 12: Dead vegetation on east bank below the AH southbound pedestal. Looking southeast.
