**NORTH CENTRAL REGION GRMP
EDSON / STONY PLAIN
SITE INSPECTION FORM**

SITE NUMBER AND NAME: NC094 – 100 Ave at NB AHD	HIGHWAY AND KM: 216:06, km 20.550	PREVIOUS INSPECTION: N/A	CURRENT INSPECTION: June 14, 2022
LEGAL DESCRIPTION: NW-32-52-25-W4	NAD83 COORDINATES: UTM12U 5935400N, 323784E		RISK ASSESSMENT: PF: 9 CF: 4 Total: 36
AVERAGE ANNUAL DAILY TRAFFIC (AADT): 97,590 (2021)		CONTRACTOR MAINTENANCE AREA (CMA): AHD

SUMMARY OF INSTRUMENTATION: No instrumentation installed at this site. LAST READING DATE: N/A	INSPECTED BY: Stantec: Leslie Cho, Sonja Pharand AT: Rocky Wang
PRIMARY SITE ISSUE: Slumping of the side slope embankment south of 100 Ave between two overpass bridges (81038 S2-7 and 81038 N1-1) for the Anthony Henday Drive (AHD).	
APPROXIMATE DIMENSIONS: Landslide approximately 13 m wide by 8 m long x 2 m deep	
DATE OF ANY REMEDIAL ACTION: No remedial action completed to date

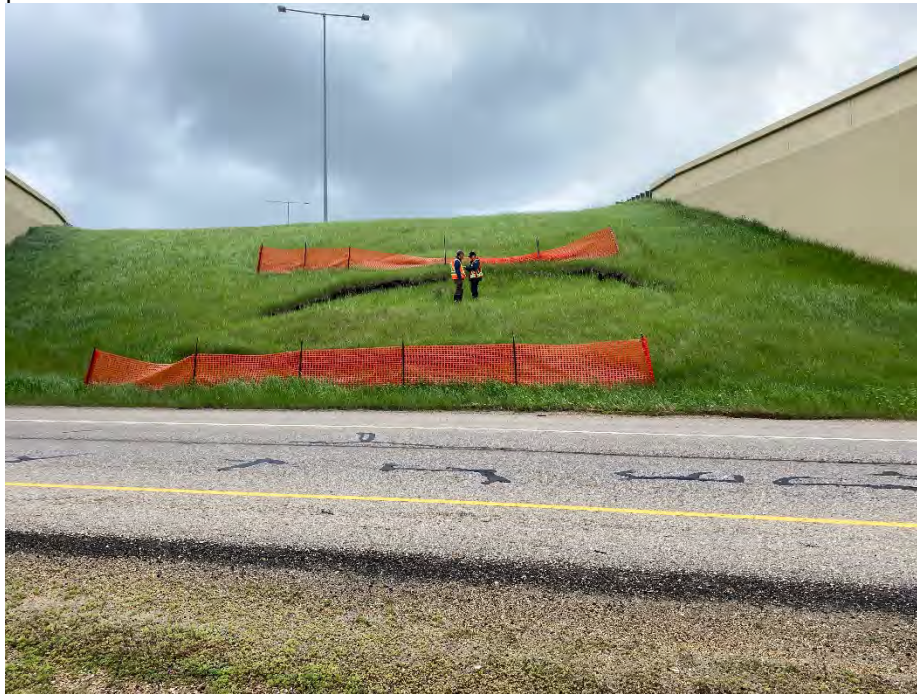
Photo 1: Slump on south embankment. Looking south.

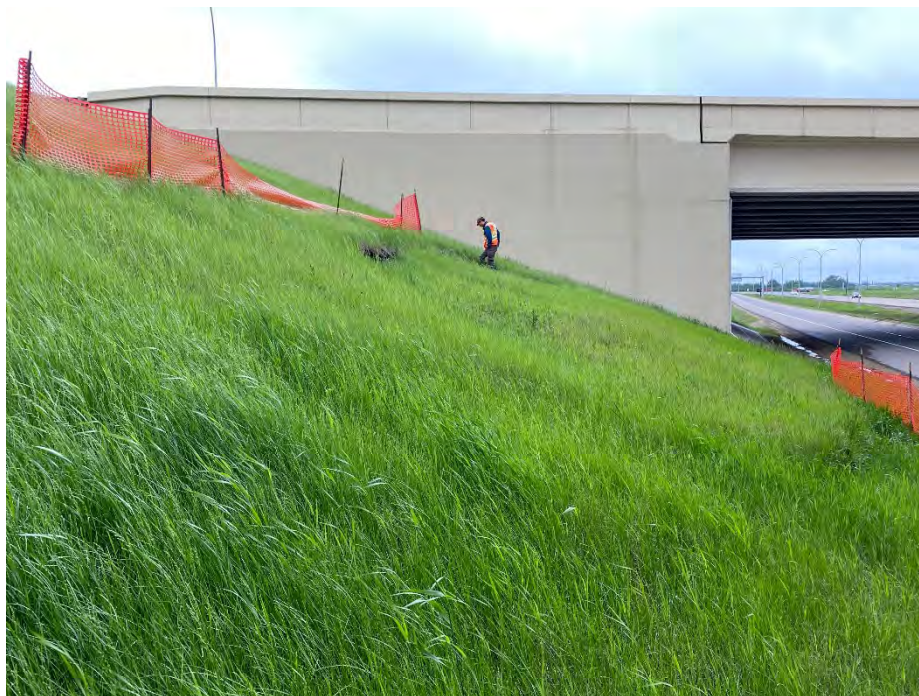
Photo 2: Slump on south embankment. Looking west.

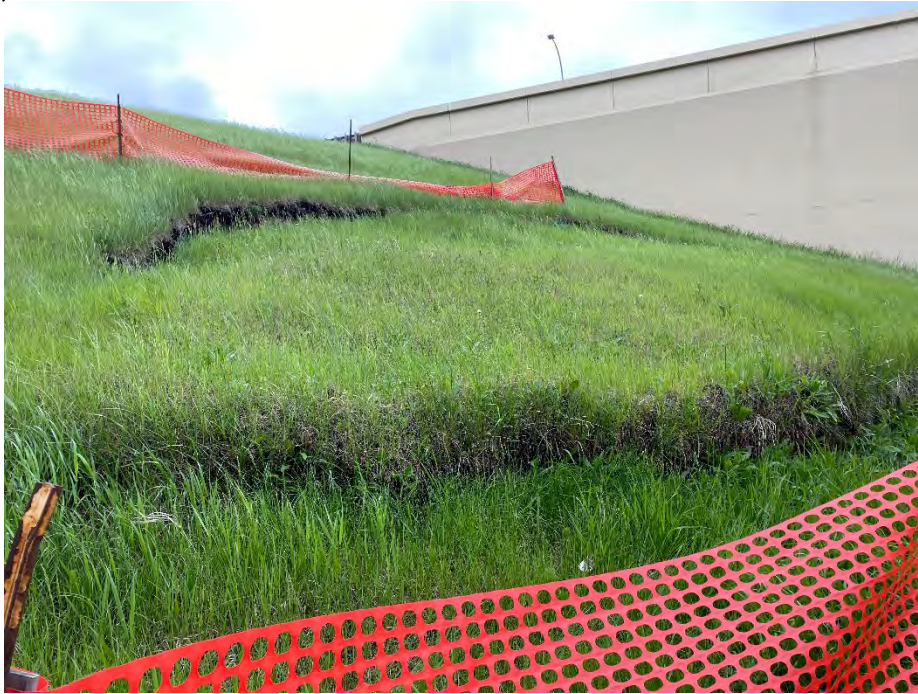
Photo 3: Slump on south embankment. Looking southwest.

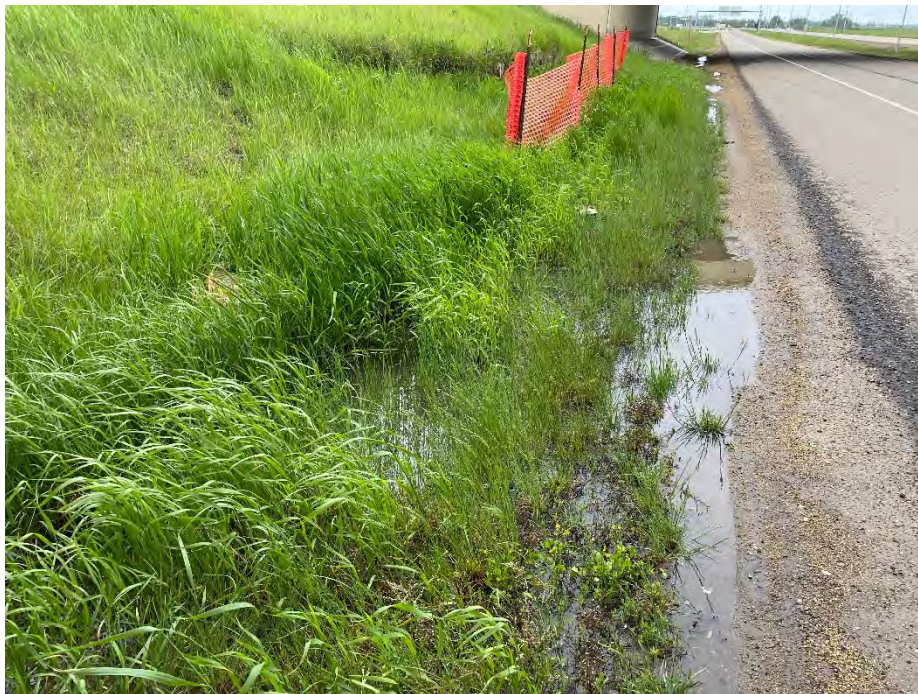
Photo 4: Ponded water on east side of embankment toe. Looking west.

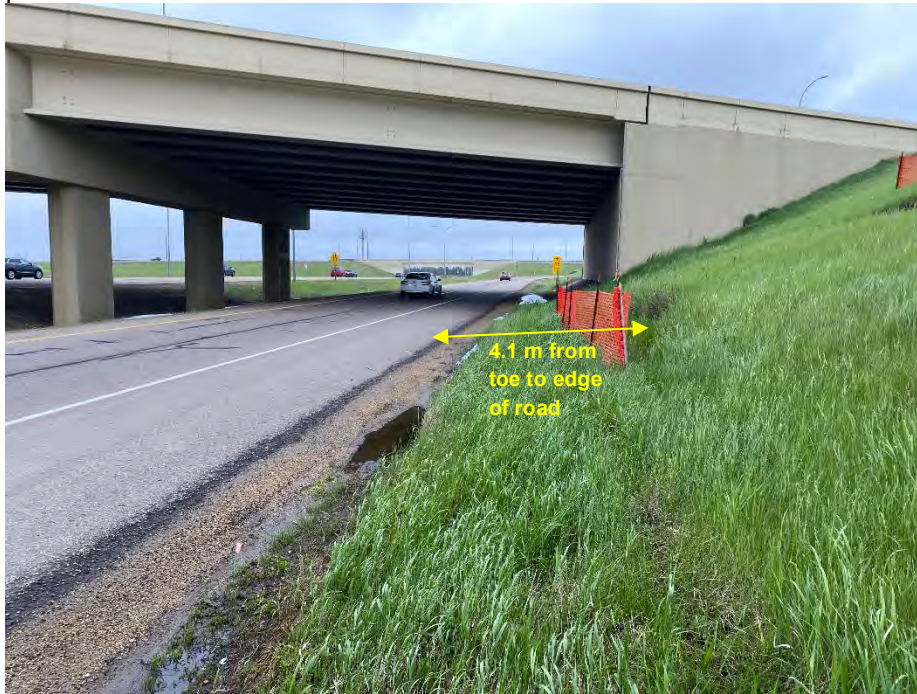
Photo 5: Toe of the embankment. Looking east.

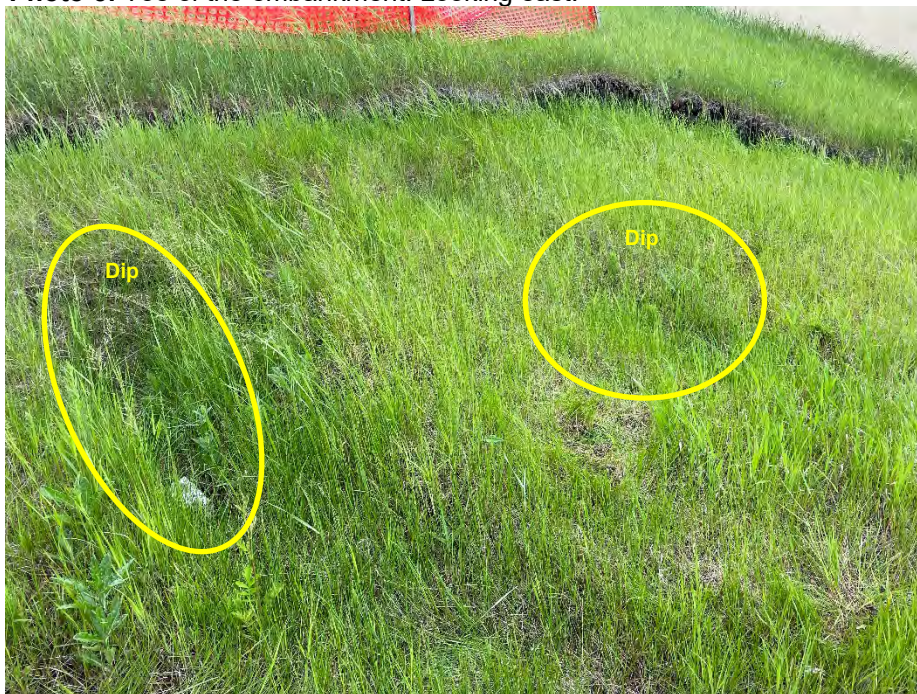
Photo 6: Dips in the ground below top of slump. Looking southwest.

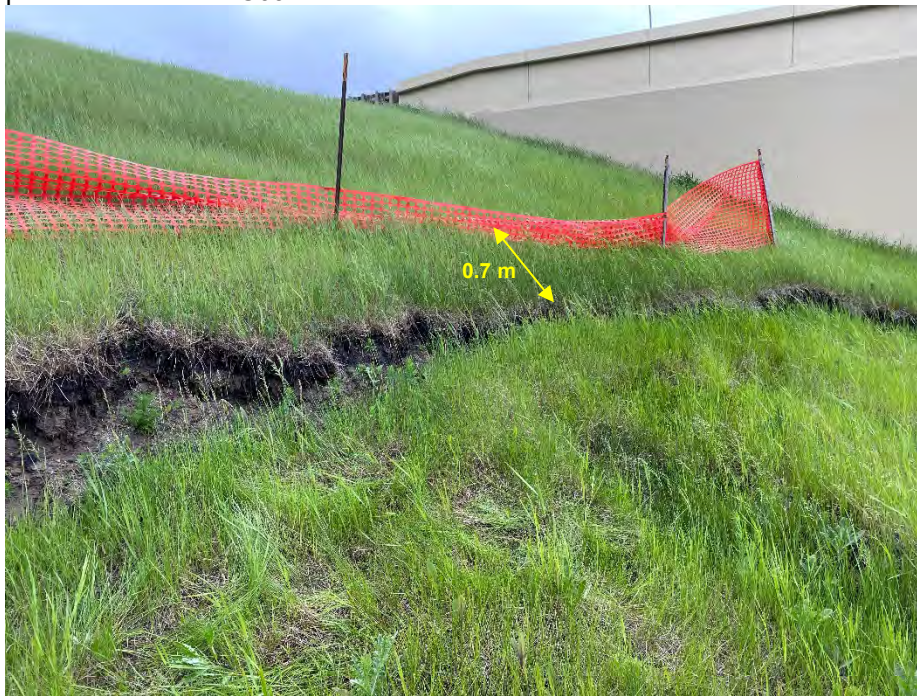
Photo 7: Upper scarp. Looking southwest.

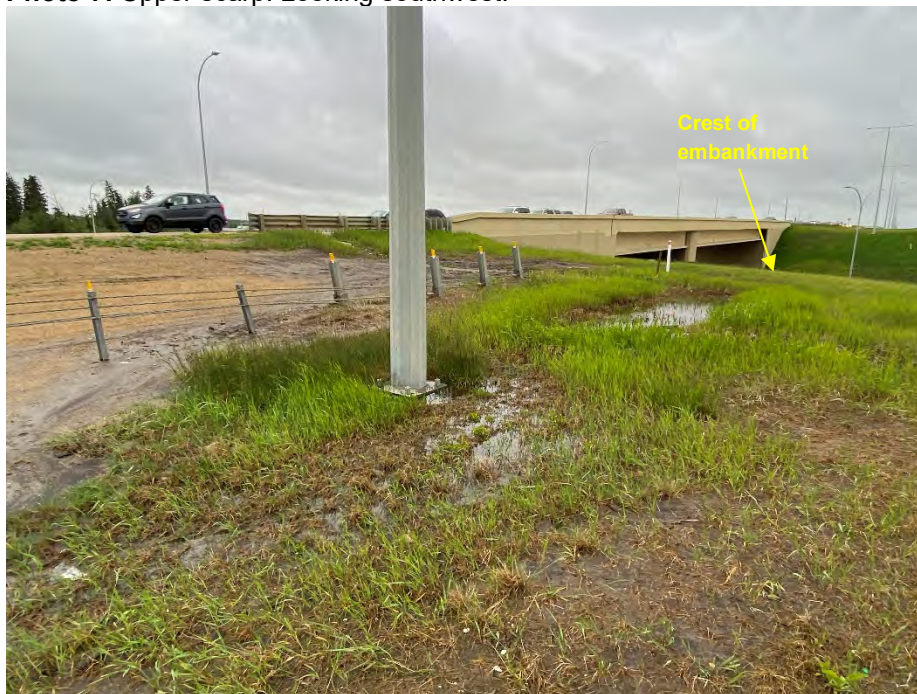
- A possible scour hole was observed at the base of the light standard at the top of the slope with pooling water 20 cm deep.
- Standing water north of the light standard. Water appears to be directed to this location from AHD on both sides of slope. Drainage mats present. Overall drainage at the top of the embankment appears to be towards the south and away from the bridge.

Photo 8: Water ponding at the top of the embankment. Looking northwest.

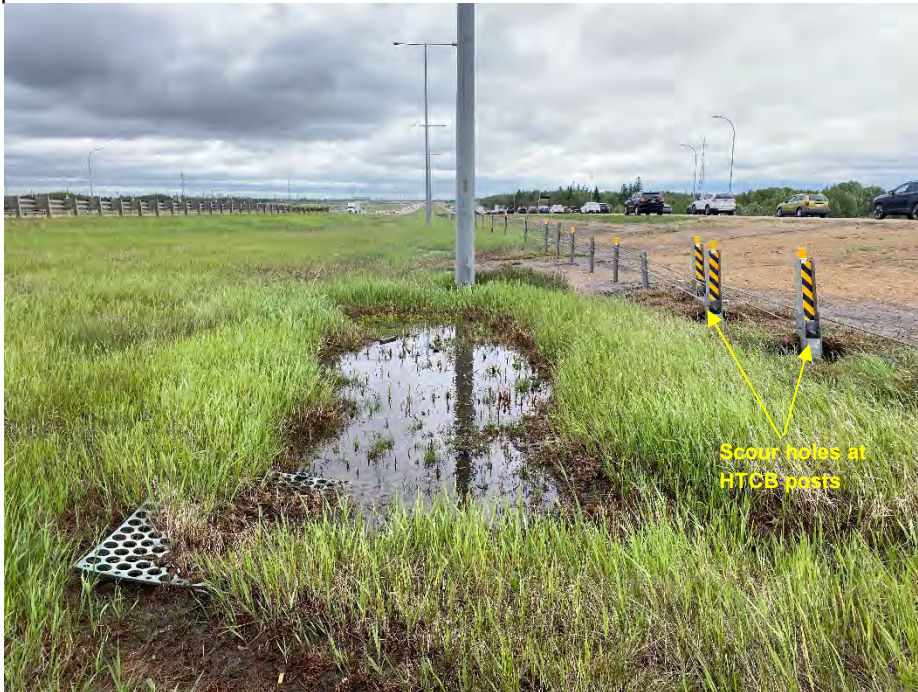
Photo 9: Ponding water at top of embankment. Looking south.

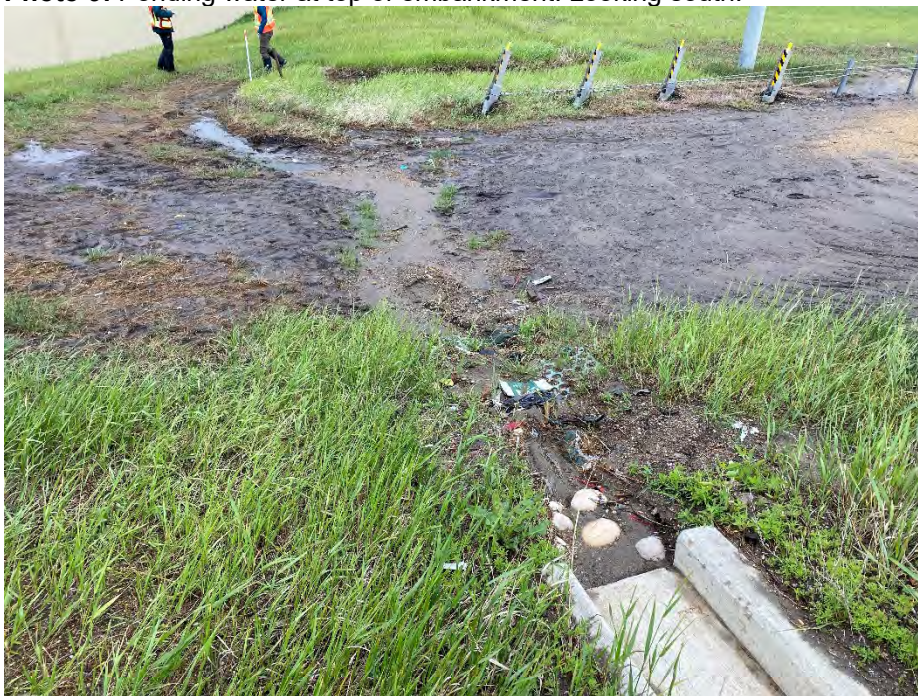
Photo 10: Drainage pathways from bridge surfaces. Looking east.
