<b>SITE NUMBER AND NAME:</b> NC092 – Cattlepass Culvert BF 80823	<b>HIGHWAY AND KM:</b> 37:02, km 23.855	<b>PREVIOUS INSPECTION:</b> June 14, 2022	<b>CURRENT INSPECTION:</b> June 1, 2023
<b>LEGAL DESCRIPTION:</b> NE 33-54-27-W4M	<b>NAD83 COORDINATES:</b> UTM12U 5955908N, 307552E		<b>RISK ASSESSMENT:</b> PF: 10 CF: 6 Total: 60
<b>AVERAGE ANNUAL DAILY TRAFFIC (AADT):</b> 2610 (2022)		<b>CONTRACTOR MAINTENANCE AREA (CMA):</b> 510

NORTH CENTRAL REGION GRMP  
EDSON / STONY PLAIN  
SITE INSPECTION FORM

2023 Site Inspection Photos at NC092

**Client/Project**  
Transportation and Economic Corridors  
Geohazard Monitoring Program  
NC92 - Highway 37:2 East of RR272

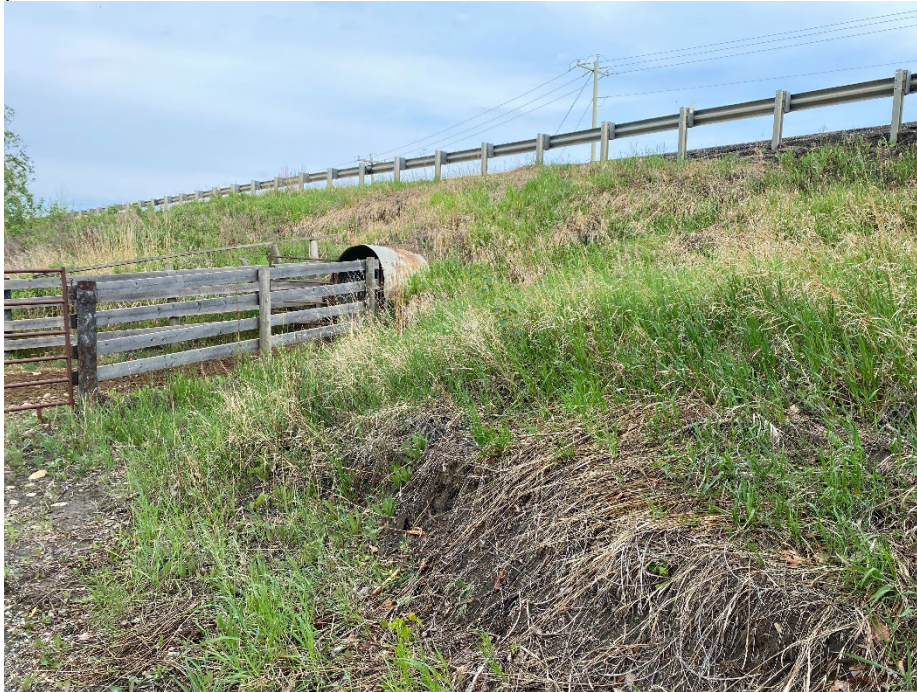
**Photo 1:** Slump and toe bulge at east side of cattlepass culvert. Looking northwest

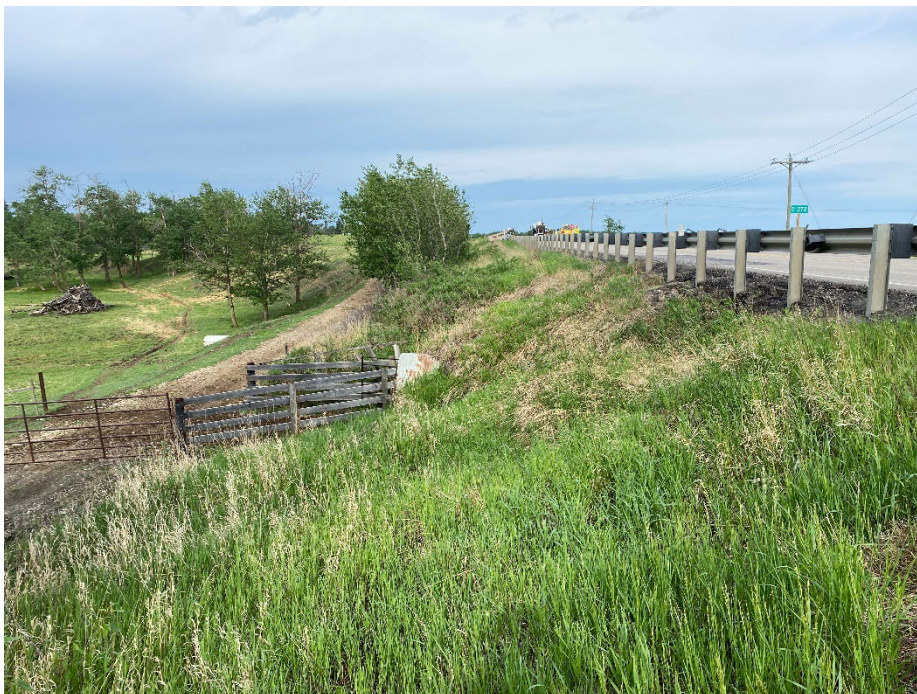
**Photo 2:** Slump across cattlepass culvert. Looking west

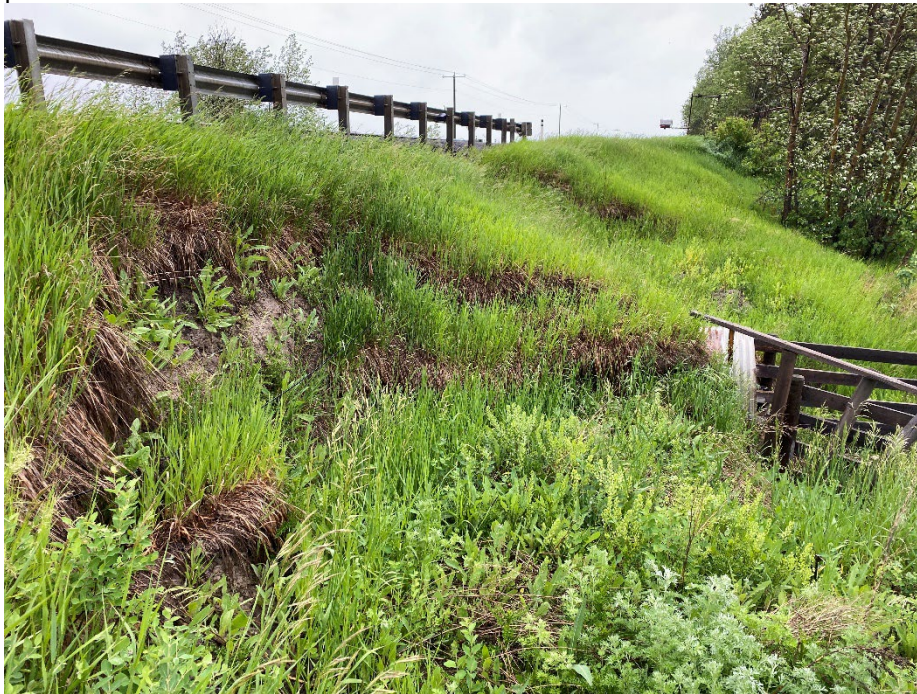
**Photo 3:** Scarp at west slump. Looking east.

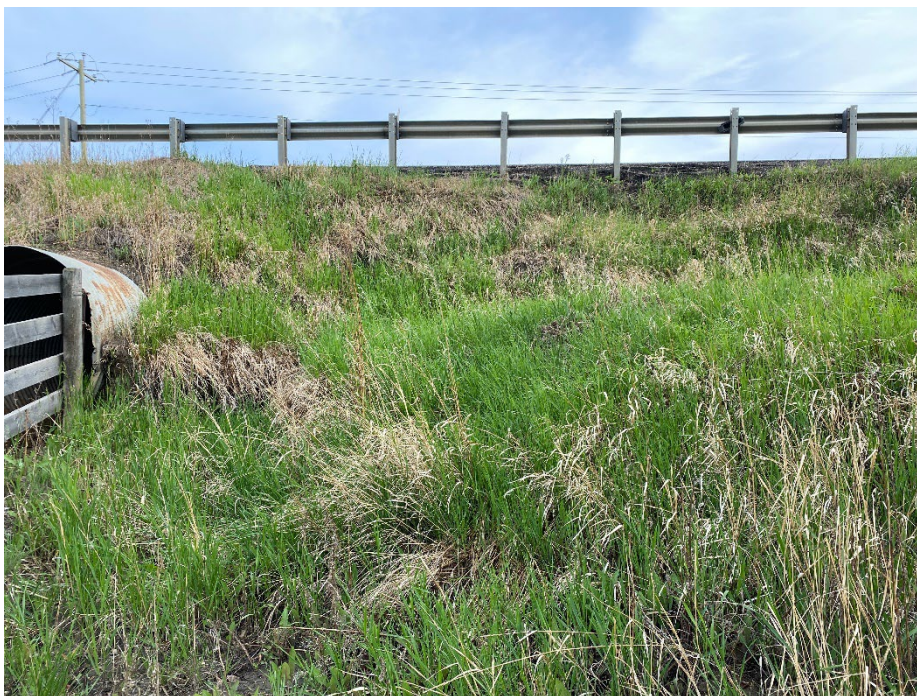
area 1.7 m wide and long, and 0.7 m high. No signs of recent grading were observed during the current site inspection.

**Photo 4:** Possible regraded area on east side of culvert. Looking north.

- The MCI should discuss possible solutions with the farmer to maintain functionality of the gate but to refrain from further grading work at the toe of the landslide. Loss of soil support at the toe can trigger additional slope movements.

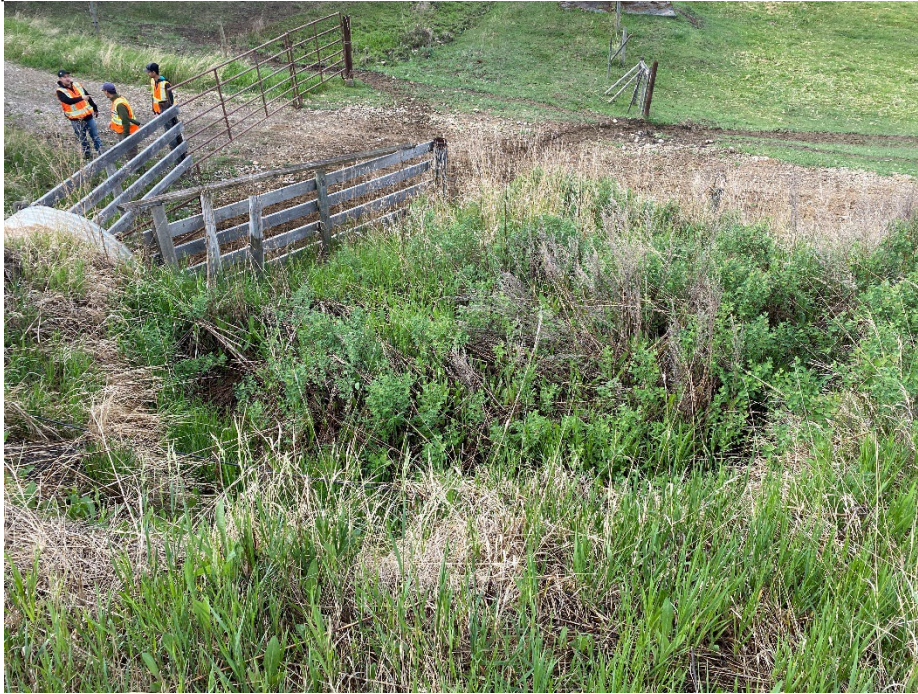
**Photo 5:** West slump next to culvert entrance. Looking south.

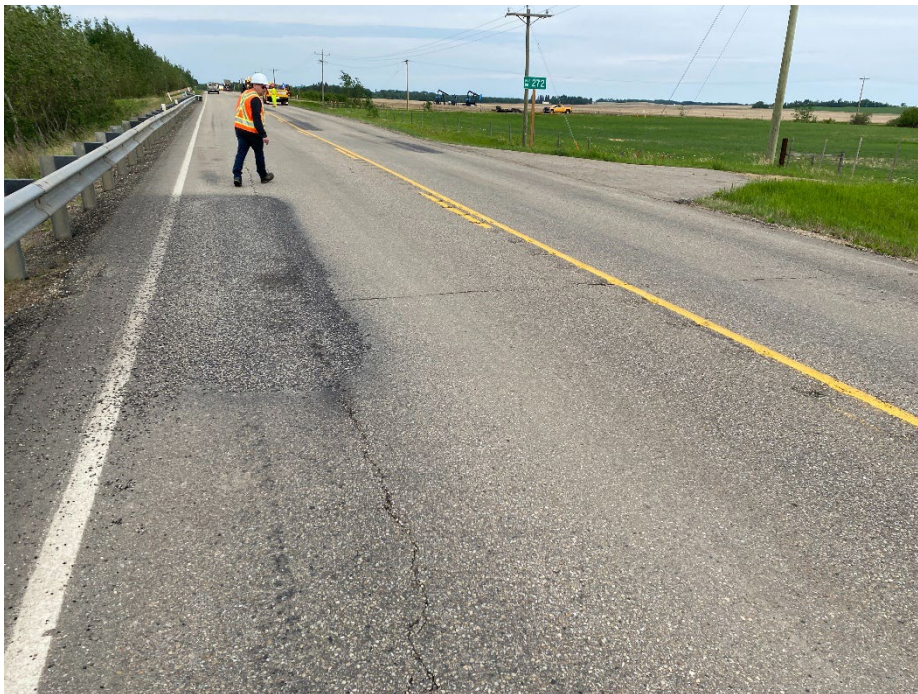
- At the time of the site visit, pavement crack sealing operations were in progress.
- A longitudinal crack in the EBL was observed above the culvert and was mostly patched during the site visit. The crack extends past the patch on both sides and is approximately 5 mm wide (Photo 6).
- The transverse crack previously observed above the eastern scarp has extended across the remainder of the WBL.
- The north guardrail was damaged on the east end, and the south guardrail was damaged on the west end. The posts on either side have been damaged beyond repair, and sections of rail are missing.
- A black utility cable (likely Telus) continues to be observed running east-west through the landslide

**Photo 6:** Highway surface above culvert. Looking west.

- The MCI should continue to monitor the highway surface and guardrails until remediation can be undertaken.
- For the new guardrail posts, the MCI should consider augering holes for their installation over pushing/pounding new posts to reduce vibrations within the landslide mass. The posts installed above the slump could also be replaced with deeper posts to provide additional lateral support to the rails in the event that they are struck by a vehicle, increasing the overall safety performance of the guardrail at this location.
