<b>SITE NUMBER AND NAME:</b> NC094 – 100 Ave at NB AHD	<b>HIGHWAY AND KM:</b> 216:06, km 20.550	<b>PREVIOUS INSPECTION:</b> June 30, 2022	<b>CURRENT INSPECTION:</b> June 1, 2023
<b>LEGAL DESCRIPTION:</b> NW-32-52-25-W4	<b>NAD83 COORDINATES:</b> UTM12U 5935400N, 323784E		<b>RISK ASSESSMENT:</b> PF: 13 CF: 4 Total: 52
<b>AVERAGE ANNUAL DAILY TRAFFIC (AADT):</b> 3,610 (2022, Traffic from west turning left)		<b>CONTRACTOR MAINTENANCE AREA (CMA):</b> AHD

NORTH CENTRAL REGION GRMP  
EDSON / STONY PLAIN  
SITE INSPECTION FORM

2023 Site Inspection Photos at NC094

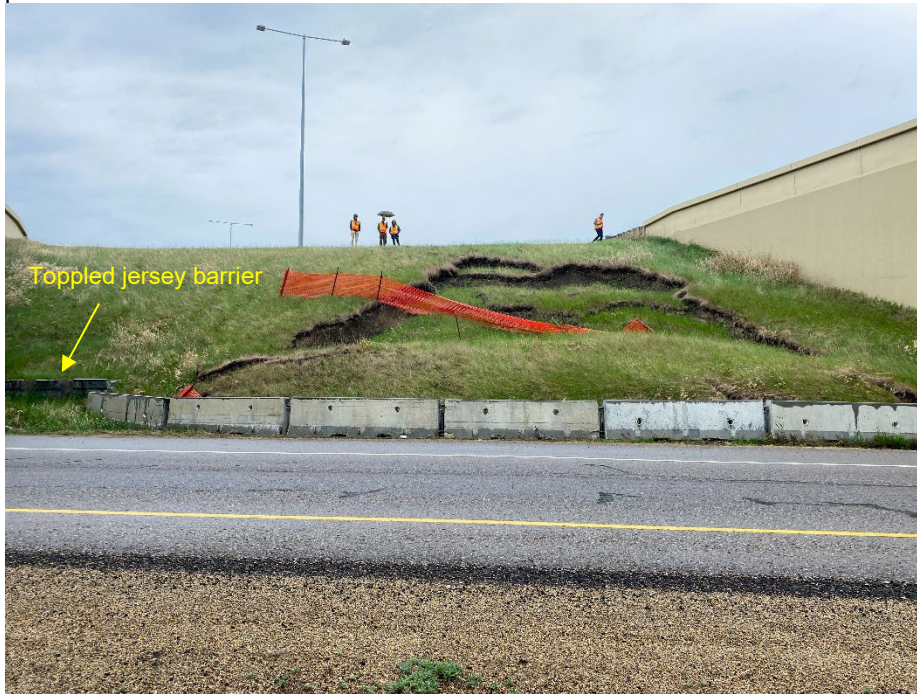
<b>COMMENTS</b>
<ul style="list-style-type: none"> <li>The overall embankment is about 33 m wide and 8 m high. The slump exists between the two bridge abutments south of the 100 Avenue on-ramp to AHD northbound (Photo 1).</li> <li>The landslide is slightly west of center of the embankment. The scarp appears to have retrogressed, lengthening the slide area by 1.4 m since the previous inspection in late June 2022. The scarp was observed at the upper portion of the embankment and is up to 1.1 m high. The current scarp is 2.6 m from the crest of the embankment, compared to 4.0 m at the time of the last investigation (Photos 1 to 7).</li> <li>The east and west flanks of the landslide are approximately 12.5 m and 4.6 m from the east and west bridge abutment walls, respectively. These measurements have not changed since the previous investigation.</li> <li>The toe bulge has progressed further downslope towards 100 Avenue and has reduced the distance to the edge of pavement from 1.8 m to 1.5 m. The toe bulge is approximately 1.5 m high (Photos 4 and 5).</li> </ul>

**Photo 1:** Slump on south embankment. Looking southwest.

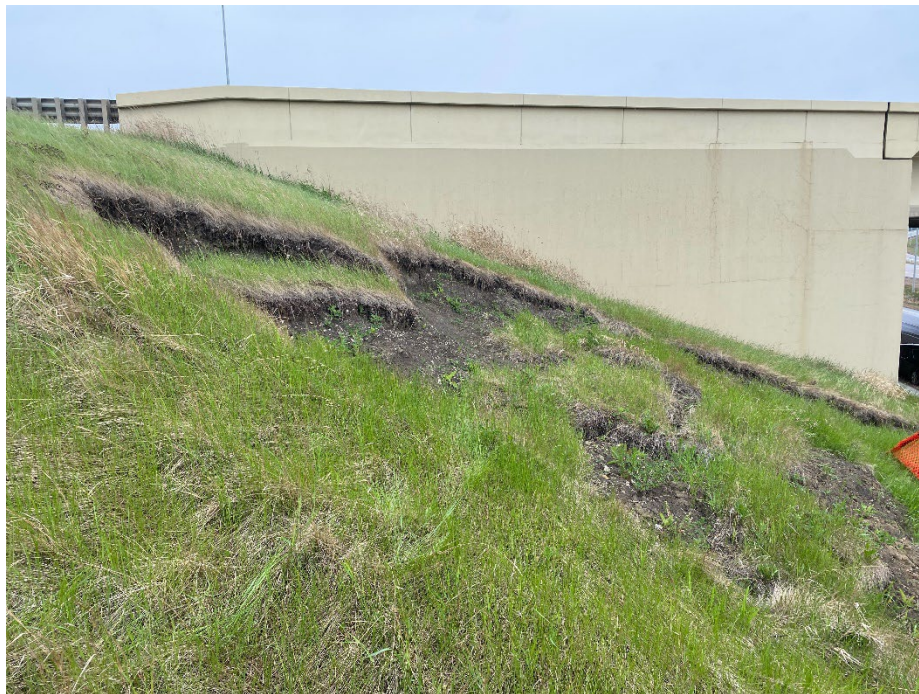
**Photo 2:** Slump on south embankment. Looking west.

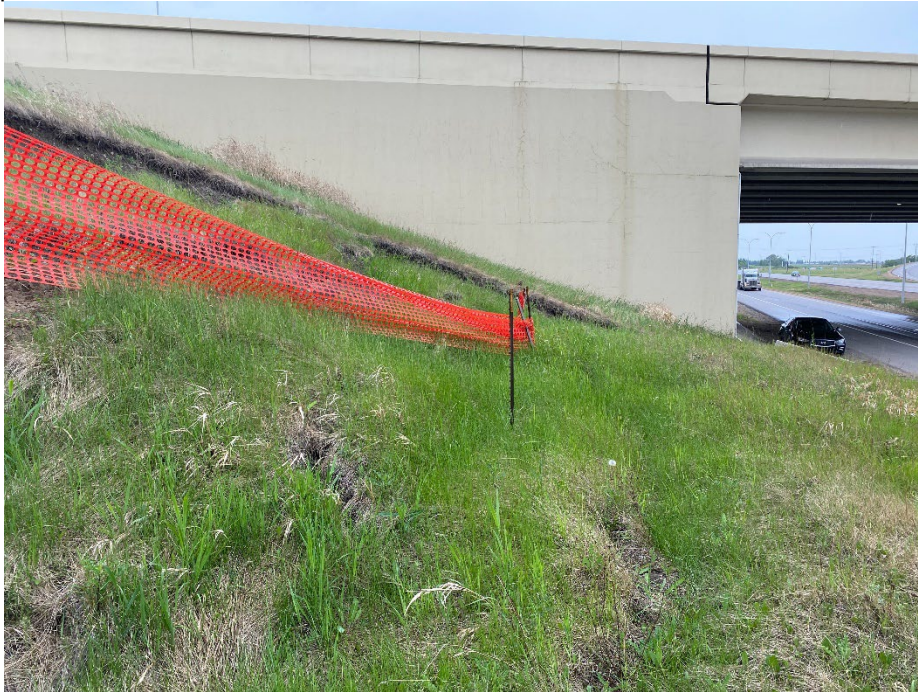
**Photo 3:** Mid slope of slump on south embankment. Looking west.

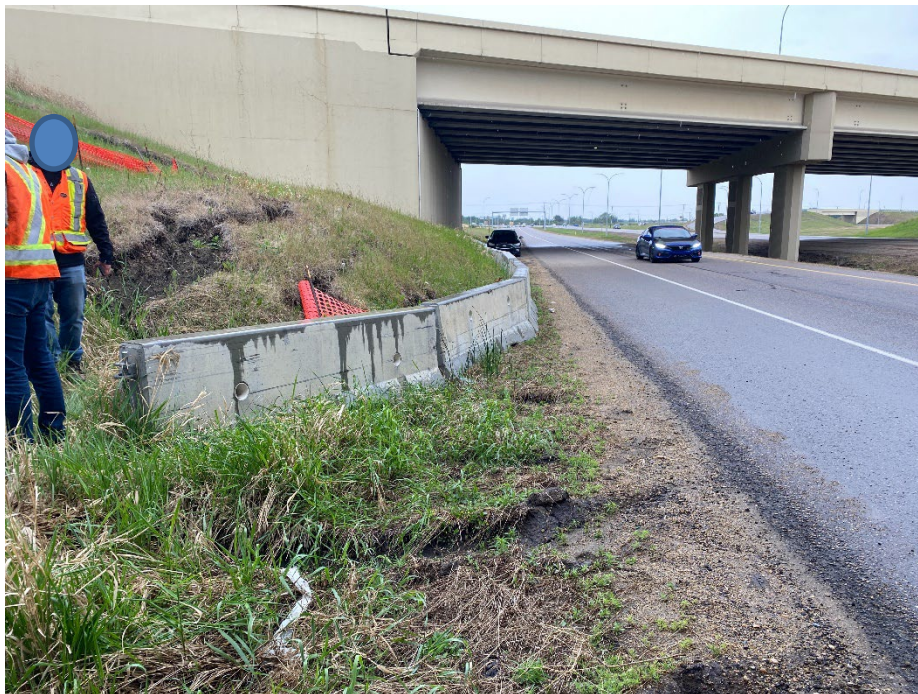
- Jersey barriers have been placed around the toe of the landslide and anchored into the ground. The edge of the jersey barrier is 1.3 m from the edge of the pavement and the toe of the slump is pushed against the back of the jersey barriers (Photos 4 and 5).

**Photo 4:** Toe bulge of slump with scarping/cracking. Looking northwest.

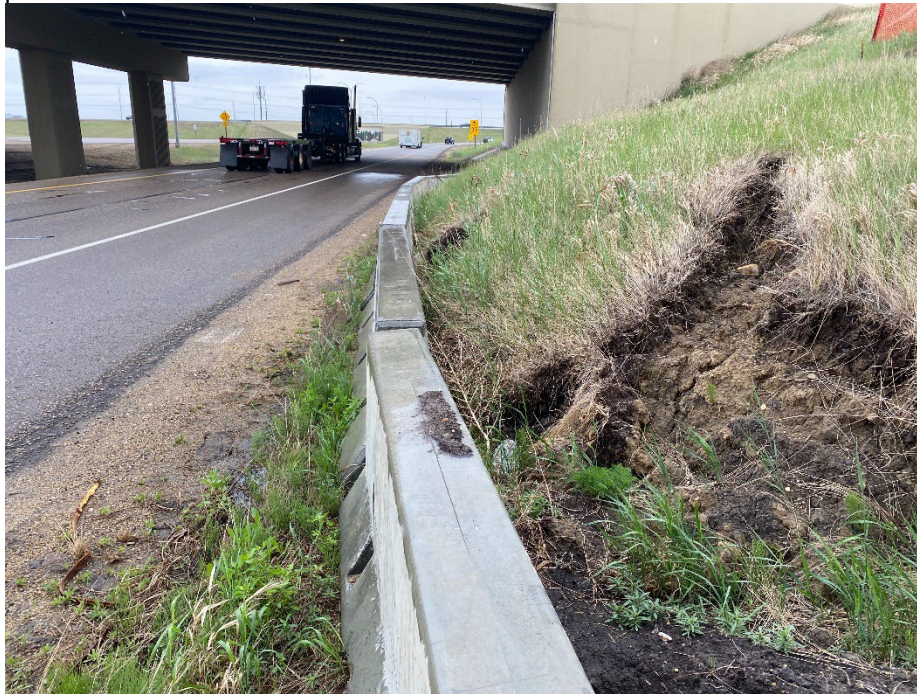
**Photo 5:** Toe of the embankment/slump. Looking southeast.

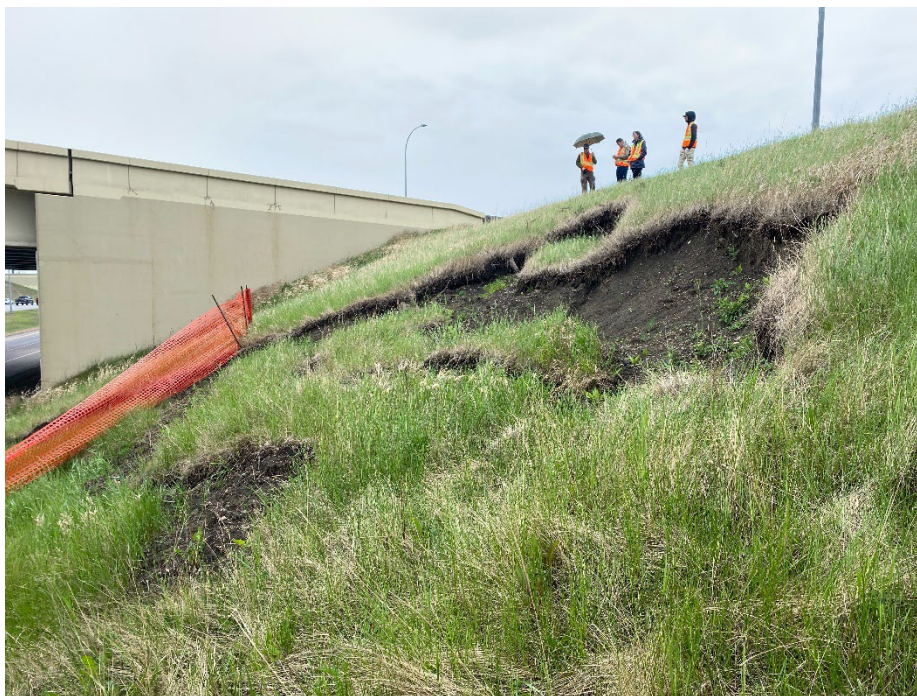
**Photo 6:** Retrogressing scarps near top of slump. Looking southeast.

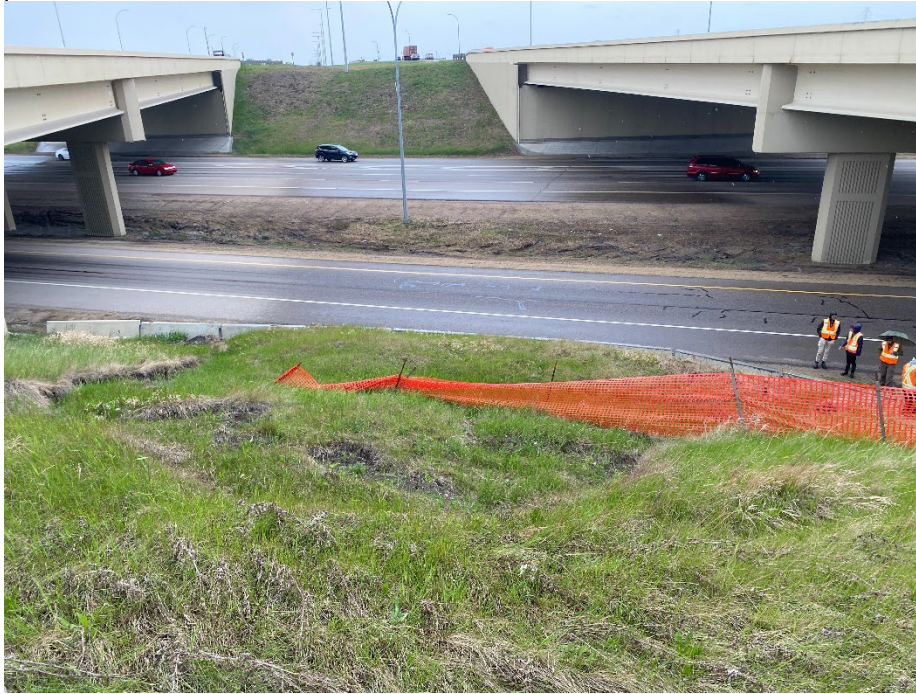
**Photo 7:** Slumping viewed from the crest of the embankment. Looking north.

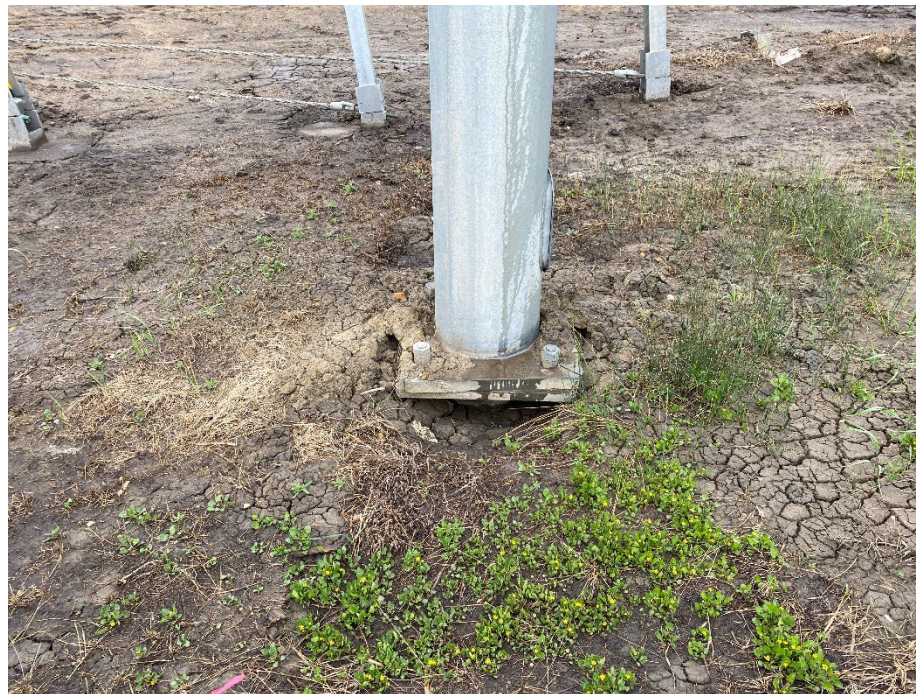
- The base of the light standard near the crest of the embankment appeared to have settled an additional 2 cm, for a total settlement of 12 cm. No ponding water was observed at the time of the call out inspection (Photo 8).

**Photo 8:** Scouring/settlement of ground around the light standard closest to the embankment. Looking west.

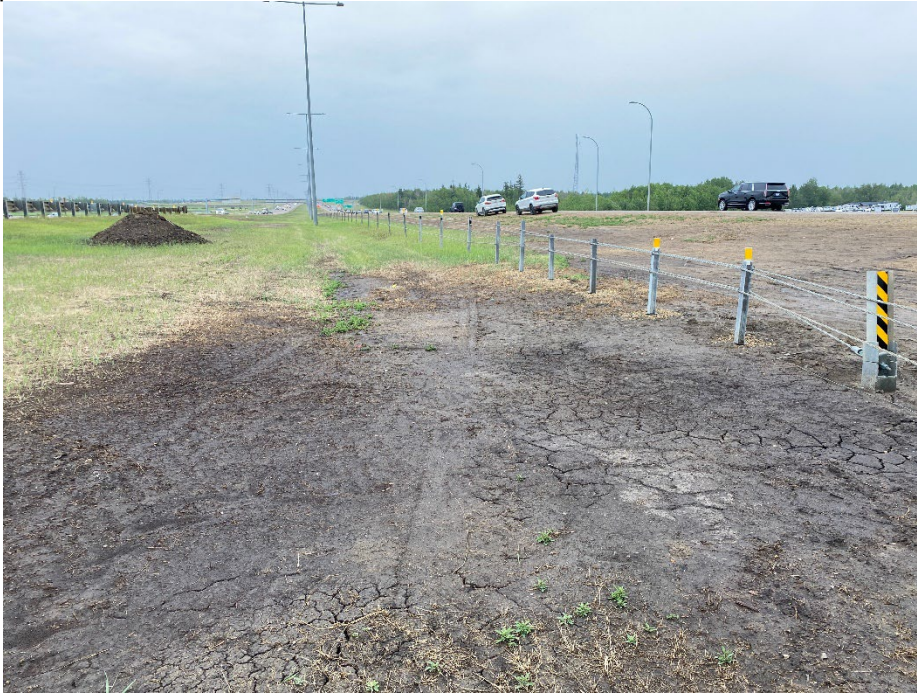
- A portion of the highway median north of the settling light standard was dry with a lack of vegetation established (Photo 9).
- During the previous call-out inspection, the exposed soils appeared wet and pieces of concrete and occasional pockets of grey fill material were observed throughout the slope. The grey fill material is believed to be from the bottom ash used during bridge abutment construction.

**Photo 9:** Highway median. Looking south.

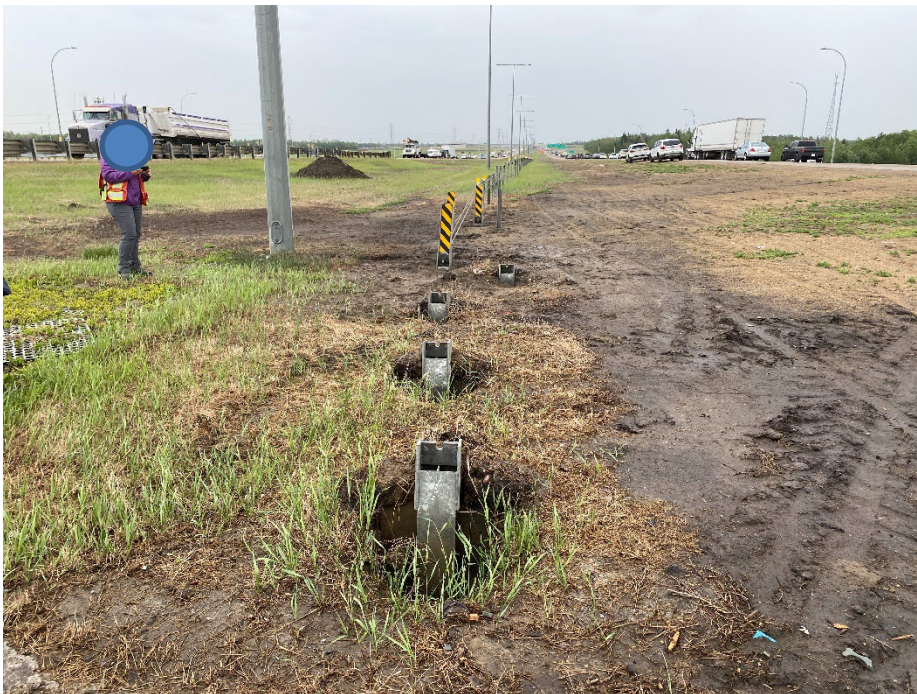
- Ponding water was observed at the toe of the embankment.
- Four high-tension cable barrier (HTCB) posts closest to the embankment have been abandoned and the cables have been strung from the post closest to the light pole continuing south. Holes around the abandoned posts are 30 cm deep with 20 cm average diameter. It is believed that the scouring may have been related to or caused by overloading during collision (Photo 10).

**Photo 10:** Abandoned posts for high tension cable barrier. Looking south.

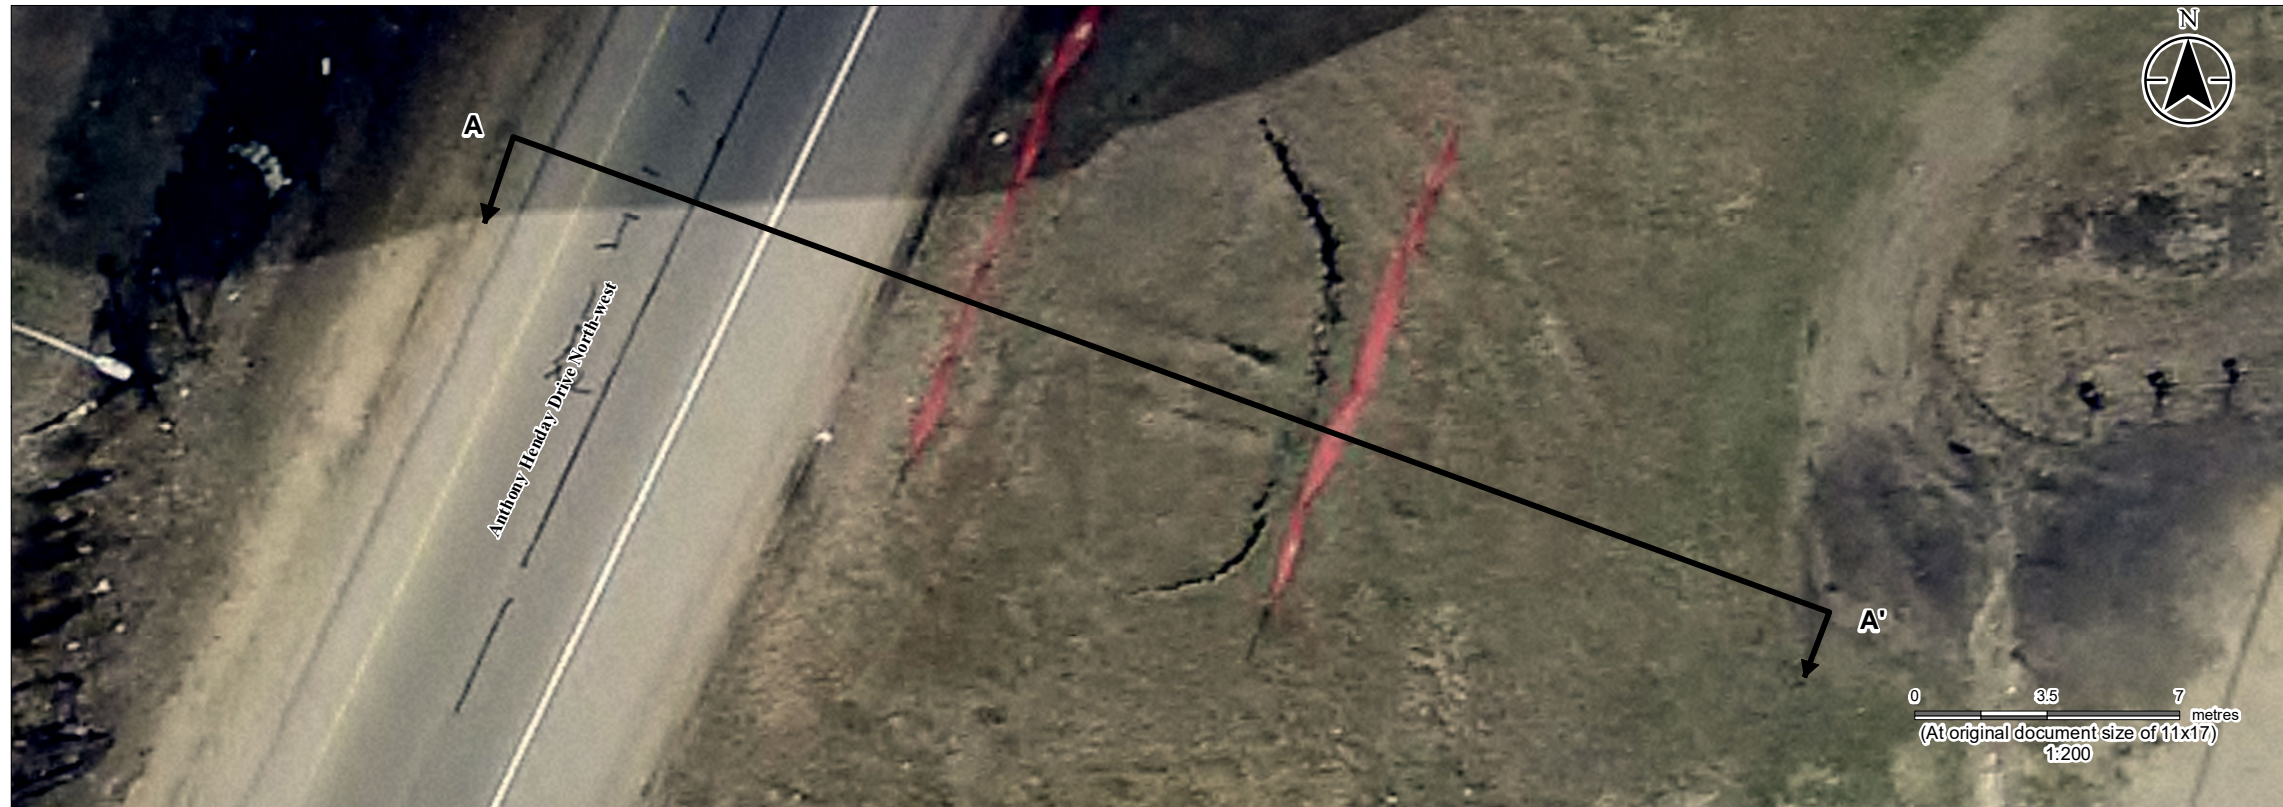
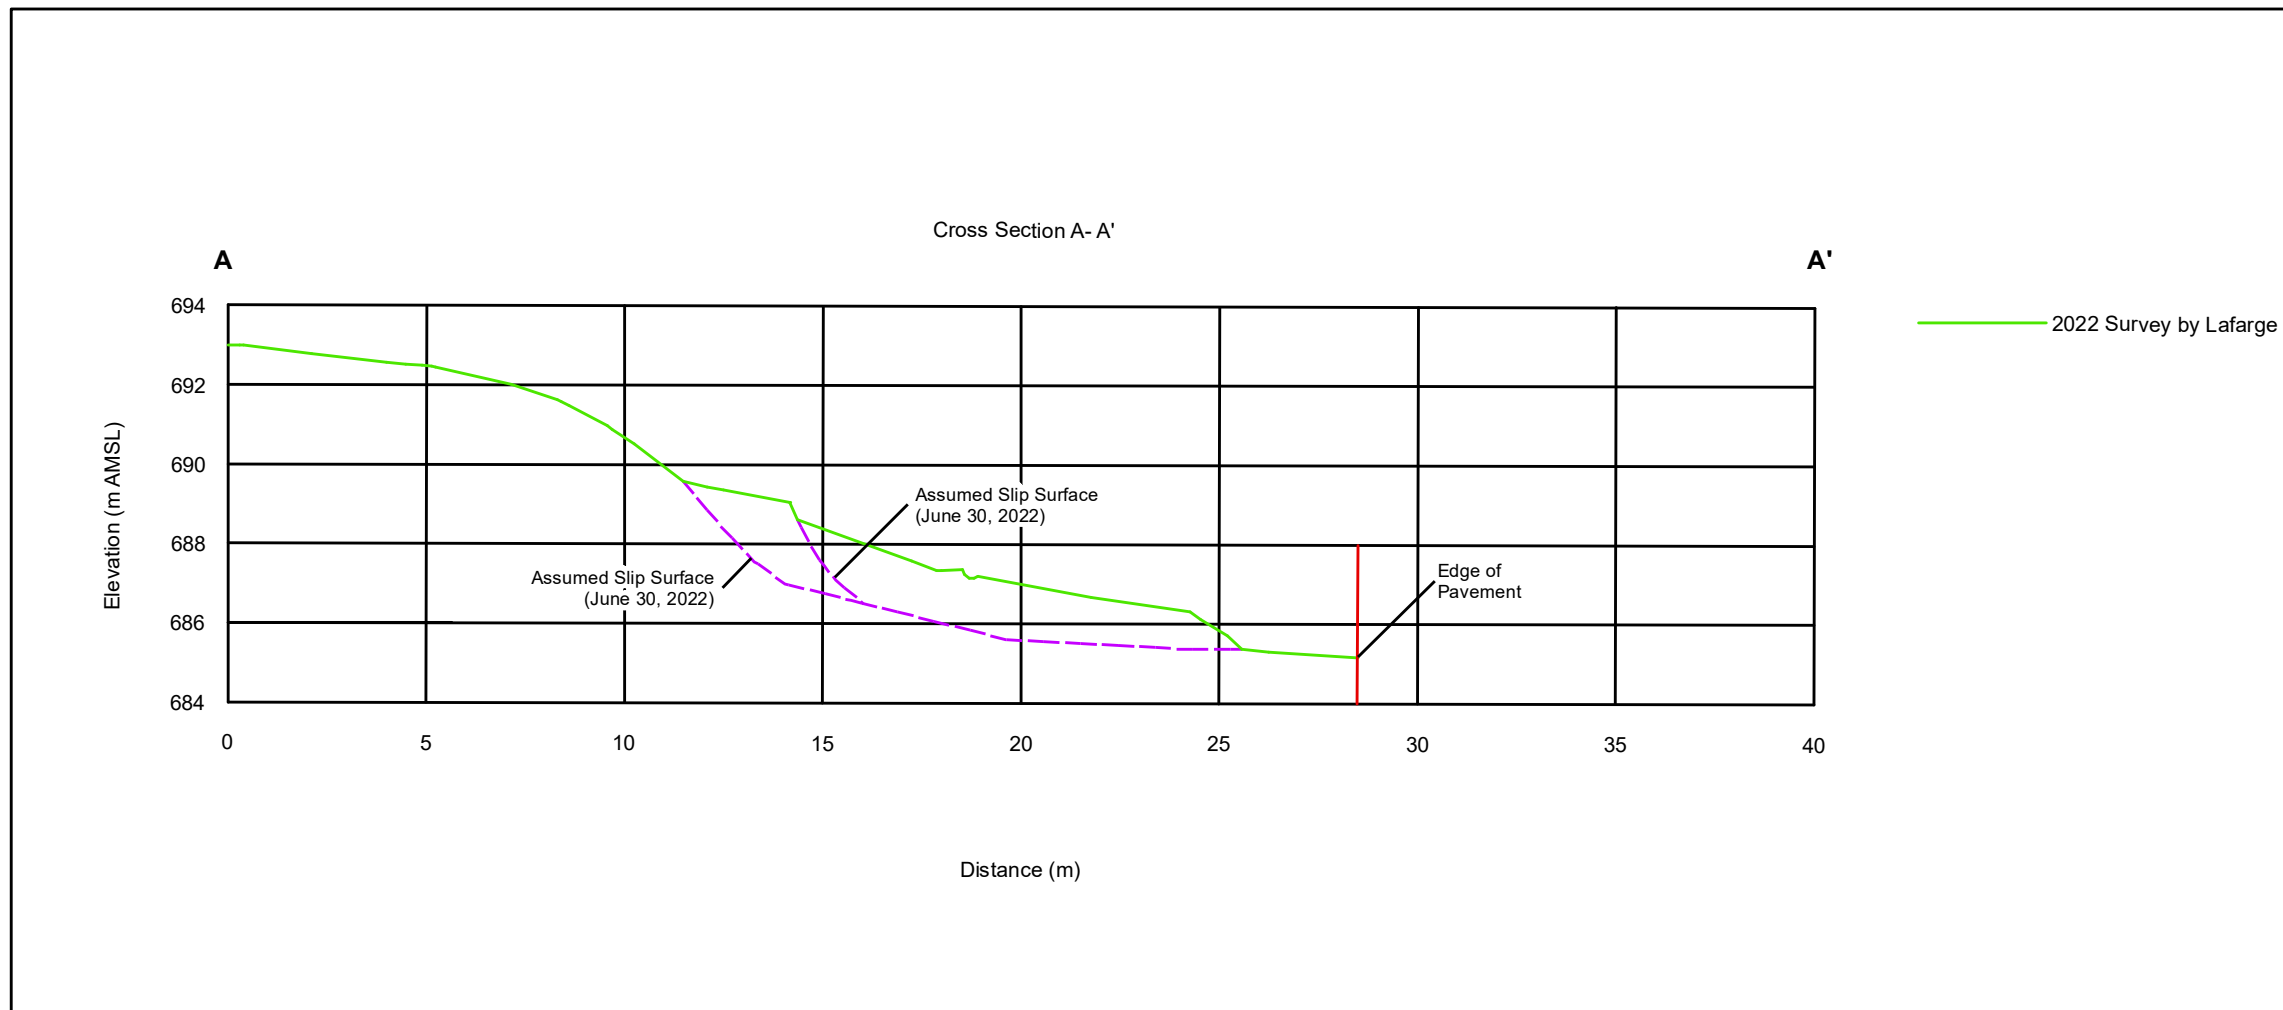
**Title**  
**Ground Profile of Section A-A'**

- The landslide appears to be a shallow failure limited to the bridge/embankment fill. The landslide may be due to a combination of poor-quality embankment backfill and softening of the embankment fill near mid-slope. In addition, typical bridge and embankment compaction methods often result in less compaction at the slope face since compaction equipment cannot adequately compact the edges and slopes. These less compacted areas could allow water to infiltrate the slope more easily.

- The MCI and/or HMC should monitor the slump for progression towards 100 Avenue and the jersey barriers should be adjusted or maintained, as necessary.
- Stantec has completed the landslide remediation design for removal and replace. The design includes excavating the landslide mass in benches with an overall slope of 2H:1V followed by rebuilding the embankment with granular fill. The estimated cost of construction for landslide remediation ranges from \$180,000 to \$210,000 including part-time contract administration fees.
- It is understood that long term remediation is scheduled to take place in 2024. If the remediation work is pushed to another year later, TEC could consider annual surveys to monitor the movement of the slide.
- Site inspection frequency should continue annually.
