**NORTH CENTRAL REGION GRMP
EDSON / STONY PLAIN
SITE INSPECTION FORM**

SITE NUMBER AND NAME: NC052 – Pembina River Bridge	HIGHWAY AND KM: 621:02, km 16.420	PREVIOUS INSPECTION: May 22, 2020	CURRENT INSPECTION: June 29, 2021
LEGAL DESCRIPTION: SE 01-50-09-W5	NAD83 COORDINATES: UTM11U 5905008N, 621749E		RISK ASSESSMENT: PF: 10 CF: 10 Total: 100
AVERAGE ANNUAL DAILY TRAFFIC (AADT): 1,040 (2020)		CONTRACTOR MAINTENANCE AREA (CMA): 509

2021 Site Inspection Photos at NC052

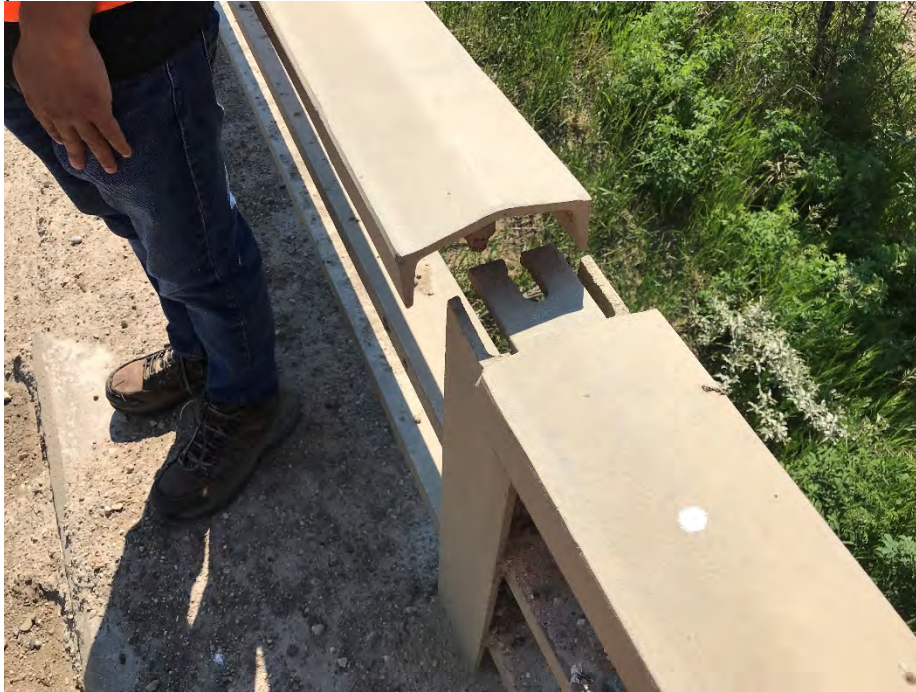
COMMENTS
<ul style="list-style-type: none"> • Bridge rotation increased since 2020. The guardrails along the bridge deck have separated with 30 mm, 70 mm, 50 mm, and 20 mm of separation at the NE, SE, NW, and SW corners, respectively (Photos 1 to 4). The top of the guardrail at the SE corner is no longer connected to the post. • Tiltmeter TW1 historically showed change in rotation between 0° and 0.025° since early 2014. The recent monitoring cycle on July 6, 2021, indicated that the rotation reversed to -0.025° prior to logger failure in November 2020. The change in rotation direction may be related to the increased bridge rotation observed. All tiltmeters are now non-functional. • All the SIs show signs of creep except for SI13-3. Creeping is occurring at a rate of less than 1 mm/year. • Piezometric levels at the site have been relatively stable since installing the horizontal drains. • Concrete cracks at both east and west abutment seats appear unchanged. A 20 mm gap was written onto the crack at the west abutment at an unknown date. This same gap was measured to be 20 mm by Stantec since 2016. (Photos 5 and 7)

Photo 1: Guardrail separation at southeast corner of bridge. Looking southeast.

- The bridge should be inspected by a bridge engineer.
- The datalogger should be repaired/replaced at each tiltmeter to collect regular readings. Otherwise, regular survey of the bridge should be conducted to monitor its rate of rotation/movement.
- The riprap channel south of the bridge should be extended downslope to the river for increased erosion protection.
- Pavement cracks should be sealed to reduce surface water infiltration into the slope.
- Site inspections should continue annually.
- Instrumentation readings should continue to be read semi-annually.

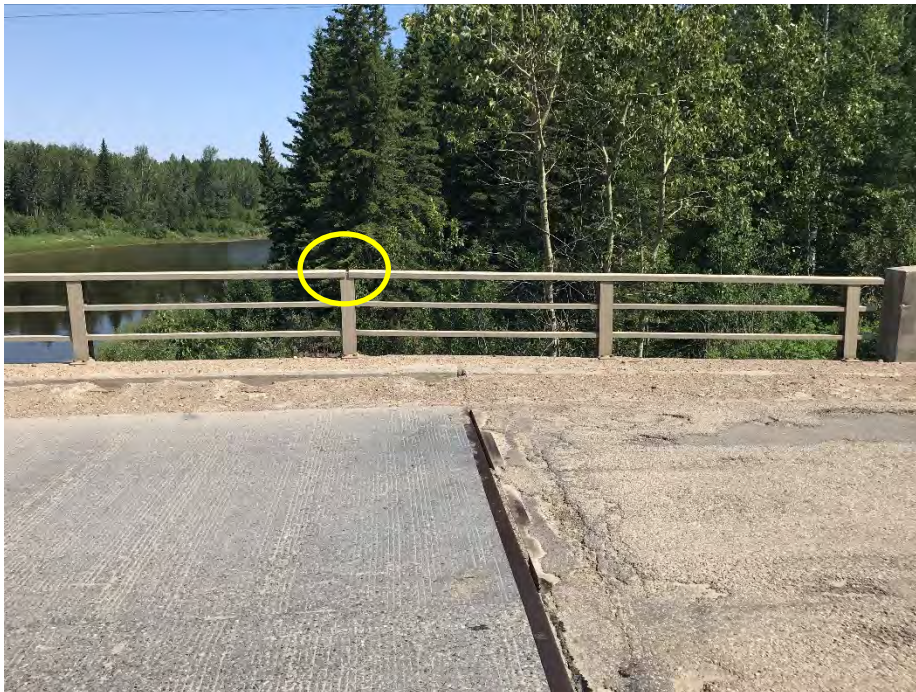
Photo 2: Guardrail separation at northeast corner of bridge. Looking north.

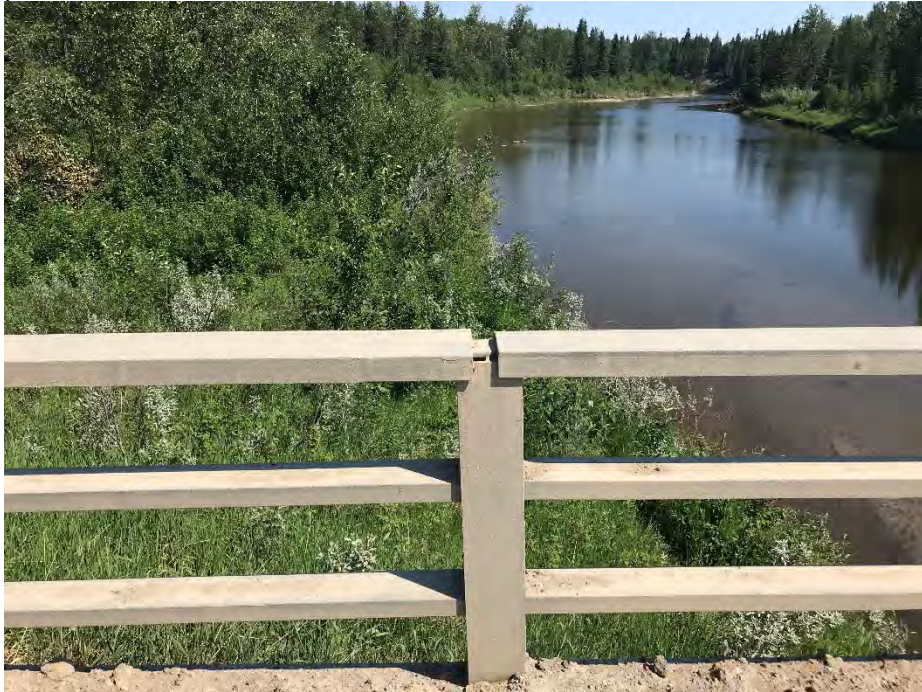
Photo 3: Guardrail separation at northwest corner of bridge. Looking north.

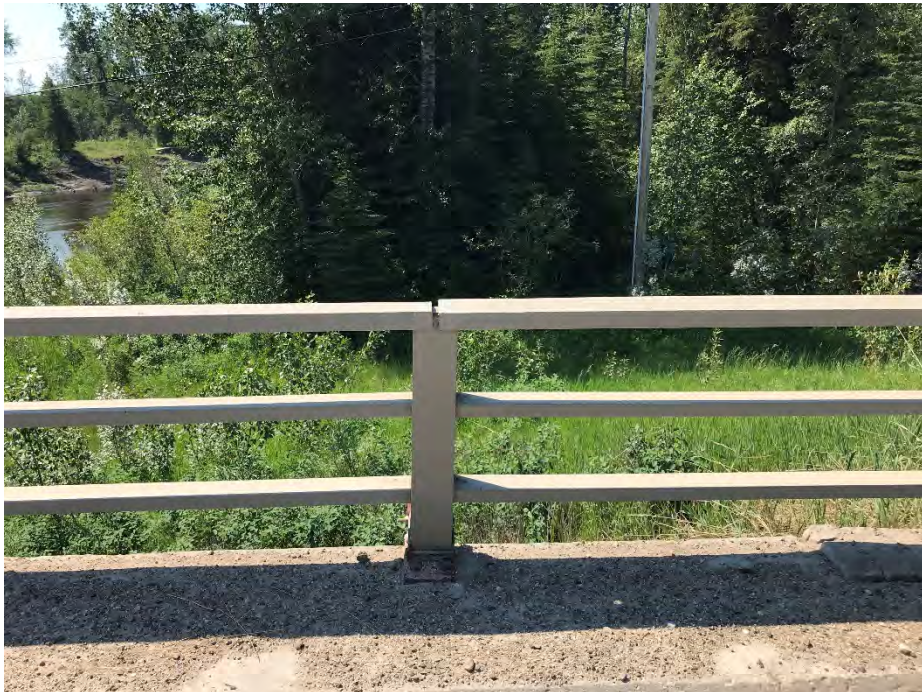
Photo 4: Guardrail separation at southwest corner of bridge. Looking south.

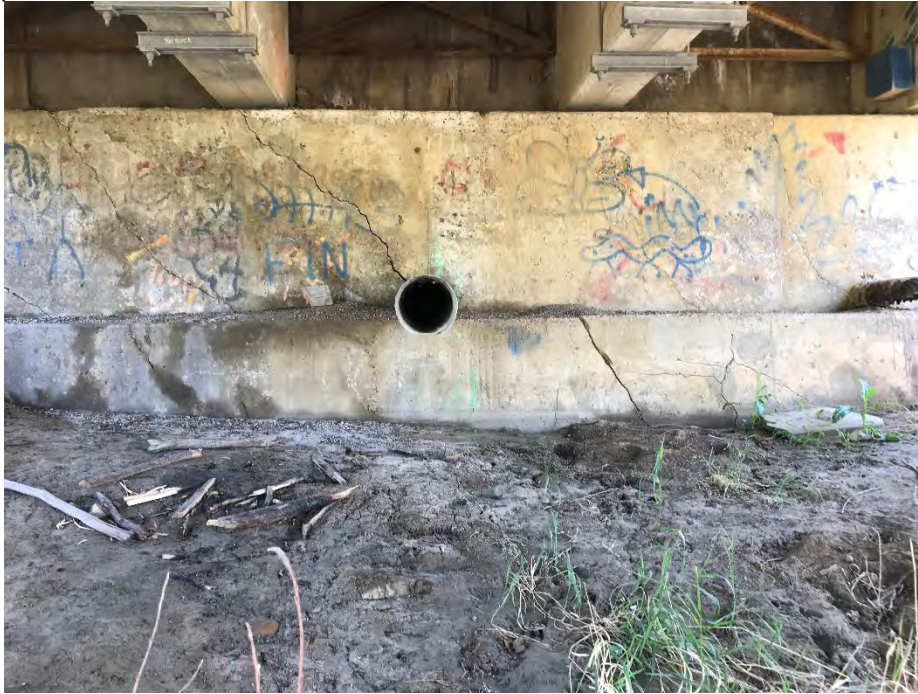
Photo 5: Cracking of east abutment. Looking east.

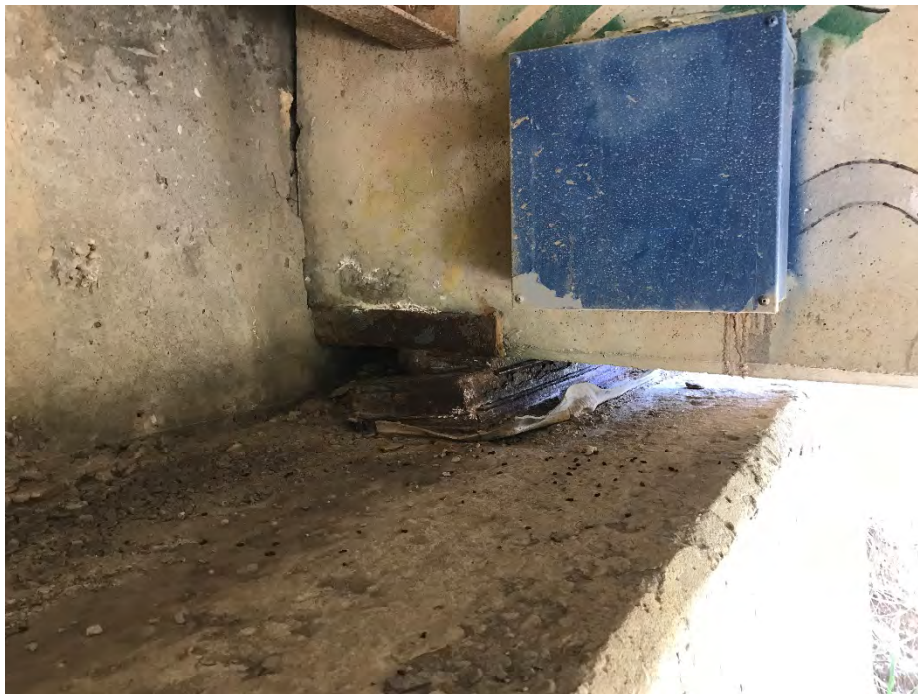
- The girders were in contact with the abutment backwall at the east abutment. The bearing plates appear to be crushed at both abutments. (Photo 6)
- The river level appears lower than what Stantec has observed during the previous 6 site inspections. Sediment appears to be depositing around S114-01 forming a dam feature. (Photo 8)

Photo 6: Girders in contact with east abutment. Movement of bearing plate. Looking south.

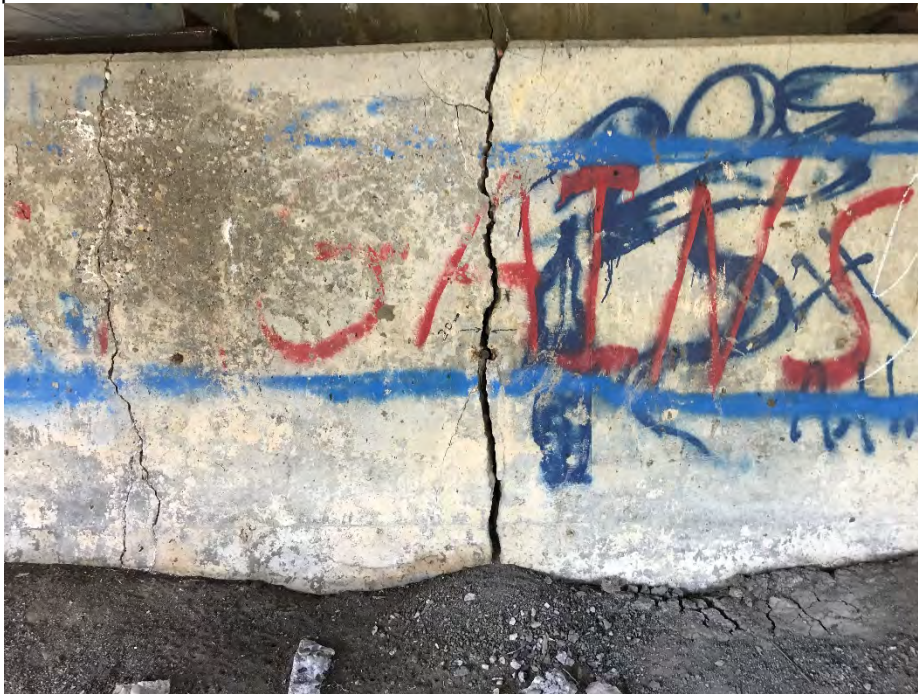
Photo 7: 20 mm crack at west abutment. Looking west.

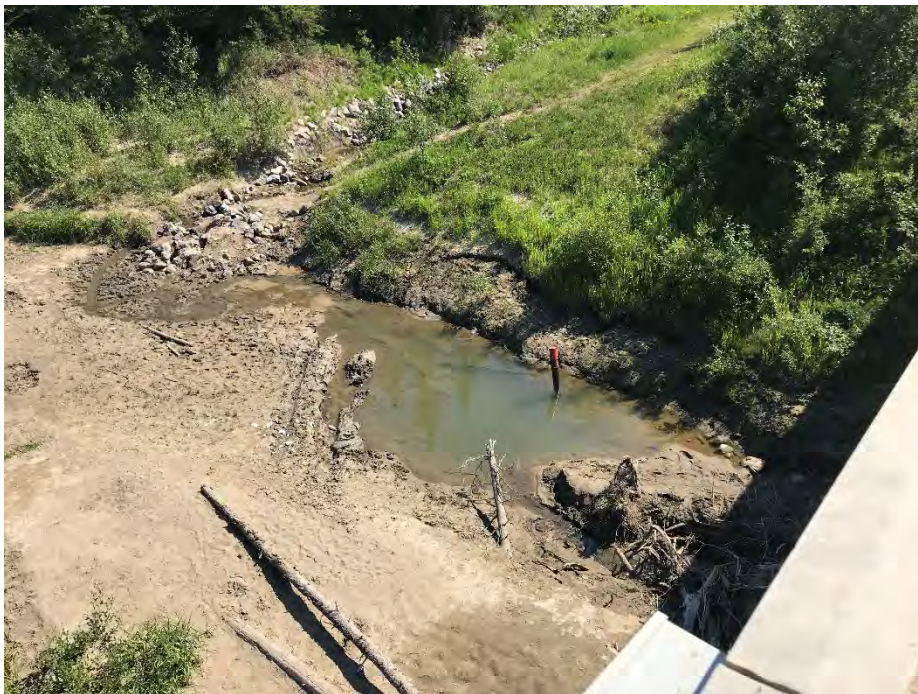
Photo 8: Riprap lined channel north of east abutment. Ground cracks near SI14-01. Looking northeast.

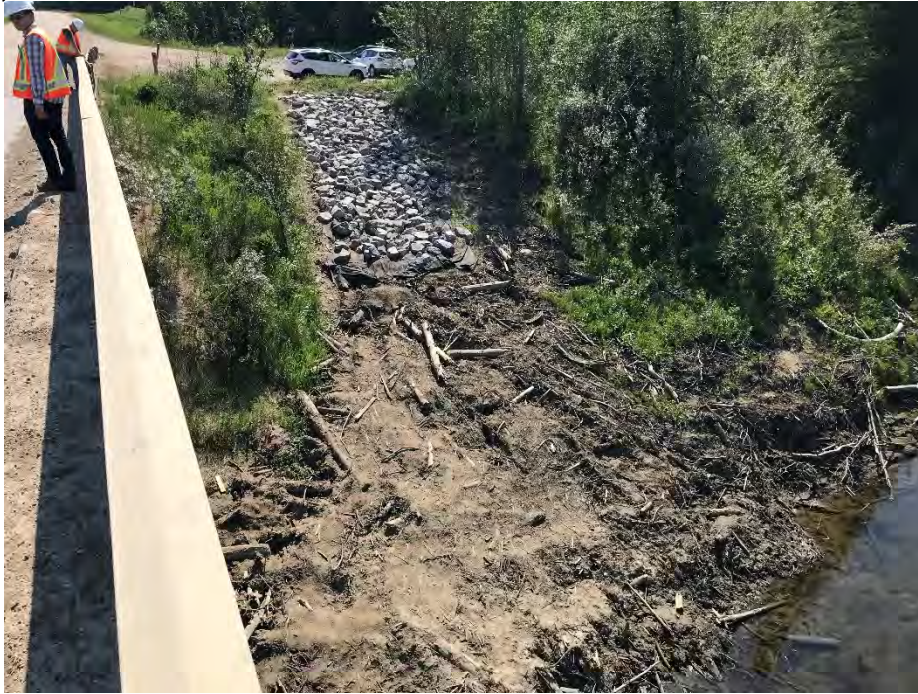
- The ground crack south of the riprap channel lengthened to about 7 m long with vertical difference up to about 0.4 m high.
- The previously observed erosion channel south of the bridge at the east abutment slope was recently regraded with riprap placed. The riprap was placed about halfway downslope (Photo 9).

Photo 9: New riprap placed south of bridge along previous erosion channel. Looking southeast.

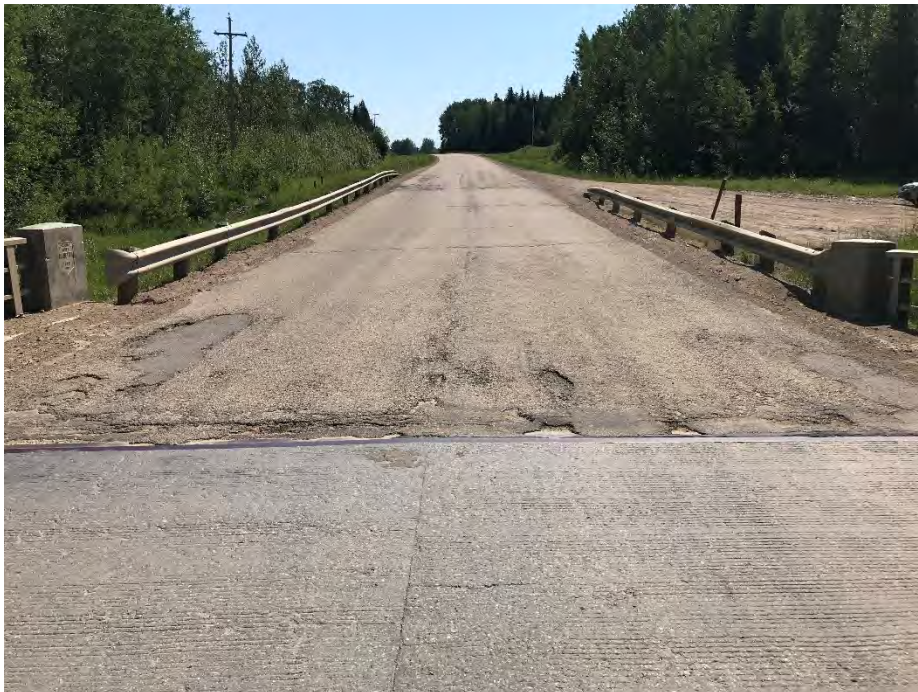
- The highway surface at the east abutment appears relatively unchanged (Photo 10).
- The nearest detour route to cross the Pembina River appears to be at Range Road 91 and Township Road 491A, approximately a 12-minute drive south of the site. This detour would require the use of gravel roads and may not be suitable for all types of traffic.

Photo 10: Highway surface at east abutment. Looking east.
