To: Amy Driessen
Alberta Transportation
File: 123315222

From: Leslie Cho and Xiteng Liu
Stantec Consulting Ltd.
Date: October 5, 2022

Reference: North Central Region, Stony Plain, Site NC052 - Highway 621:02 Pembina River Bridge Abutment, Fall 2022 Instrumentation Monitoring Report

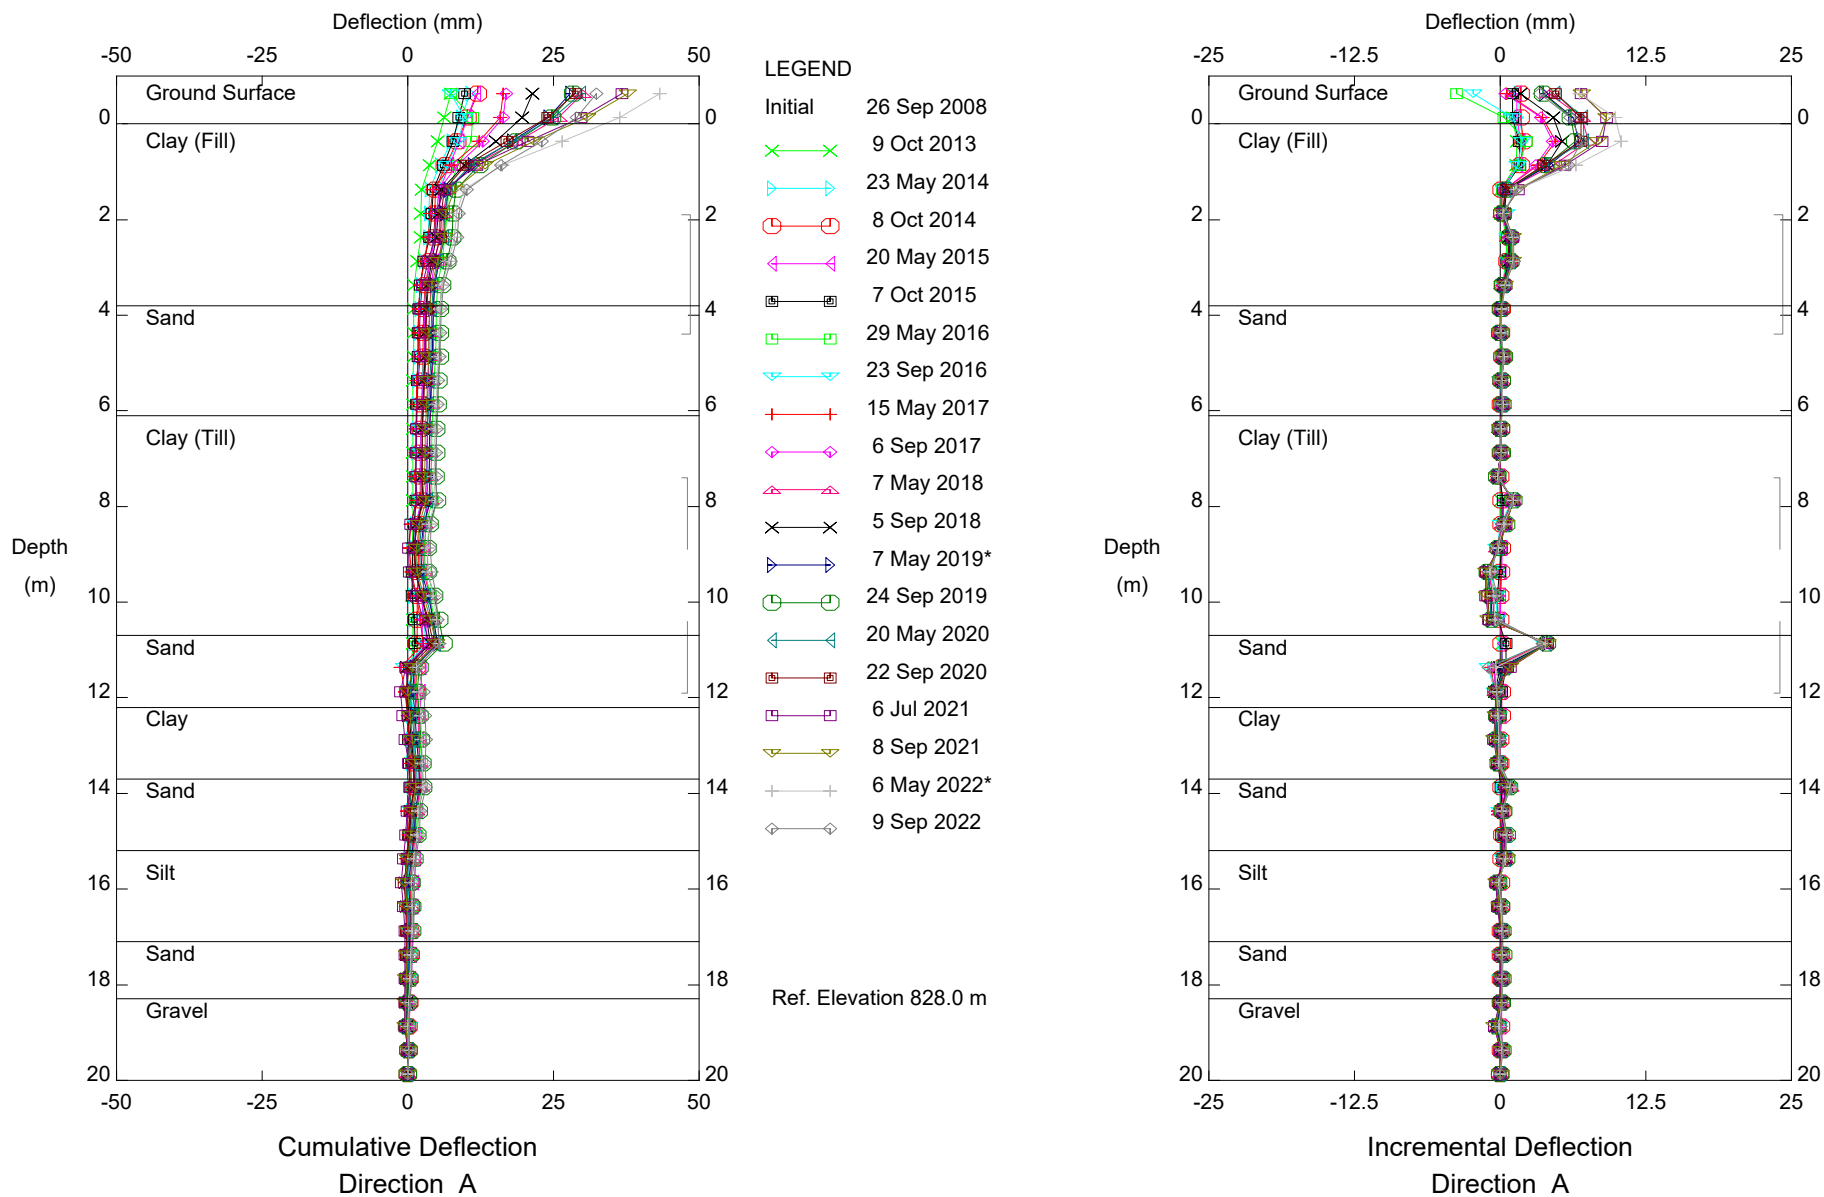
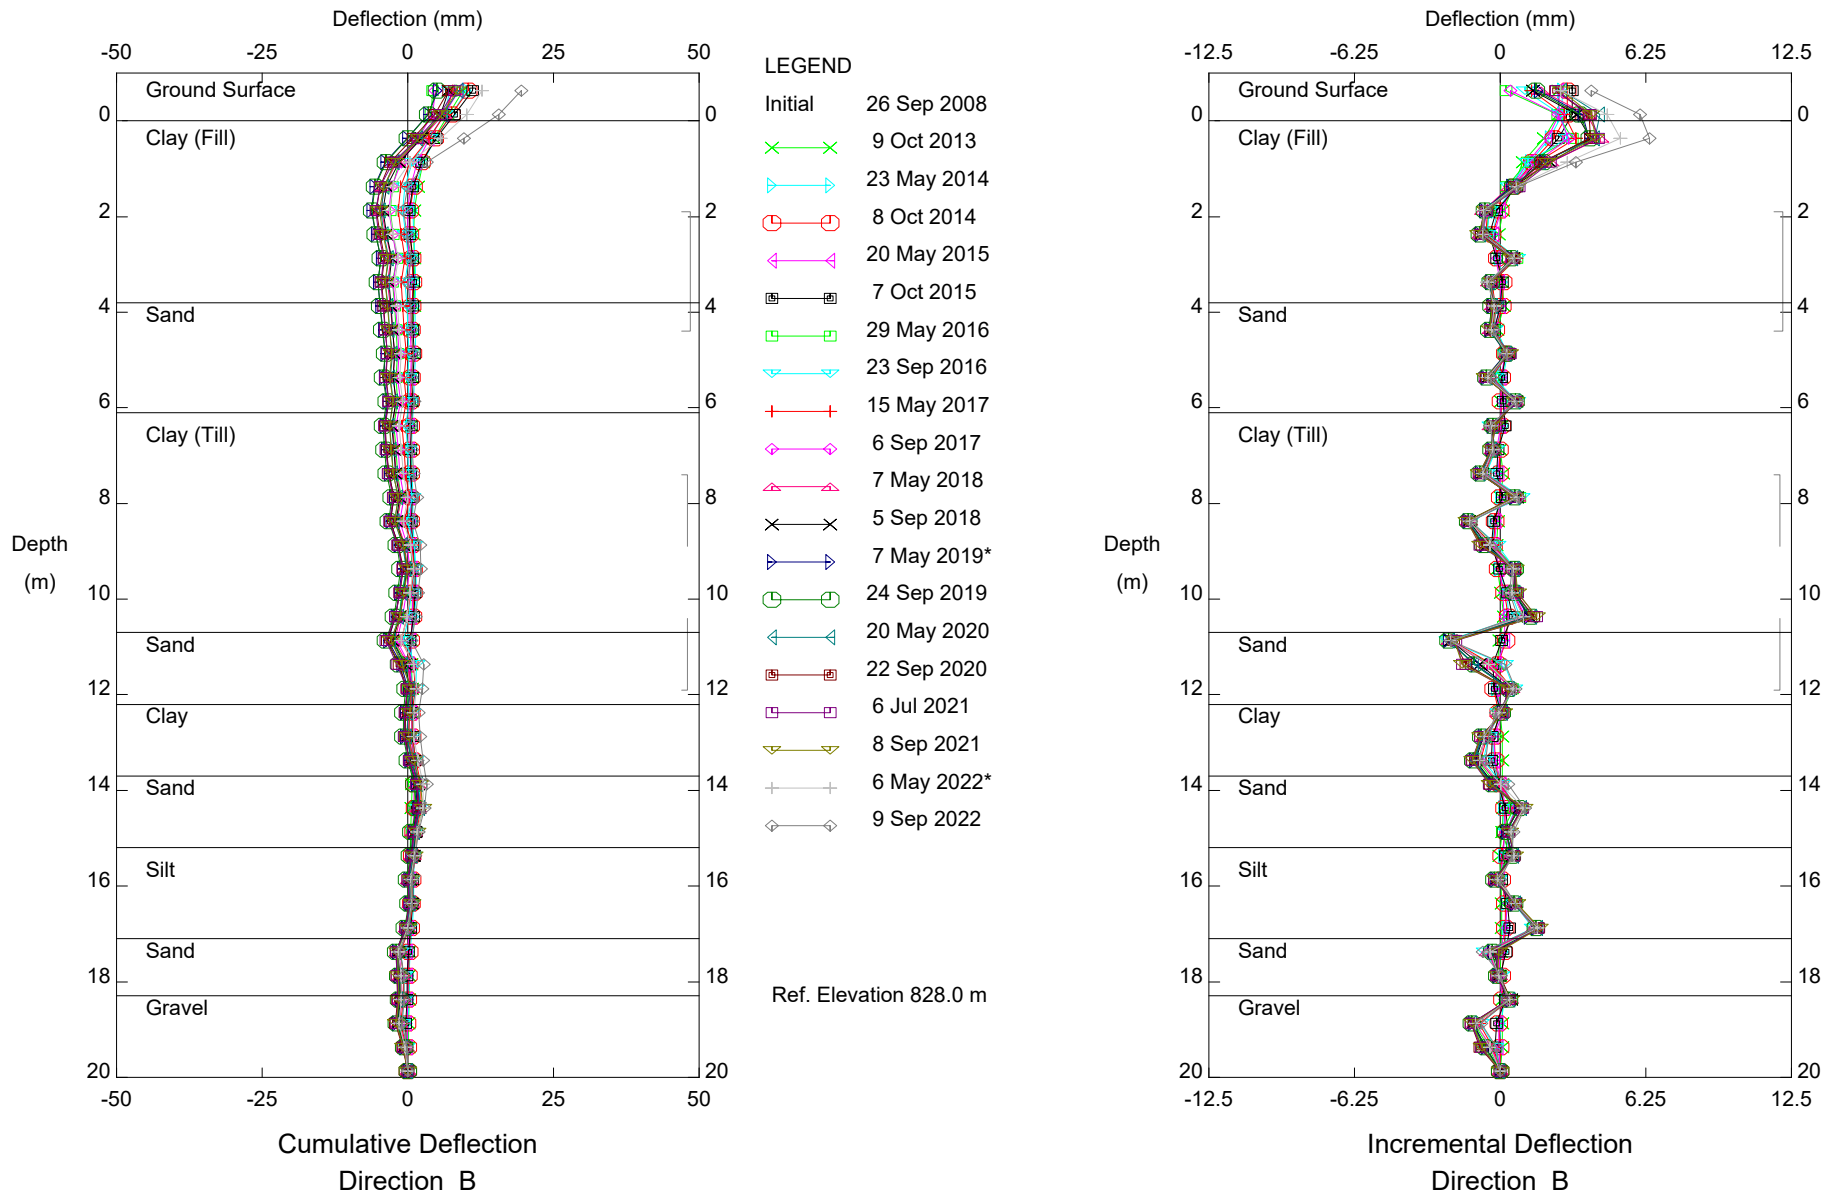
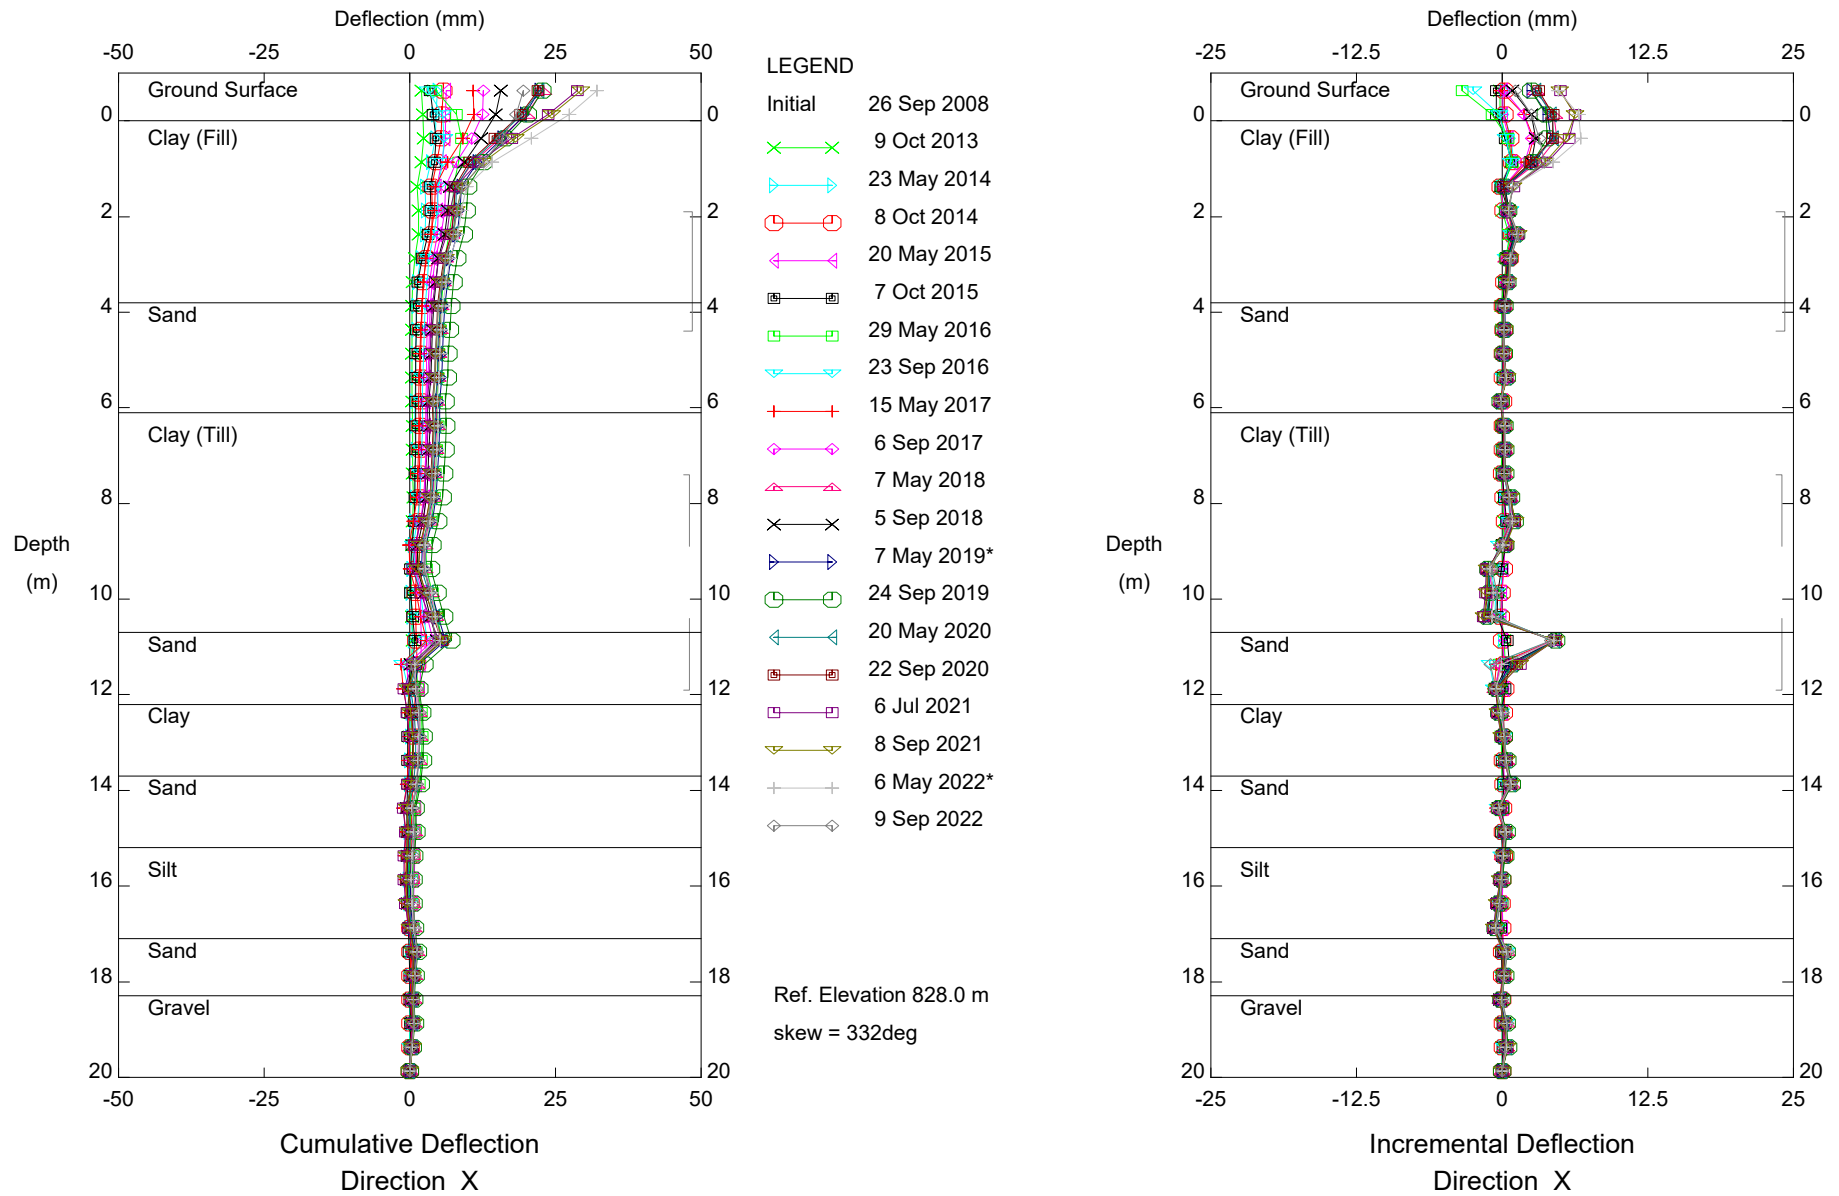
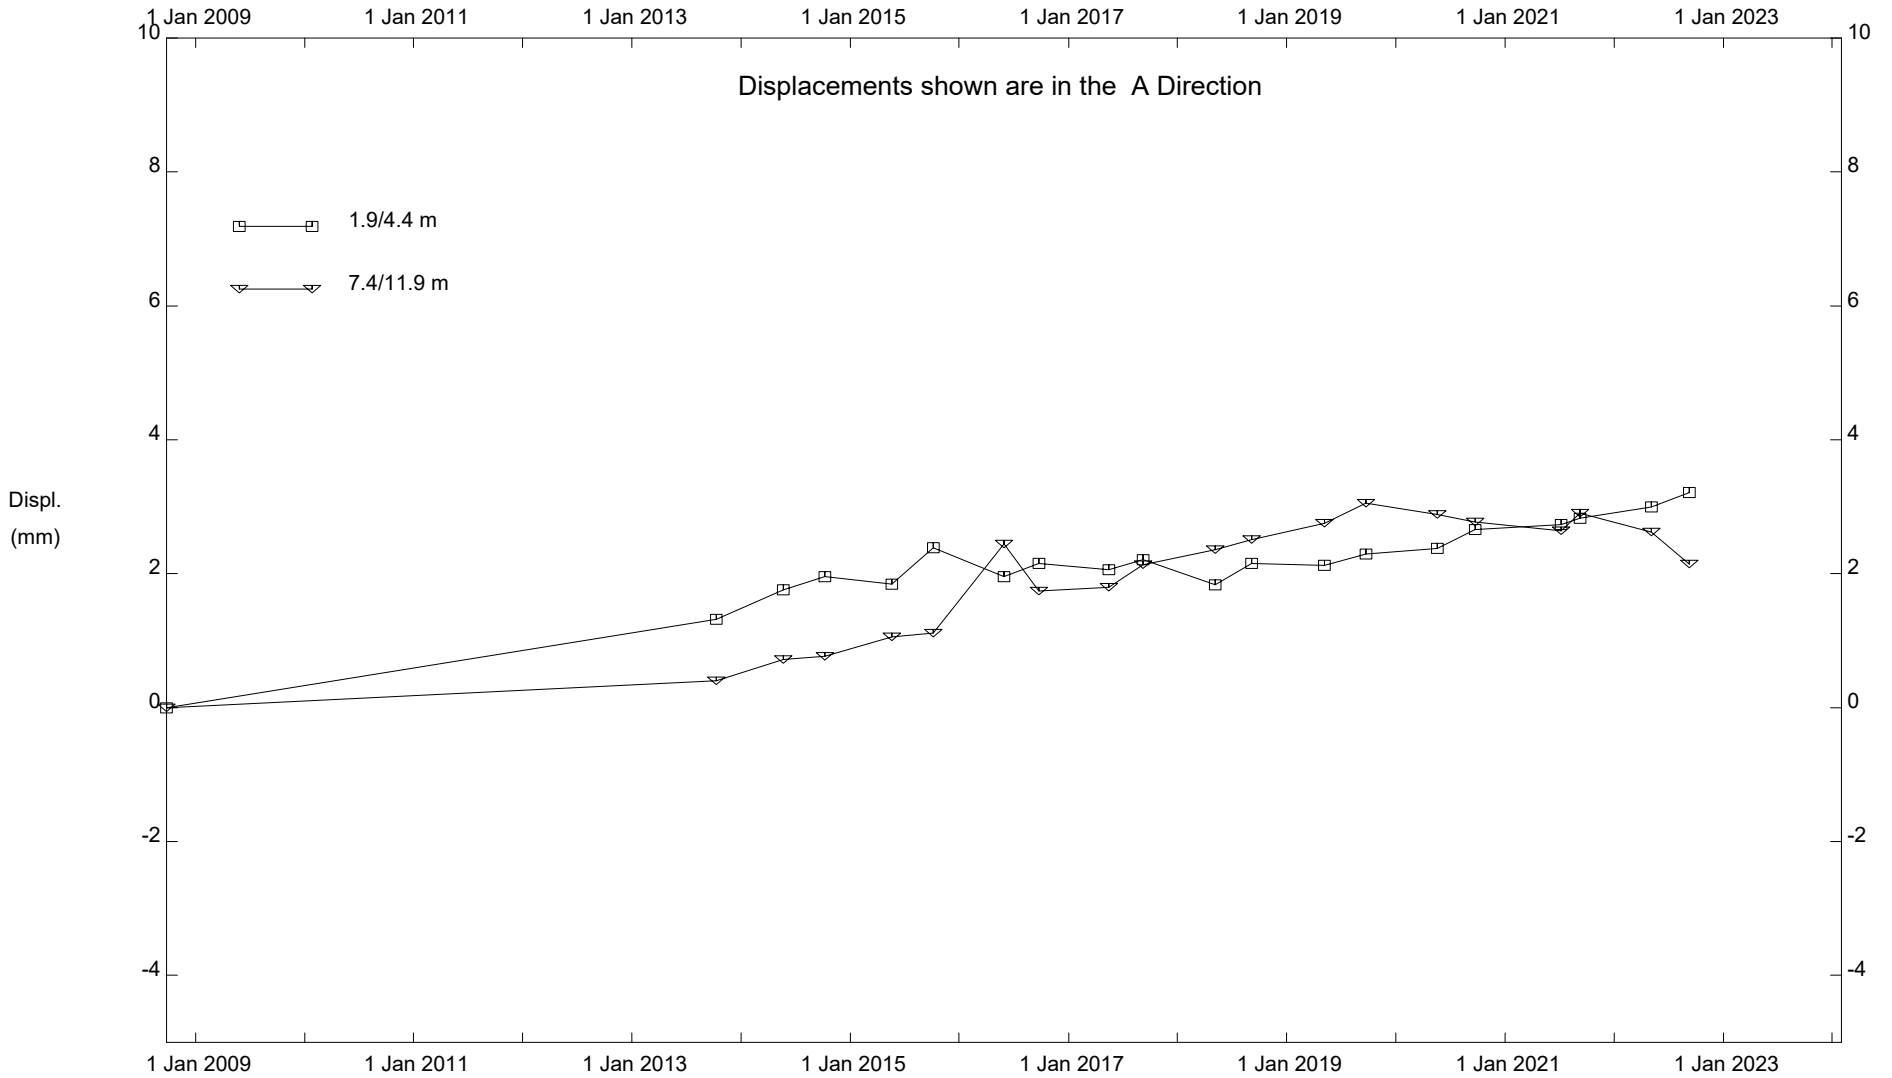
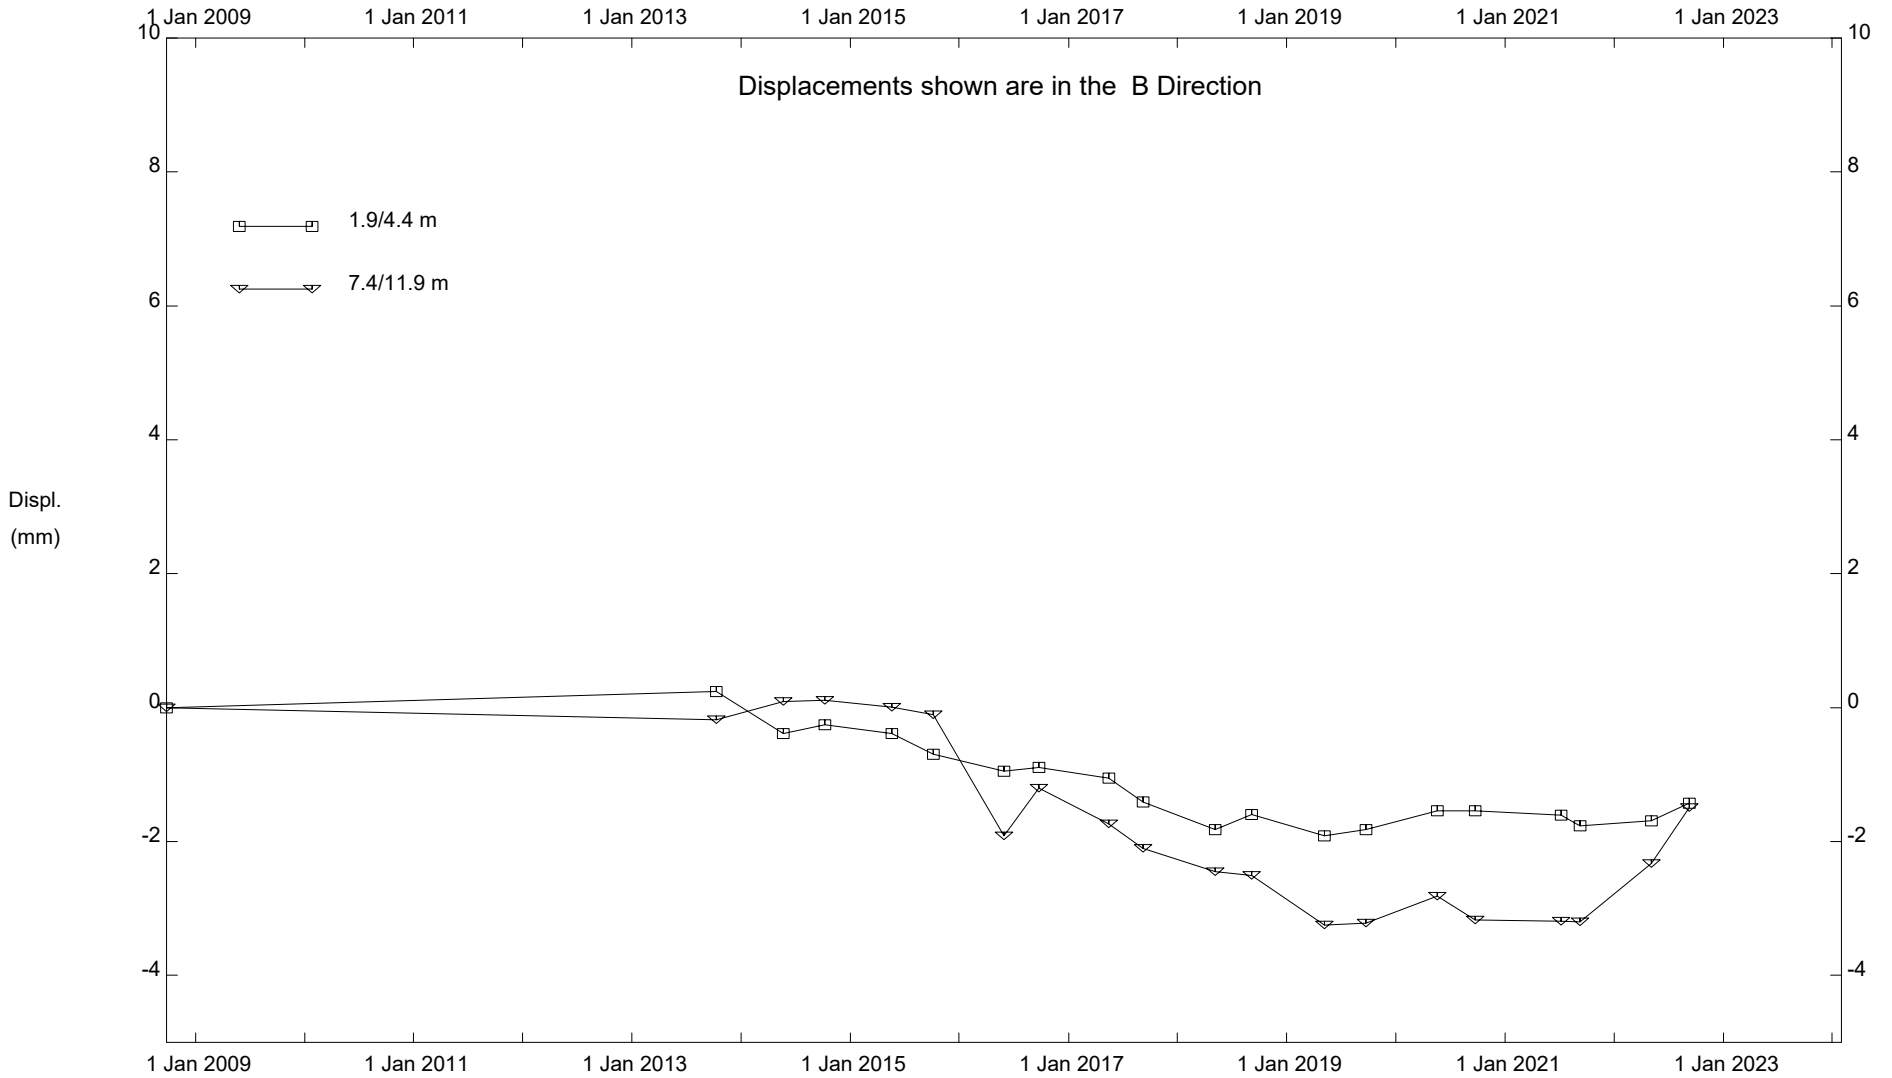
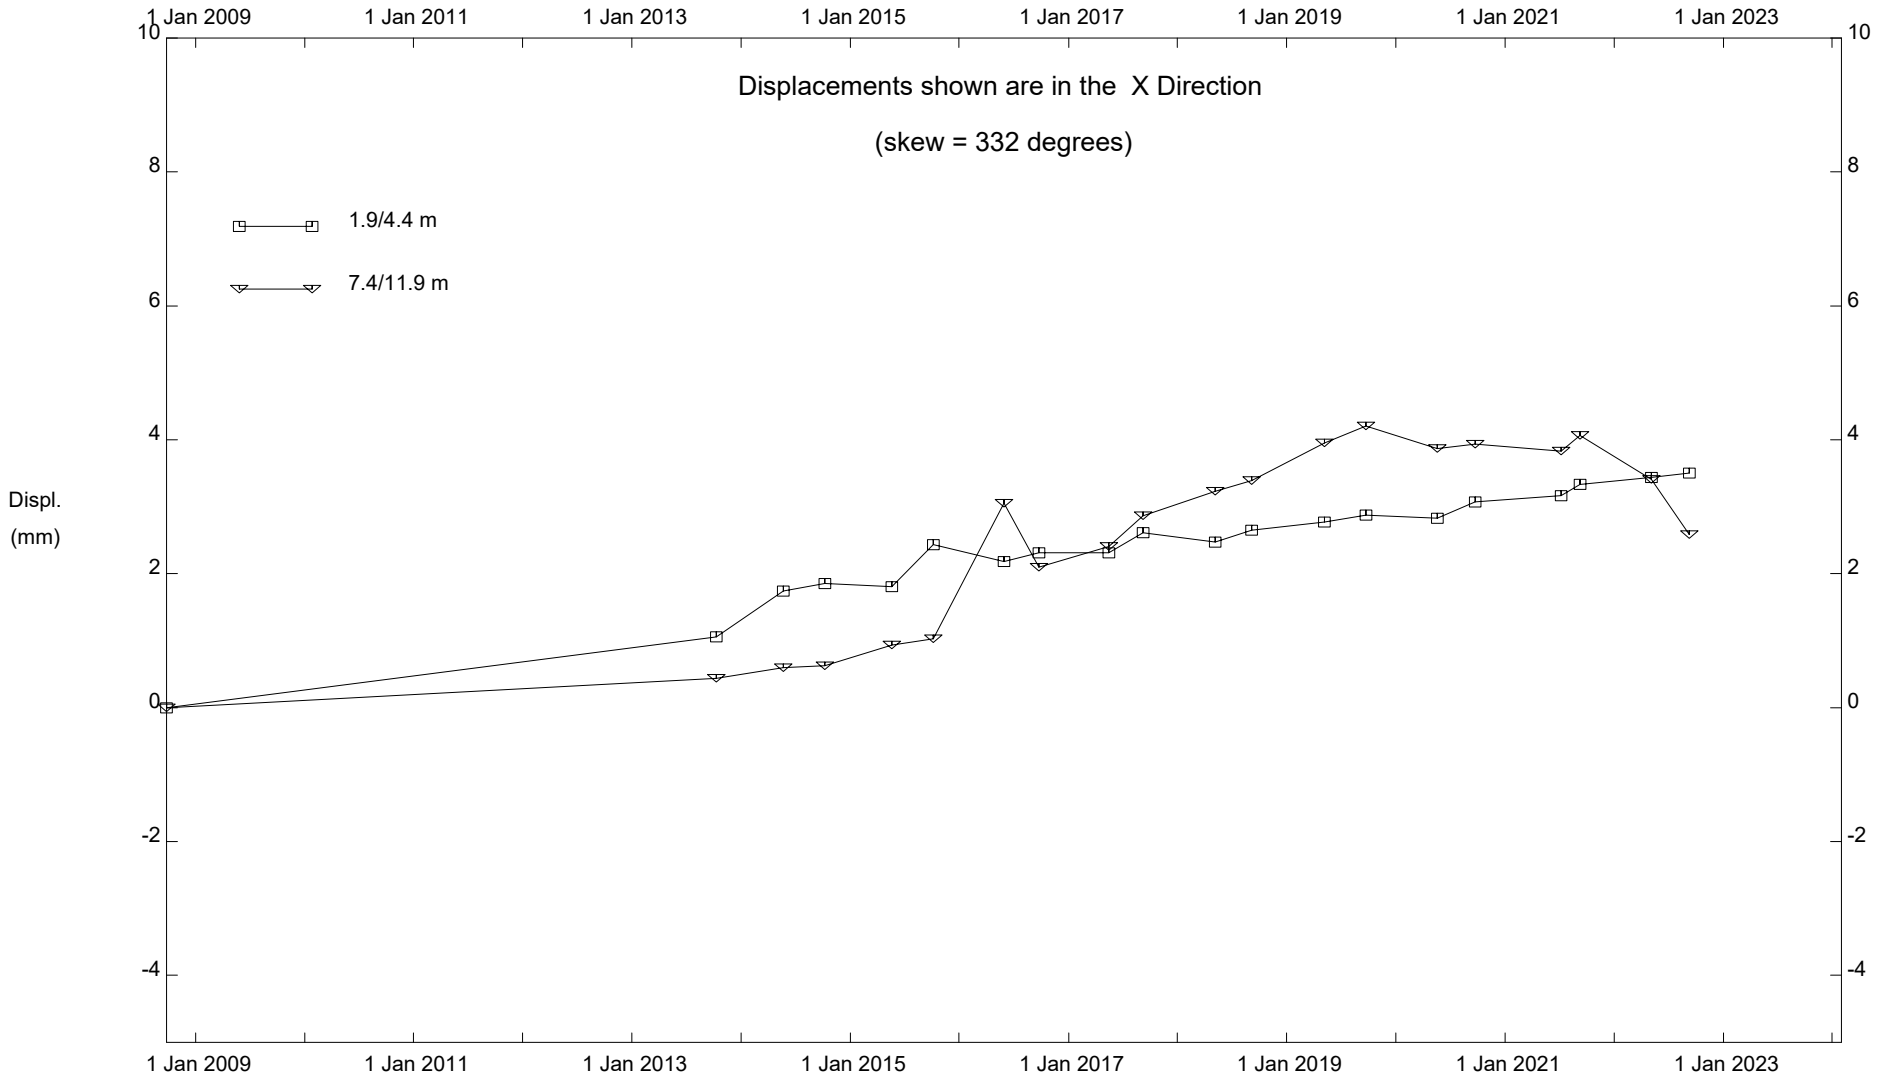
NC-52, Inclinometer SI-1

SI-1 shows negligible movement over the two zones of movement at about 3 m and 11 m depth. Total cumulative movement observed since 2006 is about 3 mm.

All slope inclinometers appear to show signs of creep movement except for SI13-3.
