To: Amy Driessen
Alberta Transportation
File: 123315222

From: Leslie Cho and Xiteng Liu
Stantec Consulting Ltd.
Date: October 5, 2022

Reference: North Central Region, Stony Plain, Site NC052 - Highway 621:02 Pembina River Bridge Abutment, Fall 2022 Instrumentation Monitoring Report

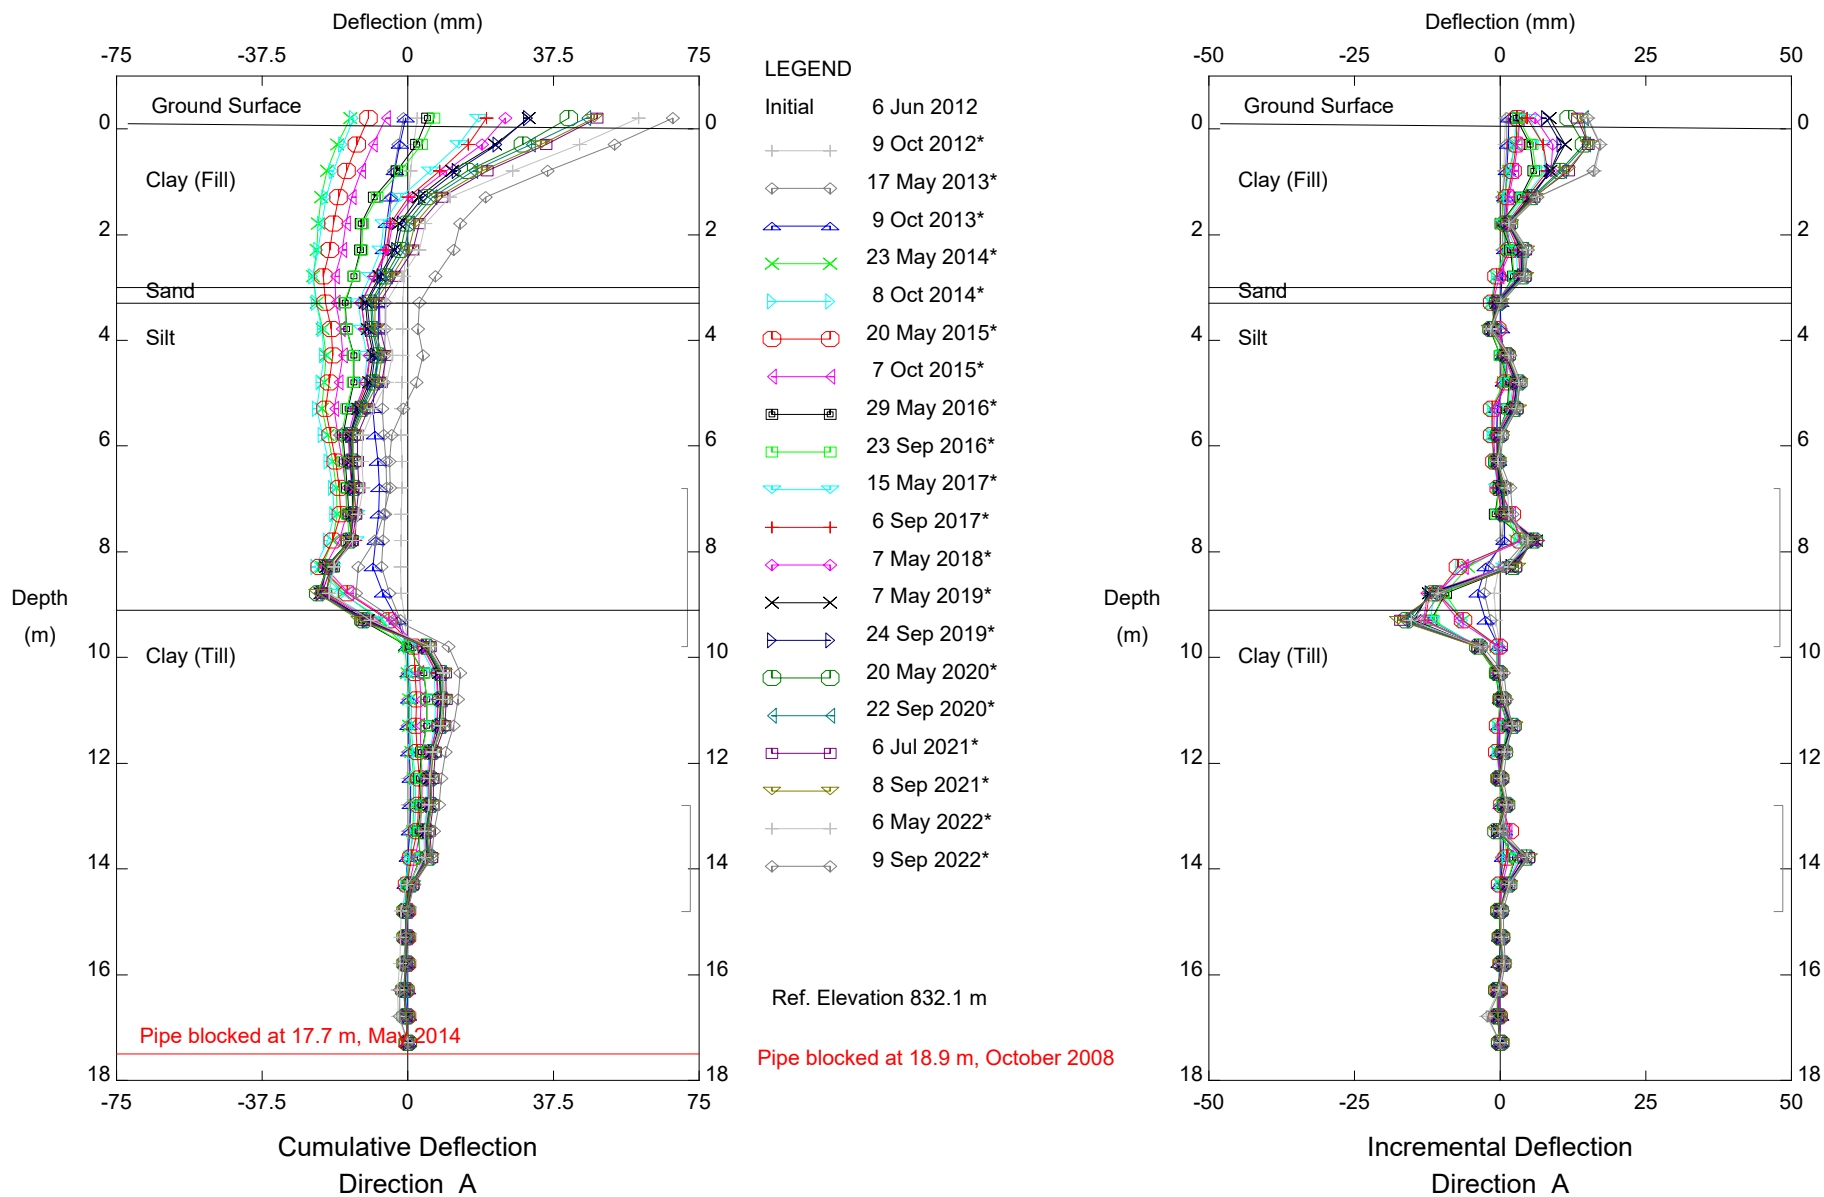
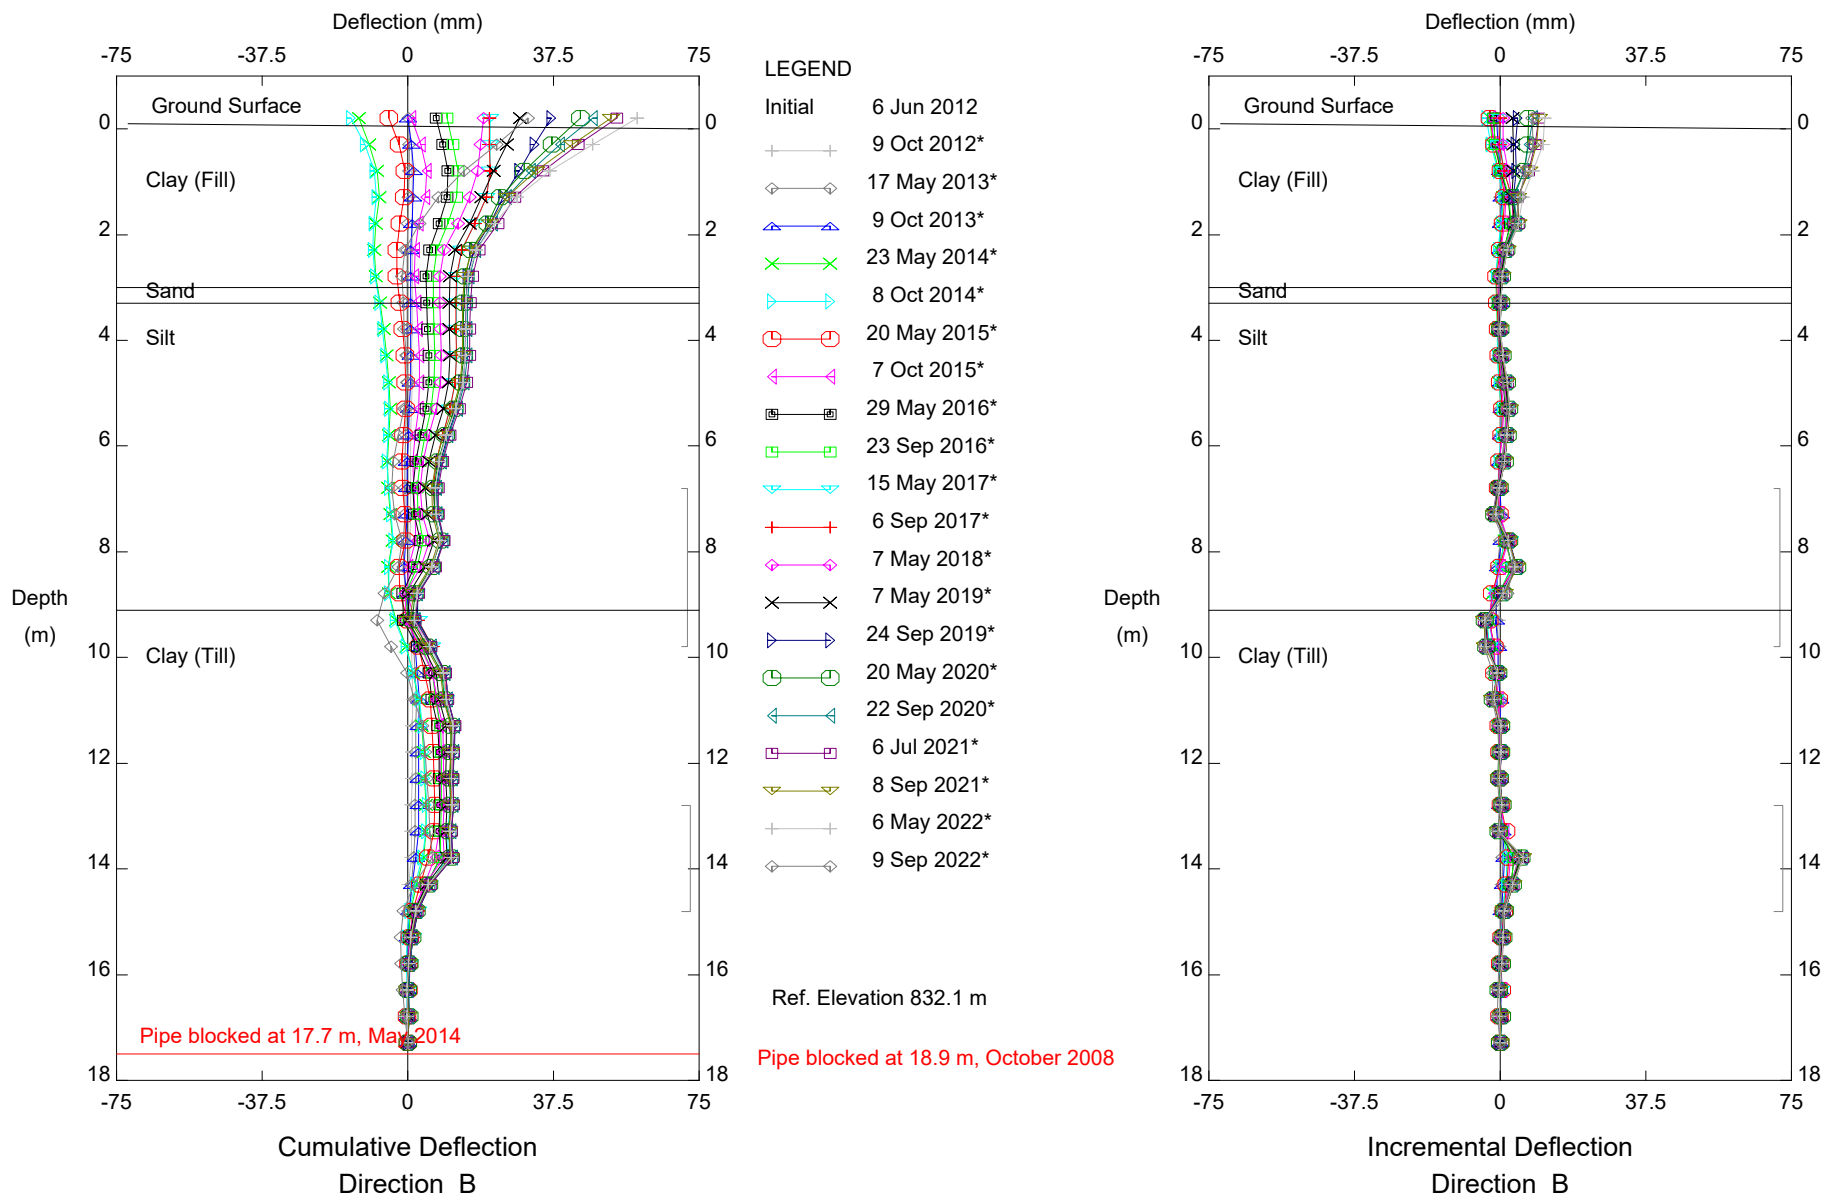
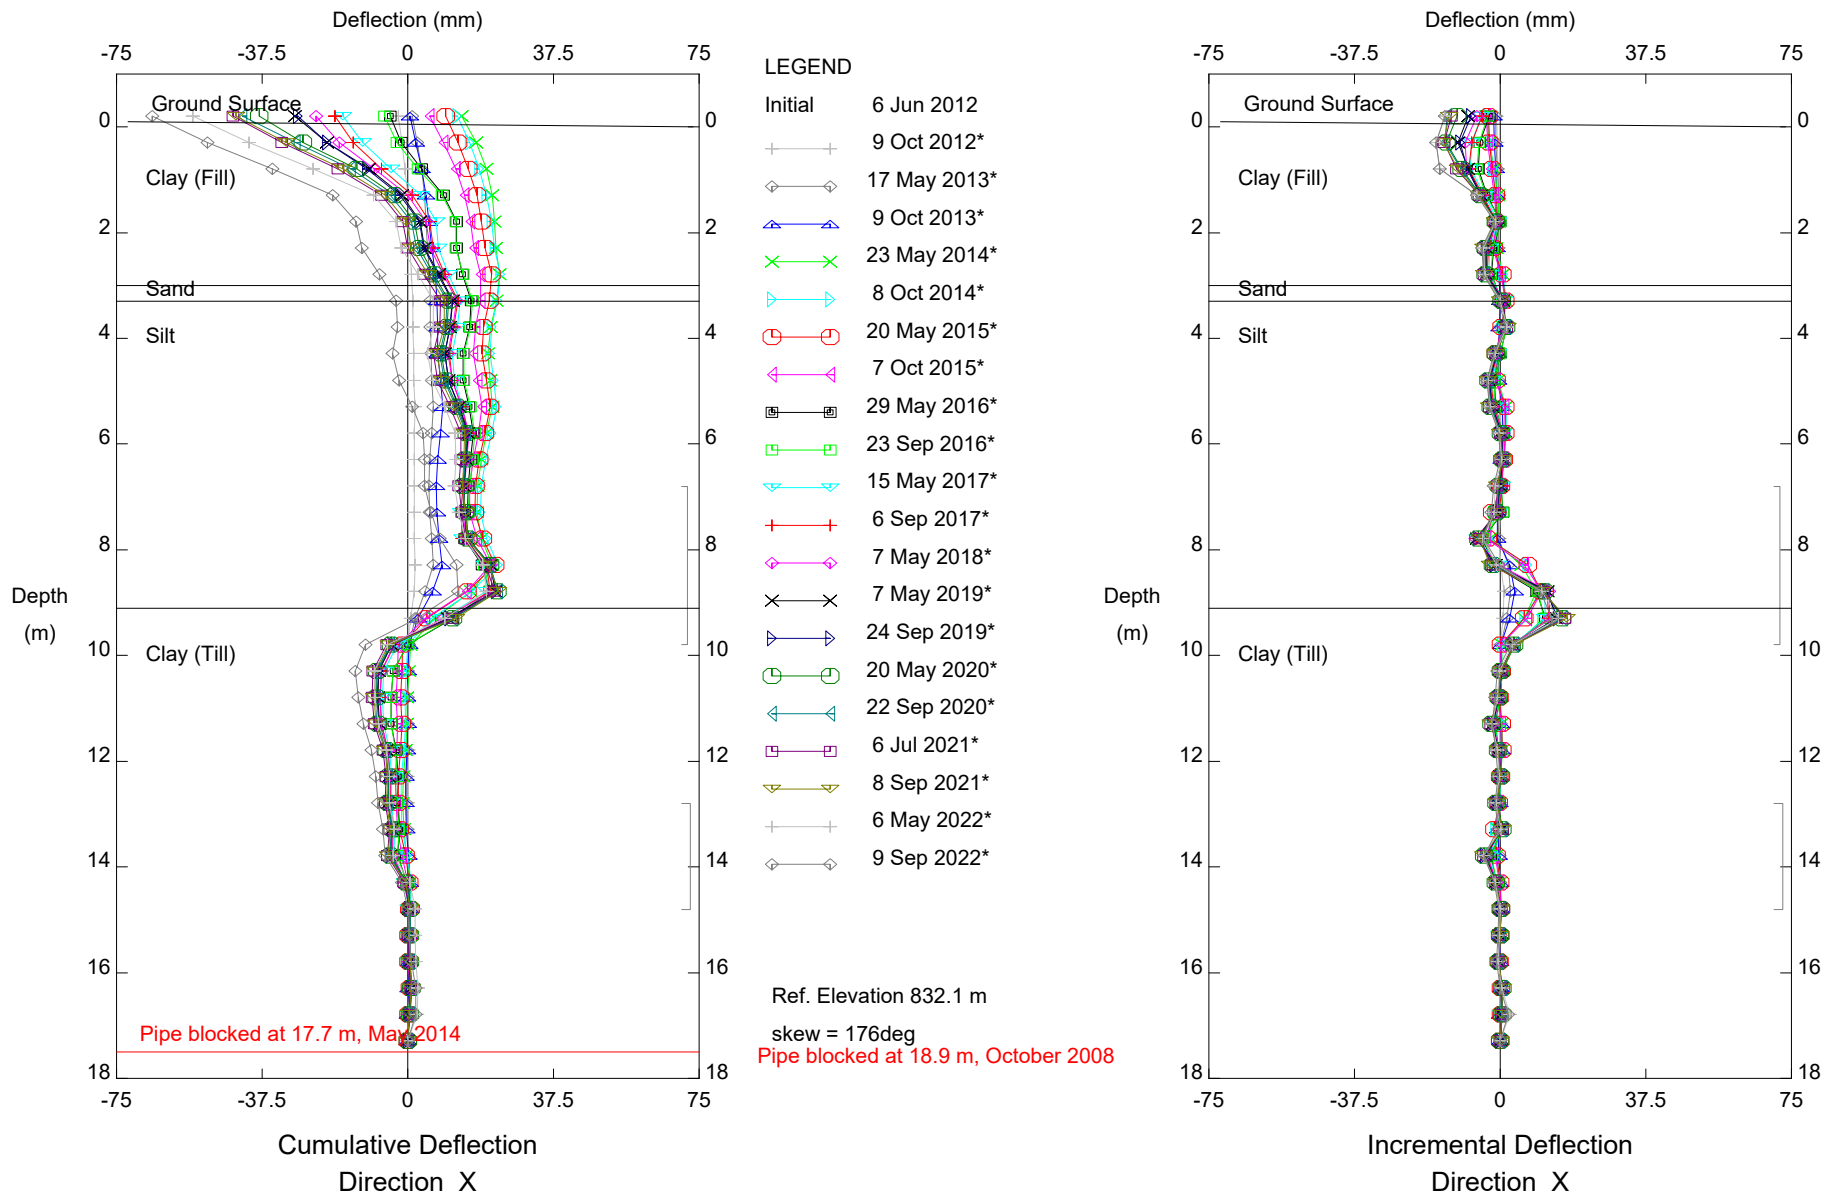
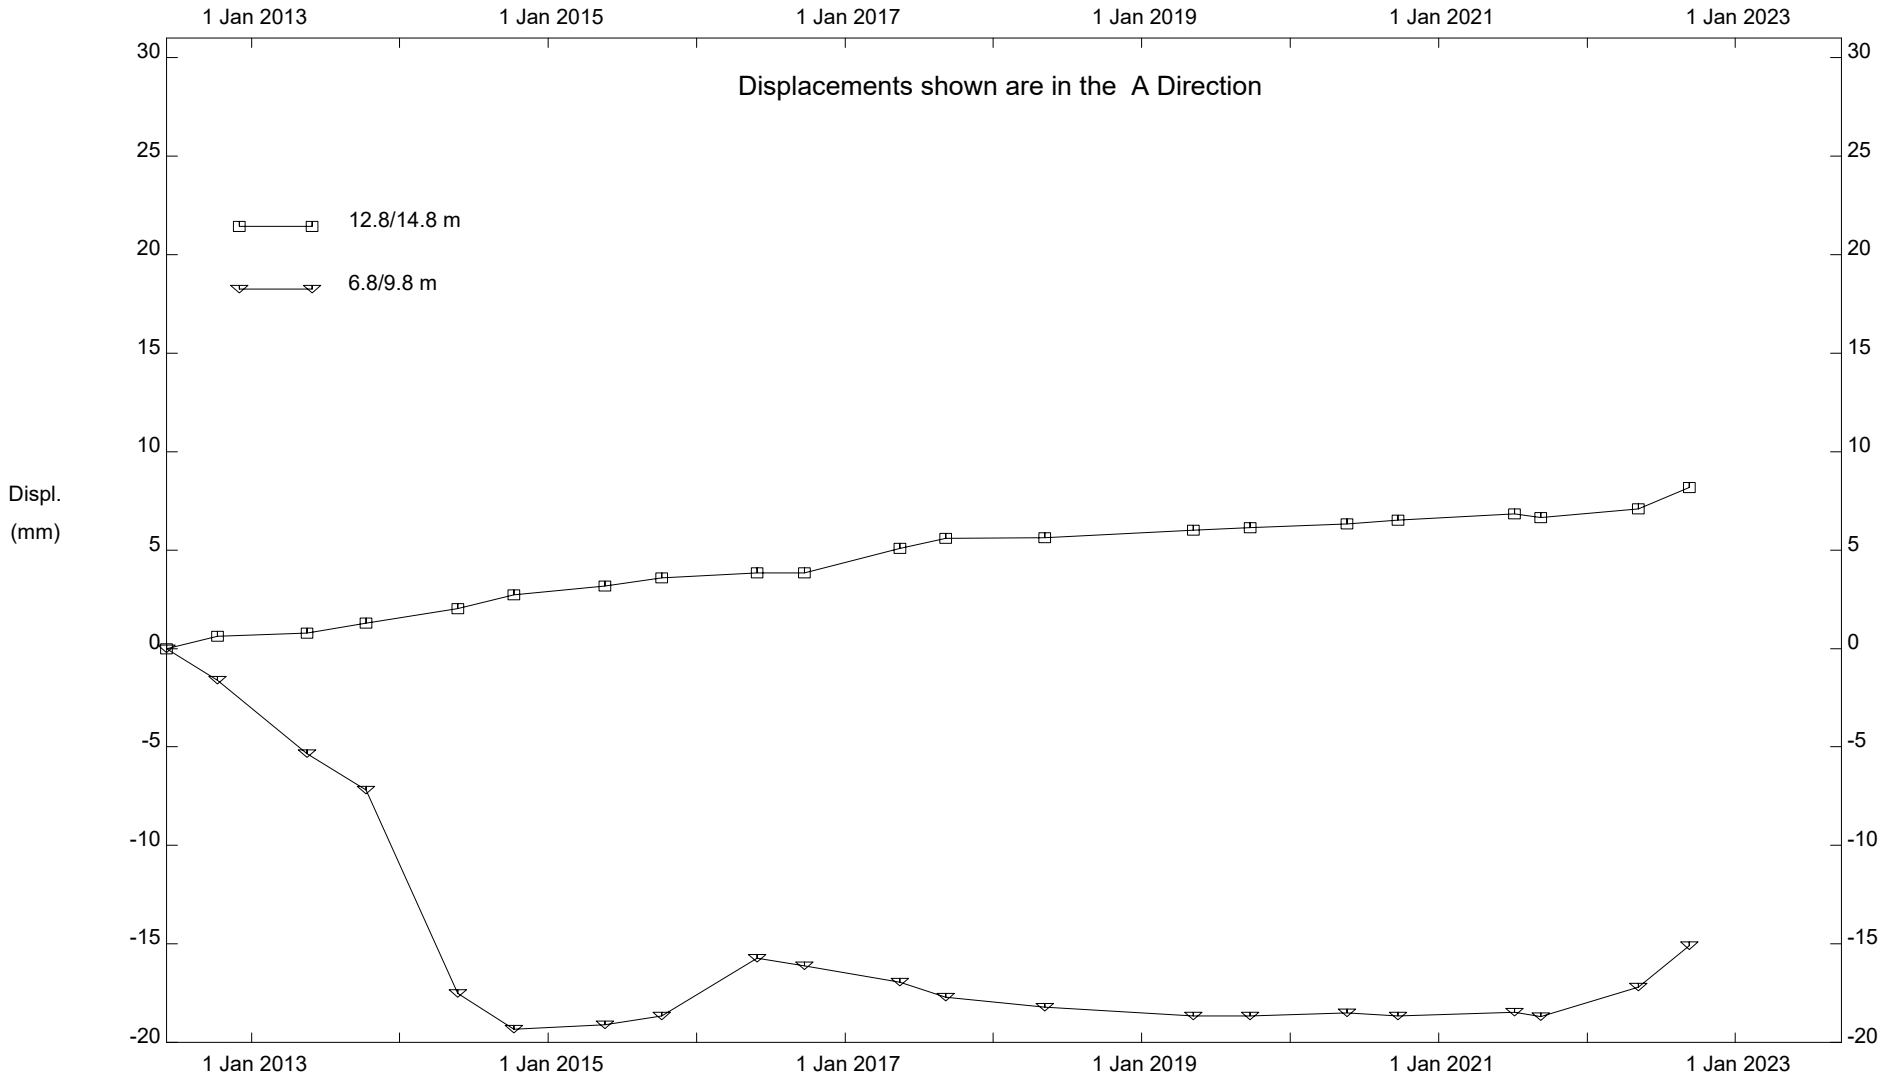
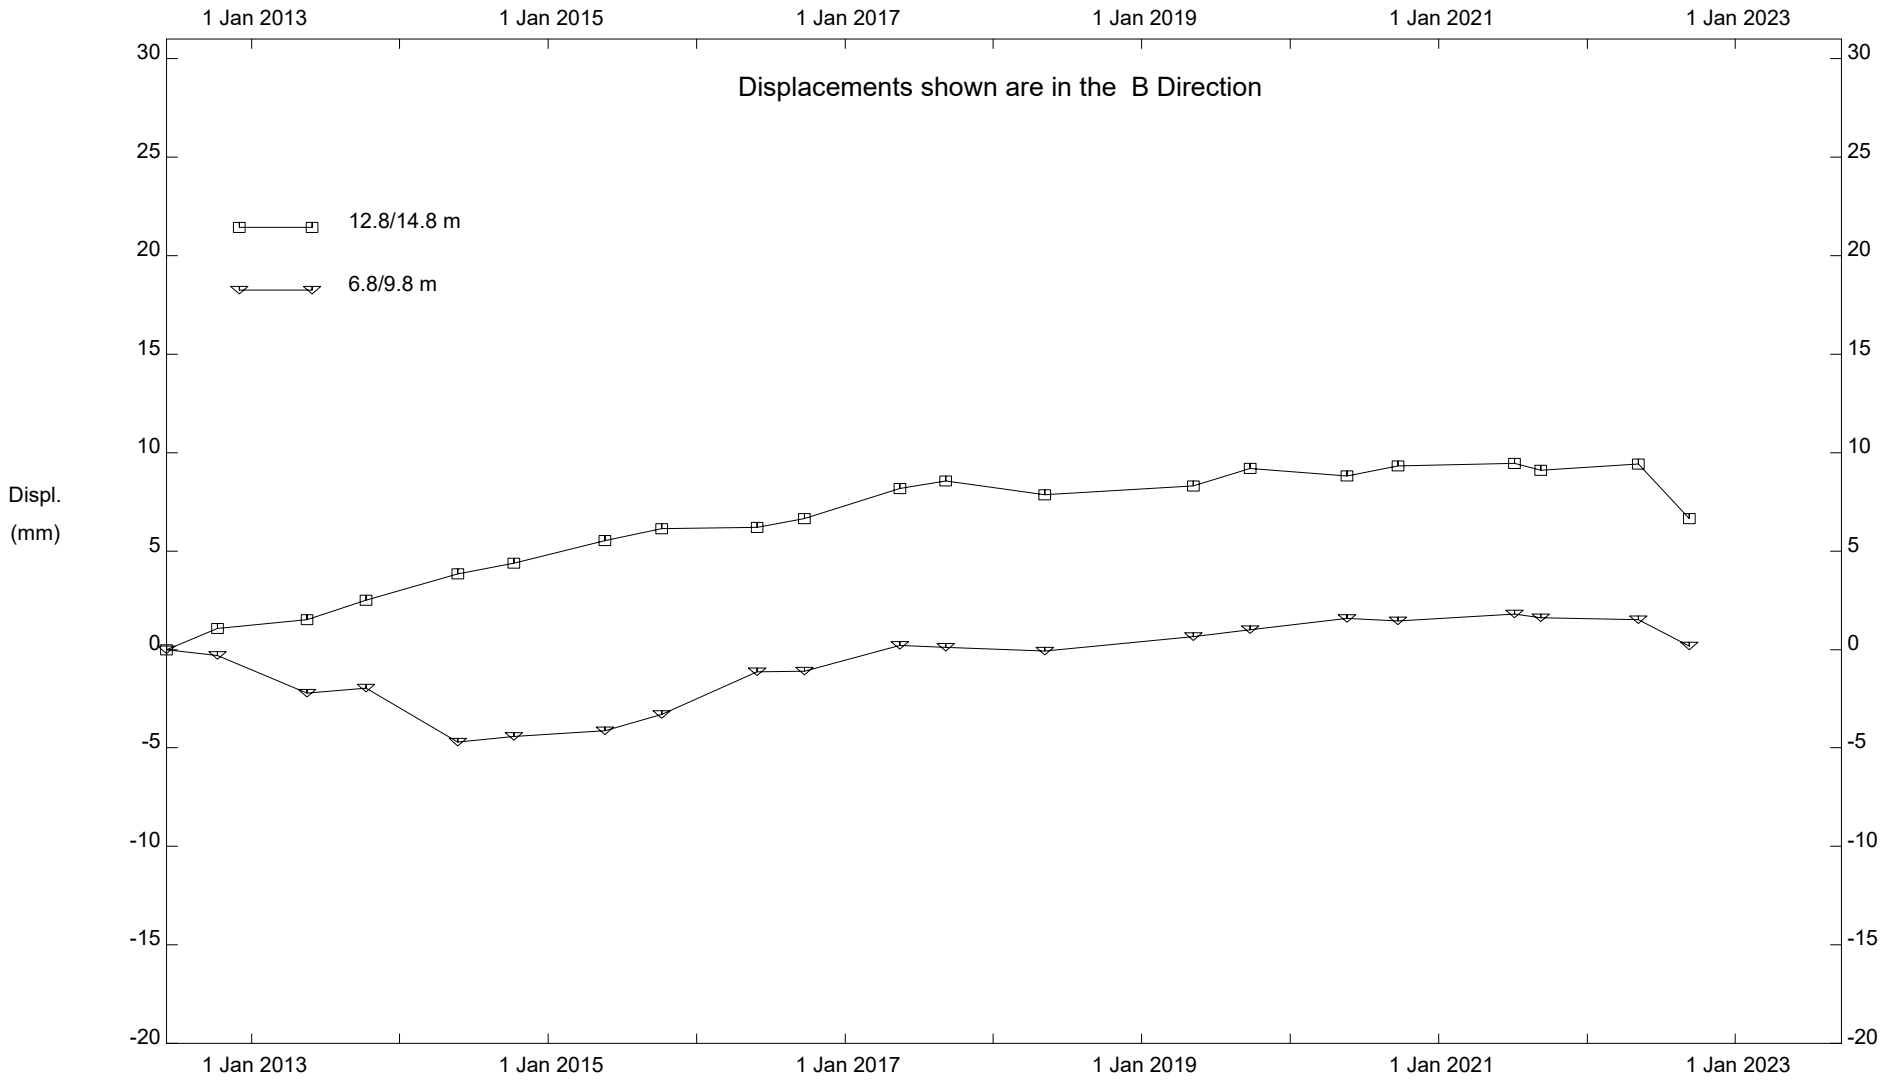
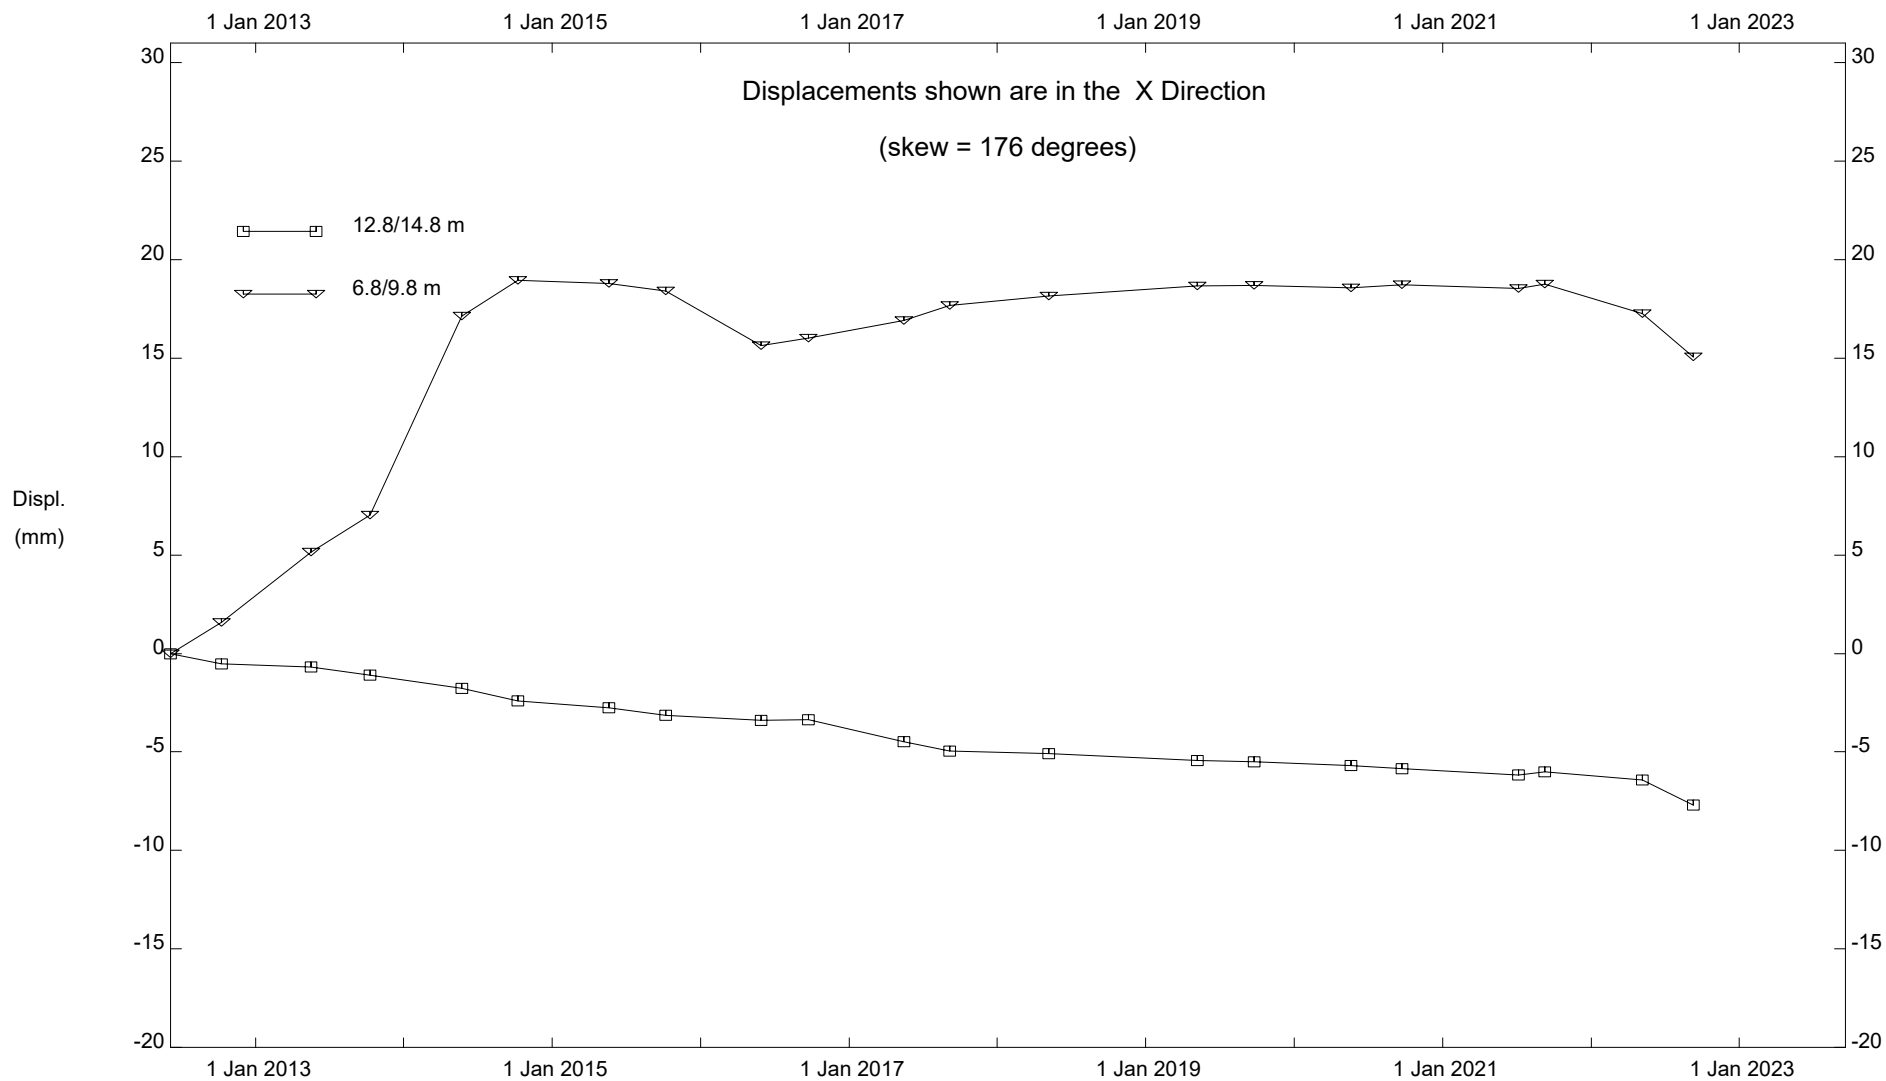
NC-52, Inclinator SI-2
 Alberta Transportation

SI-2 shows negligible movement over the two zones of movement at about 8 m and 14 m depth.

All slope inclinometers appear to show signs of creep movement except for SI13-3.
