To: Amy Driessen
Alberta Transportation
File: 123315222

From: Leslie Cho and Xiteng Liu
Stantec Consulting Ltd.
Date: October 5, 2022

Reference: North Central Region, Stony Plain, Site NC052 - Highway 621:02 Pembina River Bridge Abutment, Fall 2022 Instrumentation Monitoring Report

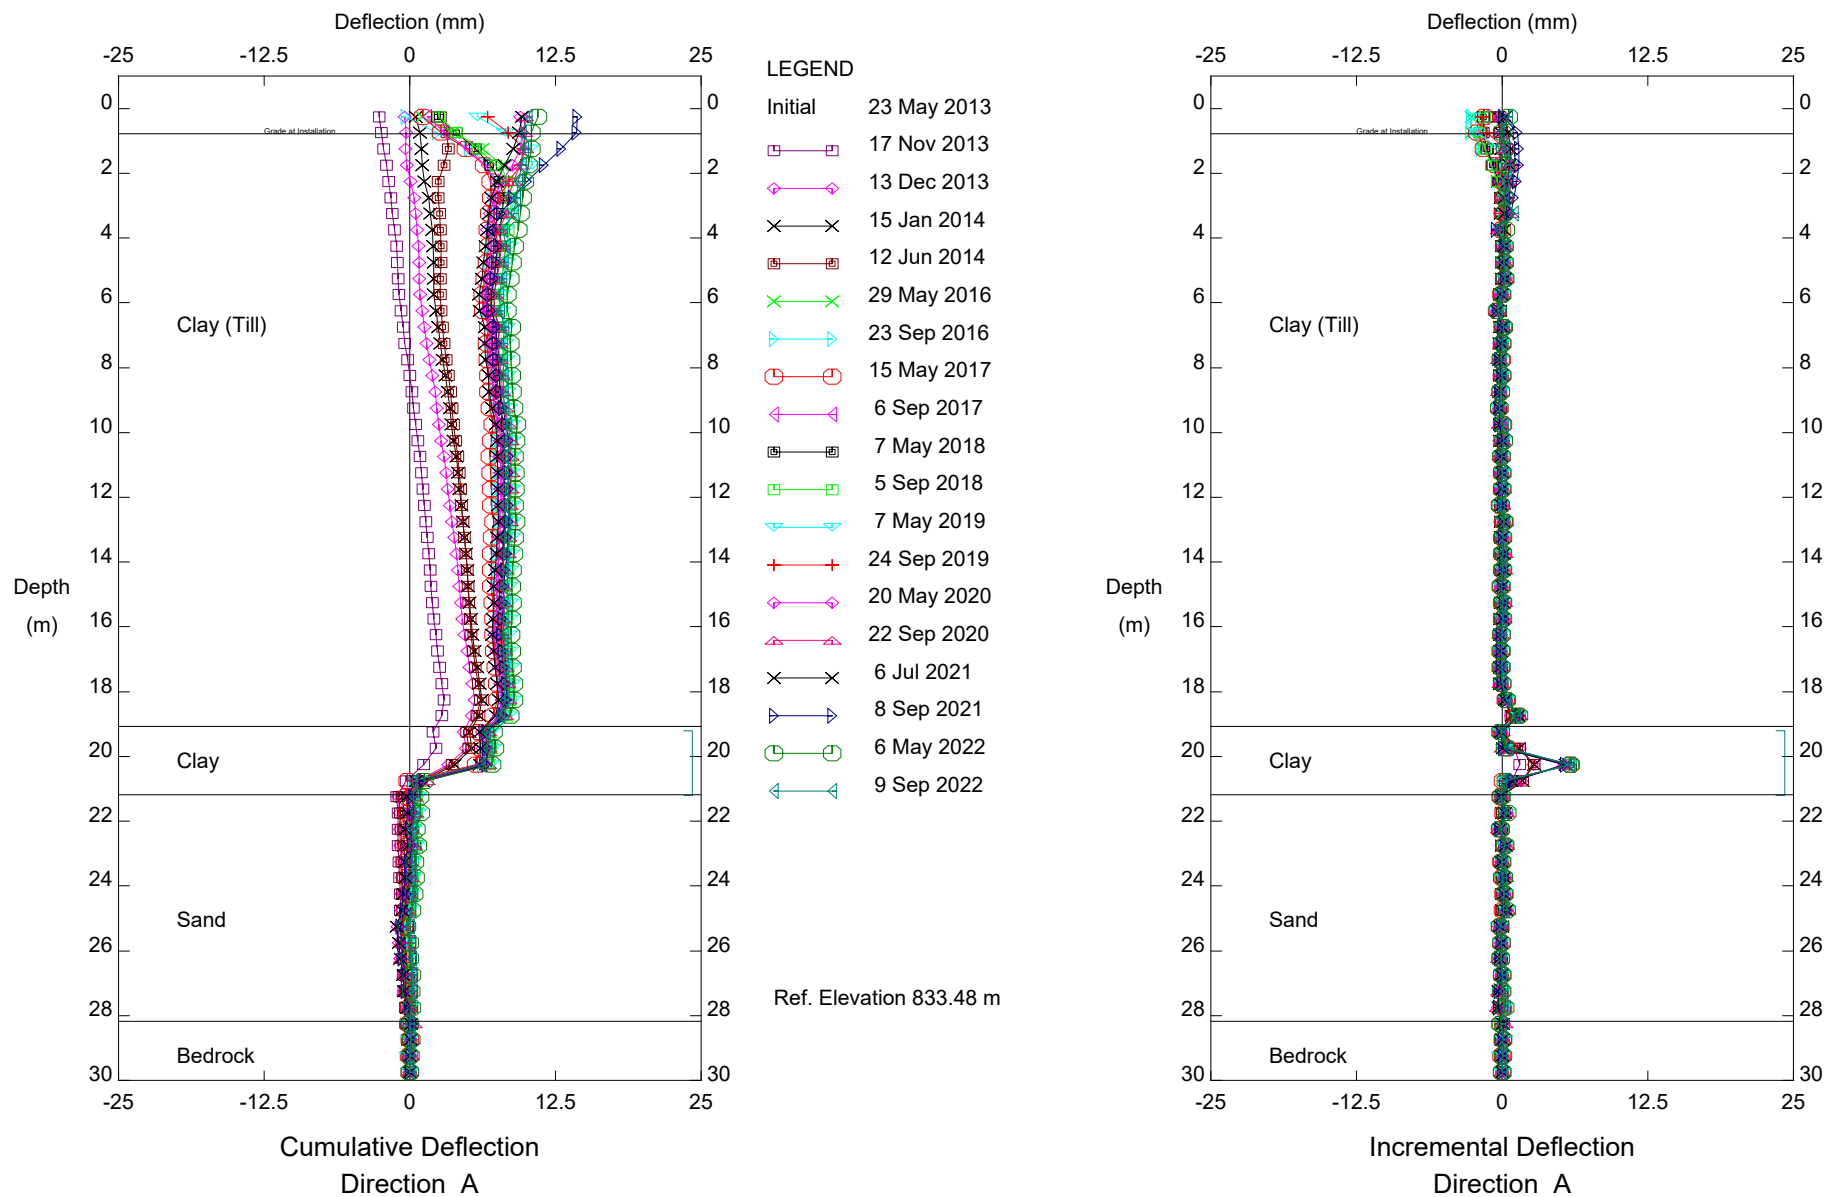
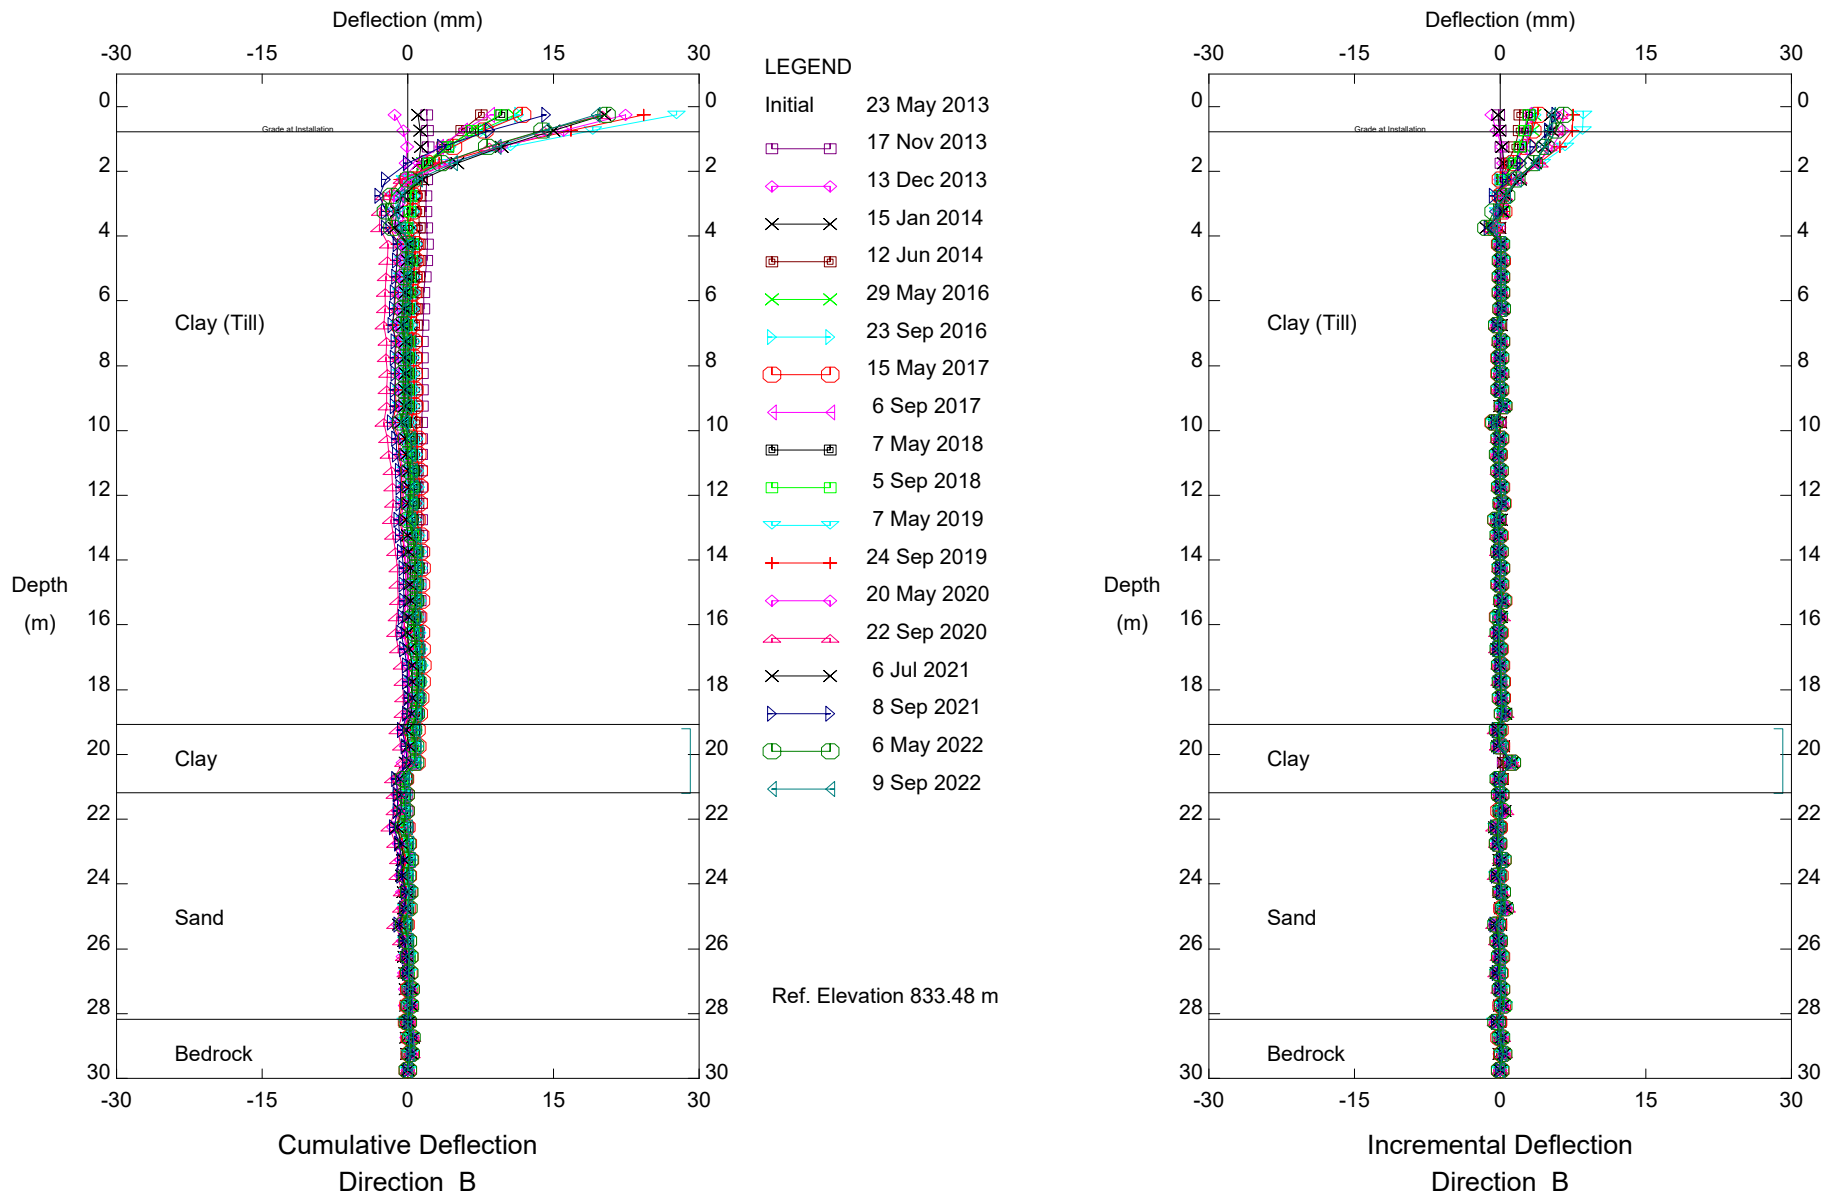
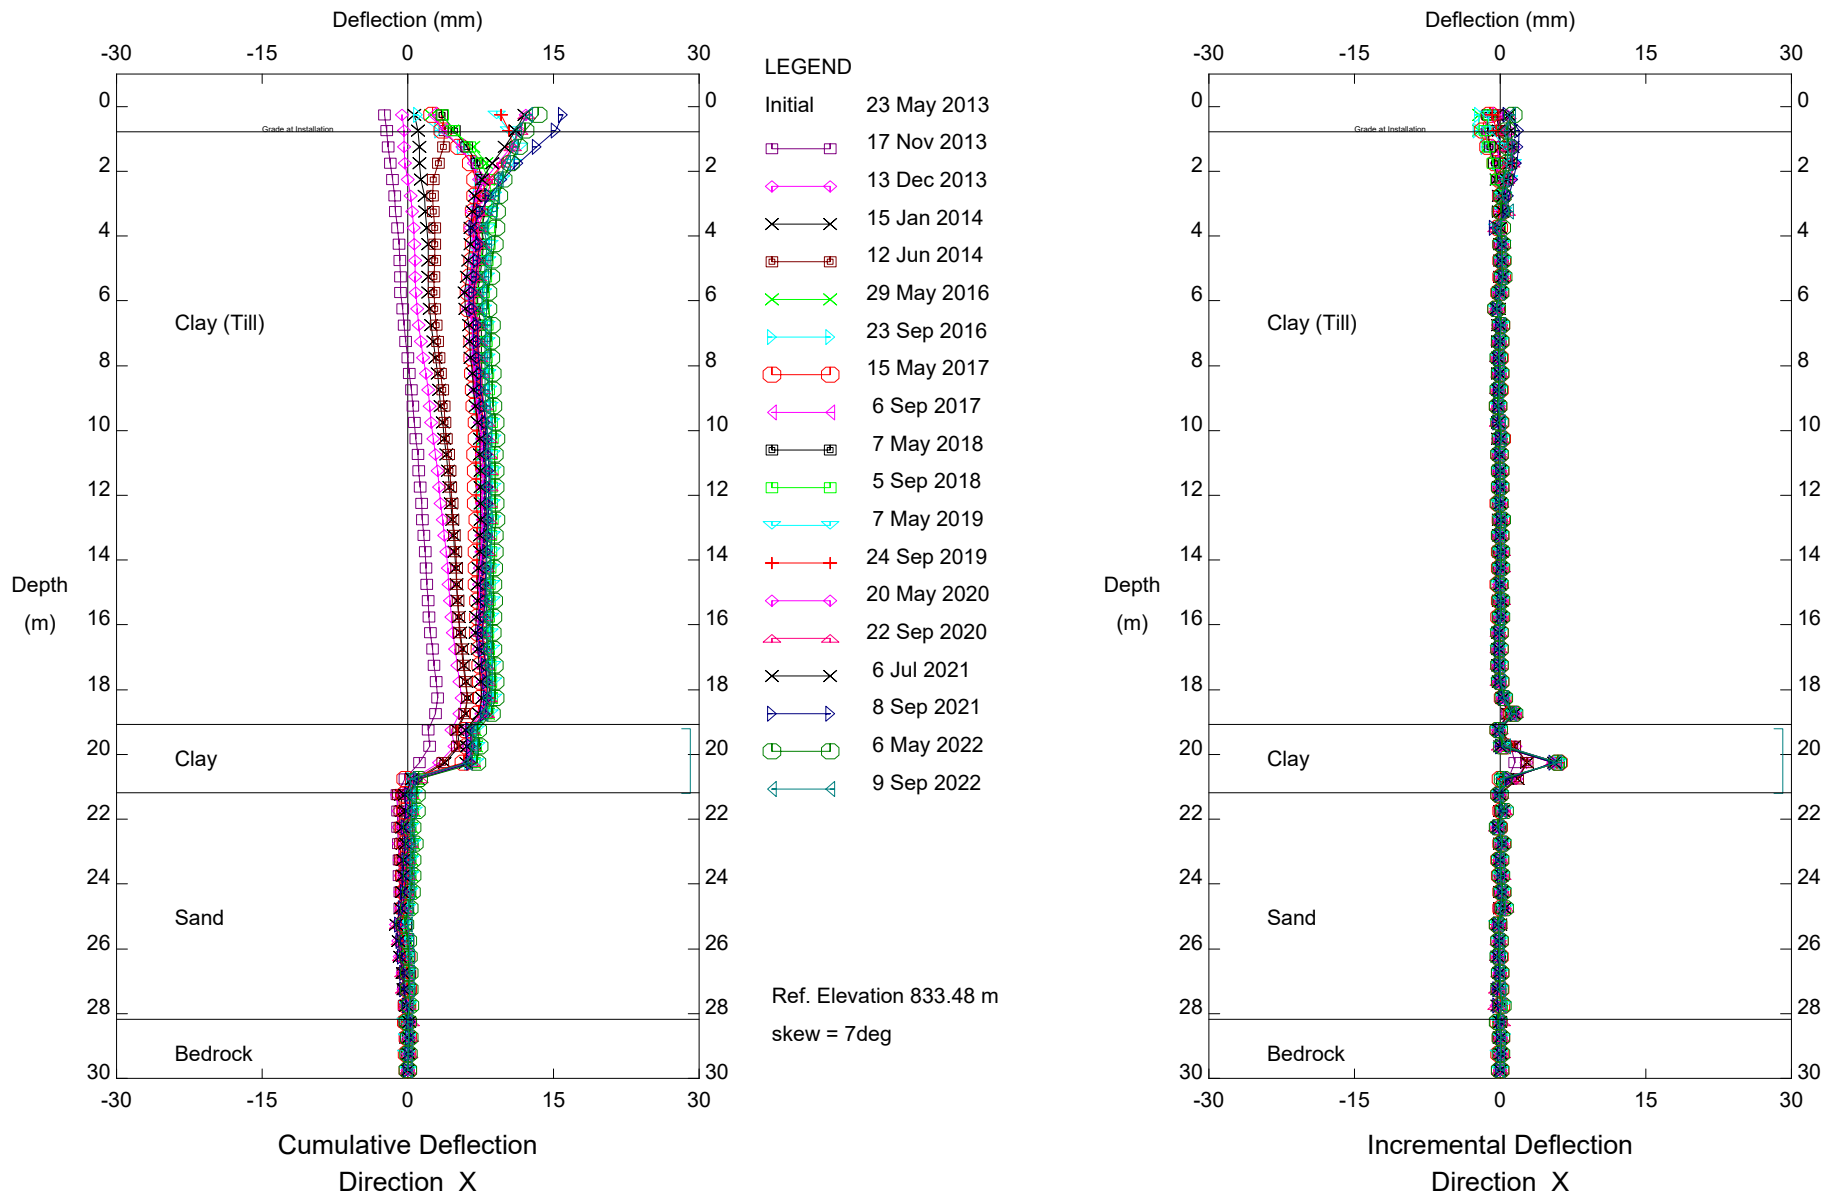
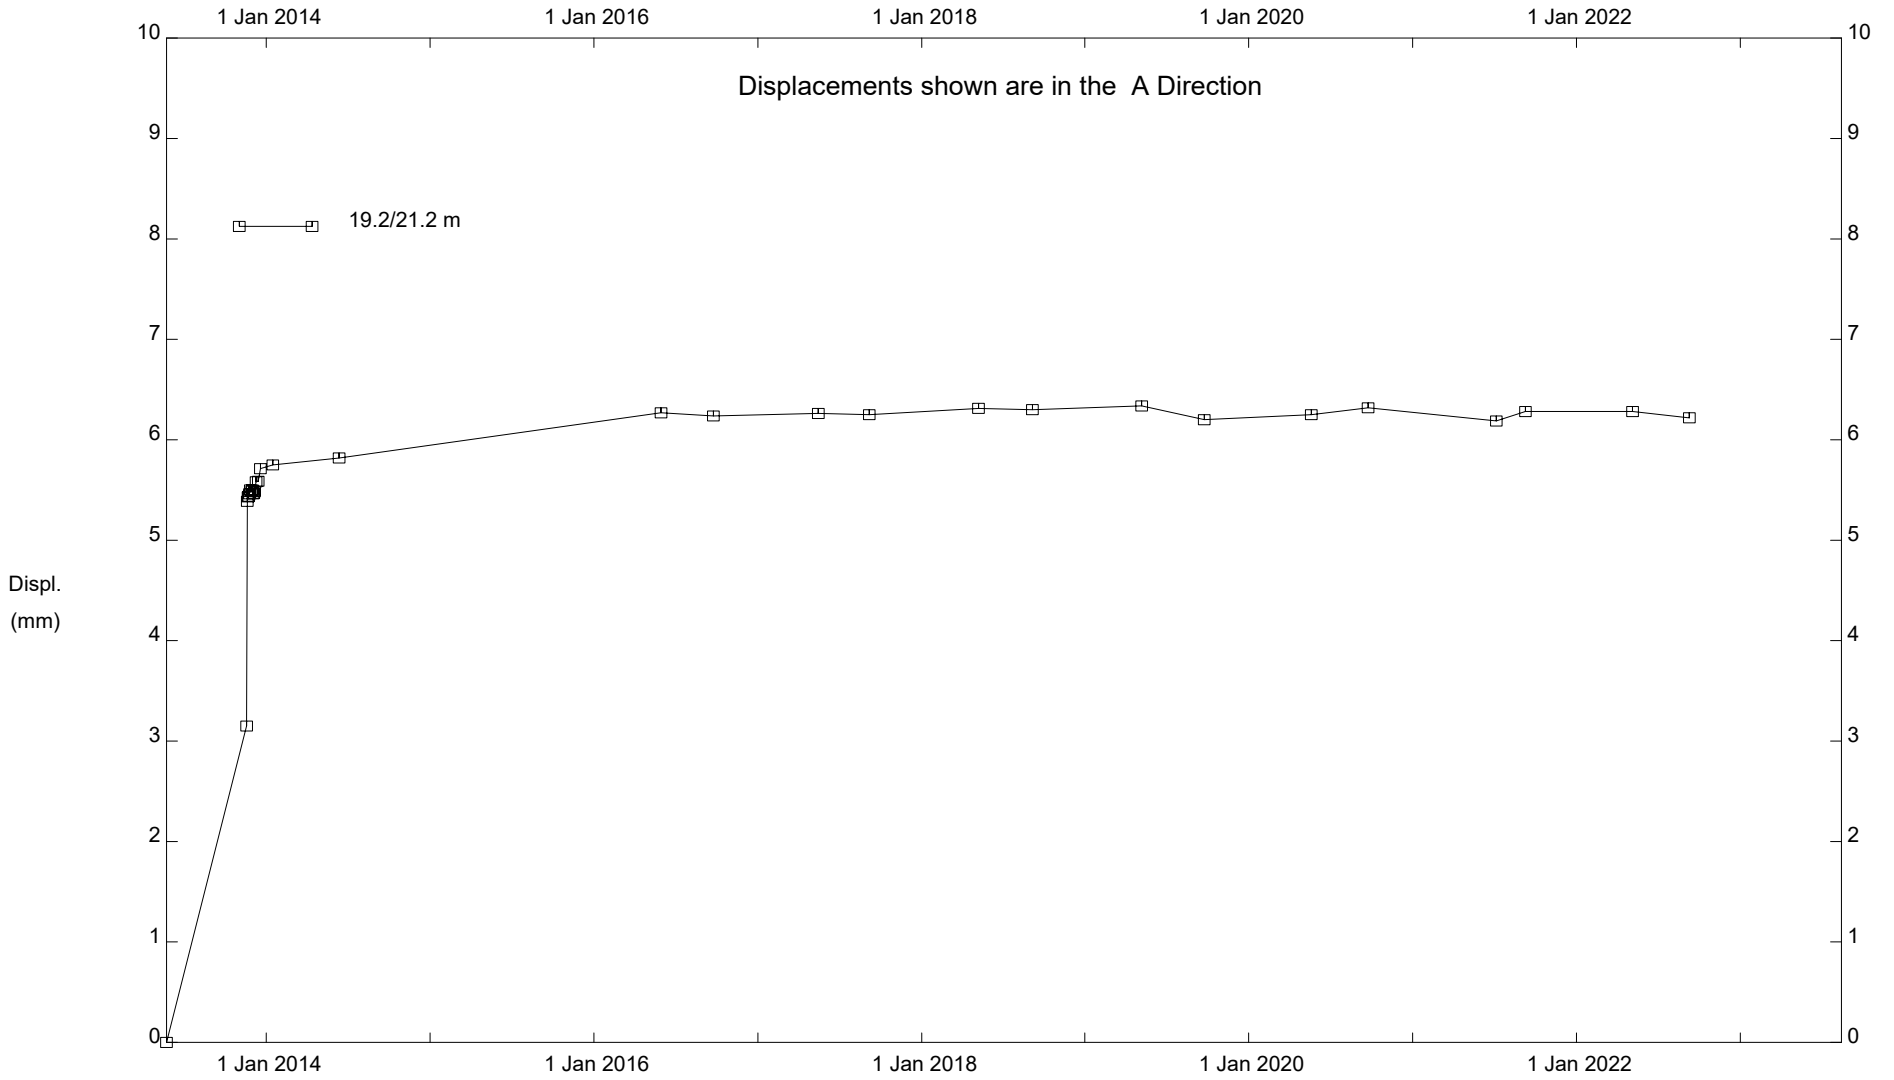
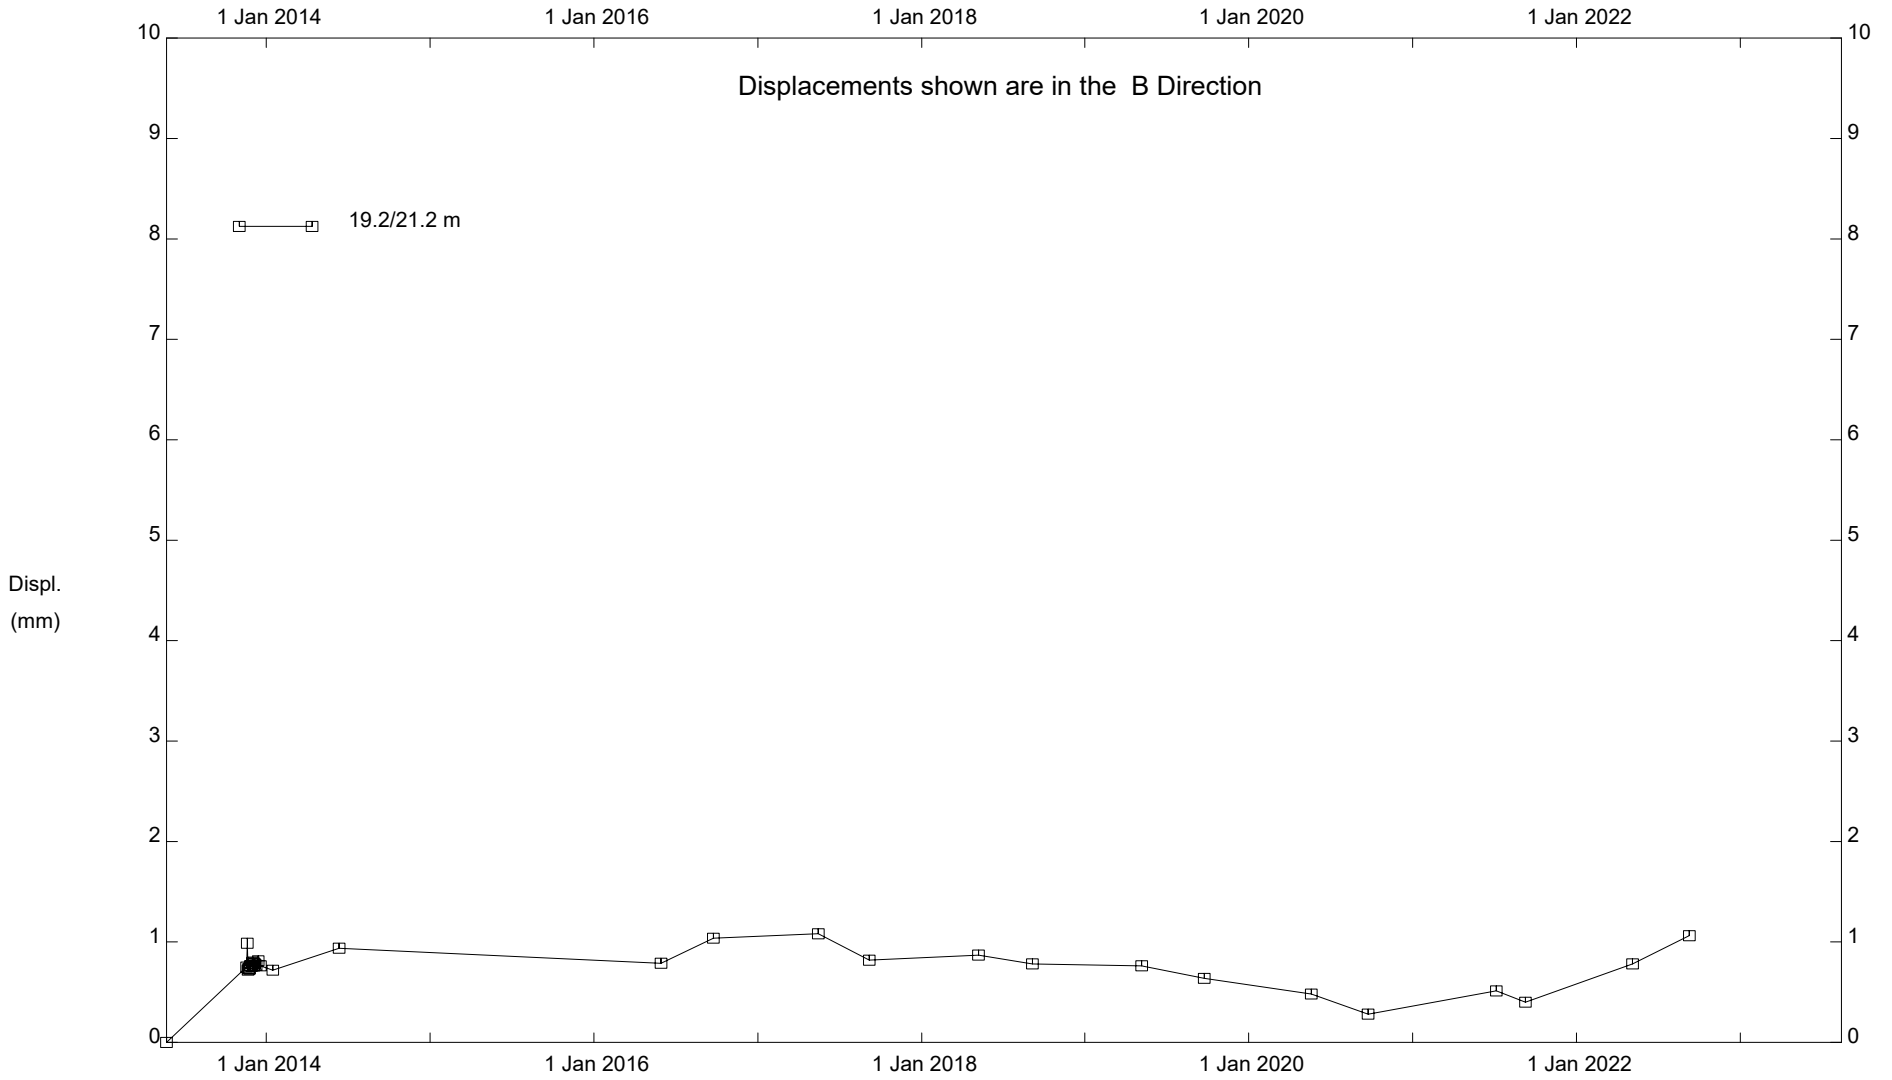
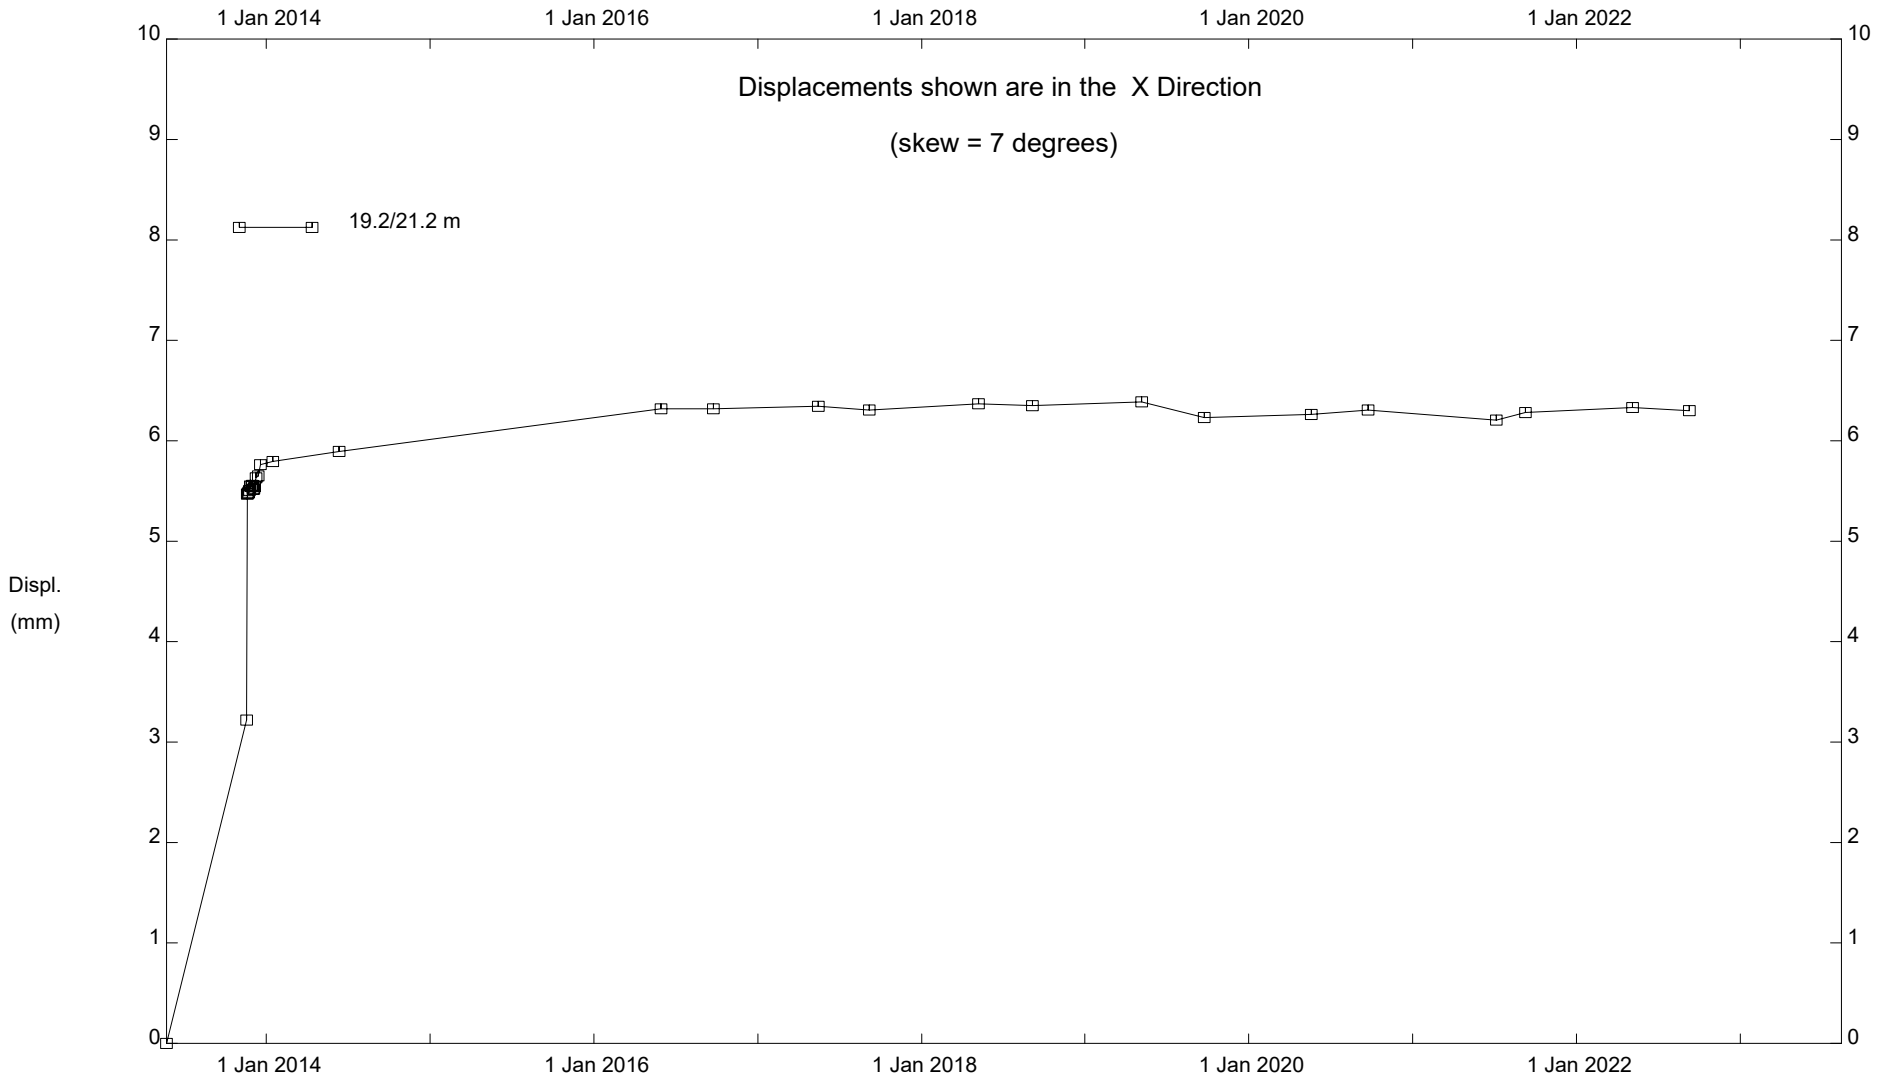
NC-52, Inclinometer SI13-3
Alberta Transportation

SI13-3 has recorded about 6 mm of cumulative movement since 2014. The recorded movement is likely related to construction activities in winter 2014. Little to no movement was observed since 2015.

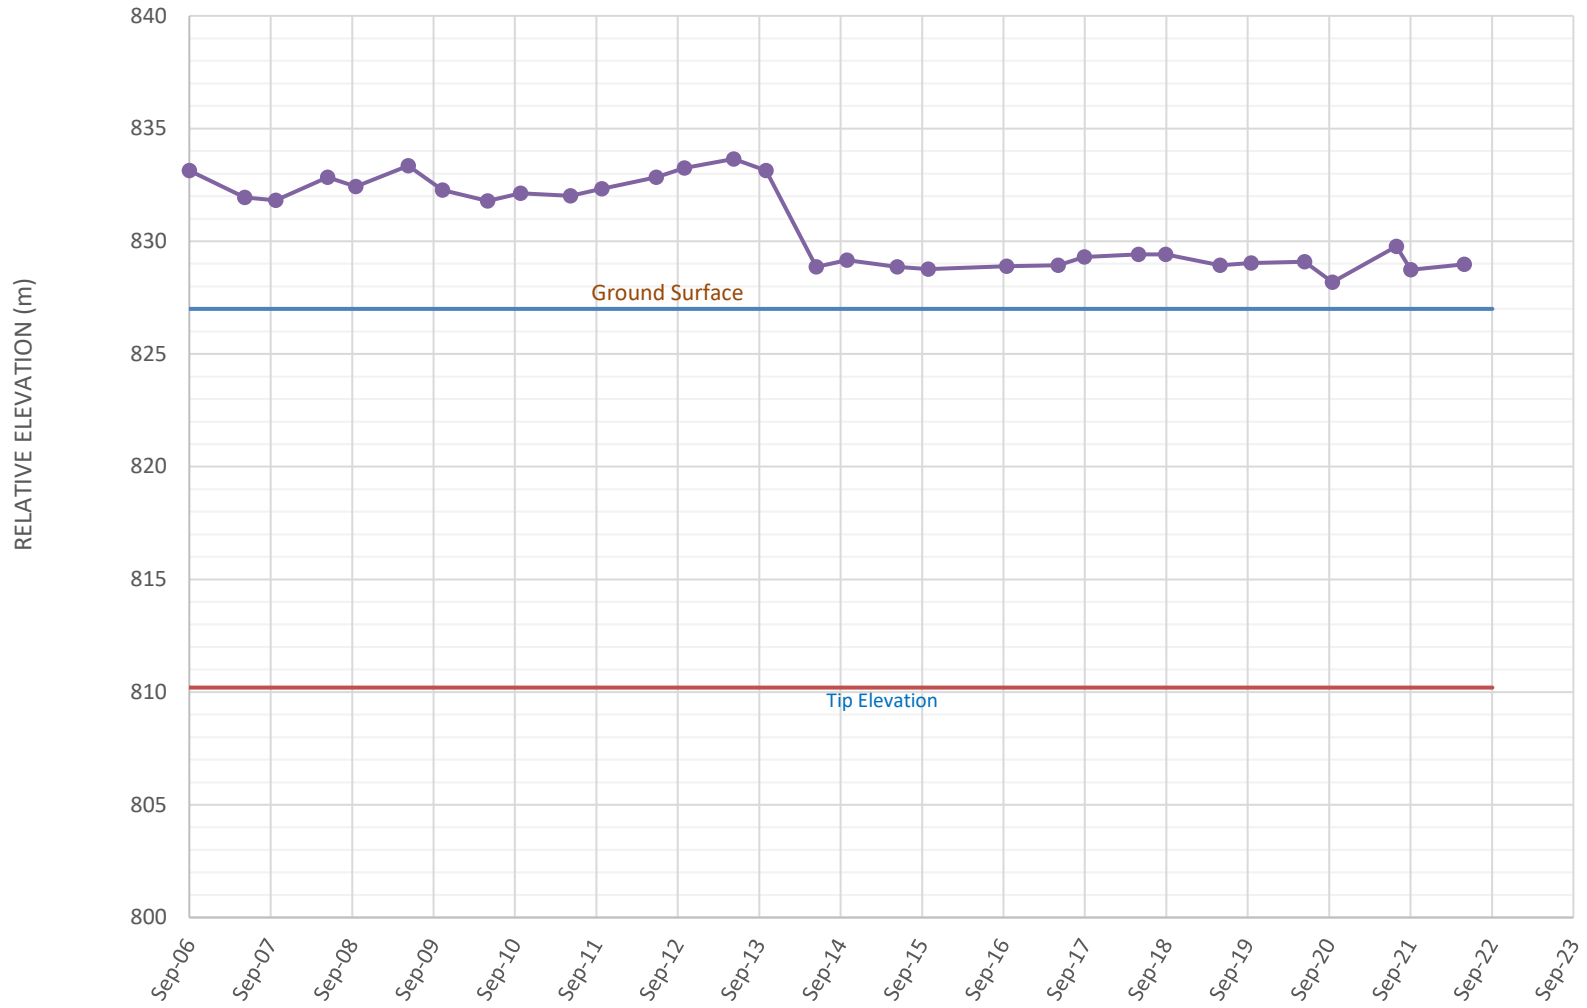
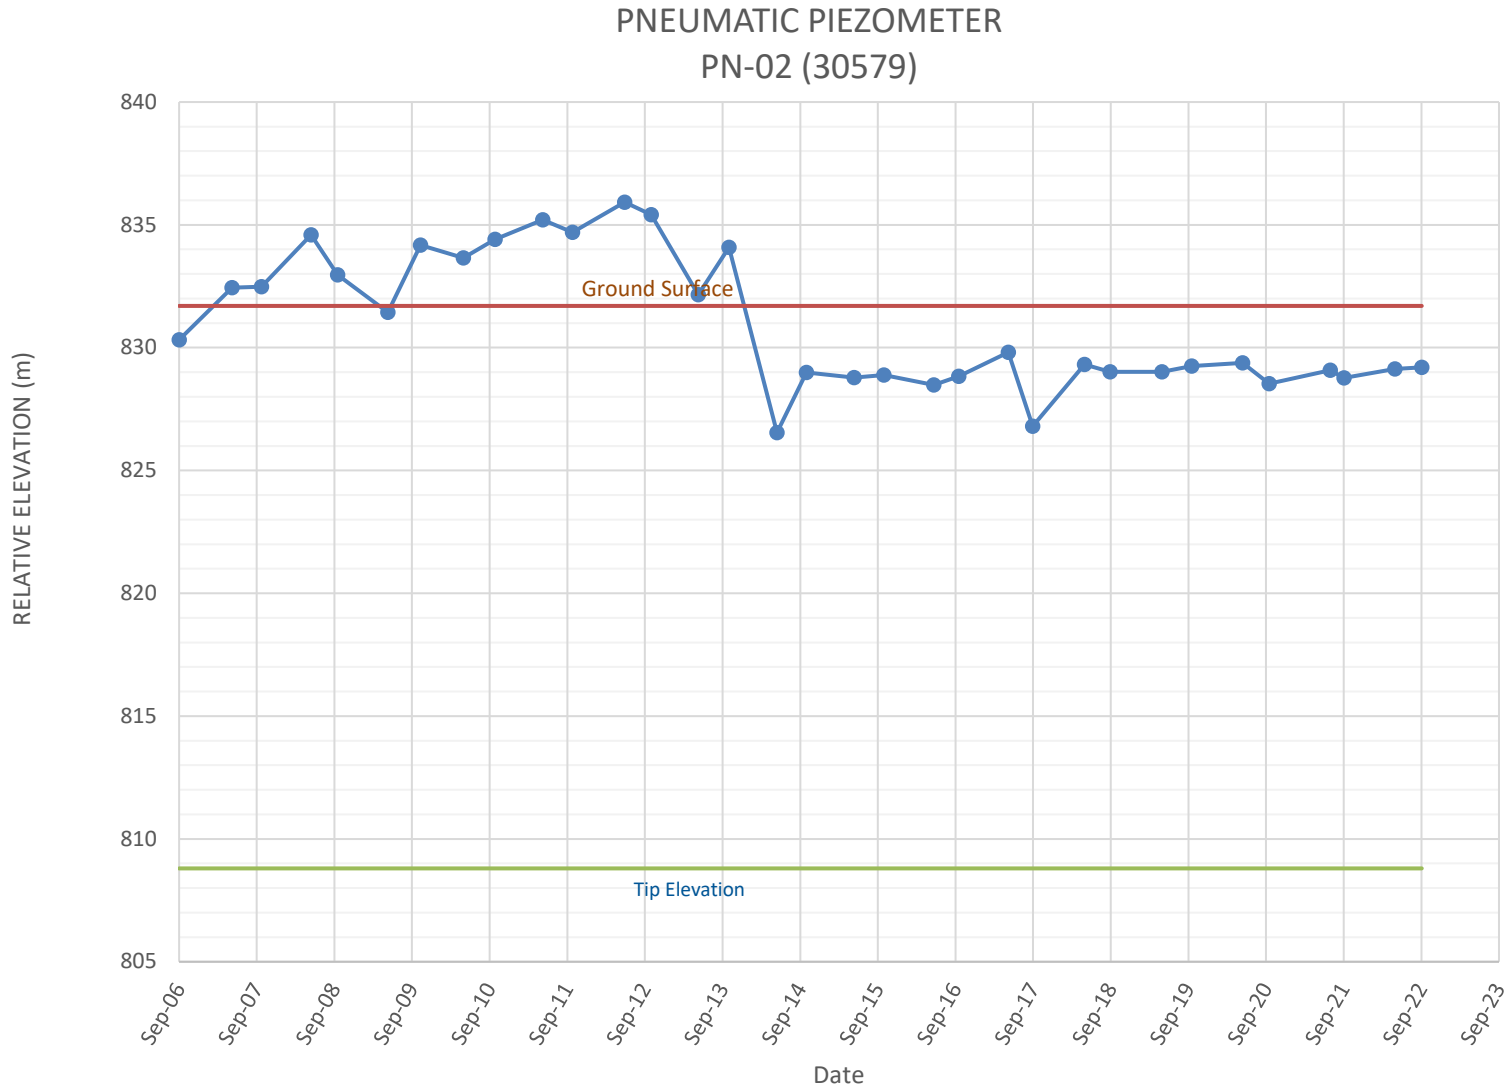
PNEUMATIC PIEZOMETER
PN-01 (30578)

PN-01 continues to show artesian conditions with a water level about 1.8 m above ground surface, which remains within the trend in water levels since 2014.

PN-02 had artesian conditions until 2014 where the pore pressure decreased as a result of remedial work to relieve pore pressures in the east slope. The current water level is at 2.5 m below ground surface, consistent with historical trends since 2014.

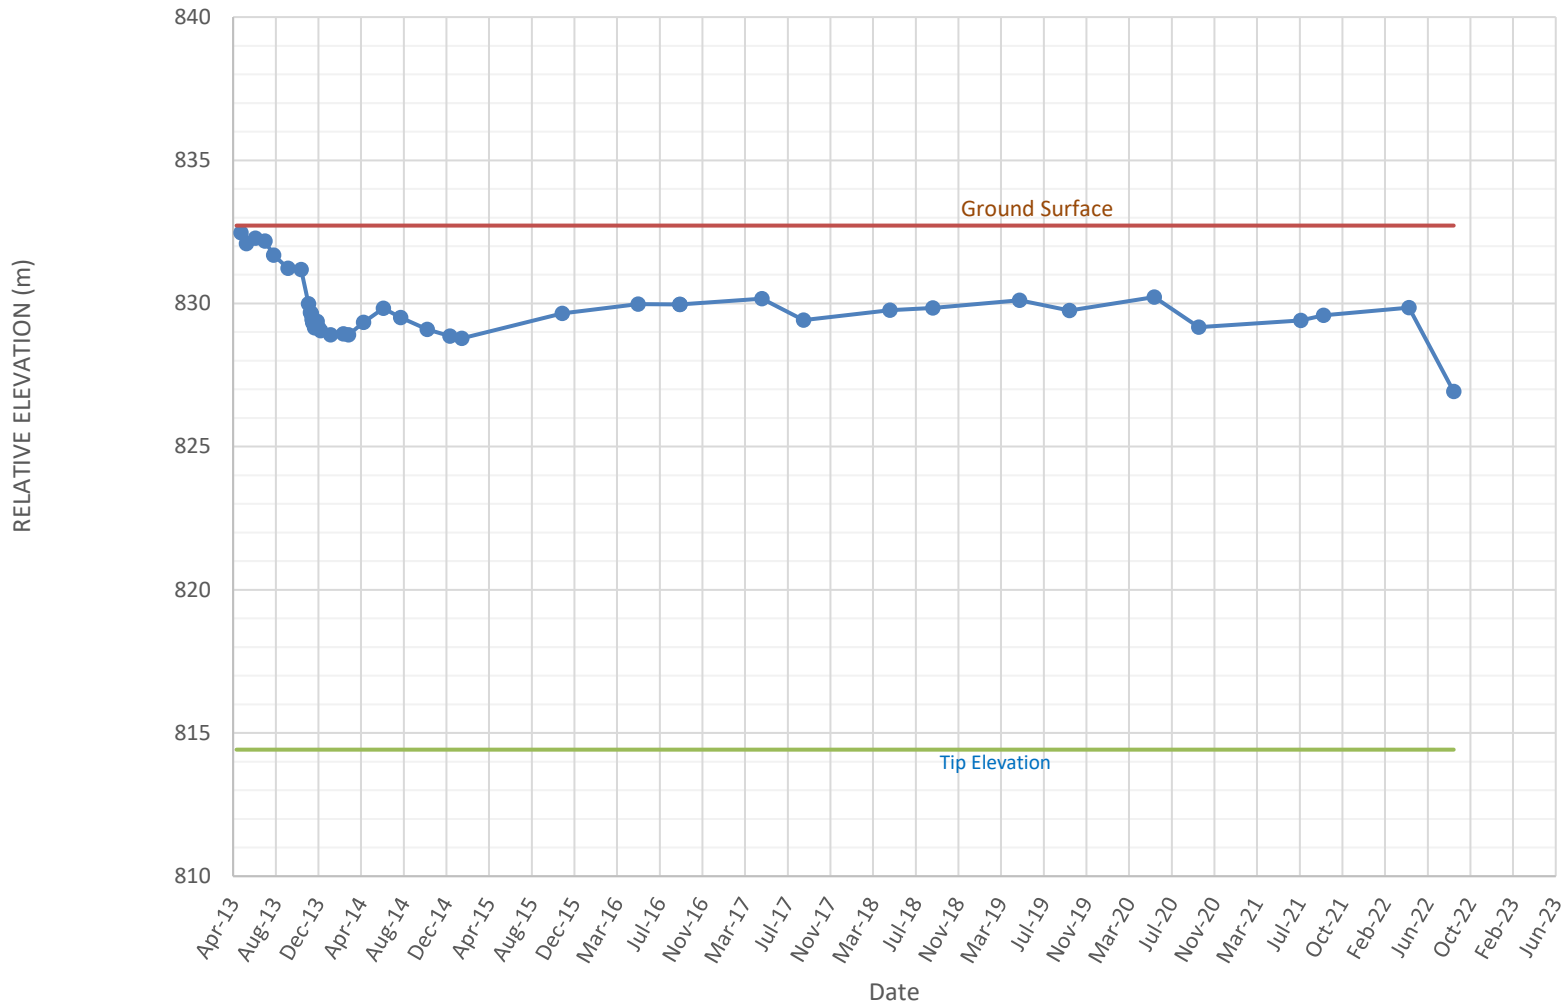
VIBRATING WIRE PIEZOMETER
VW13-3

VW13-3 showed a decrease in piezometric level by about 2.9 m since the previous reading cycle.

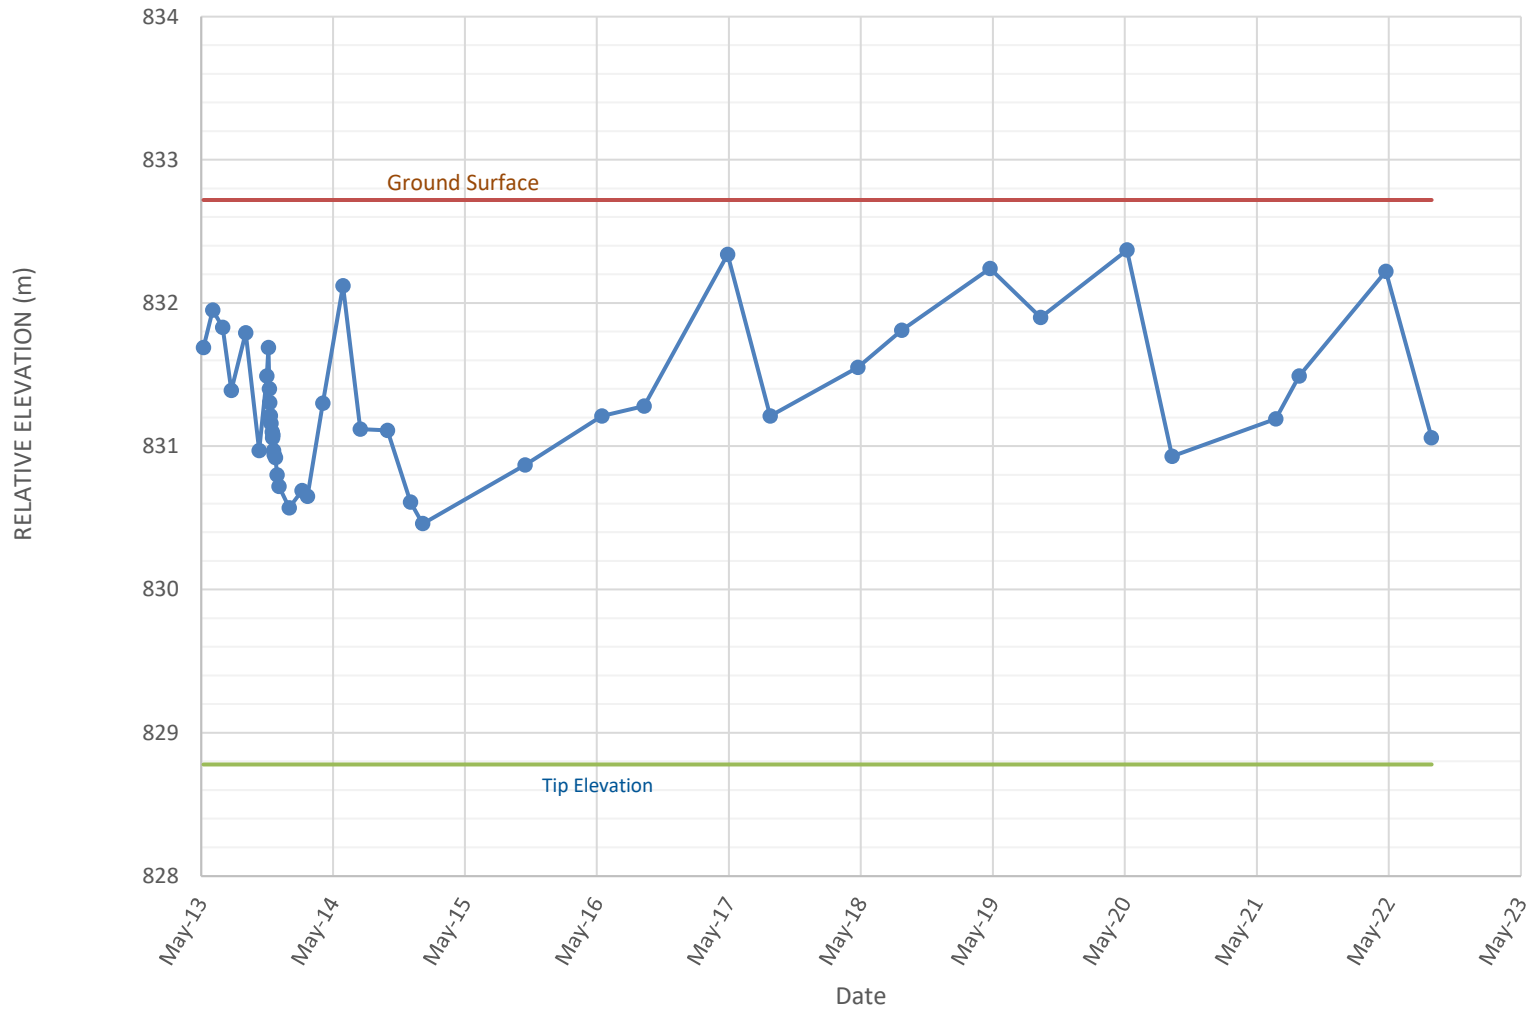
STANDPIPE PIEZOMETER
SP13-3A

The water level in **SP13-3A** decreased by about 1.7 m after construction in winter 2014. The water level gradually increased to above pre-construction levels in May 2017. A 1.1 m drop was measured in September 2017 whereafter water levels increased again to above pre-construction levels until May 2020. Another significant drop in water levels was observed in September 2020. There appears to be a cycle developing where water levels increase for 2-3 years followed by a sharp drop in water levels. The current measured water level decreased by 1.2 m bgs from previous reading cycle.
