<b>SITE NUMBER AND NAME:</b> NC052 – Pembina River Bridge	<b>HIGHWAY AND KM:</b> 621:02, km 16.420	<b>PREVIOUS INSPECTION:</b> June 29, 2021	<b>CURRENT INSPECTION:</b> June 15, 2022
<b>LEGAL DESCRIPTION:</b> SE 01-50-09-W5	<b>NAD83 COORDINATES:</b> UTM11U 5905008N, 621749E		<b>RISK ASSESSMENT:</b> PF: 10 CF: 10 Total: 100
<b>AVERAGE ANNUAL DAILY TRAFFIC (AADT):</b> 1,140 (2021)		<b>CONTRACTOR MAINTENANCE AREA (CMA):</b> 509

2022 Site Inspection Photos at NC052

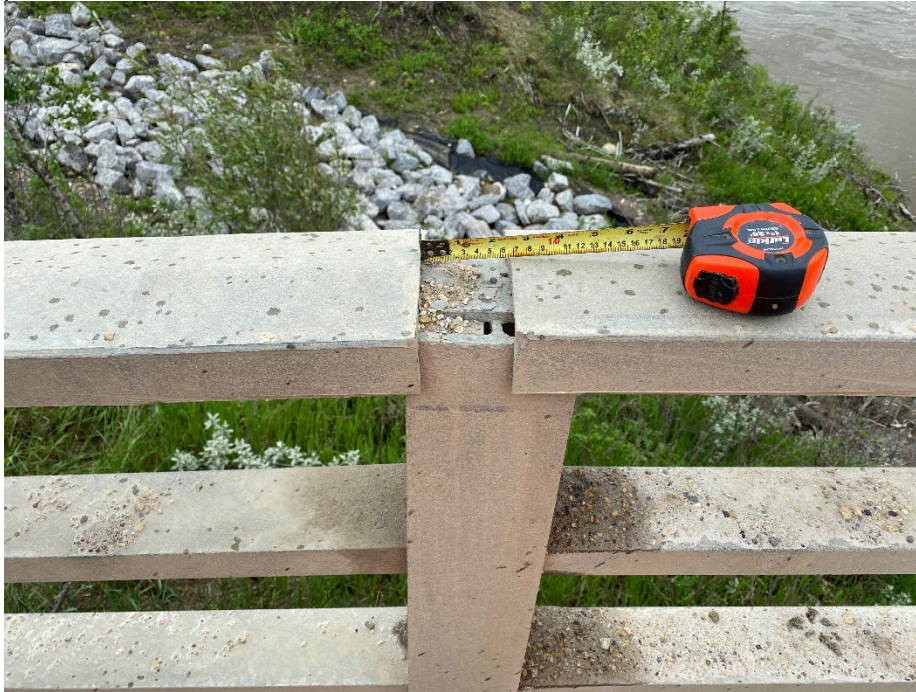
<b>COMMENTS</b>
<ul style="list-style-type: none"> <li>• Bridge rotation appears unchanged since 2021. The separation of the guardrails along the bridge deck have remained unchanged with 30 mm, 70 mm, 50 mm, and 20 mm of separation at the NE, SE, NW, and SW corners, respectively (Photos 1 to 4). The top of the guardrail at the SE corner has been reconnected to the post since the last inspection.</li> <li>• The expansion joint at the east abutment has a gap 35 mm wide in the west-bound lane where the rubber has fallen below the bridge deck (Photo 2).</li> <li>• Tiltmeter TE2 had its battery replaced in winter 2021. Data following battery replacement showed similar oscillation range as prior to replacement. The oscillation ranges were 0.05 degrees (A-axis) to 0.1 degrees (B-axis).</li> <li>• All the SIs show signs of creep. Creeping is occurring at a rate of less than 1 mm/year. Piezometric levels at the site have been relatively stable since installing the horizontal drains.</li> </ul>

**Photo 1:** Guardrail separation at southeast corner of bridge. Looking south.

- The bridge should be inspected by a bridge engineer.
- Batteries should be replaced for the remaining tiltmeters to collect regular readings. Otherwise, regular survey of the bridge should be conducted to monitor its rate of rotation/movement.
- The riprap channel south of the bridge should be extended downslope to the river or revegetated for increased erosion protection.
- Pavement cracks should be sealed and potholes should be filled to reduce surface water infiltration into the slope.
- Site inspections should continue annually.
- Instrumentation readings should continue semi-annually.

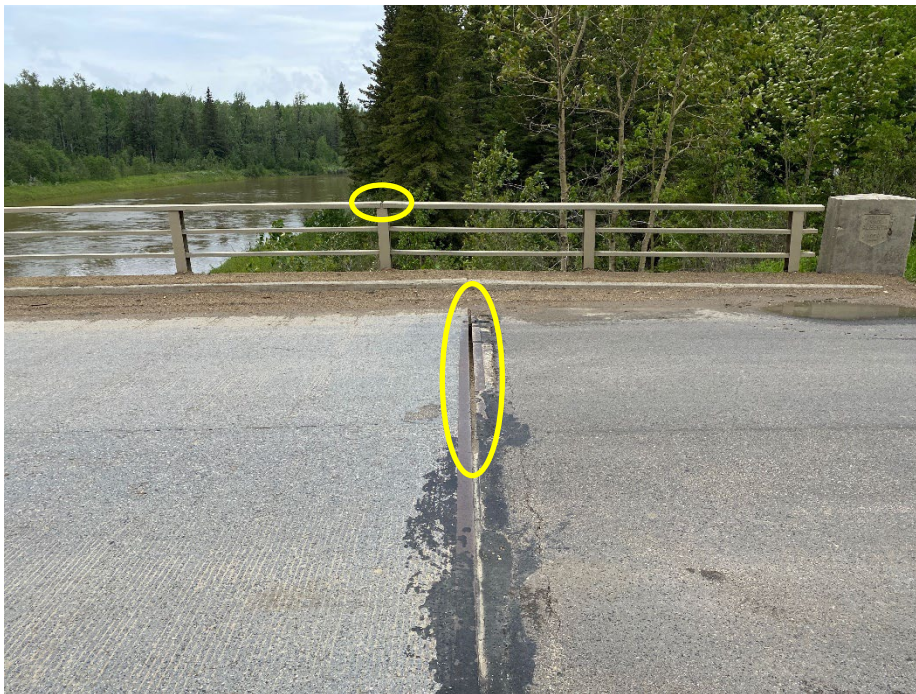
**Photo 2:** Guardrail separation at northeast corner of bridge and gap in expansion joint. Looking north.

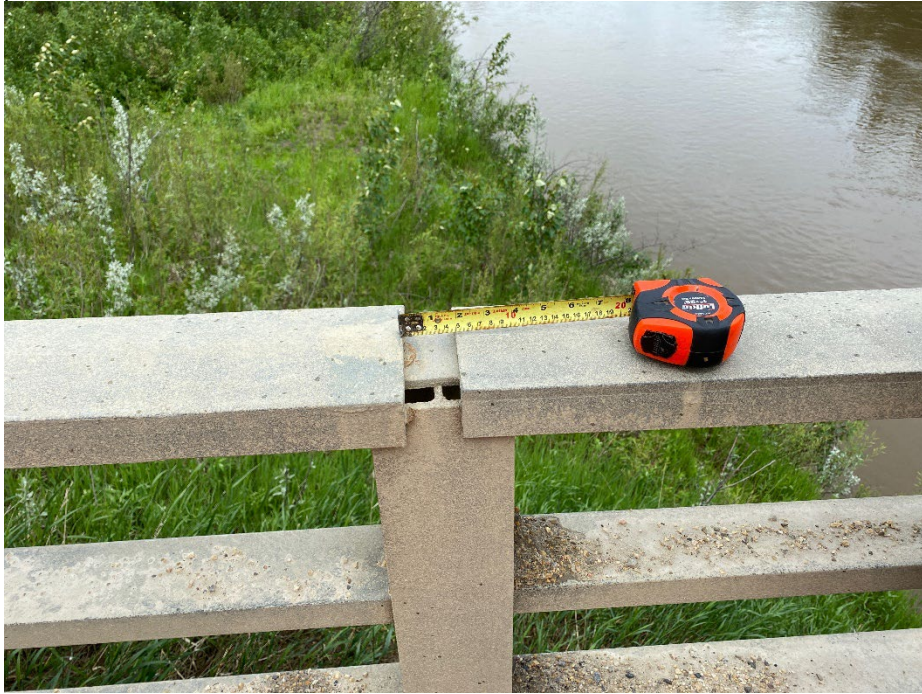
**Photo 3:** Guardrail separation at northwest corner of bridge. Looking north.

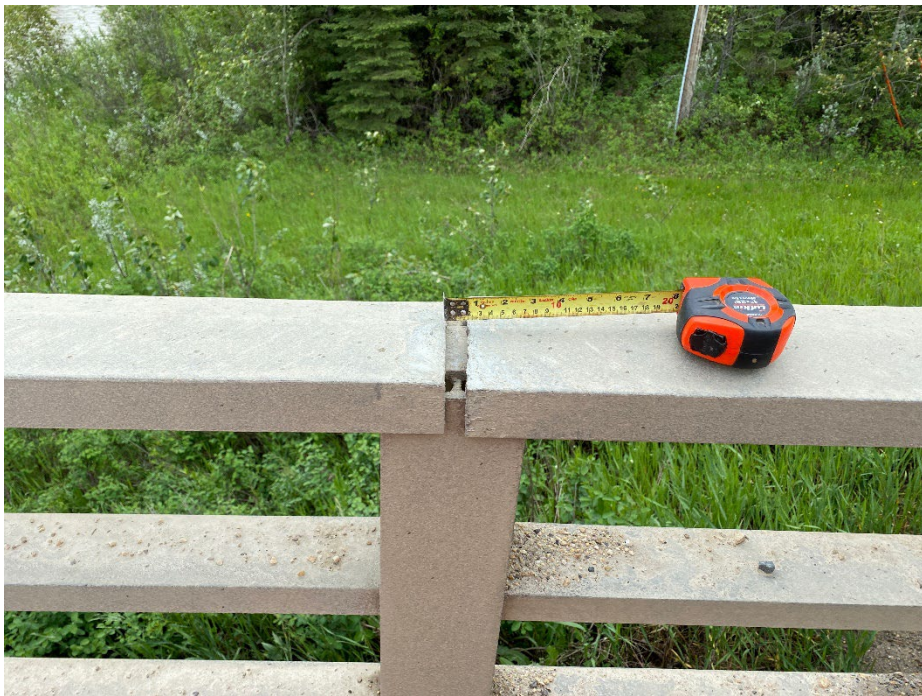
**Photo 4:** Guardrail separation at southwest corner of bridge. Looking south.

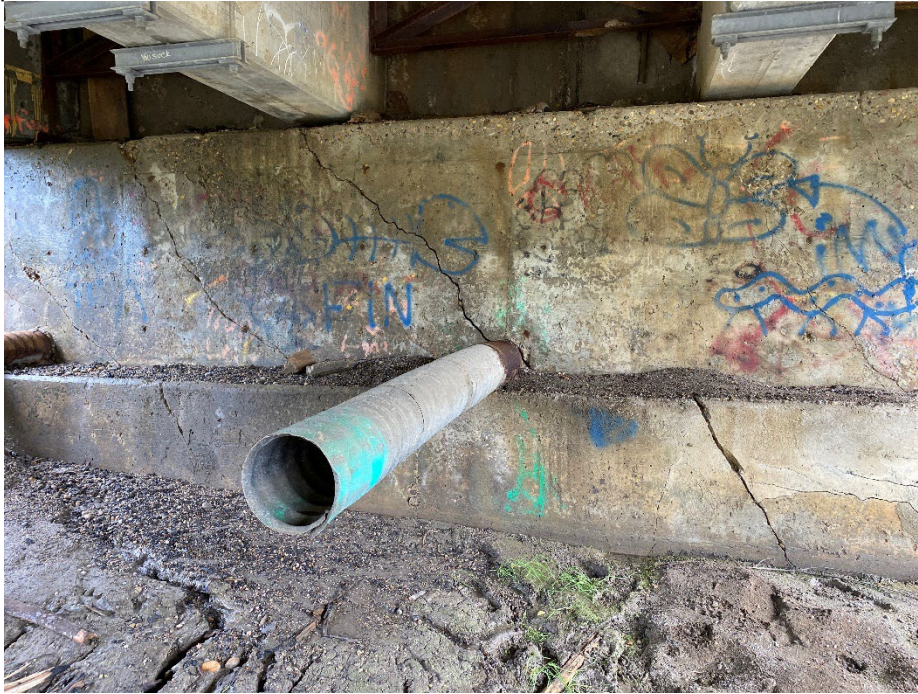
- Concrete cracks at both east and west abutment seats appear unchanged. A 20 mm gap was written onto the crack at the west abutment at an unknown date. This same gap was measured to be 20 mm by Stantec since 2016. (Photos 5 and 7)

**Photo 5:** Cracking of east abutment. Looking northeast.

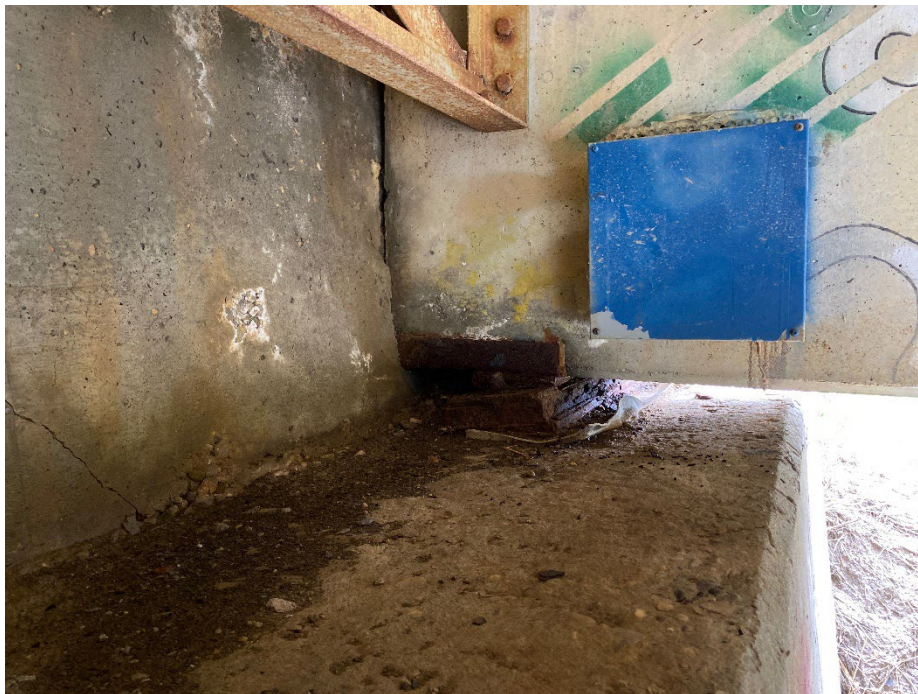
- The girders were in contact with the abutment backwall at the east abutment. The bearing plates appear to be crushed at both abutments. (Photo 6)
- The locks on the drainage galleries have been cut. In the easternmost drainage gallery, 7 of the 20 drains were flowing and in the westernmost gallery, 9 of the 32 drains were flowing. Minor flow of water was also observed at the gabion outfall.

**Photo 6:** Girders in contact with east abutment. Movement of bearing plate. Looking south.

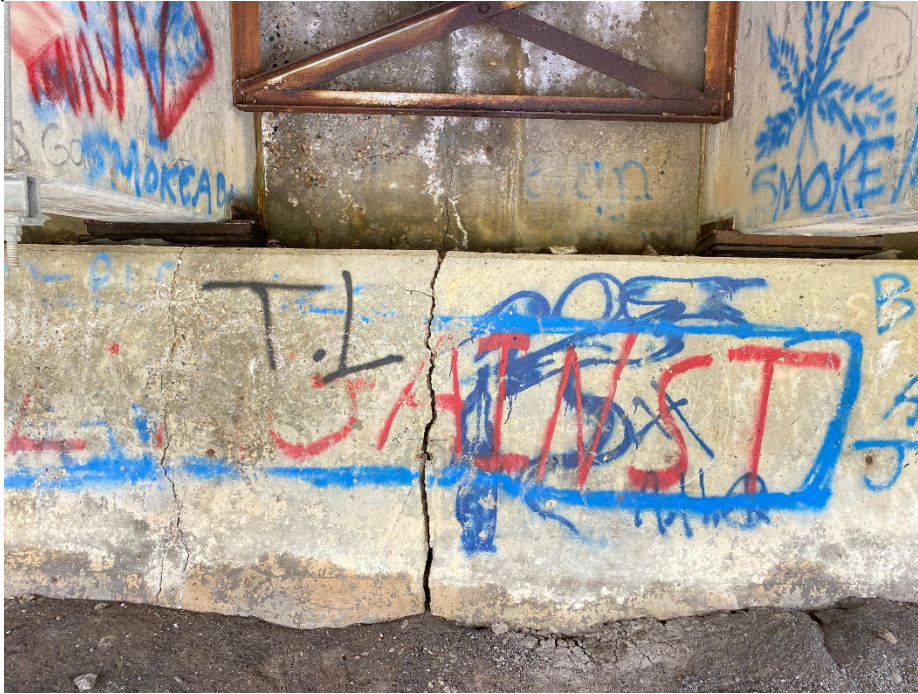
**Photo 7:** 20 mm crack at west abutment. Looking west.

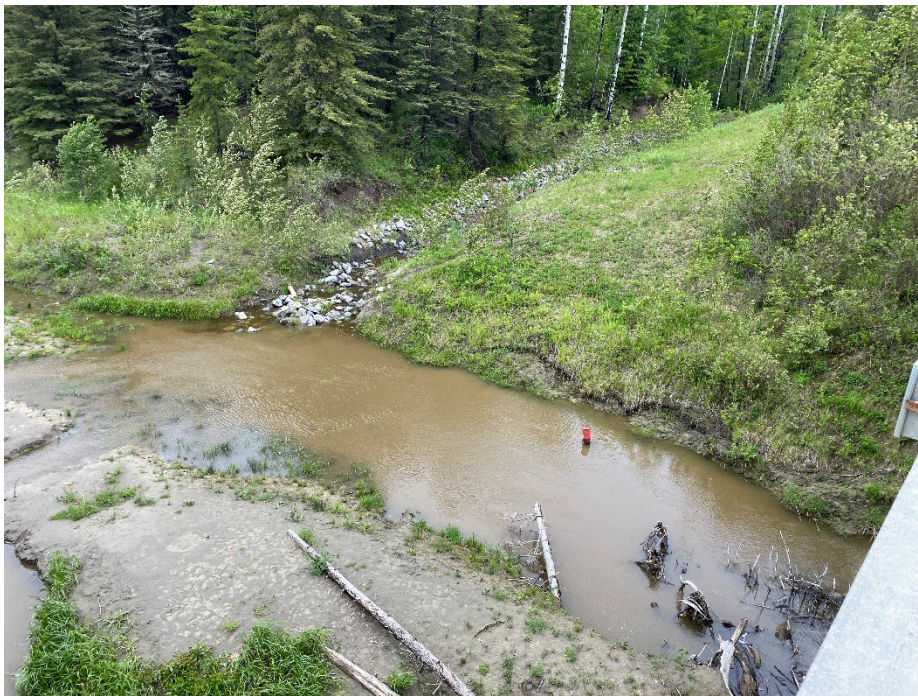
- The ground crack south of the riprap channel near S114-01 appeared unchanged at about 7 m long with vertical difference up to about 0.4 m high (Photo 8).

**Photo 8:** Riprap lined channel north of east abutment. Ground cracks near S114-01. Looking northeast.

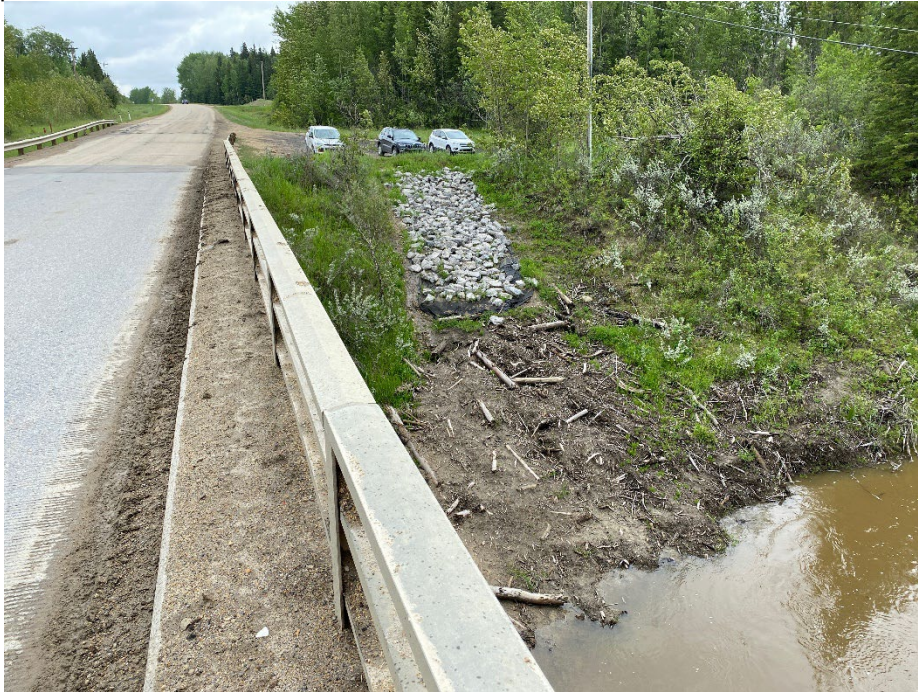
- No apparent change was observed in the riprap channel and erosion south of the bridge at the east abutment slope (Photo 9).
- The highway surface at both the east and west abutment was recently patched. Potholes are present adjacent to the west abutment patch and east of the east patch. Multiple vehicles travelling west moved into the east-bound lane to avoid uneven (rutted/potholed) pavement. (Photo 10).

**Photo 9:** Riprap placed south of bridge along previous erosion channel. Looking southeast.

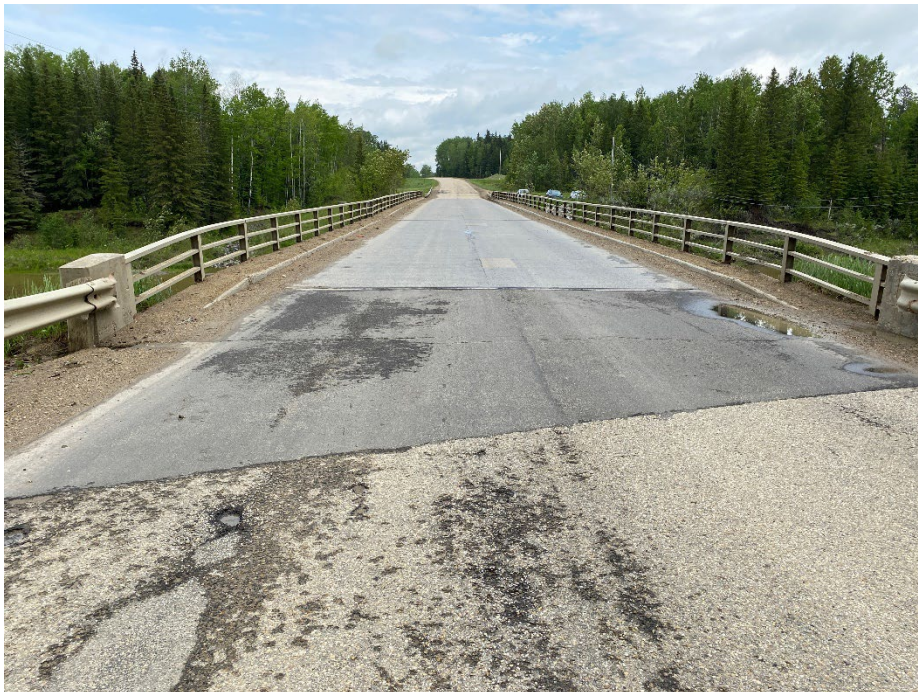
**Photo 10:** Pavement surface at west abutment. Looking east across bridge.
