| SITE NUMBER AND NAME: NC052 – Pembina River Bridge | HIGHWAY AND KM: 621:02, km 16.420 | PREVIOUS INSPECTION: June 15, 2022 | CURRENT INSPECTION: June 2, 2023 |

| PRIMARY SITE ISSUE: Slope instability at east abutment. Artesian pressures at west abutments. Shallow groundwater table at east abutment. Bridge (BF74969) rotating with crushed bearing plates. | |

2023 Site Inspection Photos at NC052

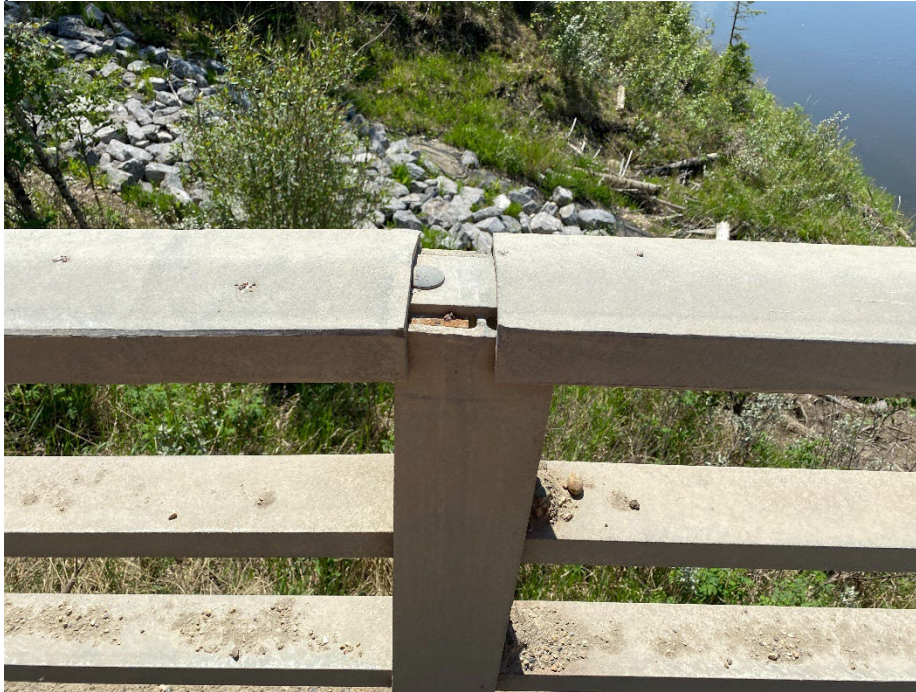
| ITEM | CONDITIONS EXIST | | DESCRIPTION AND LOCATION | NOTICEABLE CHANGE FROM LAST INSPECTION | |
|---|---|---|--|--|---|
| Bridge/Culvert Distress | X | | Top of east pier rotating to the east. East abutment pushing into bridge deck. Through cracks in both abutment seats. Separation of guardrails at all four corners of bridge deck. | | X |

| <ul style="list-style-type: none"> • Bridge rotation appears unchanged since 2021. The separation of the guardrails along the bridge deck have remained relatively unchanged with 30 mm, 70 mm, 45 mm, and 20 mm of separation at the NE, SE, NW, and SW corners, respectively (Photos 1 to 4). The NW corner saw a reduction of 5 mm in the separation. • The expansion joint at the east abutment has a gap 35 mm wide in the westbound lane where the rubber has fallen below the bridge deck (Photo 5). • The three tiltmeters installed at the bridge are all non-operational. • Spring 2023 SI readings show signs of creeping a rate of less than 1 mm/year in SI-1. SI-2 previously showed signs of creeping from Spring 2014 to Spring 2022 whereafter cumulative displacements returned to 2014 levels. • Piezometric levels at the site have been relatively stable since installing the horizontal drains. |

Photo 1: Guardrail separation at southeast corner of bridge. Looking south.

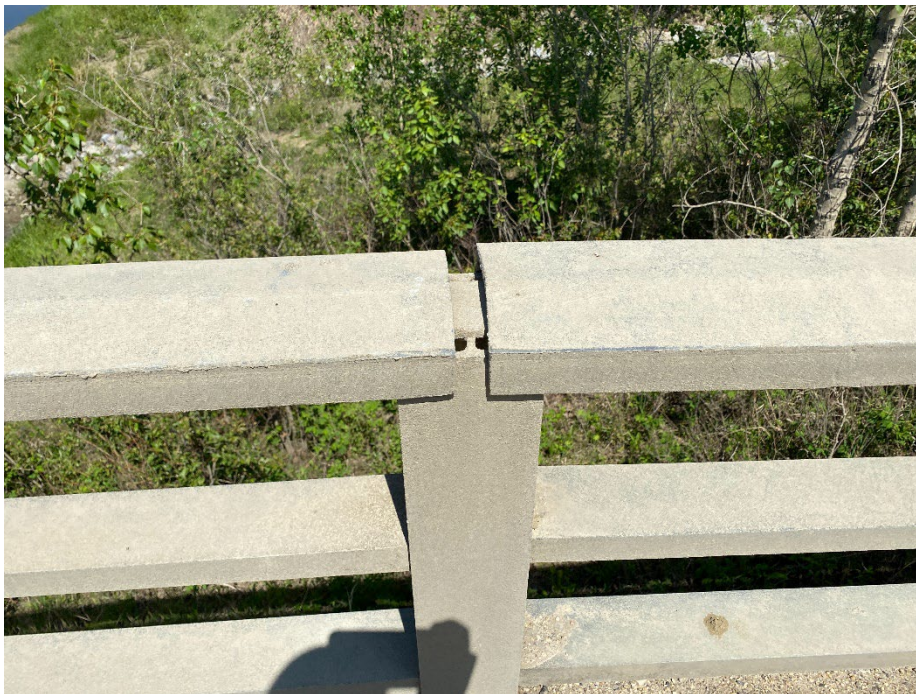
Photo 2: Guardrail separation at northeast corner of bridge. Looking north.

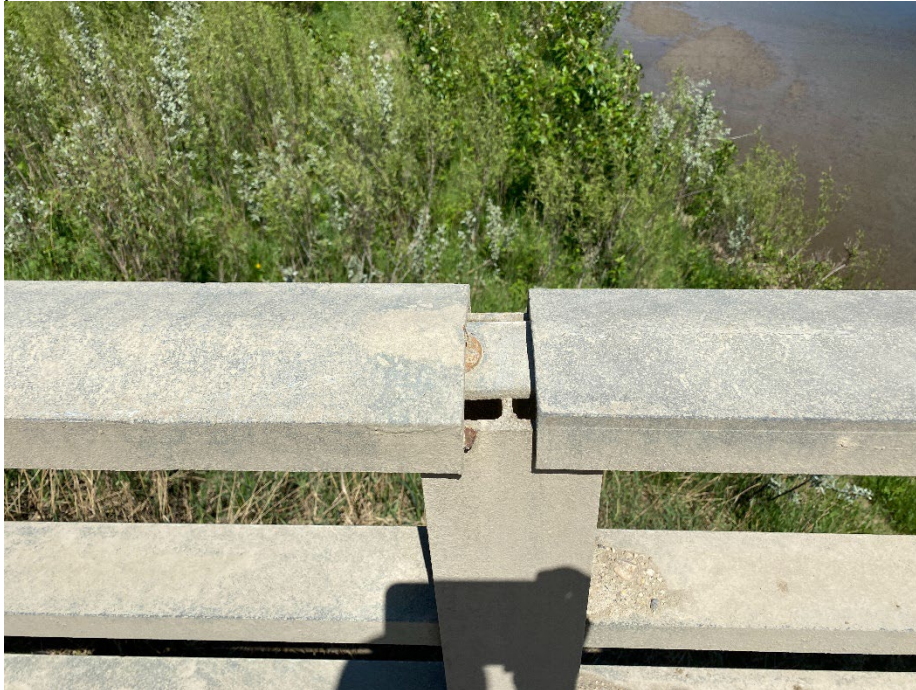
Photo 3: Guardrail separation at northwest corner of bridge. Looking north.

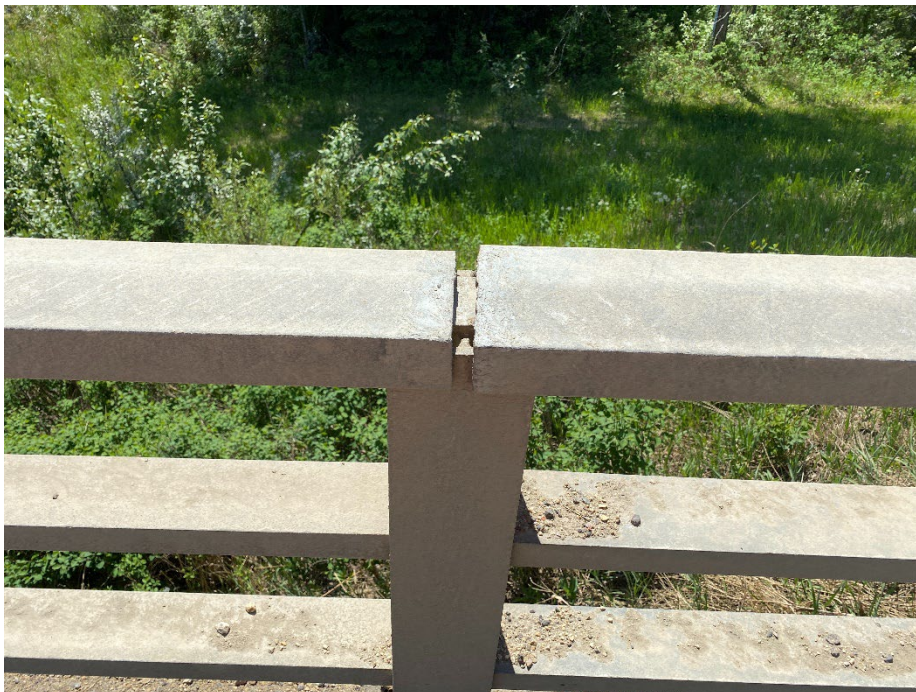
Photo 4: Guardrail separation at southwest corner of bridge. Looking south.

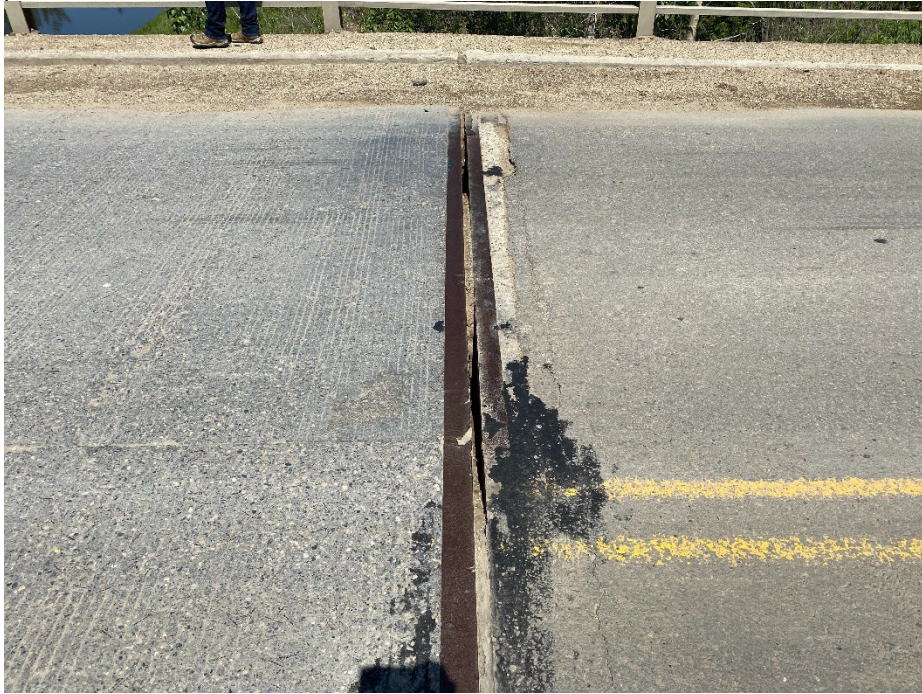
Photo 5: Gap at expansion joint with rubber falling out. Looking north.

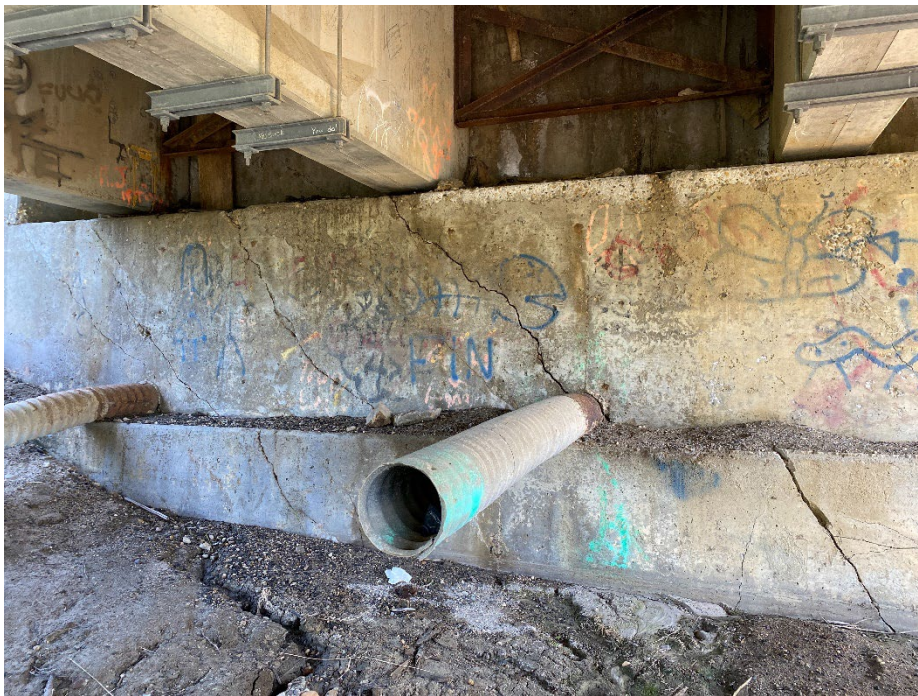
- Concrete cracks at both east and west abutment seats appear unchanged. A 20 mm gap was written onto the crack at the west abutment at an unknown date. This same gap was measured to be 20 mm by Stantec since 2016. (Photos 6 and 8)

Photo 6: Cracking of east abutment. Looking northeast.

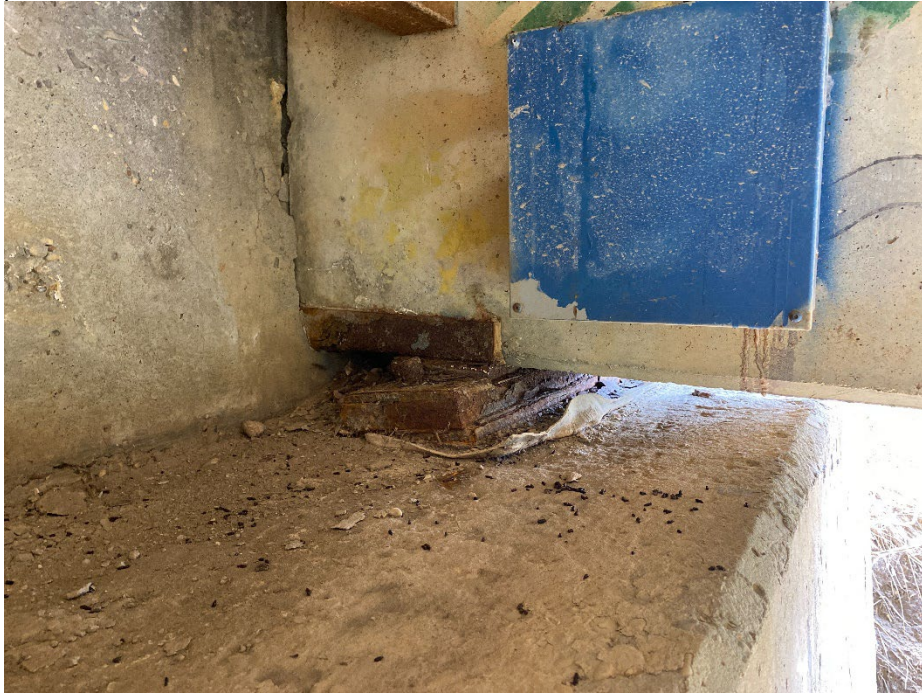
- The girders were in contact with the abutment backwall at the east abutment. The bearing plates appear to be crushed at both abutments. (Photo 7)
- The locks on the drainage galleries have been cut and will be replaced by Stantec during the Fall instrument reading cycle. In the westernmost drainage gallery, 7 of the 20 drains were flowing and in the easternmost gallery, 9 of the 32 drains were flowing. Significant build-up of minerals was observed in the subdrains.

Photo 7: Girders in contact with east abutment. Movement of bearing plate. Looking south.

- The bridge should be inspected by a bridge engineer.
- Batteries should be replaced for the remaining tiltmeters to collect regular readings. Otherwise, regular survey of the bridge should be conducted to monitor its rate of rotation/movement.
- The riprap channel south of the bridge should be extended downslope to the river or revegetated for increased erosion protection.
- Pavement cracks should be sealed and potholes should be filled to reduce surface water infiltration into the slope.
- The subdrains should be cleaned/ flushed out to reduce mineral build-up and improve performance.
- Site inspections should continue annually.
- Instrumentation readings should continue semi-annually.

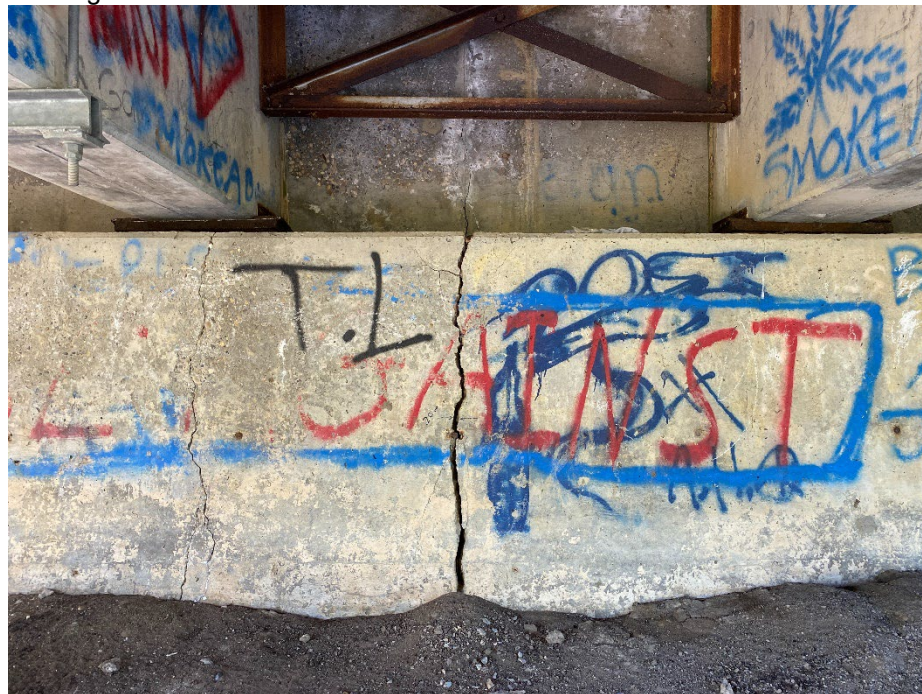
Photo 8: 20 mm crack at west abutment. Looking west.

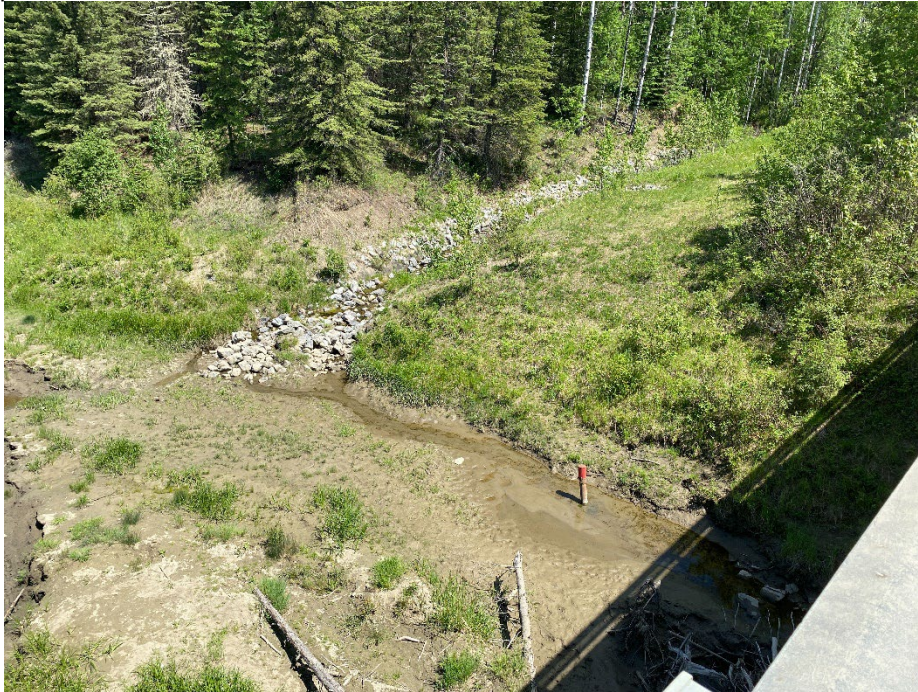
| ITEM | CONDITIONS EXIST | | DESCRIPTION AND LOCATION | NOTICEABLE CHANGE FROM LAST INSPECTION | |
|---|---|---|--|--|---|
| Slope Movement | X | | Ground crack at toe of east abutment south of riprap channel. | | X |

- Minor flow of water was also observed at the gabion outfall.
- The ground crack south of the riprap channel near S114-01 appeared unchanged at about 7 m long with vertical difference up to about 0.4 m high (Photo 9).

Photo 9: Riprap lined channel north of east abutment. Ground cracks near SI14-01. Looking northeast.

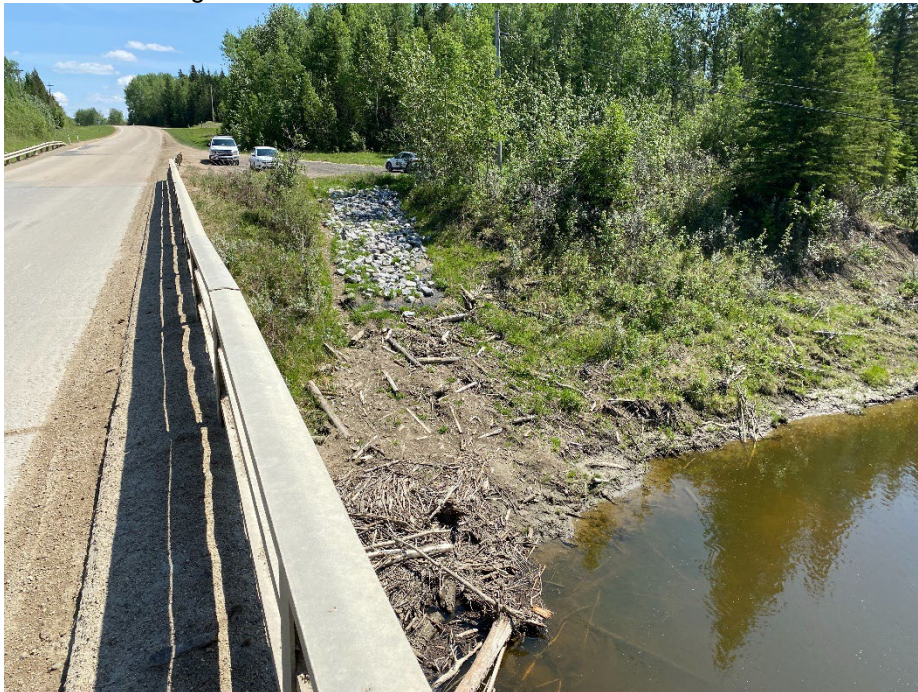
| ITEM | CONDITIONS EXIST | | DESCRIPTION AND LOCATION | NOTICEABLE CHANGE FROM LAST INSPECTION | |
|---|---|---|--|--|---|
| Erosion | X | | Downslope of riprap south of east abutment. | | X |

- No apparent change was observed in the riprap channel and erosion south of the bridge at the east abutment slope (Photo 10).
- Potholes are present adjacent to the west abutment patch and east of the east patch (Photos 11 and 12).

Photo 10: Riprap placed south of bridge along previous erosion channel. Looking southeast.

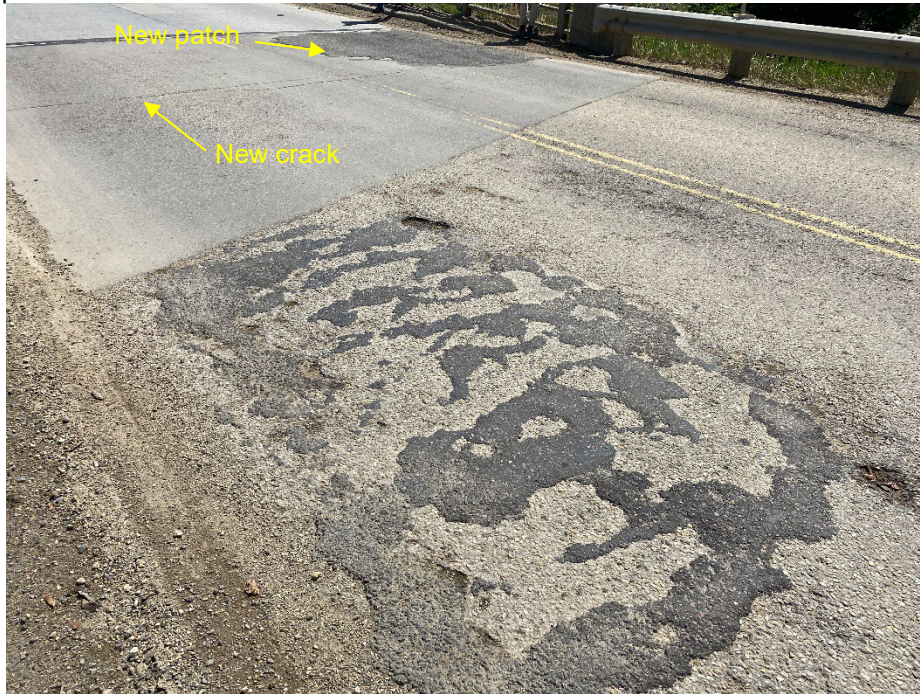
- A new transverse pavement crack across both lanes exists on an older patched section of the west abutment (Photo 11).
- The nearest detour route to cross the Pembina River appears to be at Range Road 91 and Township Road 491A, approximately a 12-minute drive south of the site. This detour would require the use of gravel roads and would not be suitable for all types of traffic.

Photo 11: Pavement surface at west abutment. Looking southeast.

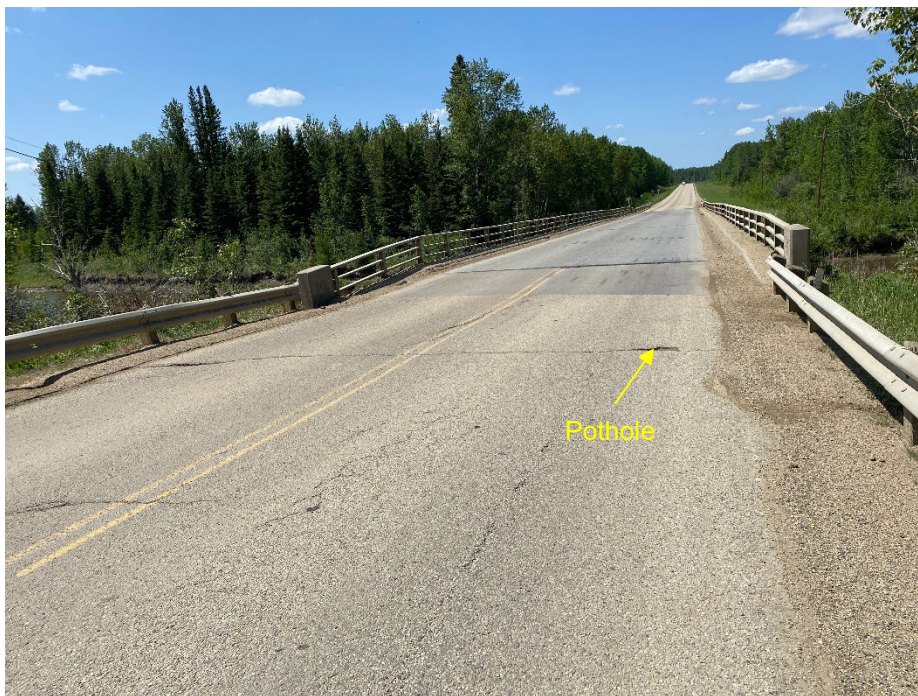
Photo 12: Pavement surface at east abutment. Looking west.
