To:	Amy Driessen	From:	Leslie Cho and Xiteng Liu
	Transportation and Economic Corridors		Stantec Consulting Ltd.
File:	123315222	Date:	October 18, 2024

Reference: North Central Region, Stony Plain, Site NC052 - Highway 621:02 Pembina River Bridge Abutment, Fall 2024 Instrumentation Monitoring Report

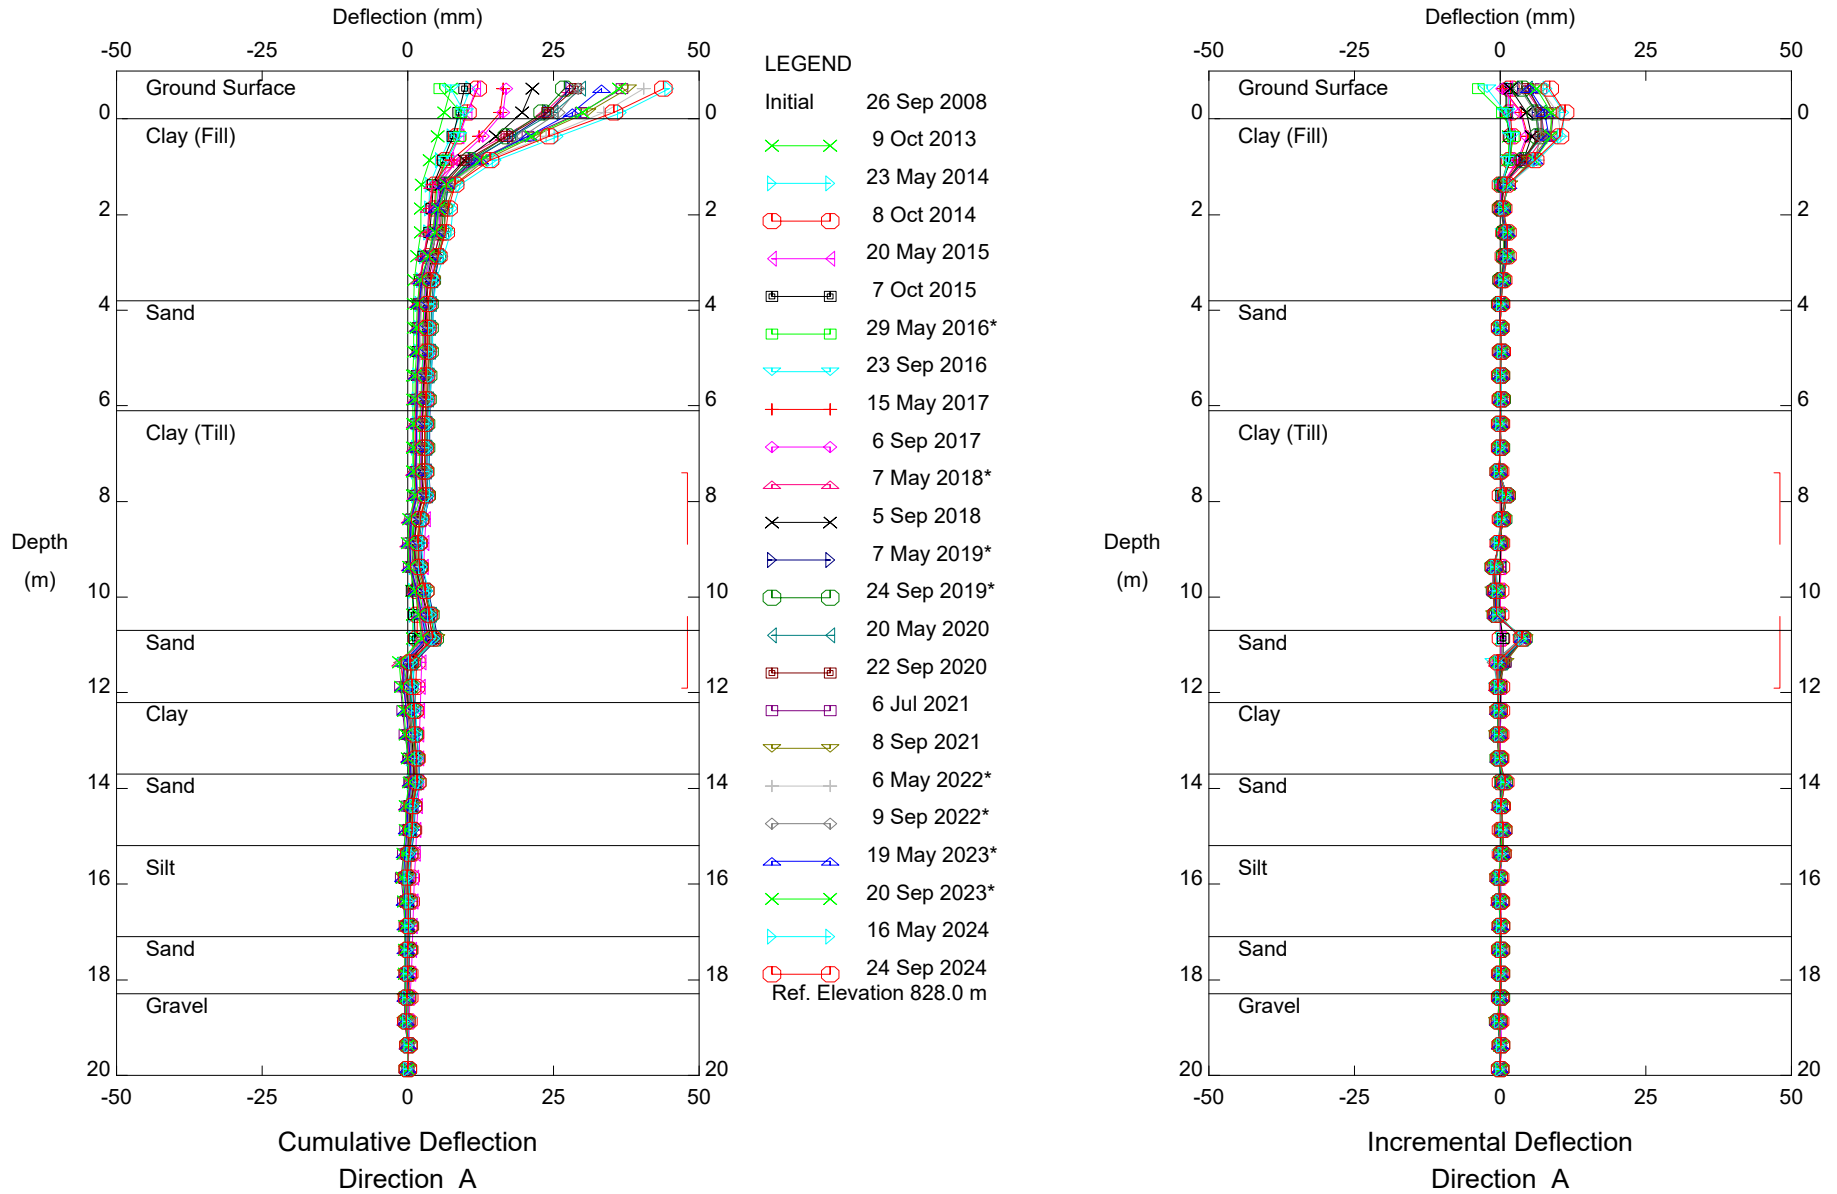
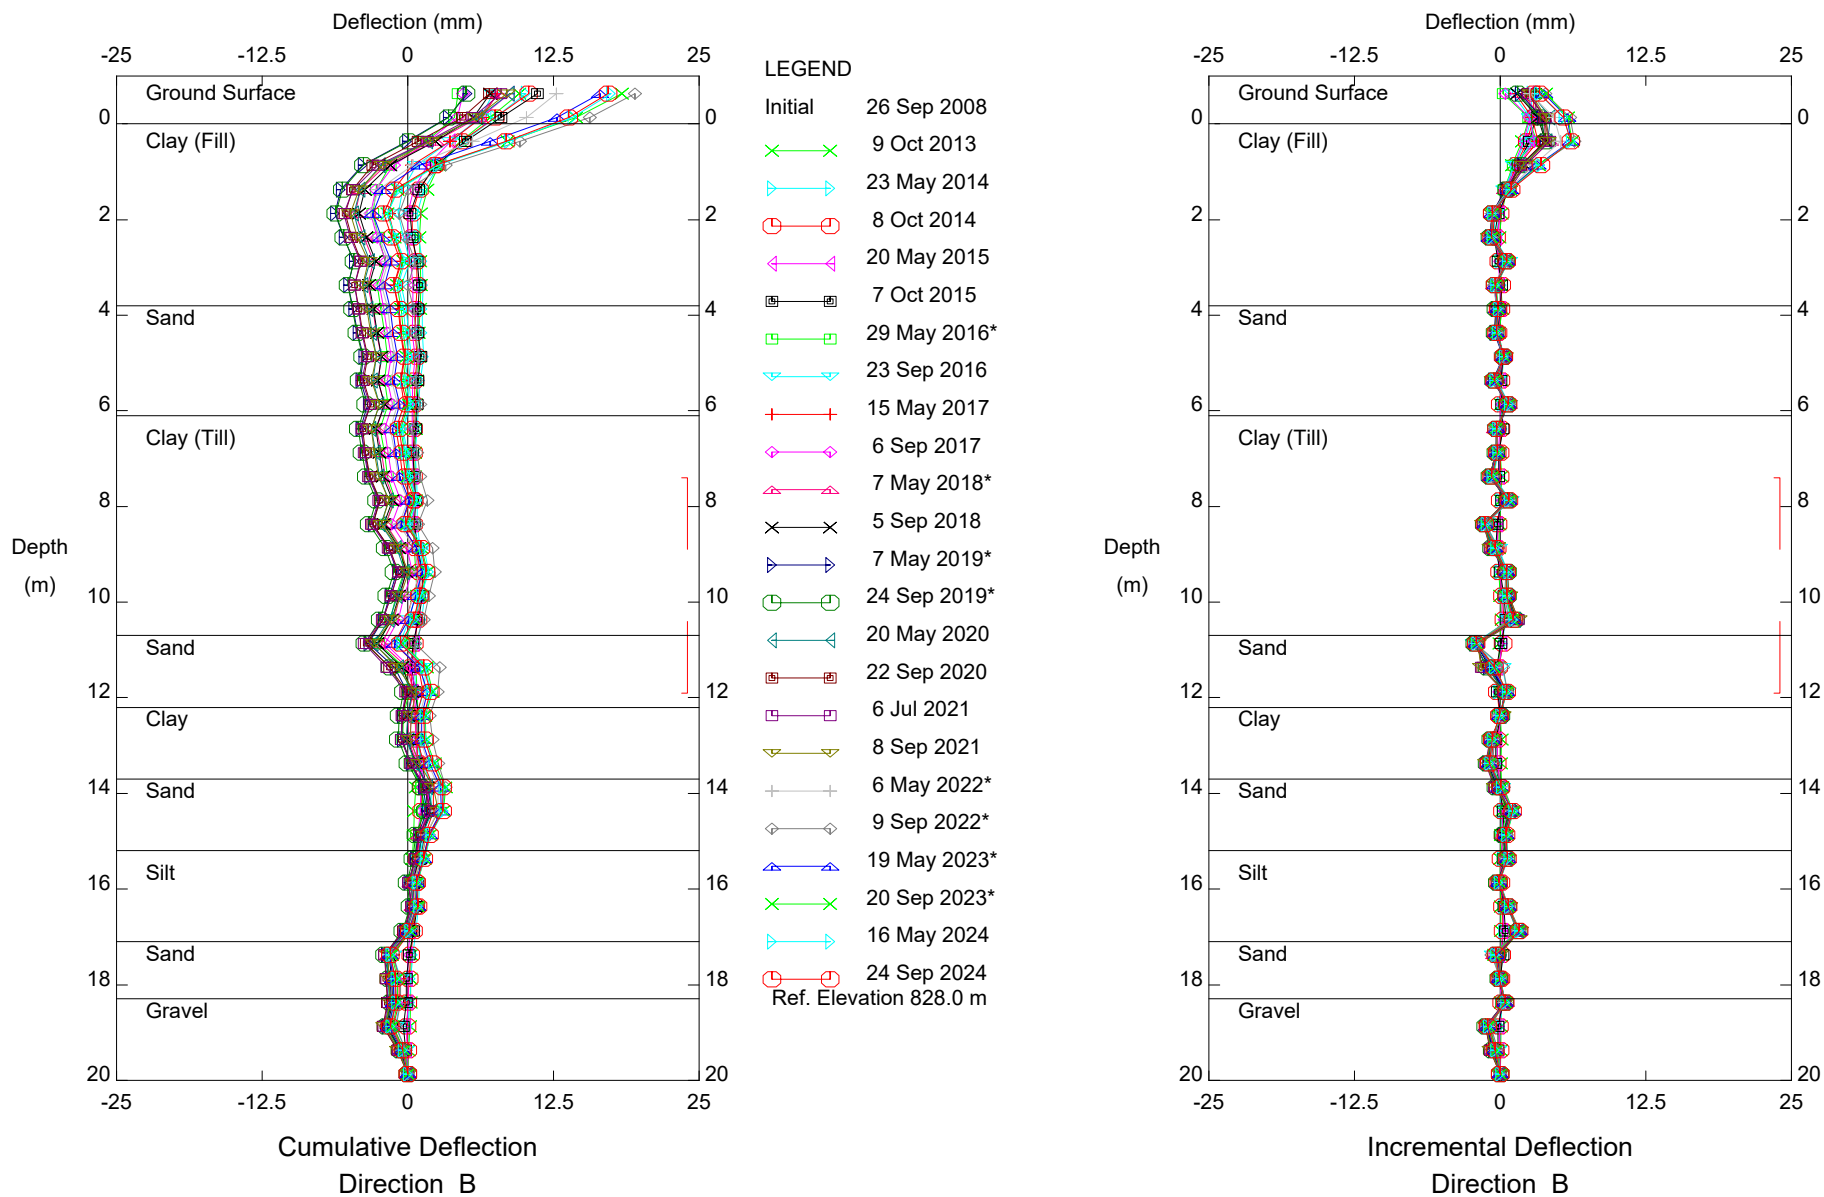
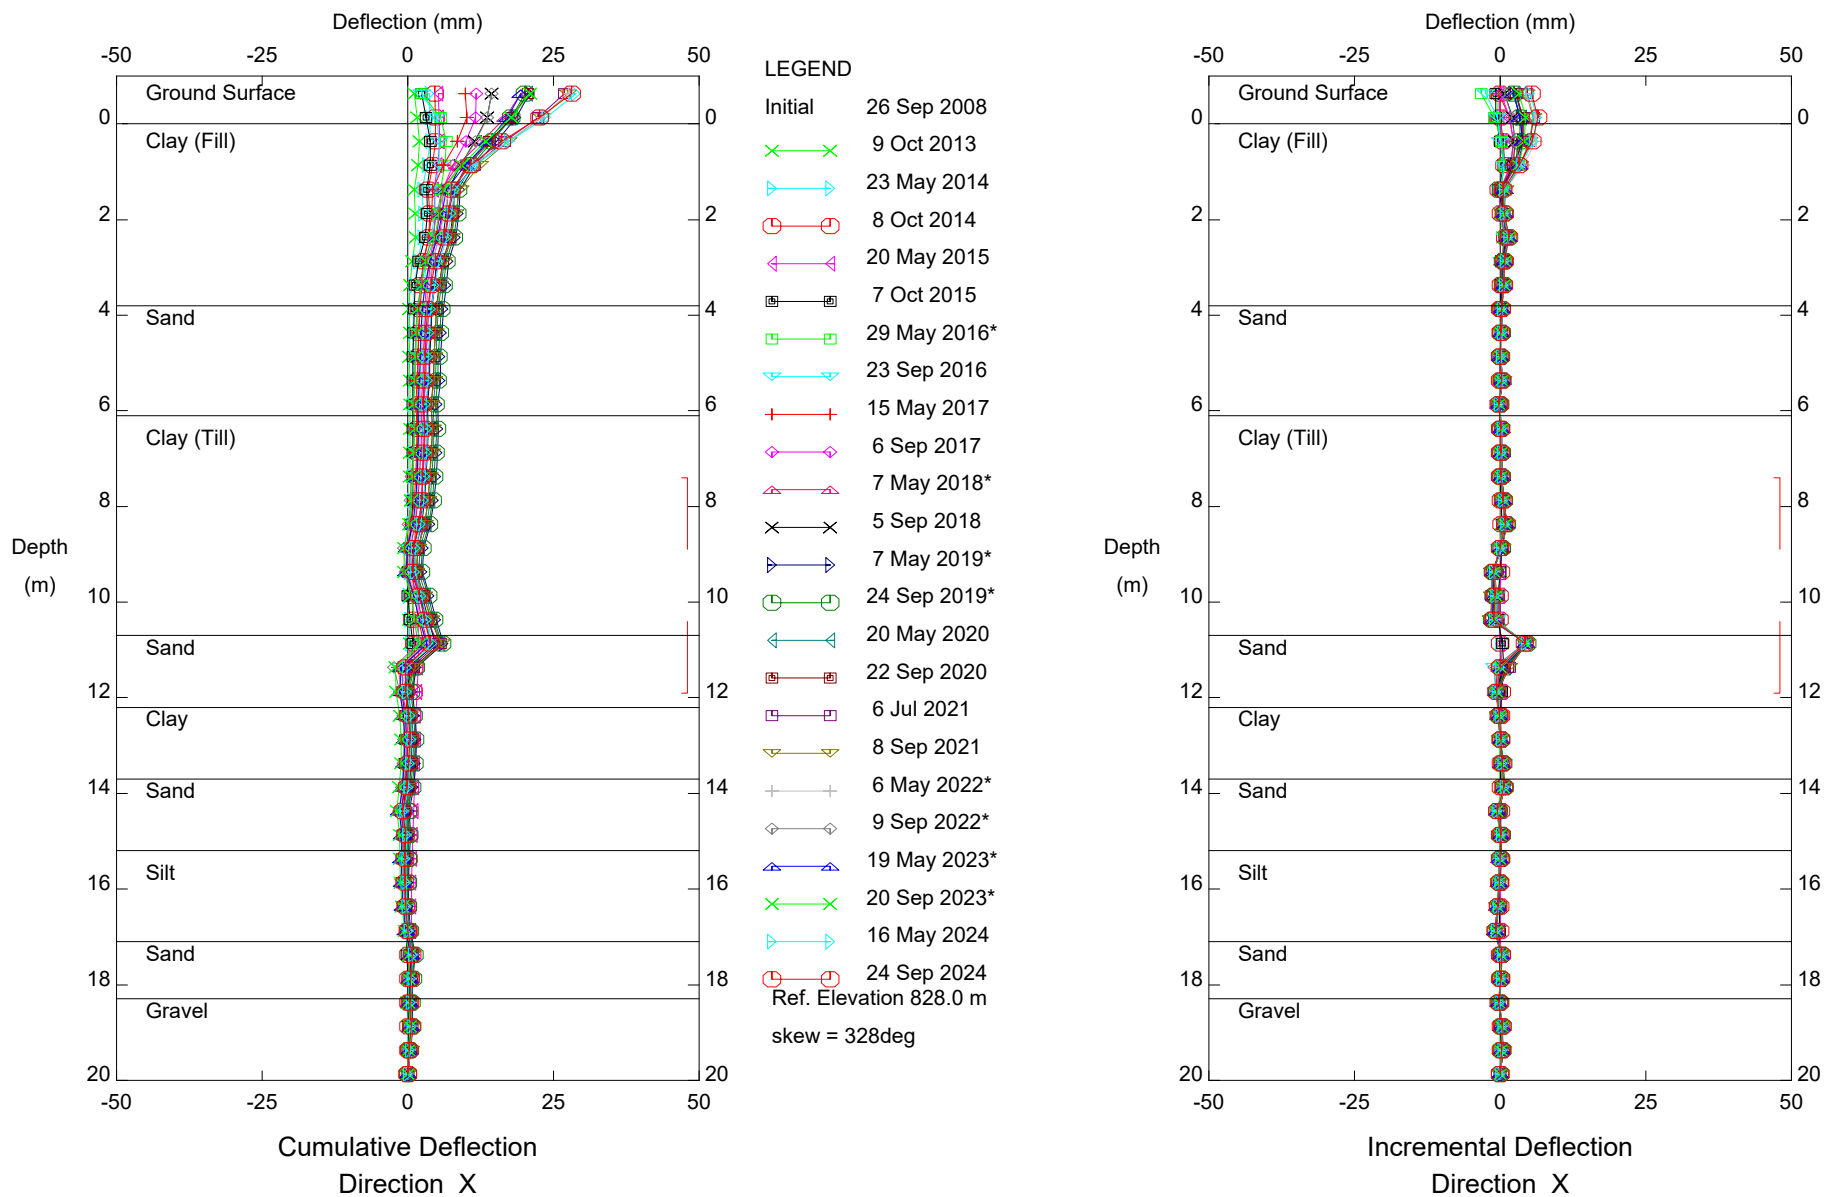
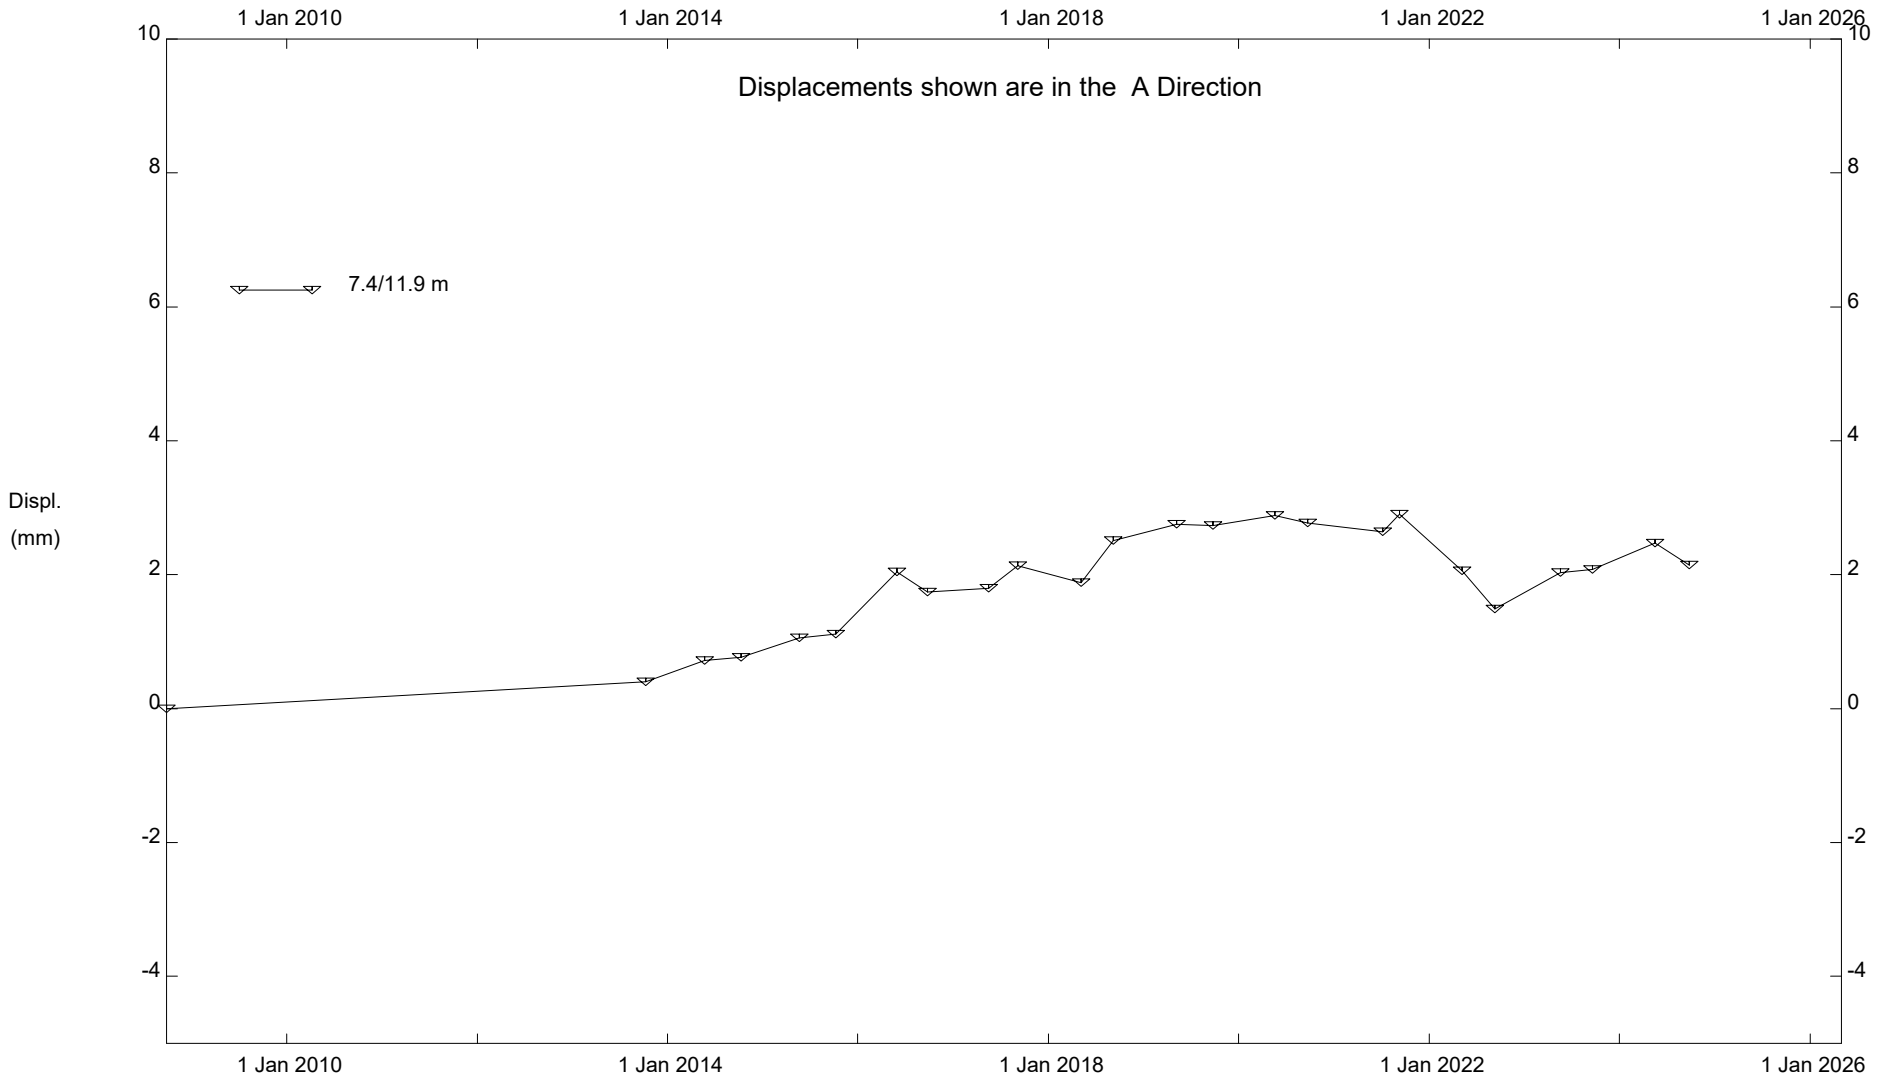
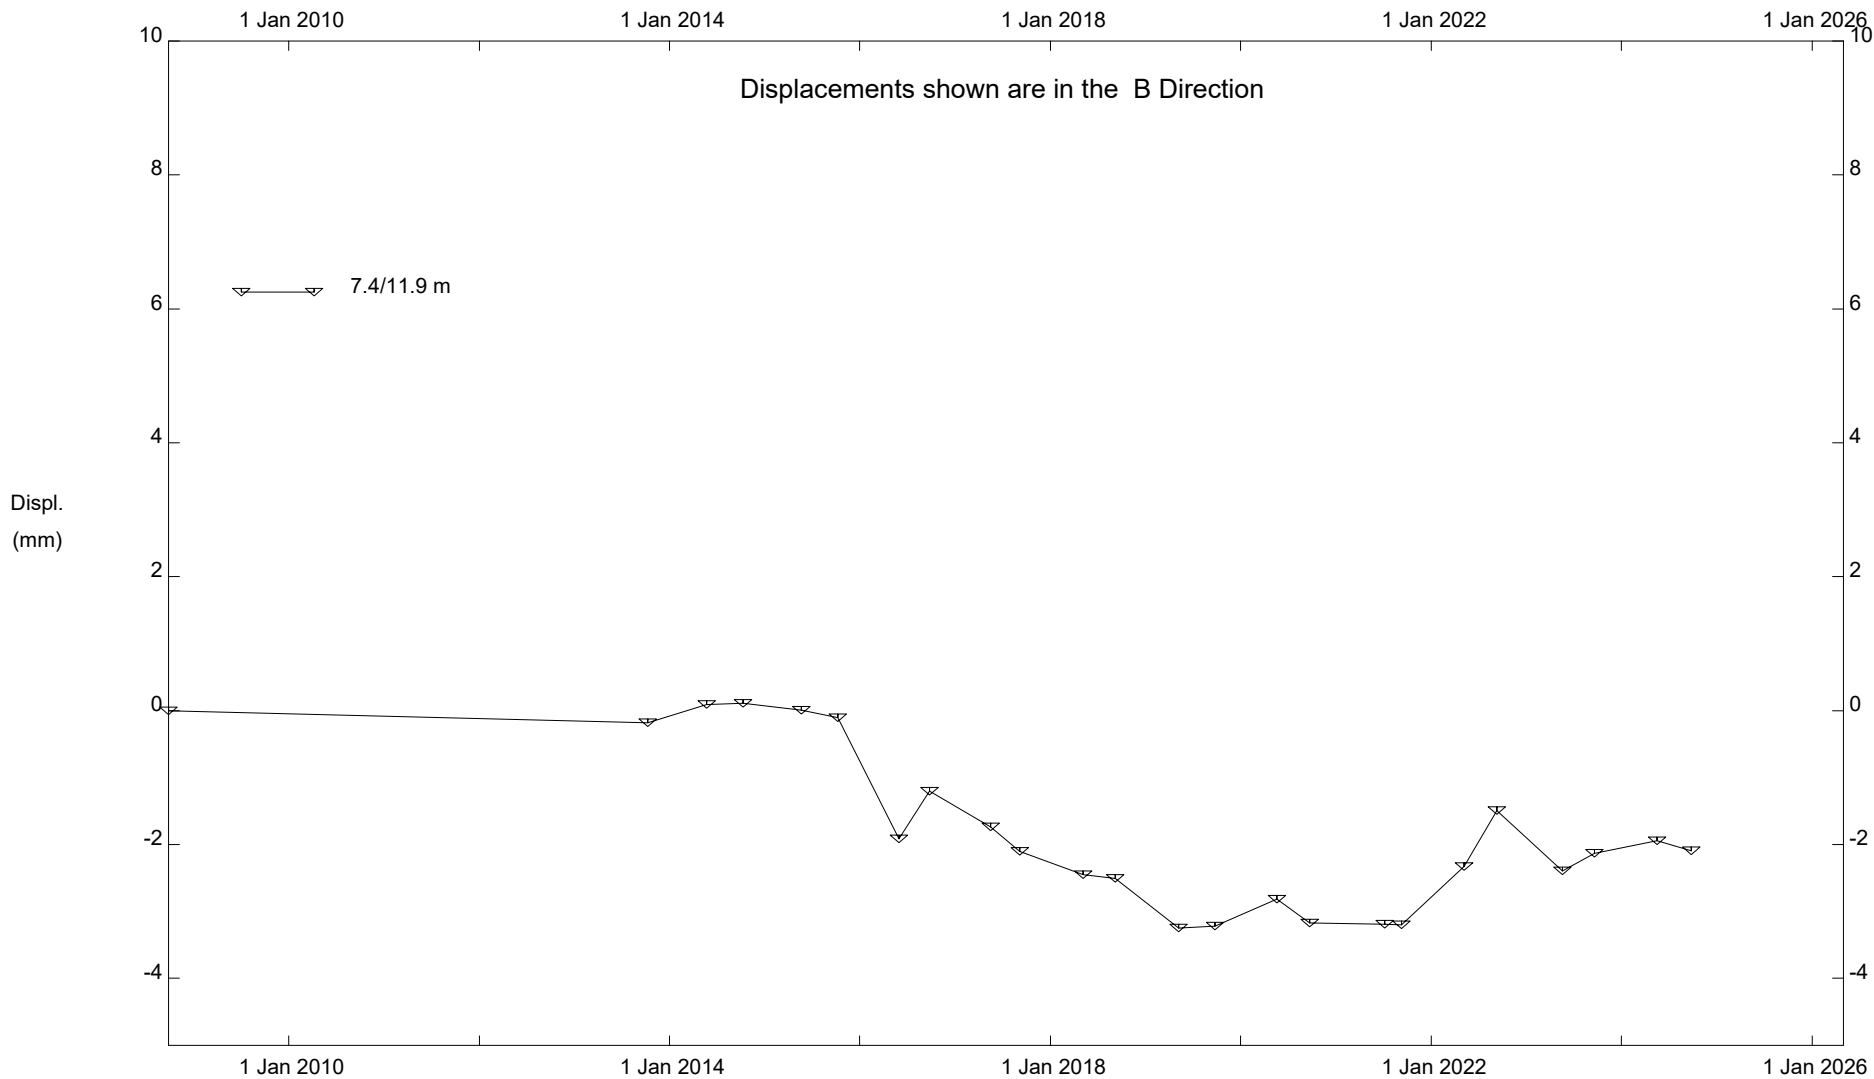
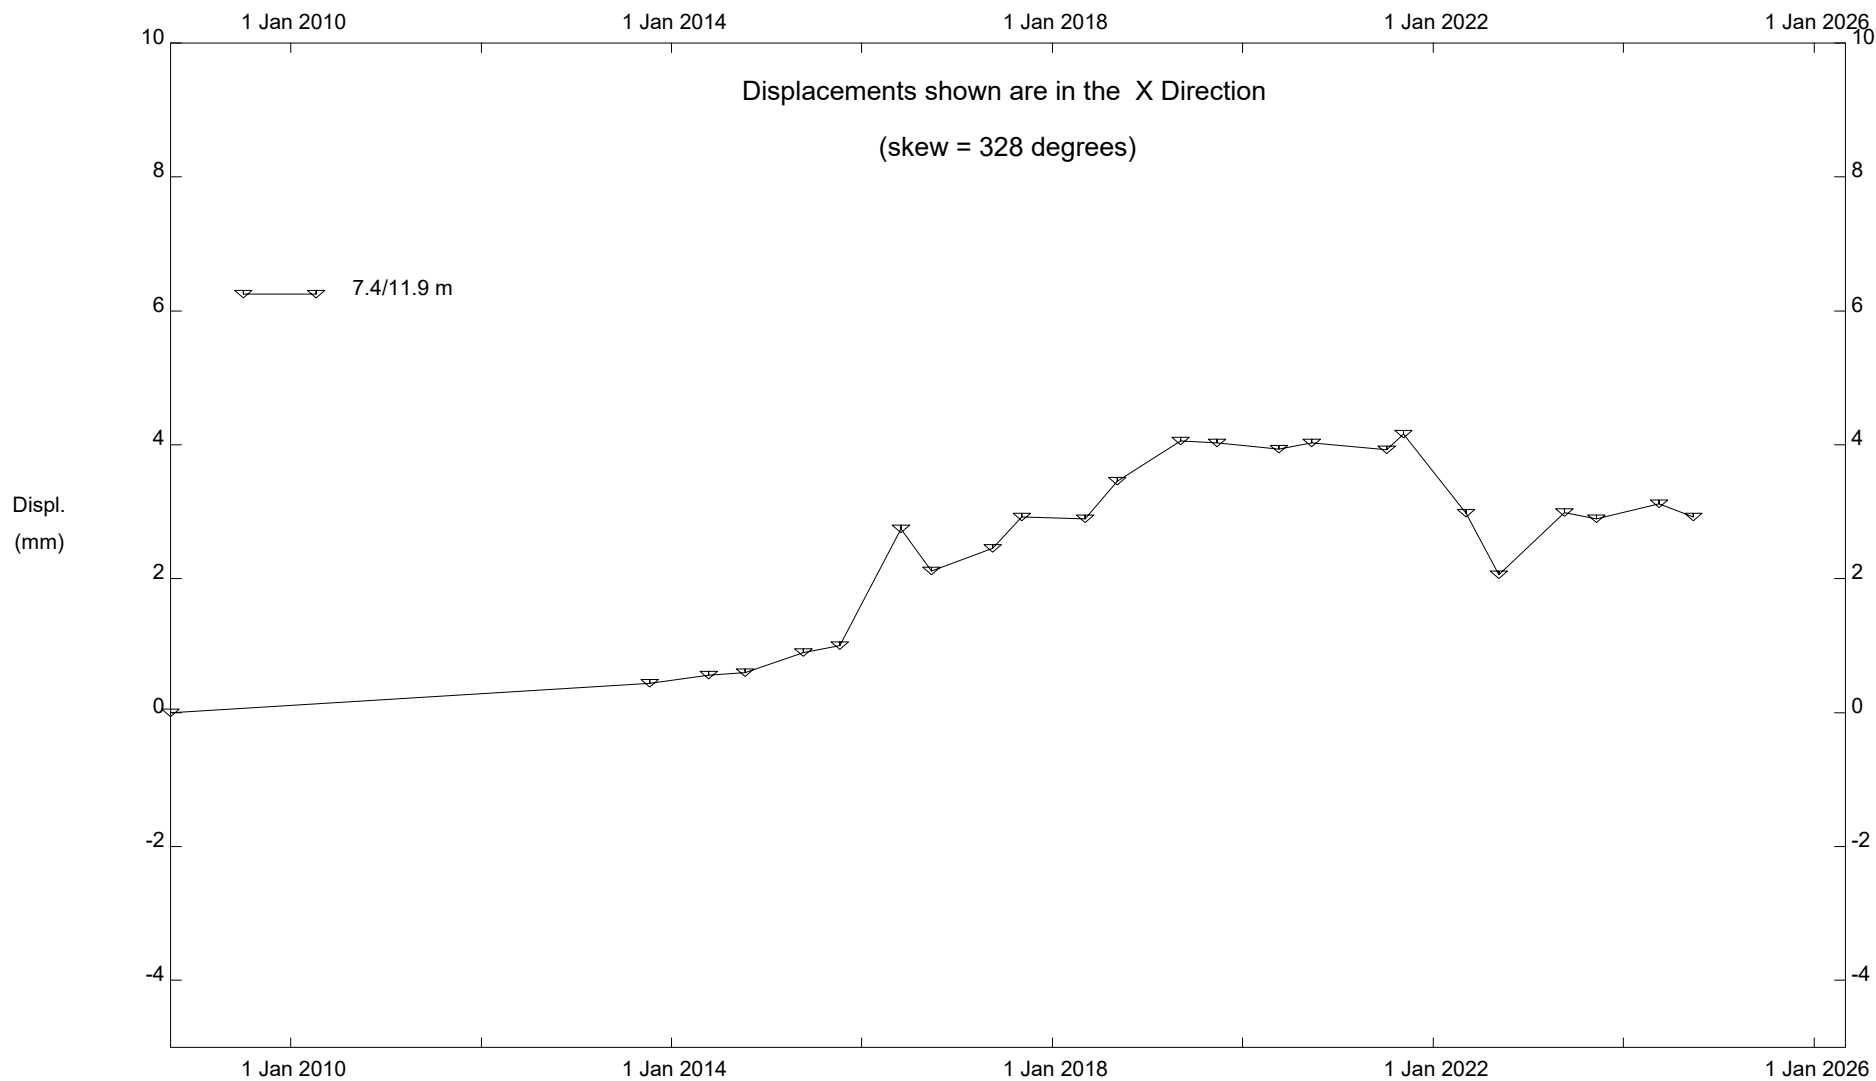
NC052, Inclinometer SI-1

SI-1 shows negligible movement over the zone of movement at about 11 m depth. Total cumulative movement observed since 2006 is about 3 mm.
