To:	Amy Driessen	From:	Leslie Cho and Xiteng Liu
	Transportation and Economic Corridors		Stantec Consulting Ltd.
File:	123315222	Date:	October 18, 2024

Reference: North Central Region, Stony Plain, Site NC052 - Highway 621:02 Pembina River Bridge Abutment, Fall 2024 Instrumentation Monitoring Report

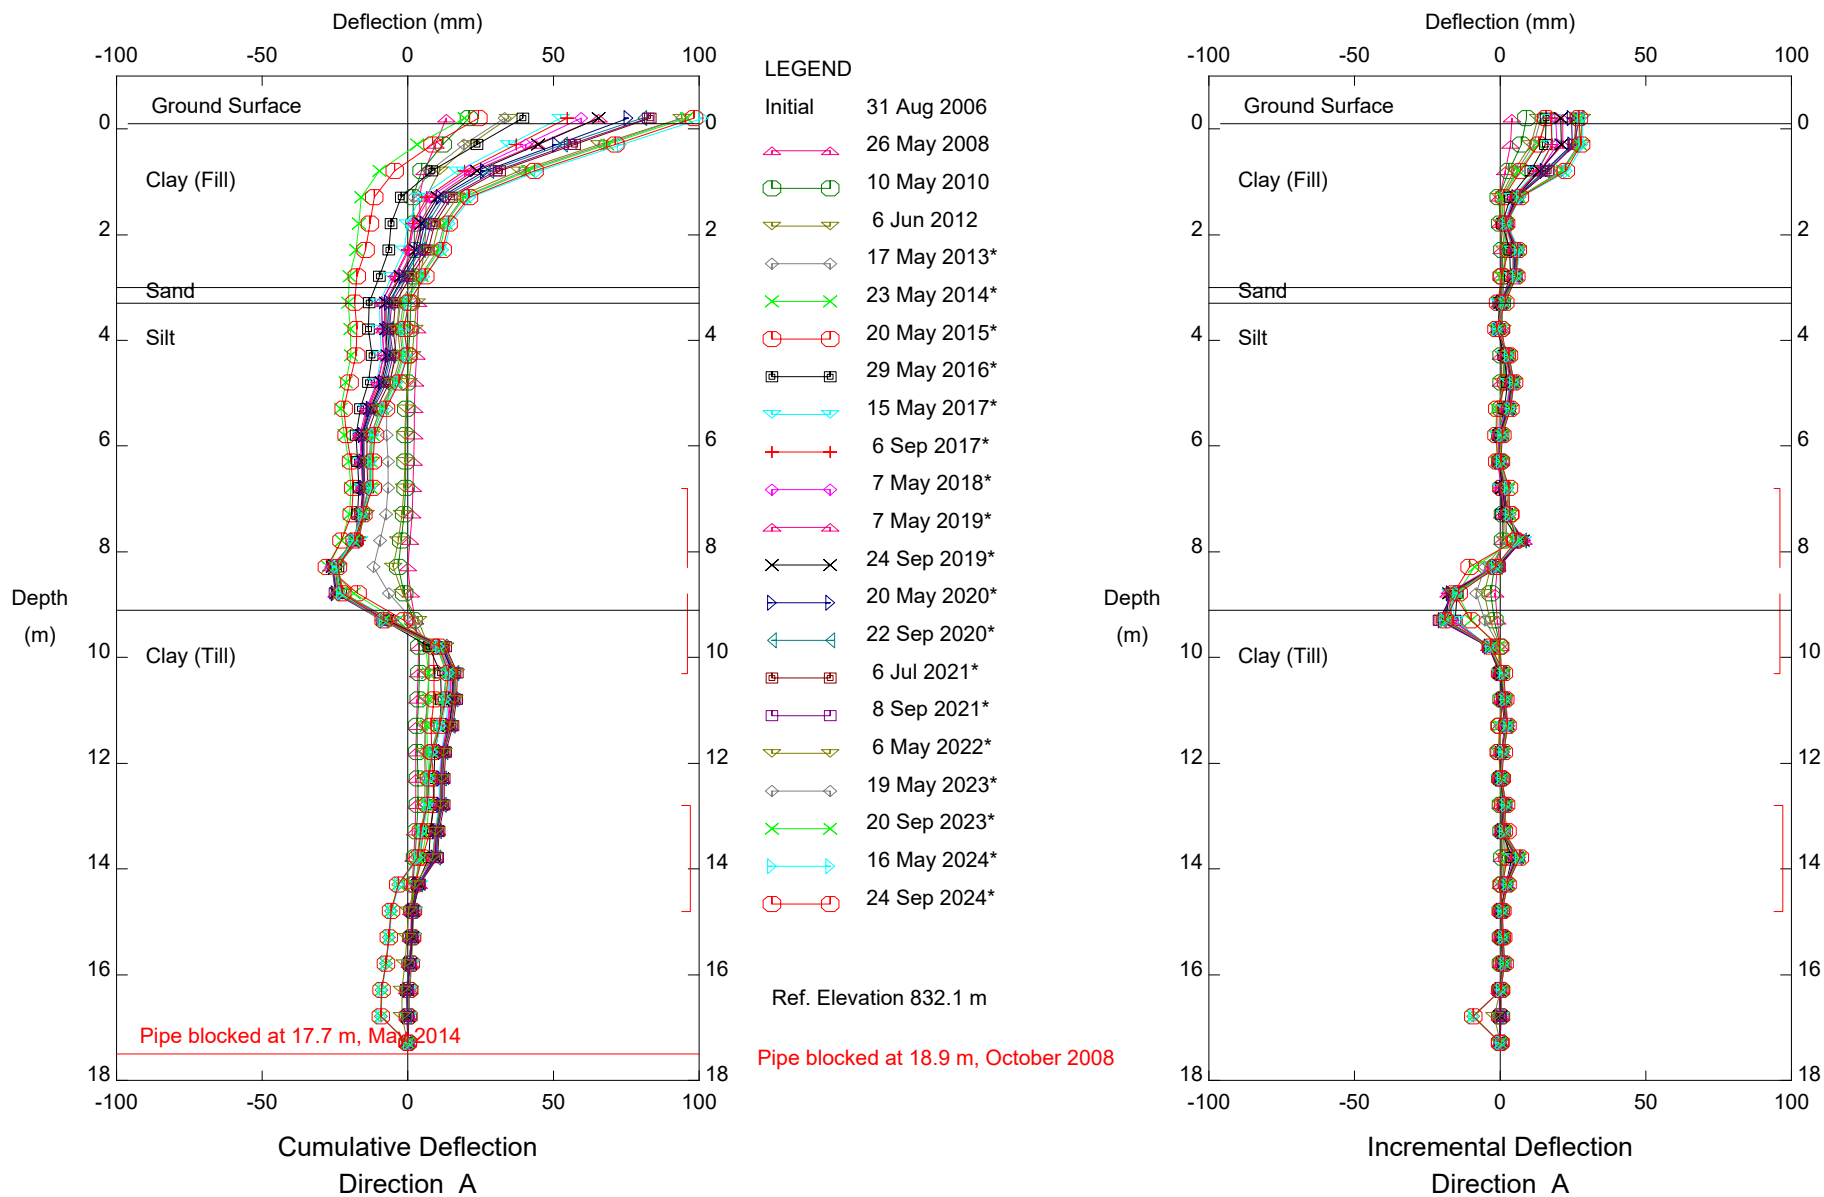
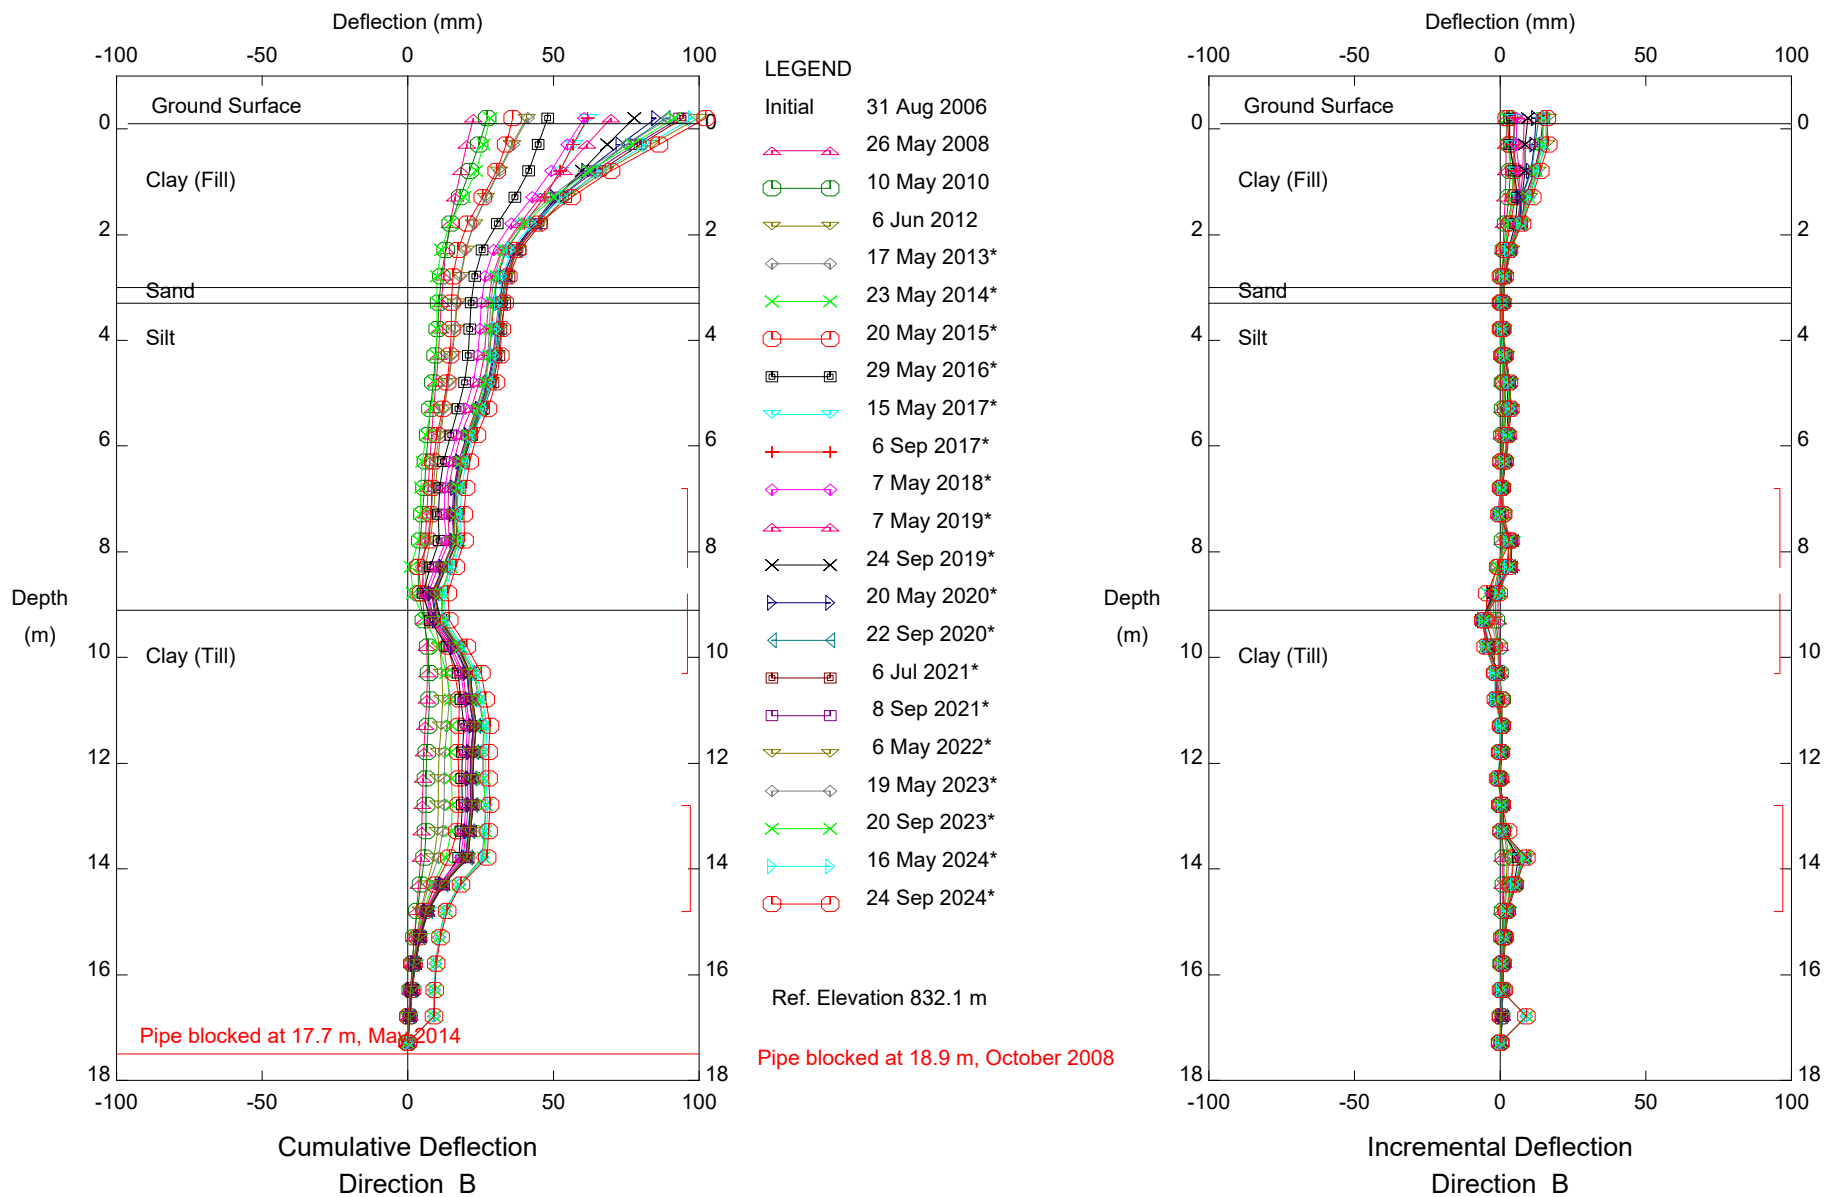
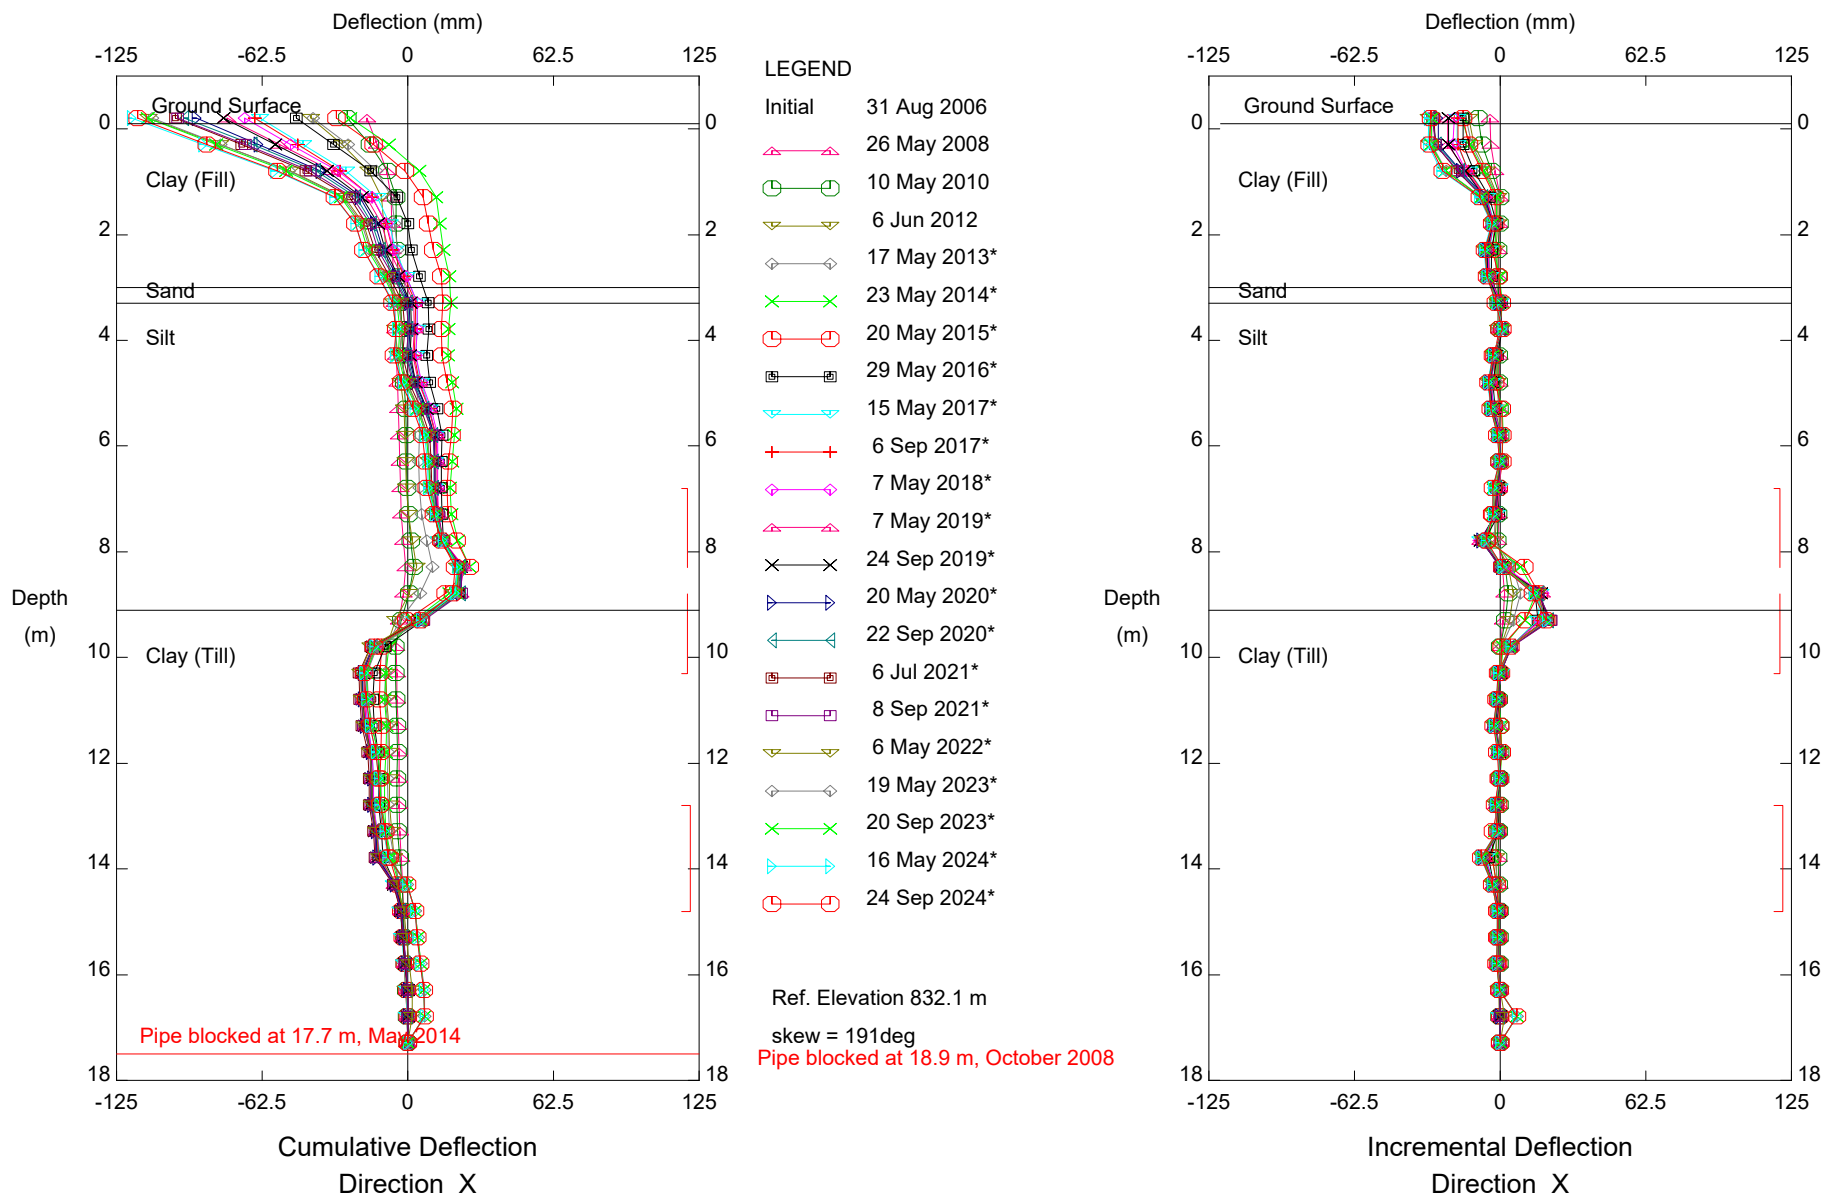
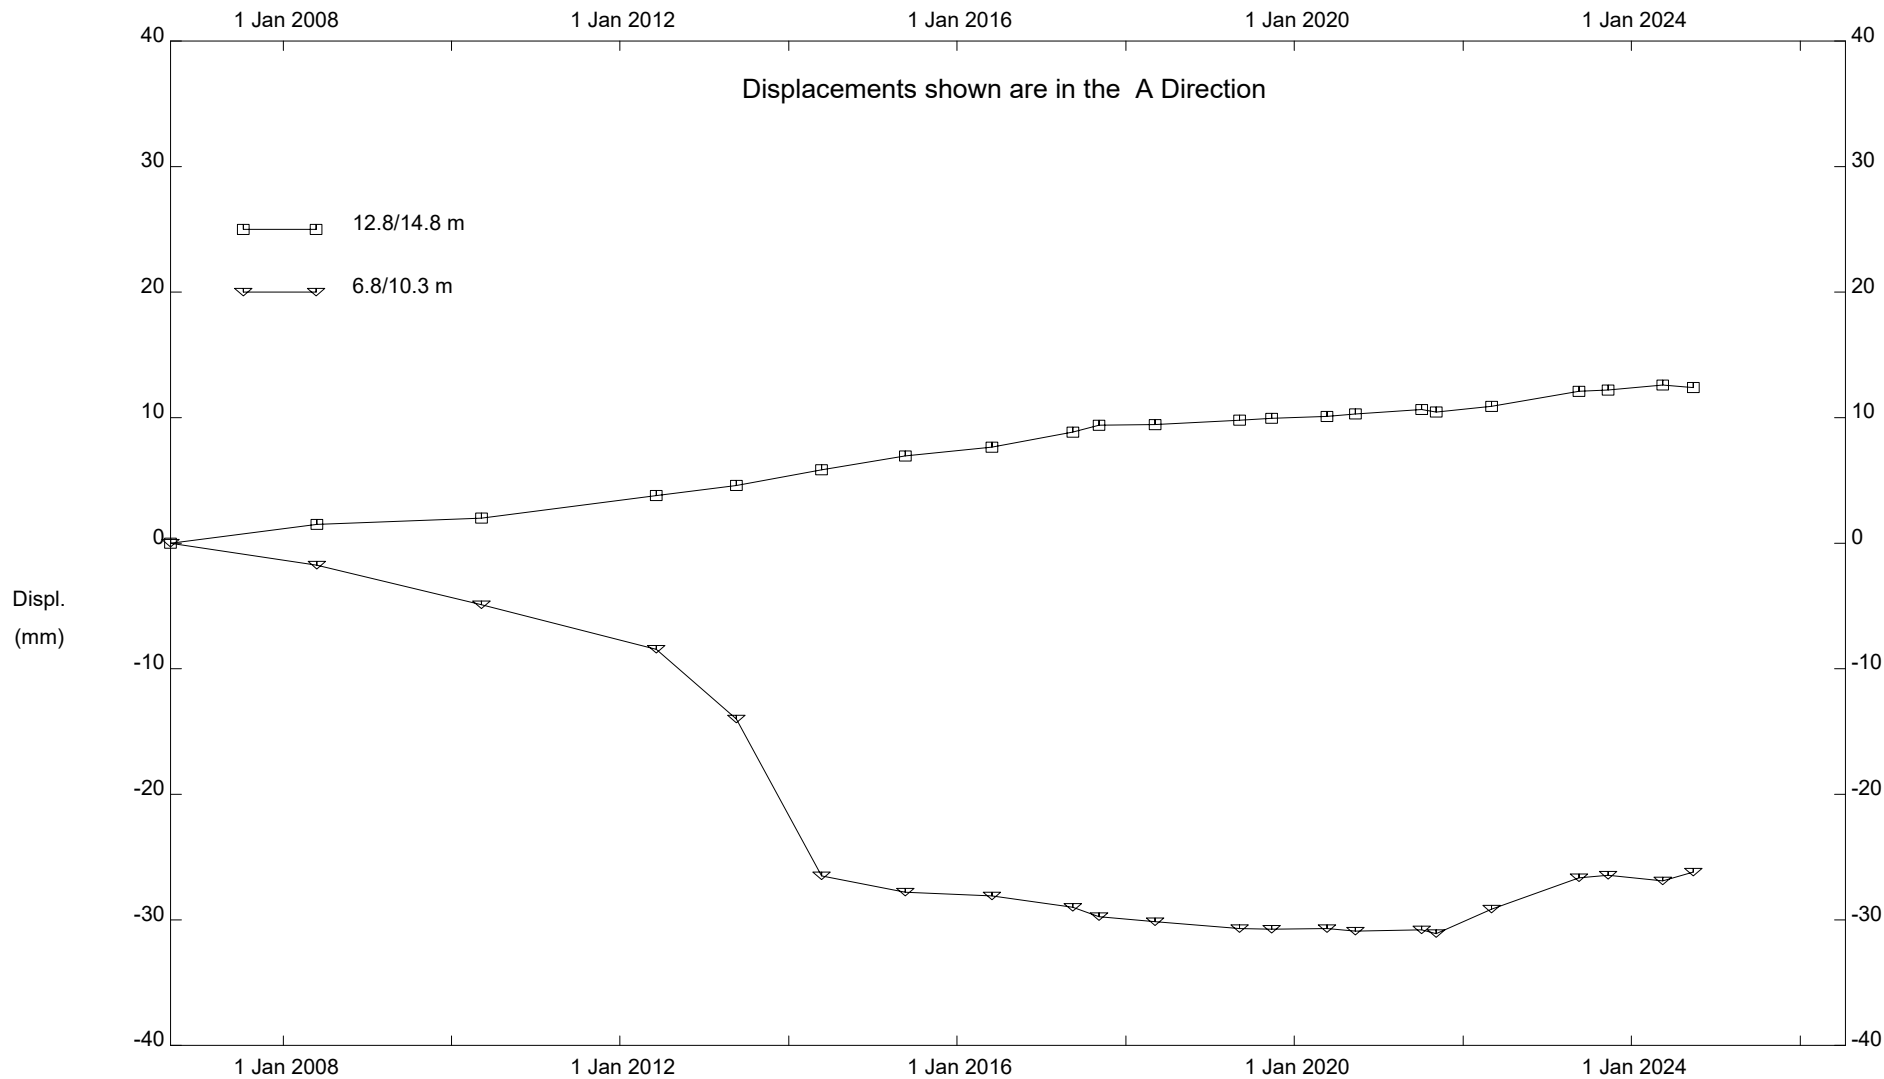
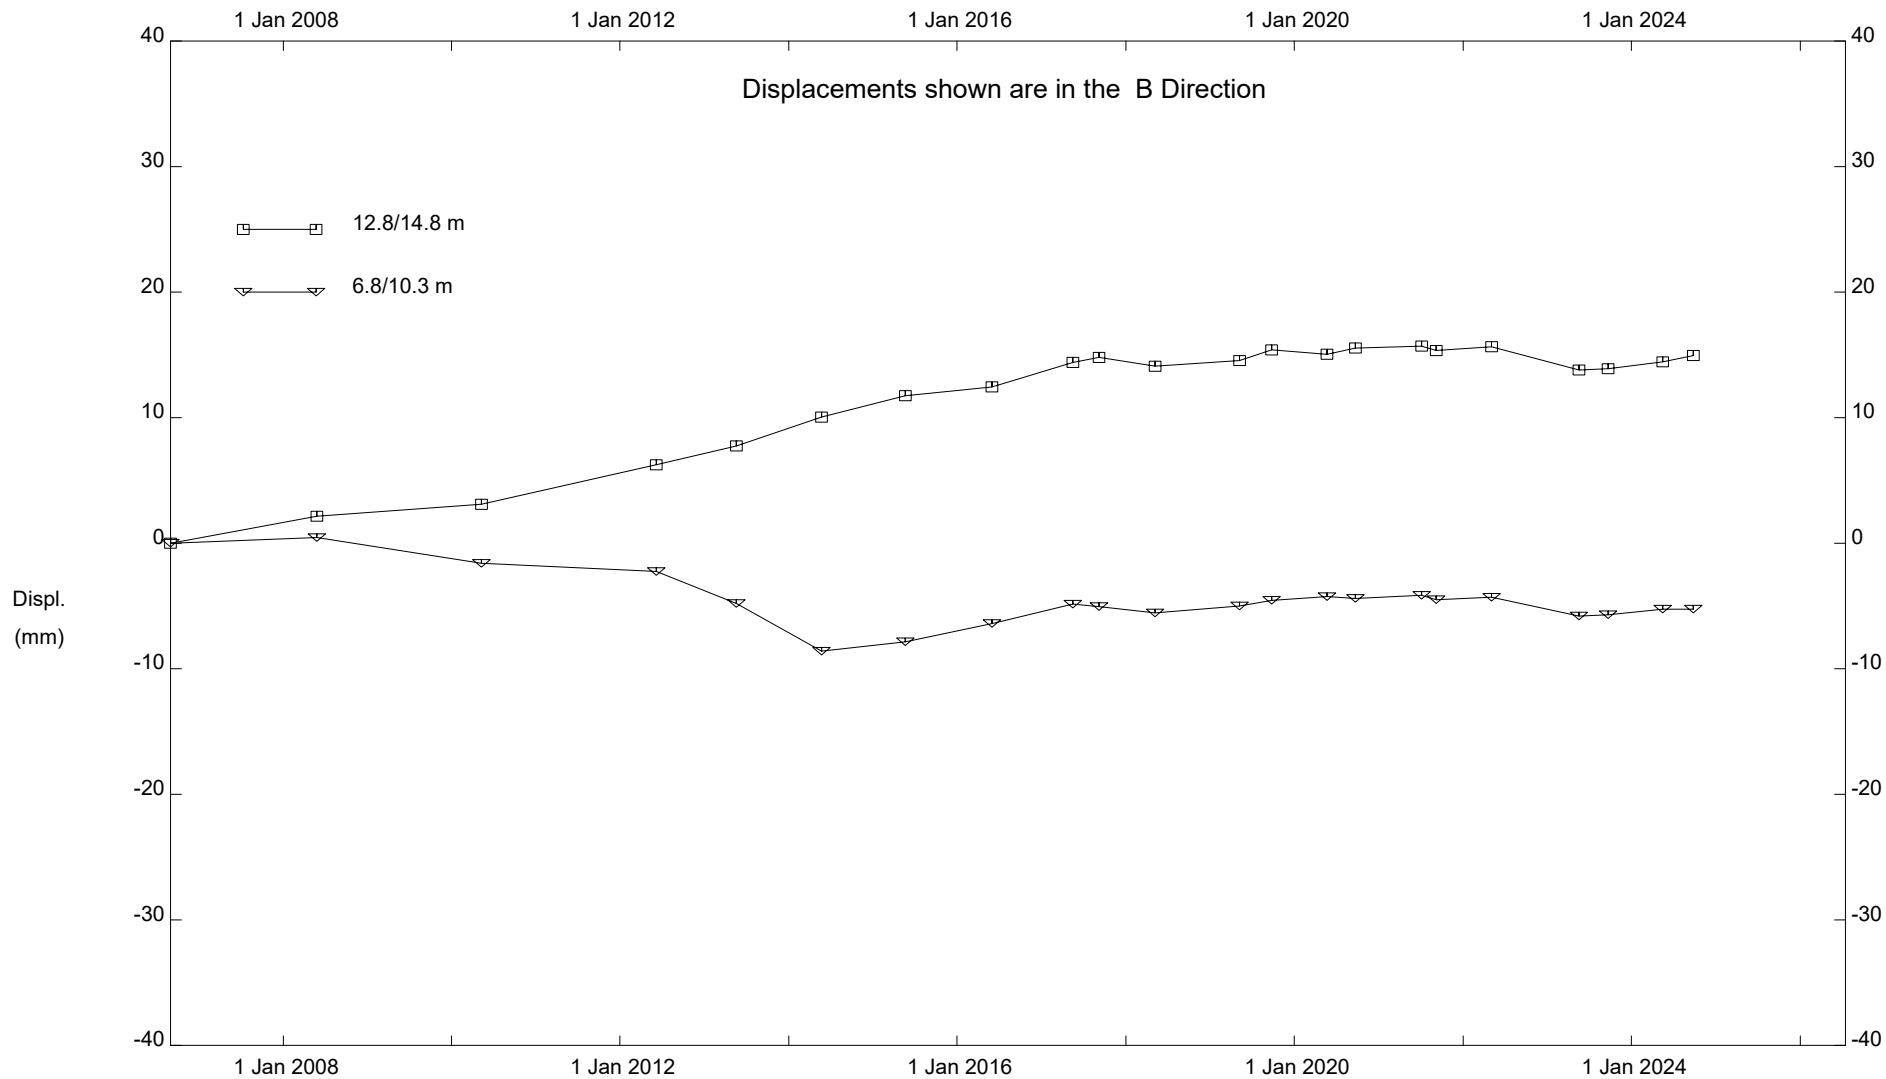
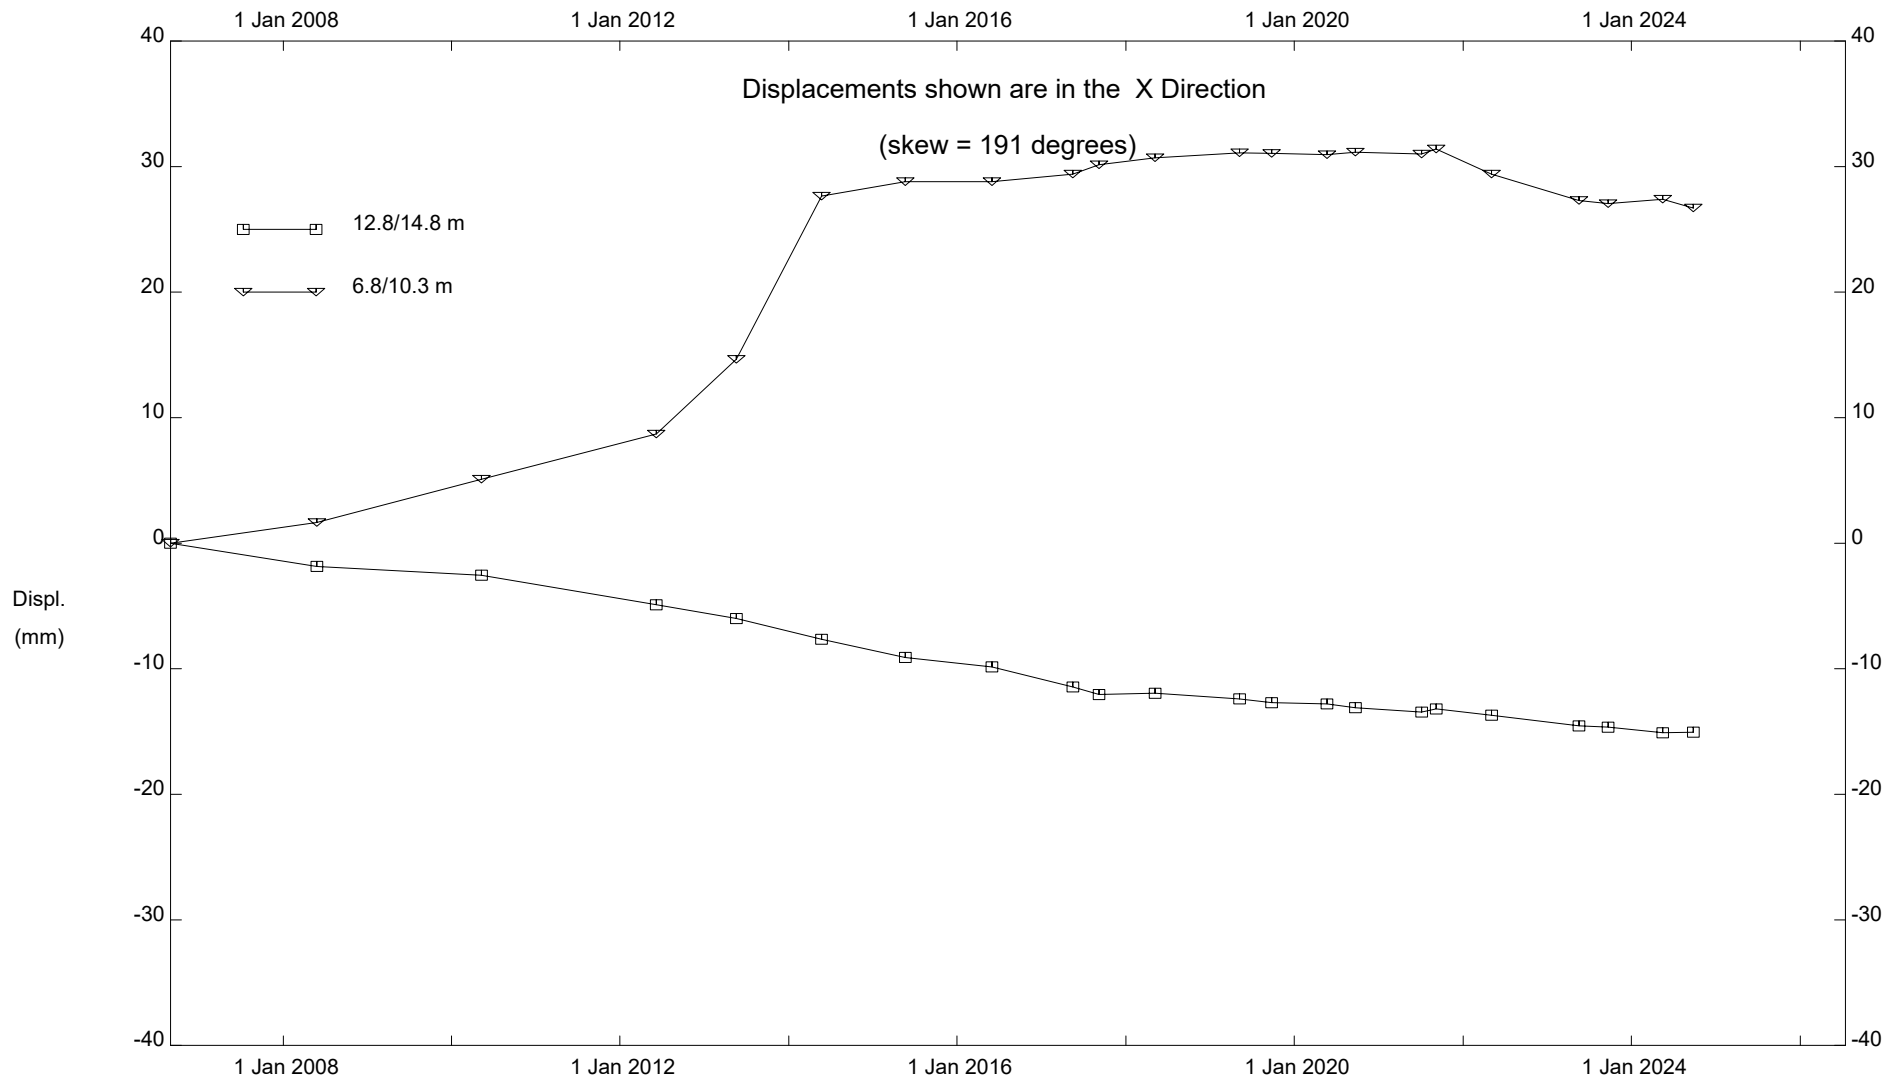
NC052, Inclinometer SI-2

SI-2 shows negligible movement rates over the two zones of movement at about 8 m and 14 m depth. It appears that the shallower zone of movement has been relatively stable with little movement recorded since 2013. There also appears to be a disturbance at the base of the SI that has been observed since Spring 2023.

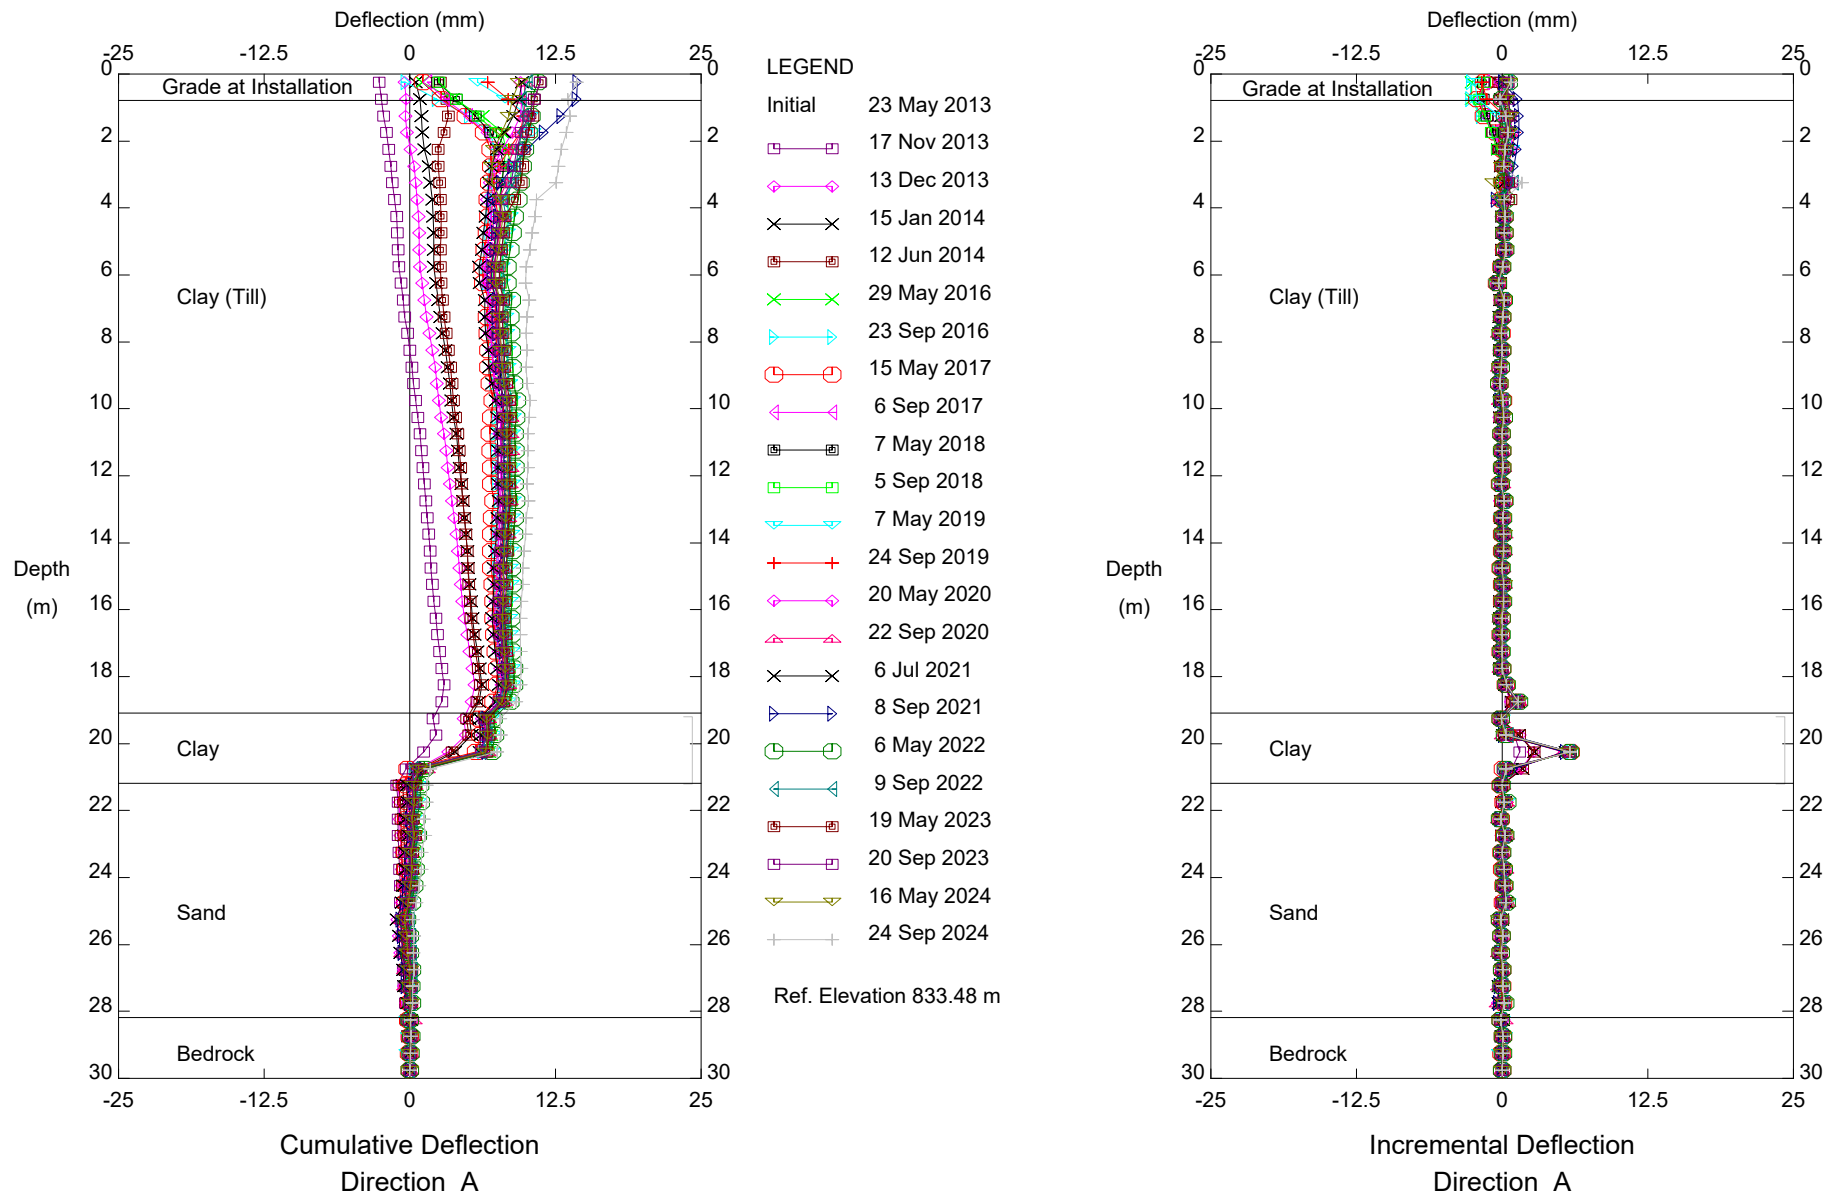
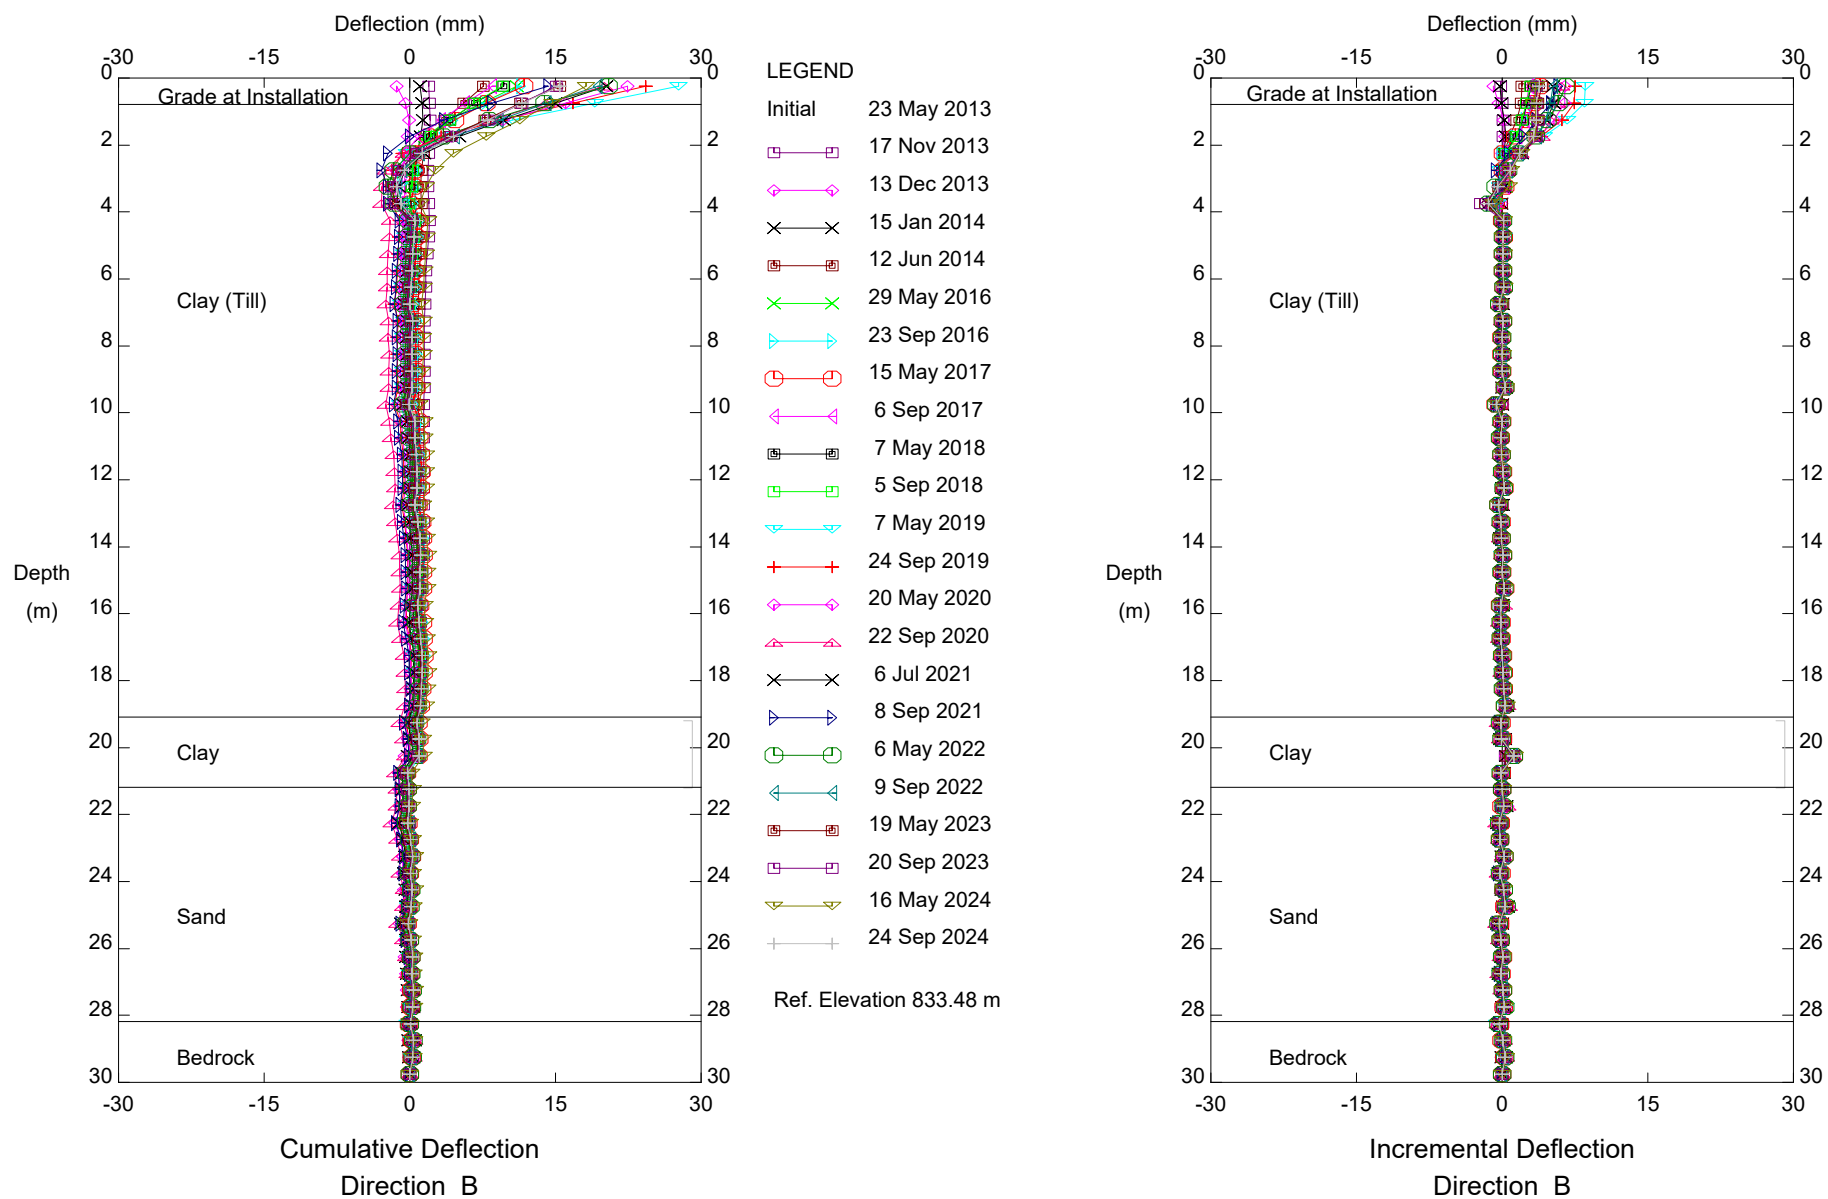
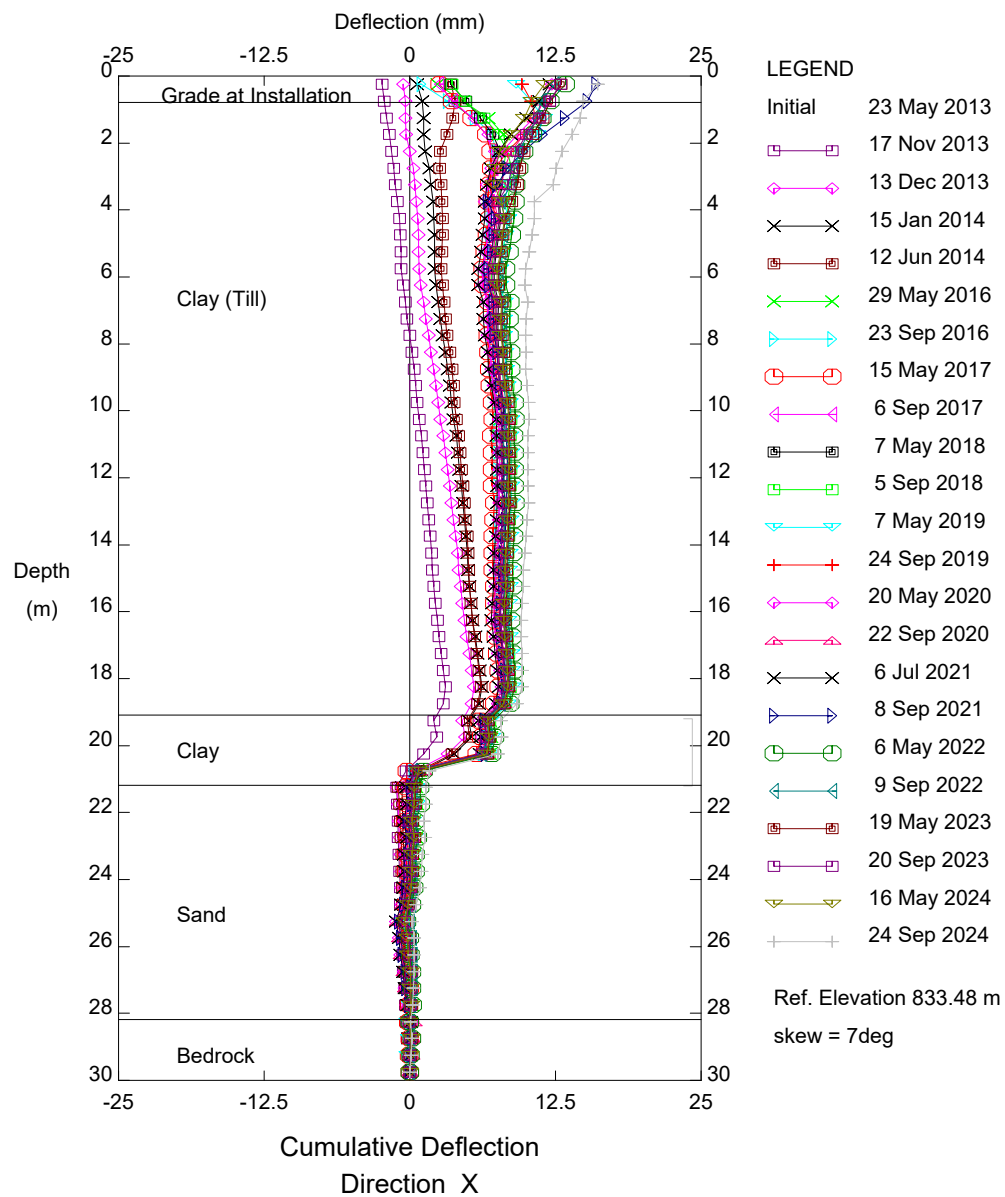
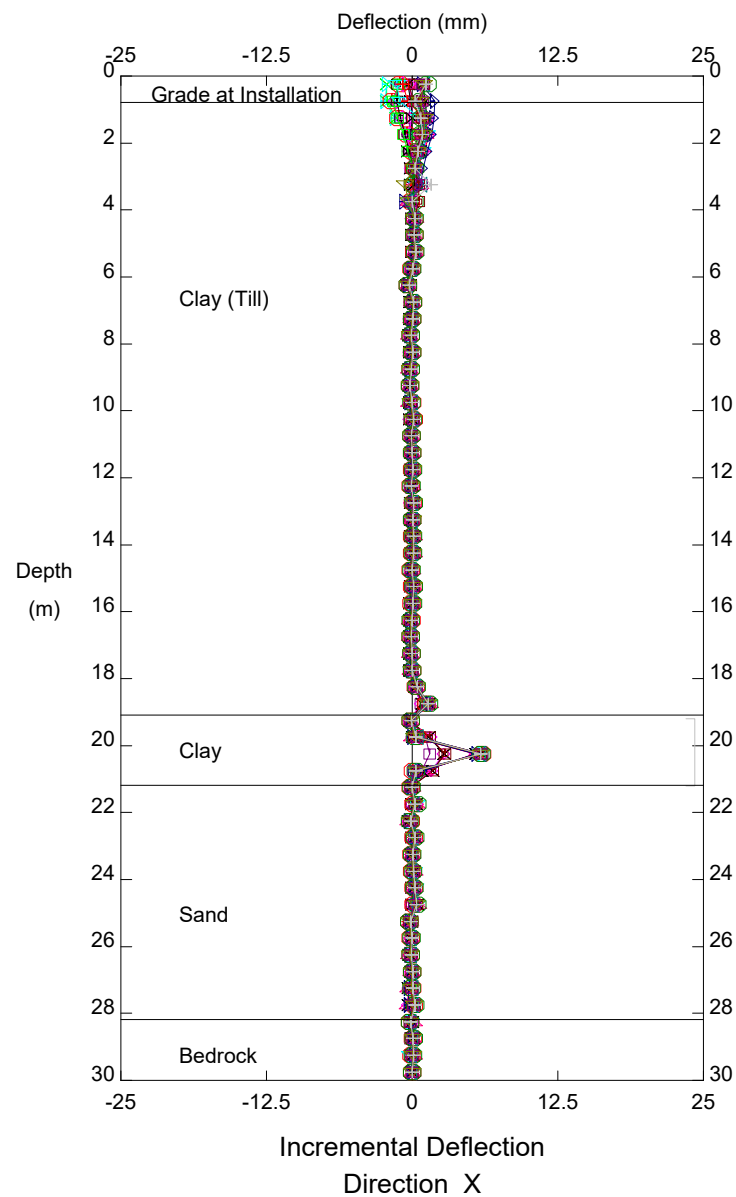
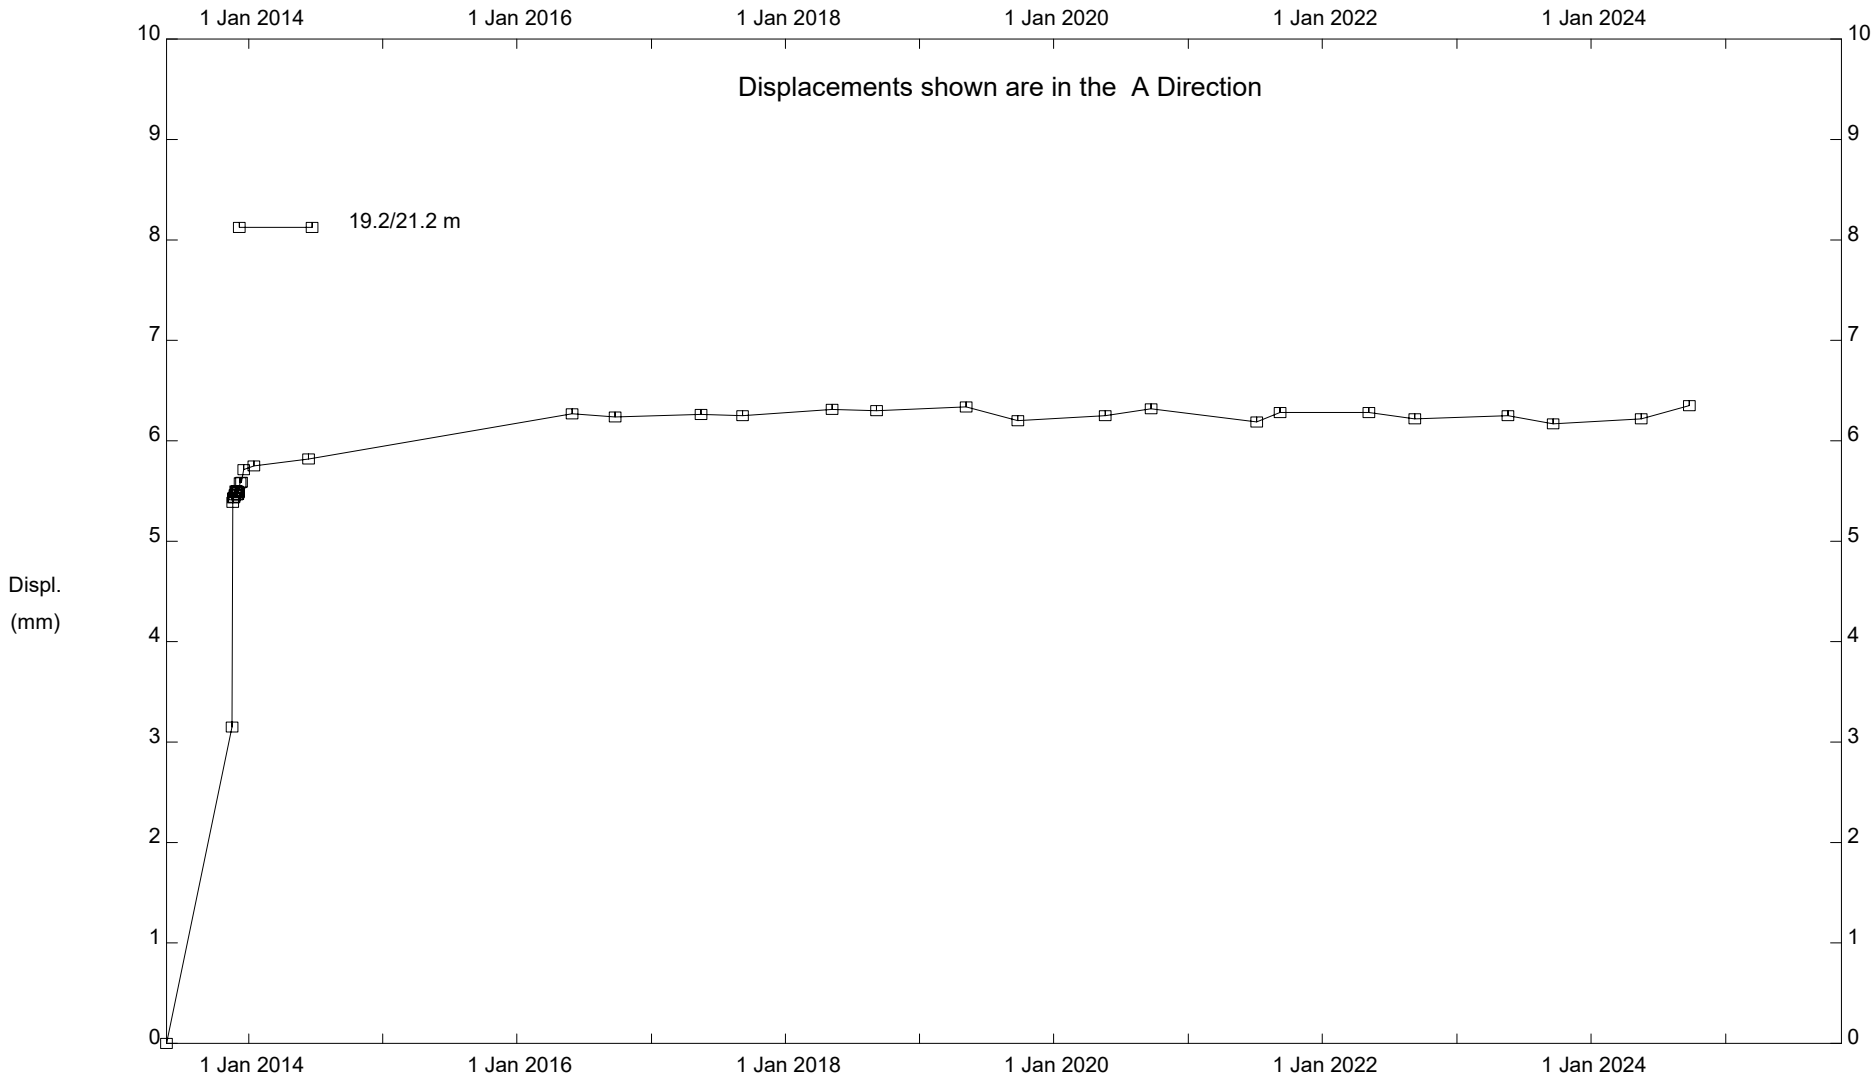
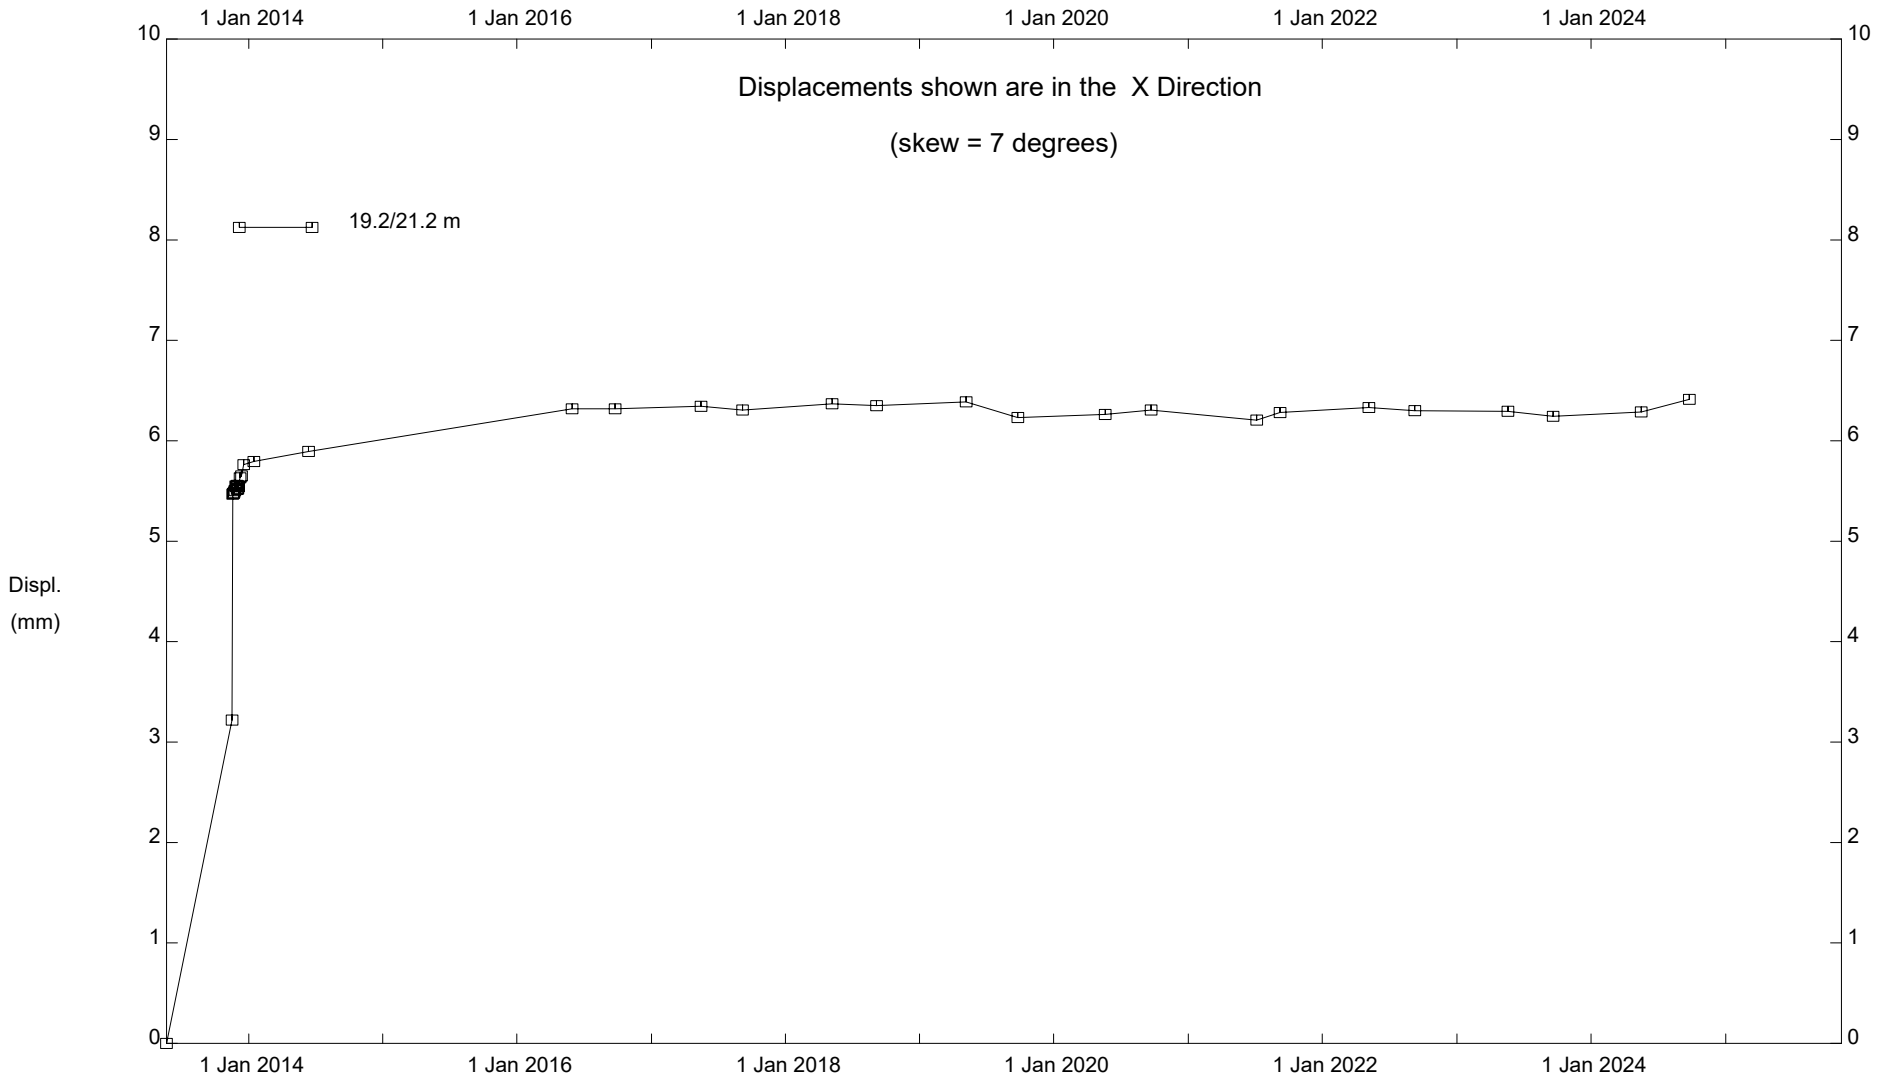
NC052, Inclinometer SI13-3
 Transportation & Economic Corridors

SI13-3 has recorded about 6 mm of cumulative movement since 2014. The recorded movement is likely related to construction activities in winter 2014. Little to no movement was observed since 2015.
