To:	Amy Driessen	From:	Leslie Cho and Xiteng Liu
	Transportation and Economic Corridors		Stantec Consulting Ltd.
File:	123315222	Date:	October 18, 2024

Reference: North Central Region, Stony Plain, Site NC052 - Highway 621:02 Pembina River Bridge Abutment, Fall 2024 Instrumentation Monitoring Report

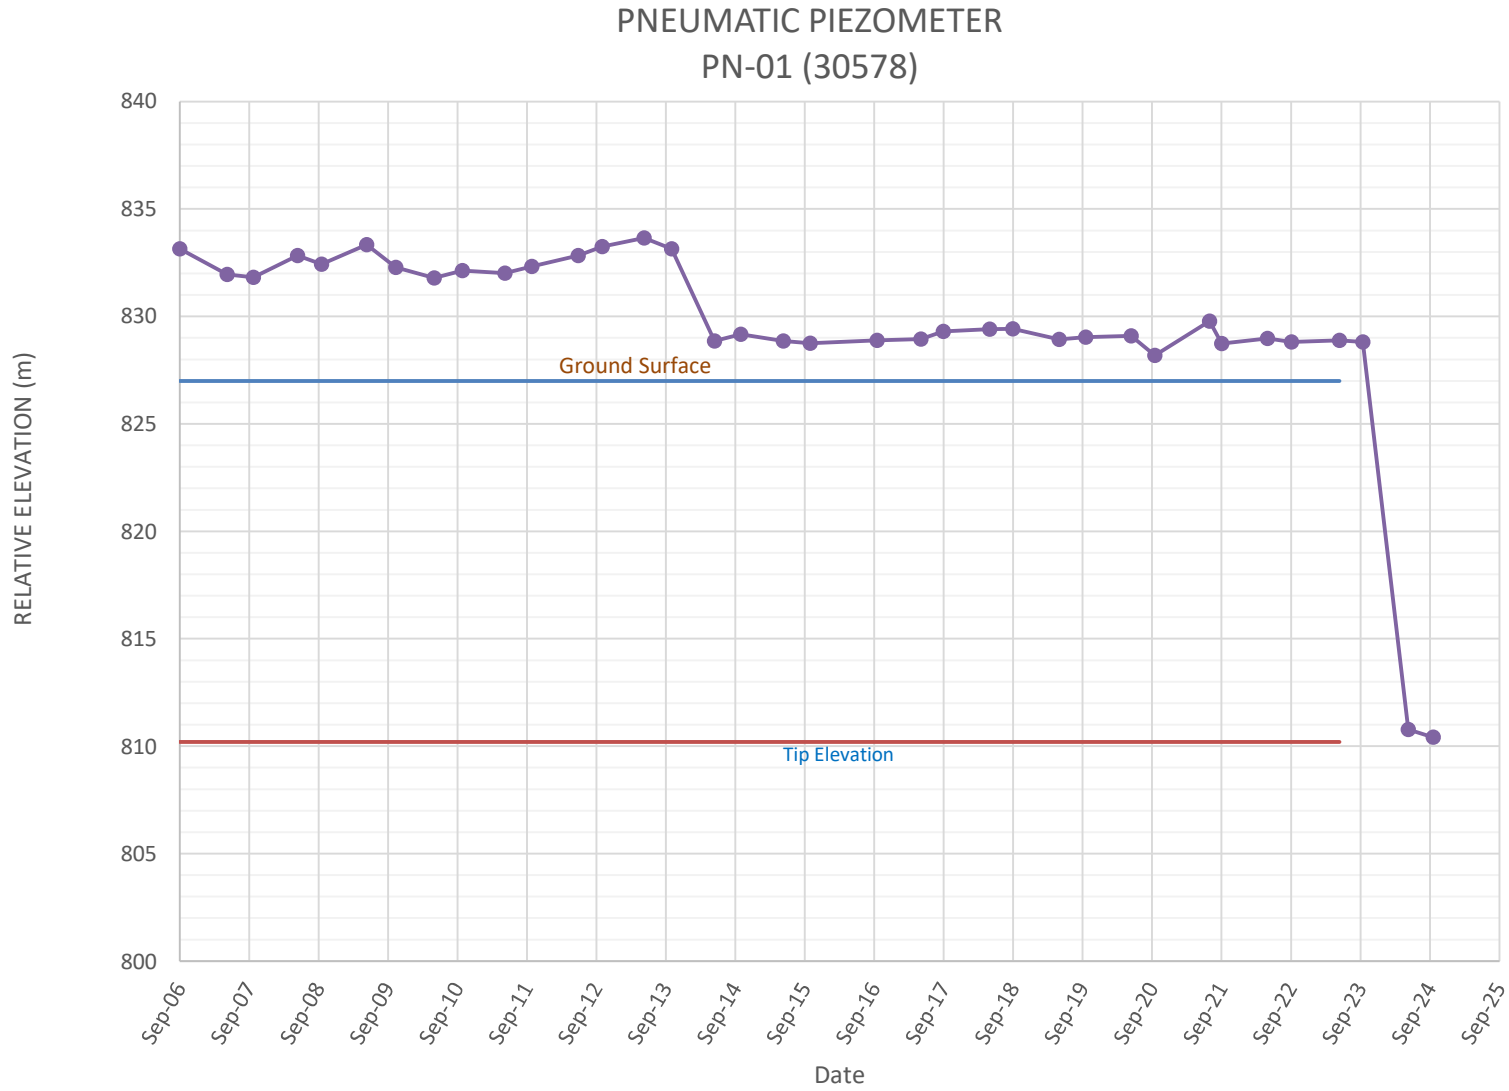
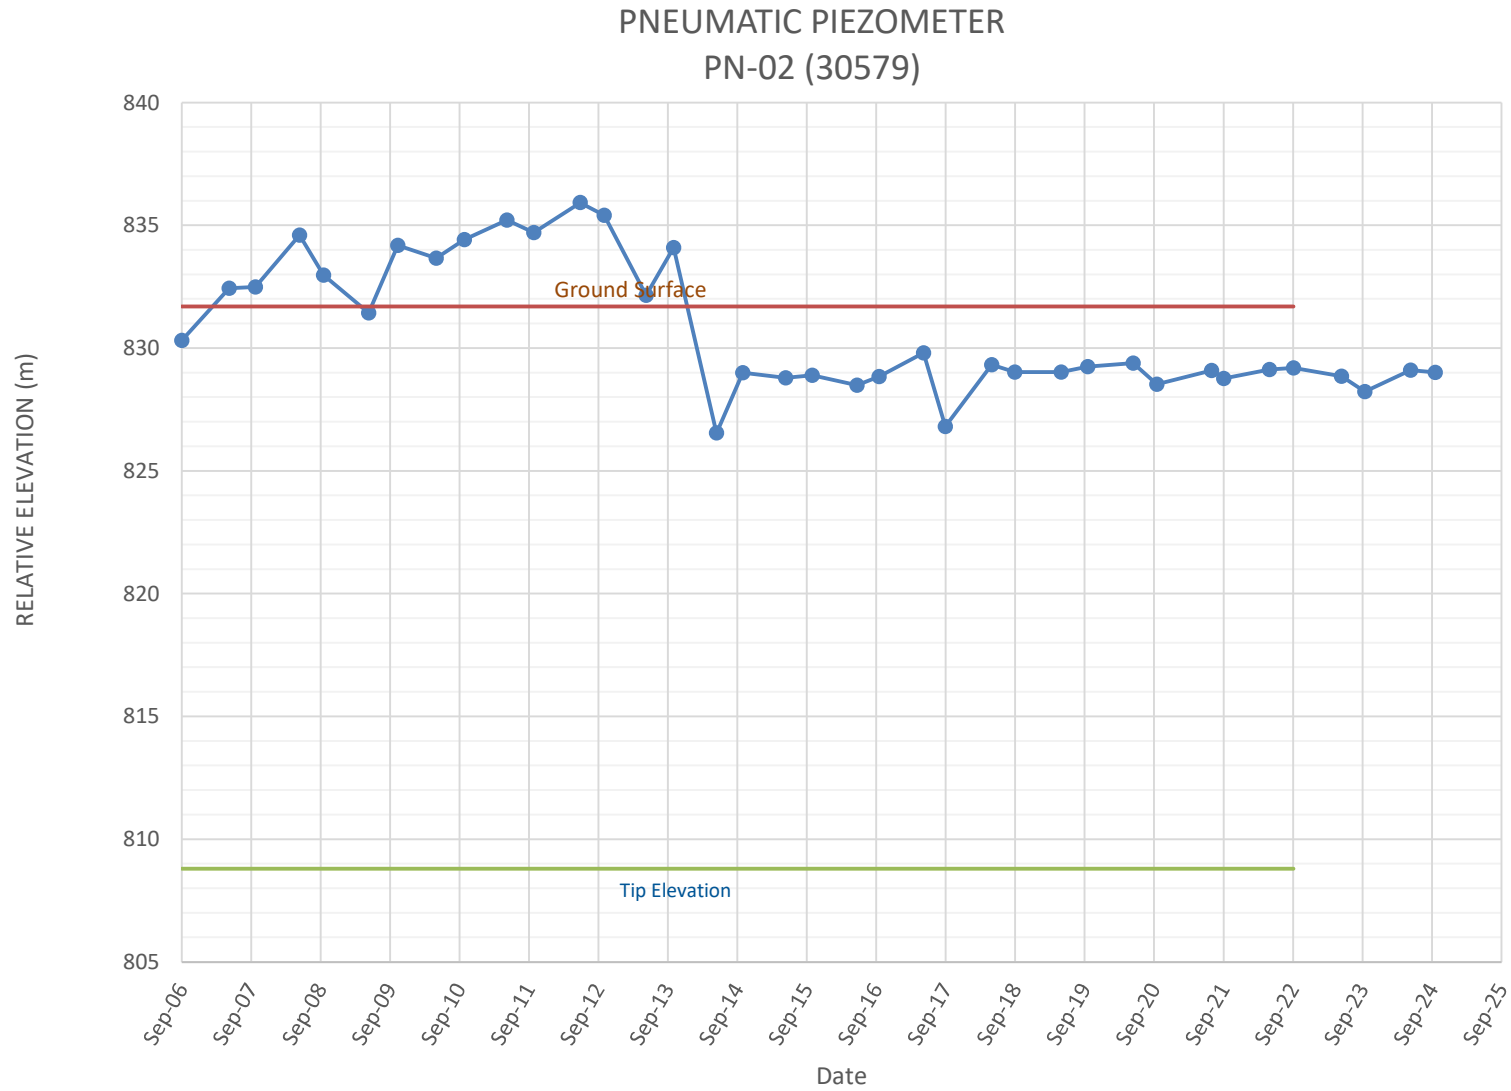
A second attempt to monitor **PN-01** was made, which continued to show a significant decrease in pore pressure despite water flow out of the SI casing being observed. The data is likely erroneous due to a leak within the pneumatic piezometer tubing.

PN-02 had artesian conditions until 2014 where the pore pressure decreased as a result of remedial work to relieve pore pressures in the east slope. The current water level is at 2.7 m below ground surface, consistent with historical trends since 2014.

An attempt to repair PN-01 could be made since the ability to hear the hissing sound suggests the leak is within the exposed portion of cabling. If the leak location is identified, PN-01 could potentially be repaired by splicing below the leak.

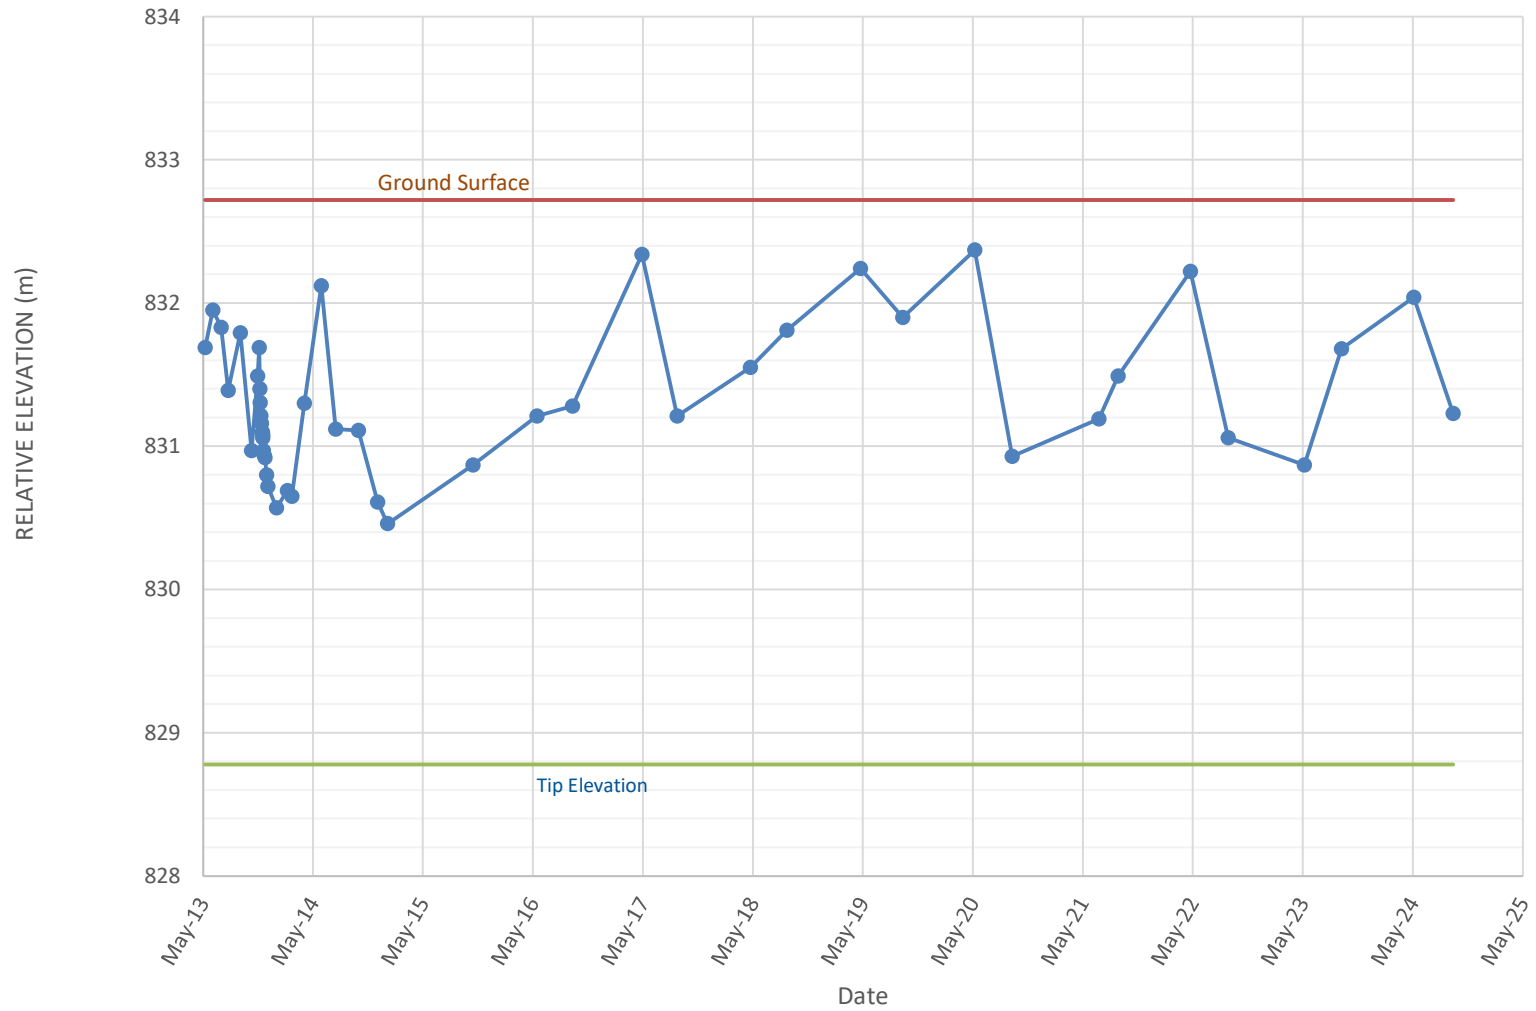
STANDPIPE PIEZOMETER
SP13-3A

The water level in **SP13-3A** decreased by about 1.7 m after construction in winter 2014. The water level gradually increased to above pre-construction levels in May 2017. A 1.1 m drop was measured in September 2017 whereafter water levels increased again to above pre-construction levels until May 2020. Another significant drop in water levels was observed in September 2020. There appears to be a trend where water levels increase for 2-3 years followed by a sharp drop in water levels. The current measured water level decreased by 0.8 m from previous reading cycle in Spring 2024 corresponding to a water level depth of 1.5 m bgs.

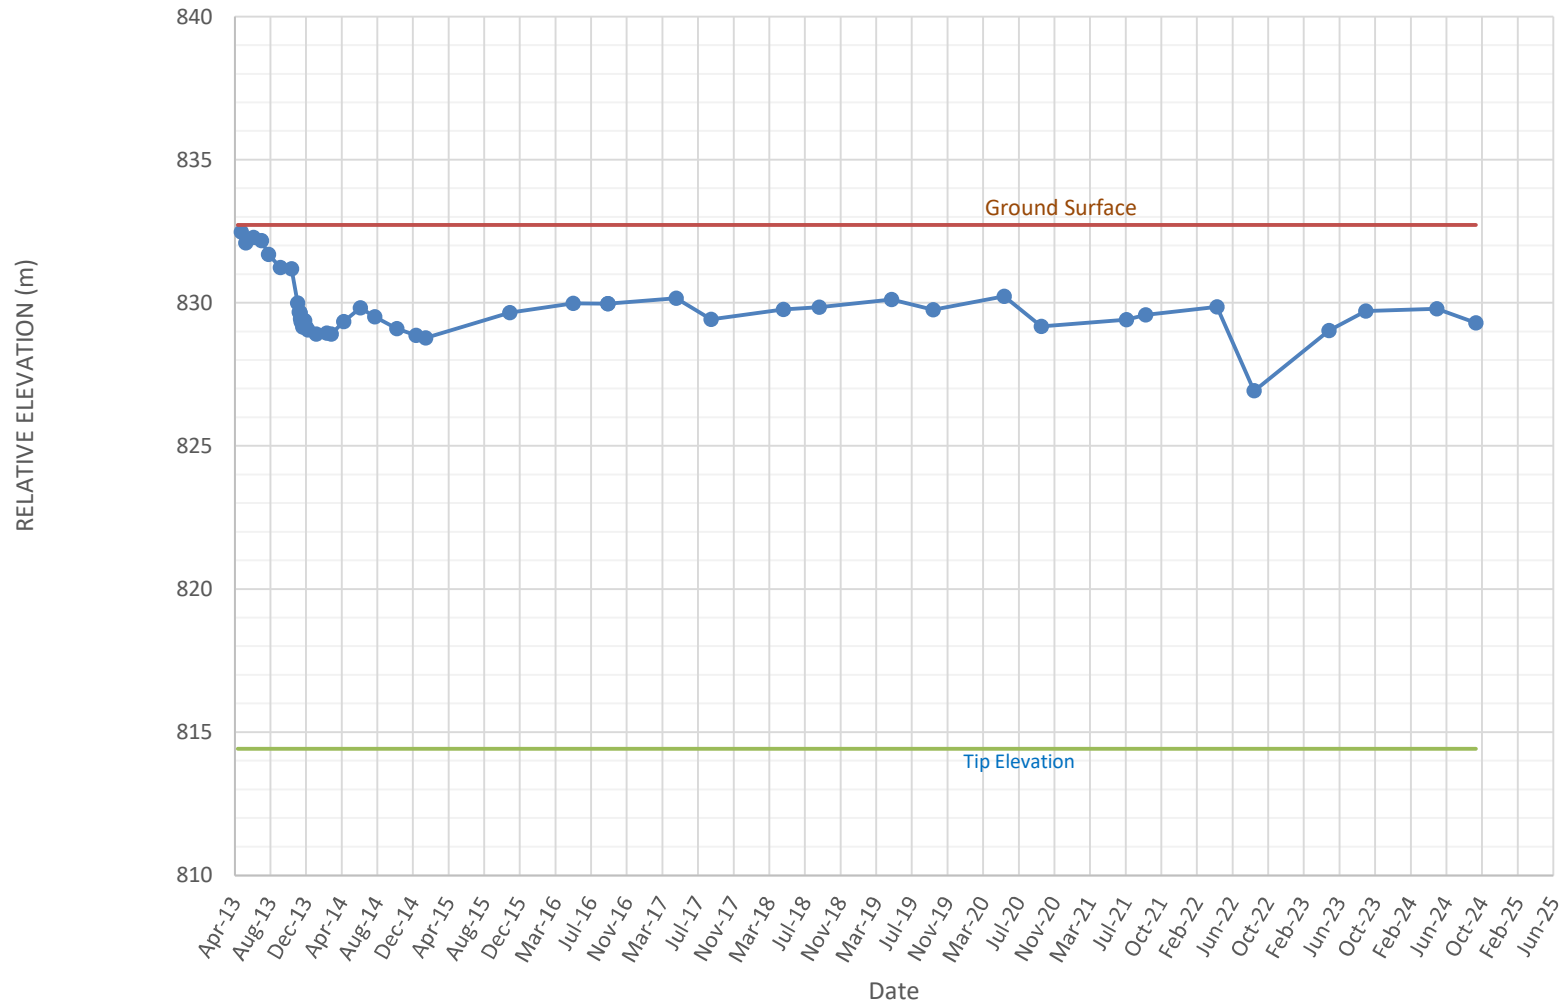
VIBRATING WIRE PIEZOMETER
VW13-3

VW13-3 showed a decrease of 0.5 m in piezometric level since the previous reading in Spring 2024. The piezometric level in VW13-3 has been relatively stable since about 2015.
