SITE NUMBER AND NAME: NC052 – Pembina River Bridge	HIGHWAY AND KM: 621:02, km 16.420	PREVIOUS INSPECTION: June 2, 2023	CURRENT INSPECTION: June 14, 2024
LEGAL DESCRIPTION: SE 01-50-09-W5	NAD83 COORDINATES: UTM11U 5905008N, 621749E		RISK ASSESSMENT: PF: 10 CF: 10 Total: 100
AVERAGE ANNUAL DAILY TRAFFIC (AADT): 1,030 (2023)		CONTRACTOR MAINTENANCE AREA (CMA): 509

Client/Project: Transportation and Economic Corridors
 Geohazard Monitoring Program
 NC52 HWY 621:02 Pembina River Bridge

2024 Site Inspection Photos at NC052

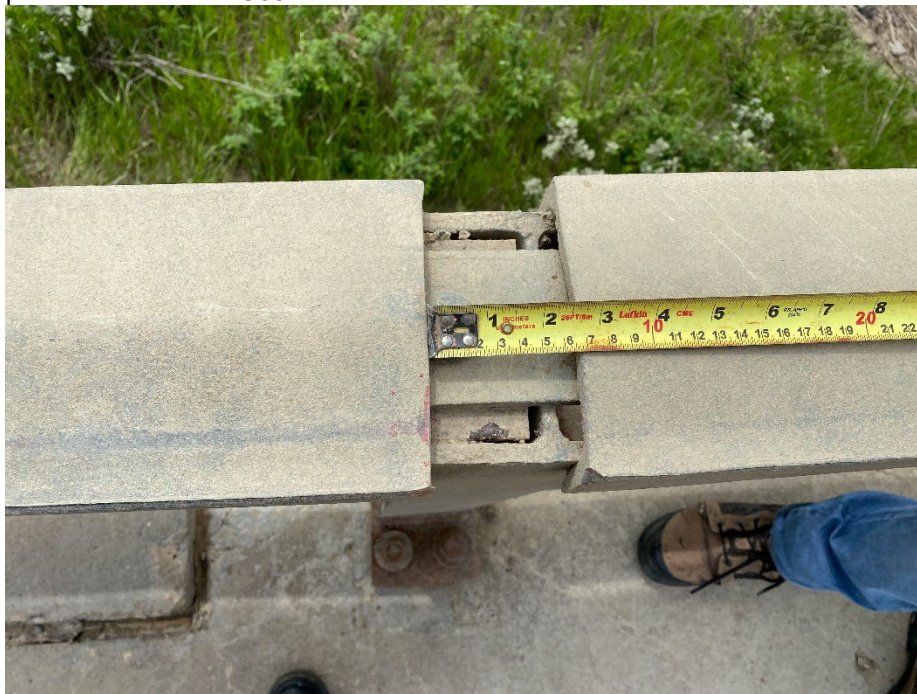
COMMENTS
<ul style="list-style-type: none"> • Bridge rotation appears unchanged since 2021. The separation of the guardrails along the bridge deck have remained relatively unchanged with 30 mm, 70 mm, 45 mm, and 20 mm of separation at the NE, SE, NW, and SW corners, respectively (Photos 1 to 4). • The expansion joint at the east abutment has a gap 35 mm wide in the westbound lane where the rubber has fallen below the bridge deck, similar to the previous inspection in 2023 (Photo 5). • The three tiltmeters installed at the bridge are all non-operational. • Spring 2023 SI readings show signs of creeping a rate of less than 1 mm/year in SI-1. SI-2 previously showed signs of creeping from Spring 2014 to Spring 2022 whereafter cumulative displacements returned to 2014 levels. • Piezometric levels at the site have been relatively stable since installing the horizontal drains.

Photo 1: Guardrail separation at southeast corner of bridge. Looking south.

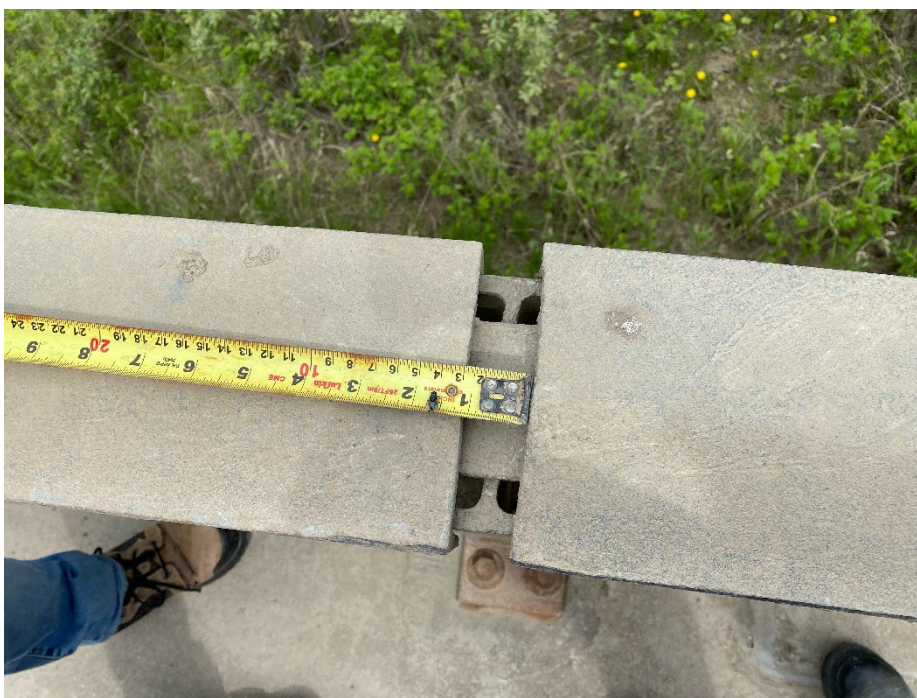
Photo 2: Guardrail separation at northeast corner of bridge. Looking north.

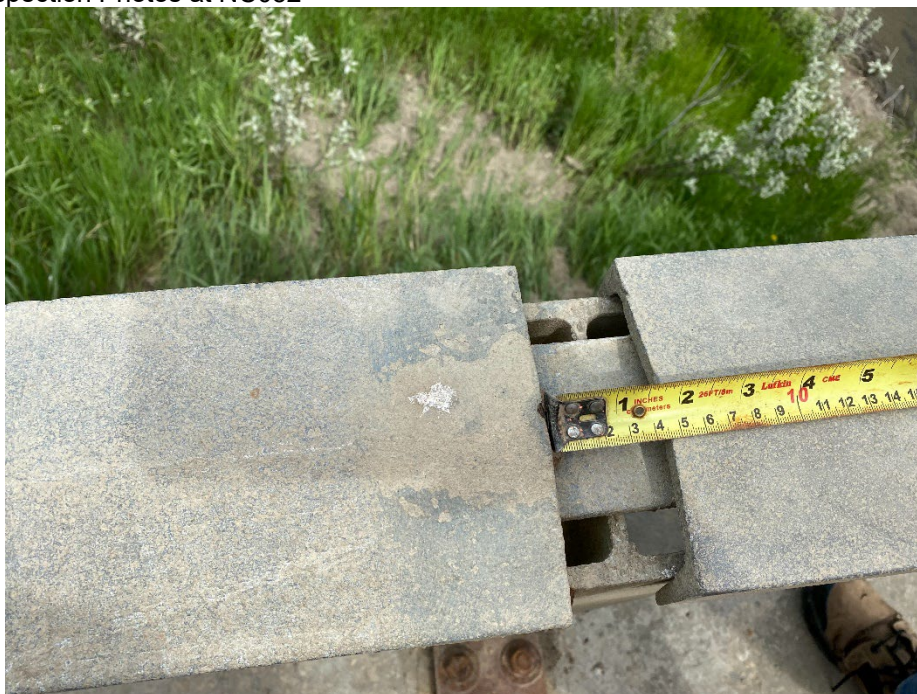
Photo 3: Guardrail separation at northwest corner of bridge. Looking north.

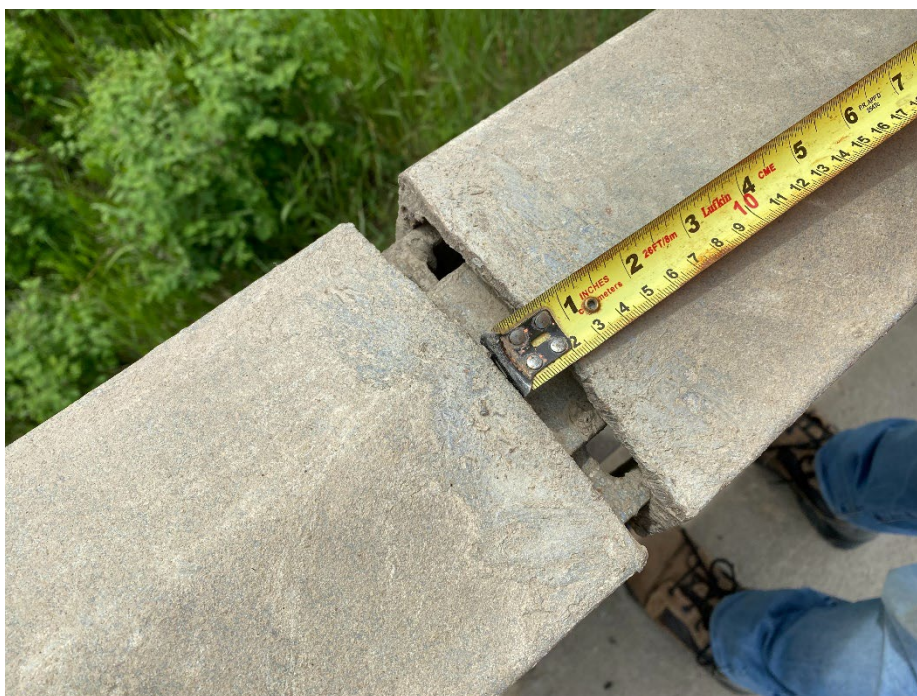
Photo 4: Guardrail separation at southwest corner of bridge. Looking southwest.

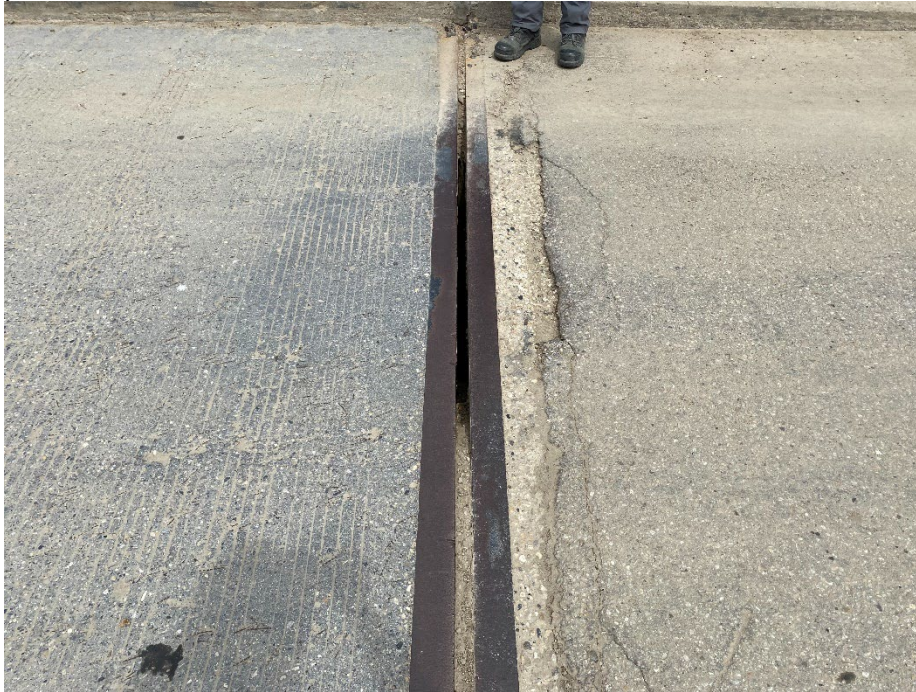
Photo 5: Gap at expansion joint with rubber falling out. Looking north.

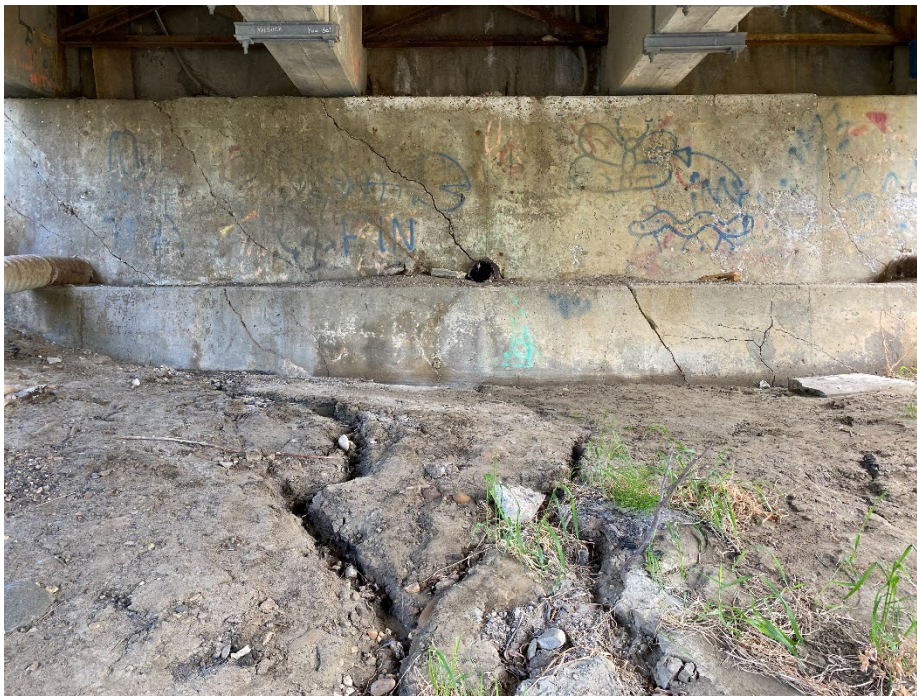
- Concrete cracks at both east and west abutment seats appear unchanged. A 20 mm gap was written onto the crack at the west abutment at an unknown date. This same gap was measured to be 20 mm by Stantec since 2016 (Photos 6 and 8). The overhanging outlet for the drain pipe near the centre of the east abutment has been broken / removed.

- Erosion gullies remain present on the headslope below the east abutment (Photo 6).
- The girders were in contact with the abutment backwall at the east abutment. The bearing plates appear to be crushed at both abutments (Photo 7).

Photo 6: Cracking of east abutment and gullies on headslope. Looking east.

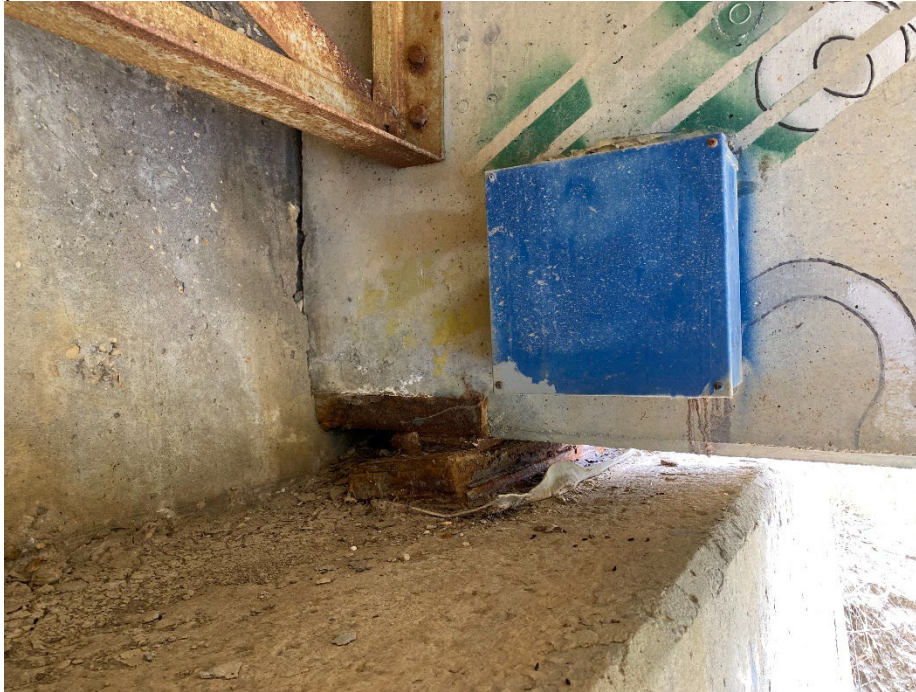
Photo 7: Girders in contact with east abutment. Movement of bearing plate. Looking south.

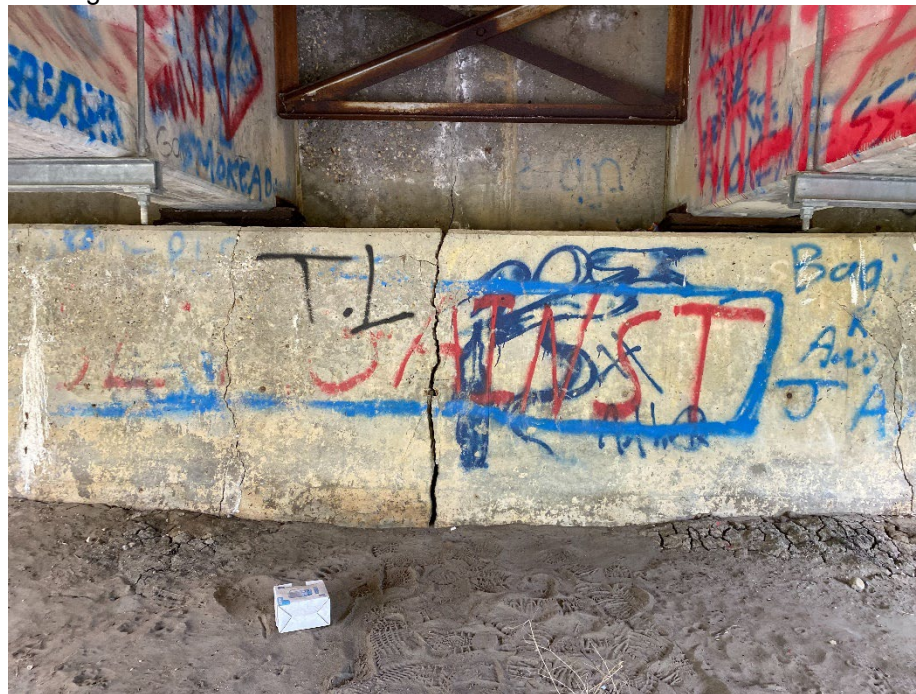
Photo 8: 20 mm crack at west abutment. Looking west.

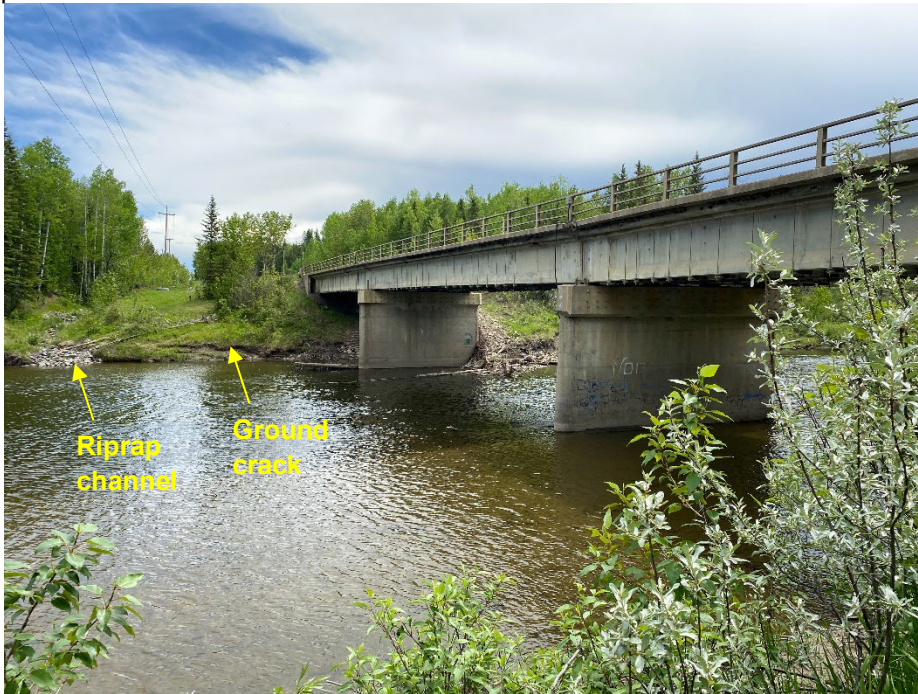
- Slow flow was observed at the gabion outfall. The water around the gabion was murky, and algae-covered.
- The ground crack south of the riprap channel near SI14-01 appeared unchanged at about 7 m long with vertical difference up to about 0.4 m high (Photo 9).

Photo 9: Riprap lined channel and ground crack north of east abutment. Looking east.

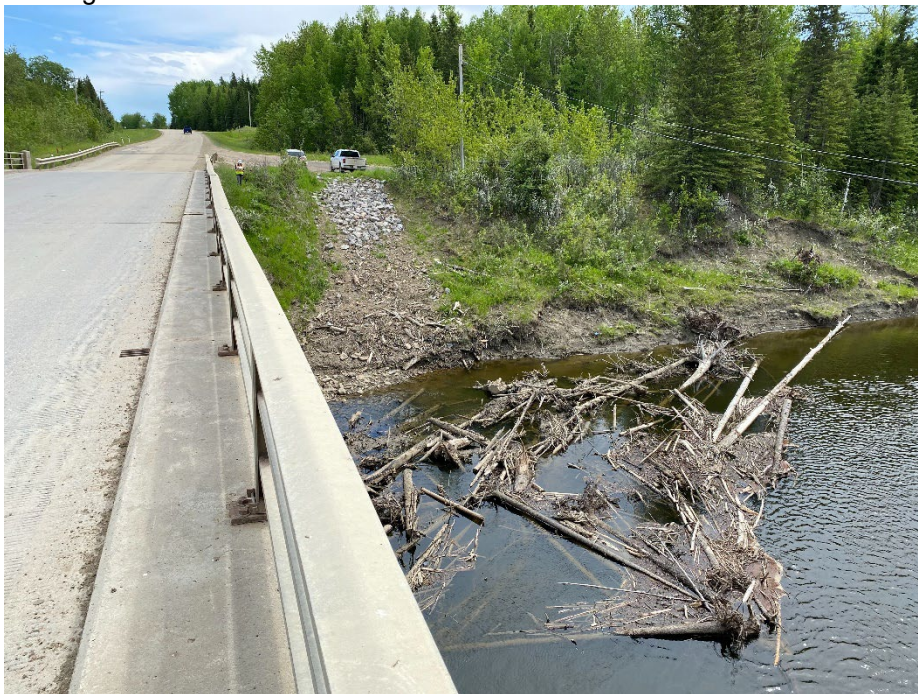
- No apparent change was observed in the riprap channel and erosion south of the bridge at the east abutment slope (Photo 10).
- Driftwood was observed (Photo 10) against the south and east sides of the east pier. Two pieces of driftwood are stuck behind the underslung diaphragms against the east side of the bridge, above the east pier.

Photo 10: Riprap placed south of bridge along previous erosion channel. Driftwood collected near the east pier. Looking southeast.

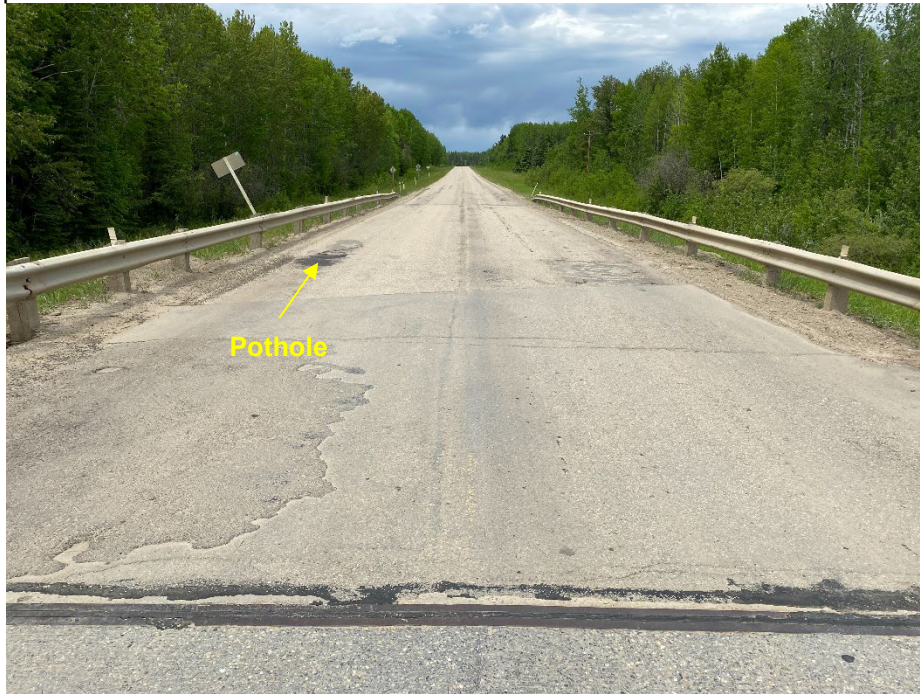
- Potholes are present adjacent to the west abutment patch and east of the east patch (Photos 11 and 12).
- The nearest detour route to cross the Pembina River appears to be at Range Road 91 and Township Road 491A, approximately a 12-minute drive south of the site. This detour would require the use of gravel roads and would not be suitable for all types of traffic.

Photo 11: Pavement surface at west abutment. Looking northwest.

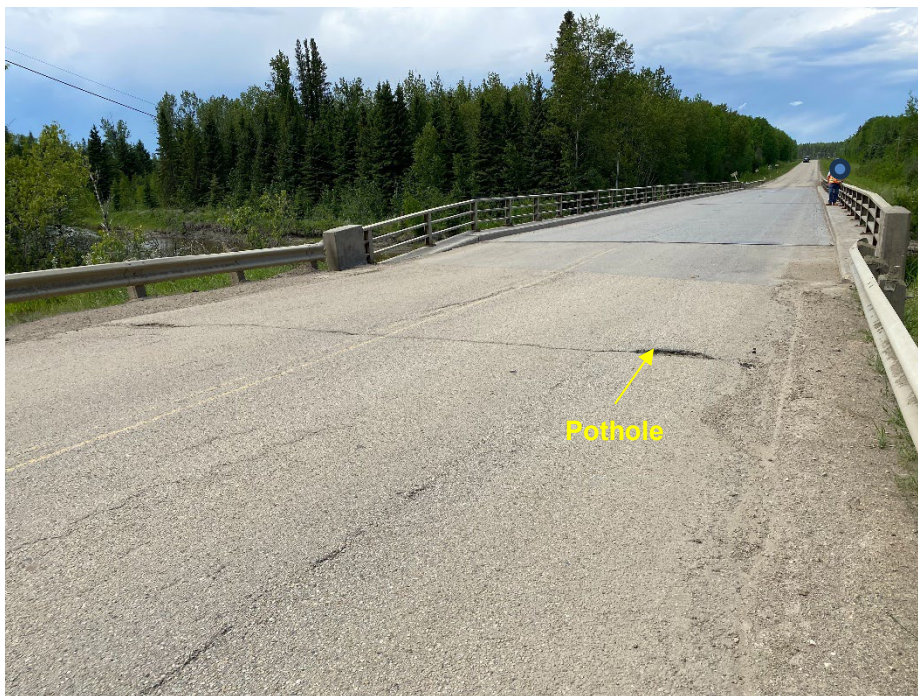
Photo 12: Pavement surface at east abutment. Looking west.
