To:	Amy Driessen	From:	Leslie Cho and Xiteng Liu
	Transportation and Economic Corridors		Stantec Consulting Ltd.
File:	123315222	Date:	June 18, 2024

Reference: North Central Region, Stony Plain, Site NC052 - Highway 621:02 Pembina River Bridge Abutment, Spring 2024 Instrumentation Monitoring Report

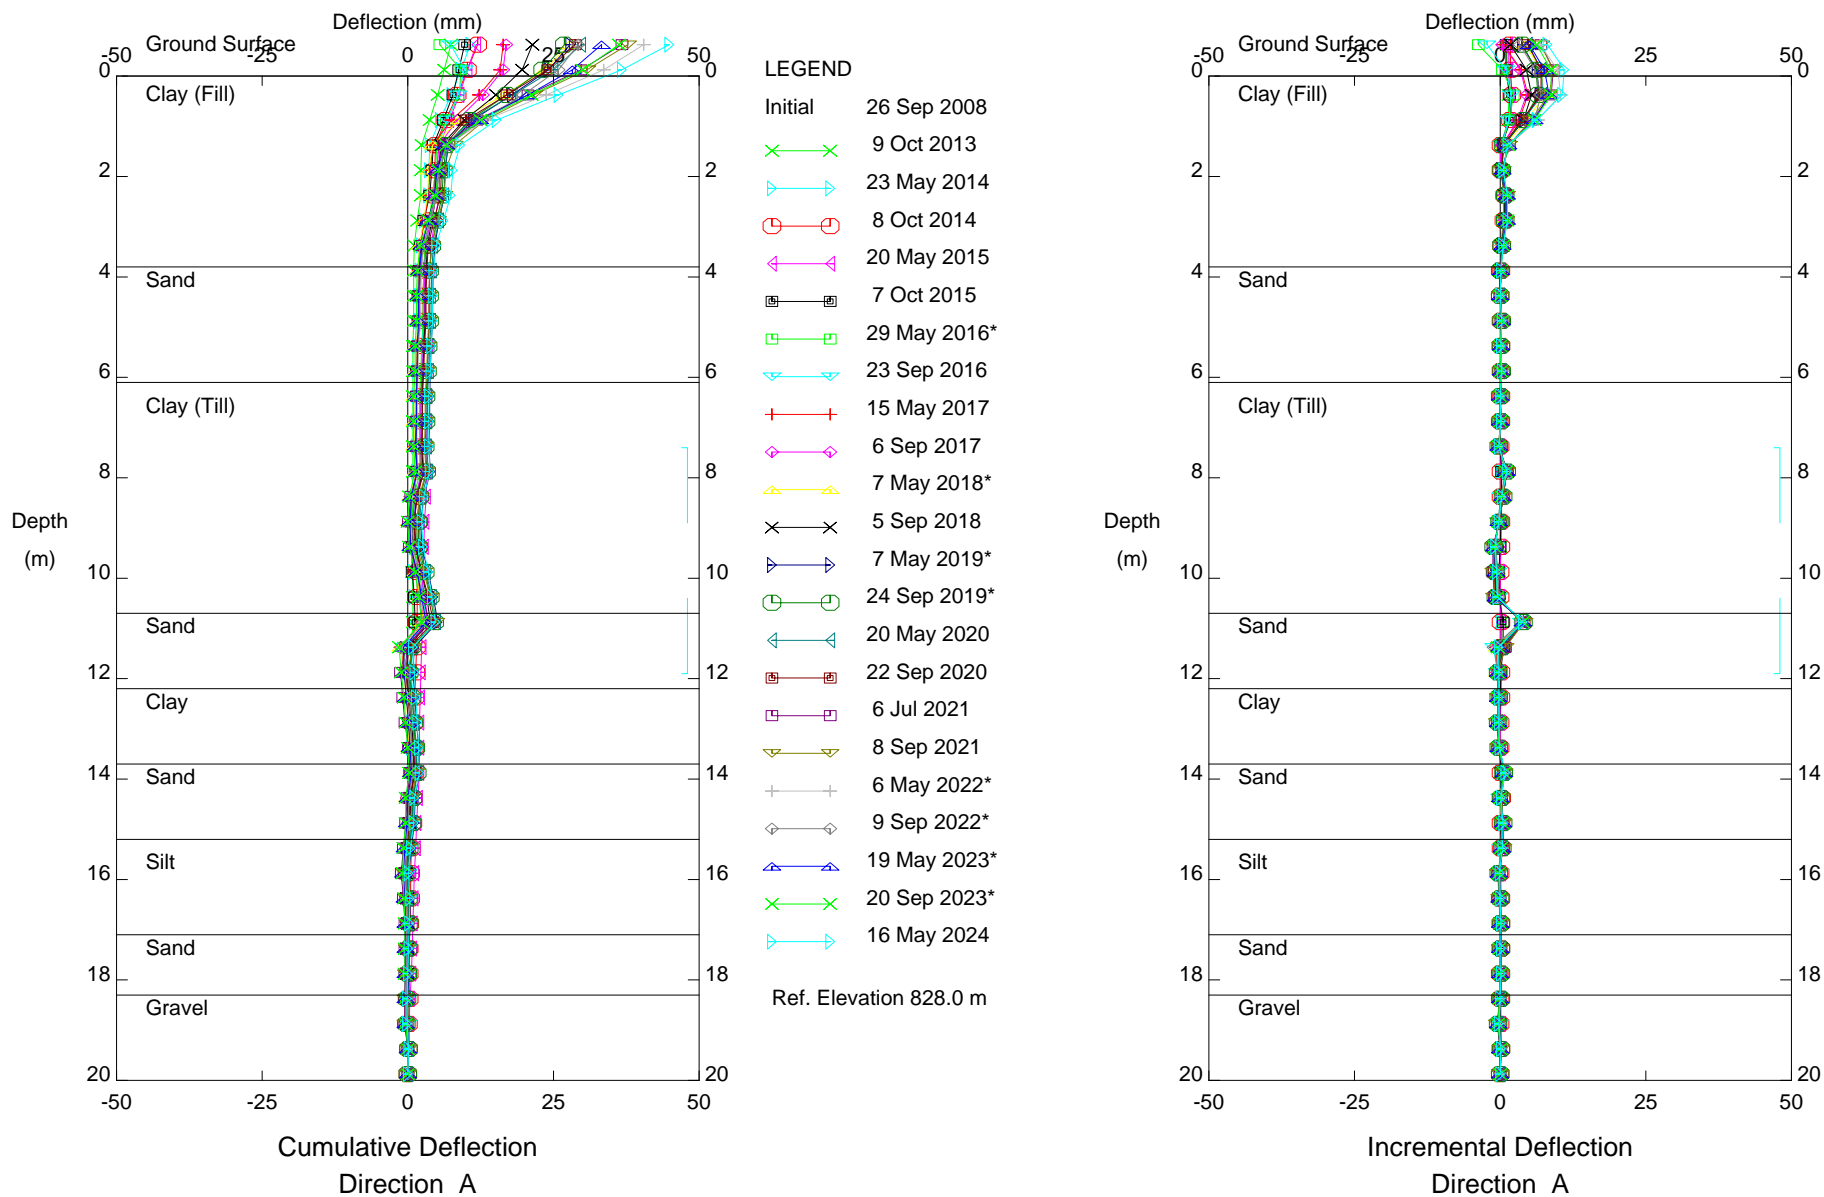
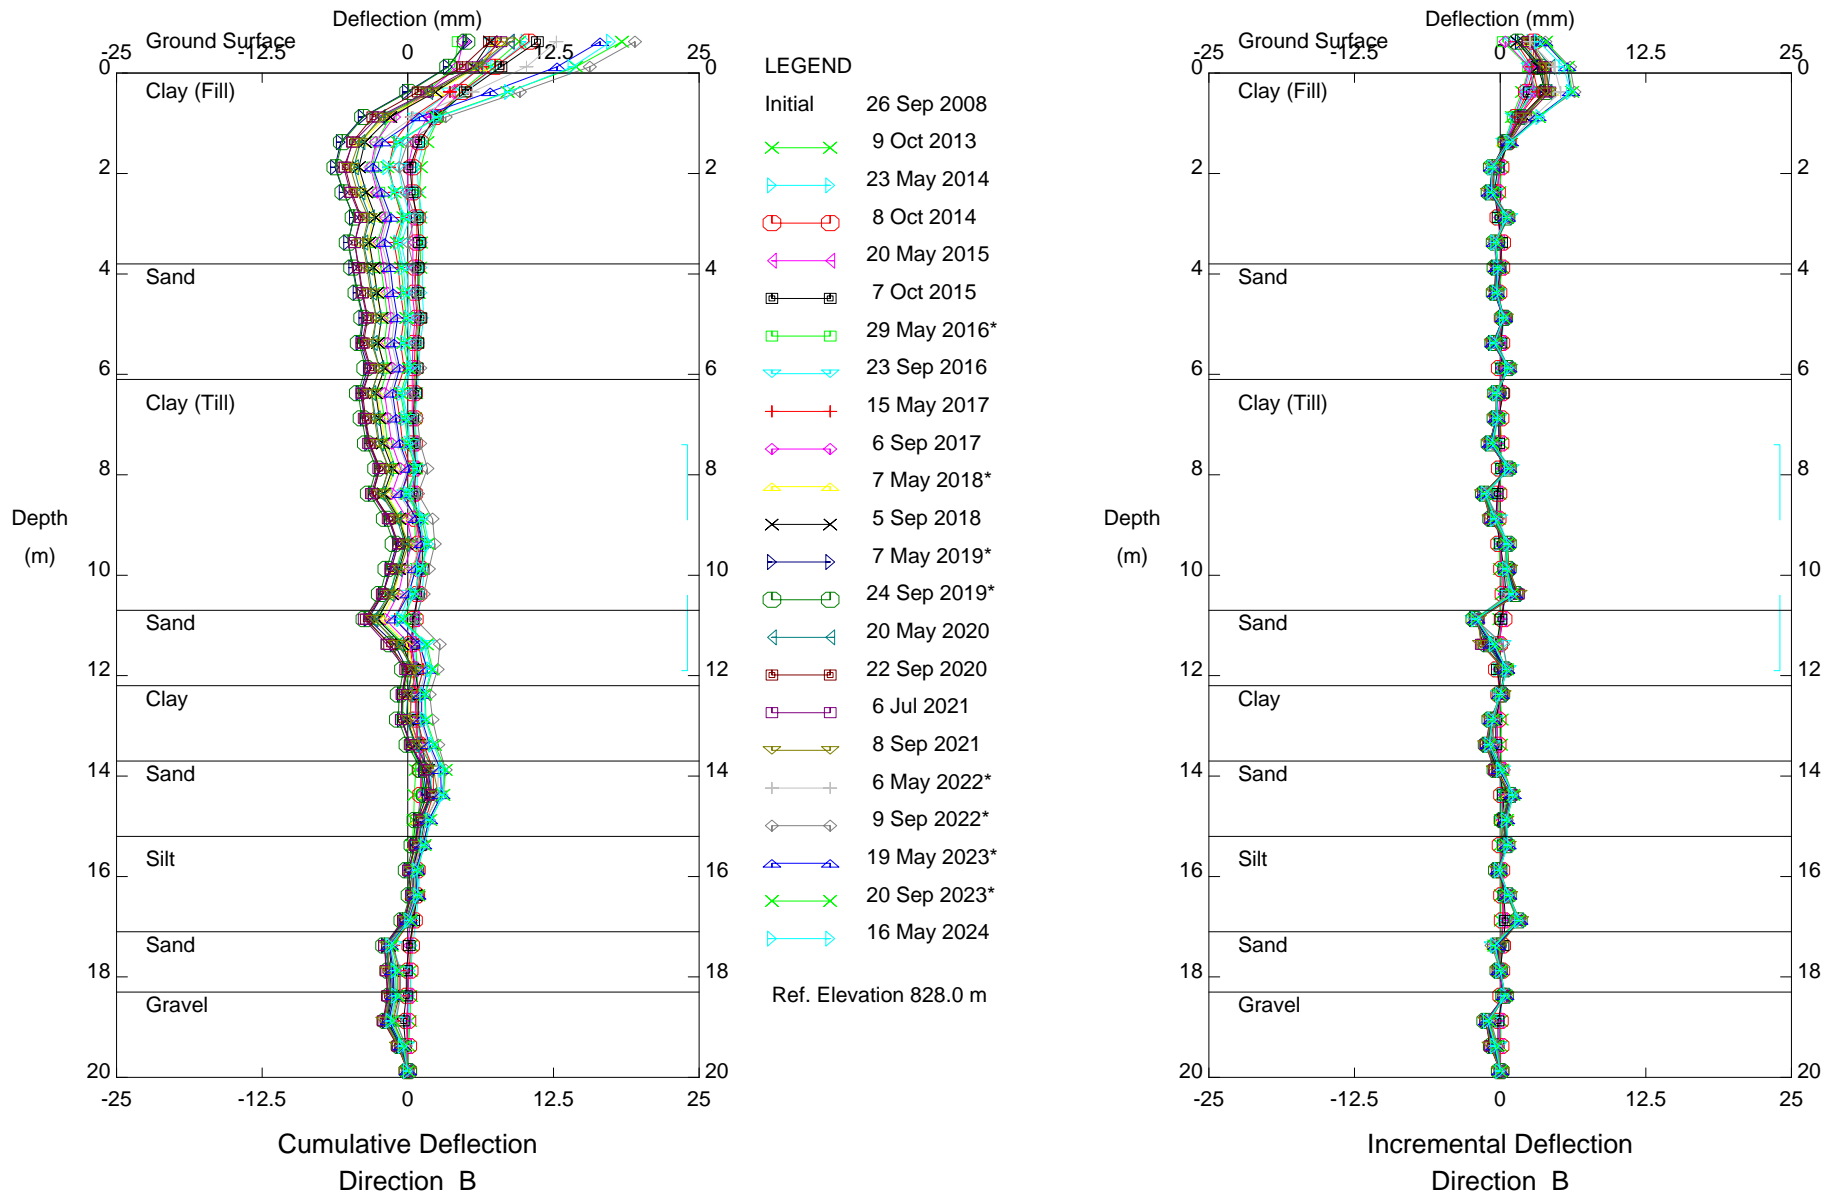
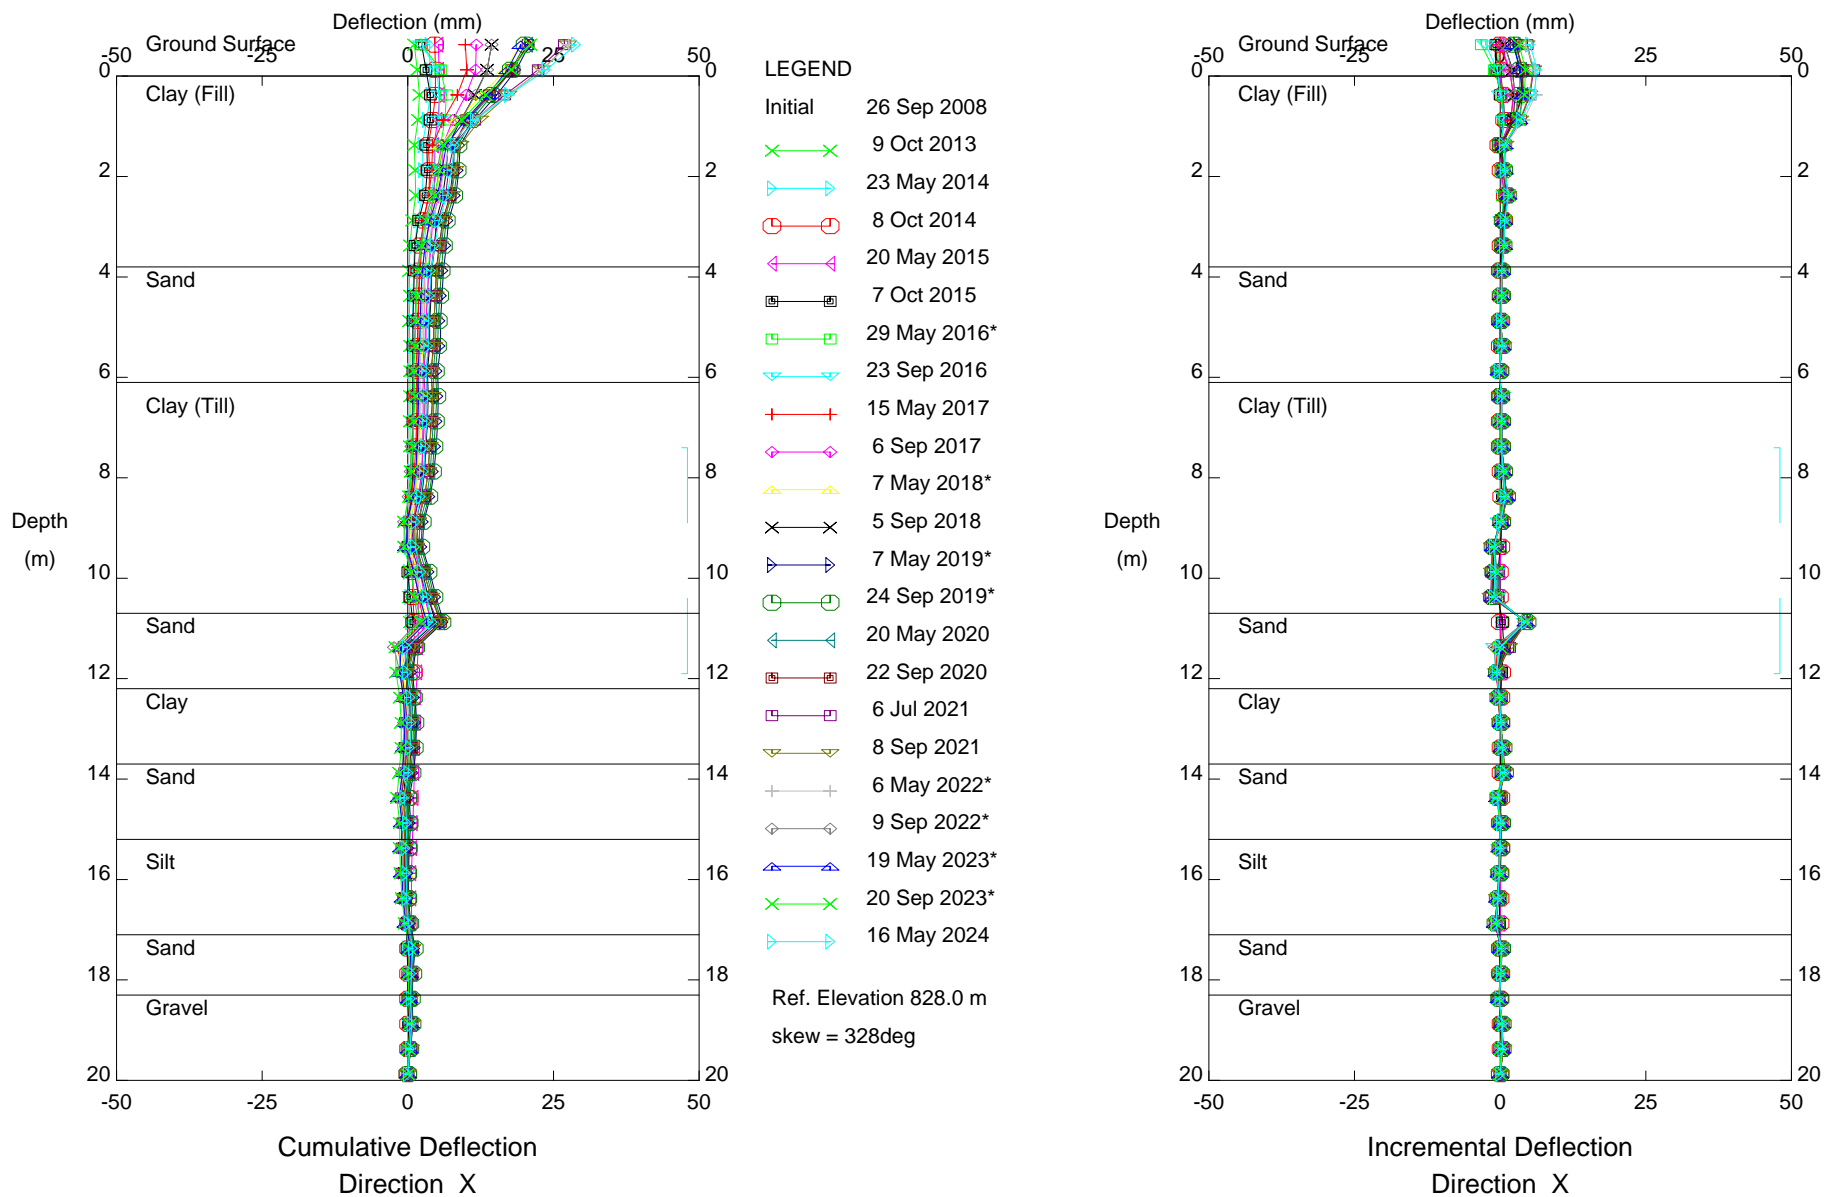
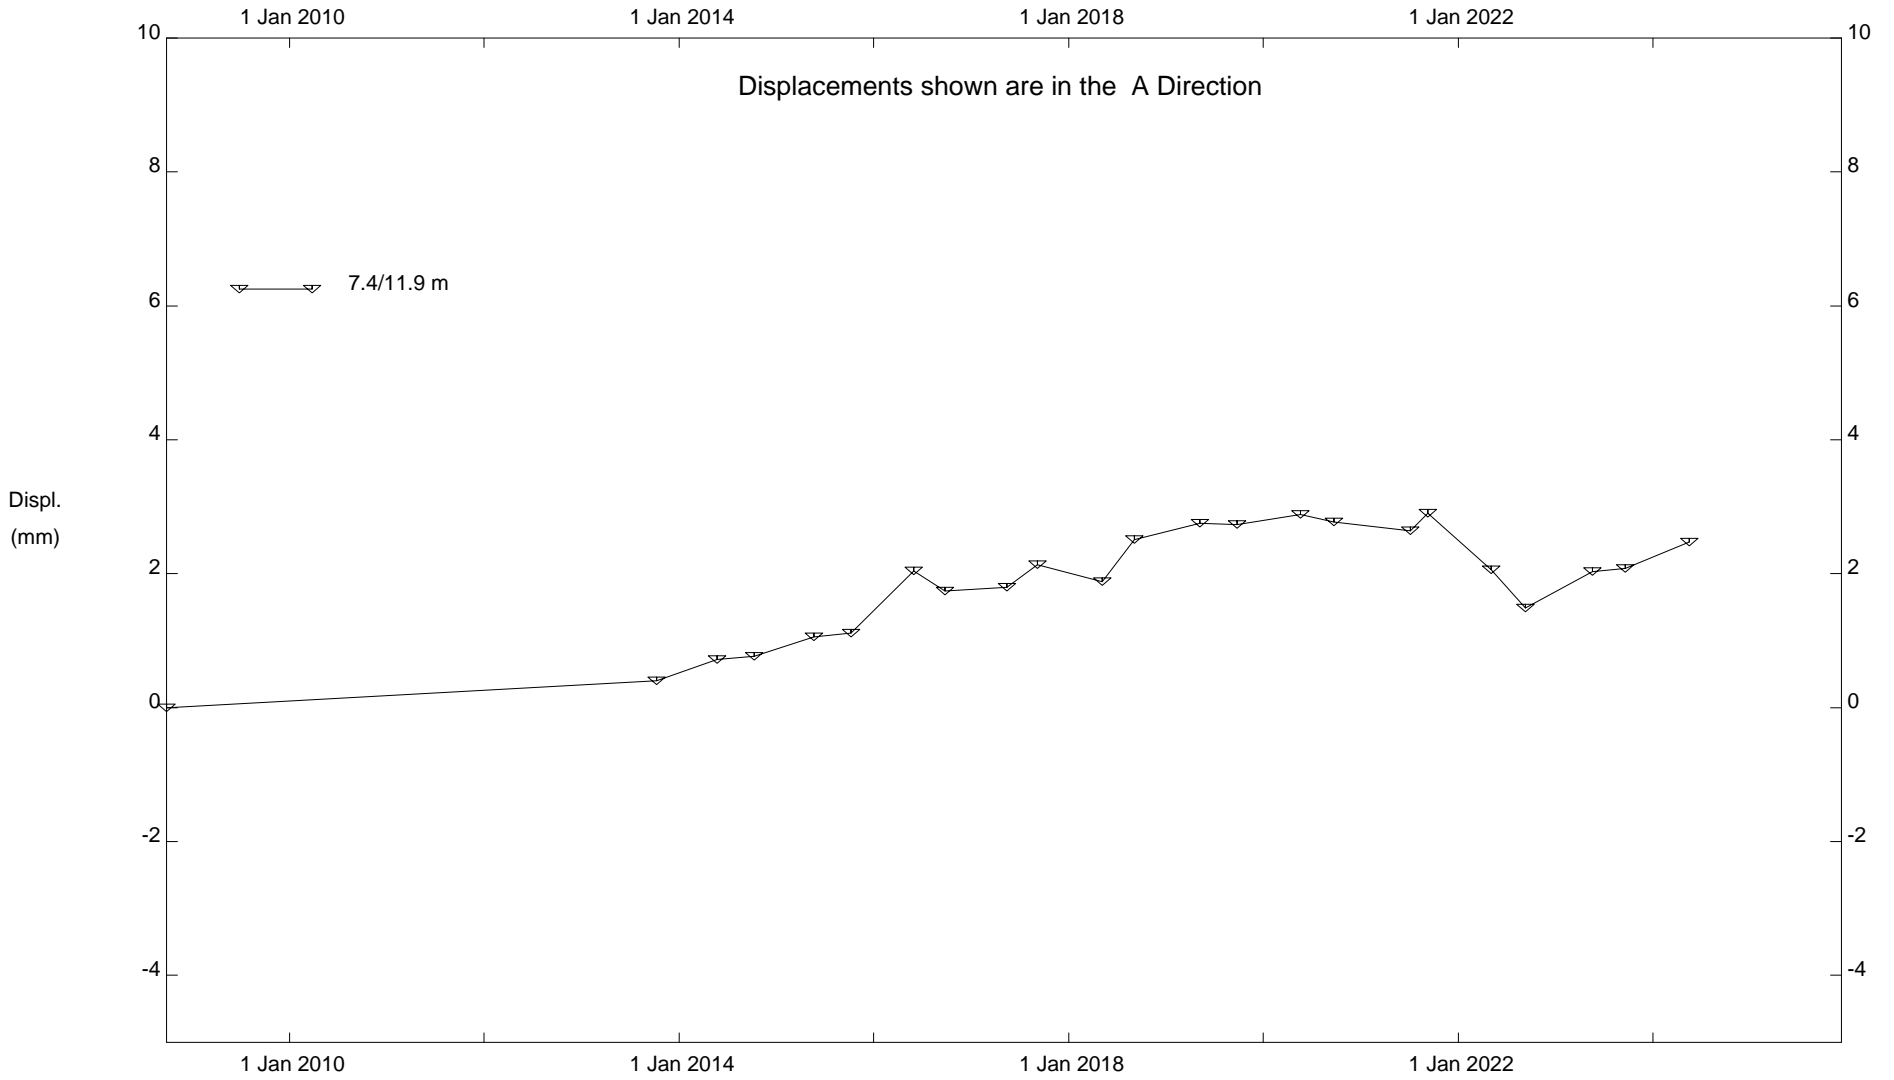
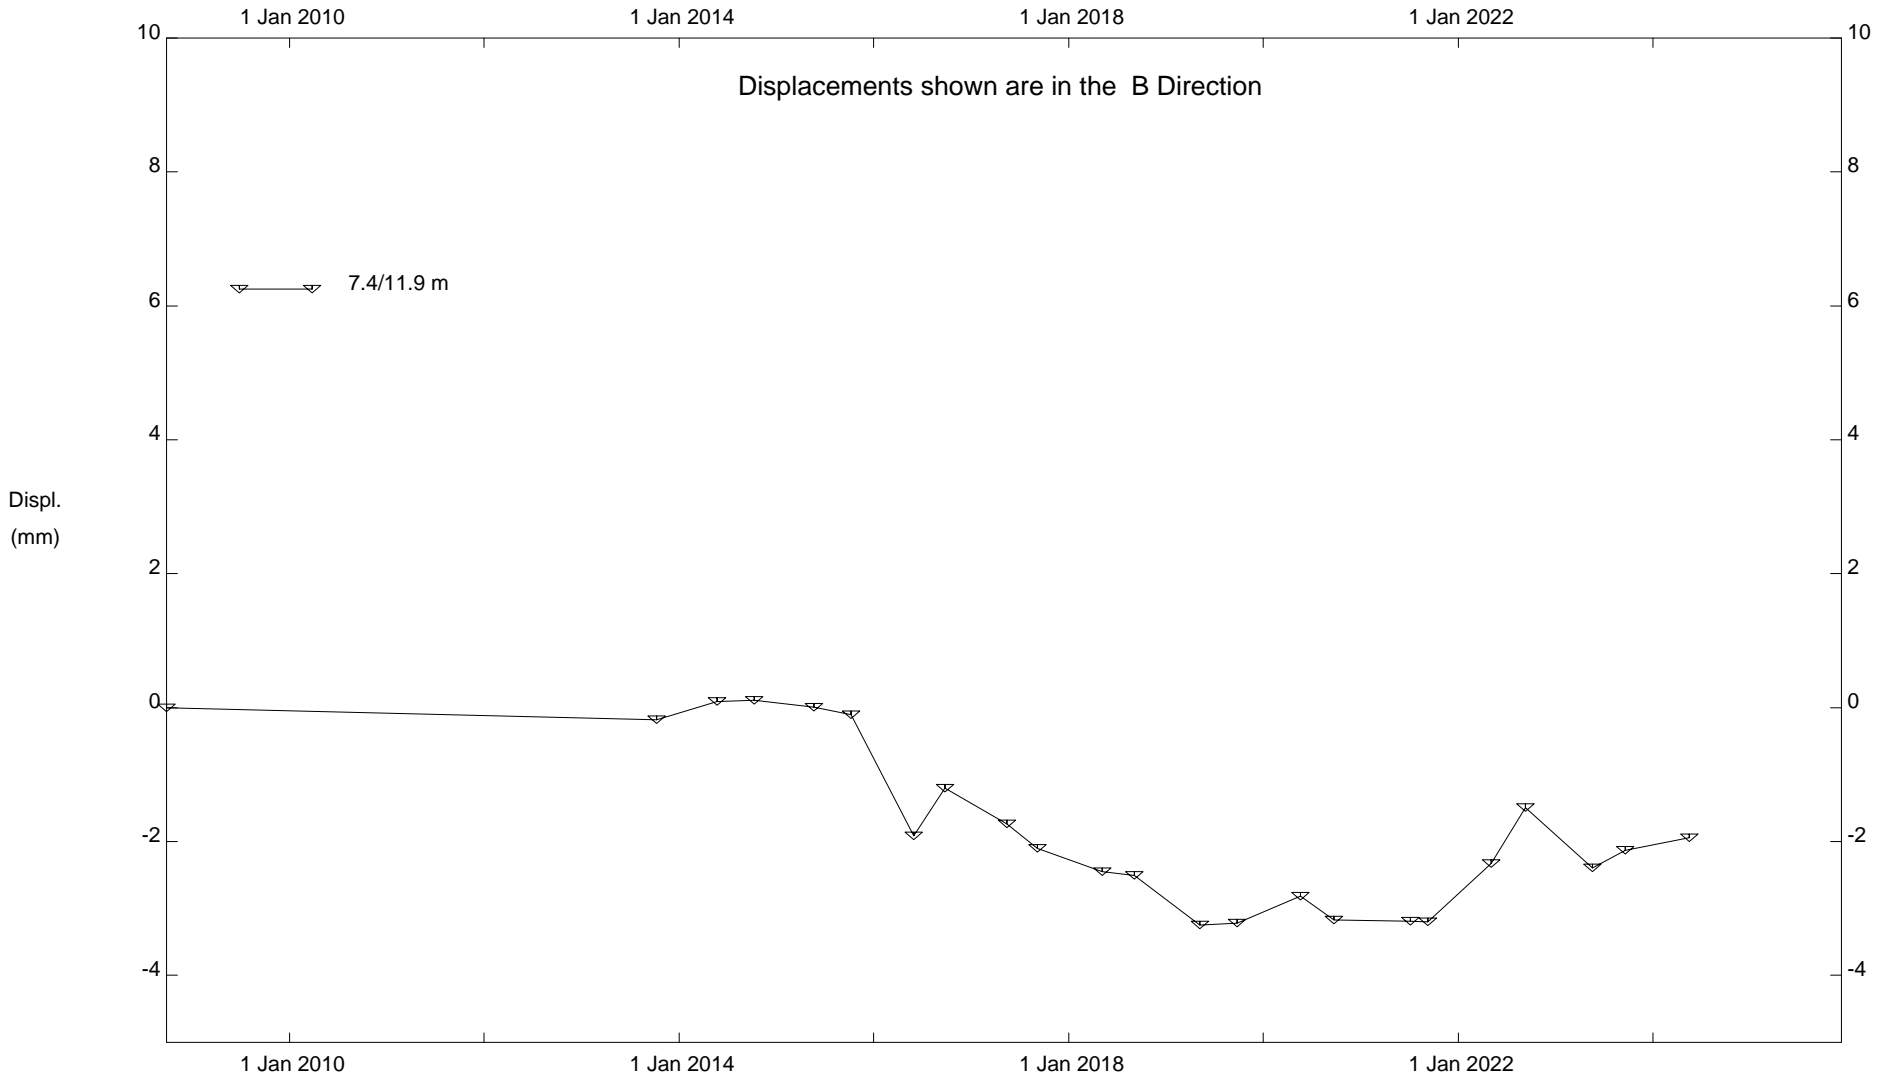
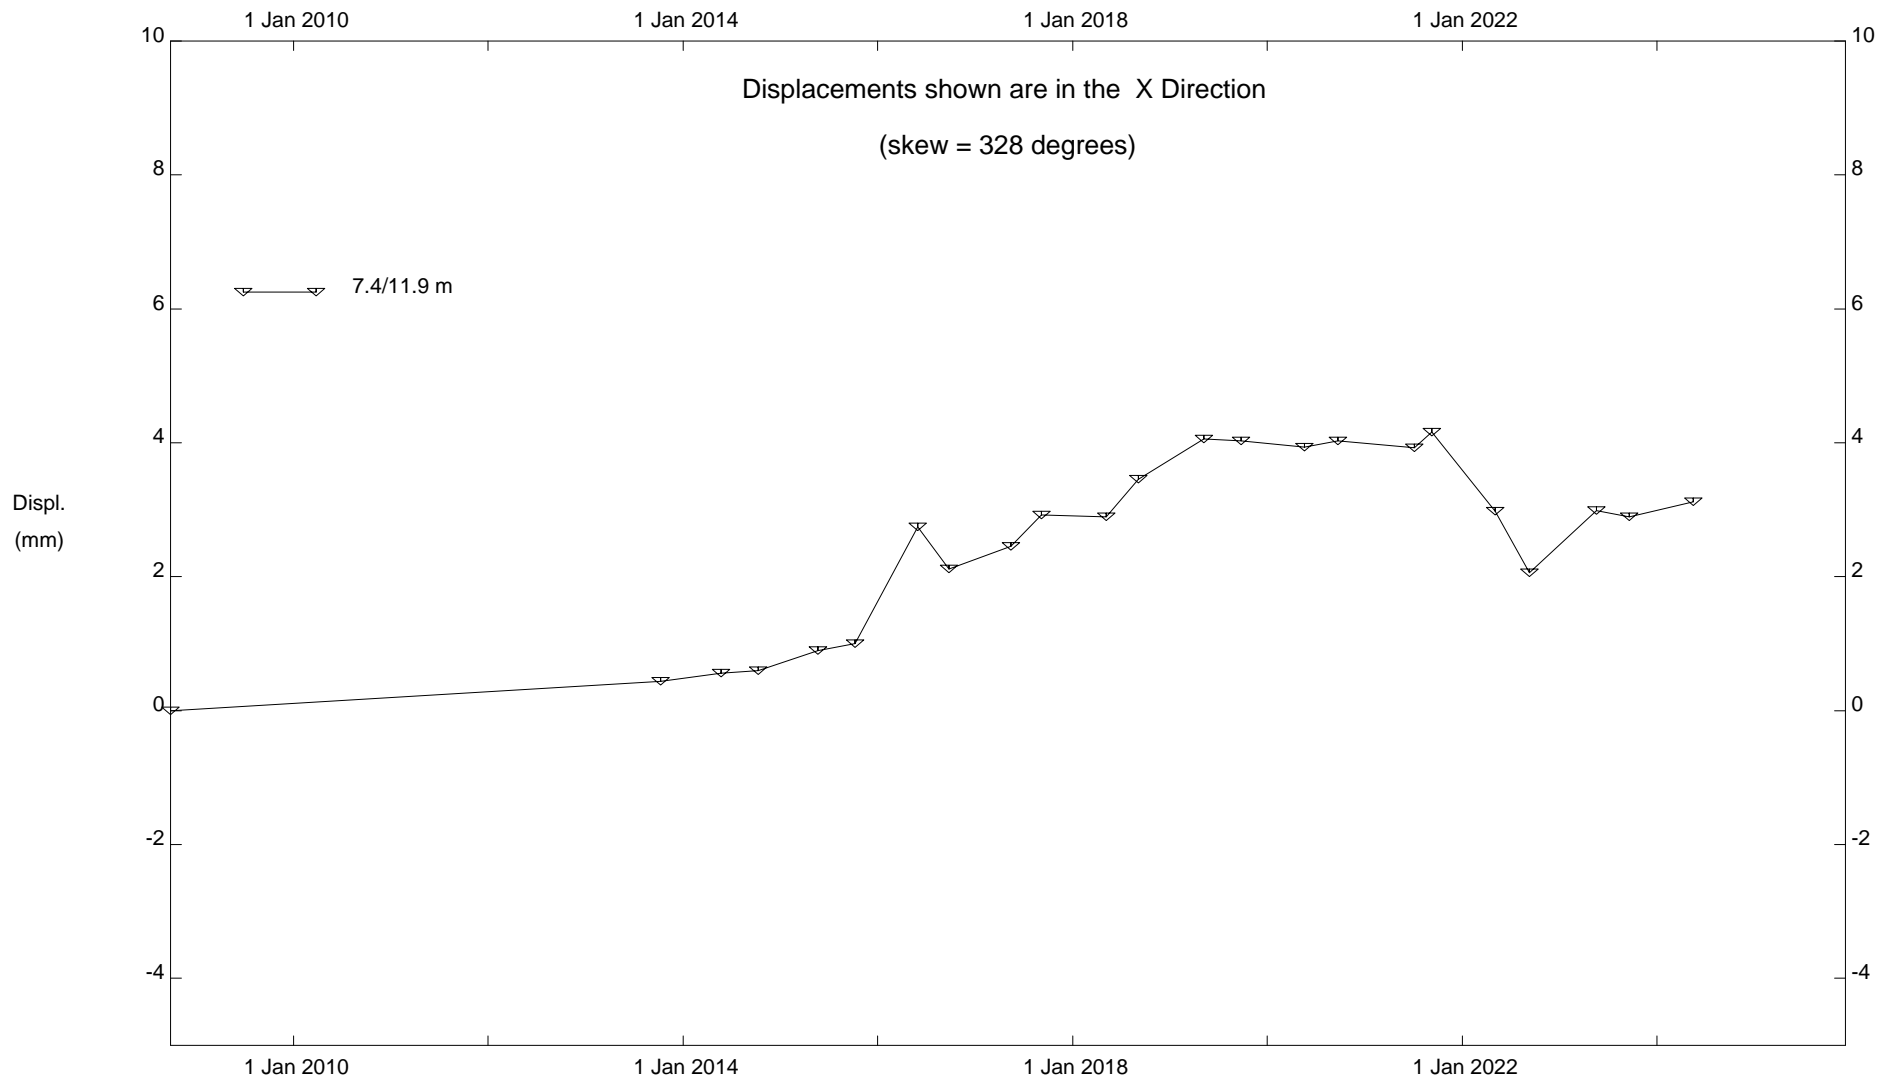
NC052, Inclinometer SI-1

SI-1 shows negligible movement over the zone of movement at about 11 m depth. Total cumulative movement observed since 2006 is about 3 mm.

All slope inclinometers appear to show signs of creep movement except for SI13-3.

It is recommended that all instruments be read again for the Fall 2024 reading cycle.
