To:	Amy Driessen	From:	Leslie Cho and Xiteng Liu
	Transportation and Economic Corridors		Stantec Consulting Ltd.
File:	123315222	Date:	June 18, 2024

Reference: North Central Region, Stony Plain, Site NC052 - Highway 621:02 Pembina River Bridge Abutment, Spring 2024 Instrumentation Monitoring Report

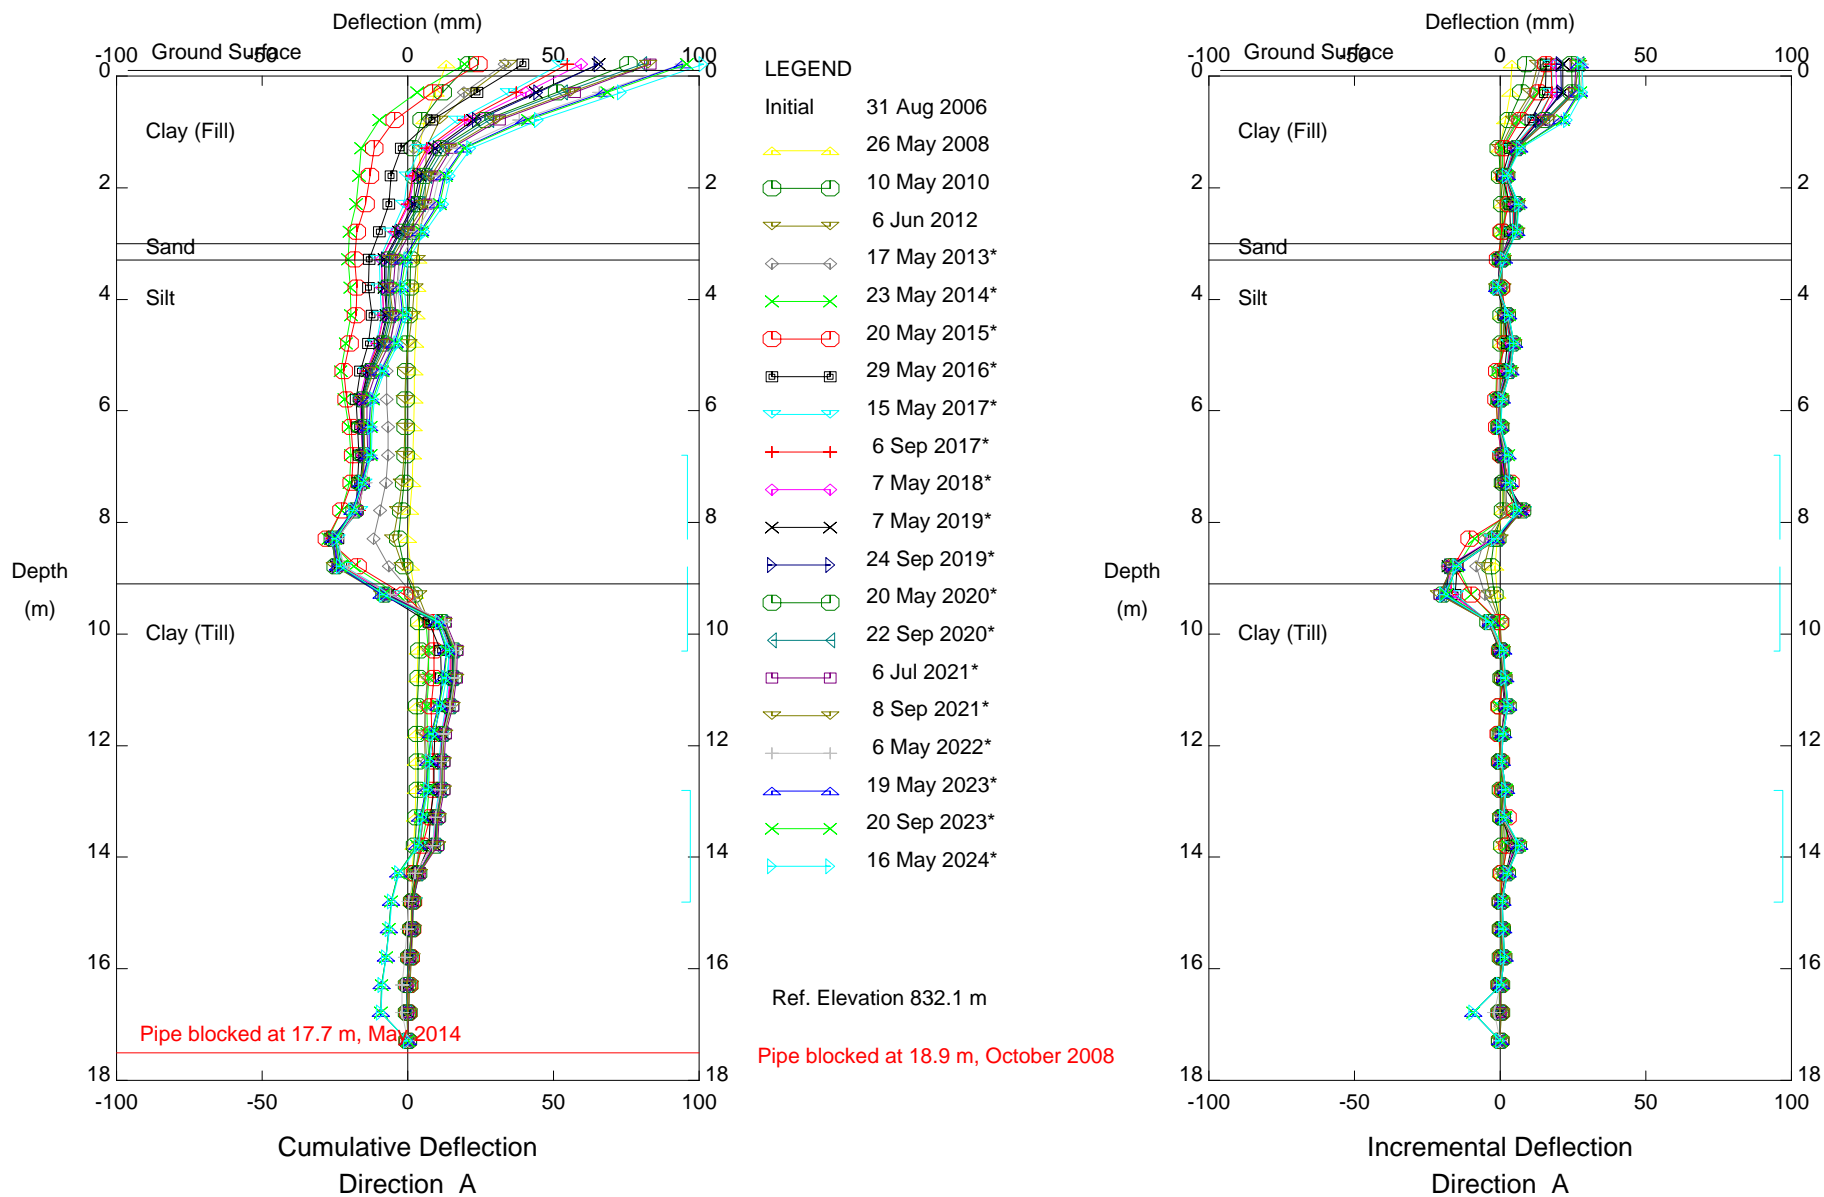
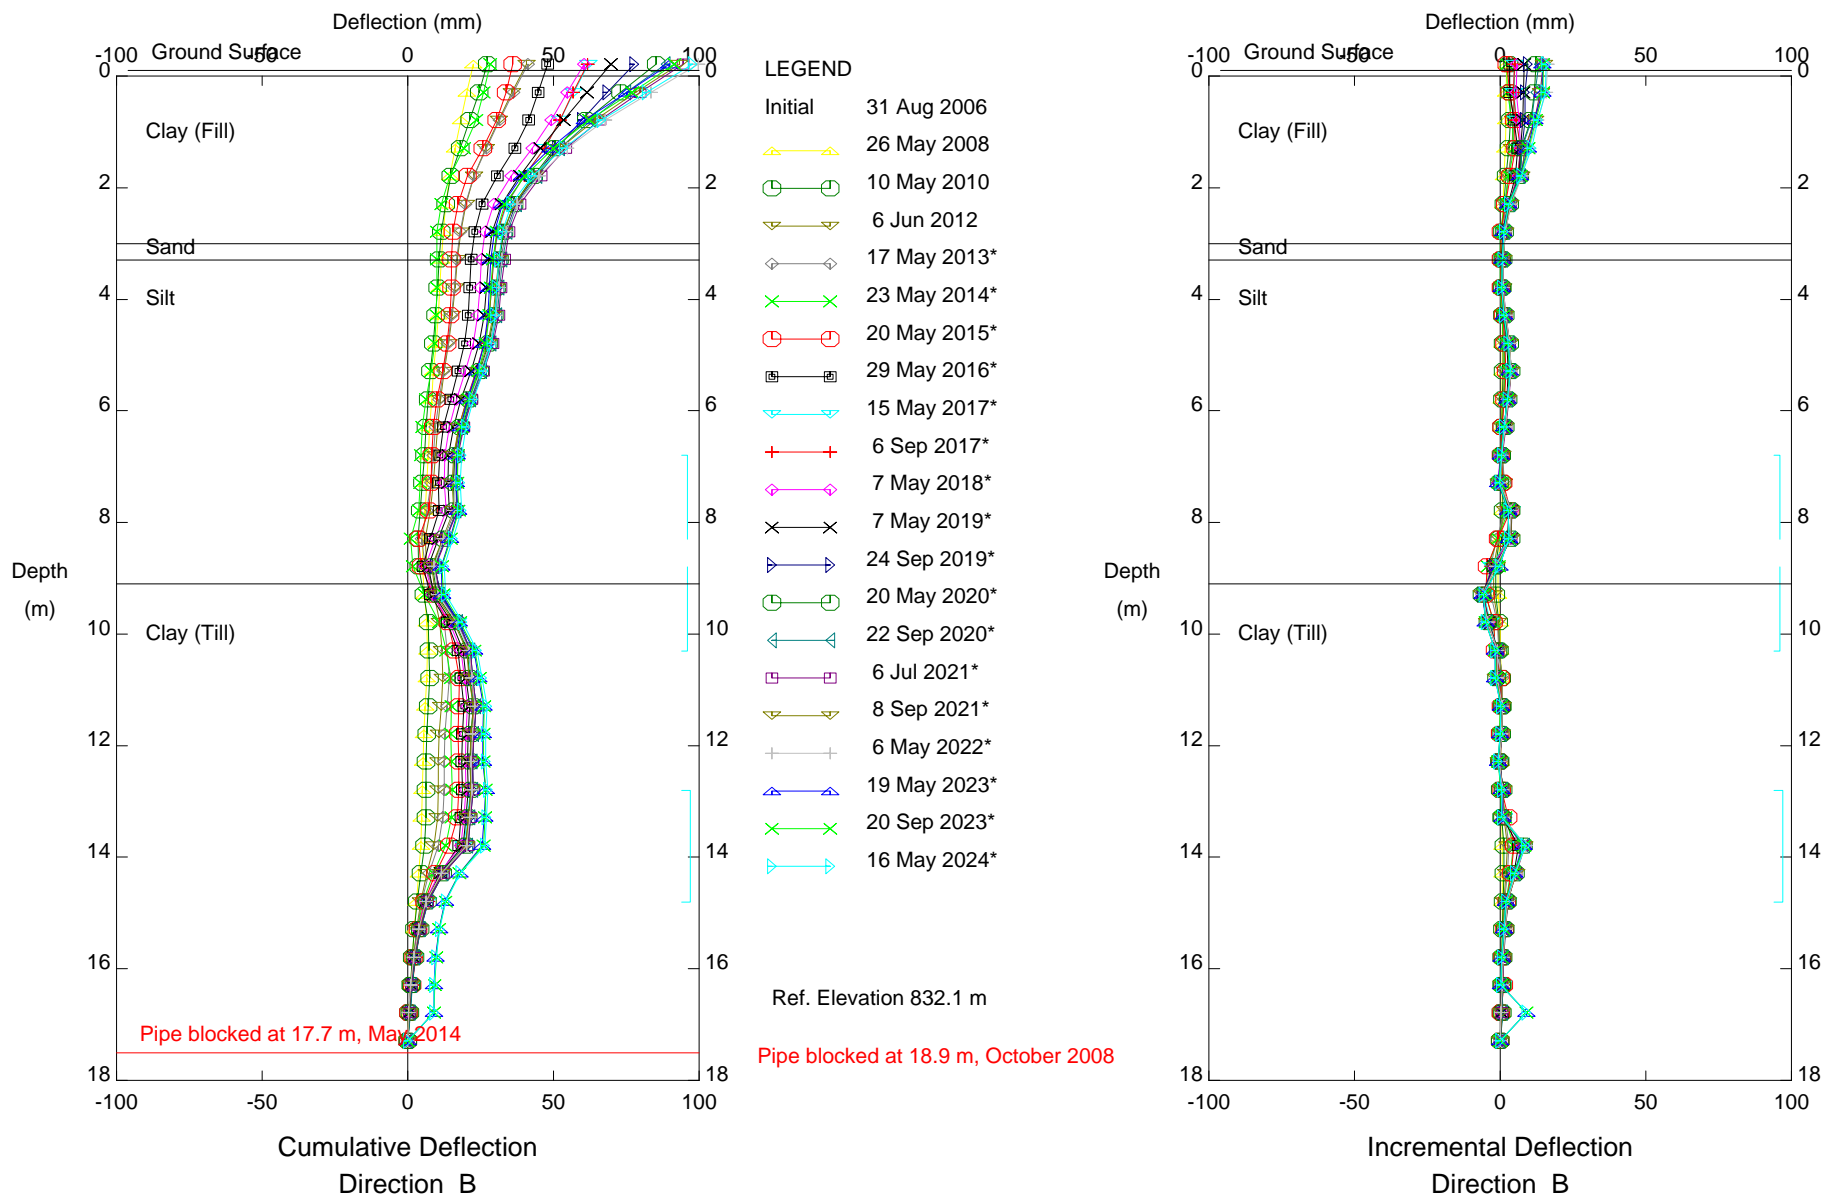
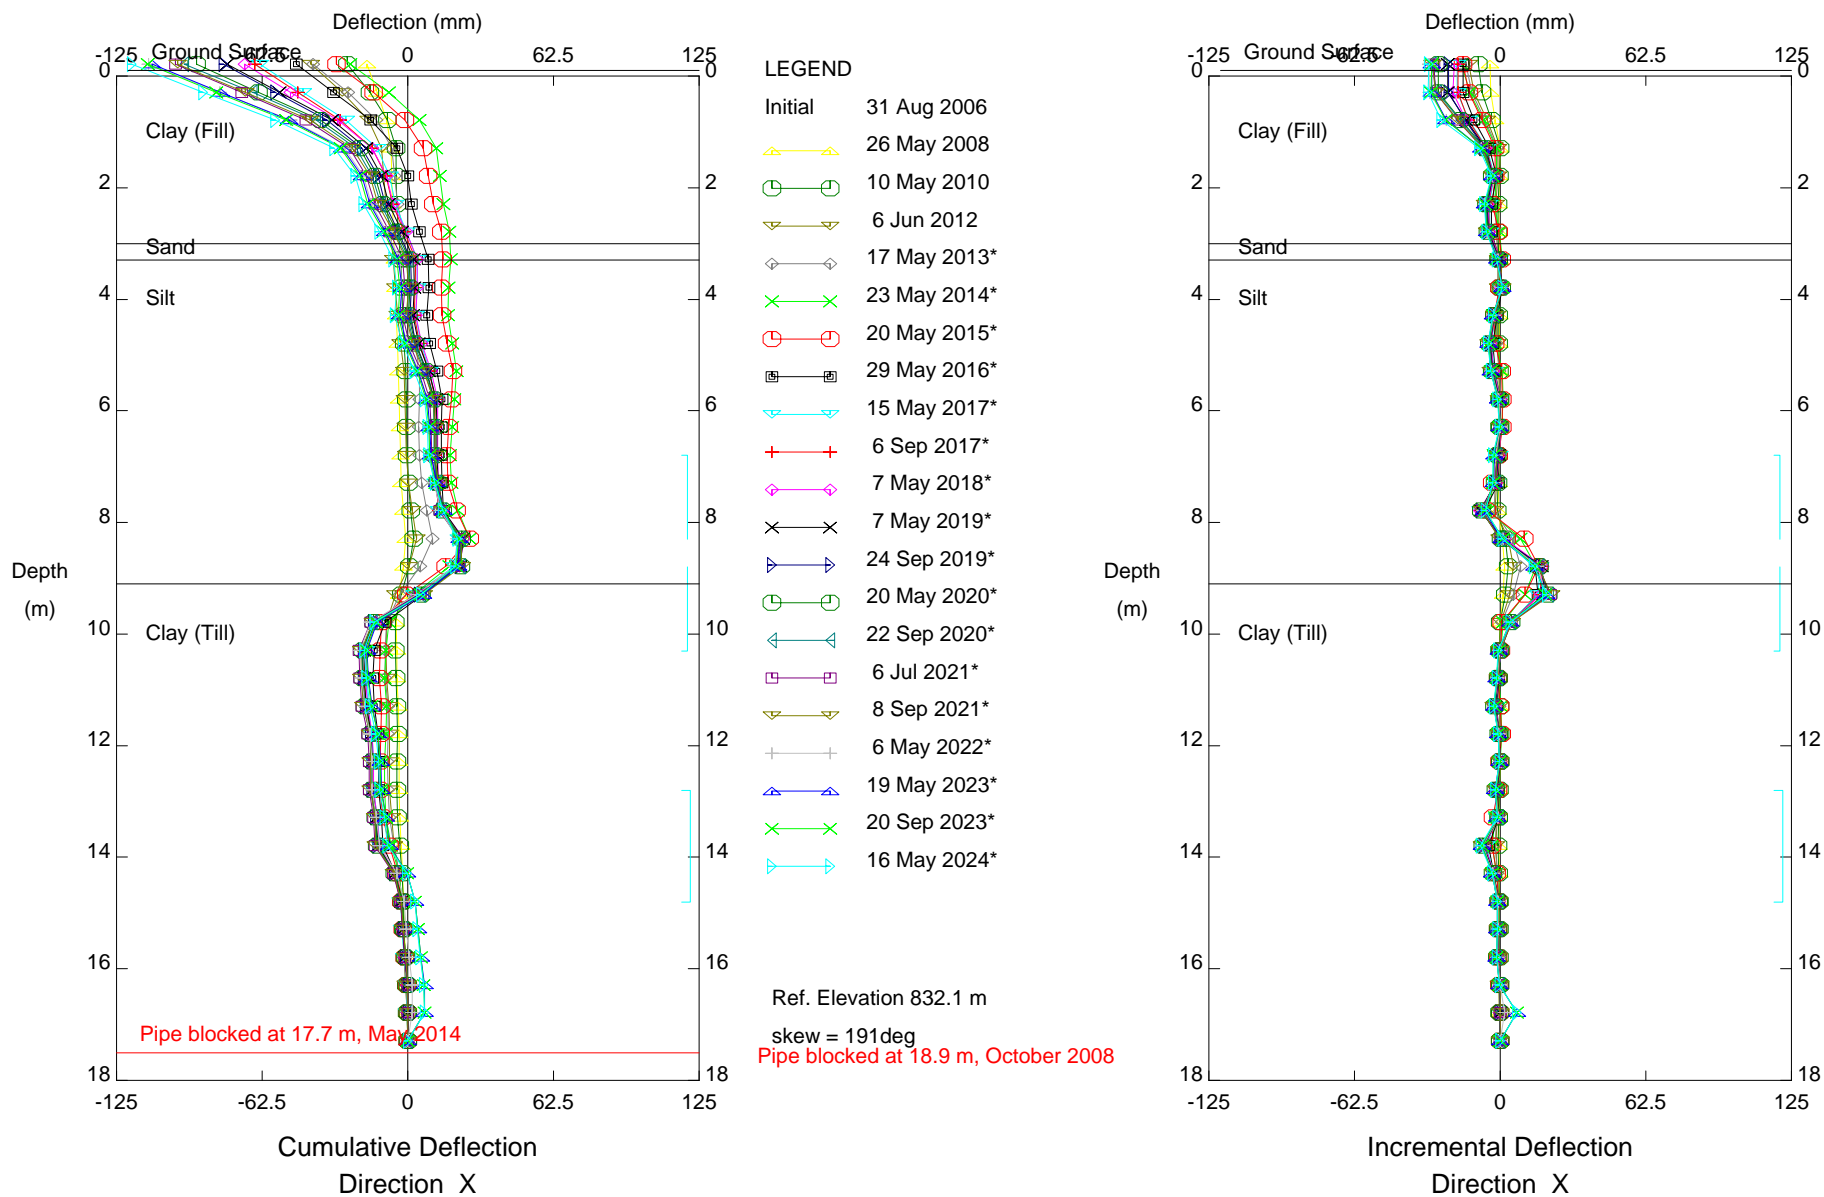
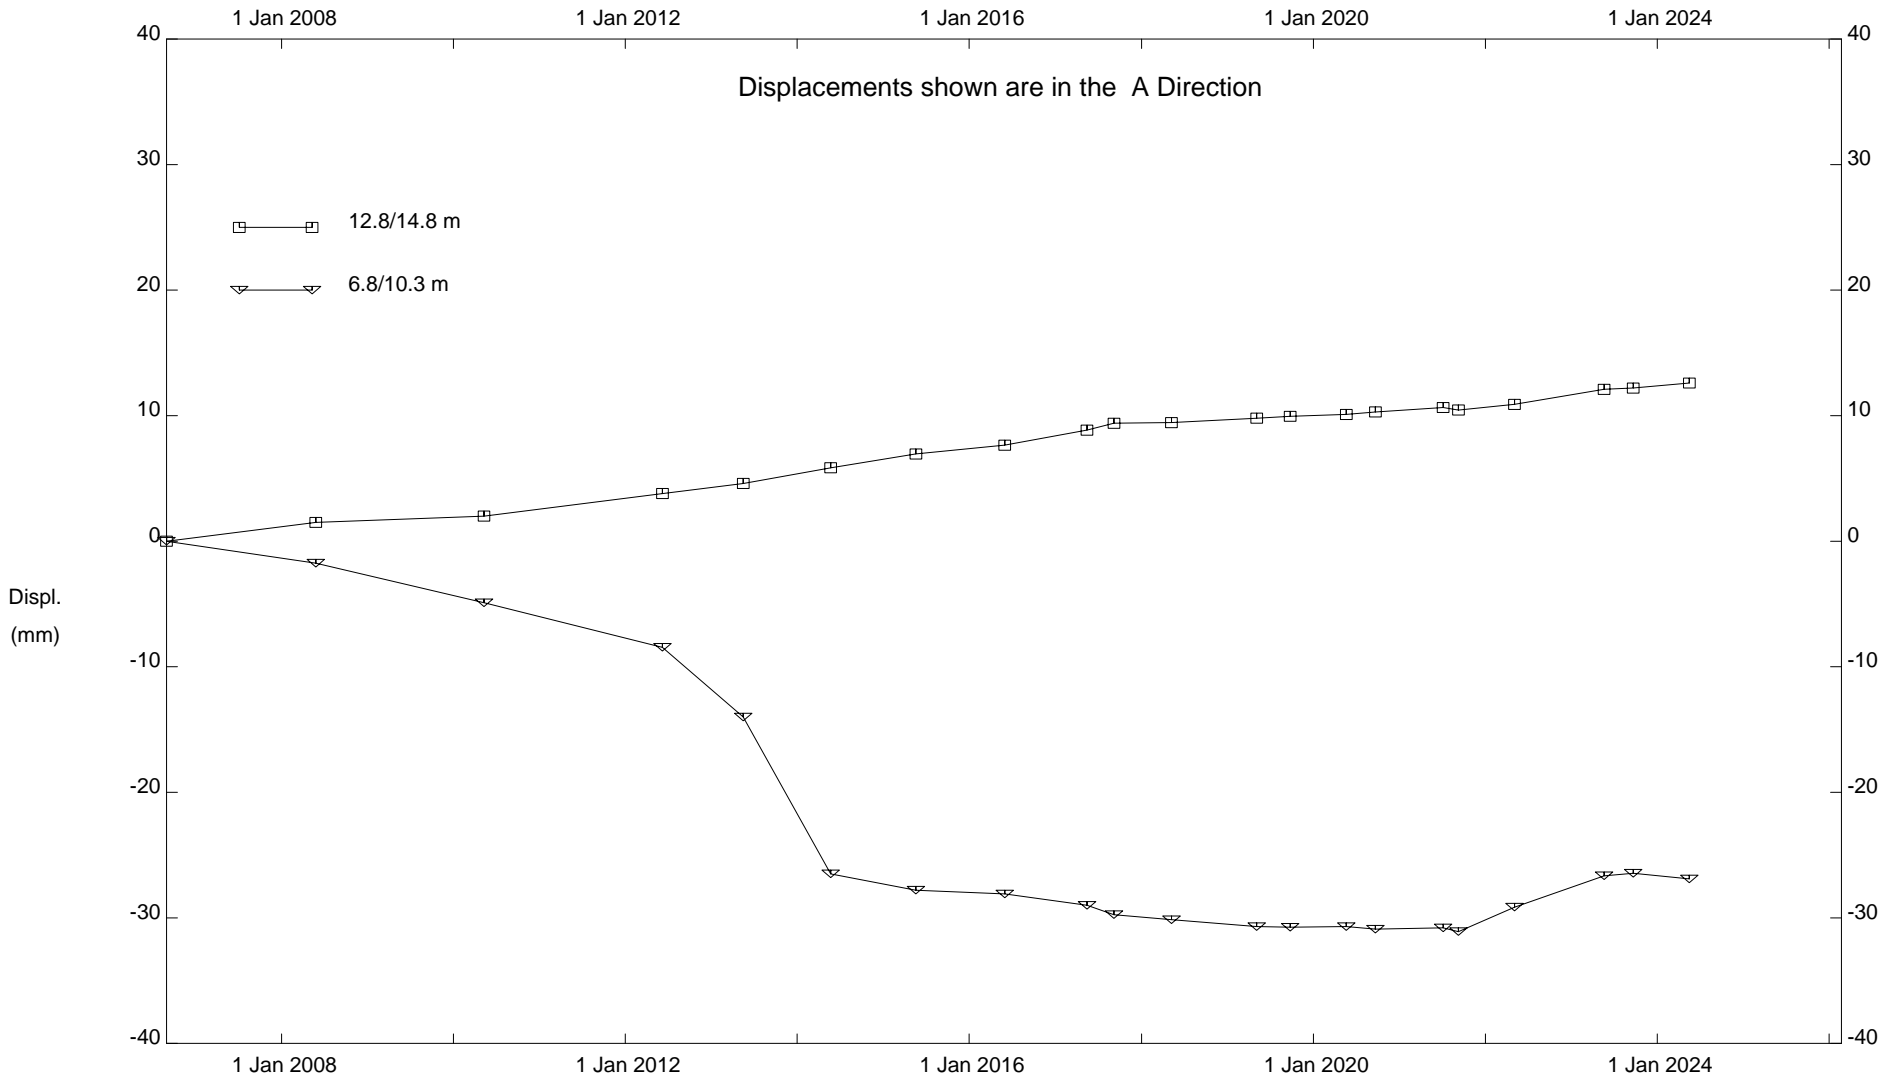
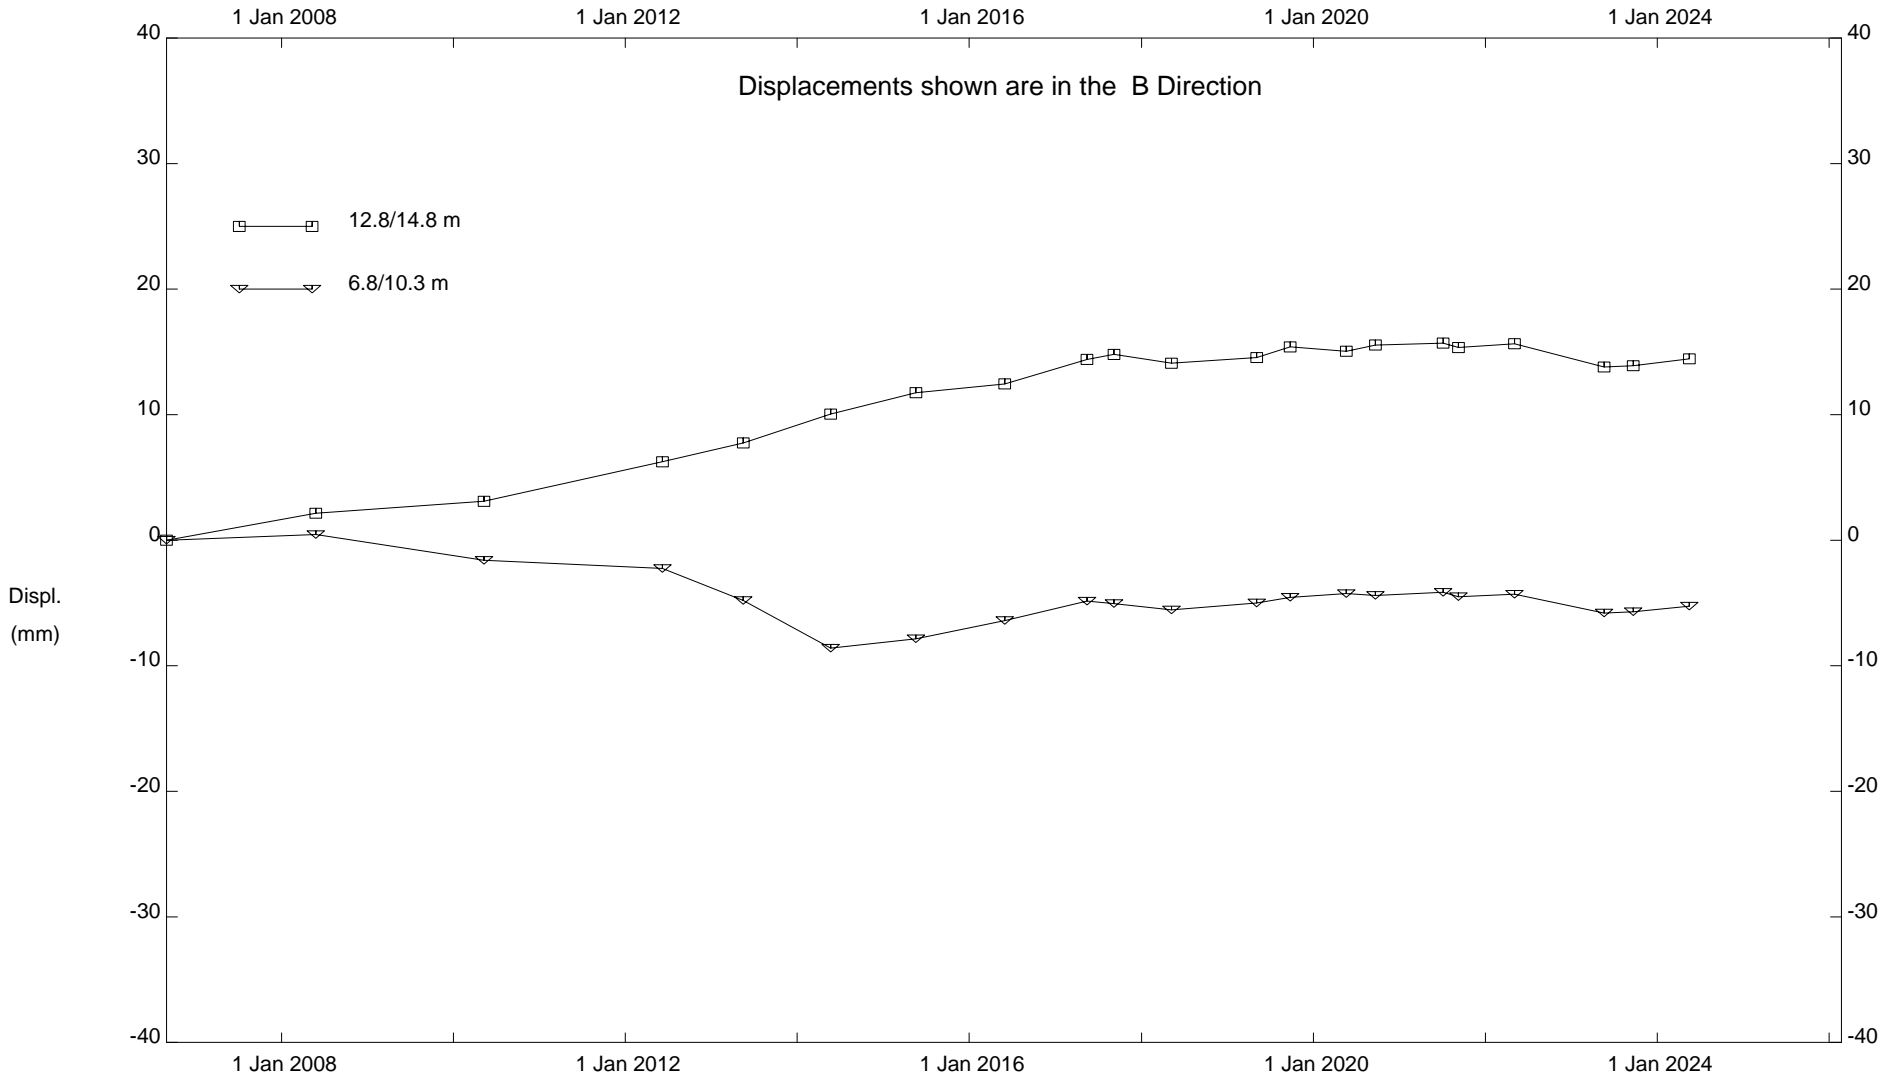
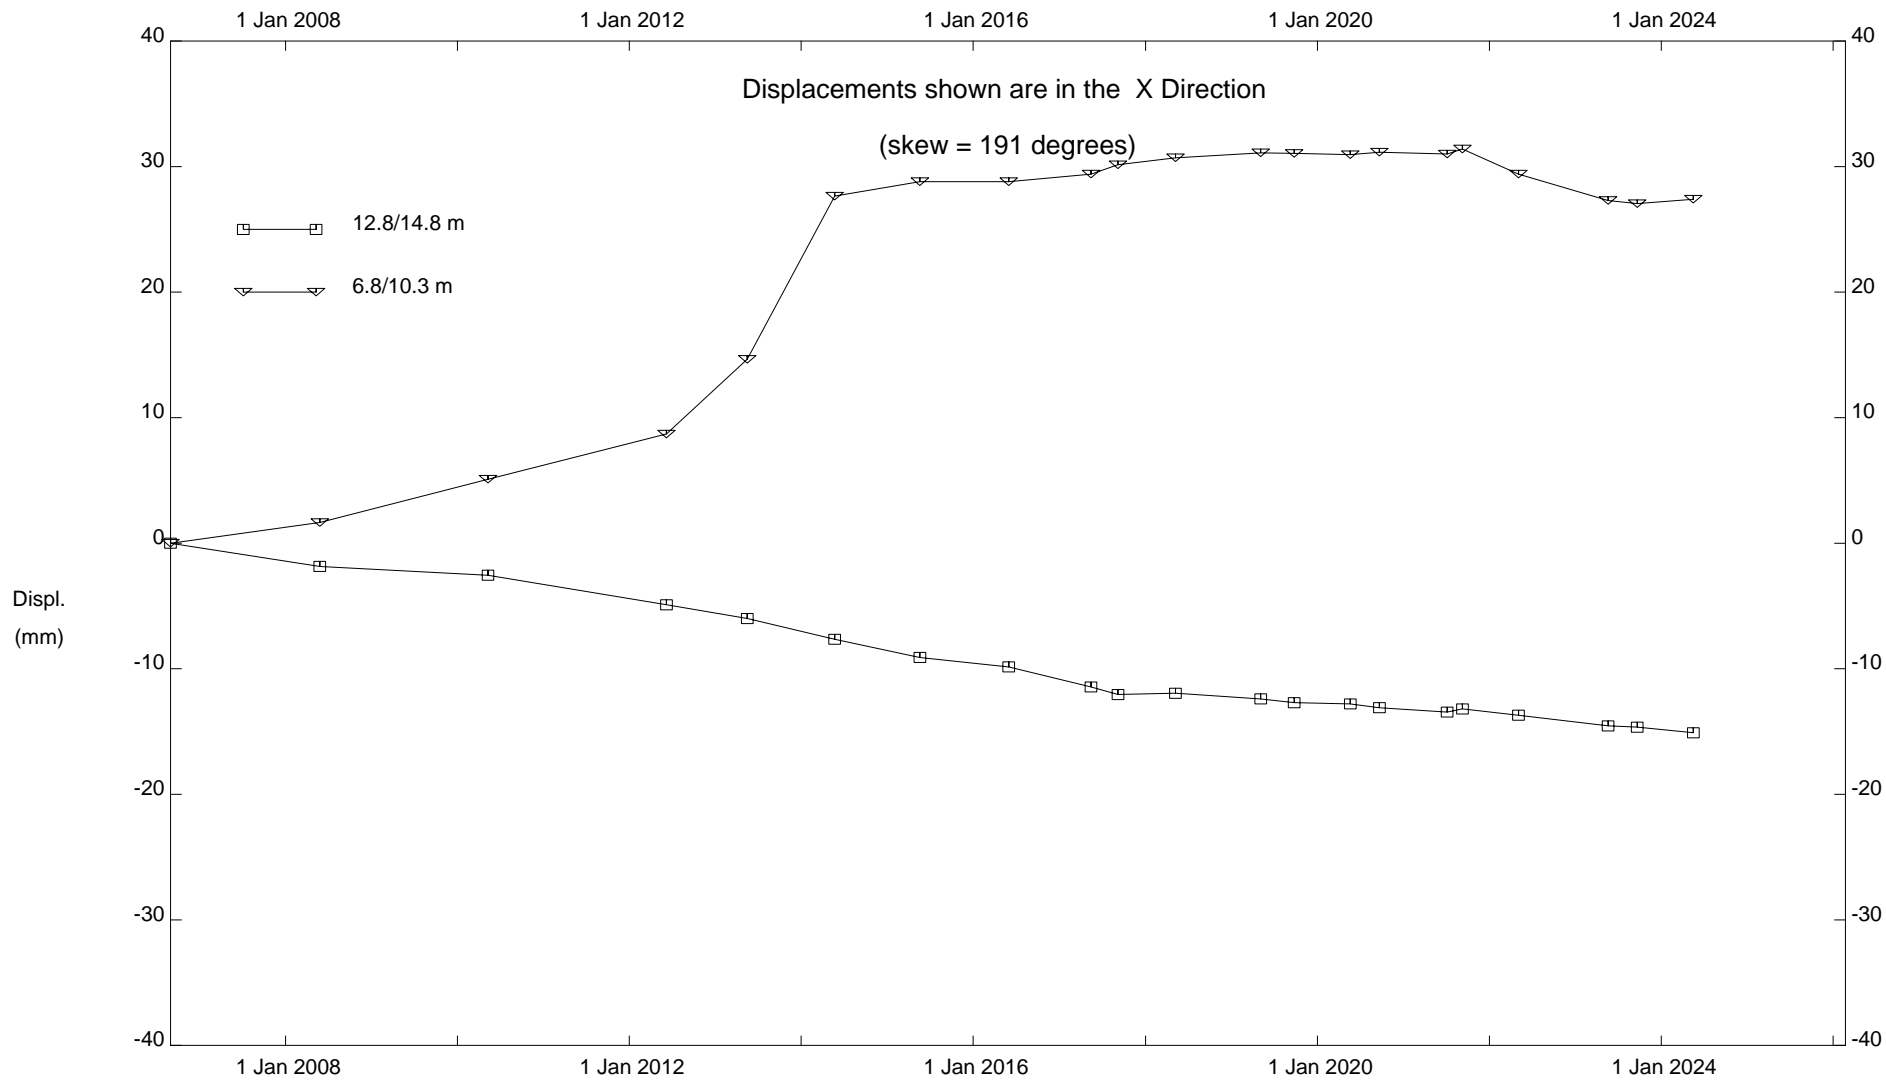
NC052, Inclinometer SI-2

SI-2 shows negligible movement rates over the two zones of movement at about 8 m and 14 m depth. It appears that the shallower zone of movement has been relatively stable with little movement recorded since 2013. There also appears to be a disturbance at the base of the SI that has been observed since Spring 2023.

All slope inclinometers appear to show signs of creep movement except for SI13-3.

It is recommended that all instruments be read again for the Fall 2024 reading cycle.
