To:	Amy Driessen	From:	Leslie Cho and Xiteng Liu
	Transportation and Economic Corridors		Stantec Consulting Ltd.
File:	123315222	Date:	June 18, 2024

Reference: North Central Region, Stony Plain, Site NC052 - Highway 621:02 Pembina River Bridge Abutment, Spring 2024 Instrumentation Monitoring Report

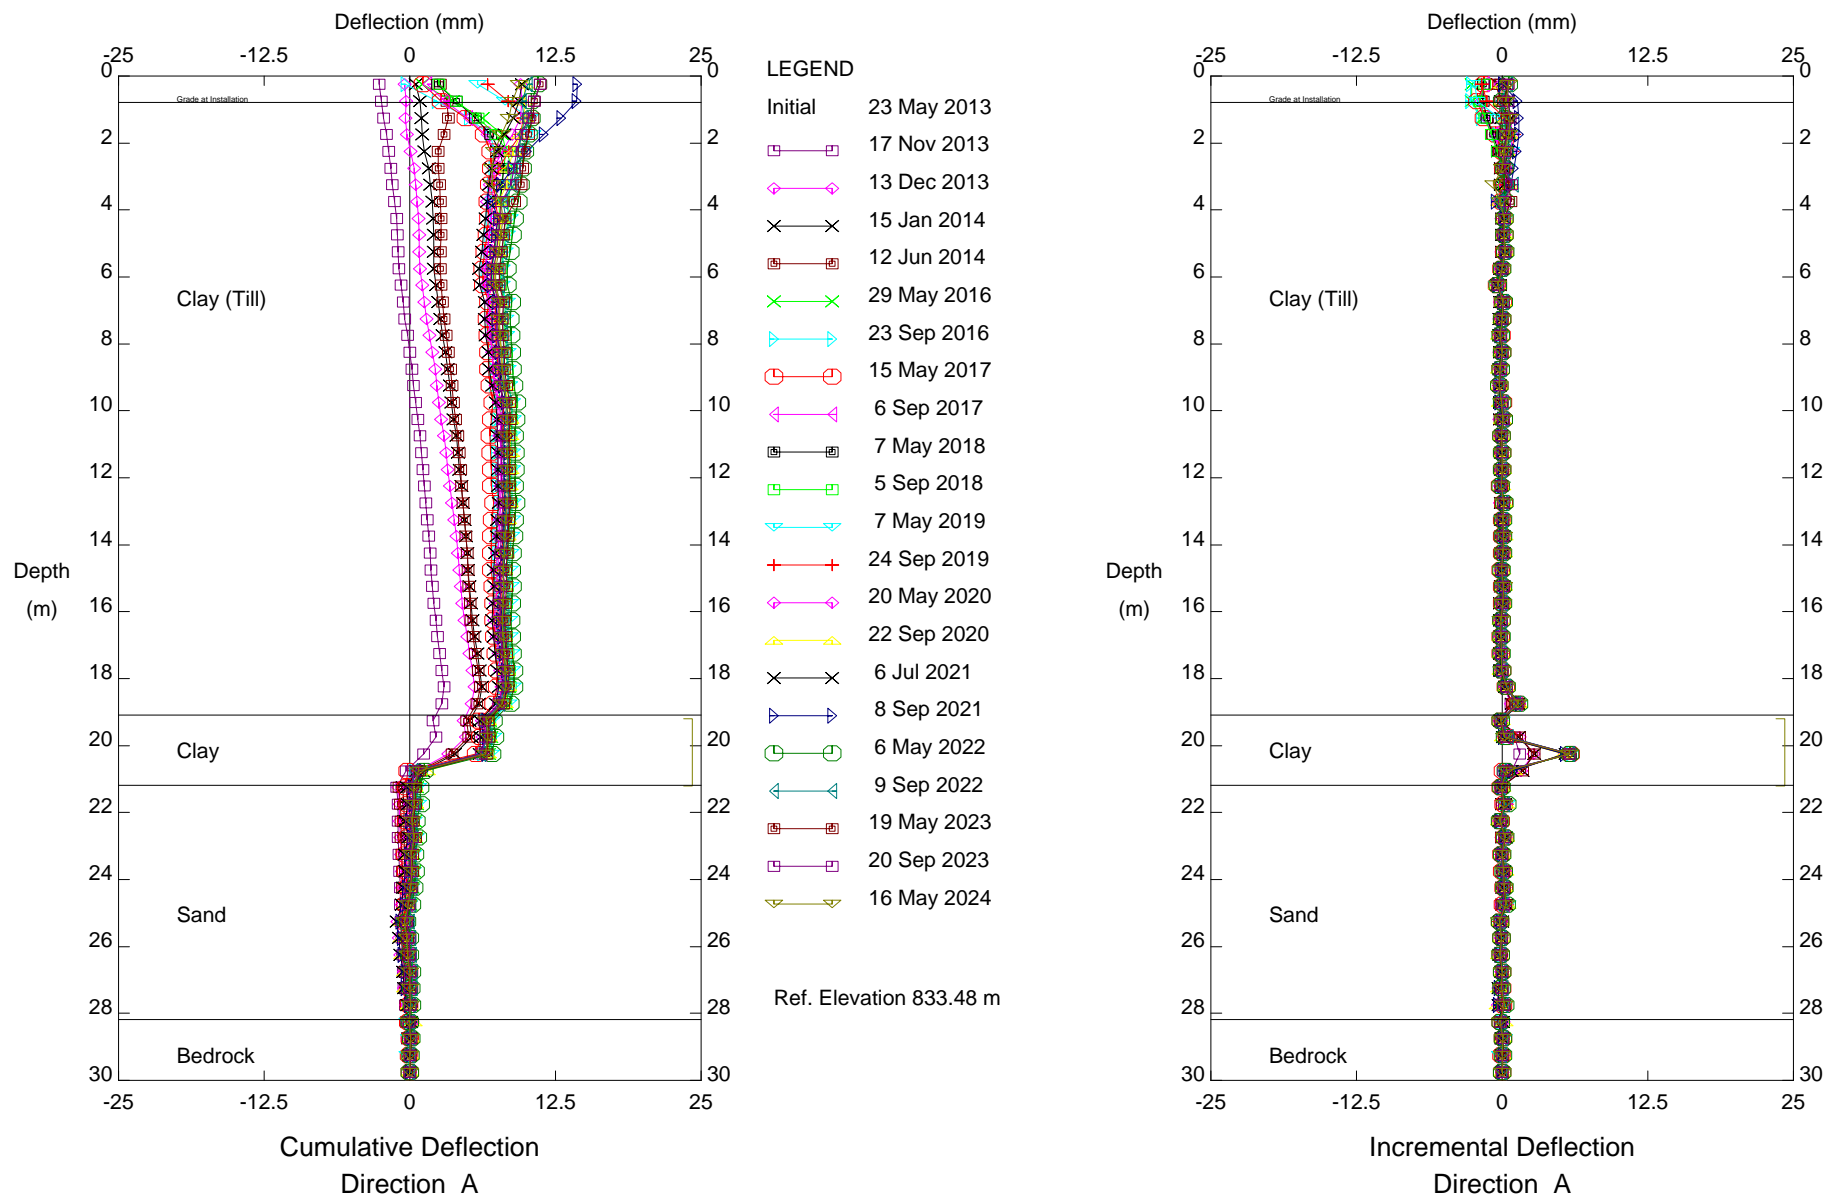
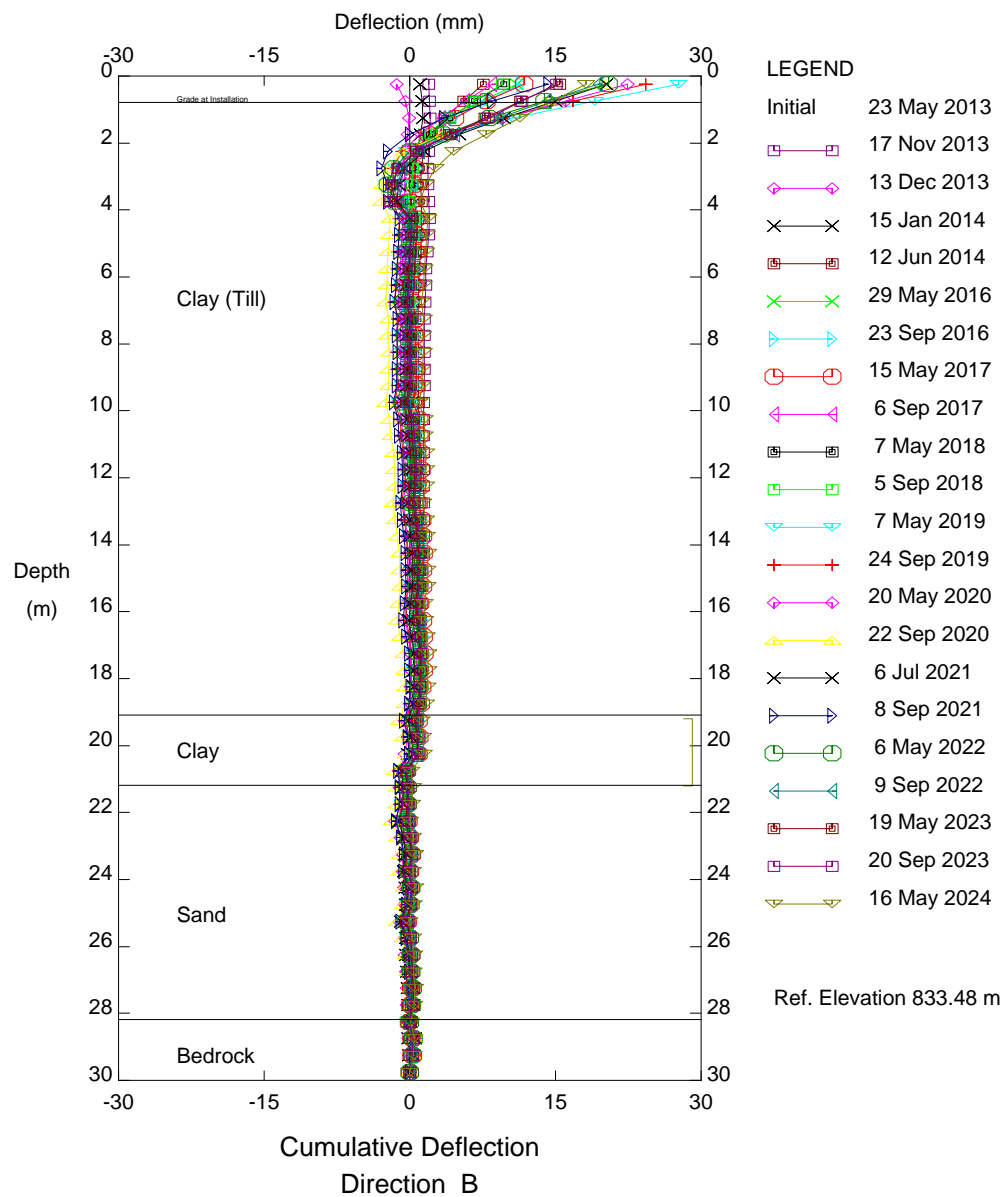
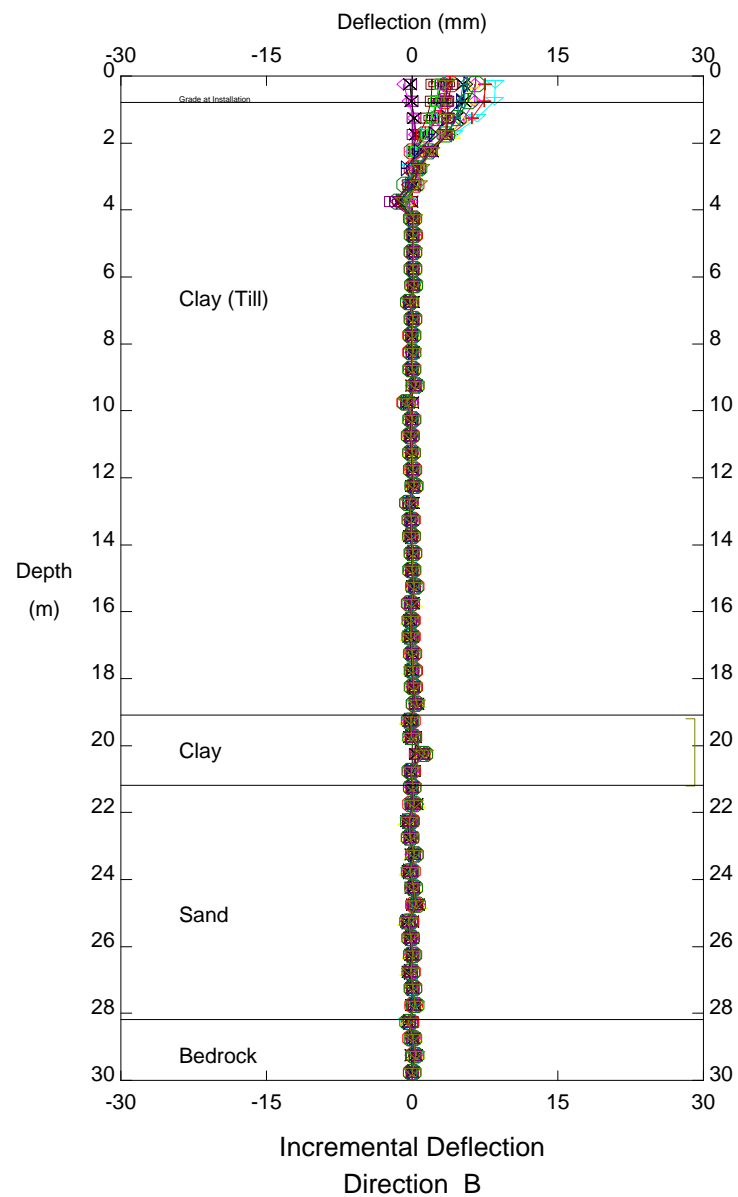
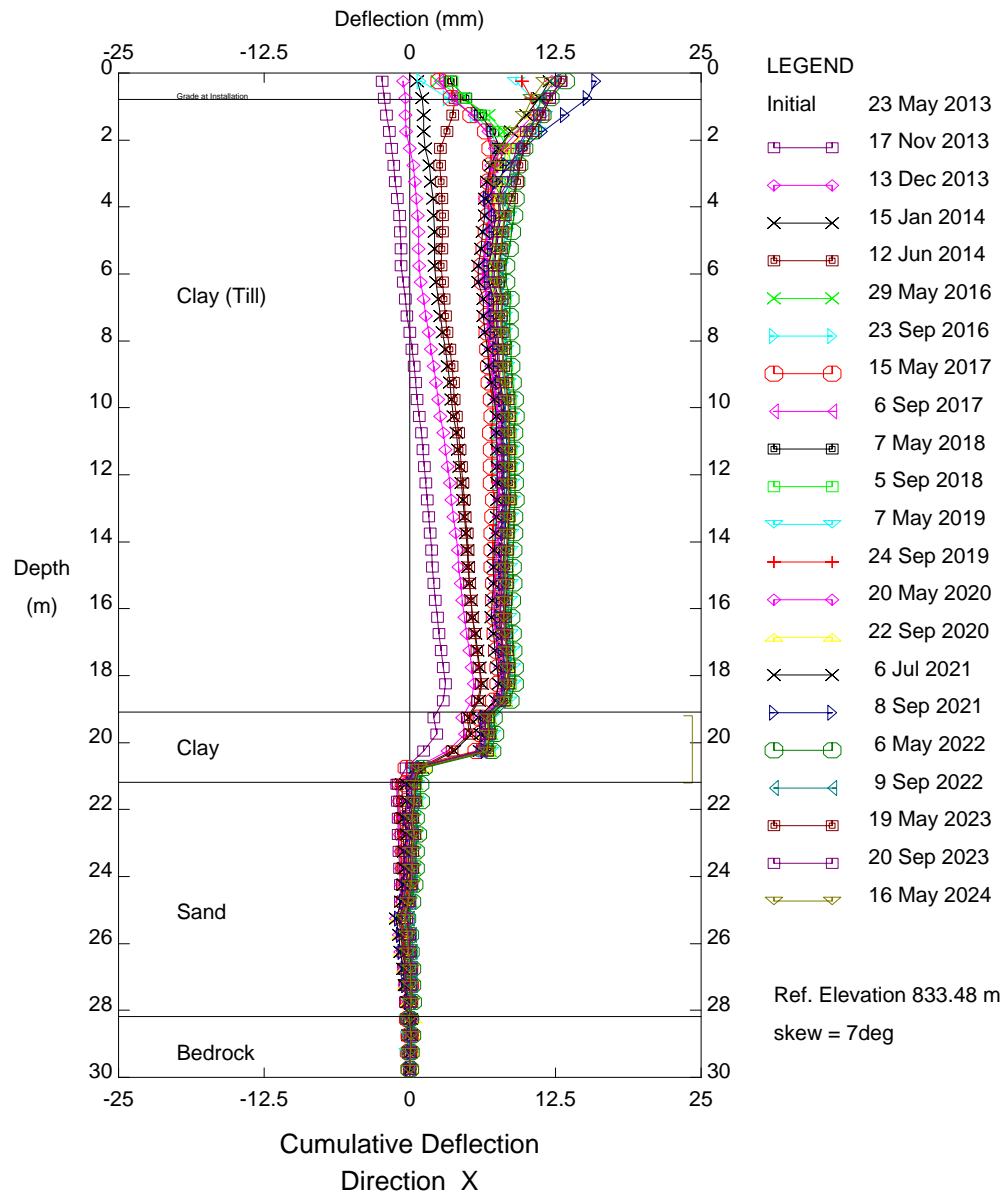
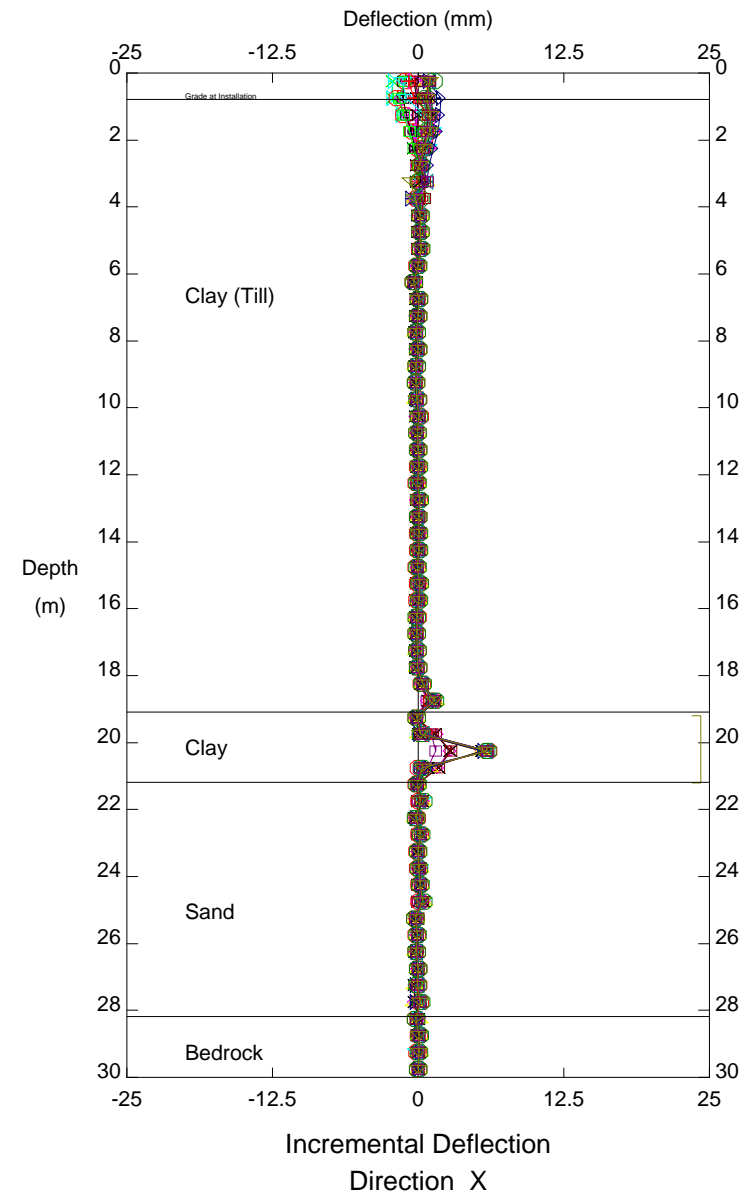
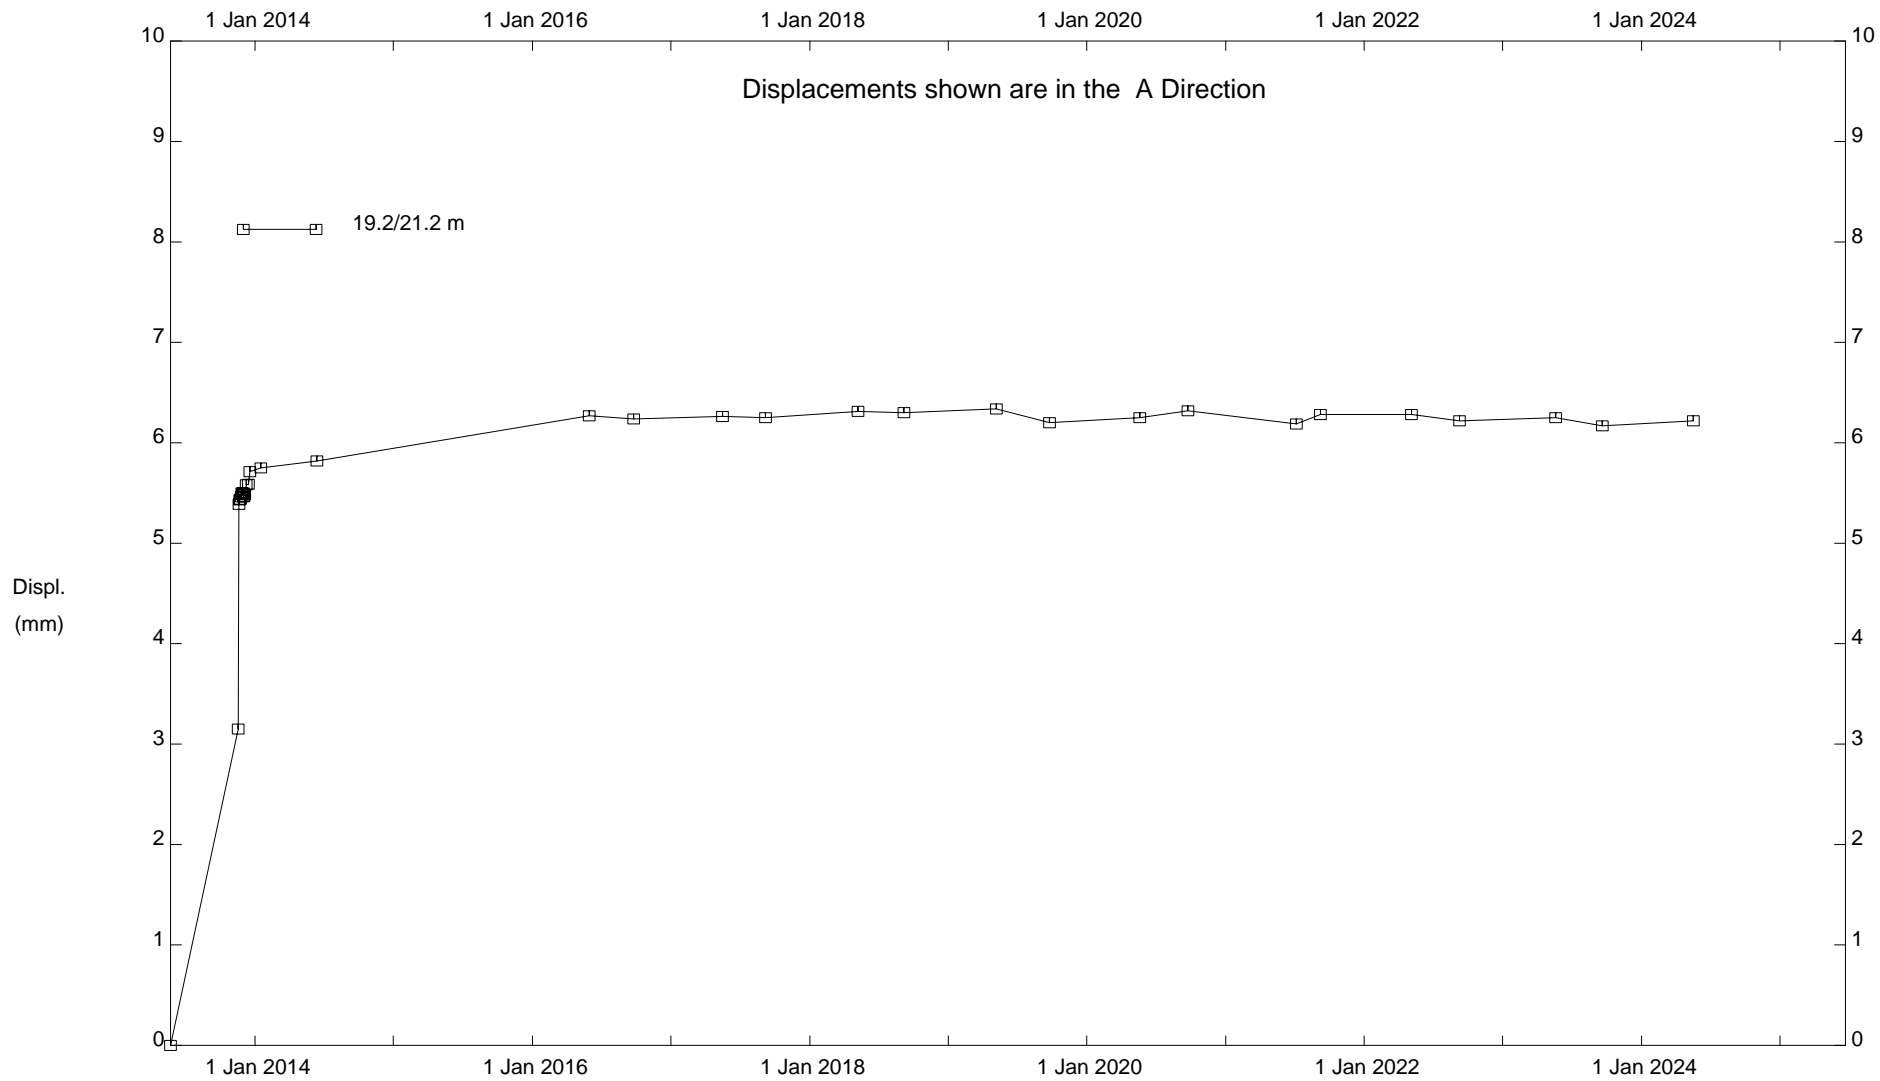
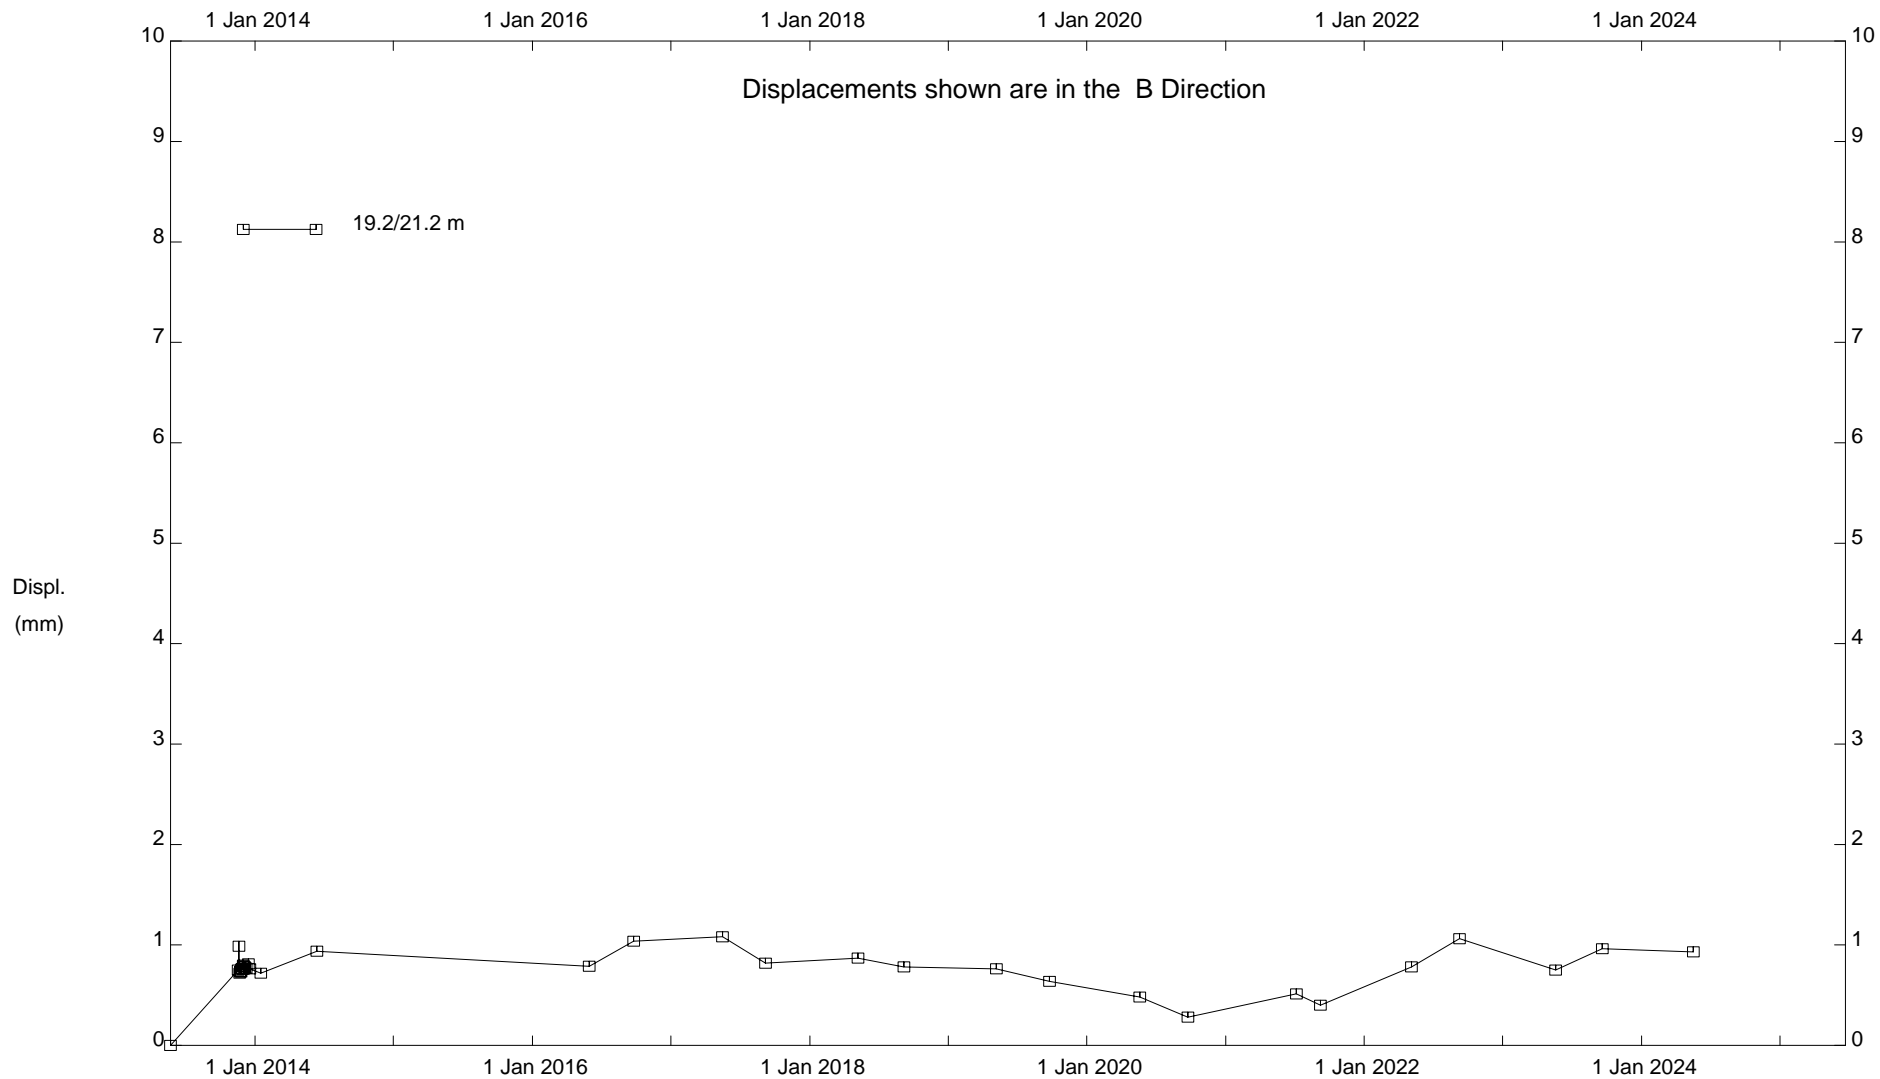
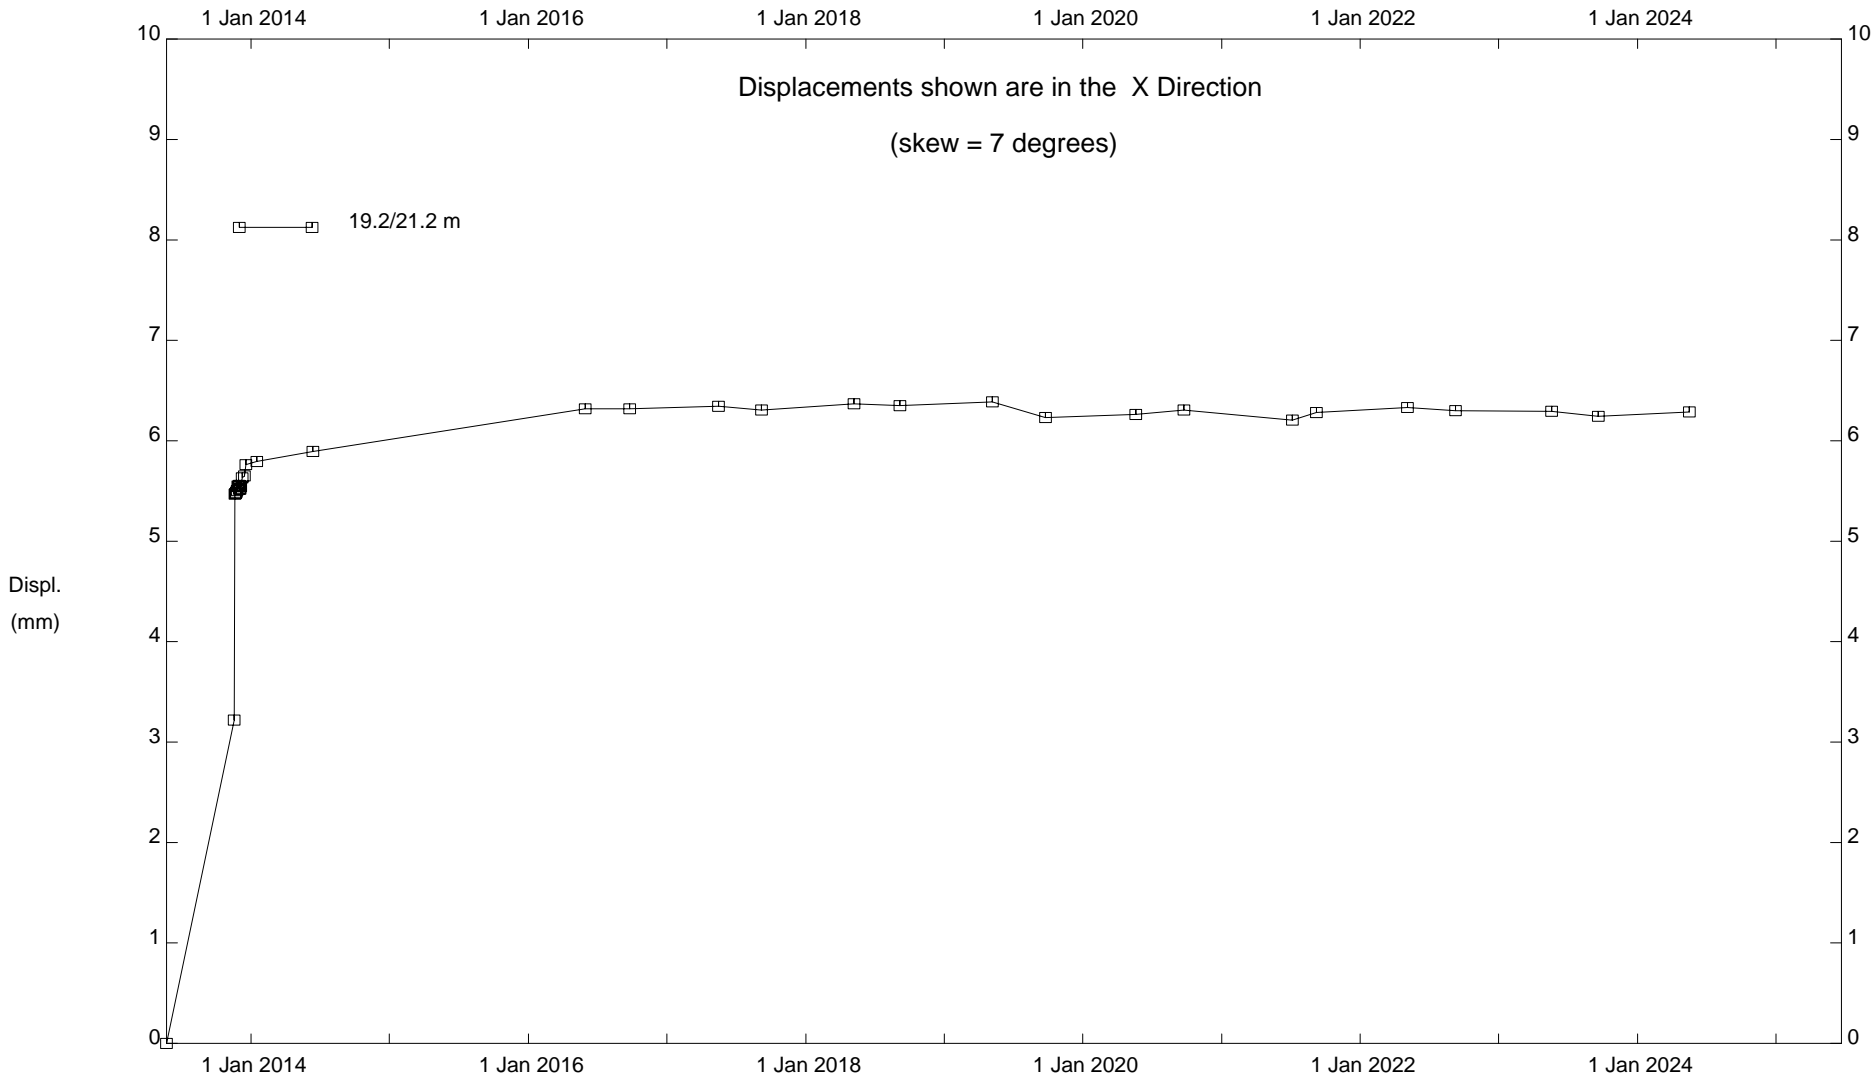
NC052, Inclinometer SI13-3
 Transportation & Economic Corridors

SI13-3 has recorded about 6 mm of cumulative movement since 2014. The recorded movement is likely related to construction activities in winter 2014. Little to no movement was observed since 2015.

It is recommended that all instruments be read again for the Fall 2024 reading cycle.

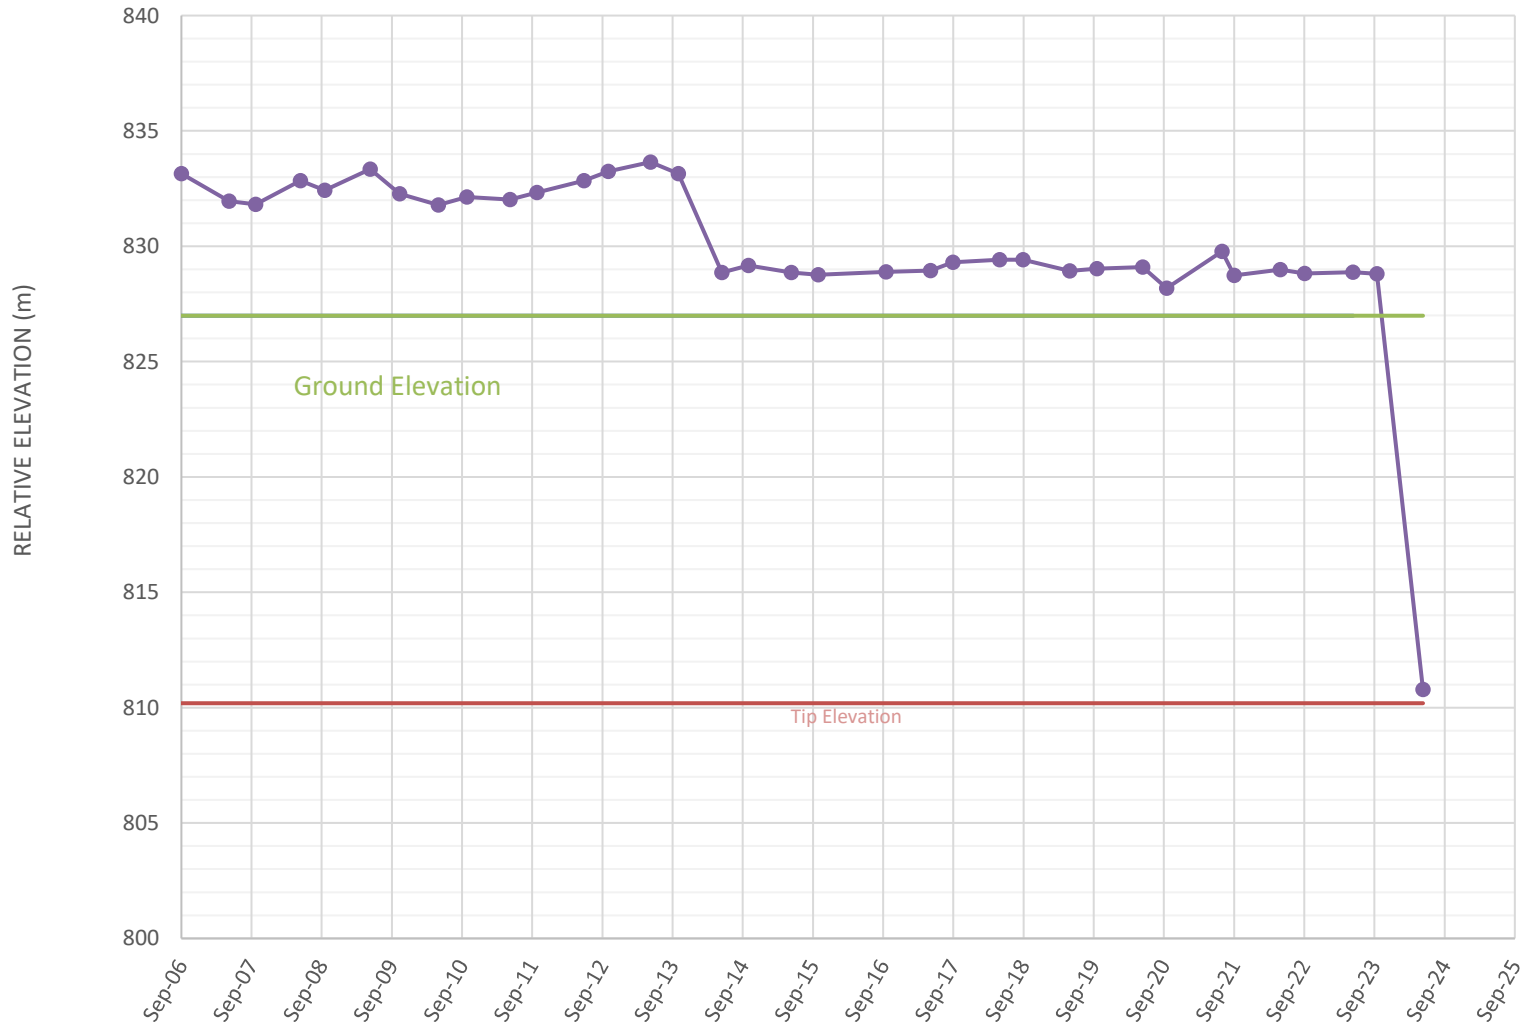
PNEUMATIC PIEZOMETER
PN-01 (30578)

An attempt to monitor **PN-01** was made, however, the data is likely erroneous since it resulted in a decrease in piezometric elevation of about 18 m. The erroneous reading is likely due to a leak within the pneumatic piezometer tubing.

An attempt to repair PN-01 could be made since the ability to hear the hissing sound suggests the leak is within the exposed portion of cabling. If the leak location is identified, PN-01 could potentially be repaired by splicing below the leak.

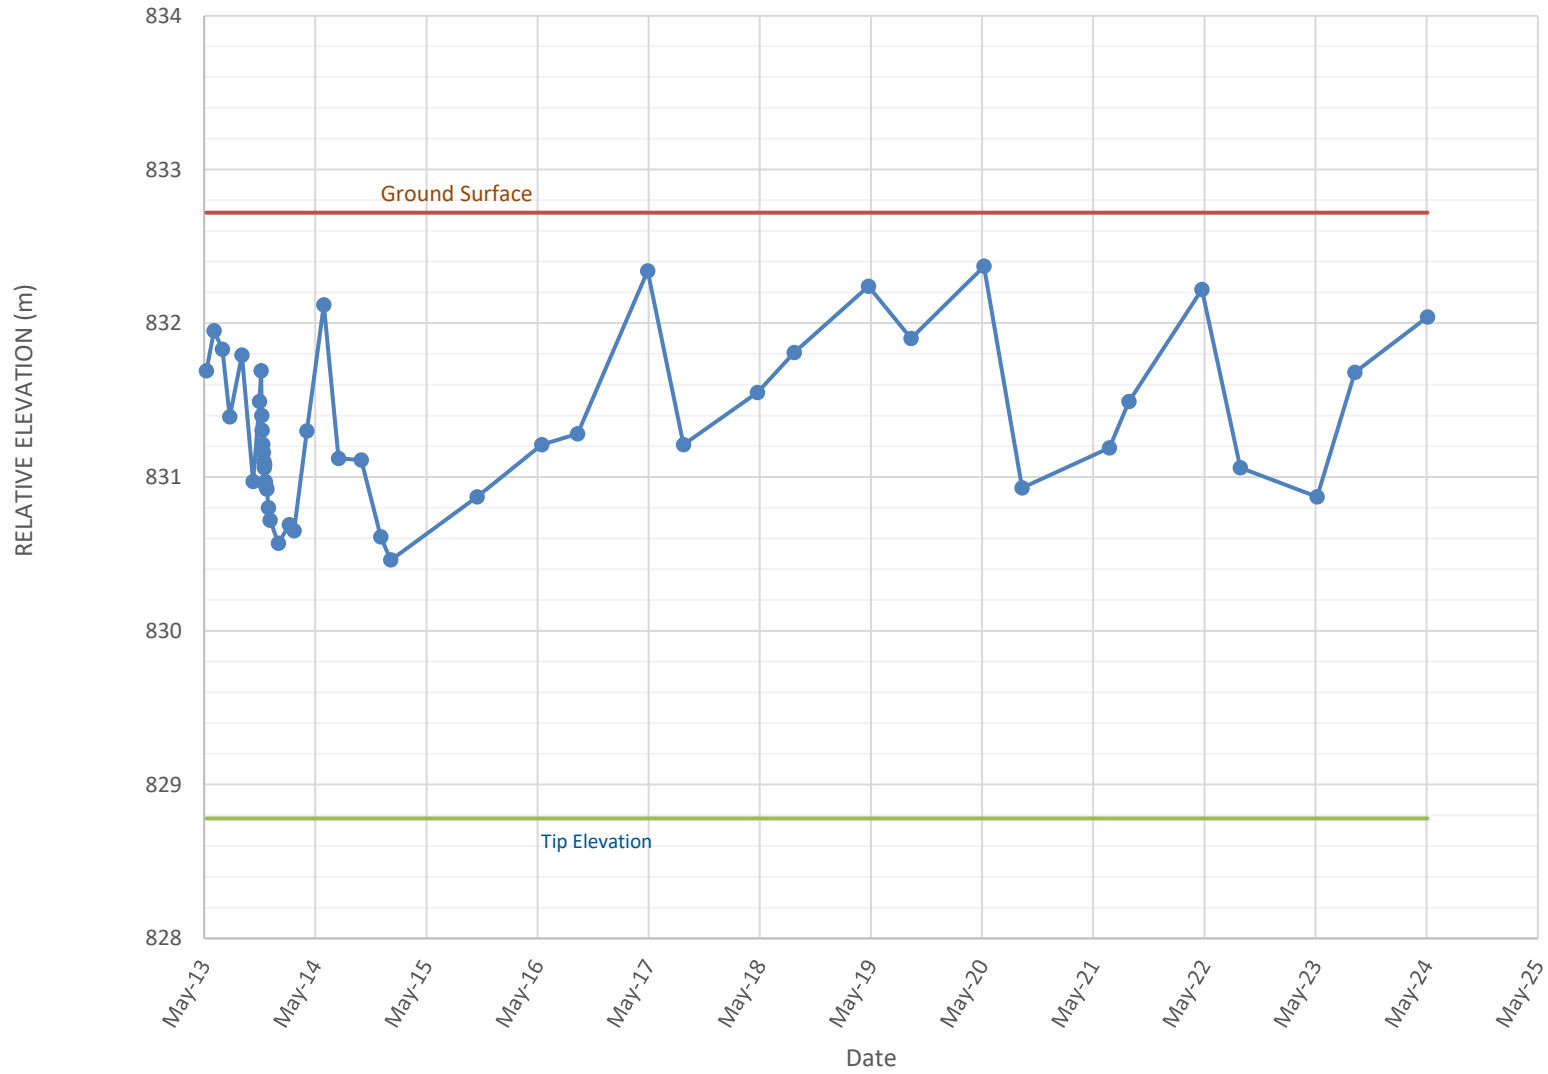
STANDPIPE PIEZOMETER
SP13-3A

The water level in **SP13-3A** decreased by about 1.7 m after construction in winter 2014. The water level gradually increased to above pre-construction levels in May 2017. A 1.1 m drop was measured in September 2017 whereafter water levels increased again to above pre-construction levels until May 2020. Another significant drop in water levels was observed in September 2020. There appears to be a cycle developing where water levels increase for 2-3 years followed by a sharp drop in water levels. The current measured water level increased by 0.3 m bgs from previous reading cycle in Fall 2023 corresponding to a water level depth of 0.7 m bgs.

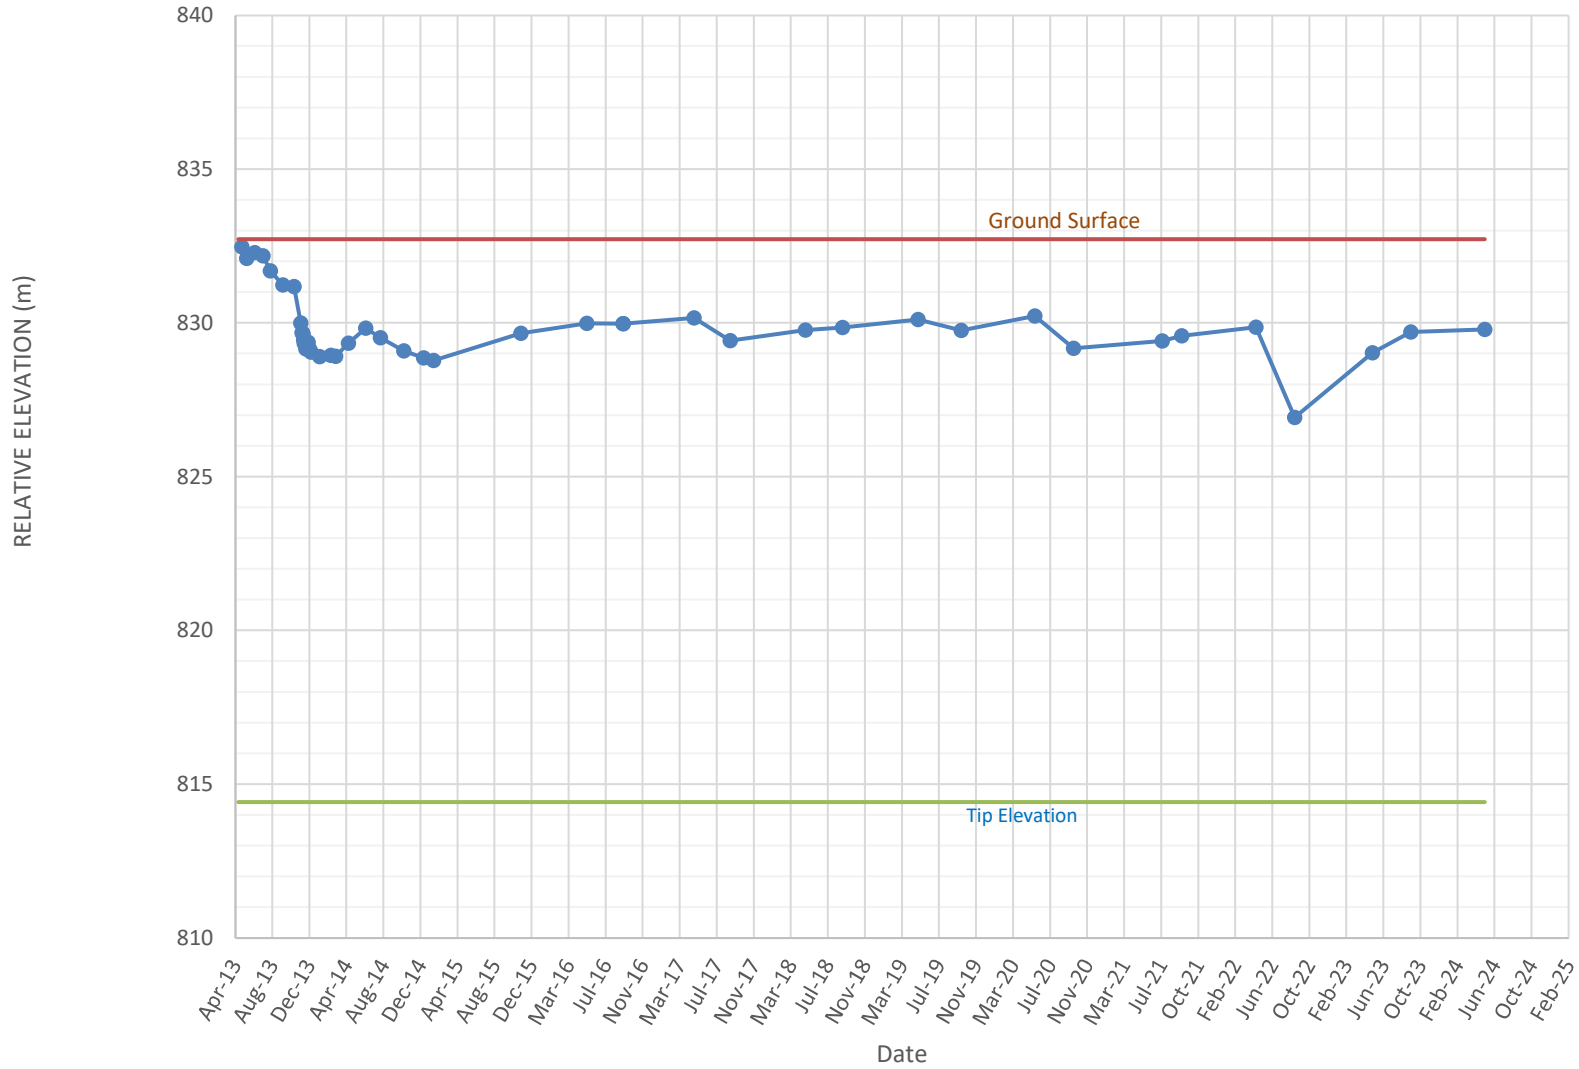
VIBRATING WIRE PIEZOMETER
VW13-3

VW13-3 showed an negligible change (less than 0.1 m increase) in piezometric level since the previous reading in Fall 2023. The piezometric level in VW13-3 has been relatively stable since about 2015.
