SITE NUMBER AND NAME: NC057 – Highway 624 Embankment Failure	HIGHWAY AND KM: 621:02, km 16.420	PREVIOUS INSPECTION: May 22, 2020	CURRENT INSPECTION: June 29, 2021
LEGAL DESCRIPTION: NE & NW 34-50-07-W5	NAD83 COORDINATES: UTM11U 5915066N, 637131E		RISK ASSESSMENT: PF: 10 CF: 6 Total: 60
AVERAGE ANNUAL DAILY TRAFFIC (AADT): 1,260 (2020)		CONTRACTOR MAINTENANCE AREA (CMA): 509

2021 Site Inspection Photos at NC057

Client/Project
 Alberta Transportation
 Geohazard Monitoring Program
 NCS7 Embankment Failure on Hwy 624

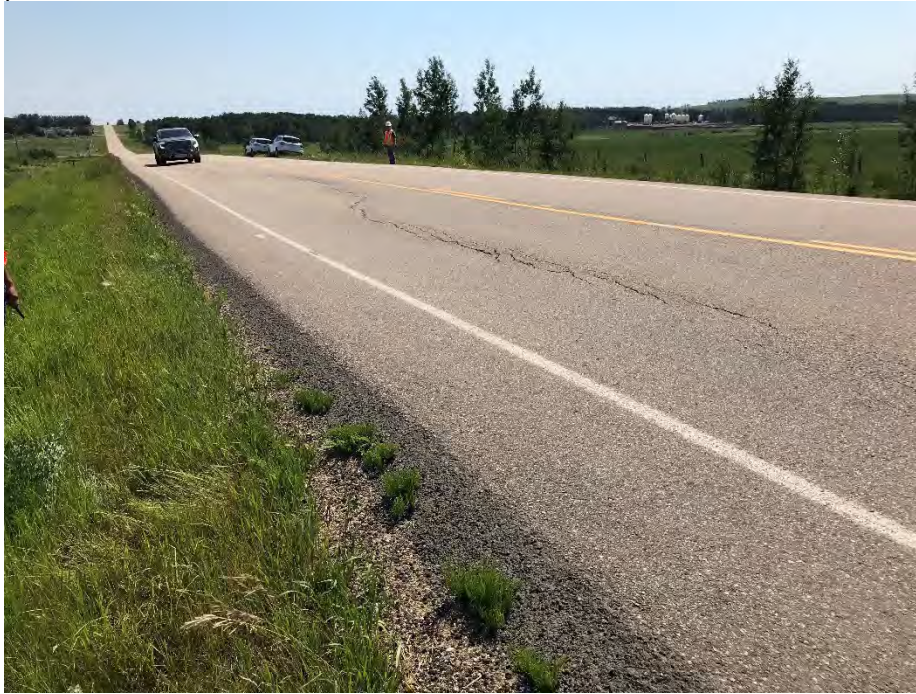
Photo 1: West limits of WBL pavement cracks. Approx. 25 mm dip. Looking southeast.

- Pavement cracks should be sealed to reduce surface water infiltration into the embankment. Additional pavement patches are not recommended since it is considered an additional driving force on the embankment. Mill and fill could be completed to address the vertical displacement until remediation is completed.

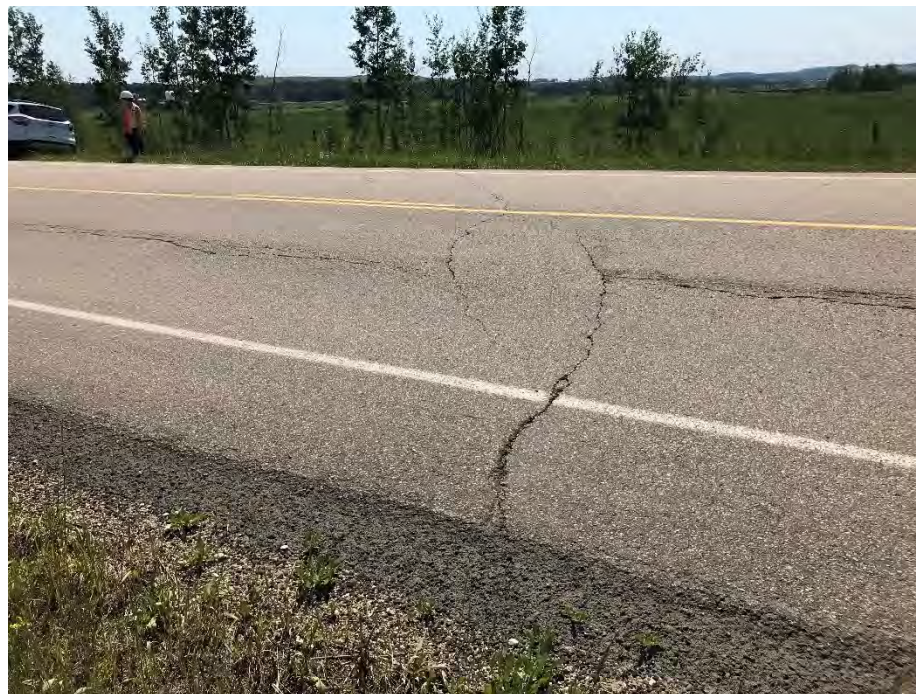
Photo 2: Diagonal pavement cracks approximately at km 2.55. Looking southeast.

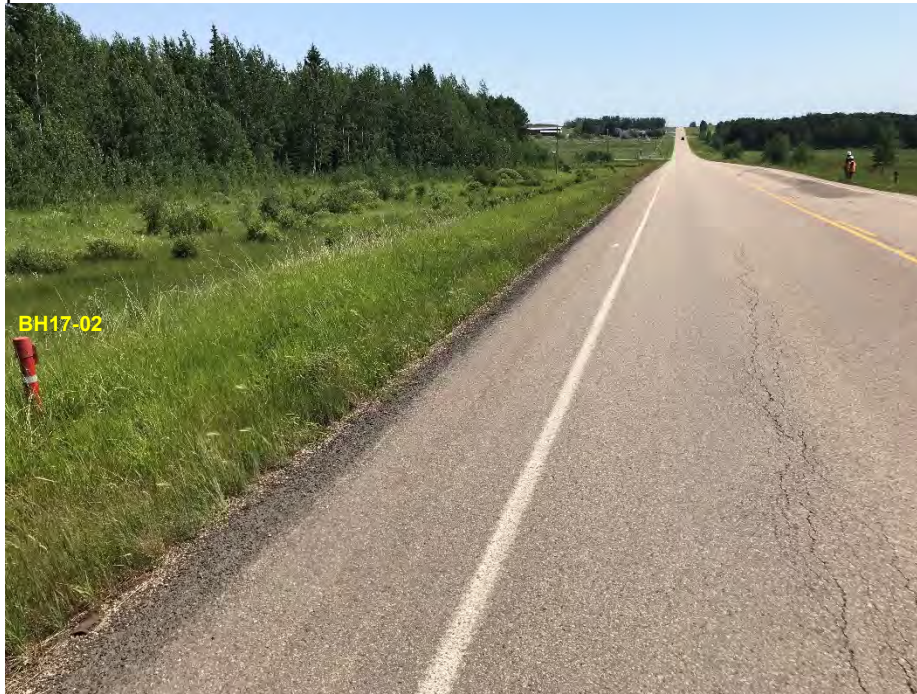
Photo 3: Faint cracks progressing east of BH17-02. Looking east.

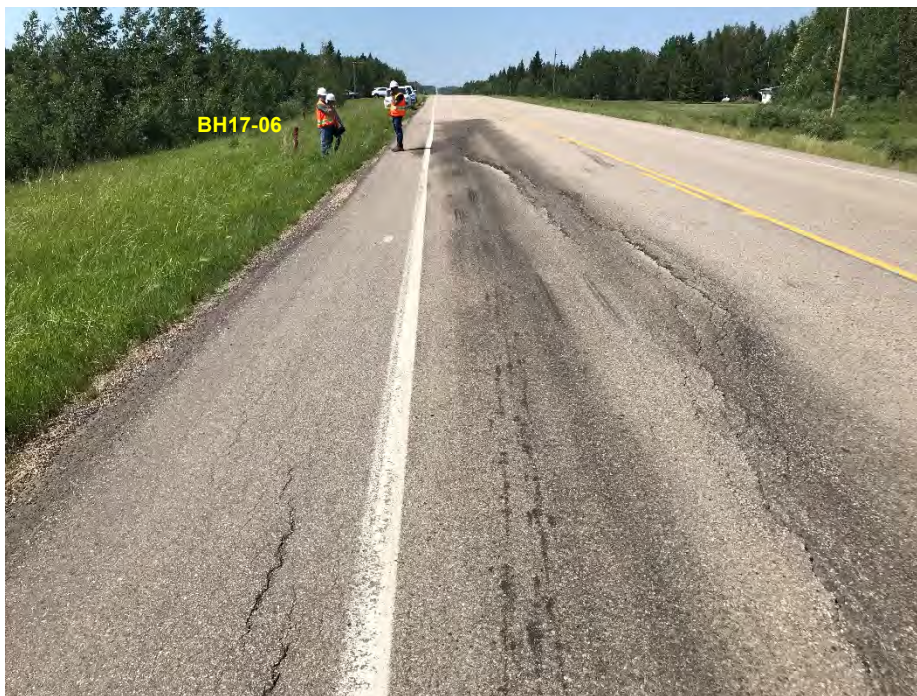
Photo 4: Pavement cracking on EBL. 70 mm to 90 mm differential. Tire marks apparent at drop location. Looking west.

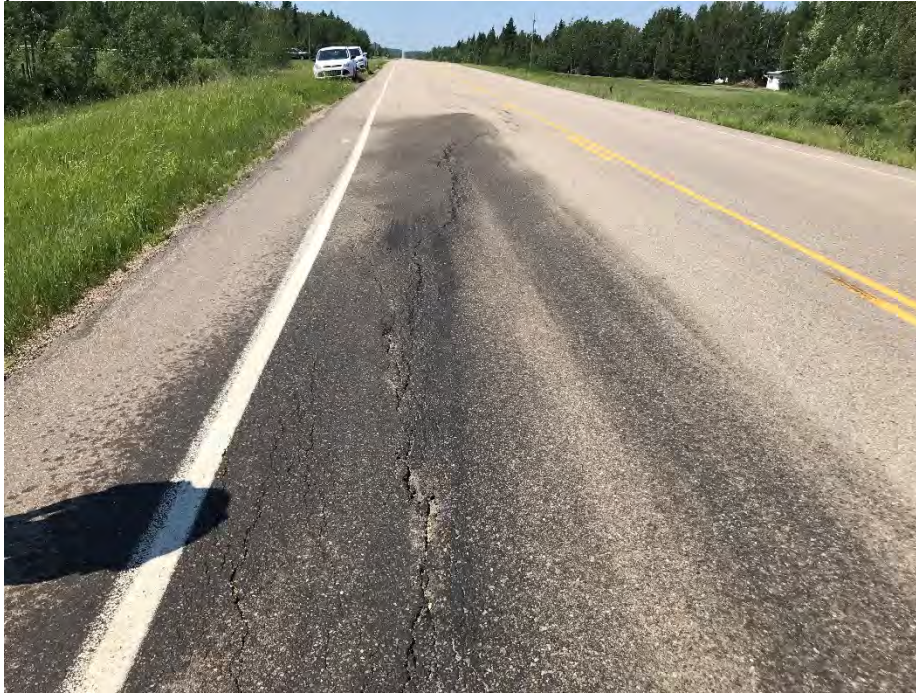
Photo 5: Pavement cracking on WBL with tire marks. Looking west.
