SITE NUMBER AND NAME: NC057 – Highway 624 Embankment Failure	HIGHWAY AND KM: 621:02, km 16.420	PREVIOUS INSPECTION: June 29, 2021	CURRENT INSPECTION: June 15, 2022
LEGAL DESCRIPTION: NE & NW 34-50-07-W5	NAD83 COORDINATES: UTM11U 5915066N, 637131E		RISK ASSESSMENT: PF: 10 CF: 6 Total: 60
AVERAGE ANNUAL DAILY TRAFFIC (AADT): 1,350 (2021)		CONTRACTOR MAINTENANCE AREA (CMA): 509

2022 Site Inspection Photos at NC057

Client/Project:
 Alberta Transportation
 Geohazard Monitoring Program
 NC57 Embankment Failure on Hwy 624

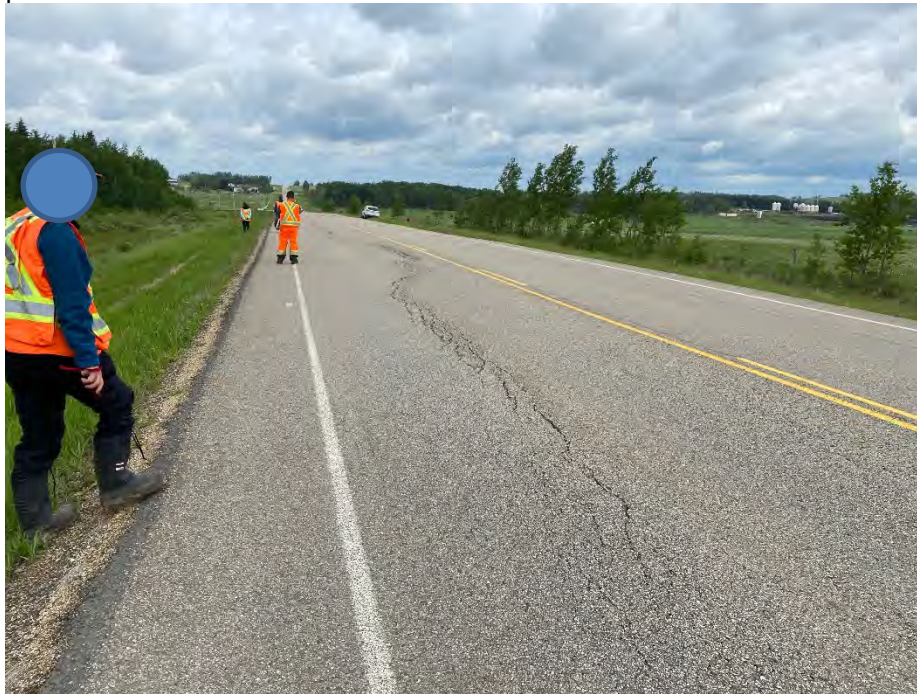
Photo 1: West limits of WBL pavement cracks. Approx. 25 mm dip. Looking east.

- Pavement cracks should be sealed to reduce surface water infiltration into the embankment. Additional pavement patches are not recommended since it is considered an additional driving force on the embankment. Mill and fill could be completed to address the vertical displacement until remediation is completed.

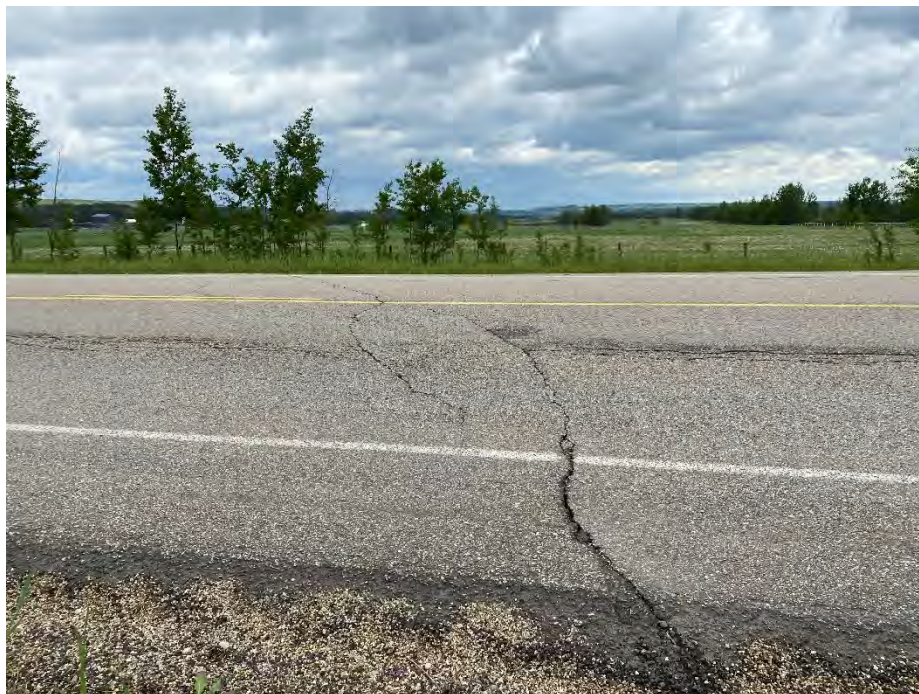
Photo 2: Diagonal pavement cracks approximately at km 2.55. Looking southeast.

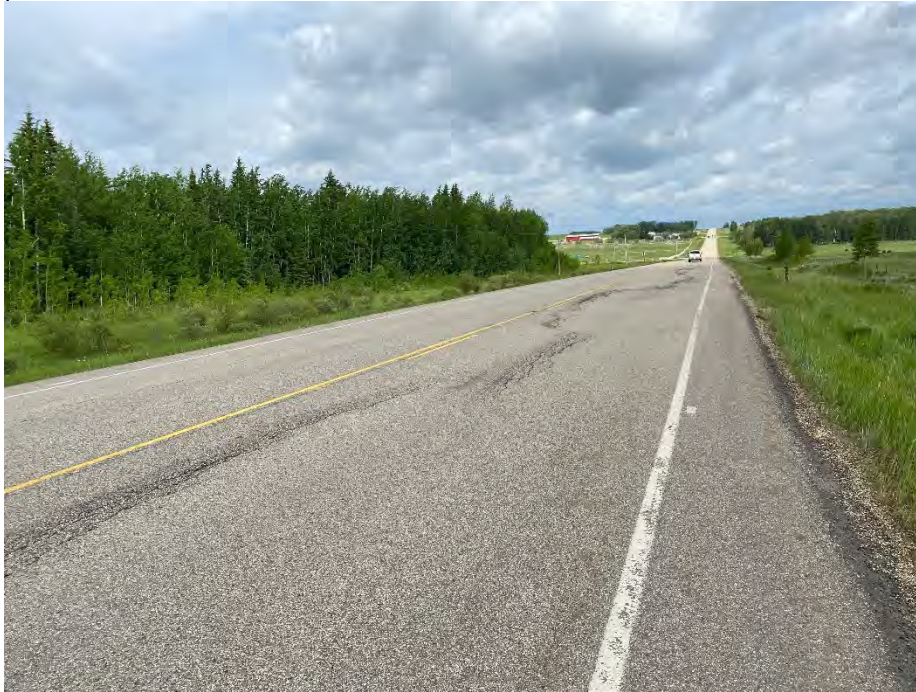
Photo 3: Pavement cracking on EBL. Looking east.

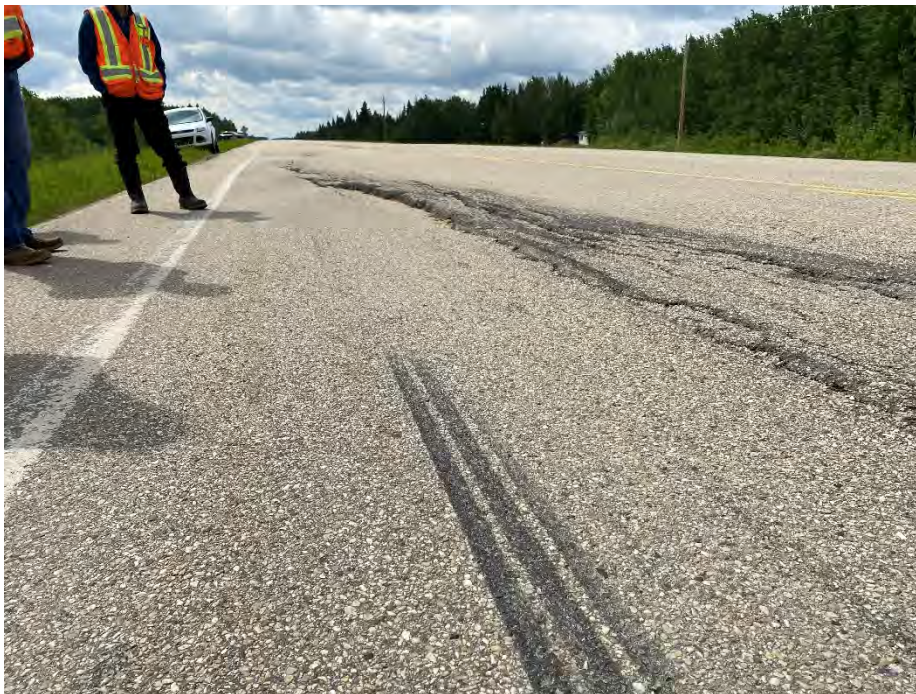
Photo 4: Pavement cracking on EBL with tire marks. Looking west.

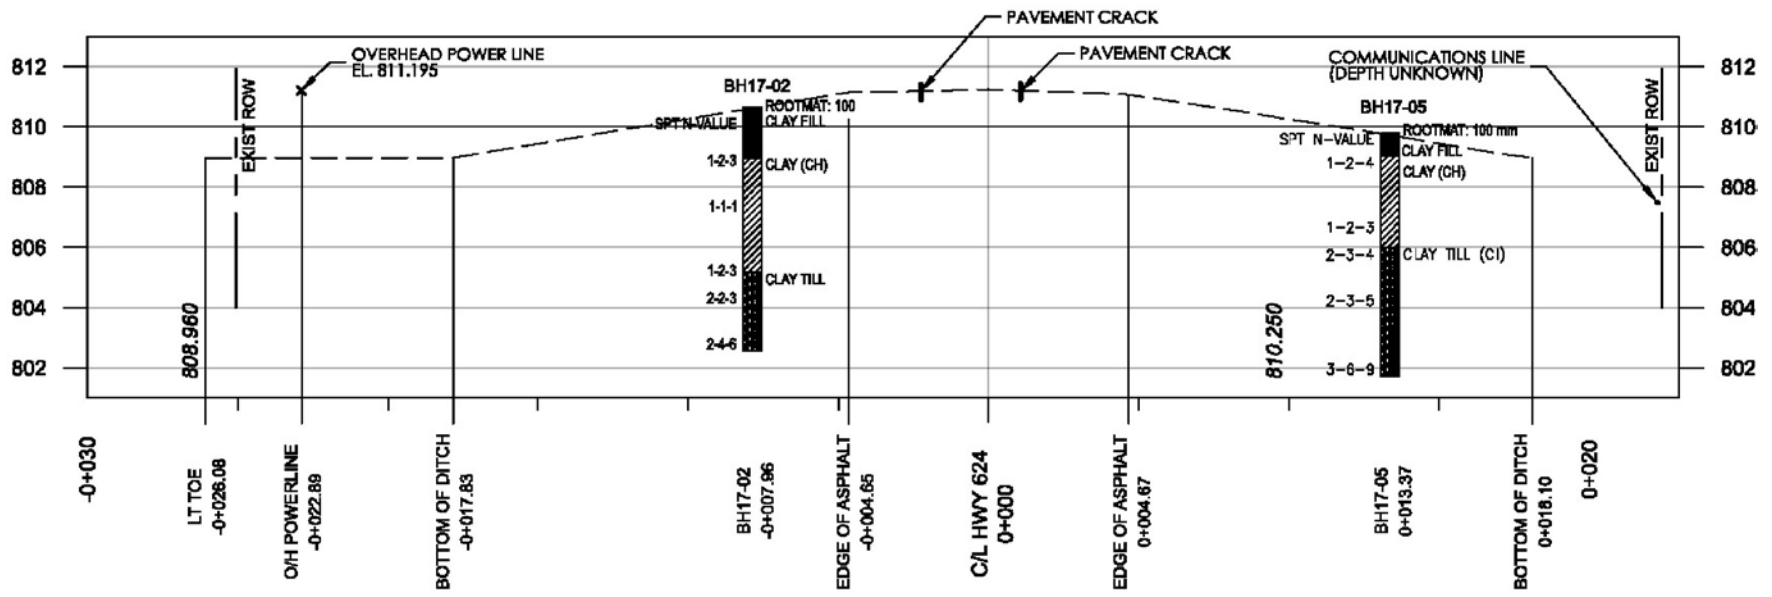
Figure No.:
2

Title:
Cross-Section A
