SITE NUMBER AND NAME: NC057 – Highway 624 Embankment Failure	HIGHWAY AND KM: 624:02, km 2.571	PREVIOUS INSPECTION: June 15, 2022	CURRENT INSPECTION: June 2, 2023
LEGAL DESCRIPTION: NE & NW 34-50-07-W5	NAD83 COORDINATES: UTM11U 5915066N, 637131E		RISK ASSESSMENT: PF: 10 CF: 6 Total: 60
AVERAGE ANNUAL DAILY TRAFFIC (AADT): 1,290 (2022)		CONTRACTOR MAINTENANCE AREA (CMA): 509

2023 Site Inspection Photos at NC057

Client/Project: Transportation and Economic Corridors
Geohazard Monitoring Program
NC57 Embankment Failure on Hwy 624

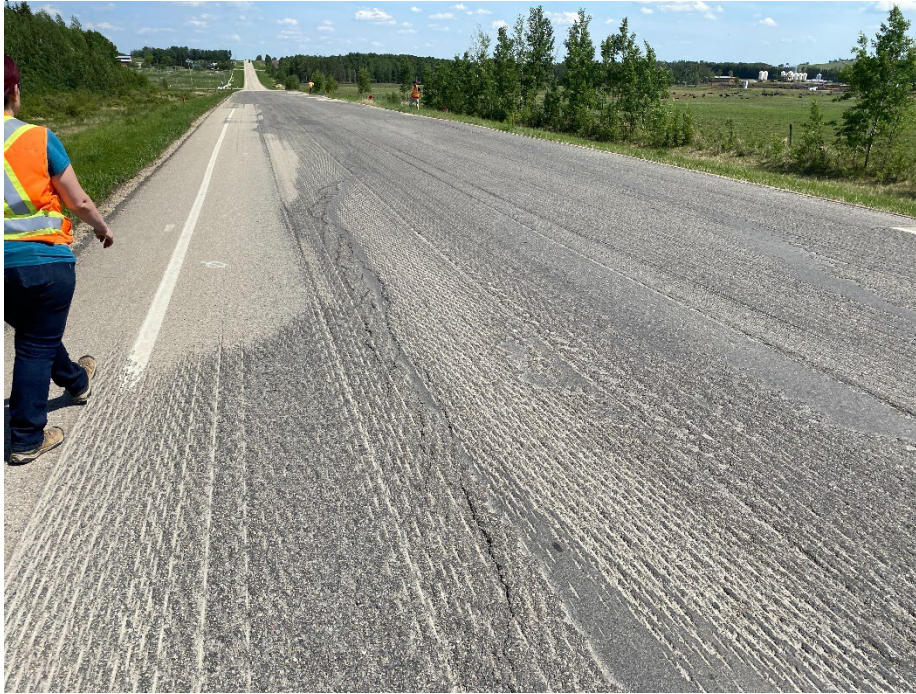
COMMENTS
In general, little change was observed since the 2022 inspection. The following summarizes Stantec's observations: <ul style="list-style-type: none"> • Pavement cracks are visible within the milled asphalt surface (Photos 1 to 4). • On the WBL, cracking has progressed to about 25 m east of BH17-02. • Vertical displacement was observed at the west extents of the pavement cracks on the WBL due to transition from milled to non-milled pavement (Photo 1). • The EBL pavement cracks near BH17-06 show about 20 to 40 mm vertical displacement after milling. A portion of pavement near BH17-06, at the location of the greatest vertical displacement south of the crack, was not milled (Photo 4) • A potential bulge was observed south of BH17-06 approximately halfway down the embankment slope.

Photo 1: West limits of WBL pavement cracks. Looking east.

- Pavement cracks should be sealed to reduce surface water infiltration into the embankment. Additional pavement patches are not recommended since it is considered an additional driving force on the embankment. Mill and fill could be completed to address the vertical displacement until remediation is completed.

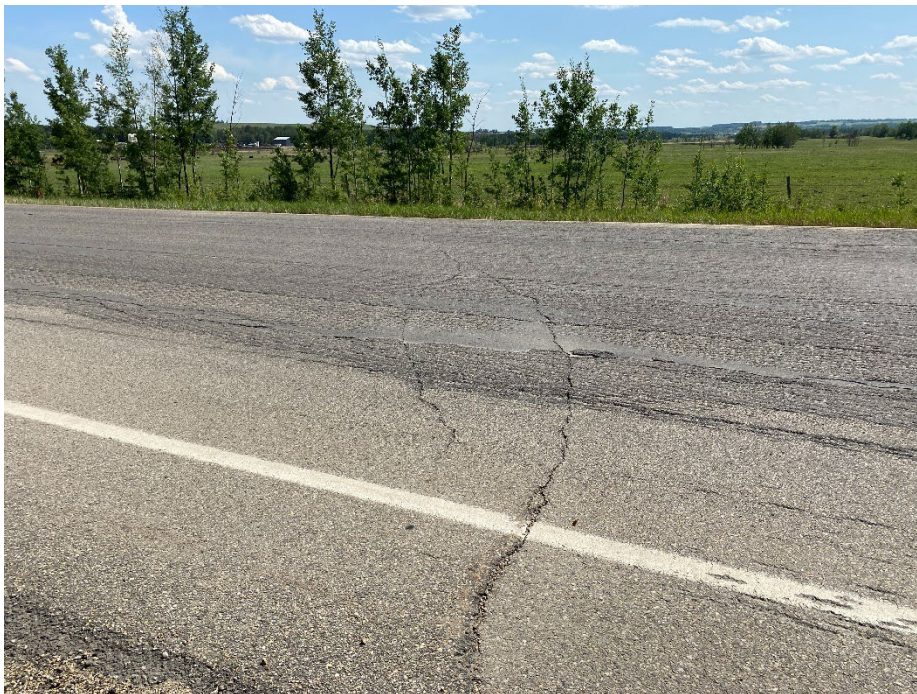
Photo 2: Diagonal pavement cracks approximately at km 2.55. Looking southeast.

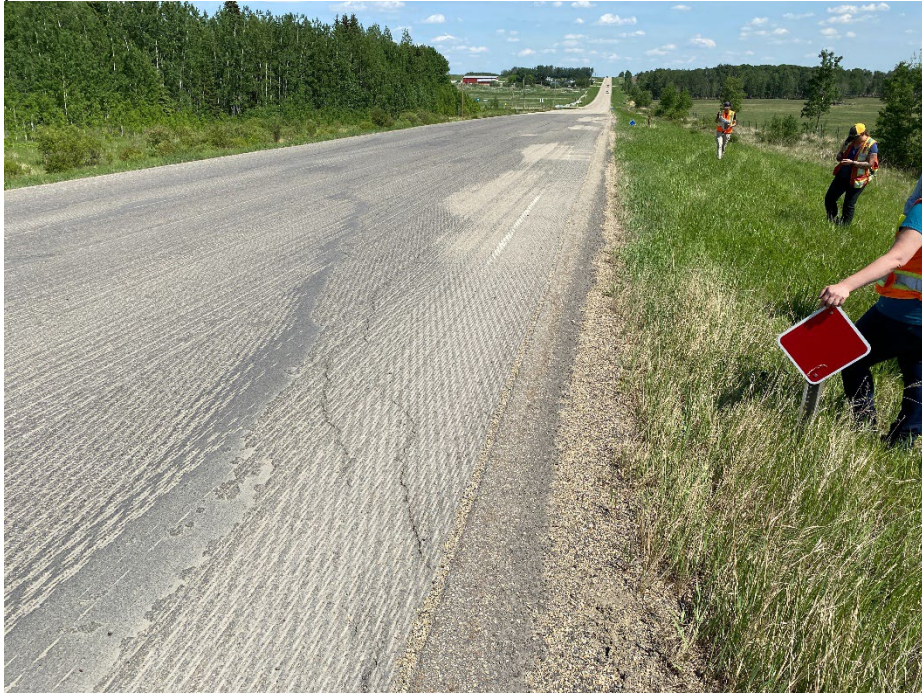
Photo 3: Pavement cracking on EBL. Looking northeast.

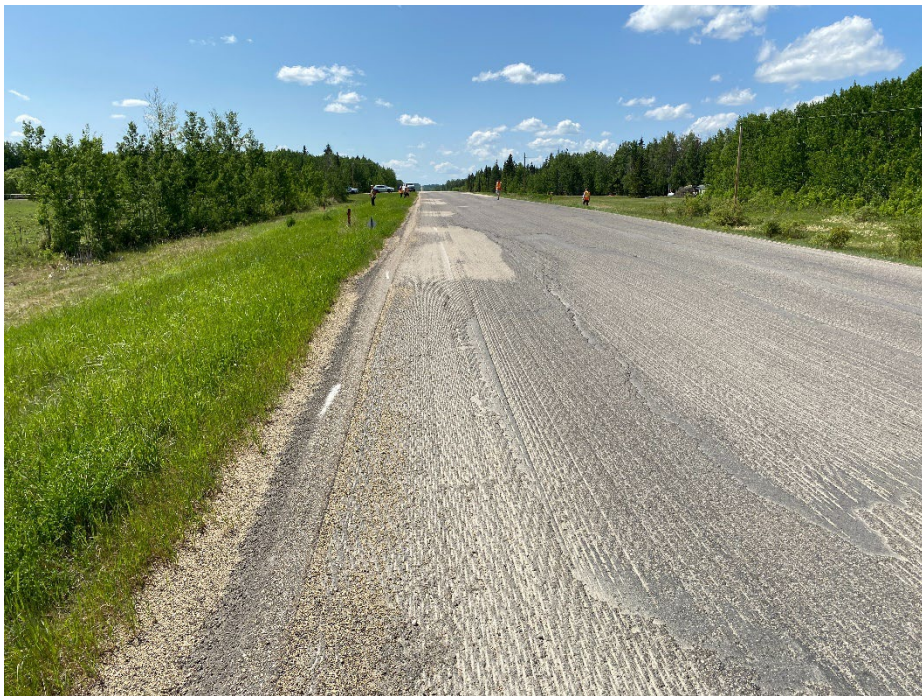
Photo 4: Pavement cracking on EBL. Looking west.

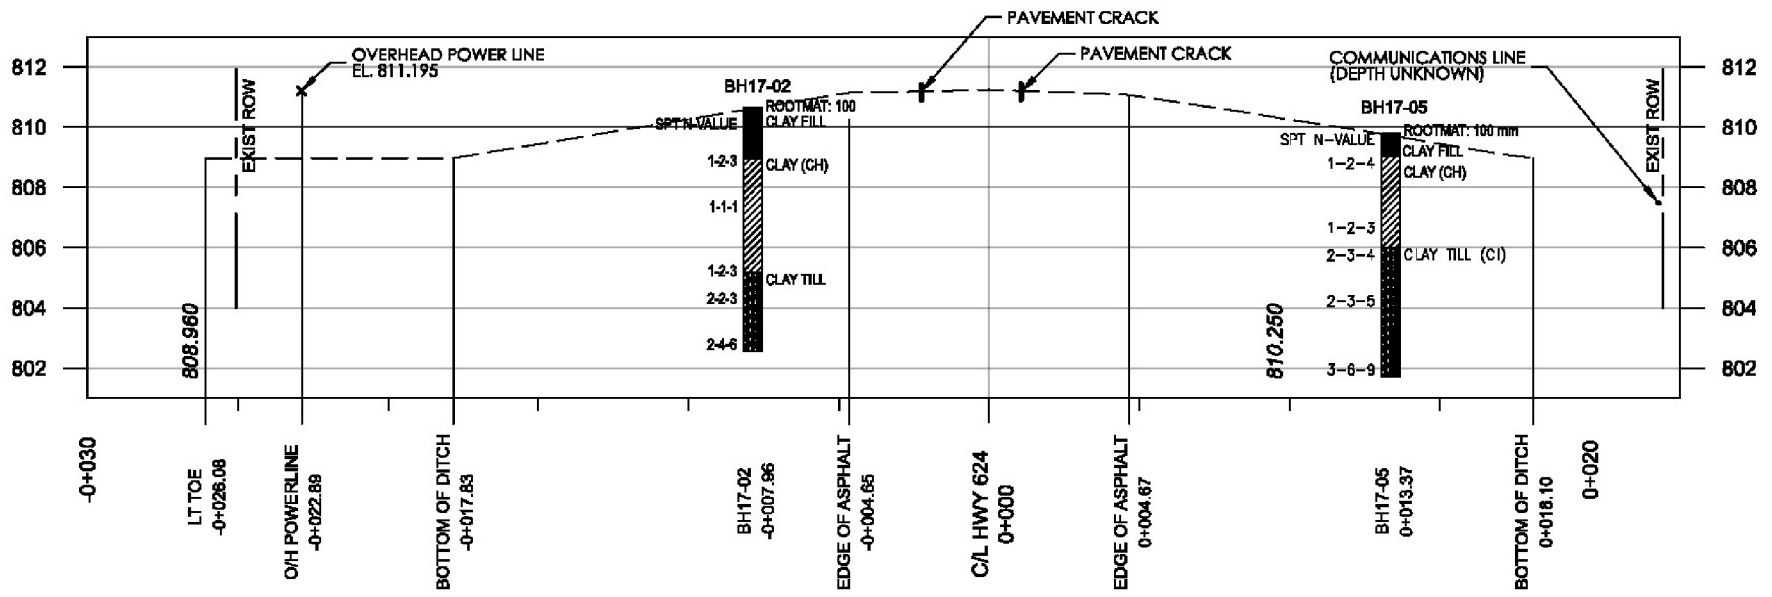
Figure No.: 2
 Title: Cross-Section A

- The piezometer levels remain high at this site with the piezometers showing artesian conditions as high as 0.3 m above ground surface. High piezometric levels are likely contributing to the embankment instability.
- Range Roads 71 and 72 could be used for detours and would require less than 20 minutes of additional travel time. However, travel over gravel roads would be required and may not be suitable for transport trucks. Transport trucks may see additional travel times in the order of 30 minutes on paved roadways.
