Reference: North Central Region, Stony Plain, Site NC057 - Highway 624:02, Fall 2024 Instrumentation Monitoring Report

Client/Project: Transportation and Economic Corridors
 Geohazard Monitoring Program
 NC57 Hwy 624 Embankment Failure

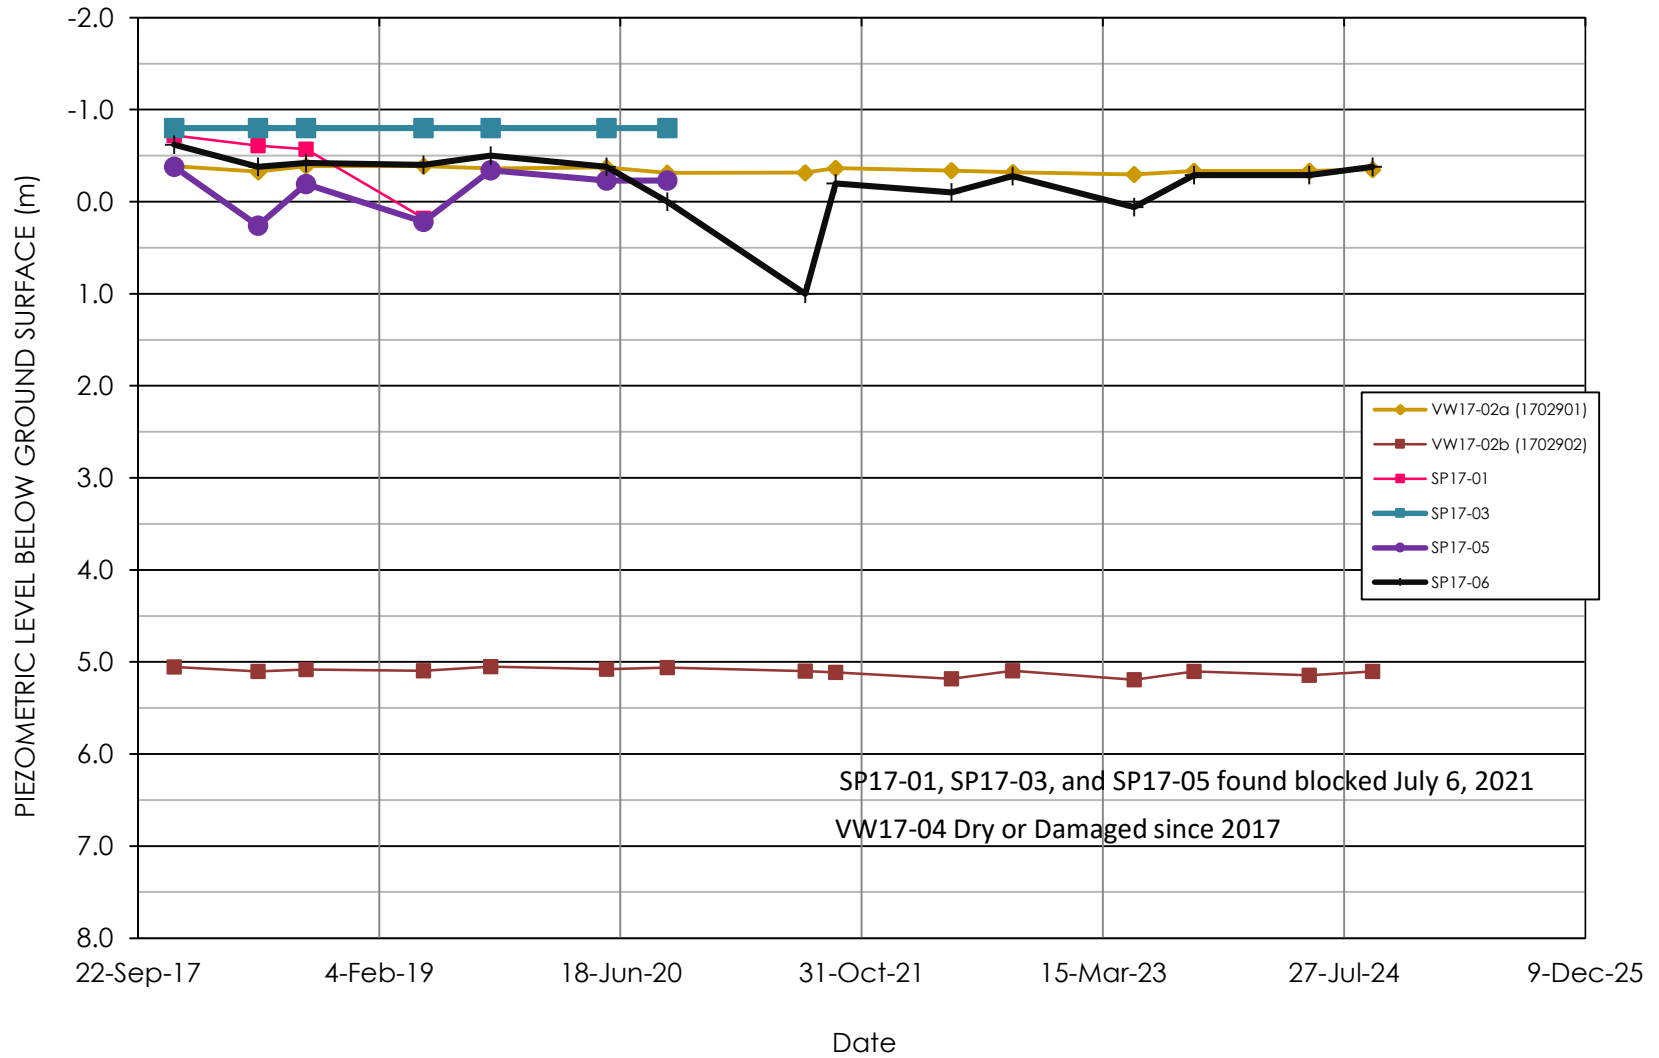
PIEZOMETER DATA

The water levels in most of the piezometers remained relatively steady since the first reading in December 2017.

Compared with the water level measured during the Spring 2024 reading cycle, the water level in both VW17-02a and VW17-02b showed an increase of less than 0.1 m during the Fall 2024 reading cycle. The water level in VW17-02a is about 0.4 m above ground surface (artesian) and the water level in VW17-02b is about 4.9 m below ground surface.

SP17-06 showed an increase in water level by approximately 0.1 m since the previous reading in Spring 2024 and indicated a piezometric level 0.4 m above ground surface.
