SITE NUMBER AND NAME: NC057 – Highway 624 Embankment Failure	HIGHWAY AND KM: 624:02, km 2.571	PREVIOUS INSPECTION: June 2, 2023	CURRENT INSPECTION: June 14, 2023
LEGAL DESCRIPTION: NE & NW 34-50-07-W5	NAD83 COORDINATES: UTM11U 5915066N, 637131E		RISK ASSESSMENT: PF: 10 CF: 6 Total: 60
AVERAGE ANNUAL DAILY TRAFFIC (AADT): 1,540 (2023)		CONTRACTOR MAINTENANCE AREA (CMA): 509

Client/Project: Transportation and Economic Corridors
 Geohazard Monitoring Program
 NC57 Hwy 624 Embankment Failure

2024 Site Inspection Photos at NC057

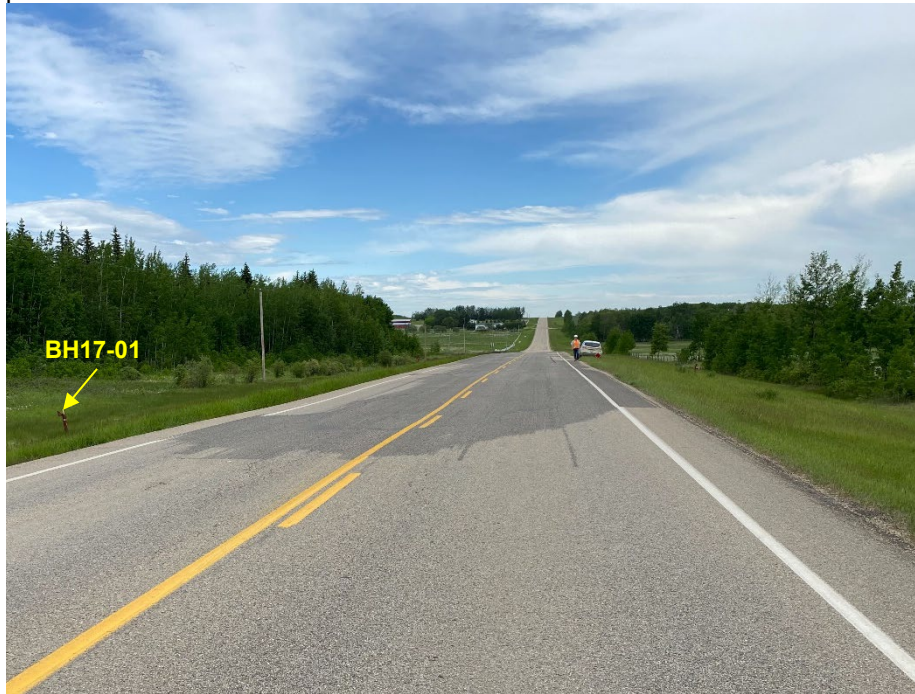
COMMENTS
In general, little change was observed since the 2023 inspection. The following summarizes Stantec's observations: <ul style="list-style-type: none"> Pavement cracks are visible within the milled asphalt surface (Photos 1 to 5). The cracks were observed to be up to 5 mm wide. Additional faint, diagonal cracks were observed during this inspection. On the WBL, cracking has progressed to about 25 m east of BH17-02, similar to the observation in 2023. Vertical displacement was observed at the west extents of the pavement cracks on the WBL due to transition from milled to non-milled pavement (Photo 1). The EBL pavement cracks near BH17-06 show about 20 to 40 mm vertical displacement after milling. A portion of pavement near BH17-06, at the location of the greatest vertical displacement south of the crack, was not milled (Photos 4 and 5).

Photo 1: West extent of milled pavement. Looking east.

- Pavement cracks should be sealed to reduce surface water infiltration into the embankment. Additional pavement patches are not recommended since it is considered an additional driving force on the embankment. Mill and fill could be completed to address the vertical displacement until remediation is completed.
- Detailed design of this site is complete. The remediation option will include removal of the existing embankment and reconstructing it using tire derived aggregate to improve embankment drainage.
- Site inspections should continue annually.
- Instrumentation should continue to be read semi-annually.
- If remediation is delayed by more than two years, slope inclinometers should be considered to monitor the depth and rate of slope movement. This information will be useful for characterizing the failure and optimizing the design.

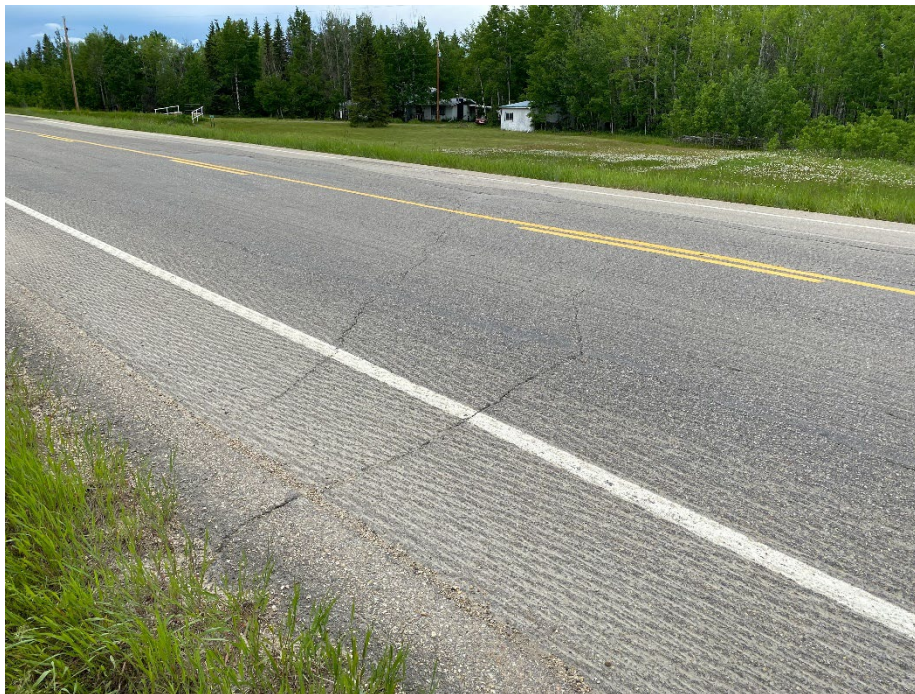
Photo 2: Diagonal cracking across milled pavement, looking northwest.

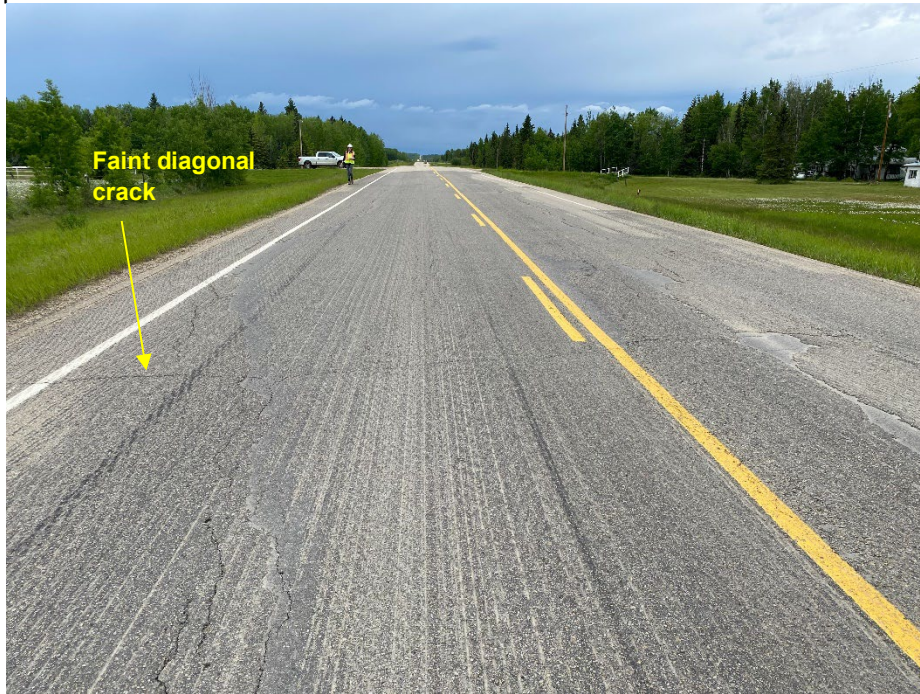
Photo 3: Middle section of milled pavement, looking west.

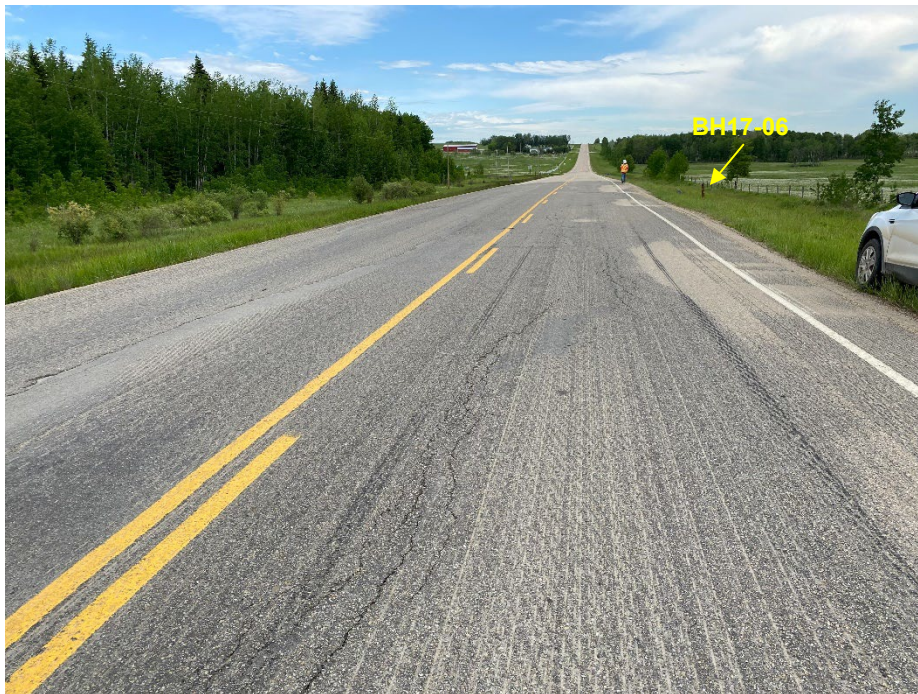
Photo 4: Pavement cracking on EBL. Looking east.

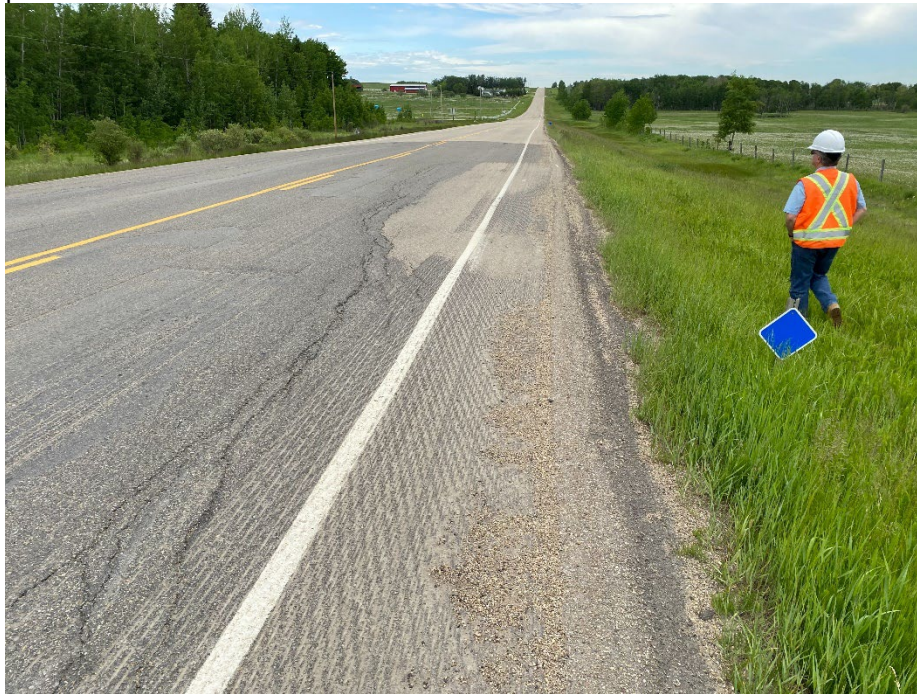
Photo 5: Pavement cracking on EBL. Looking east.

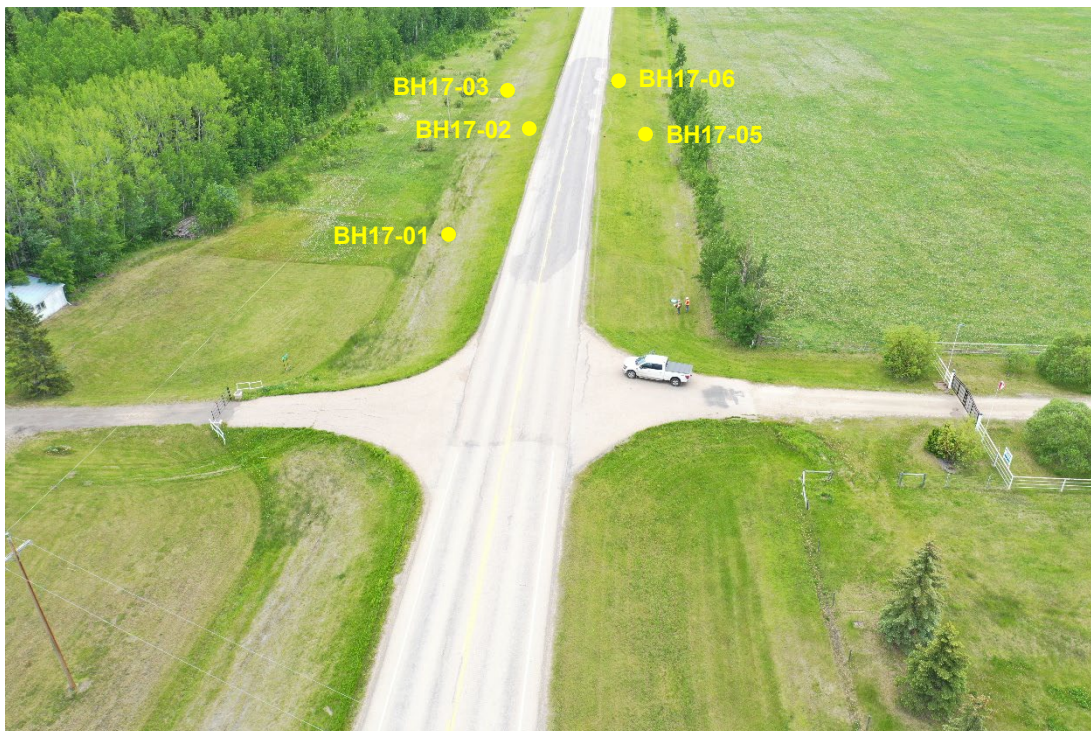
Photo 6: Site overview, photo taken by drone. Looking east.

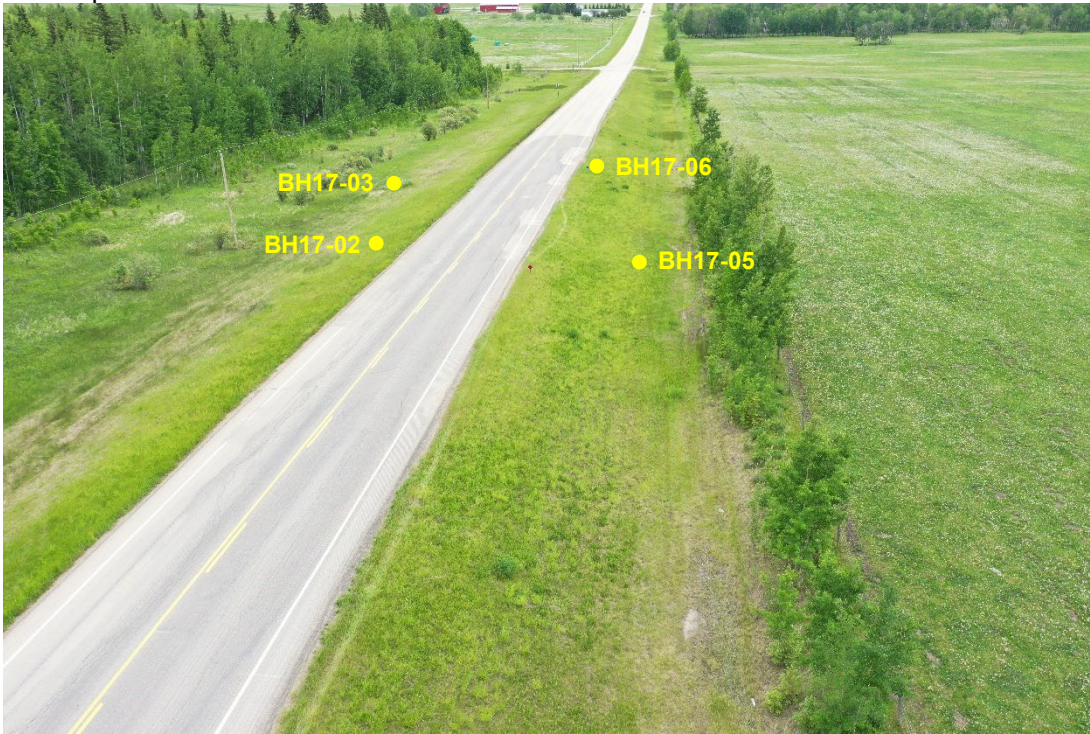
Photo 7: Site overview, taken by drone. Looking northeast.
