To:	Amy Driessen	From:	Leslie Cho and Xiteng Liu
	Transportation and Economic Corridors		Stantec Consulting Ltd.
File:	123315222	Date:	June 18, 2024

**Reference: North Central Region, Stony Plain, Site NC057 - Highway 624:02, Spring 2024
Instrumentation Monitoring Report**

Client/Project: Transportation and Economic Corridors
 Geohazard Monitoring Program
 NC57 Embankment Failure on Hwy 624

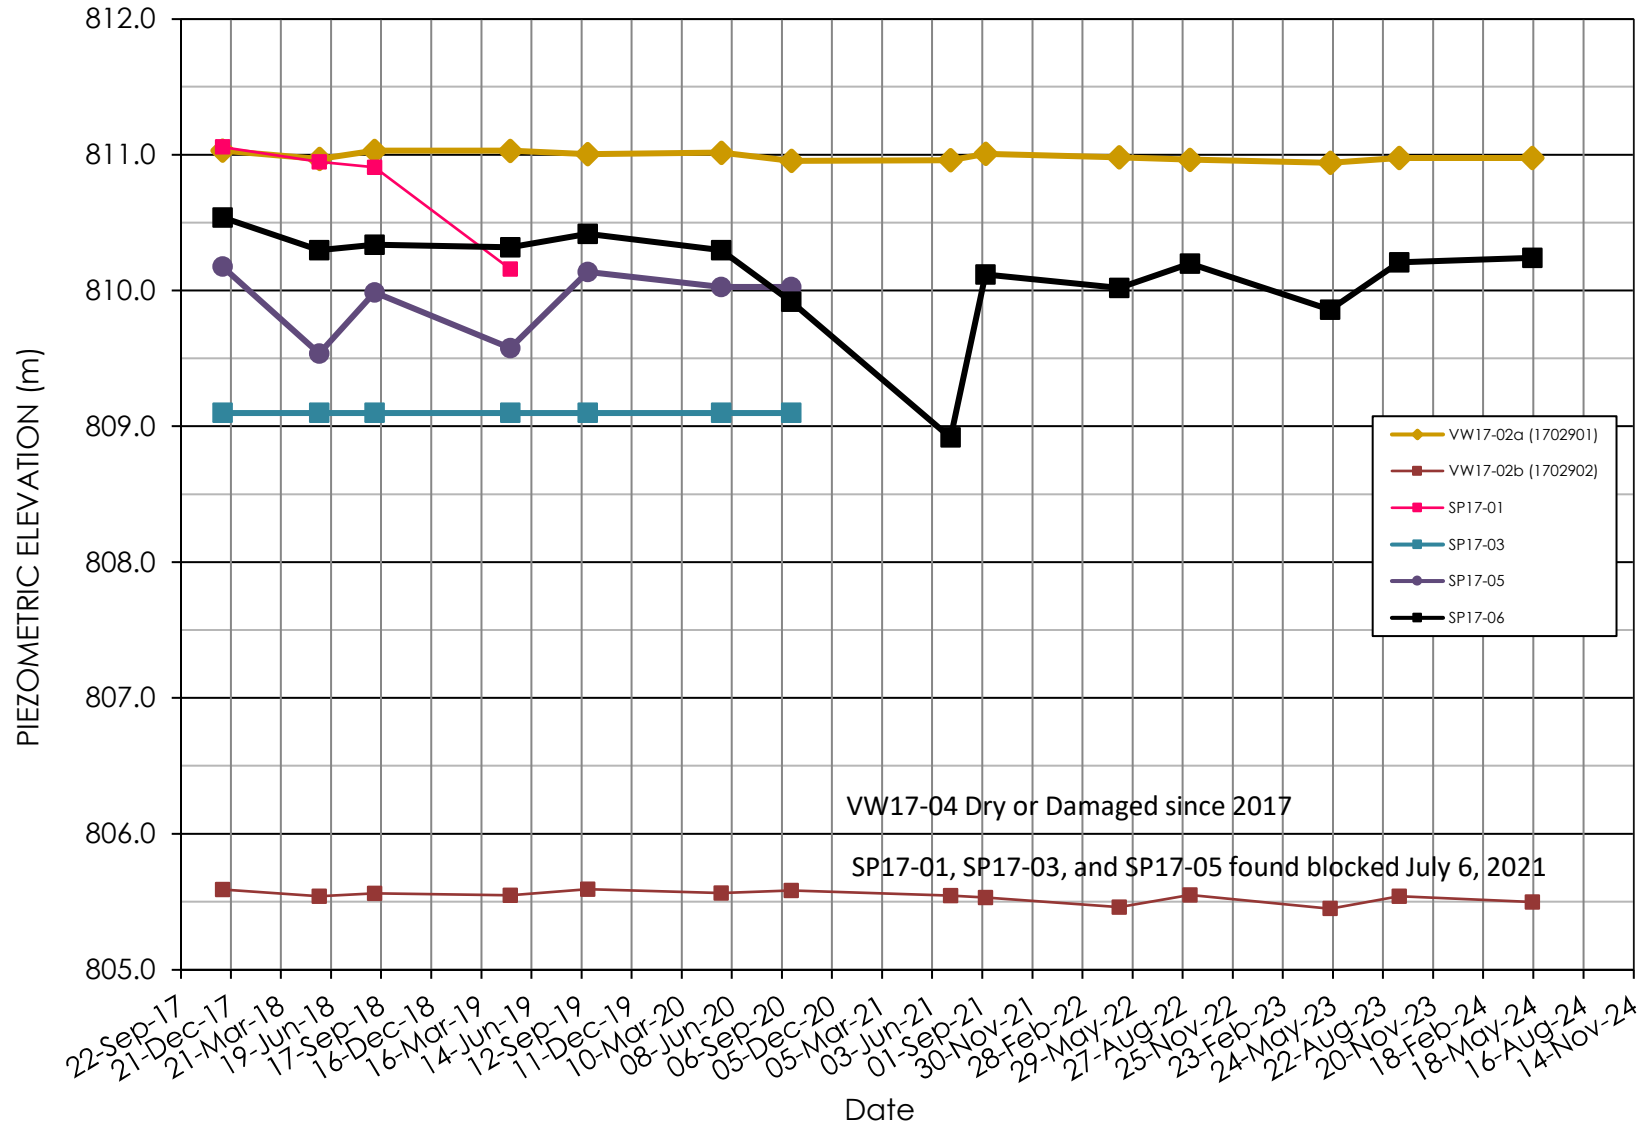
PIEZOMETER DATA

The water levels in most of the piezometers remained relatively steady since the first reading in December 2017.

Compared with the water level measured during the Fall 2023 reading cycle, the water level in VW17-02a showed no change while that in VW17-02b dropped by less than 0.1 m during the Spring 2024 reading cycle. The water level in VW17-02a is about 0.3 m above ground surface (artesian) and the water level in VW17-02b is about 5.2 m below ground surface.

SP17-06 showed an increase in water level by less than 0.1 m since the previous reading in Fall 2023 and indicated a piezometric level 0.3 m above ground surface.
