GEOHAZARD RISK MANAGEMENT PROGRAM

North Central Region – Edson / Stony Plain Area

2018 Inspection Report

Site Number	Site Name		Hwy	km
NC33	South of Tomahawk		759:02	15.17
Legal Land Description	SE 26-50-6-W5M			
NAD 83 Coordinates	3TM 114	N5912013	E -50618	
Operational Site Instrumentation	Slope Inclinometers		1	
	Pneumatic Piezometers		2	
	Vibrating Wire Piezometers		0	
	Standpipe Piezometers		0	
Date of Last Instrumentation Readings	May 7, 2018

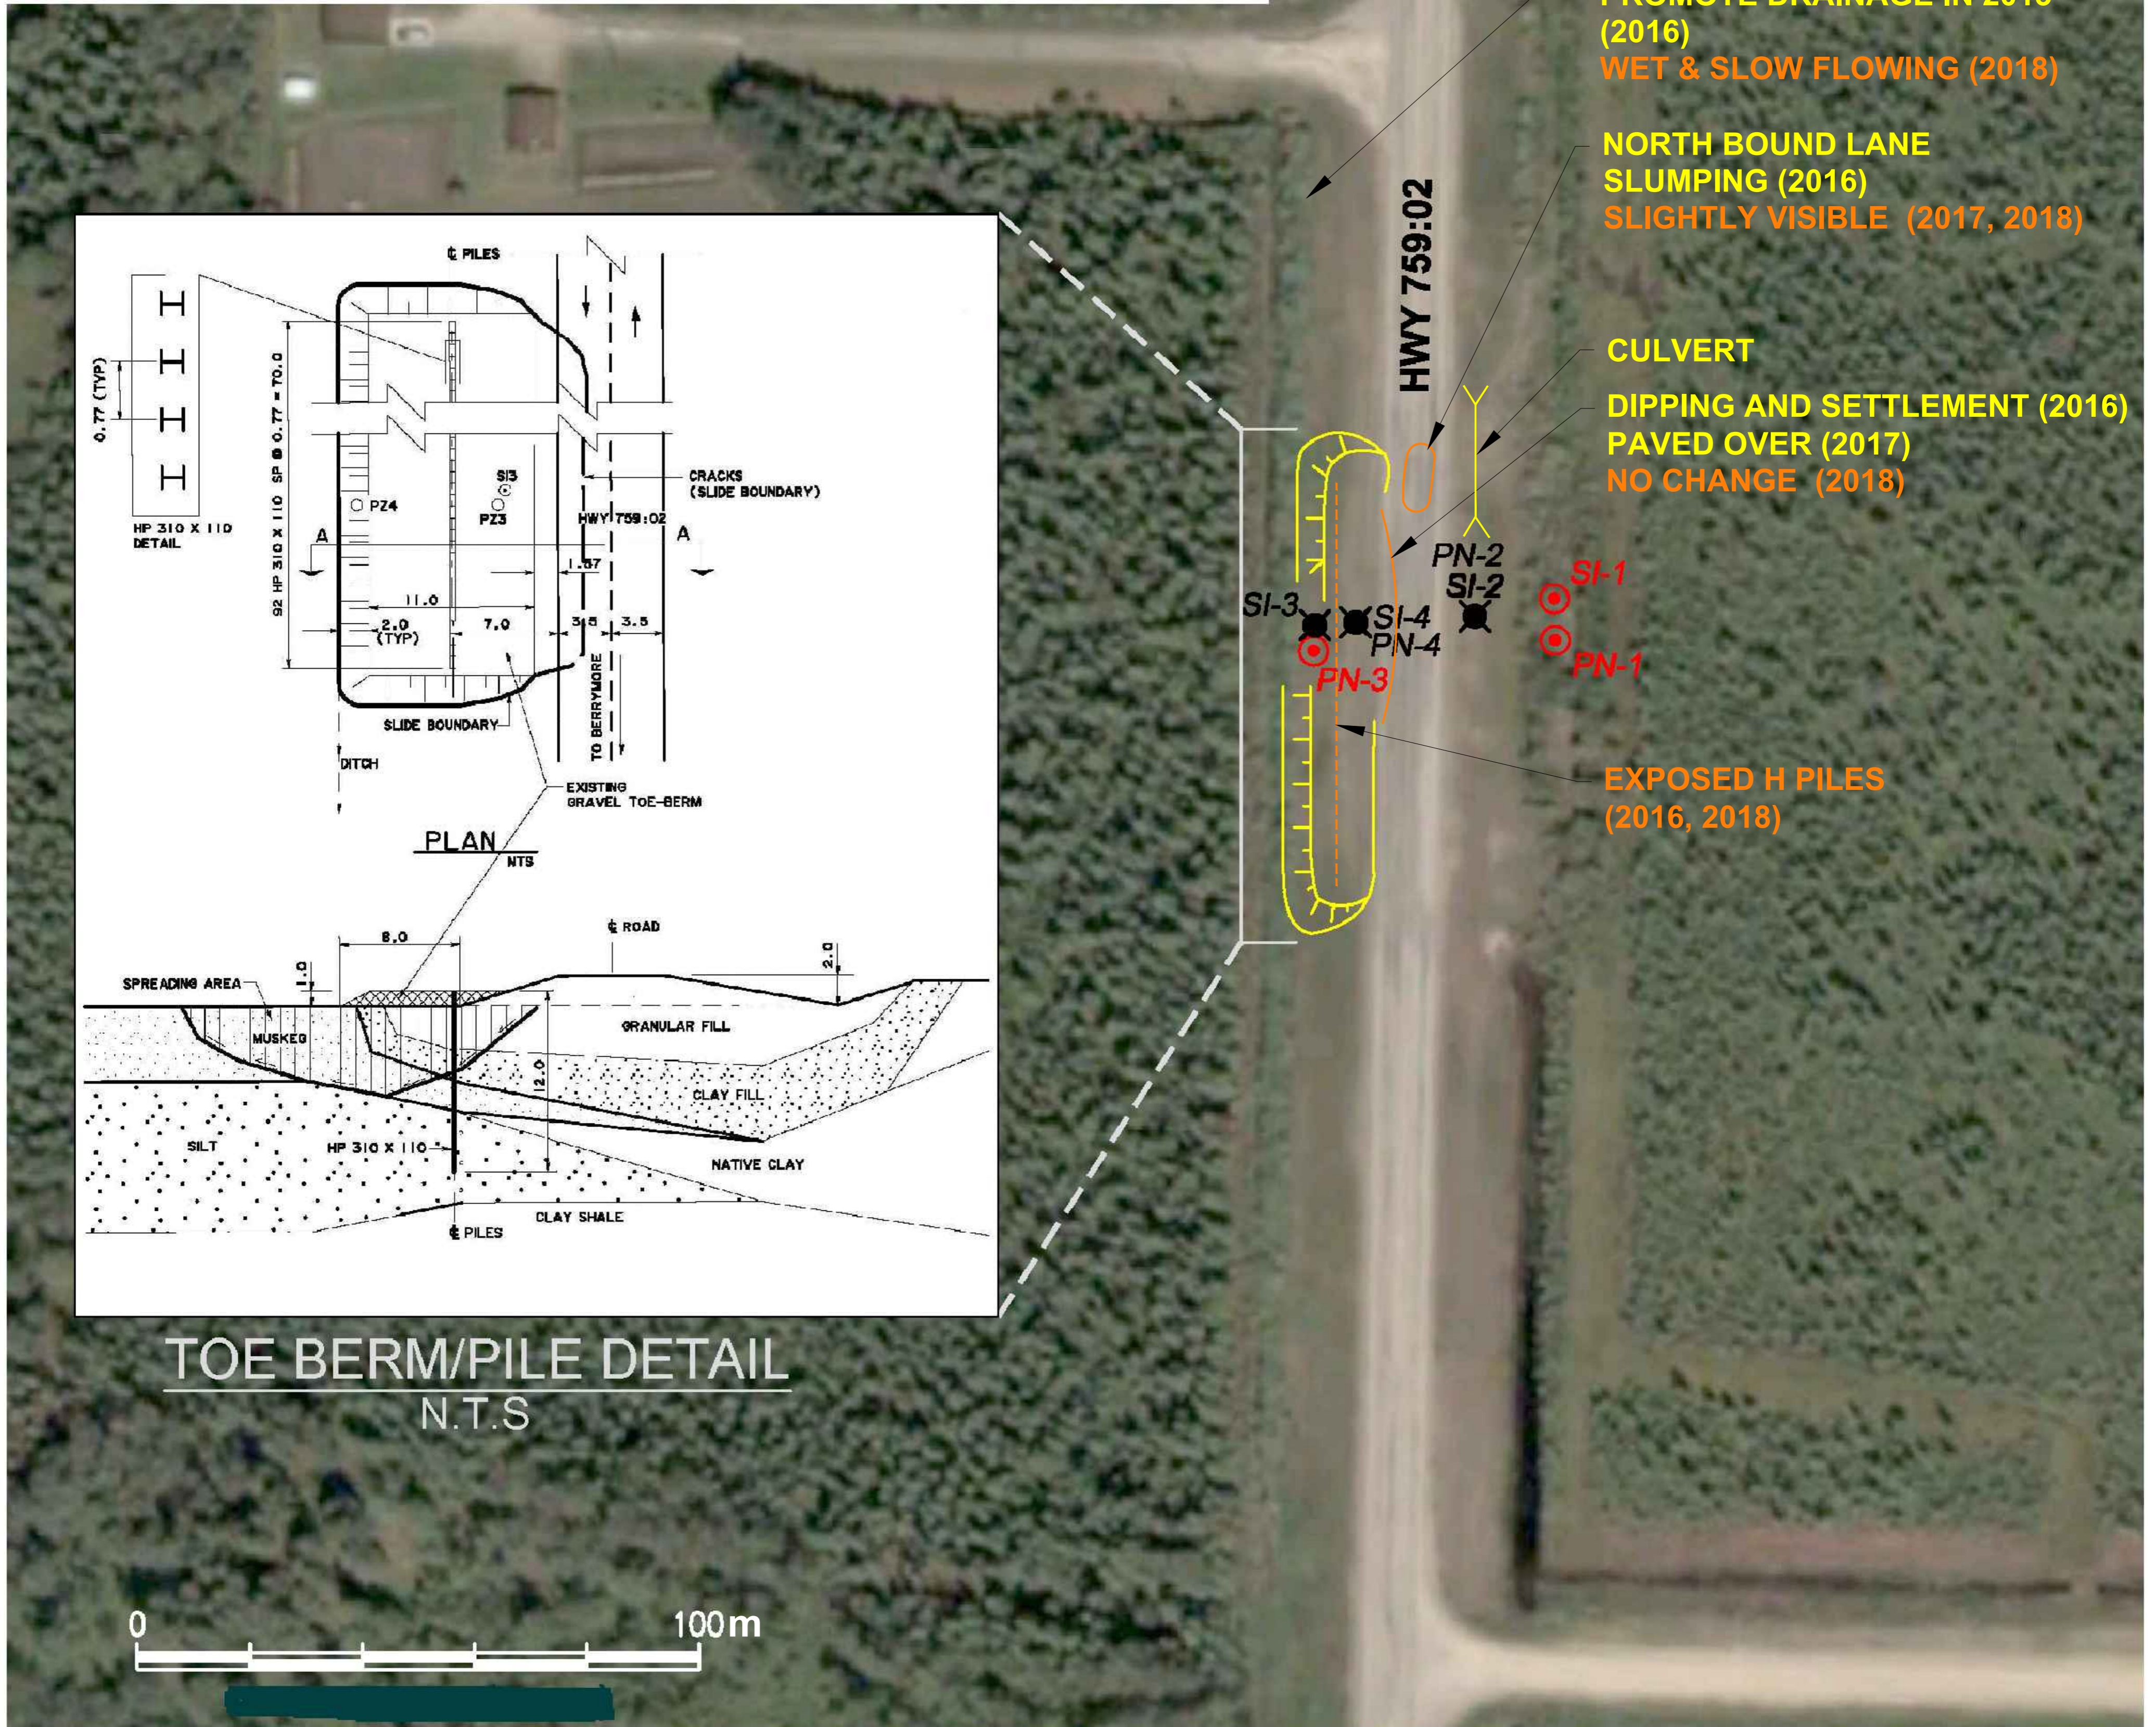
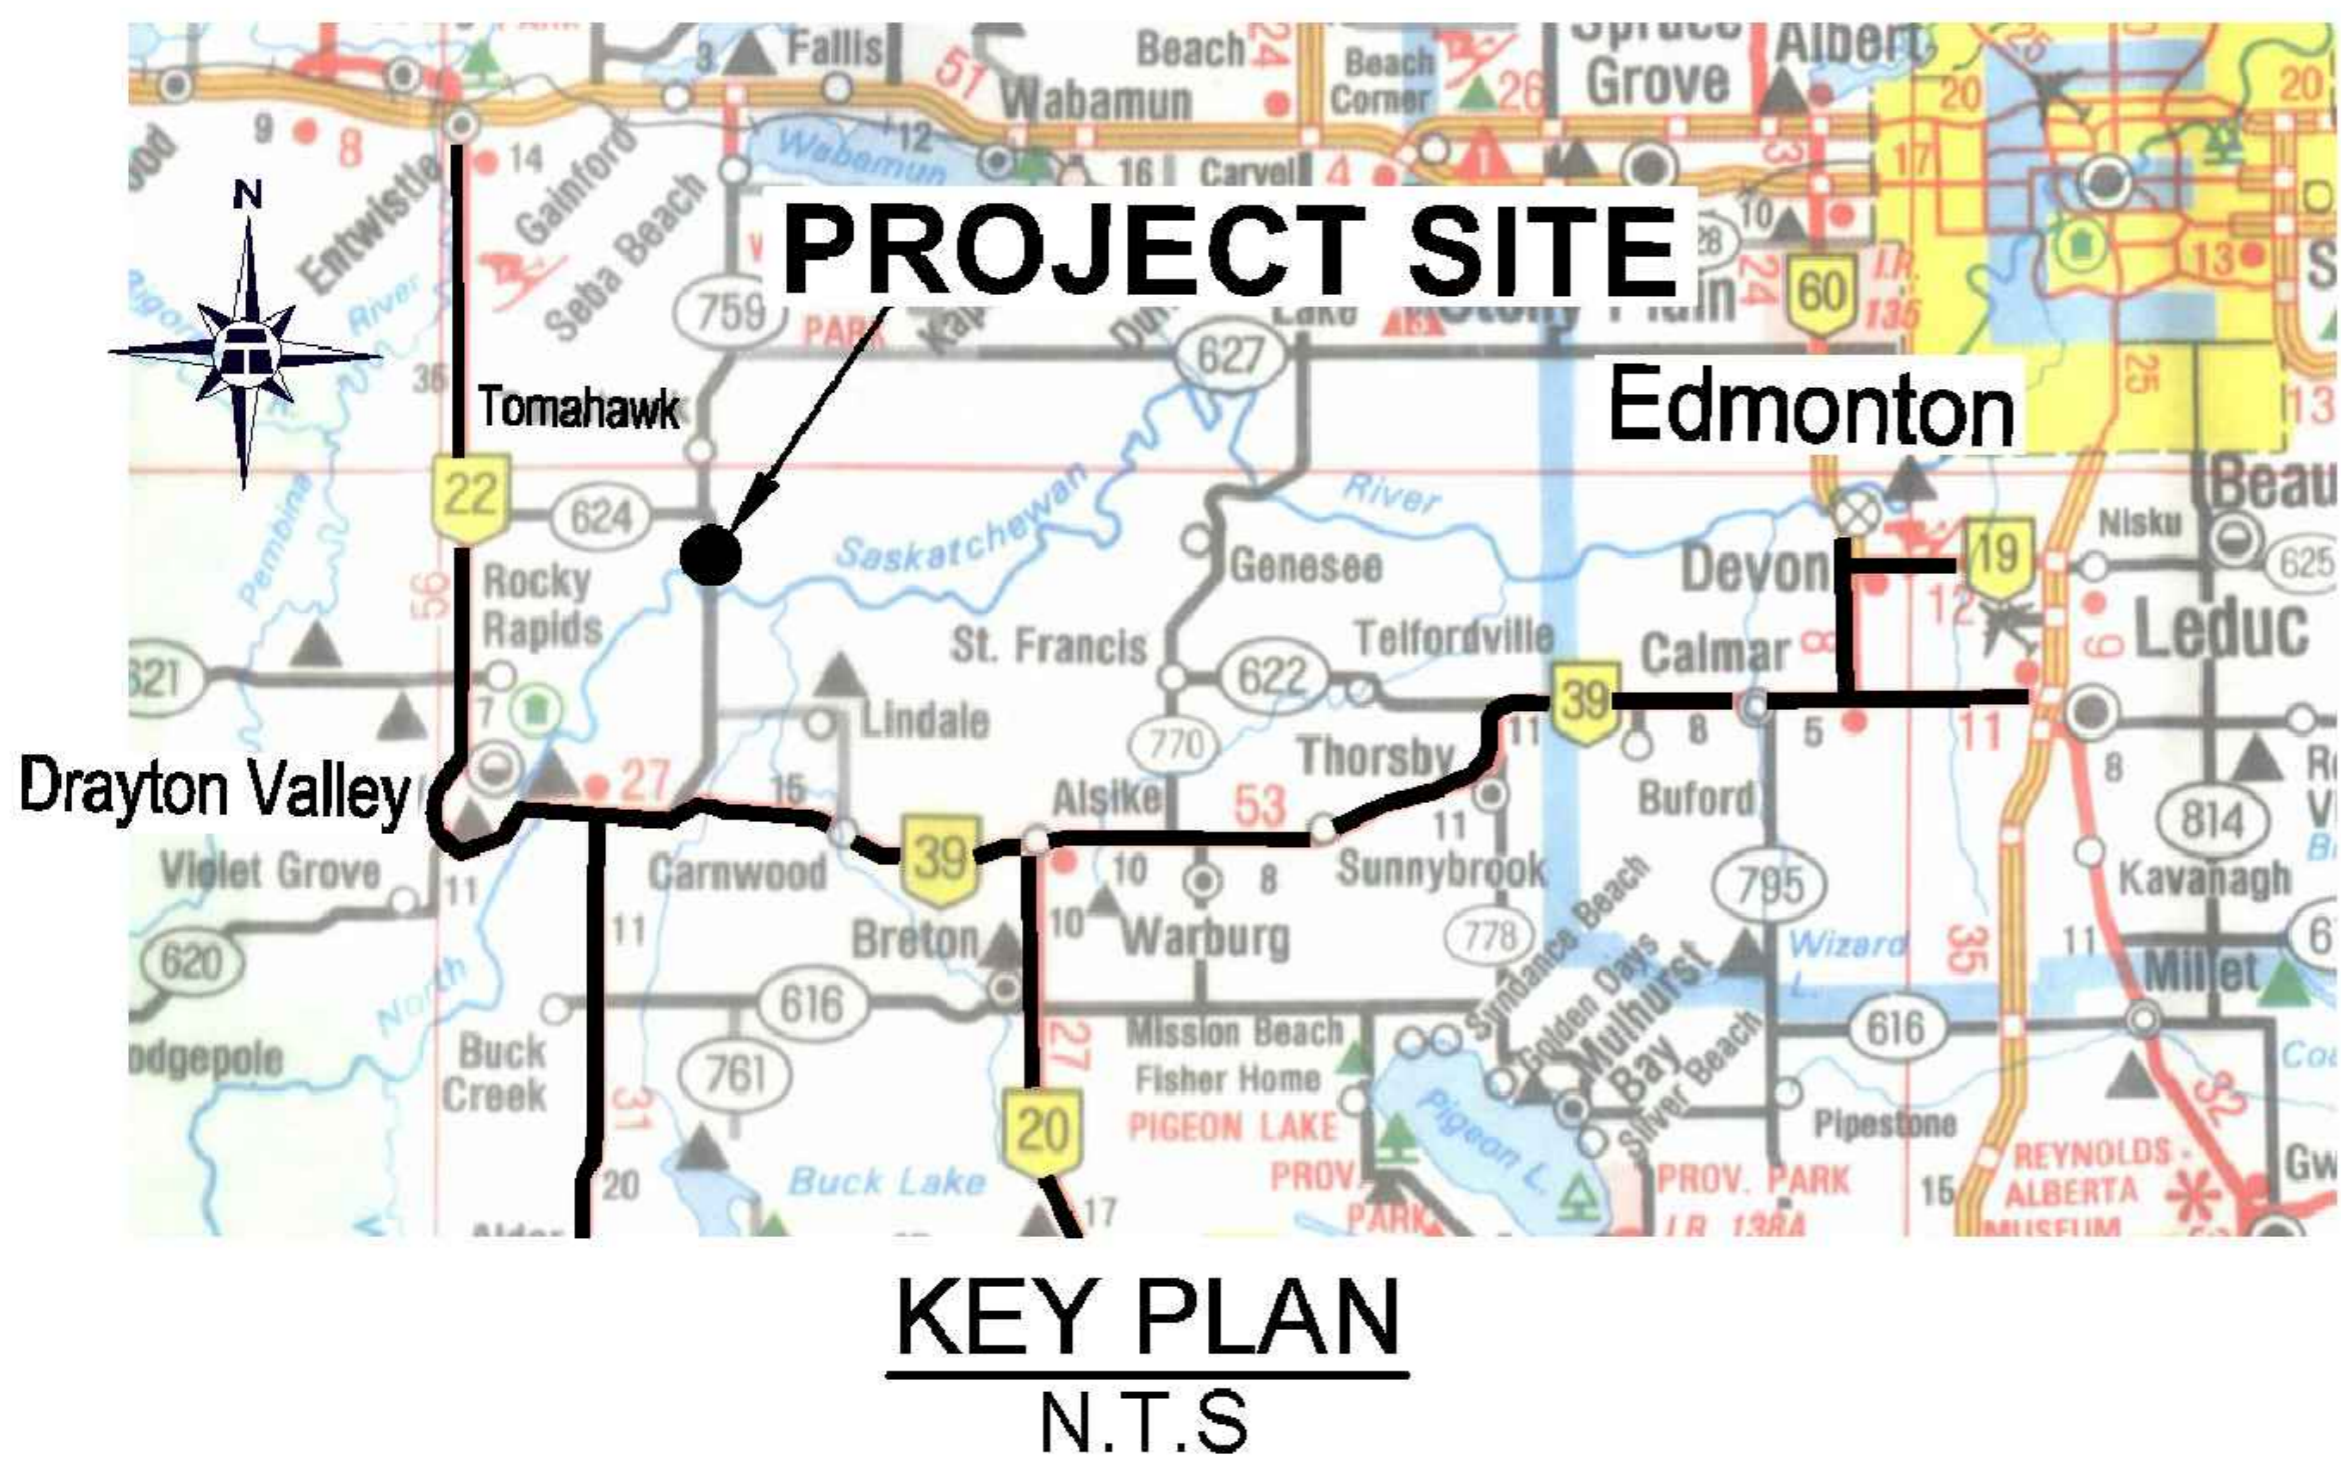
FIGURE -1

ALBERTA TRANSPORTATION
GEOHAZARD MONITORING PROGRAM
NC33 SOUTH OF TOMAHAWK
HWY 759:02 - SITE PLAN

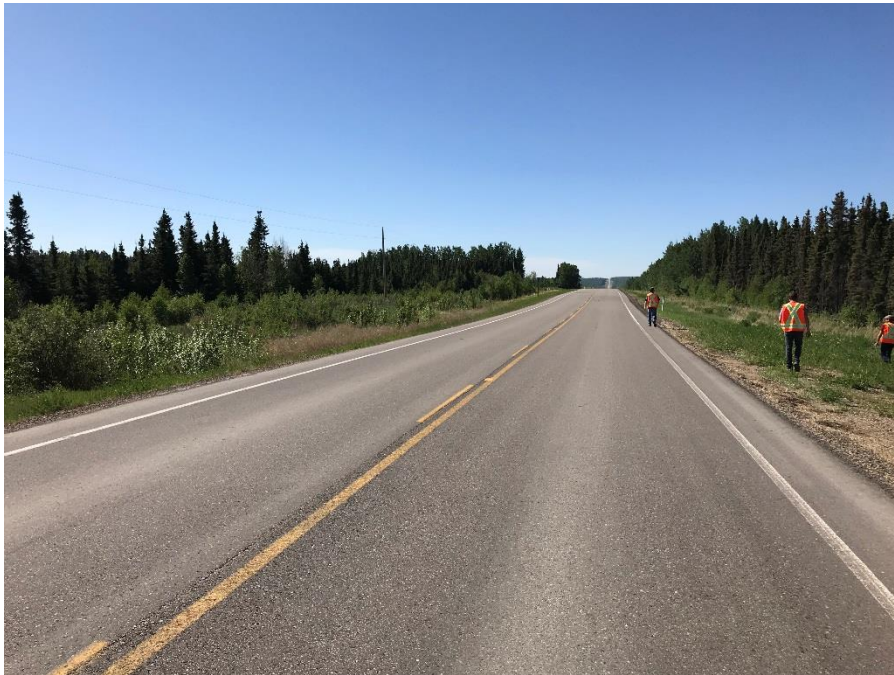
Discussion	<p>The pavement was milled and paved in the summer of 2016. Cracking in the pavement was not observed as shown in Photos 1 and 2. A dip in the northbound lane across from the approach was observed as shown in Photo 2.</p> <p>Similar to previous inspections, the excavated west ditch contained slowly flowing water as shown in Photo 3.</p> <p>The top of most of the piles were visible along its alignment. As much as 200 mm of the pile was exposed as shown in Photo 4. Voids were also observed between the flanges of some piles.</p> <p>No signs of visual distress were observed on the west or east sides of the highway as shown in Photos 5 and 6.</p>
-------------------	---

Photo 1: Highway recently paved with no observable cracks. Looking south.

Recommendations	<p>Pavement sealing will not be required at this time. It should be noted that the overlay is considered an additional load and will likely lead to more settlement and lateral deformation.</p> <p>Re-grading of the west ditch may be considered to promote surface water drainage.</p> <p>Any voids between the H-pile flanges should be filled to reduce water infiltration. A survey of the H-piles should also be completed to measure the lateral deflection of the pile wall.</p> <p>Slope inclinometers may be installed near the pile wall to monitor its performance.</p> <p>Instrumentation monitoring should continue to be completed semi-annually. During the site inspection, AT and Stantec discussed reducing the frequency of site inspections at NC33 to every two years (i.e. next visit in 2020).</p>

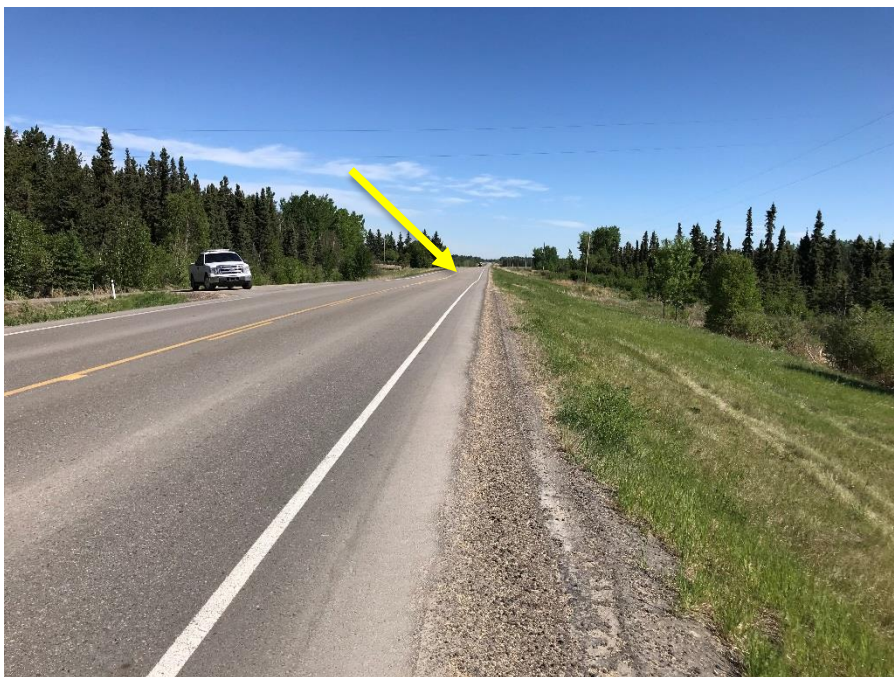
Photo 2: Pavement dip across from approach. Looking north.

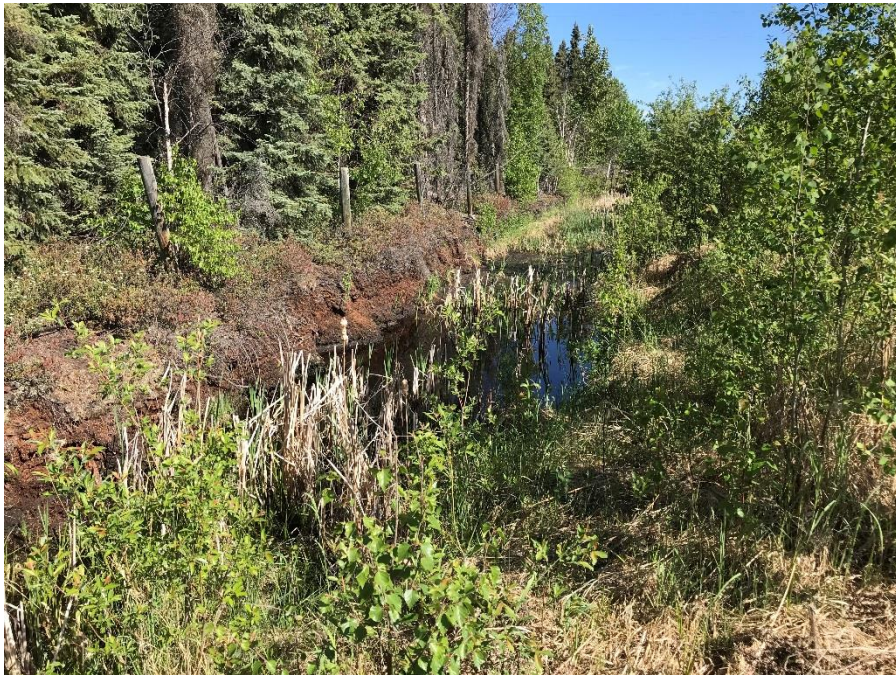
Assessment	<p>The piezometer measurements continued to remain stable with a slight decrease in pore pressure in both piezometers (up to 0.3 m decrease). Both measured pore pressures in PN1 and PN3 remain within historic trends. Site drainage appears to be poor as suggested by the standing water in the west ditch since the site's inception into the monitoring program, however drainage is being promoted since the peat in the ditch was excavated in 2013.</p> <p>SI2 recorded approximately 2 mm of movement since 2007 suggesting that the east embankment slope is relatively stable. There are no remaining operational slope inclinometers on the west slope. Previous slope movements appear to be limited to the southbound lane. This may be due to less muskeg and thicker layers of granular fill underlying the northbound lane.</p> <p>After construction of the pile wall in 2013, pavement cracking along the southbound lane centerline continued to be observed indicating that the slope was still moving. The highway was milled and paved in 2016 with no pavement cracks observed since which suggests that the slope may have stabilized. The movements observed after construction of the pile wall may be due to the piles deflecting to mobilize the resistance against slope movements. Furthermore, AT mentioned that increased heavy traffic volume was observed at the site between 2013 and 2015 which caused additional pavement damage.</p>

Photo 3: Standing water in the excavated west ditch flowing slowly. Looking north.

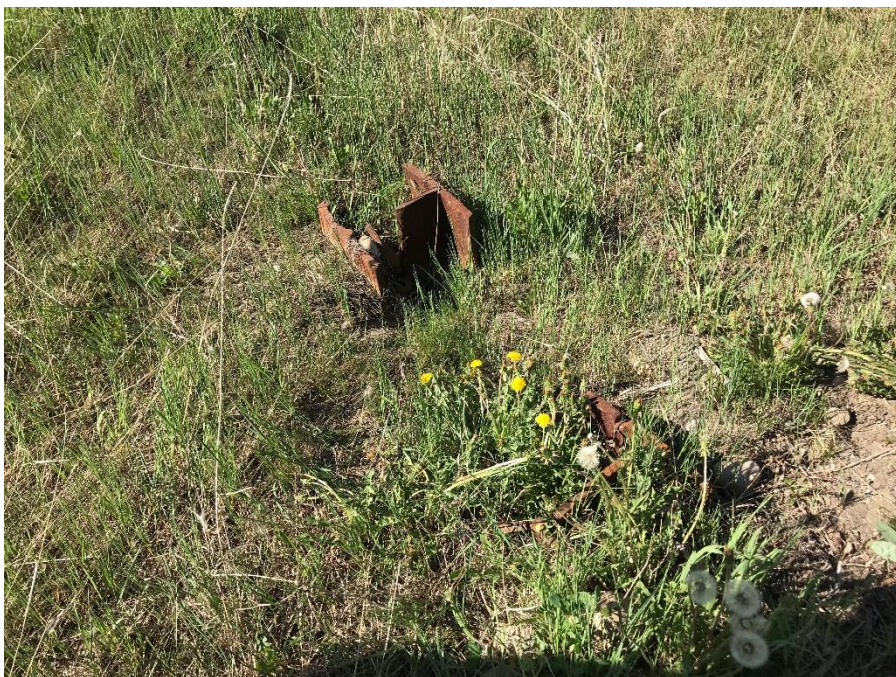
Photo 4: Exposed H-piles at the surface of the toe berm.

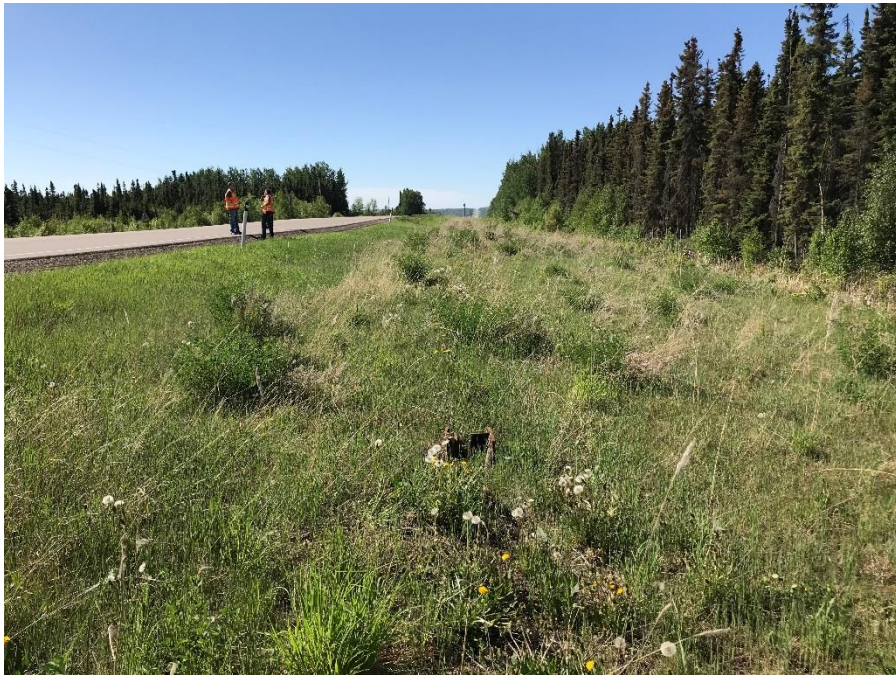
Photo 5: View of the west slope. Looking south.

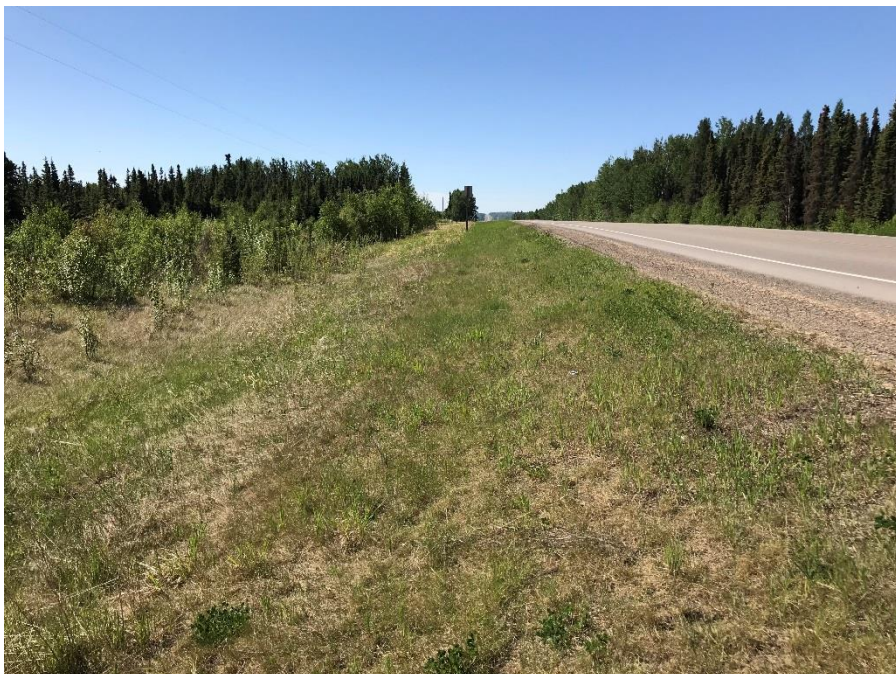
Photo 6: View of the east slope. Looking south.
