GEOHAZARD RISK MANAGEMENT PROGRAM

North Central Region – Edson / Stony Plain Area

2019 Inspection Report

Site Number	Site Name		Hwy	km
NC33	South of Tomahawk		759:02	15.17
Legal Land Description	SE 26-50-6-W5M			
NAD 83 Coordinates	3TM 114	5912013 N	-50618 E	
Operational Site Instrumentation	Slope Inclinometers		1	
	Pneumatic Piezometers		2	
	Vibrating Wire Piezometers		0	
	Standpipe Piezometers		0	
Date of Last Instrumentation Readings	May 6, 2019

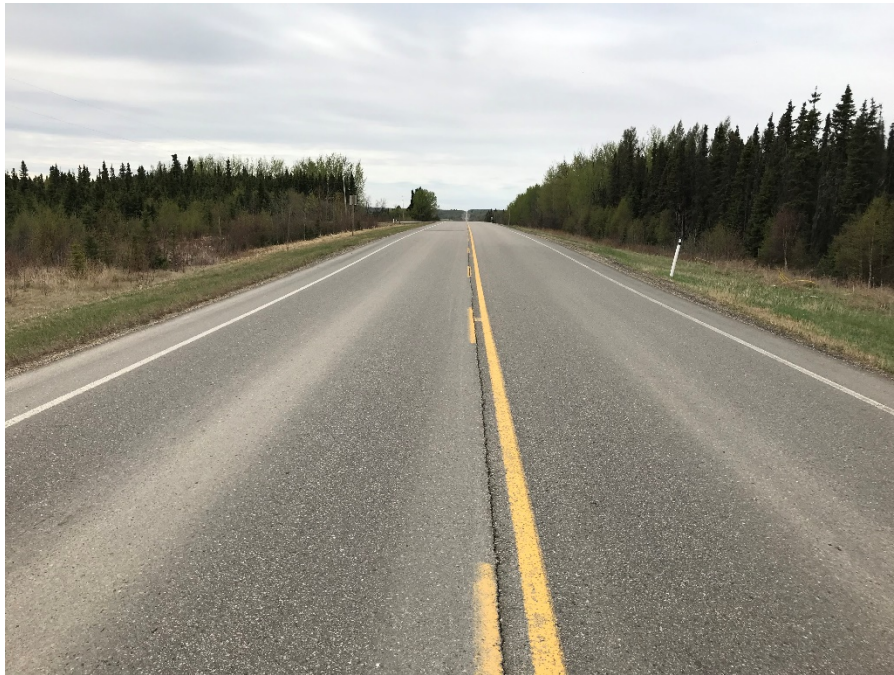
Discussion	<p>The pavement was milled and paved in the summer of 2016. New cracks in the pavement were not observed. However, the separation of the pavement joints between the northbound lane (NBL) and southbound lane (SBL) appeared wider as shown in Photos 1 and 2.</p> <p>Like previous inspections, the excavated west ditch contained slowly flowing water as shown in Photo 3.</p> <p>The top of most of the piles were visible along its alignment. As much as 200 mm stickup as shown in Photo 4. Voids were also observed between the flanges of some piles, likely due to soil plug during pile driving.</p> <p>No signs of visual distress were observed on the west or east sides of the highway as shown in Photos 5 and 6.</p>
-------------------	--

Assessment	<p>Piezometers PN-1 and PN3 showed an increase in pore pressures of 1.0 m and 1.9 m respectively. In PN-1, pore pressures are the highest it has been since 2009. Site drainage appears to be poor as suggested by the standing water in the west ditch since the site's inception into the monitoring program, however drainage is being promoted since the peat in the ditch was excavated in 2013.</p> <p>There are no remaining operational slope inclinometers on the west slope. Prior to being non-operational in Fall 2015, SI2 recorded approximately 2 mm of movement since 2007 suggesting that the east embankment slope is relatively stable. Previous slope movements appear to be limited to the SBL which may be due to less muskeg and thicker layers of granular fill underlying the NBL.</p> <p>After construction of the pile wall in 2013, pavement cracking along the SBL centerline continued to be observed indicating that the slope was still moving. The highway was milled and paved in 2016 with no pavement cracks observed in the southbound lane since which suggests that the slope may have stabilized. The movements observed after construction of the pile wall may be due to the piles deflecting to mobilize the resistance against slope movements. Furthermore, AT mentioned that increased heavy traffic volume was observed at the site between 2013 and 2015 which caused additional pavement damage. During the current inspection, the NBL and SBL joint appears to be larger and suggests deflection of the pile wall may still be on-going.</p>

Photo 1: Highway recently paved with no observable cracks. Looking south.

Recommendations	<p>Consideration should be given to seal the joints along the median to limit surface water infiltration and frost action.</p> <p>Re-grading and/or removal of vegetation in the west ditch may be considered to promote surface water drainage.</p> <p>Any voids between the H-pile flanges should be filled to reduce water infiltration. A survey of the H-piles should also be completed to measure the lateral deflection of the pile wall.</p> <p>Slope inclinometers may be installed near the pile wall to monitor its performance.</p> <p>Instrumentation monitoring should continue to be completed semi-annually. During the site inspection, AT and Stantec discussed reducing the frequency of site inspections at NC33 to every two years (i.e. next visit in 2020).</p>

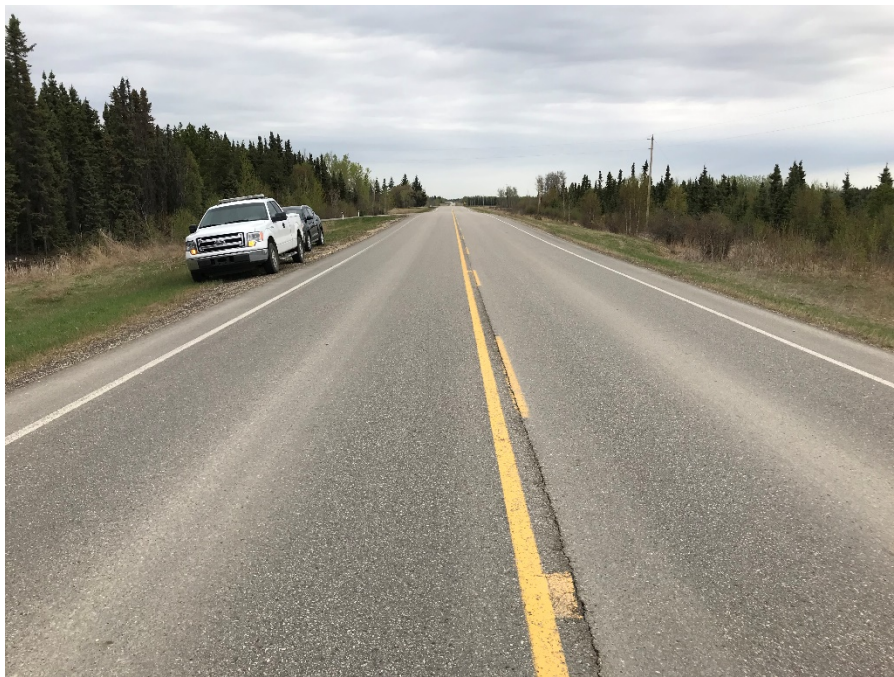
Photo 2: Highway recently paved with no observable cracks. Looking north.

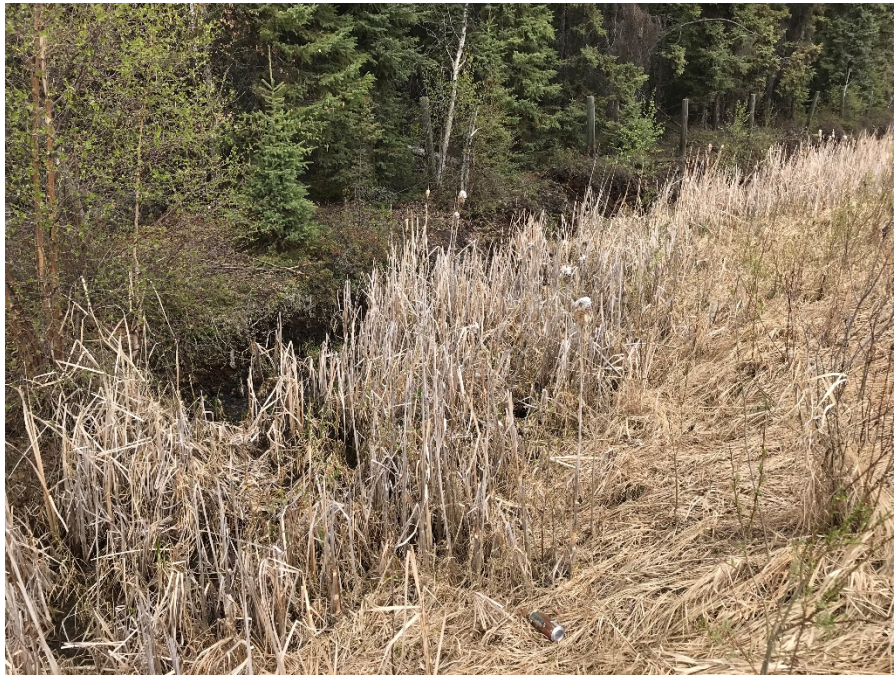
Photo 3: Standing water in the excavated west ditch flowing slowly. Looking north.

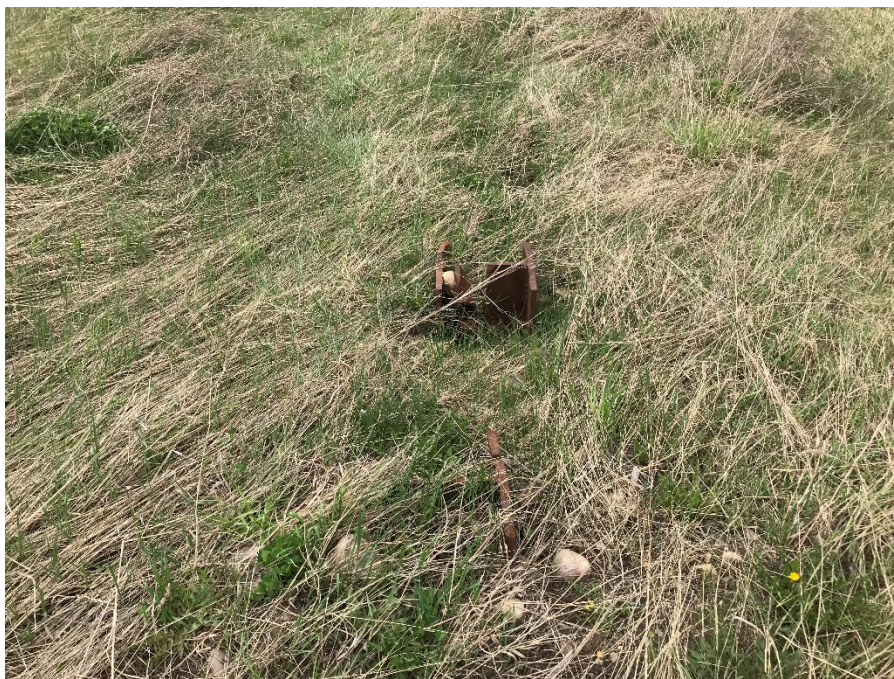
Photo 4: Exposed H-piles at the surface of the toe berm.

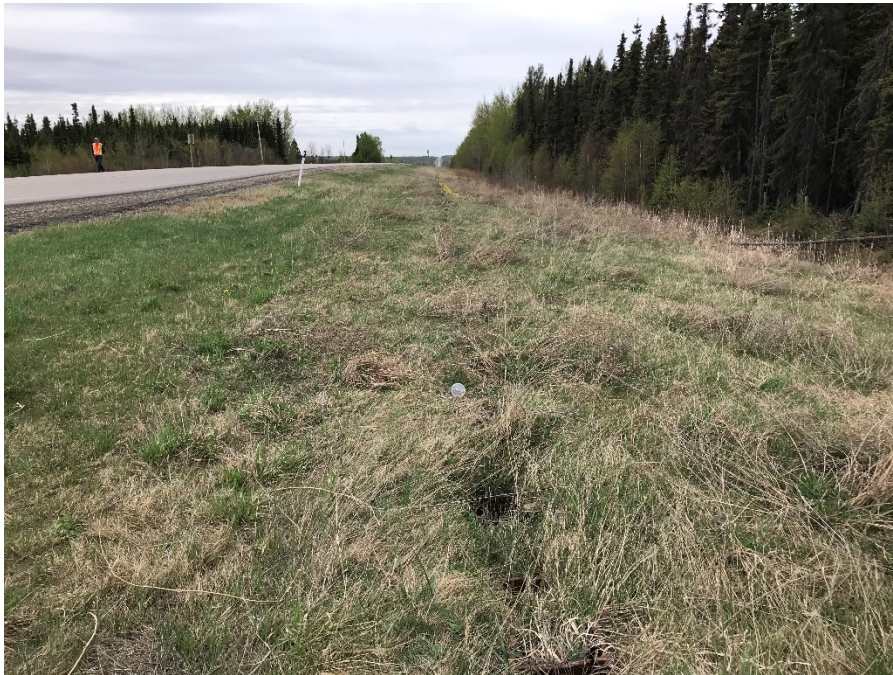
Photo 5: View of the west slope. Looking south.

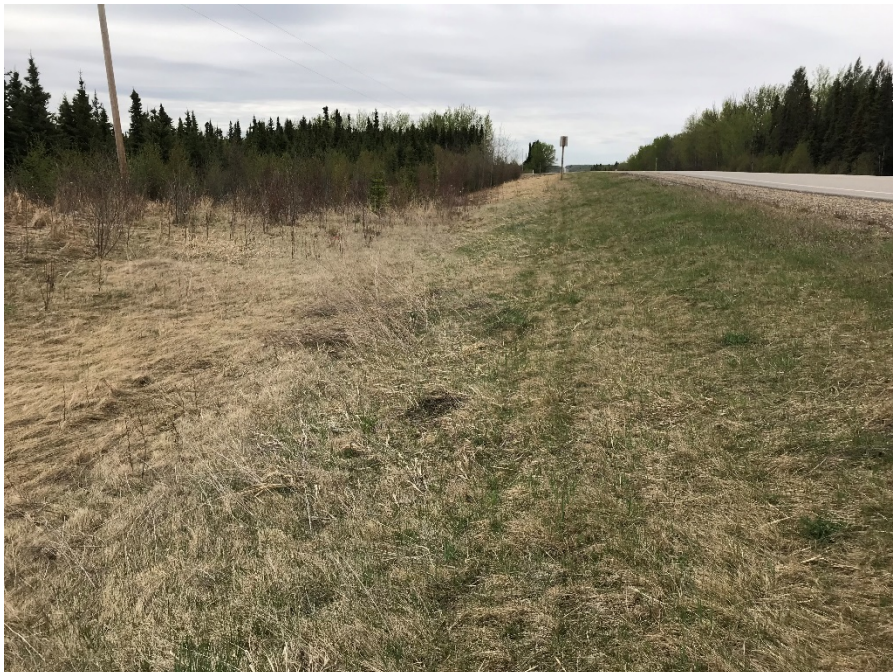
Photo 6: View of the east slope. Looking south.
