## GEOHAZARD RISK MANAGEMENT PROGRAM

### North Central Region – Edson / Stony Plain Area

#### 2019 Inspection Report

Site Number	Site Name		Hwy	km
NC40	North of North Saskatchewan River		759:02	12.6
Legal Land Description	NE 14-50-6-W5M and NW 13-50-6-W5M			
NAD 83 Coordinates	3TM 114	5909492 N	-50475 E	
Operational Site Instrumentation	Slope Inclinometers		0	
	Pneumatic Piezometers		0	
	Vibrating Wire Piezometers		0	
	Standpipe Piezometers		0	
Date of Last Instrumentation Readings	May 11, 2010

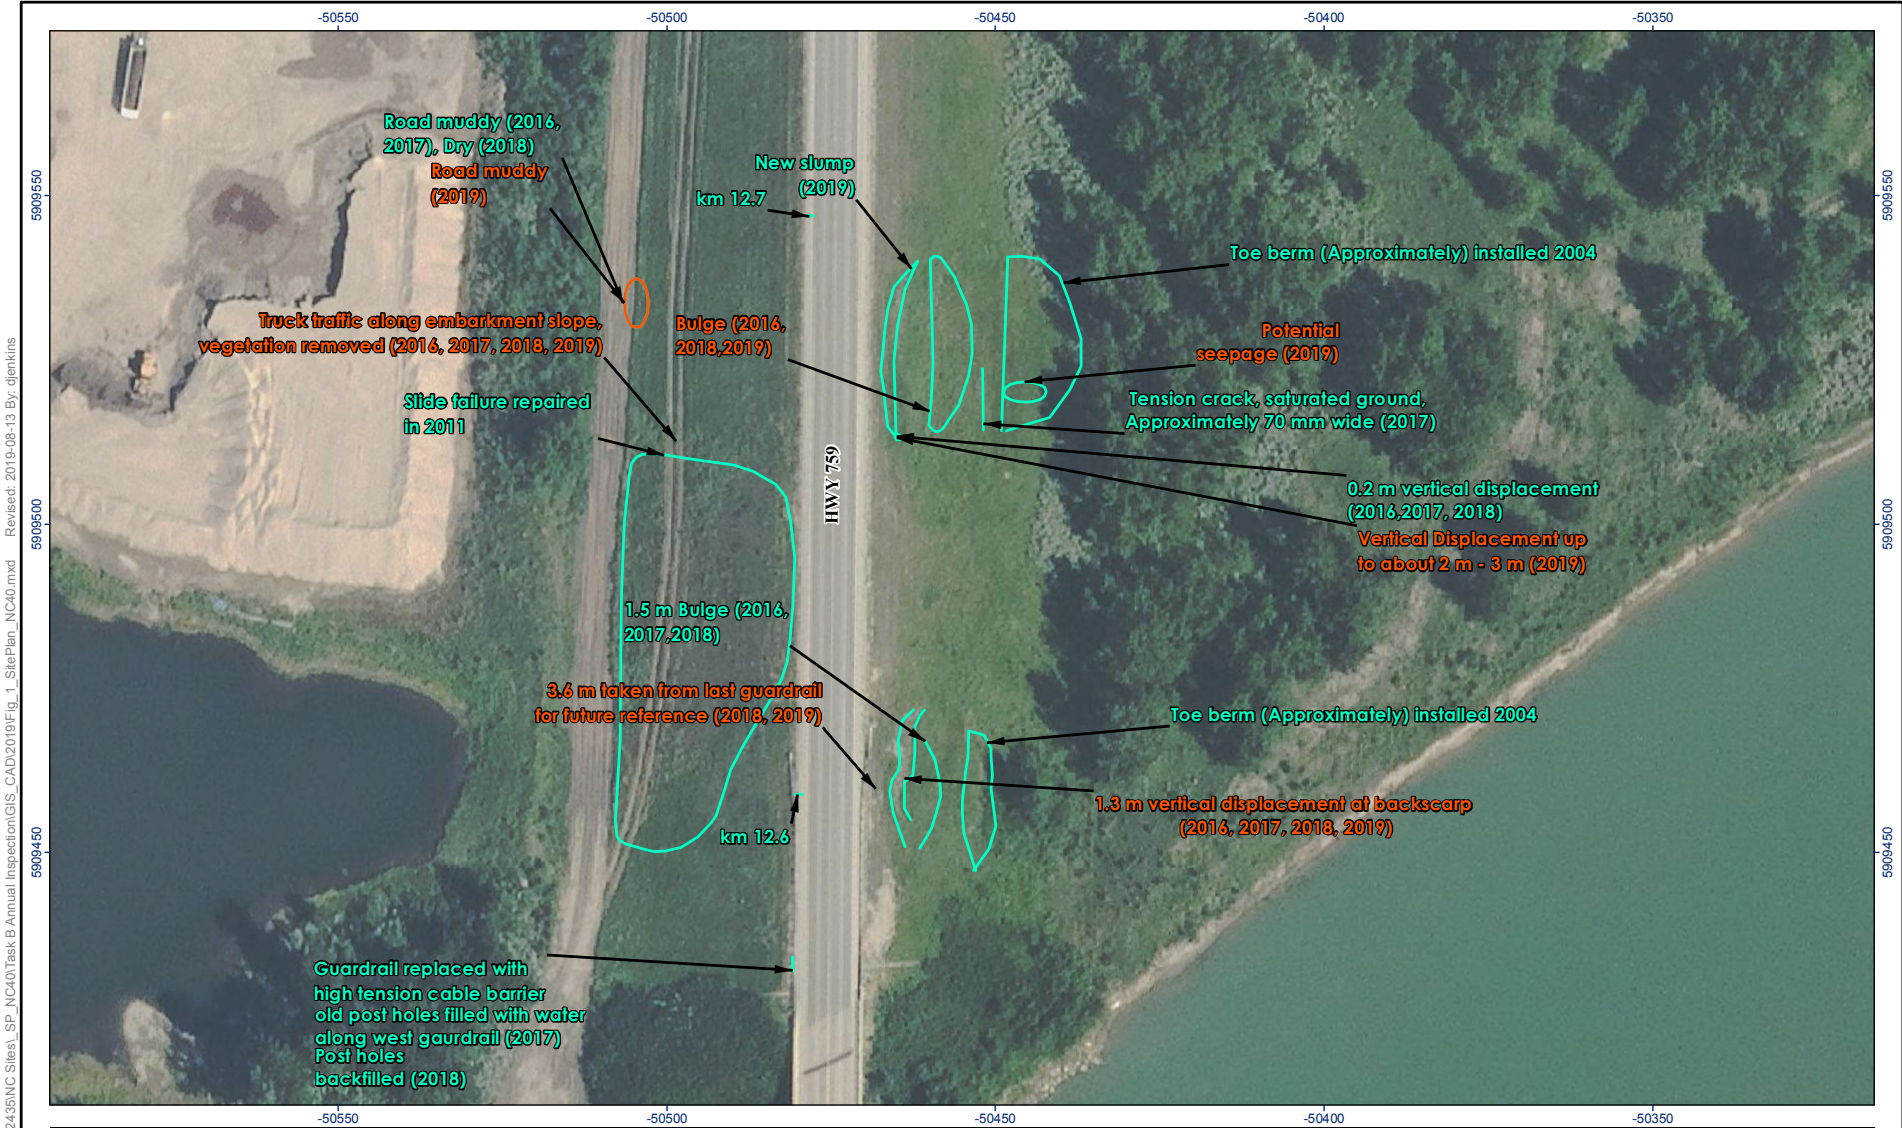
Figure No.: **1**

Title: **Site Plan**

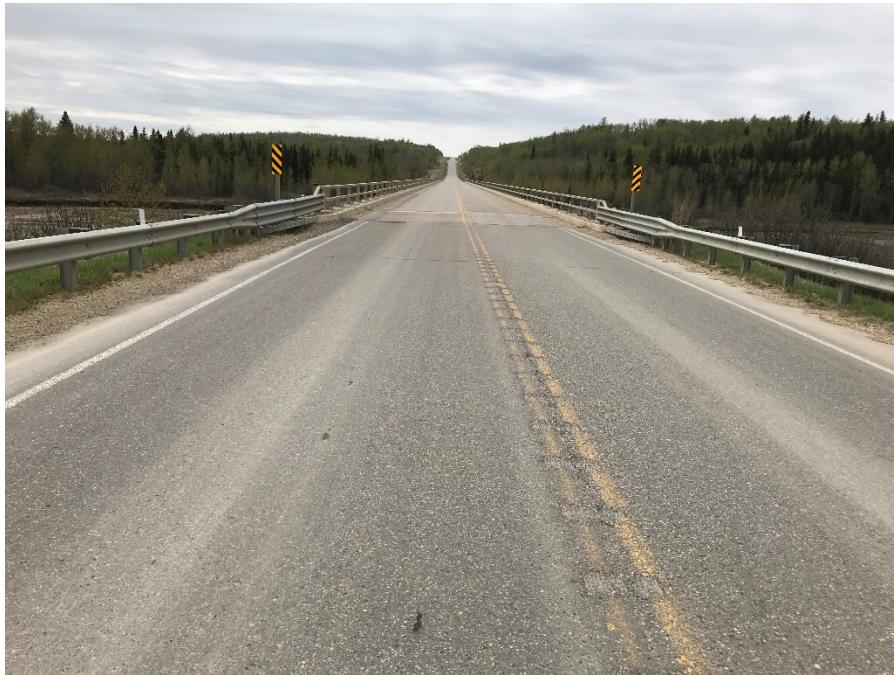
<b>Discussion</b>	<p>Highway 759 was last milled and paved in the summer of 2016. Pavement cracking was not observed as shown in Photos 1 and 2.</p> <p>No visual signs of slope instability were observed along the west slope. Vehicle tracks were observed several meters upslope from the service road. Repeated vehicle access had removed vegetation from the west slope as shown in Photo 3.</p> <p>The south slump on the east slope appeared unchanged from 2016 as shown in Photos 4 and 5. The scarp at this slump was measured to be approximately 1.2 m high and estimated to be approximately 18 m long. A 1 m high toe bulge associated with this slump was observed downslope as shown in Photo 5.</p> <p>The distance between the last guardrail beam to the edge of the scarp was measured to be 3.6 m, same as the 2018 inspection. This distance will be measured during future inspections to track retrogression of the slide.</p> <p>The scarp of the north slump appeared to be larger increasing from about 0.2 m high to about 2 m to 3 m high. The north slump is shown on Photos 6 and 7.</p> <p>A potential seepage location was observed on the east side of the previously constructed toe berm.</p>

<b>Assessment</b>	<p>The previously observed pavement distresses are believed to likely be unrelated to slope movements. Instead, the distress may be caused by heavy vehicle traffic.</p> <p>The repairs completed on the west slope appear to be functioning well since no visual signs of slope distress were observed. However, vehicle traffic appears to be moving upslope and along the embankment to avoid ponded water along the service road. This is leading to removed vegetation along the wheel paths.</p> <p>On the east side of embankment, the south slump appeared to be unchanged since 2014 indicating relatively little movement within the slope. However, movement may be triggered due to water infiltration into the slope through the exposed scarps.</p> <p>The north slump appeared more defined with a larger vertical scarp than observed in previous inspections. Coupled with the potential presence of seepage at the toe of the slope, recent slope movements may be driven by increased pore pressure within the slope.</p>

**Photo 1:** Pavement last milled and paved in 2016. Looking south.

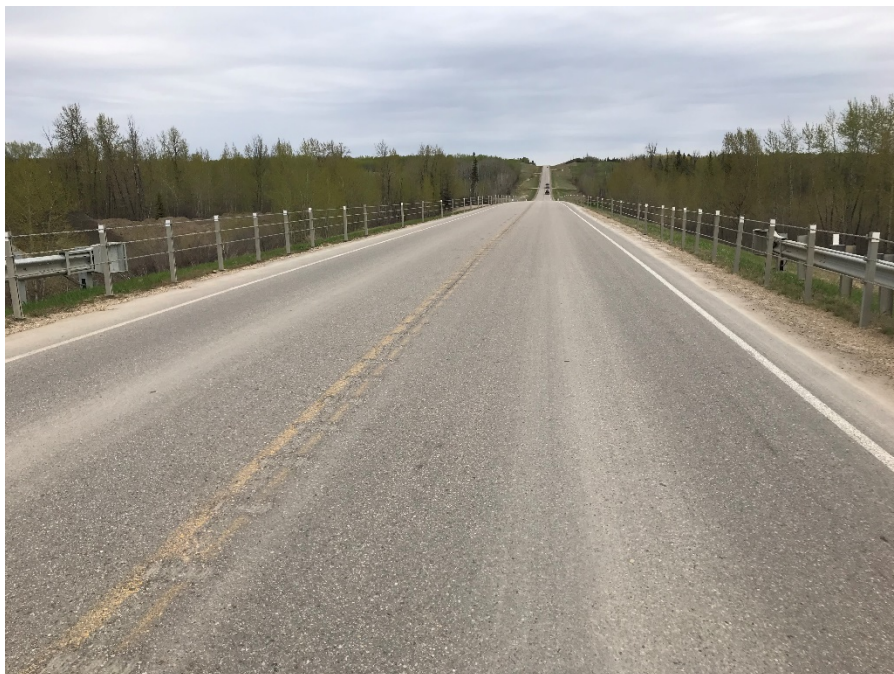
**Photo 2:** Pavement last milled and paved in 2016. Looking north.

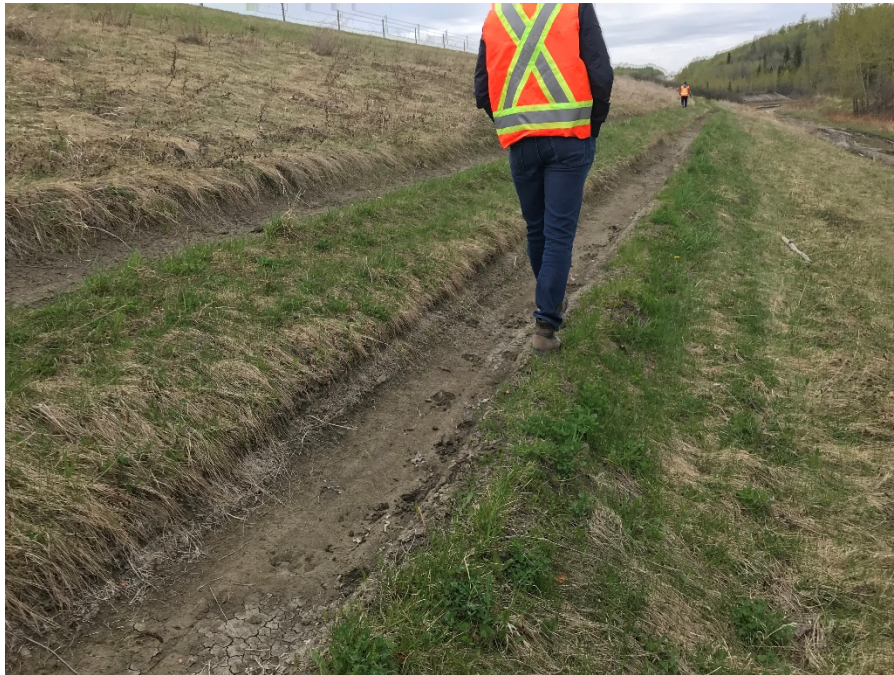
**Photo 3:** Vehicle access along west slope has removed vegetation. Looking south.

<b>Recommendations</b>	<p>The service road along the west slope should be regraded to provide better drainage away from the slope. Vegetation should be replaced along the wheel paths of the west slope.</p> <p>It is recommended that the slope failure be monitored for regression into the highway. This can be completed by regularly monitoring the distance between selected guardrails and the backscarp.</p> <p>Long term recommendations include removal of the failed masses on the east slope and replacement with engineered granular fill. The gravel pit on the west side of the highway may be a potential source of gravel.</p> <p>Site inspections should continue to be completed annually.</p>

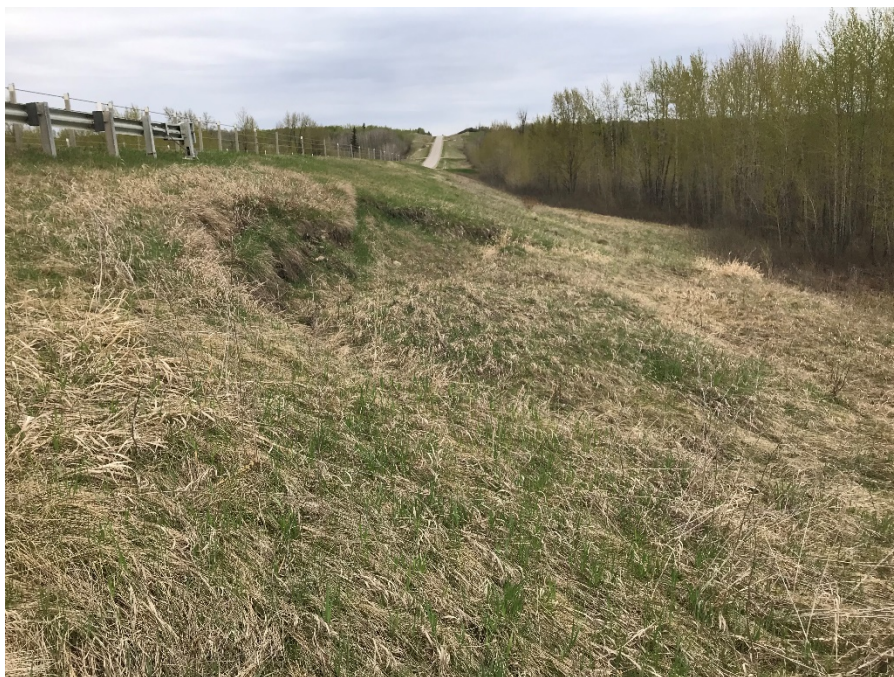
**Photo 4:** South slump on the east slope. Looking north.

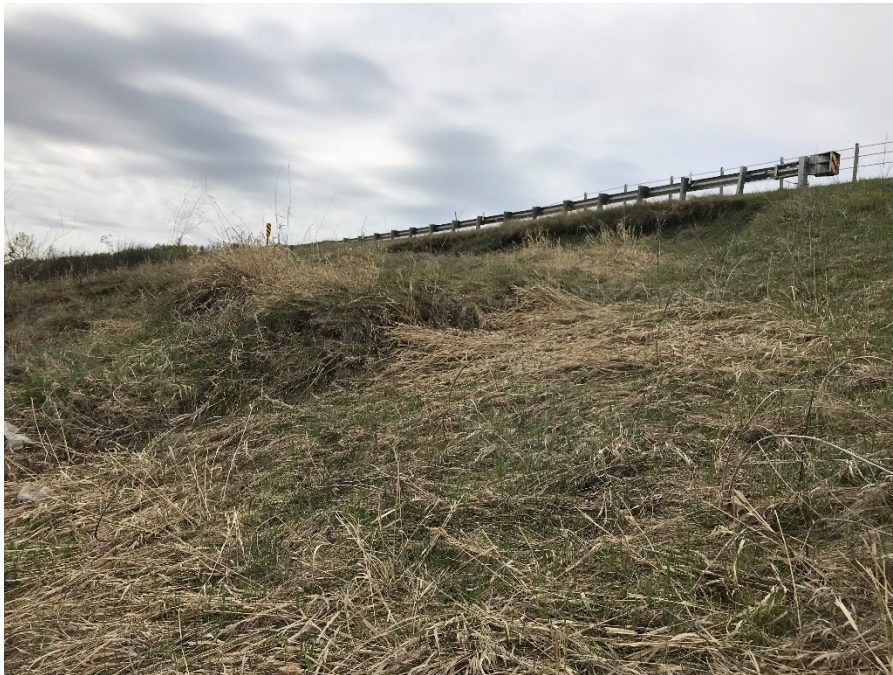
**Photo 5:** Toe bulge at south slump. Looking south.

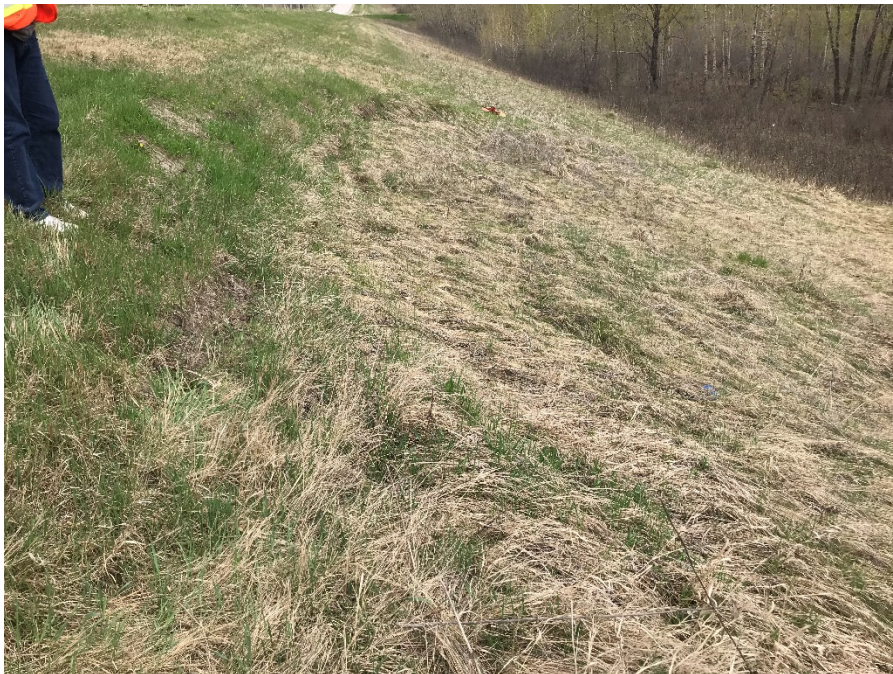
**Photo 6:** North slump on east slope looking northwest.

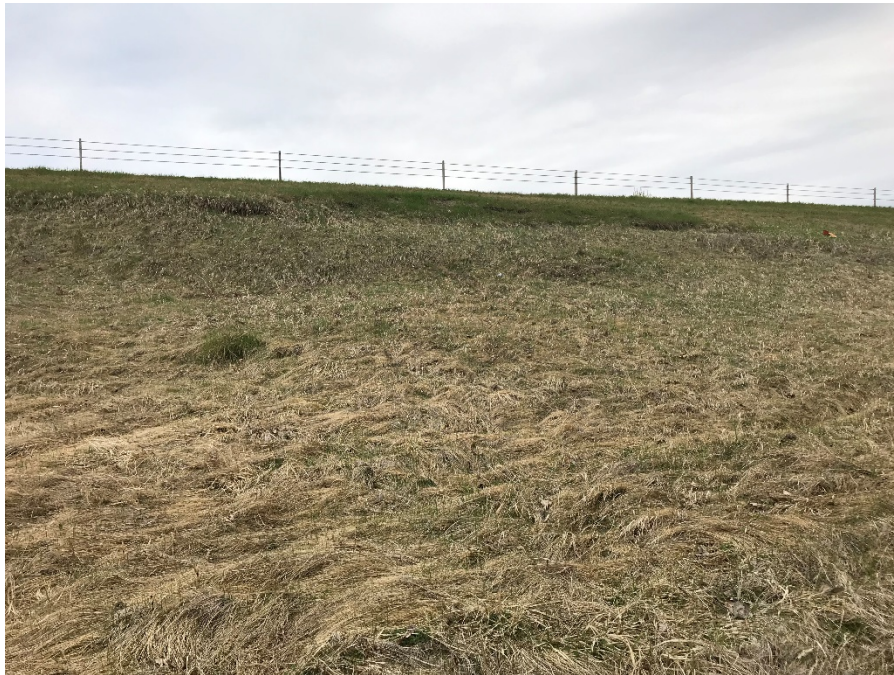
**Photo 7:** North slump on east slope looking west.
