## GEOHAZARD RISK MANAGEMENT PROGRAM

### North Central Region – Edson / Stony Plain Area

#### 2020 Inspection Report

Site Number	Site Name		Hwy	km
NC40	North of North Saskatchewan River		759:02	12.6
Legal Land Description	NE 14-50-6-W5M and NW 13-50-6-W5M			
NAD 83 Coordinates	3TM 114	5909492 N	-50475 E	
Operational Site Instrumentation	Slope Inclinometers		0	
	Pneumatic Piezometers		0	
	Vibrating Wire Piezometers		0	
	Standpipe Piezometers		0	
Date of Last Instrumentation Readings	May 11, 2010

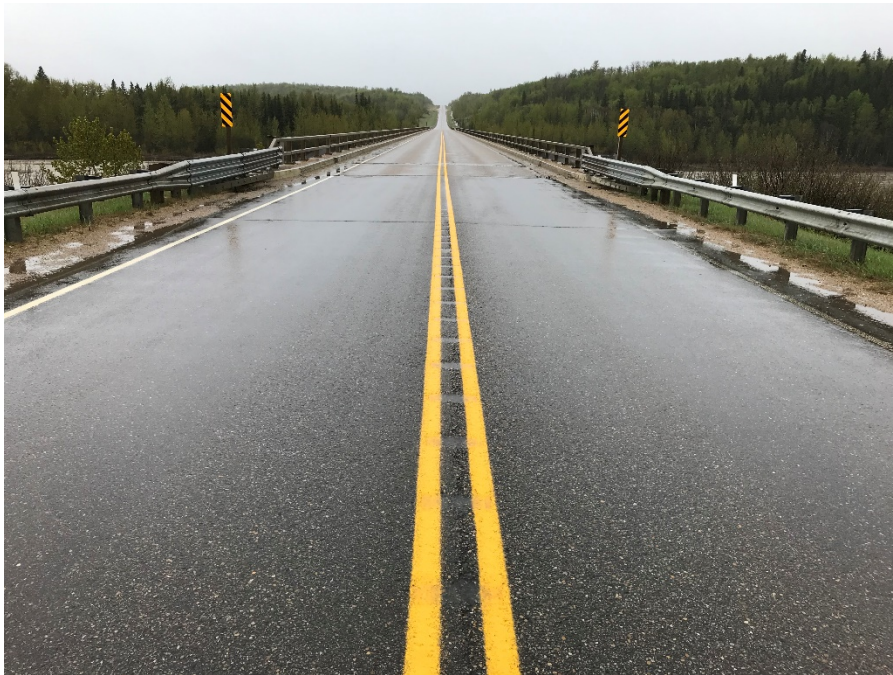
<b>Discussion</b>	<p>Highway 759 was last milled and paved in the summer of 2016. Pavement cracking was not observed as shown in Photos 1 and 2.</p> <p>No visual signs of slope instability were observed along the west slope. Vehicle tracks were observed several meters upslope from the service road. Repeated vehicle access had removed vegetation from the wheel path.</p> <p>The south slump on the east slope appeared unchanged from 2016 as shown in Photos 3 and 4. The scarp at this slump was measured to be approximately 1.3 m high and estimated to be approximately 18 m long. A 1 m high toe bulge associated with this slump was observed downslope as shown in Photo 4.</p> <p>The distance between the last guardrail beam to the edge of the scarp was measured to be 3.6 m, unchanged since the 2018 inspection.</p> <p>The scarp of the north slump appeared to be larger and more pronounced than in previous years. The north slump is shown on Photos 5 and 6.</p> <p>A potential seepage location was observed on the east side of the previously constructed toe berm in 2019 but could not be observed during the current inspection due to rain.</p>

**Photo 1:** Pavement last milled and paved in 2016. Looking south.

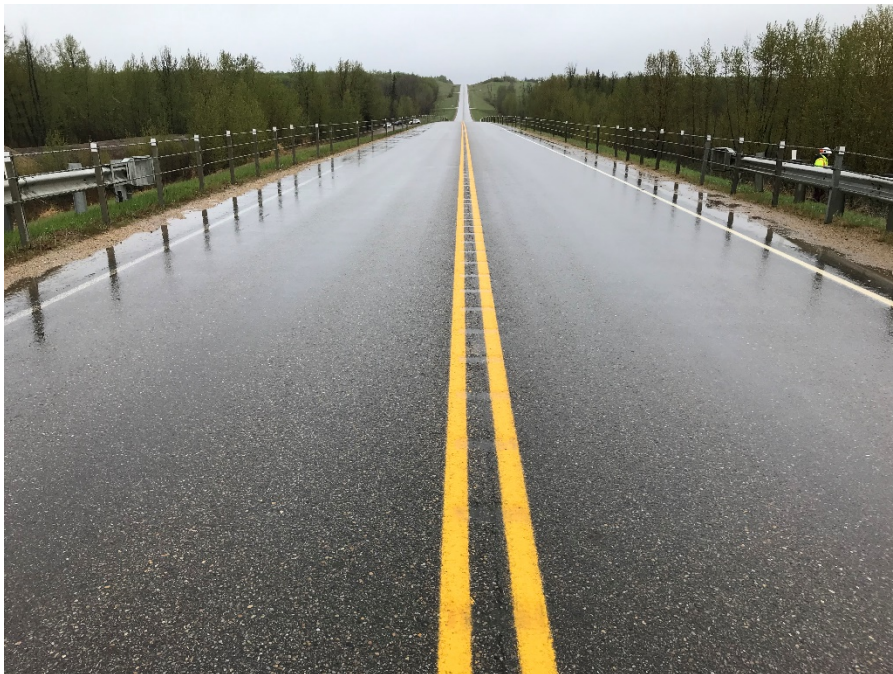
**Photo 2:** Pavement last milled and paved in 2016. Looking north.

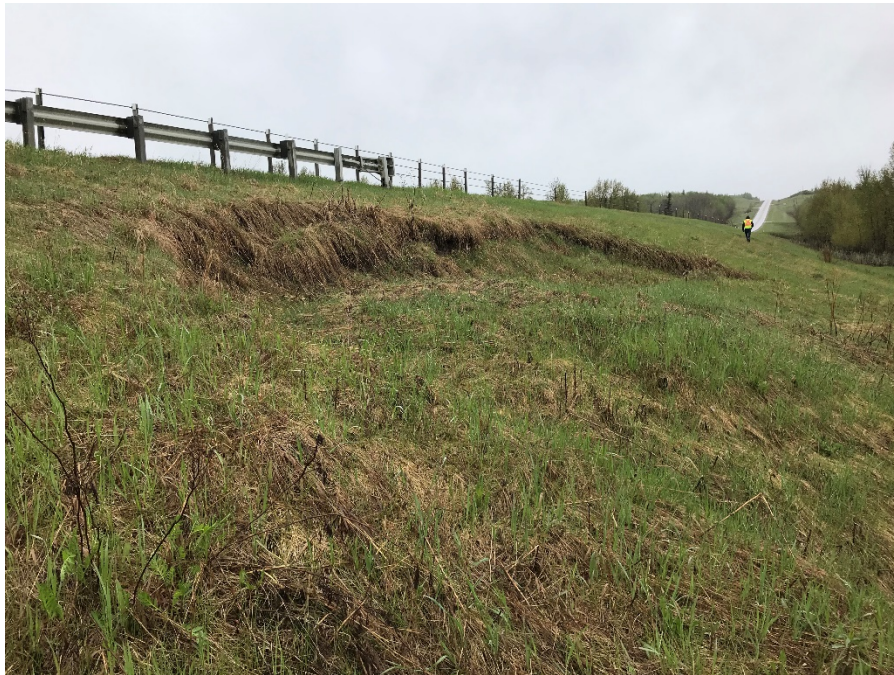
<b>Assessment</b>	<p>The previously observed pavement distresses are believed to likely be unrelated to slope movements. Instead, the distress may be caused by heavy vehicle traffic.</p> <p>The repairs completed on the west slope appear to be functioning well since no visual signs of slope distress were observed. However, vehicle traffic appears to be moving upslope and along the embankment to avoid ponded water along the service road. This is leading to removed vegetation along the wheel paths.</p> <p>On the east side of embankment, the south slump appeared to be unchanged since 2014 suggesting relatively little movement within the slope. However, movement may be triggered due to water infiltration into the slope through the exposed scarps.</p> <p>The north slump appeared more defined with a larger vertical scarp than observed in previous inspections. Coupled with the potential presence of seepage at the toe of the slope, recent slope movements may be driven by increased pore pressure within the slope.</p>

**Photo 3:** South slump on the east slope. Looking north.

<b>Recommendations</b>	<p>The service road along the west slope should be regraded to provide better drainage away from the slope. Vegetation should be replaced along the wheel paths of the west slope.</p> <p>It is recommended that the slope failure be monitored for regression into the highway. This can be completed by regularly monitoring the distance between selected guardrails and the backscarp.</p> <p>Long term recommendations include removal of the failed masses on the east slope and replacement with engineered granular fill. The gravel pit on the west side of the highway may be a potential source of gravel.</p> <p>Site inspections should continue to be completed annually.</p>

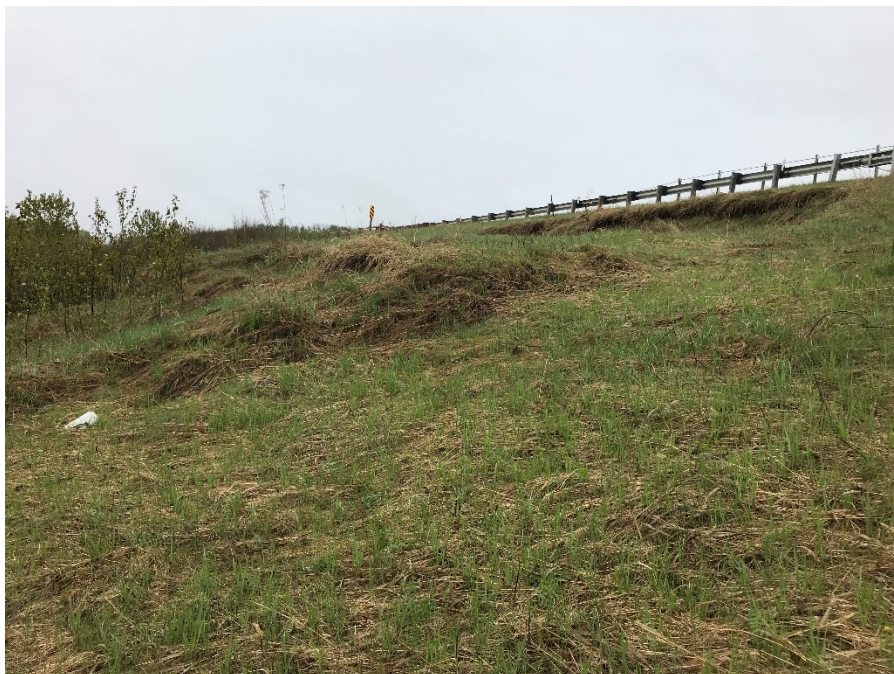
**Photo 4:** Toe bulge at south slump. Looking south.

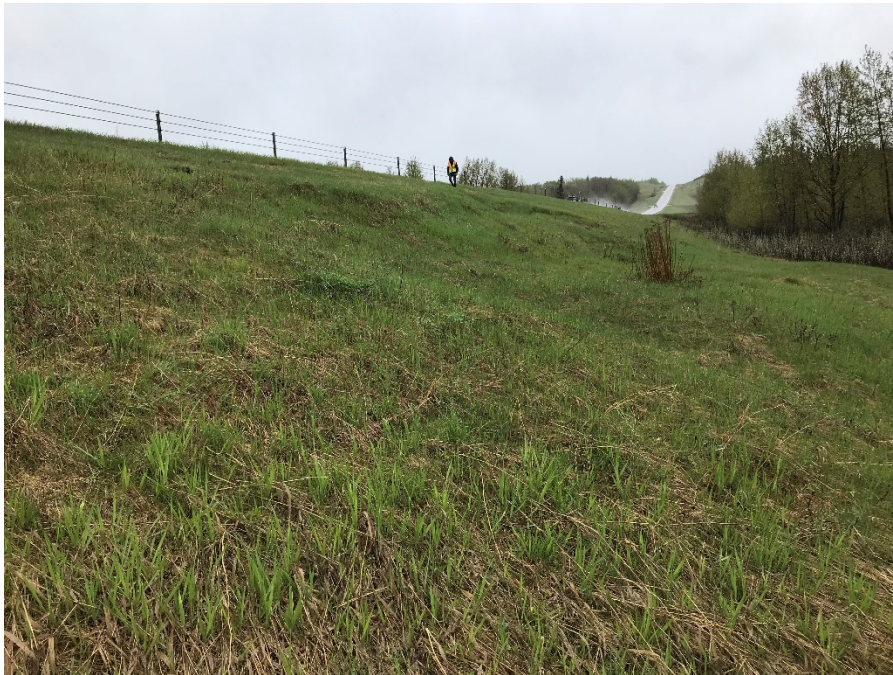
**Photo 5:** North slump on east slope looking northwest.

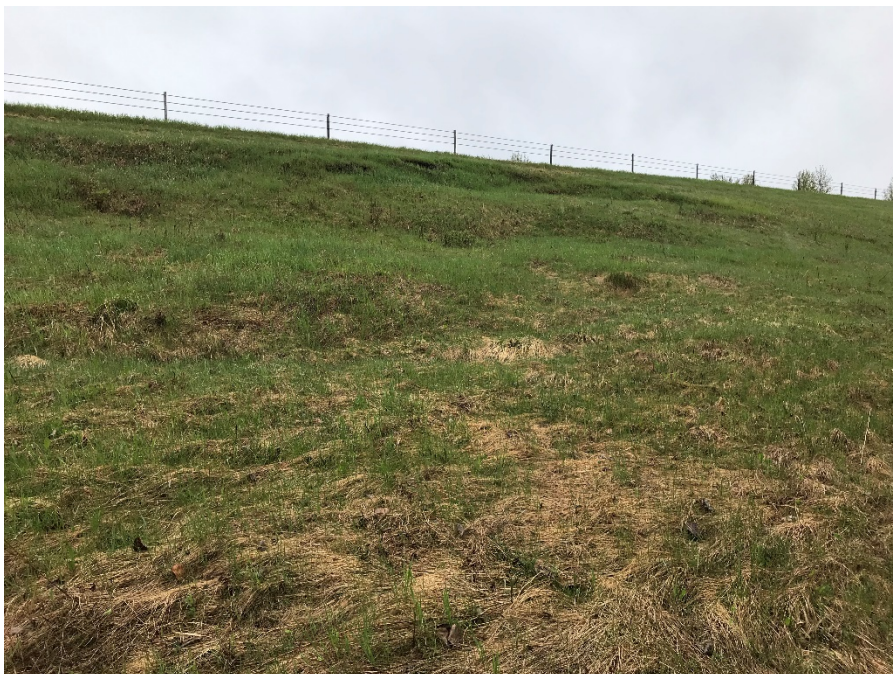
**Photo 6:** North slump on east slope looking west.
