<b>SITE NUMBER AND NAME:</b> NC040 – North of N. Sask River	<b>HIGHWAY AND KM:</b> 759:02, km 12.587	<b>PREVIOUS INSPECTION:</b> June 2, 2023	<b>CURRENT INSPECTION:</b> June 14, 2024
<b>LEGAL DESCRIPTION:</b> NE-12-13-50-6-W5 NW-9-14-50-6-W5	<b>NAD83 COORDINATES:</b> UTM11U 5909780 N, 649396 E		<b>RISK ASSESSMENT:</b> PF: 11 CF: 5 Total: 55
<b>AVERAGE ANNUAL DAILY TRAFFIC (AADT):</b> 1,660 (2023)		<b>CONTRACTOR MAINTENANCE AREA (CMA):</b> 509

**PRIMARY SITE ISSUE:**  
Slope failure of the west embankment along Highway 759. Two slope failures on the east embankment.

2024 Inspection Photos at NC040

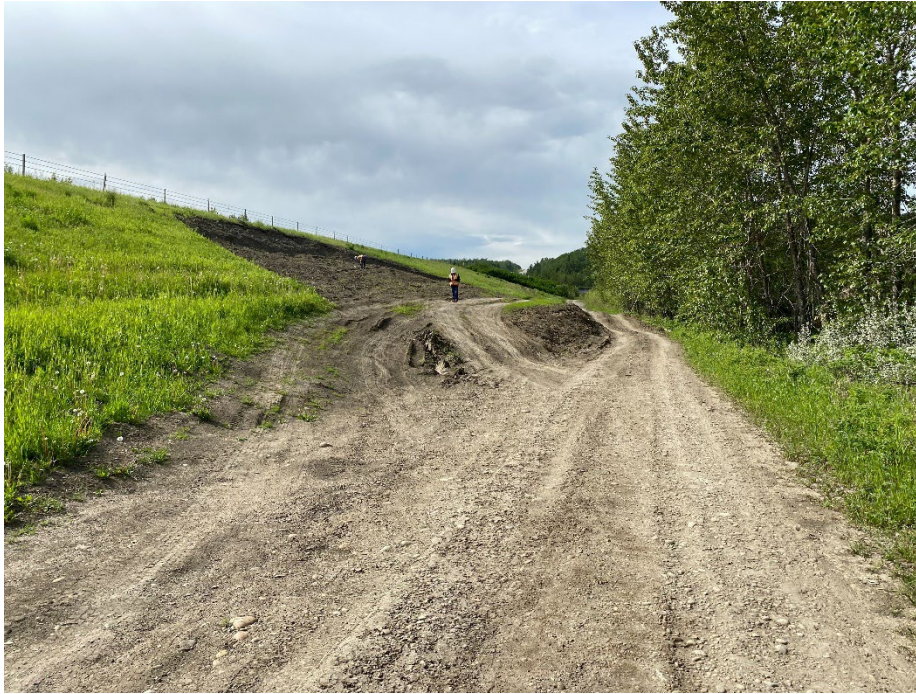
<b>COMMENTS</b>
<ul style="list-style-type: none"> <li>The landslide on the west embankment has been regraded (Photos 1 to 3). The toe is still present and approximately 1.5 m high, though the service road has been re-established. The repaired scarp is 1.8 m from the edge of the highway.</li> <li>Two samples of the soil were taken from the regraded area of the west embankment for lab testing. The results will be used in the Section F design. The test results indicated high plastic clay and silt material.</li> </ul>

**Photo 1:** Failure at north extent of west side slope. Service road at landslide toe has been opened up. Looking south.

- In the short-term, erosion control blankets should be placed on the regraded landslide surface on the west embankment, and the area should be reseeded for temporary erosion control. The landslide is about 175 m away from the North Saskatchewan River and sedimentation into the river during major precipitation events is a possibility.
- At the time of the site inspection, Stantec had been preparing a Section F remediation design of the west embankment slope. The preferred remediation option was understood to be removal and replacement. It was discussed with TEC on site that the east embankment slope could be repaired with the same approach and is to be added to Stantec's current remediation design work.
- Site inspections should continue annually.

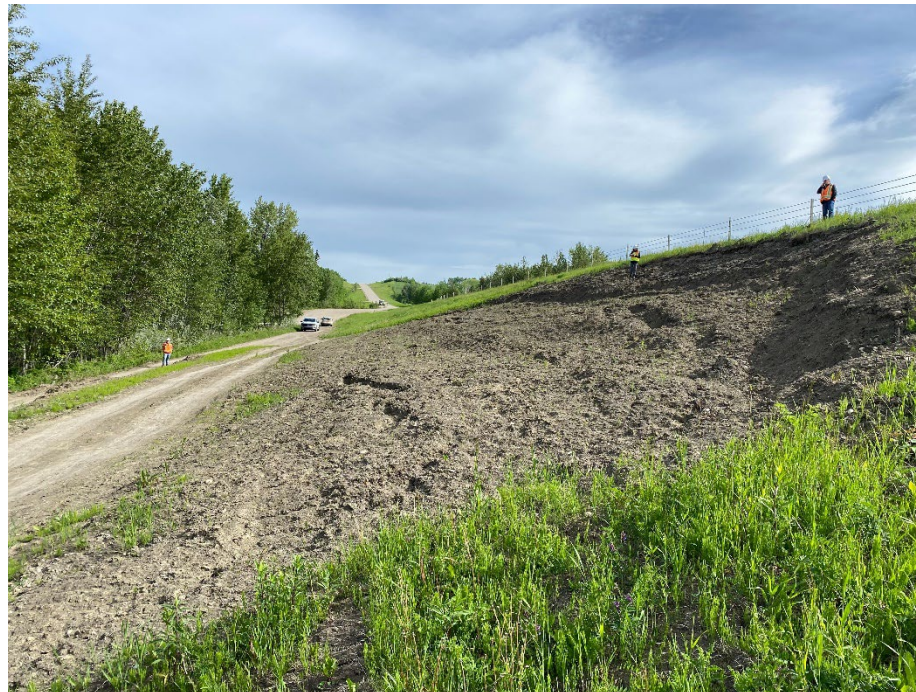
**Photo 2:** Failure at south extent of west side slope. Looking north.

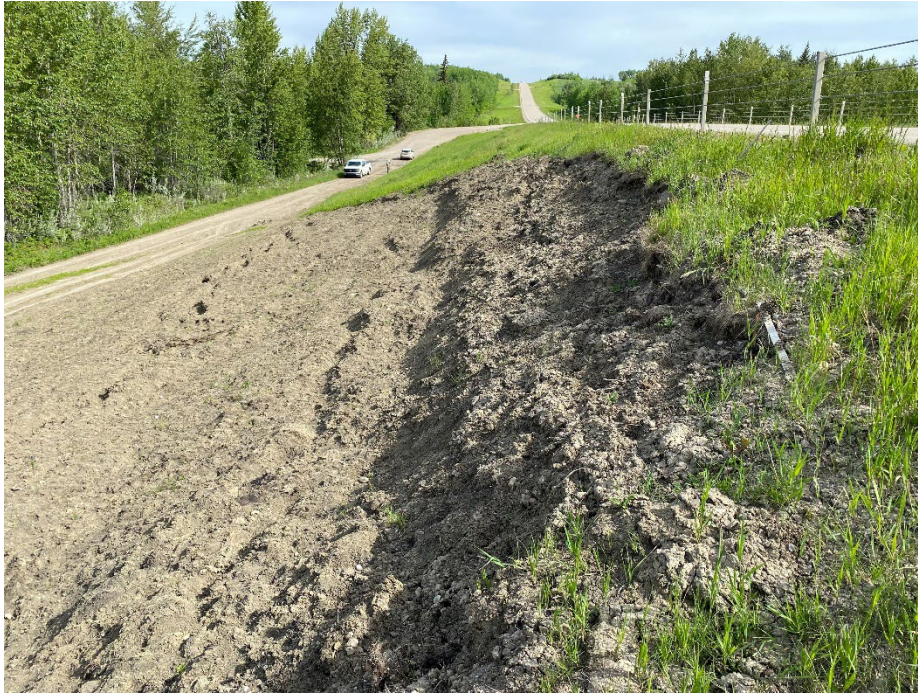
**Photo 3:** Backslope of failure regraded since previous inspection. Looking north.

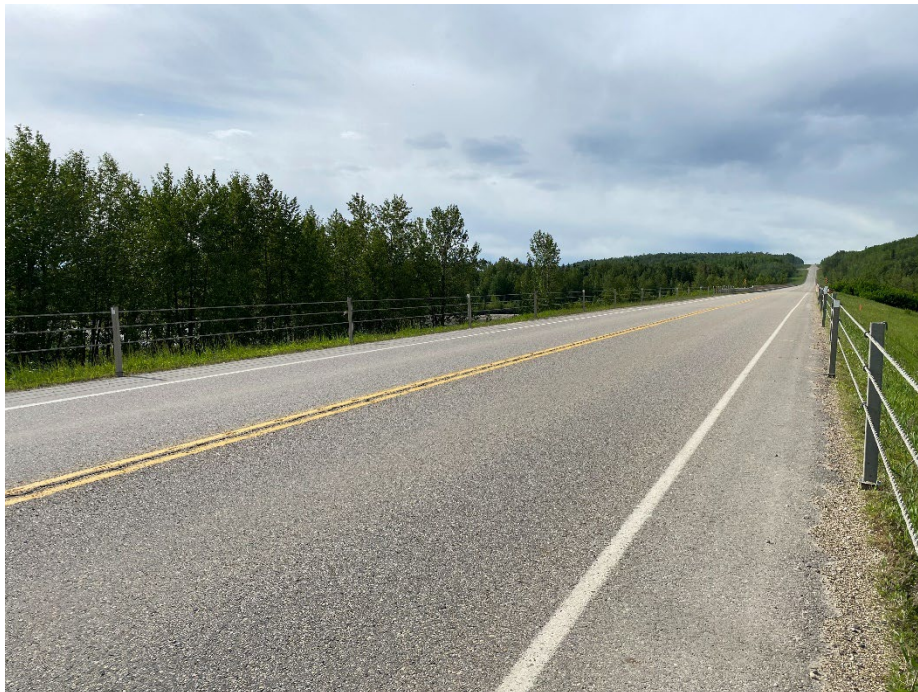
- No landslide related pavement cracks were observed along the highway as shown on Photos 4 and 5.
- The surrounding embankment slopes were at approximately 3H:1V and were well-covered with grass. Wheel tracks continue to be observed about one-third of the way up the embankment.

**Photo 4:** Highway surface above west sideslope failure. Looking southeast.

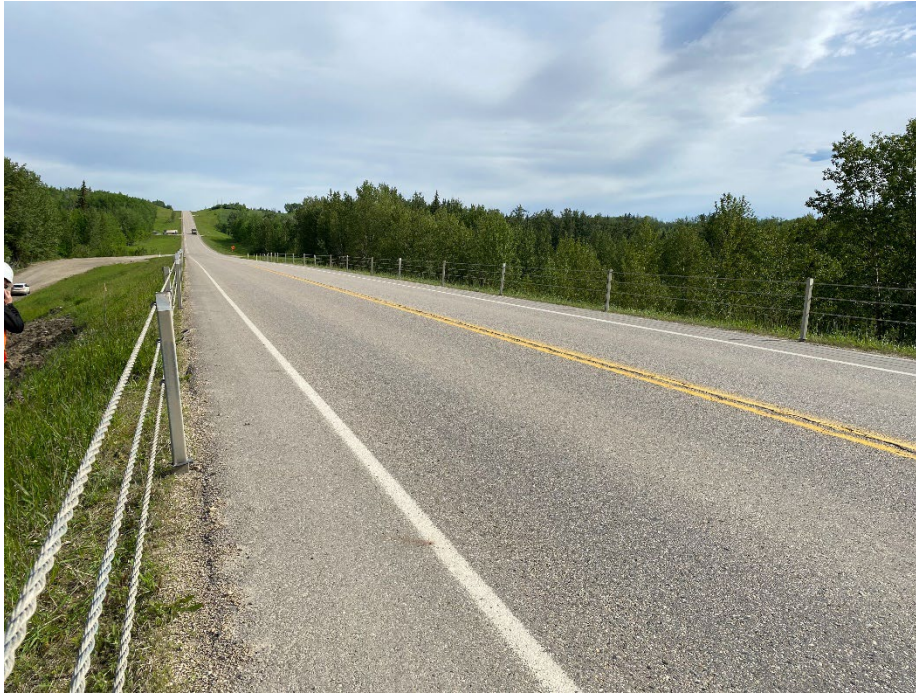
**Photo 5:** Highway surface above west sideslope failure. Looking northeast.

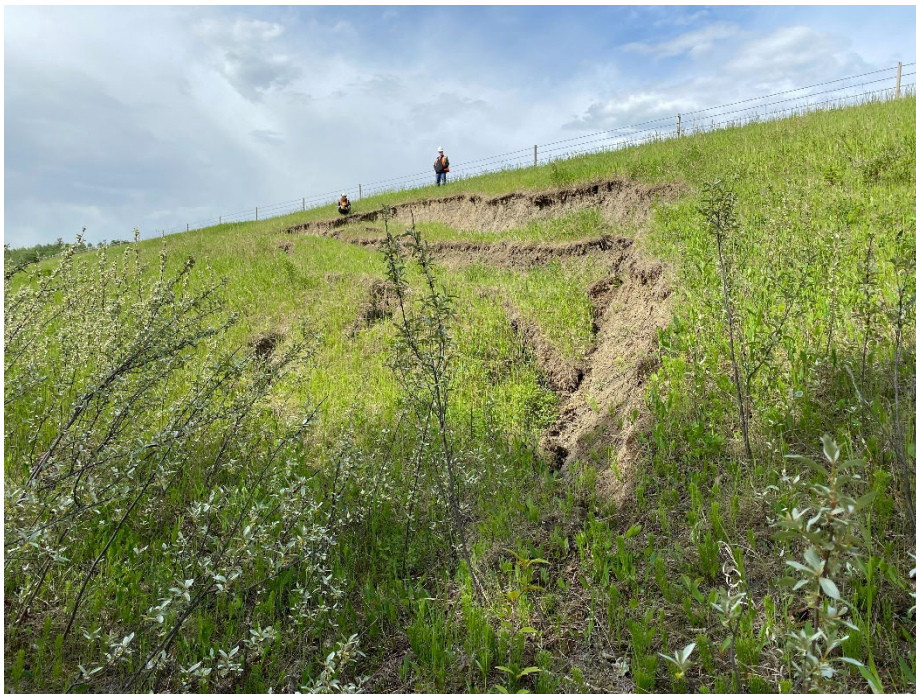
- A new landslide is present at the north end of the east embankment. The scarp was measured to be up to 1.8 m high and 2.9 m from the edge of the highway at its closest point. The toe bulge appears to be pushing against the shrubs, upslope from the tree line (Photos 6 and 7).

**Photo 6:** New slump on north end of east sideslope. Looking southwest from toe.

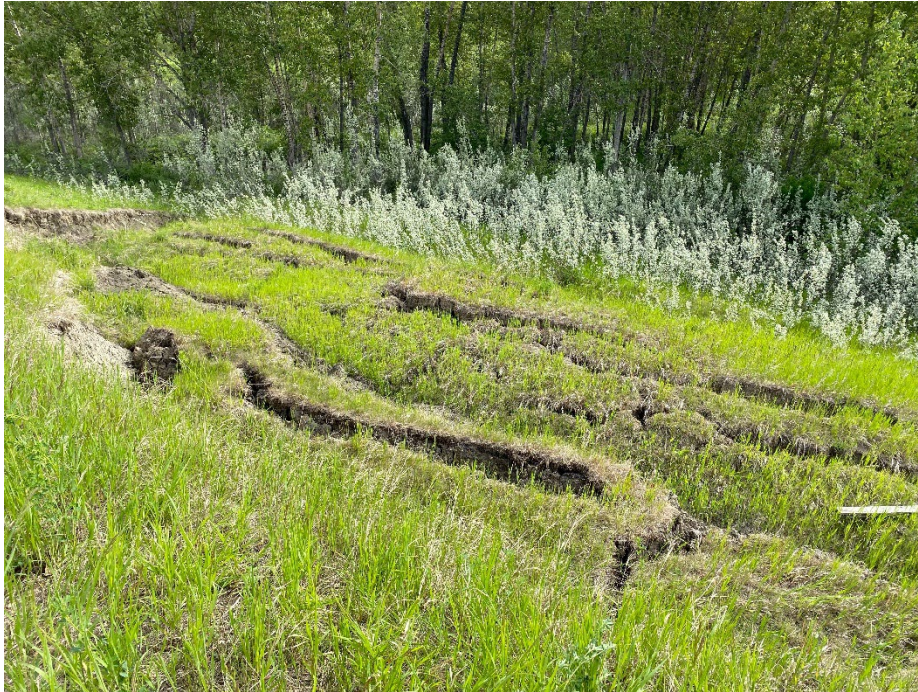
**Photo 7:** Toe bulge of northern slump on east sideslope. Looking northeast.

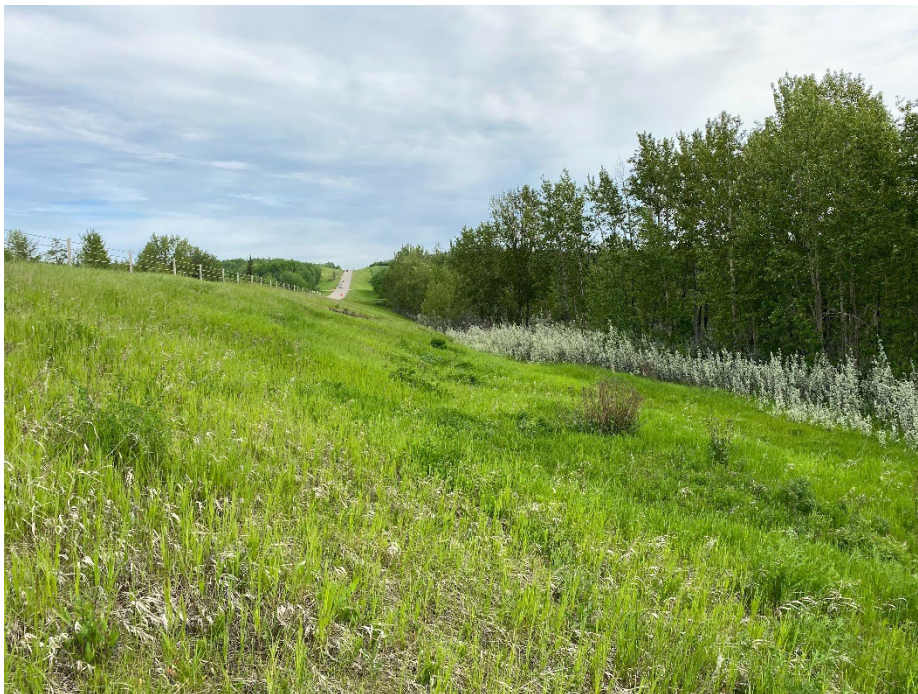
- Little to no change was observed at the other two embankment failures on the east side slope since Stantec's previous call-out inspection in 2023 (Photos 8 to 10).

**Photo 8:** Middle slump on east sideslope, little change. Looking north.

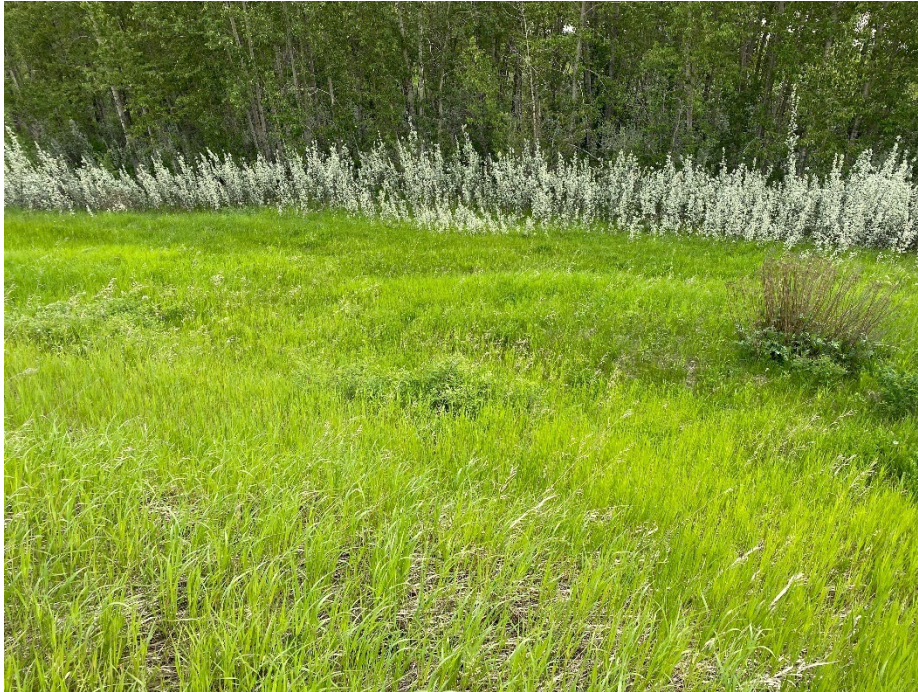
**Photo 9:** Bulging apparent on east sideslope at middle slump. Looking east, downslope.

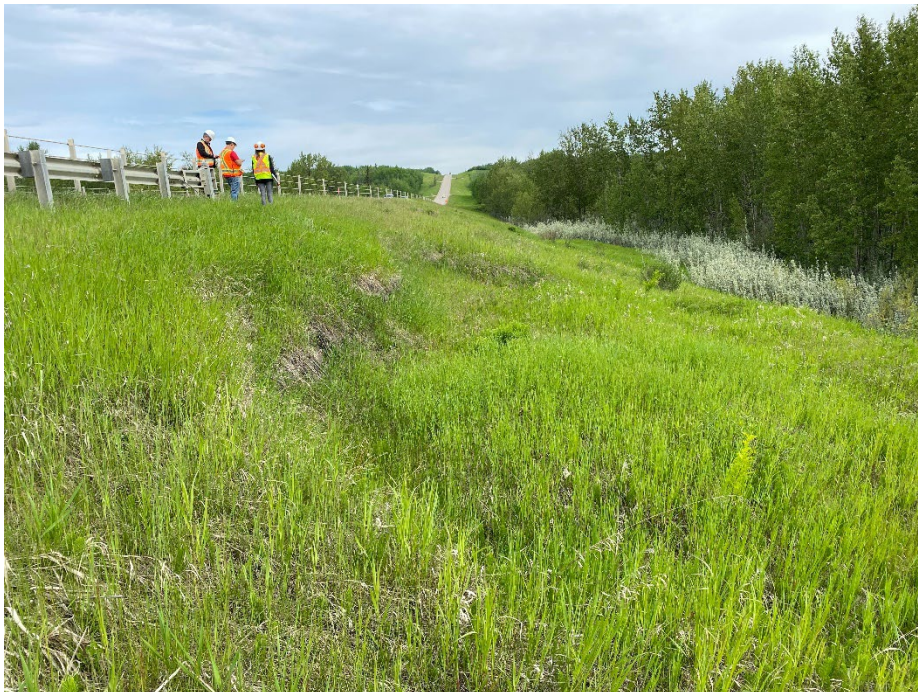
- The crest of the south slump on the east side slope was measured to be 3.6 m from the guardrail at its closest point since 2018. The backscarp appears more vegetated from the previous inspection in 2023 (Photo 10).

**Photo 10:** South slump on east sideslope relatively unchanged. Looking north.
