**Reference: Call Out Site – Highway 825 at Sturgeon River Crossing
Task D – Call Out Report**

This letter documents the findings of a call out inspection of an erosion disturbance adjacent to Highway 825 at the Sturgeon River crossing approximately 200 m south of Township Road 555. The legal land description of the site is NW-28-55-22-W4M. The location of the site is shown on **Figure 1** in **Attachment B**.

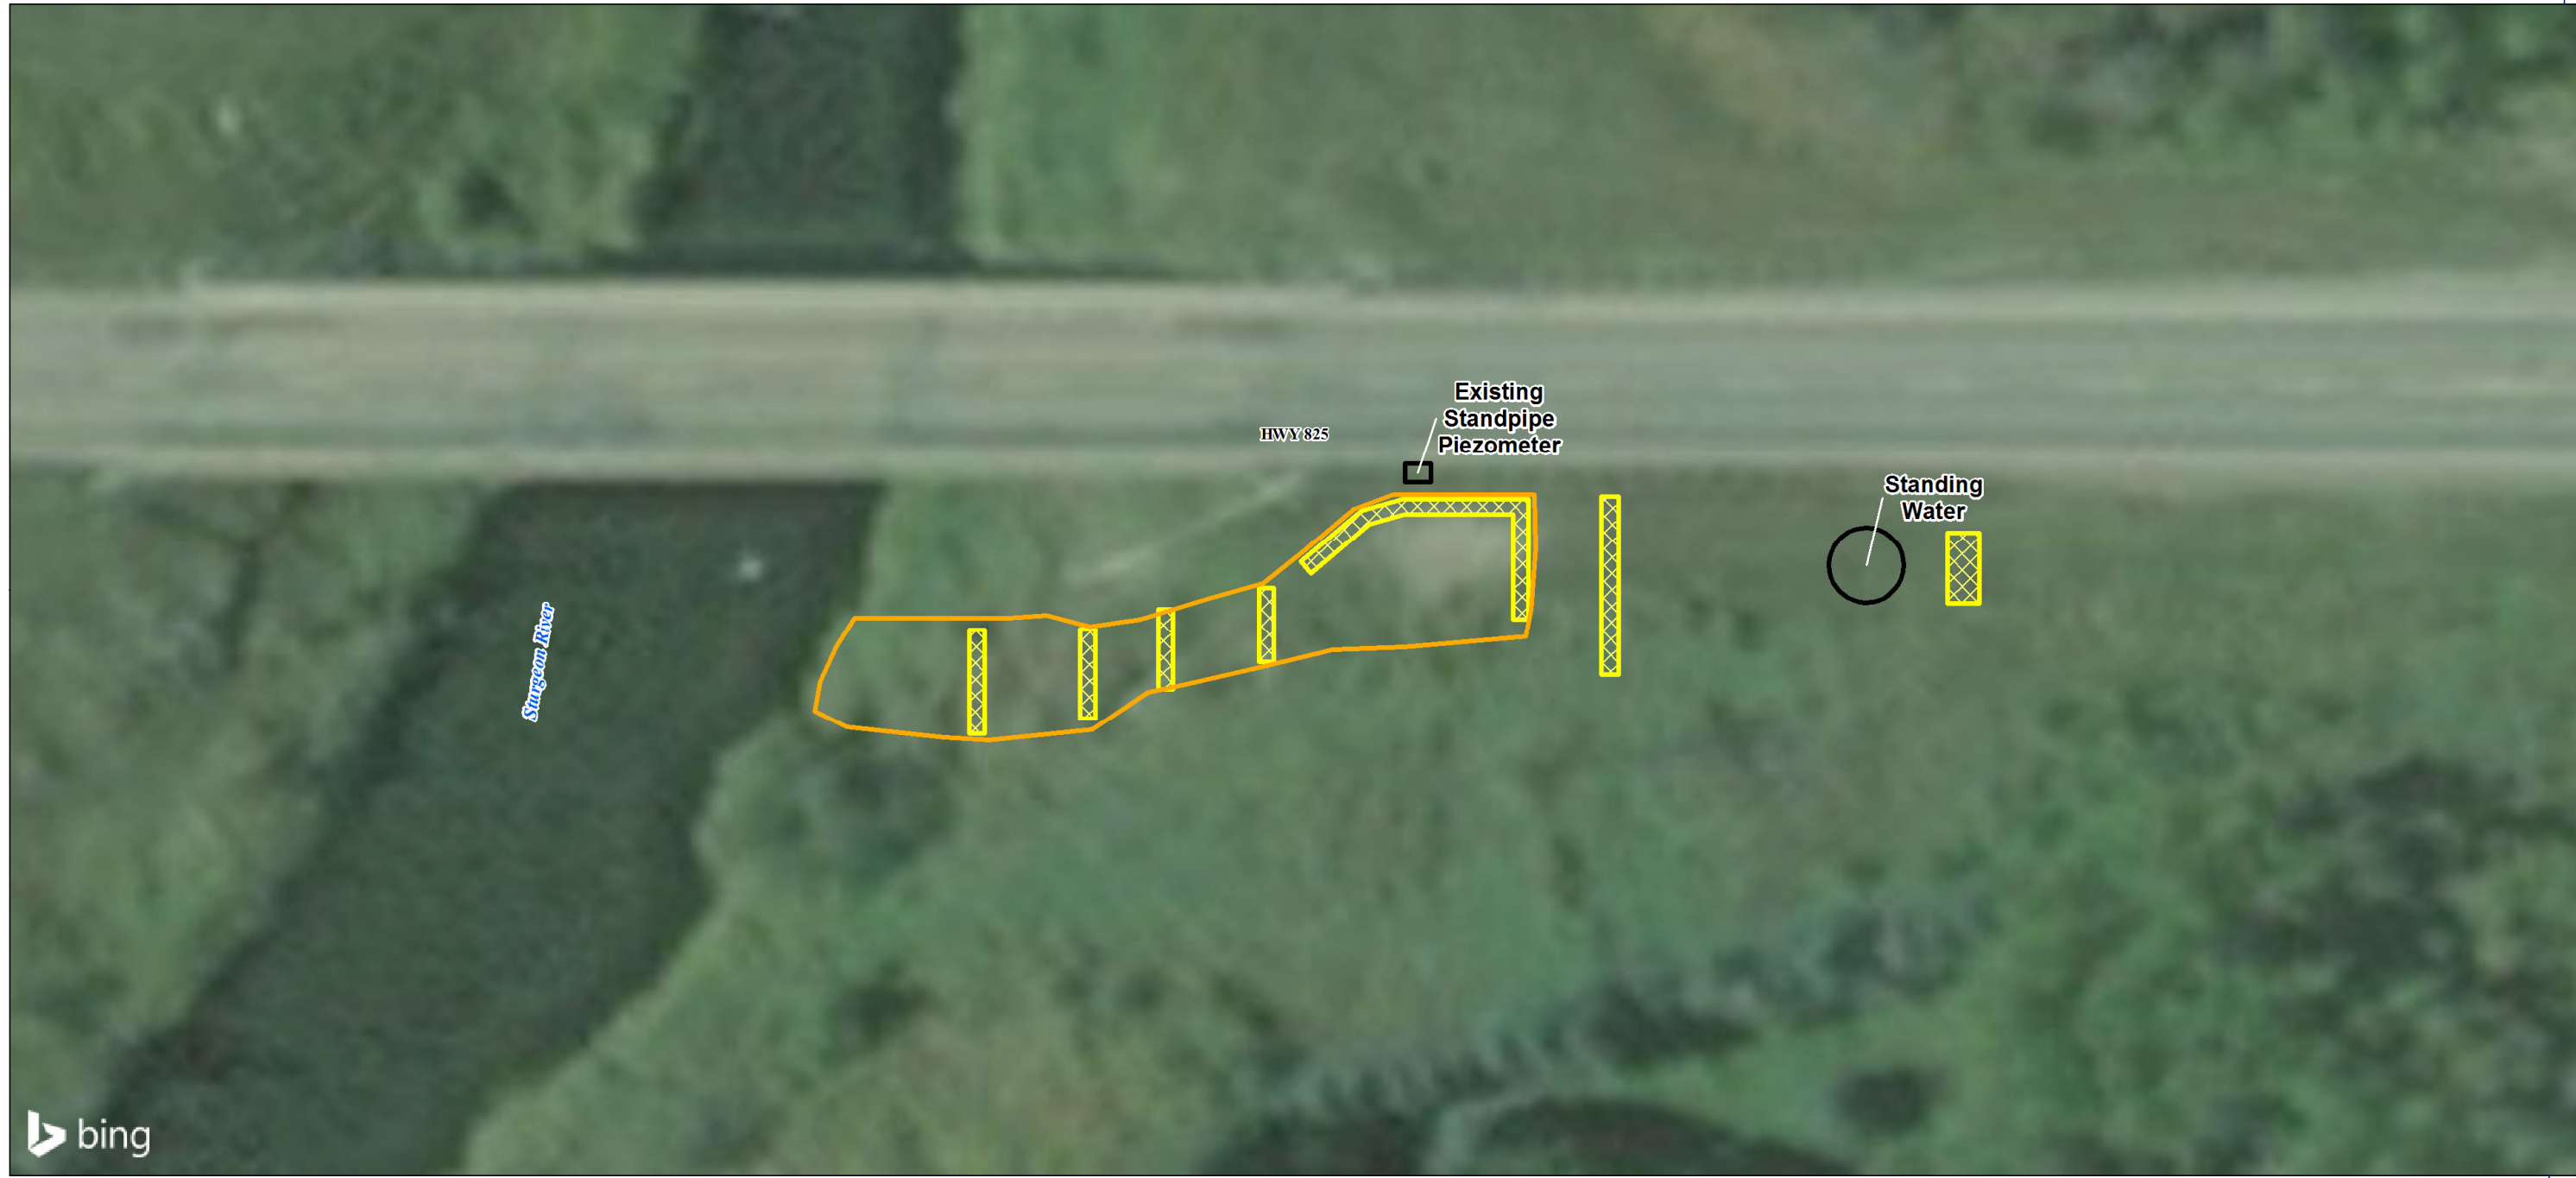
Figure No.
3

Eroded Area (Approximate)
-

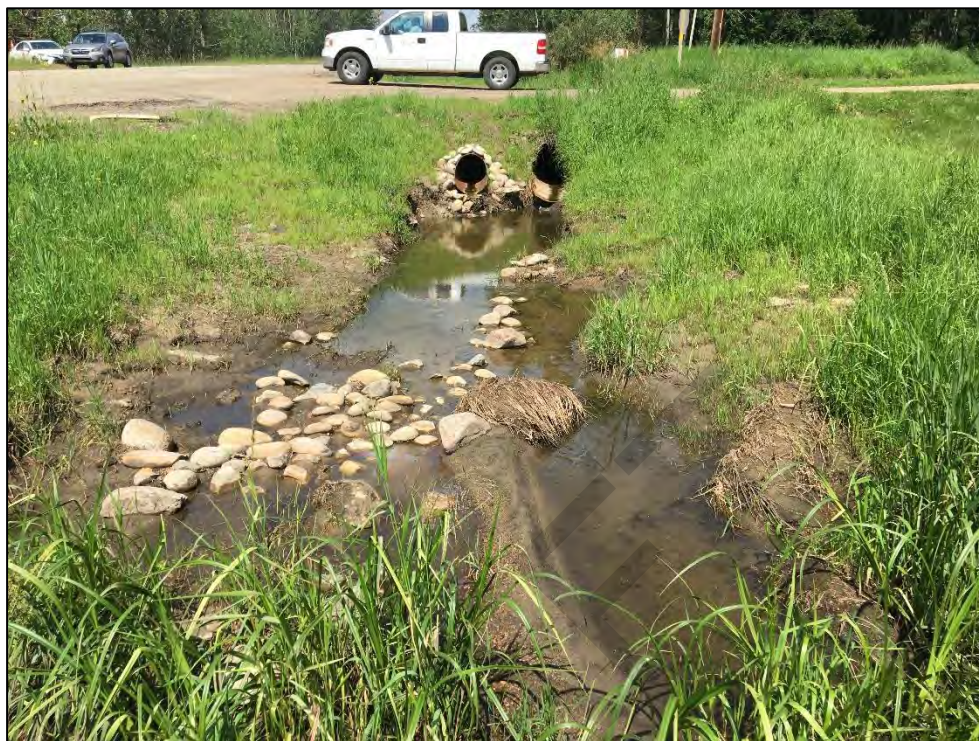
At the time of the site inspection, standing water was observed at the culvert outlet at the access to the North Bank Potato Farm (**Photo 1**). There was some erosion noted at the outlet, as well as riprap that appeared to have been displaced downstream. The culvert had recently been replaced by installing a smooth-walled steel pipe adjacent to the existing corrugated steel pipe (CSP) culvert. Water was observed flowing in both culverts. The invert of the original CSP was above the water level at the inlet (**Photo 2**), indicating some amount of groundwater seepage along the length of this culvert.

Photo 1: Standing water at culvert outlet at North Bank Potato Farm access, facing north.

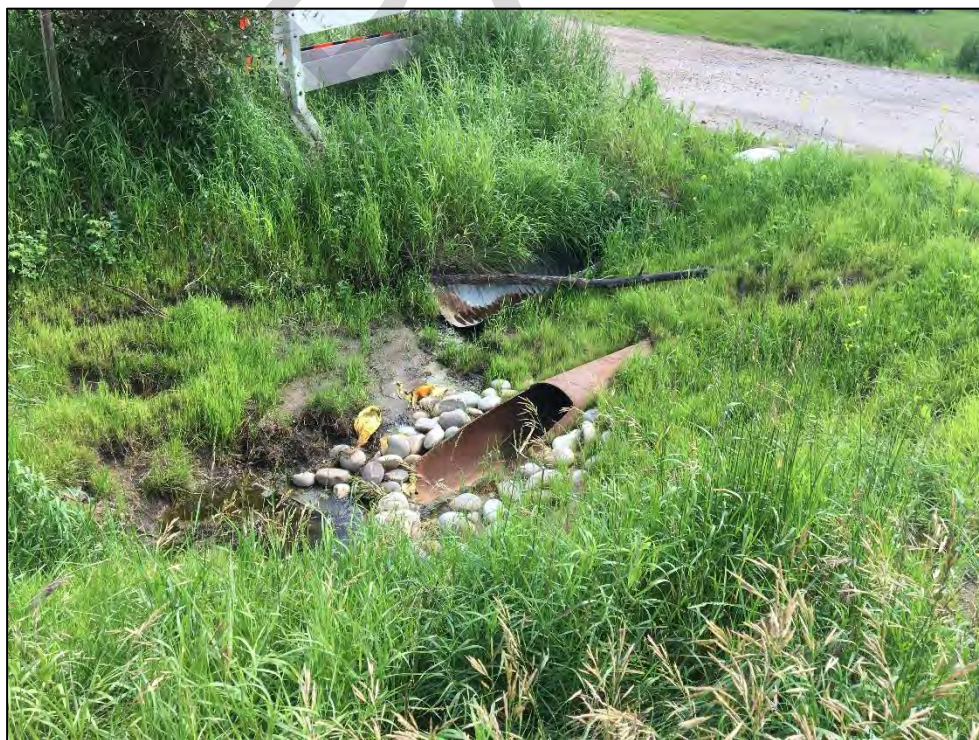
Photo 2: Inlet of culverts at North Bank Potato Farm access, facing south. Note that invert of CSP is above water level.

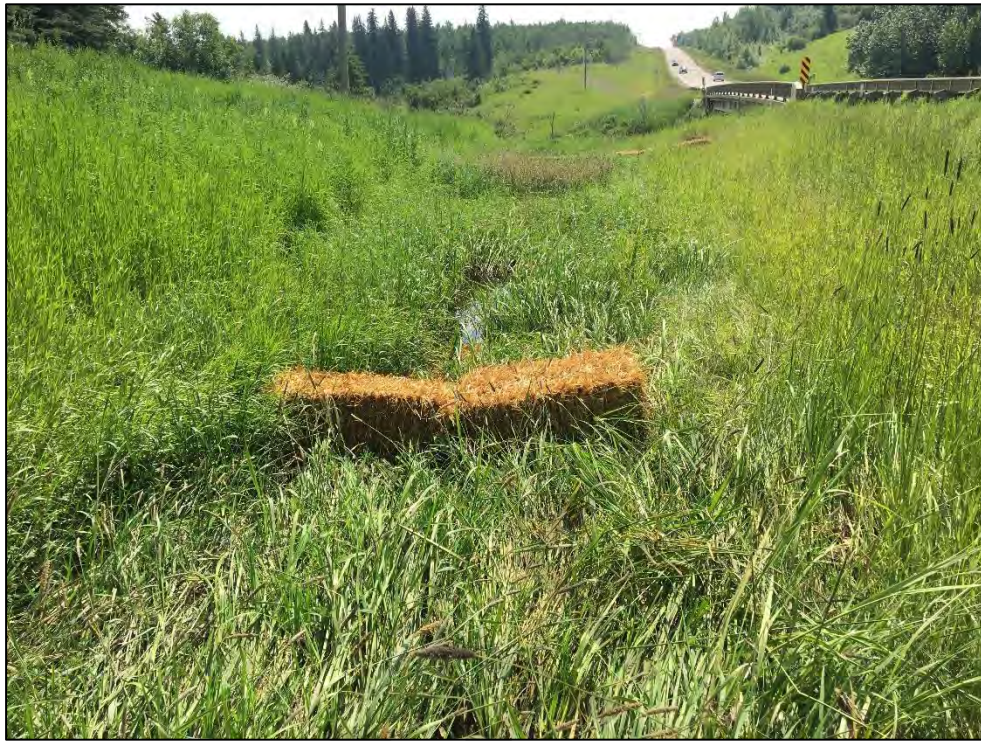
The ground surface in the east ditch was saturated. Standing water was observed throughout the ditch in what appeared to be off-highway vehicle ruts (**Photo 3**). The ditch was heavily vegetated along its entire length from the farm access to the river. The maintenance contractor had placed hay bales within the ditch to reduce the velocity of surface water flow in advance of the eroded area.

Photo 3: Standing water in ditch, facing south.

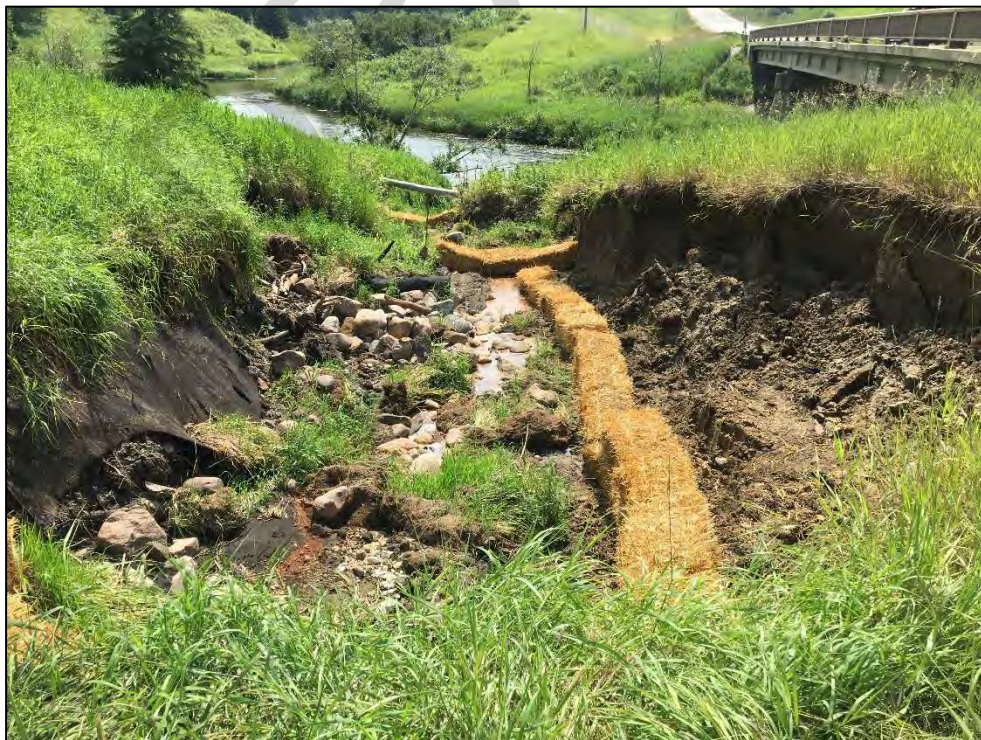
The eroded area was between approximately 7 and 8 m wide at the north limit, with a depth of 2 to 3 m. (**Photos 4 through 6**). The west extent of the eroded area was about 4 m from the edge of the pavement. An existing standpipe piezometer was located between the west edge of the eroded area and the edge of pavement, as seen in **Photo 5** and **Figure 3**. The operational status of this instrument is currently unknown. Damaged geotextile was observed beneath what was assumed to be fill along the east face of the eroded area. The soil along the eroded face consisted of sandy clay with trace to some gravel. Riprap erosion protection was observed in the base of the eroded area.

The visual observations made during the call out inspection are indicative of erosion likely due to the amount of rainfall leading up to the event. The 3 m of “black organic fill - old grade” noted on the as-built drawings would have become saturated and soft after prolonged rainfall. The soil is very prone to erosion from surface run off based on site observations of the exposed soil with high sand/silt content. The high volume of rainfall would have resulted in high velocity concentrated flow in the ditch, increasing the rate of erosion. The concentrated water flow will down-cut the soil and cause soil to collapse at a small local scale. The local collapses would then propagate until a mass wash out occurs by surface water flow.

Photo 4: Upper section of eroded area, facing south.

- Removing loose soil, riprap, organics, and other debris from the eroded area;
- Backfilling the eroded area with imported medium plastic clay fill;

- Re-instating the ditch and valley wall grades and re-armouring the valley wall (e.g. rip rap) to match previous conditions. Consideration could be given to filling in low spots where water is ponding in the ditch;
- Installing erosion protection (ditch blocks, Turf reinforced mat or similar) within the ditch near the valley wall; and
- Seeding the ditch to promote vegetation growth.

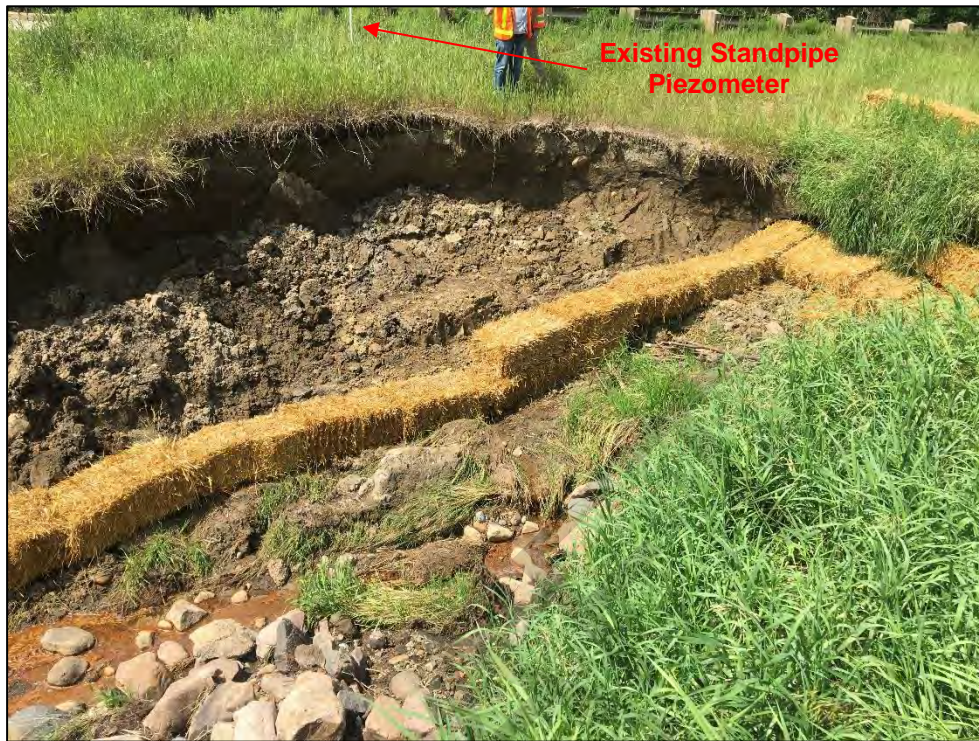
Photo 5: Upper section of eroded area, facing west.

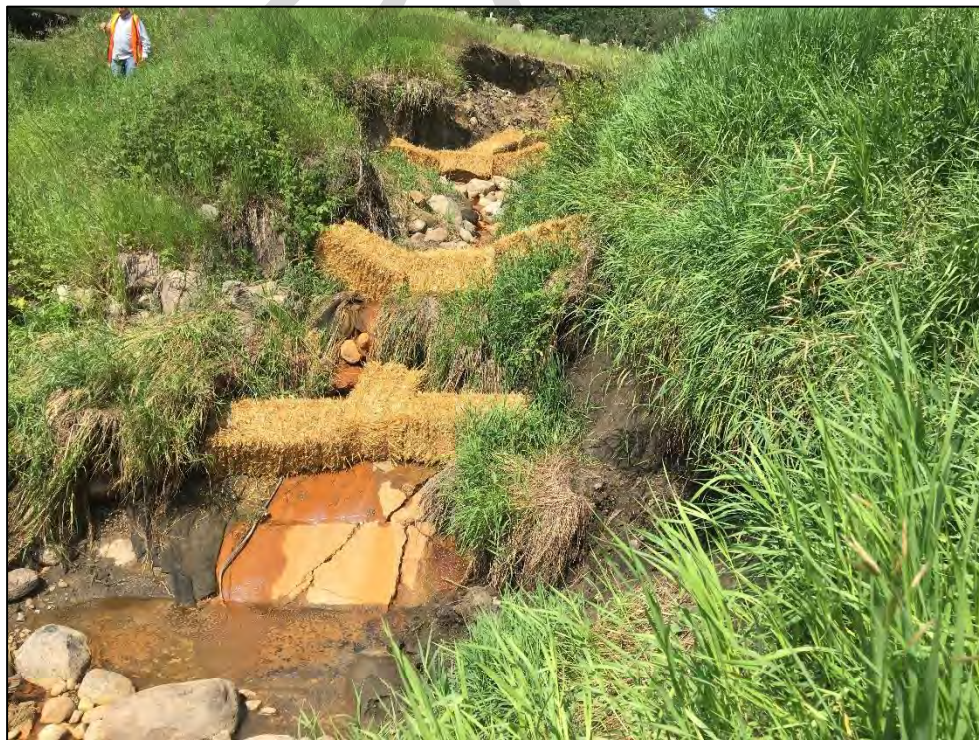
A concrete apron was observed at the toe of the erosion (**Photo 6**). The apron was cracked in several places and is believed to have been part of the erosion protection installed during bridge construction. An above-ground water pipe was located at the toe bank and had been undermined by the erosion (**Photo 8**). This pipe is likely used for irrigation at the North Bank Potato Farm. It is unknown if the pipe was buried or placed on the ground surface prior to the erosion taking place.

Photo 6: Upper section of eroded area, facing north.

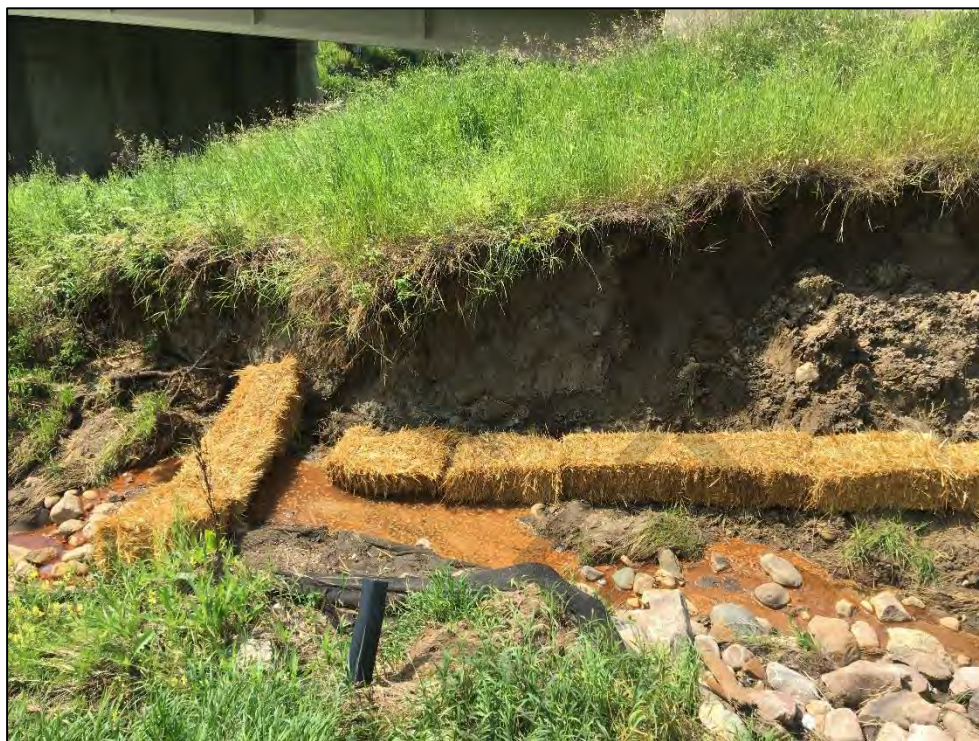
Groundwater seepage was not visually observed. However, surface water was observed at the bottom of the eroded area (**Photo 7**) that was slowly flowing towards the river. The maintenance contractor had placed several rows of hay bales within the eroded area.

Photo 7: Water at base of eroded area, facing west.

Consideration should be given to including subsurface drainage. A French drain should be sub-excavated along the longitudinal axis of the eroded area and filled with clean drainage rock wrapped in non-woven geotextile prior to backfilling. A perforated pipe should be installed within the drainage rock to carry groundwater flow towards the river. The French drain should daylight within the valley wall and riprap erosion protection should be placed at the outlet. The riprap that is existing on site could be salvaged and re-used for this purpose. The outlet should be placed at an elevation greater than the high-water level to avoid increasing the porewater pressure in the slope due to a rise in river level. The high-water level based on the as-constructed drawings was estimated to be approximately 3.5 m below the road grade at the north abutment. This may require the French drain to be partially or completely installed in the fill material depending on current elevations.

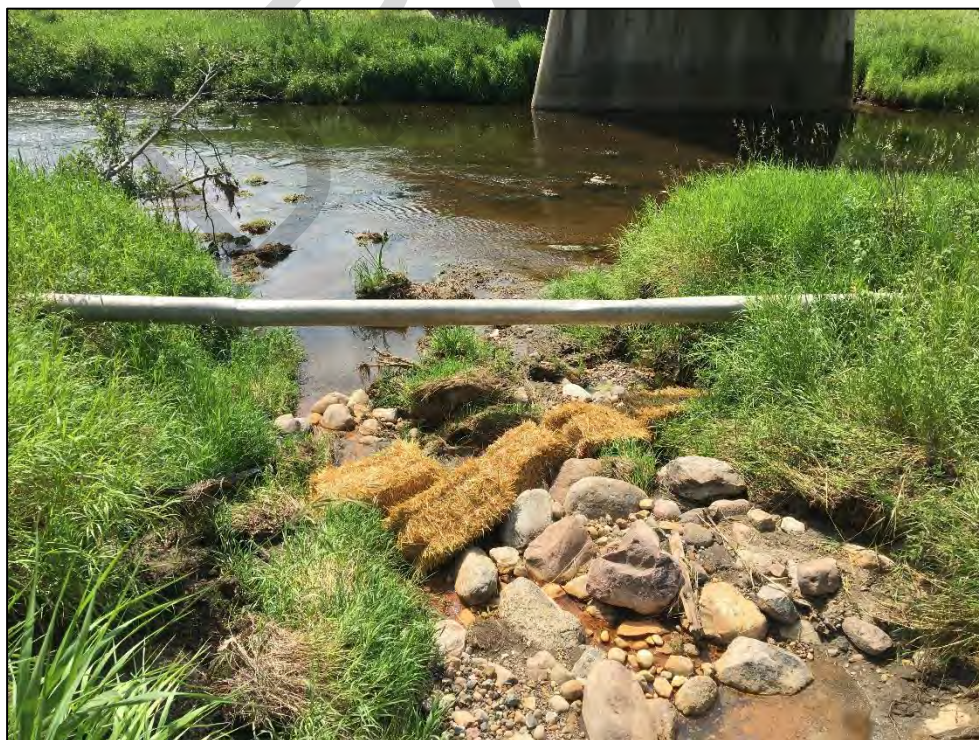
Photo 8: Undermined water pipe at lower section of eroded area, facing south.
