<b>SITE NUMBER AND NAME:</b> NC039 – South of Sturgeon River Crossing	<b>HIGHWAY AND KM:</b> 825:02, km 9.1	<b>PREVIOUS INSPECTION:</b> May 21, 2020	<b>CURRENT INSPECTION:</b> June 1, 2023
<b>LEGAL DESCRIPTION:</b> NW 28-55-22-W4M	<b>NAD83 COORDINATES:</b> UTM12U 5962150N, 353532E		<b>RISK ASSESSMENT:</b> PF: 3 CF: 4 Total: 12
<b>AVERAGE ANNUAL DAILY TRAFFIC (AADT):</b> 3,860 (2022)		<b>CONTRACTOR MAINTENANCE AREA (CMA):</b> 510

2023 Site Inspection Photos at NC039

**Client/Project**  
 Transportation and Economic Corridors  
 Geohazard Monitoring Program  
 NC39 - Hwy 825 at Sturgeon River

**Title**  
 Site Plan

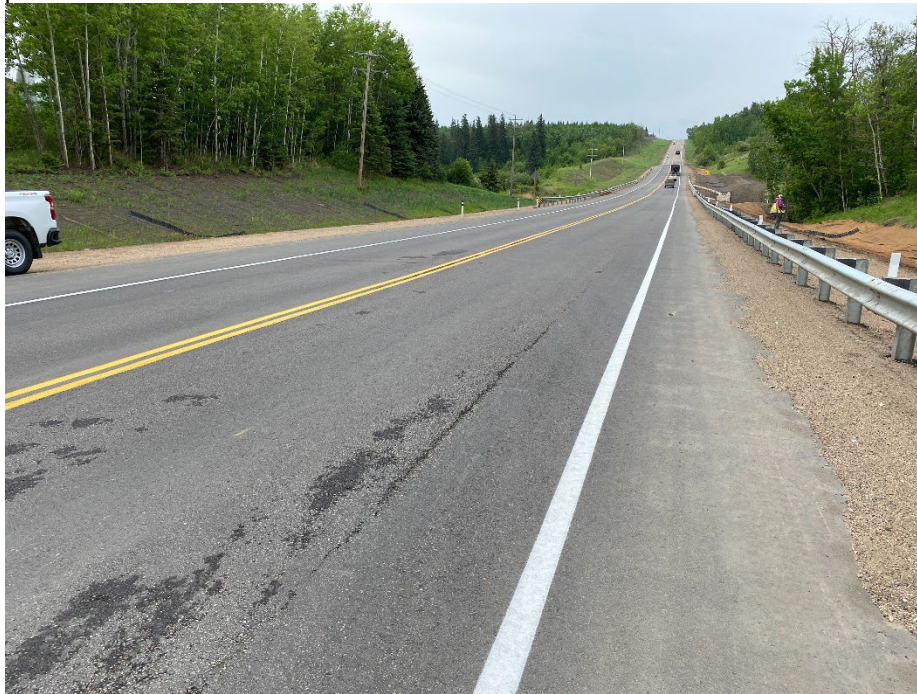
**Photo 1:** Highway 825, looking south.

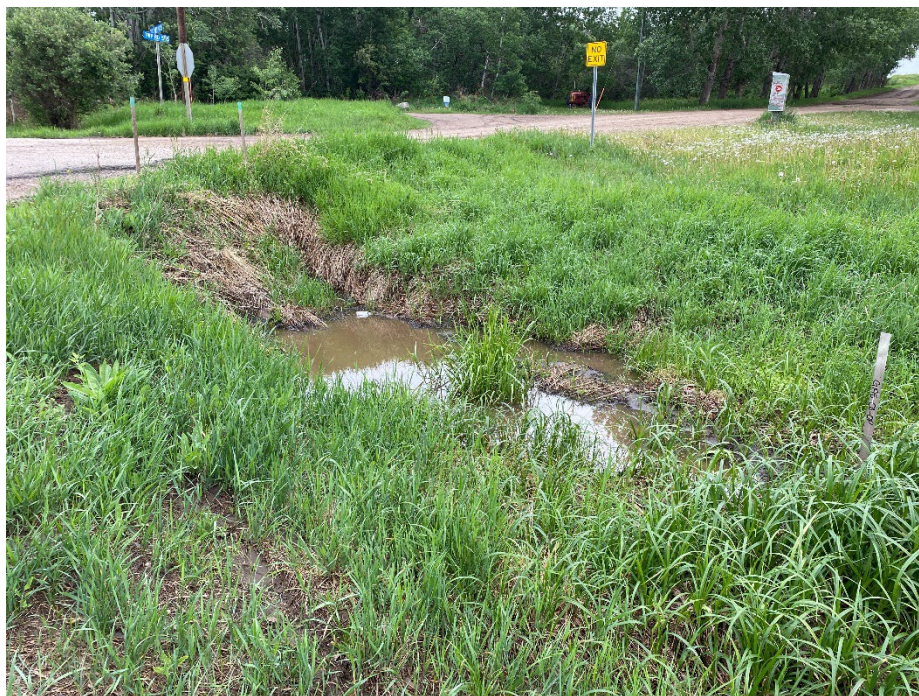
**Photo 2:** Ponded water in east ditch by culvert outlets. Looking northeast.

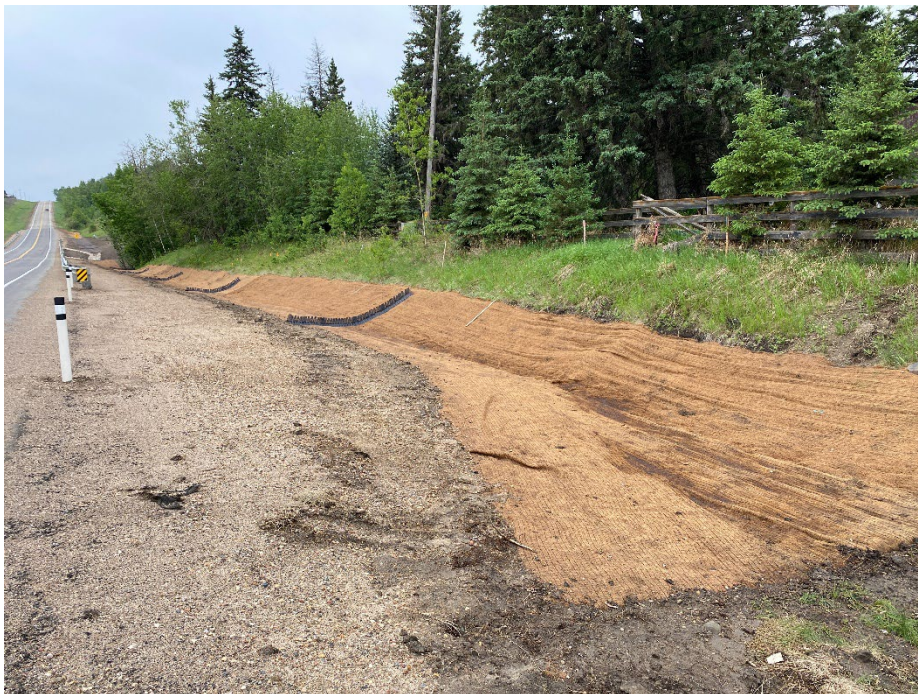
- The west ditch was observed to be mostly dry with some moisture near the north extent of the remediation. There was no vegetation within the ditch (Photo 4).

**Photo 4:** Erosion control blankets and georidges in west ditch. No vegetation observed in the ditch. Looking southwest.

- The site should be monitored regularly by the MCI for retrogression of the scarp towards the roadway and bridge structure.
- The contractor should be asked to return to the site and re-seed the west ditch as no vegetation had sprouted at the time of the site visit.
- Any pavement cracks that may appear should be crack sealed to reduce infiltration of water into the highway structure.
- It's recommended that the site inspection frequency remain at every 2 years.

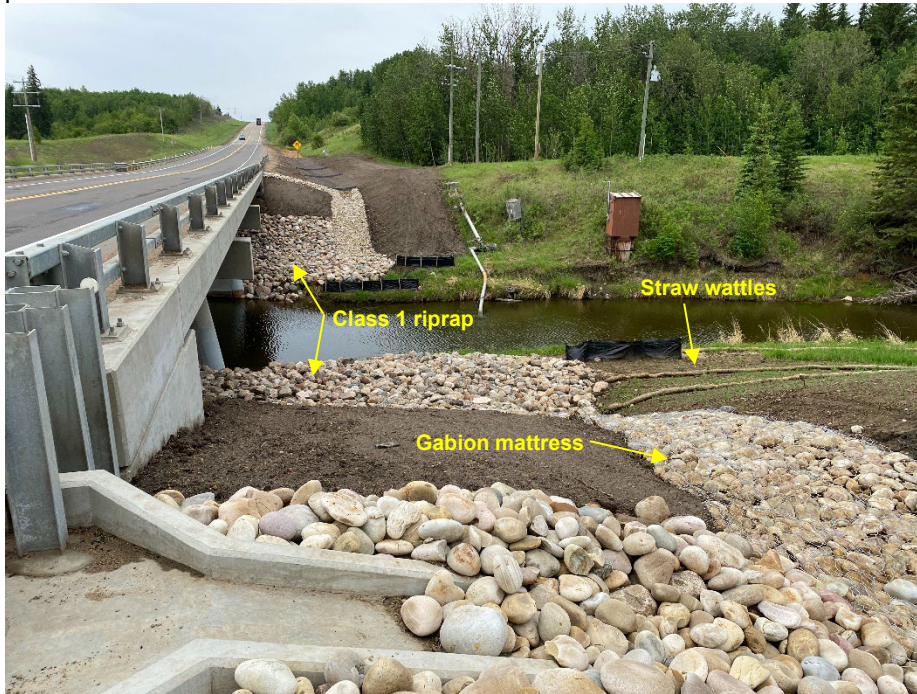
- Gabion mattresses were installed on the west side of the north bridge abutment (Photo 5).
- Three tiers of straw wattles (first tier at the edge of the river bank) have been placed southeast from the gabion mattresses installed in the slope (Photo 5).

- Tension cracking and soft soils were observed on the exposed slopes on the west and east sides of the gabion mattresses. Vegetation was just beginning to sprout on these slopes during the site visit (Photo 5).

- Class 1 riprap was installed approximately 0.45 m thick above non-woven geotextile on the headslope under the bridge, up to the west side of the failure on the north bank (Photo 5 and 6).

**Photo 5:** Remediation on west side of bridge, looking south.

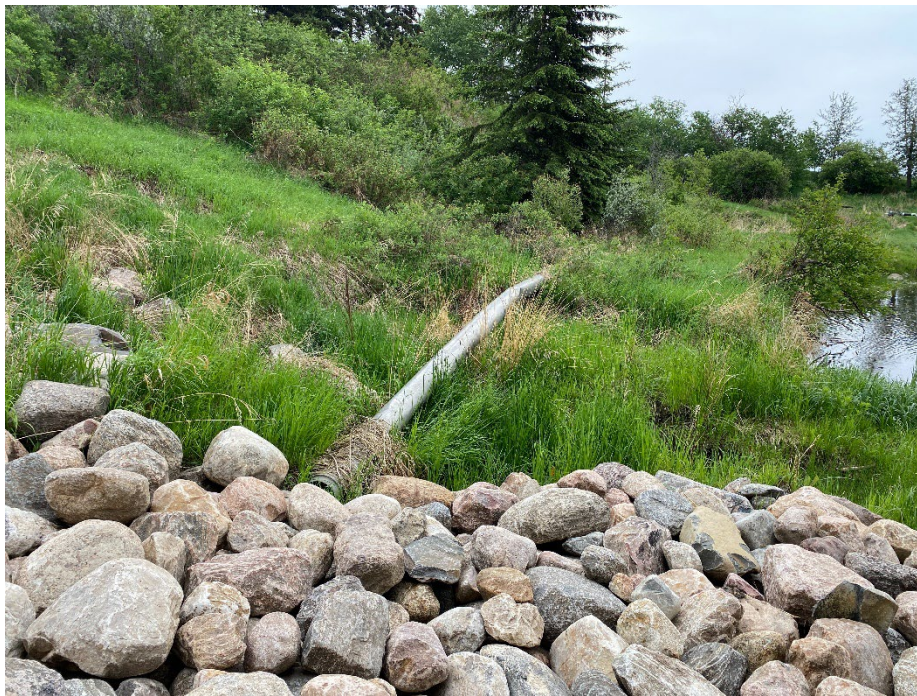
- The failure on the north bank appears to have been backfilled with Class 1 riprap and other material on the slope above the irrigation pipe. The backfilled area is largely vegetated with long grasses. At the irrigation pipe the slump remains approximately 6 m wide, and the material below the pipe on either side of the erosion channel has become well vegetated with long grasses (Photo 6 and 7).

**Photo 6:** North ditch at C/L culvert inlet. Looking southwest.

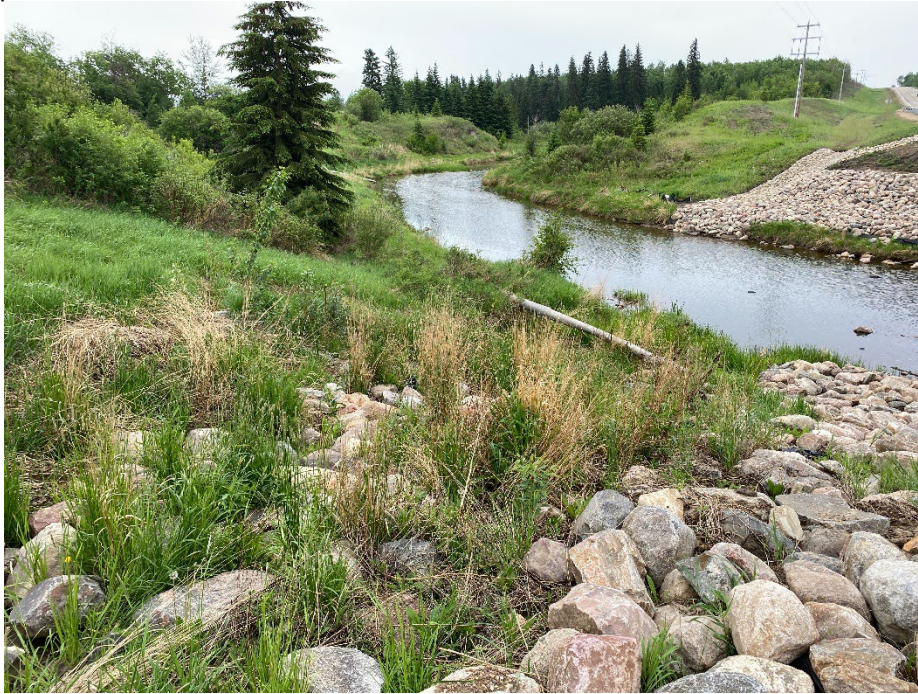
**Photo 7:** Failure on east side of north bank has been backfilled with riprap and finer soils. Well vegetated. Looking southeast.

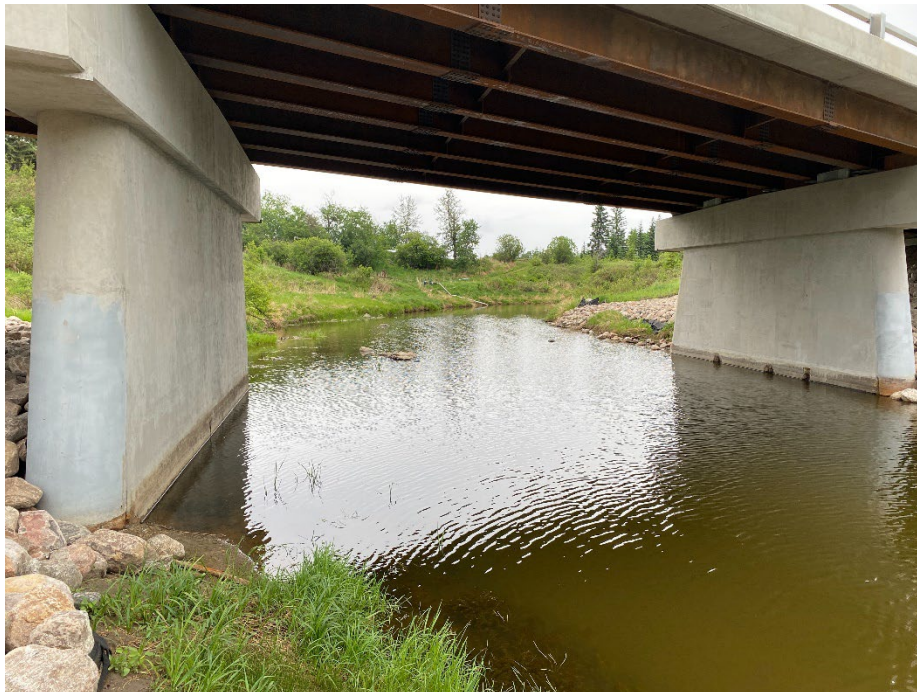
**Photo 8:** Condition of bridge structure after remediation activities. Looking southeast.
